Histographies of architecture: a first analysis of the changing roof landscape in rural Kenya

Pelle Rademakers
5203481
AR2A011 Architectural History Thesis
TU Delft 2021/2022
Supervisor D.C. Baciu

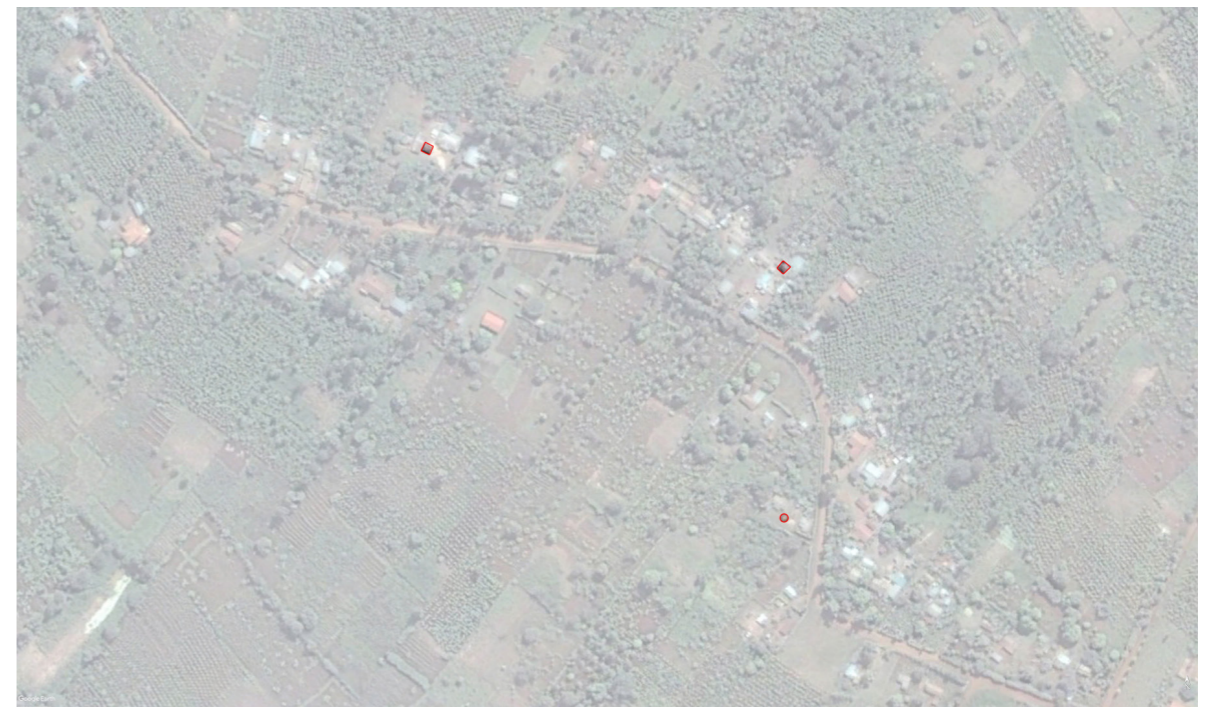
Figure 4. Nyaga satellite image June 2008 with possible thatched roof highlighted (Google, 2008), edited by the author.

The earliest readable satellite data is from 2008. As the reflection and colours suggest, all houses have metal roofs. The only possible thatched roofs are highlighted in the image; however, it is impossible to know for sure from the image alone.

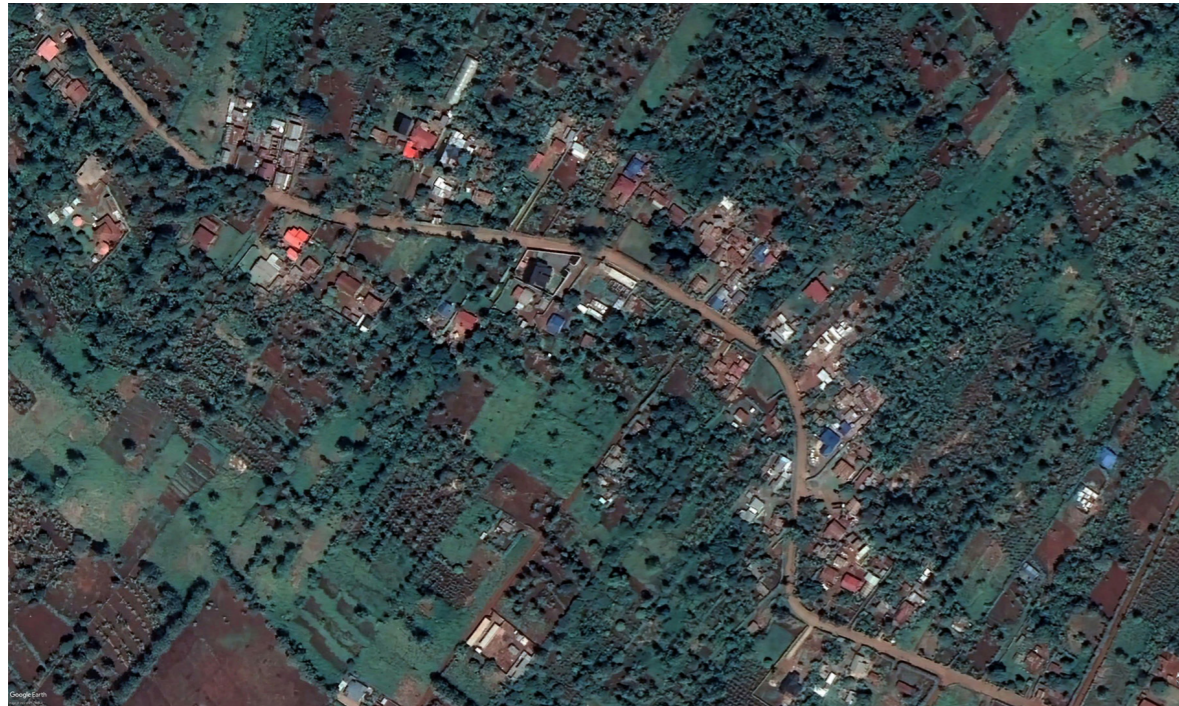
Figure 5. Nyaga satellite image November 2021 (Google, 2021).

The latest satellite data shows an expansion of houses in the area, but now all houses seem to have a metal roof. As almost half of the inhabitants could not afford iron sheets in 1978, the socio-economic factors have changed within the village.

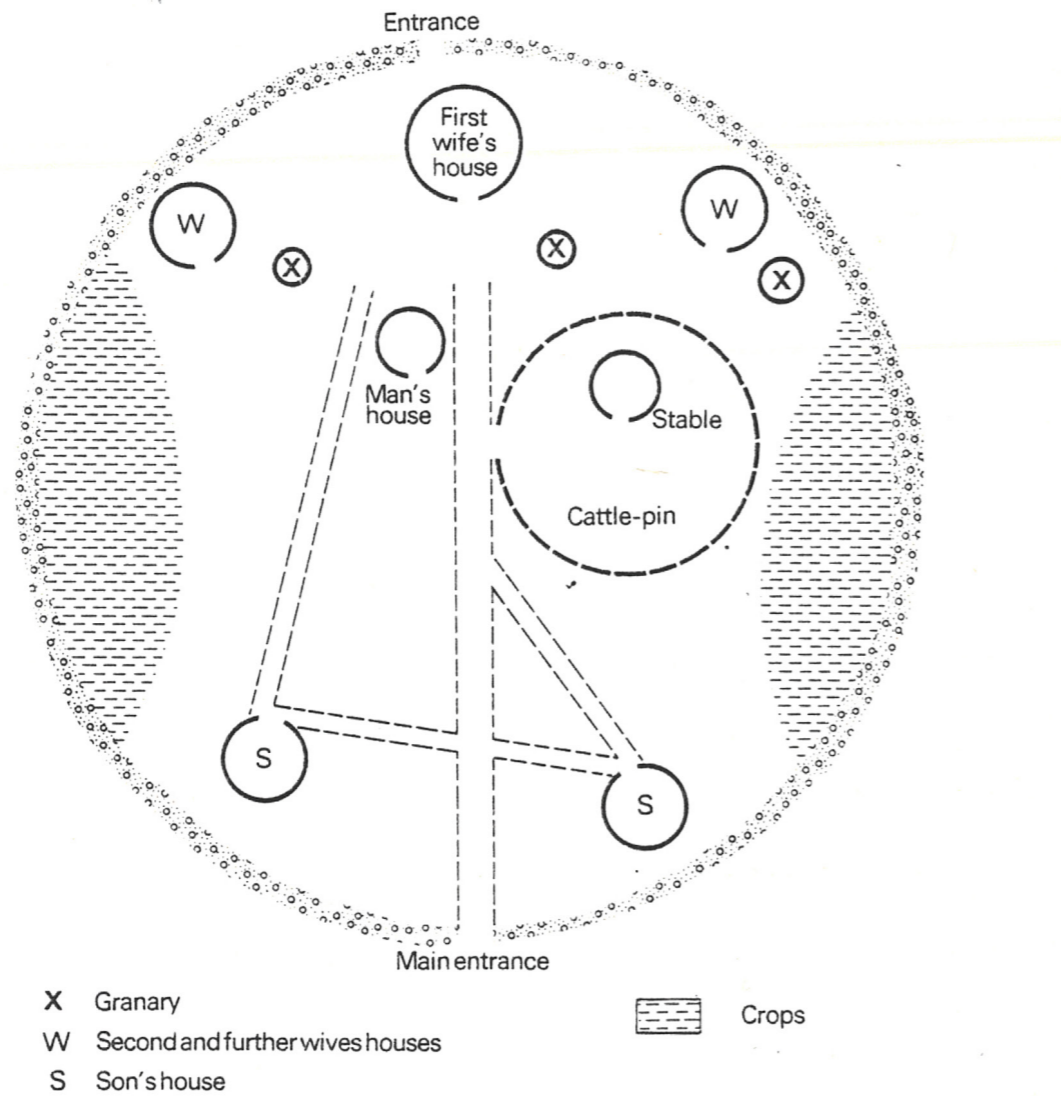
Figure 7. Floorplan of the traditional Leo homestead (Sterkenburg, Brandt, & van Beinum, 1982).

The Leo homestead generally consists of separate dwellings for the male head and his wife; however, most Leo have polygamous relationships; in that case, each wife has a separate dwelling in the homestead. Married sons and grown-up unmarried sons also have their unit in most cases. The roofing conditions of separate dwellings within this homestead differ heavily as the most expensive building materials are used for the main house (Sterkenburg, Brandt, & van Beinum, 1982).

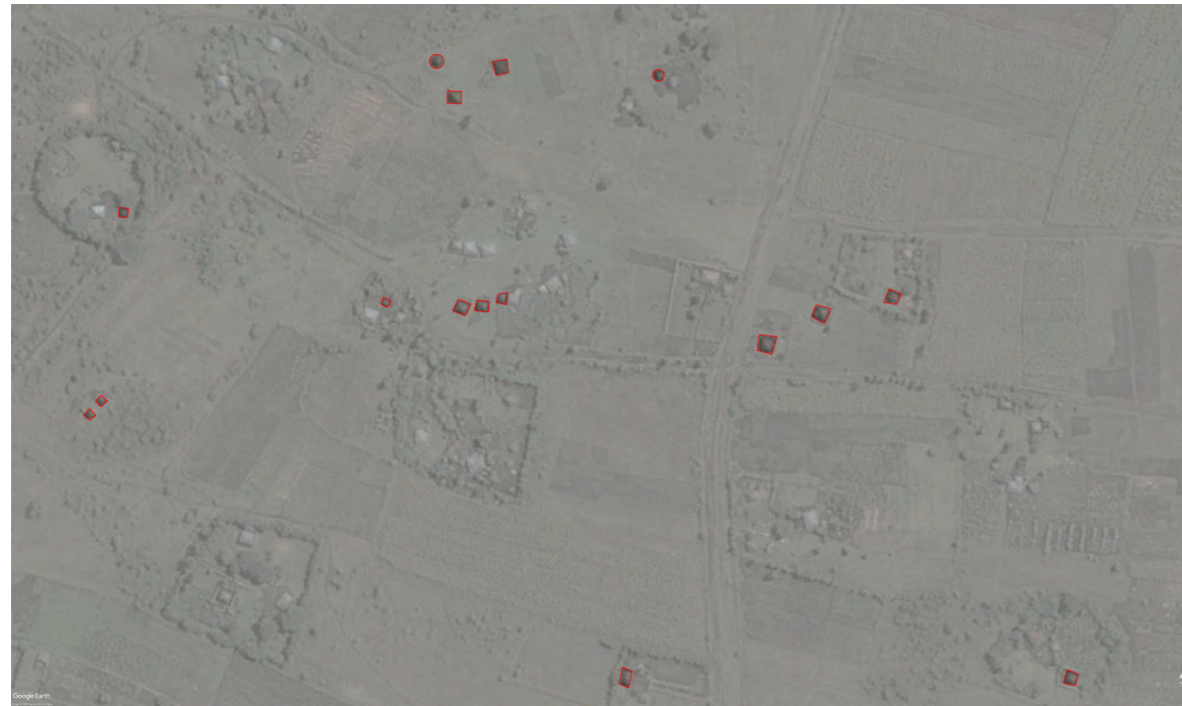
Figure 11. Kabar satellite imagery June 2004 with possible thatched roofs highlighted (Google, 2004), edited by the author.

The earliest readable satellite imagery was taken in 2004. The blue metal roofs are clearly visible in the image. However, after close inspection, there are still some possible thatched roofs in the area. The earth tone colours combined with soft corners and lack of reflection could suggest that there are still thatched roofs in the area. These possible thatched roofs are highlighted in Figure 11.

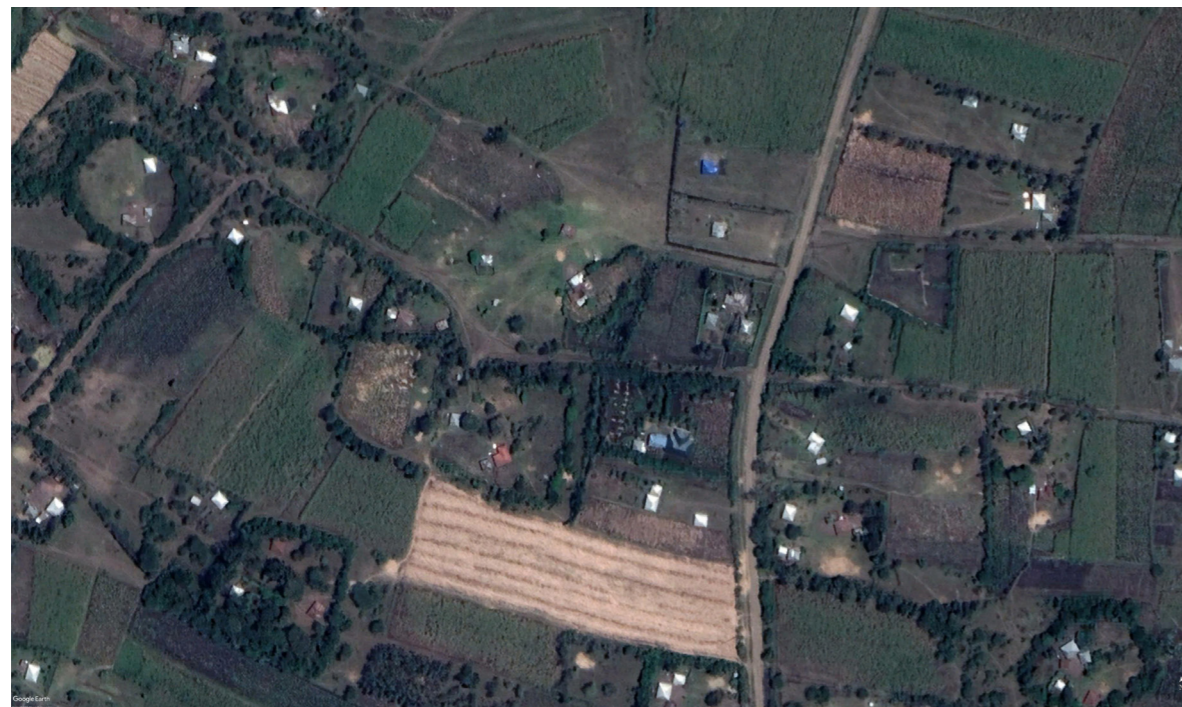
Figure 12. Kabar satellite imagery July 2021 (Google, 2021)

Figure 12 shows the most recent satellite imagery. The quality of the image is good enough to conclude that all houses now have metal roofs. Apart from that, all highlighted dwellings from figure 11 have disappeared, and the area has become more populated.

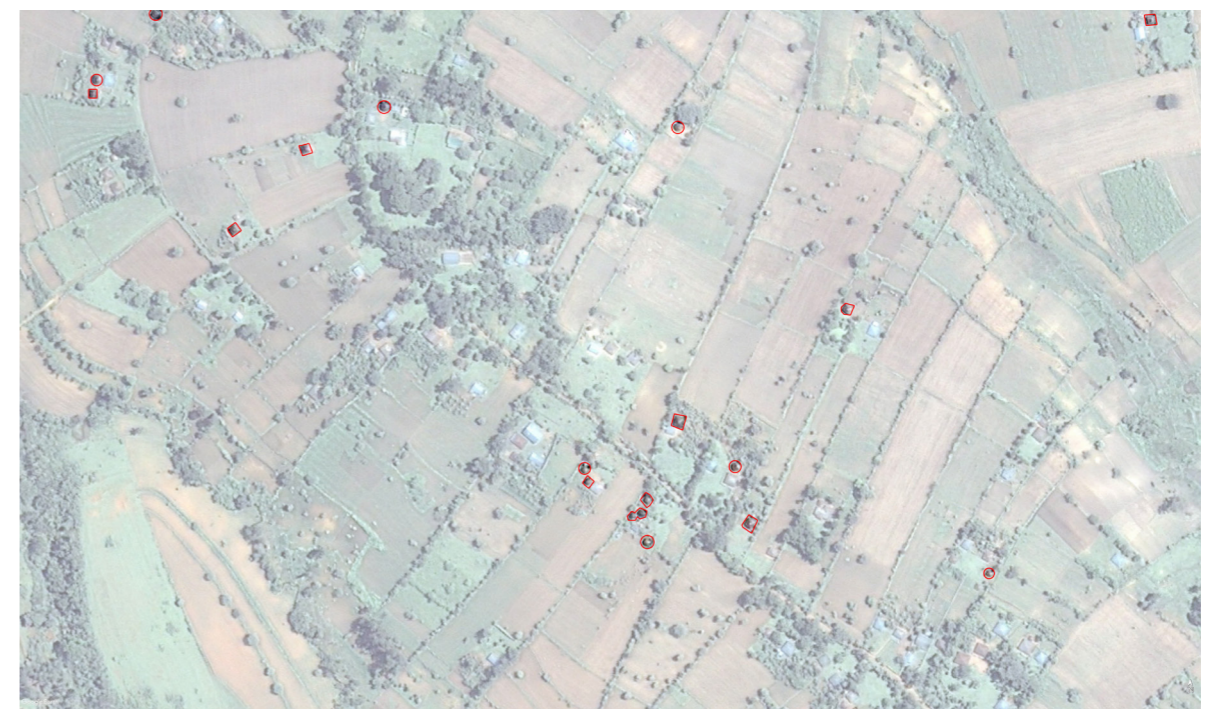
Figure 14. Shikulu satellite image April 2001 with possible thatched roofs highlighted (Google, 2001), edited by the author.

The first satellite imagery with enough resolution to see individual roofs dates back to 2001. The blue metal roofs are clearly visible, but there are still some round dwellings with thatched colour roofs. It is difficult to know for sure if the earth-tone square dwellings have thatched roofs or metal roofs, as there are also brown rusty metal roofs available. All possible thatched roofs are highlighted in figure 14.

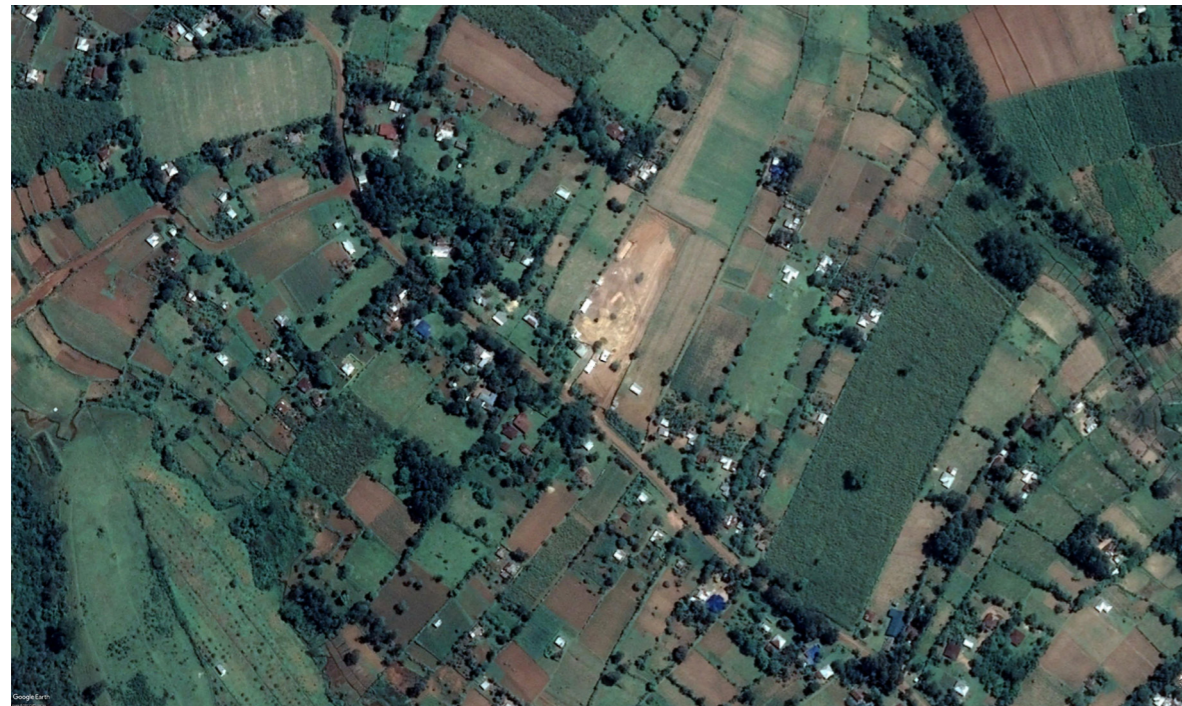
Figure 15. Shikulu satellite image October 2020 (Google, 2020)

Figure 15 shows the latest available satellite imagery of the area. The high-resolution image clearly shows that all dwellings have metal roofs. The dwellings with supposed metal roofs are also non-existent anymore as other buildings have replaced them.

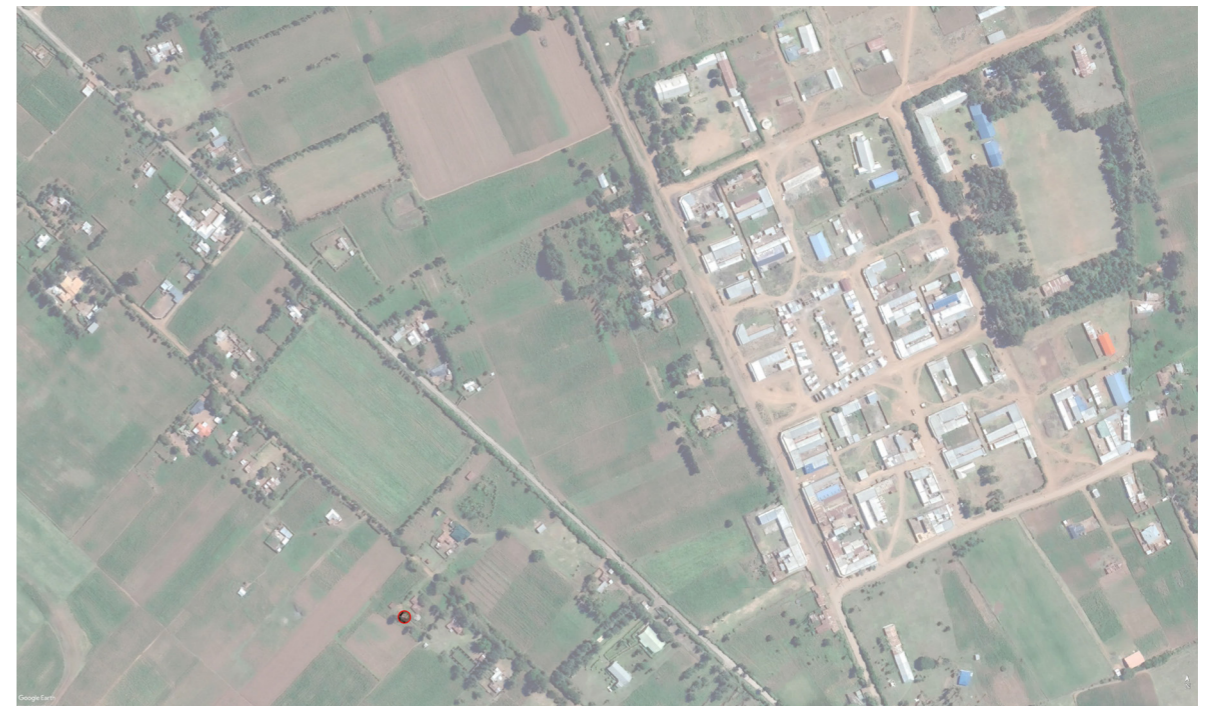
Figure 18. Piave satellite image June 2020 with possible thatched roof highlighted (Google, 2020), edited by the author.

The latest satellite imagery shows a significant increase in overall density. However, there is only one possible thatched roof among all dwellings, which means that Piave now also has metal roofs as the predominant roofing material like the rest of the surveyed villages.

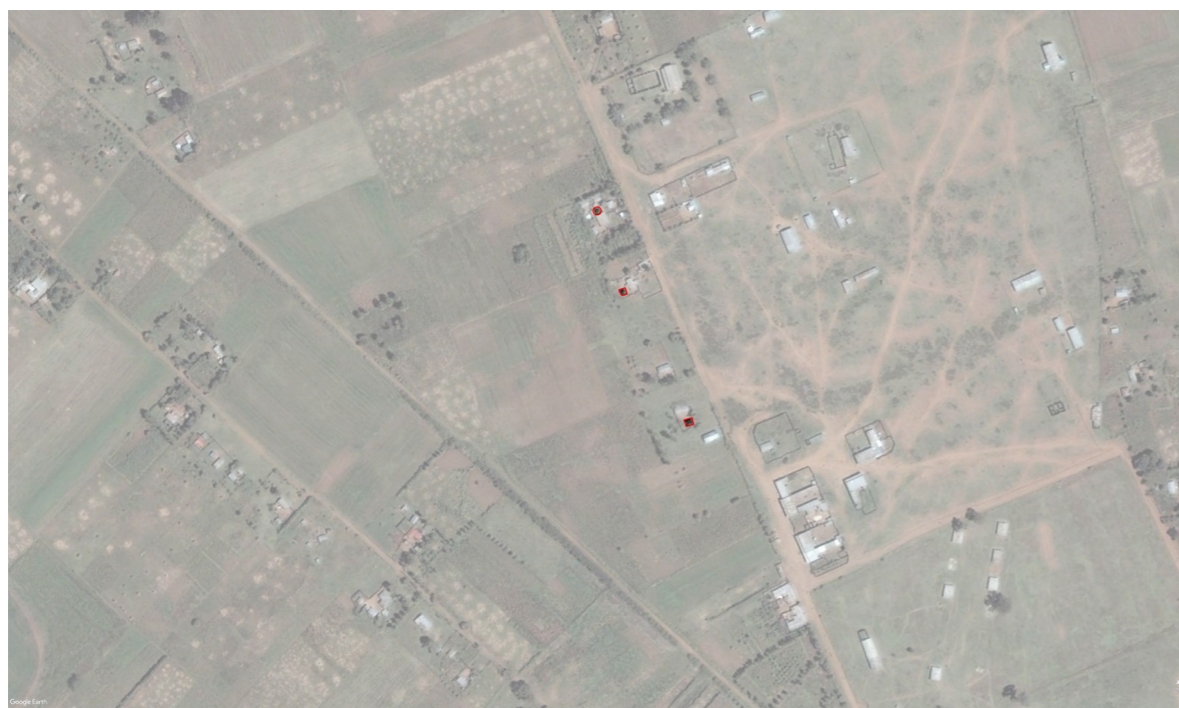
Figure 17. Piave satellite image May 2003 with possible thatched roofs highlighted (Google, 2003), edited by the author.

Satellite imagery from 2003 is sharp enough to see the individual roofs. Almost all roofs seem to be made of metal, as there are only three possible thatched roofs in the image.

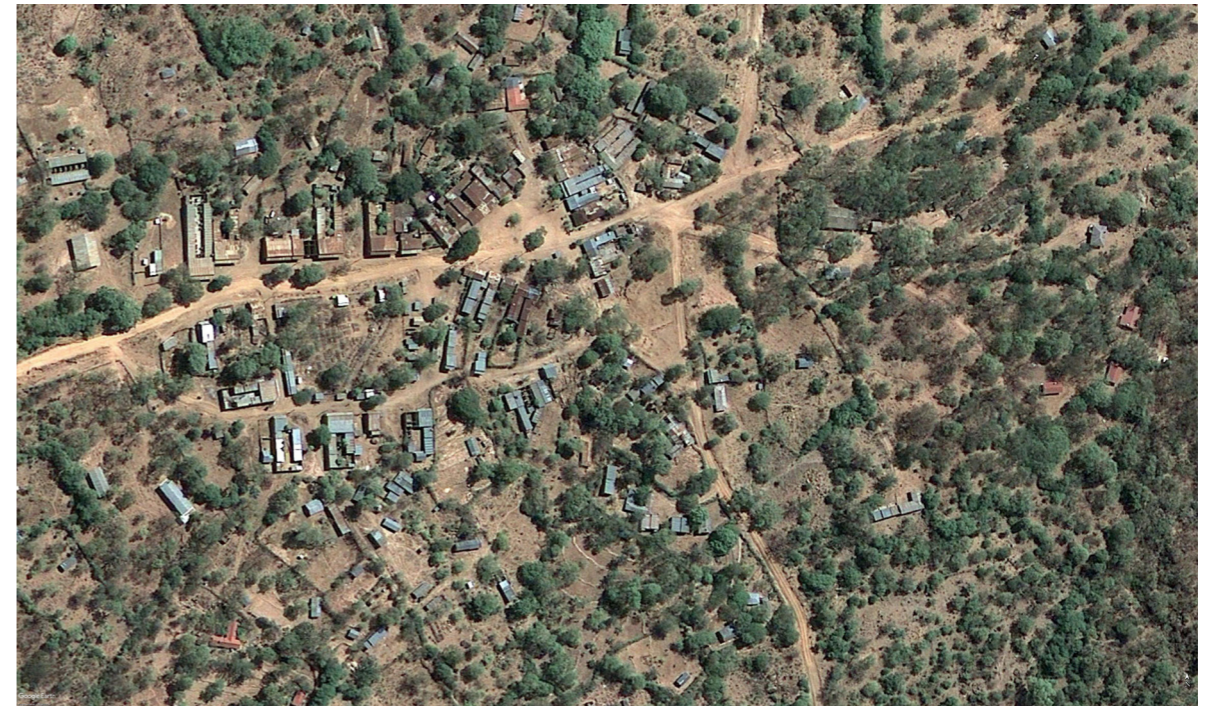
Figure 21. Chiakariga satellite image August 2009 (Google, 2009).

The satellite images from these three villages clearly show the use of corrugated iron roofs. No grass-thatched roofs can be distinguished in the areas. While this proves that the transition towards metal roofs has happened, it does not show the transition period. Therefore, it is not clear when precisely this phenomenon occurred. Interestingly, the villages have seen barely any growth in the past ten years as not much has changed.

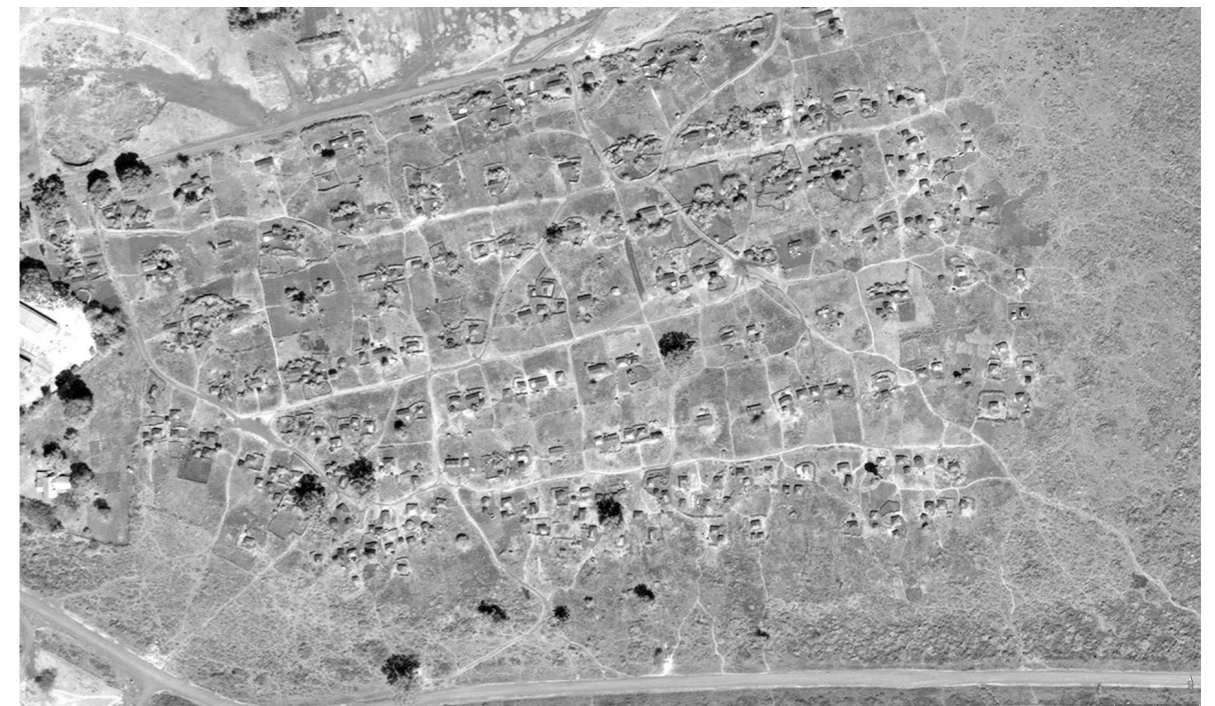
Figure 31. Japatta ADC Village satellite image February 2010 (Google, 2010).

The earliest satellite data with individual roofs comes from 2010, but it is very hard to identify thatched and metal roofs due to the black and white picture.

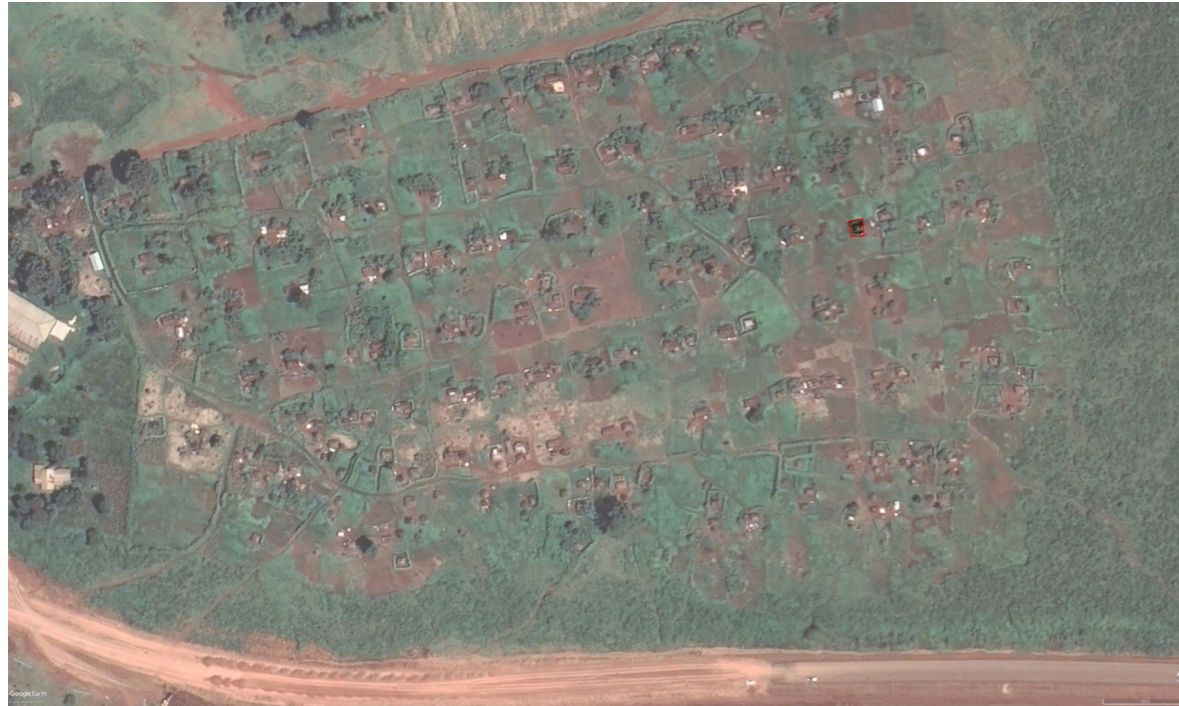
Figure 32. Japatta ADC Village satellite image October 2020 (Google, 2020).

The latest satellite imagery shows one possible thatched roof. While there could be more, the red coloured iron sheets make it very hard to distinguish the difference between metal and grass roofs.

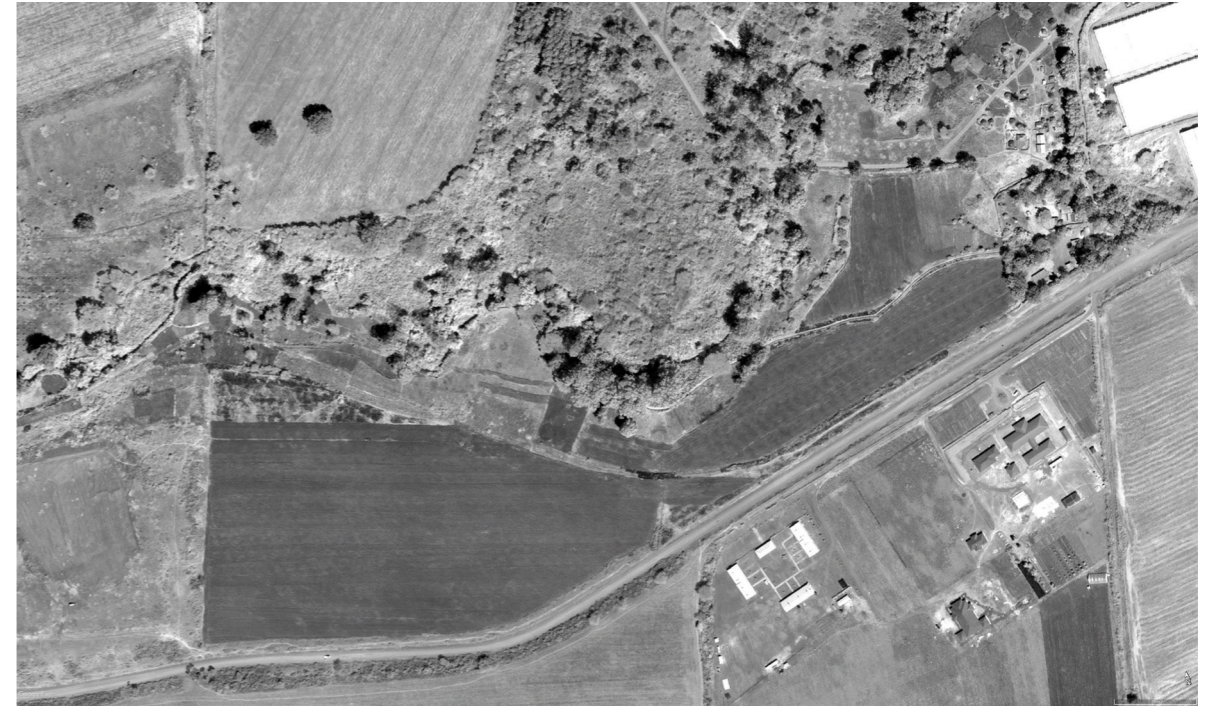
Figure 34. Habitat Village satellite image February 2010 (Google, 2010).

While the earliest readable satellite data comes from 2010, the Habitat Village got built later that year.

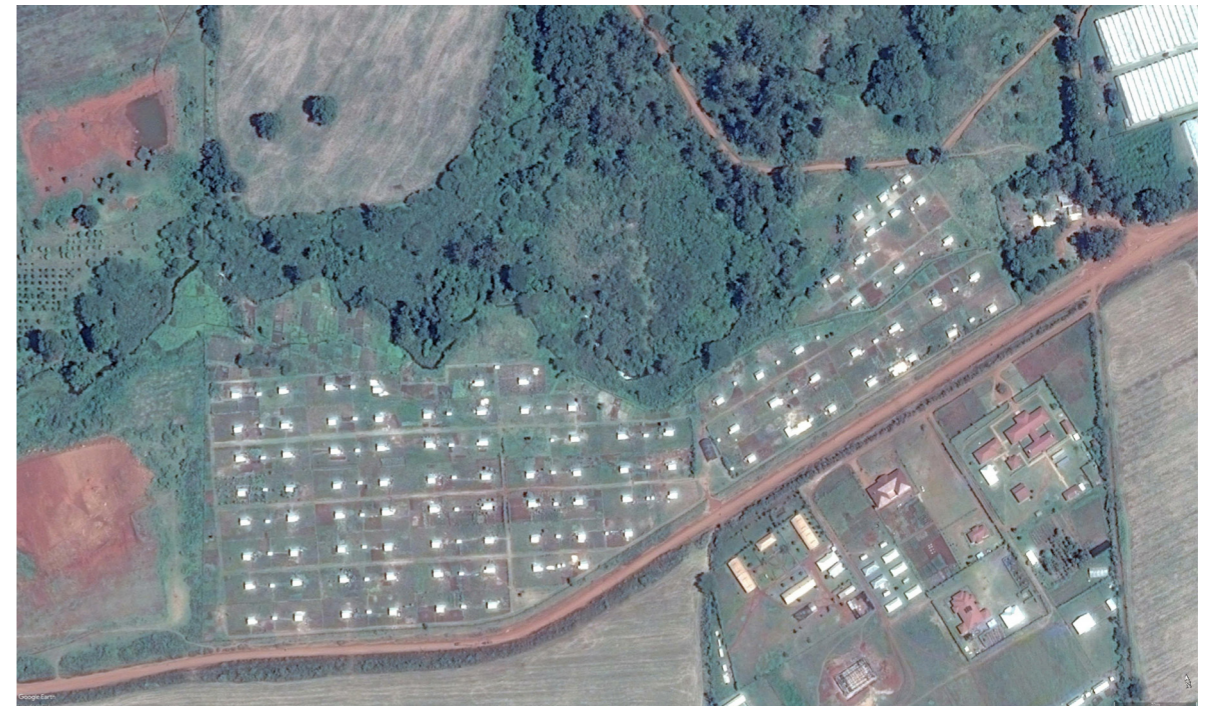
Figure 35. Habitat Village satellite image December 2013 (Google, 2013).

The following available satellite imagery shows the habitat village. The reflection of the roof clearly shows the iron sheets.

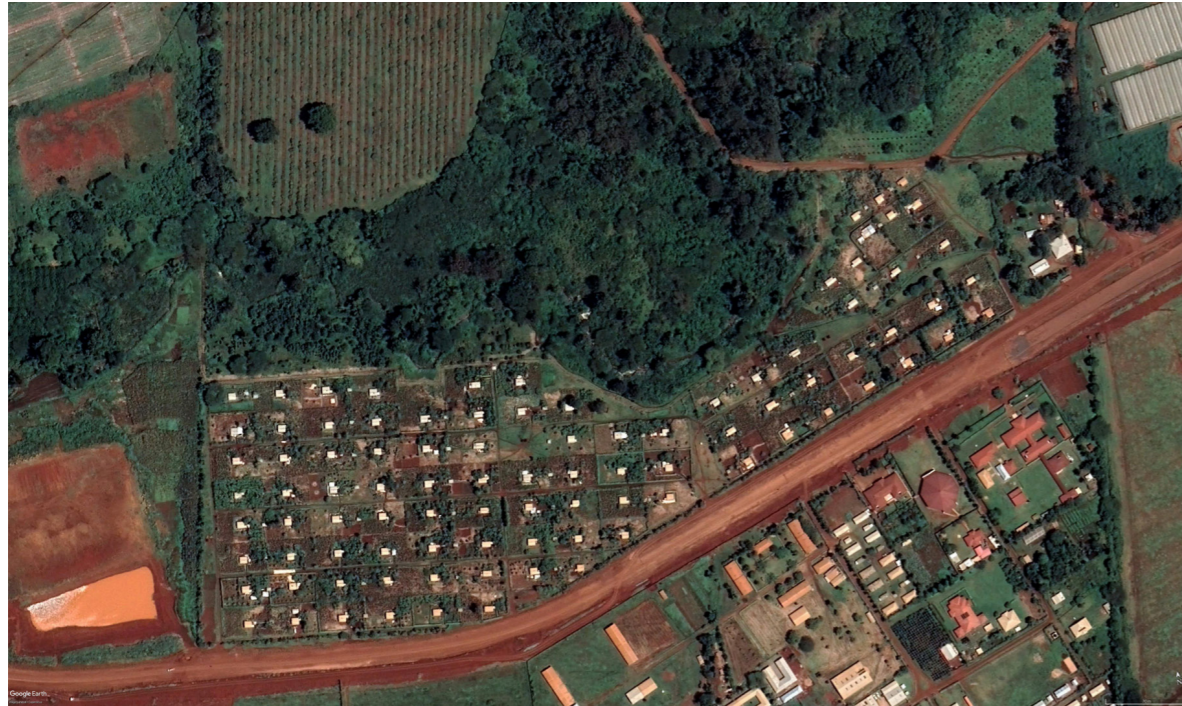
Figure 36. Habitat Village satellite image October 2020 (Google, 2020).

The latest satellite data show that nothing has happened to the roofing landscape after the initial construction phase.

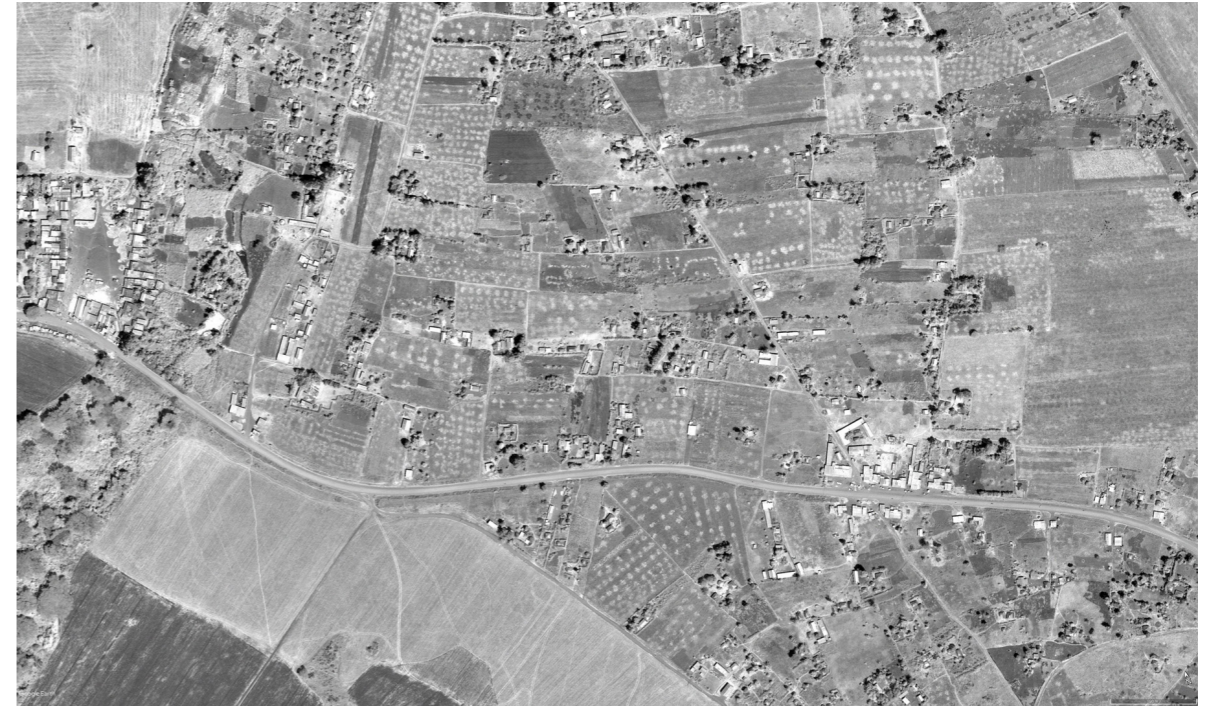
Figure 38. Chepchoina and Vamia satellite image February 2010 (Google, 2010).

The earliest visible satellite imagery shows Chepchoina and Vamia before a significant expansion happened. However, it is impossible to spot the grass-thatched roofs due to the image's colour.

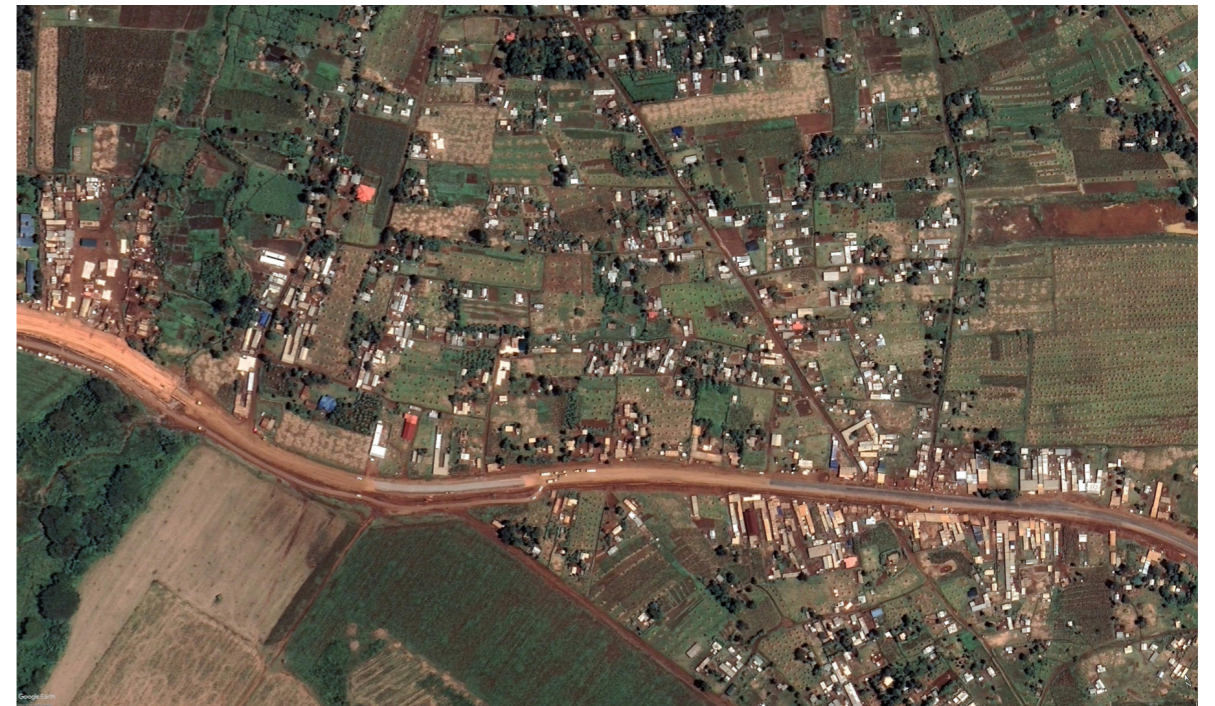
Figure 39. Chepchoina and Vamia satellite image October 2020 (Google, 2020).

The latest satellite data from Chepchoina and Vamia show a big increase in total dwellings. However, as the reflecting white roofs suggest, all roofs in the area seem to be metal roofs.
