# Investigation of the processes causing the degradation of the sandstone used on the Thorn church based on mineralogical analysis.

BSc. Thesis

Faculty of Civil Engineering and Geoscience, Delft University of Technology, Geo-Engineering

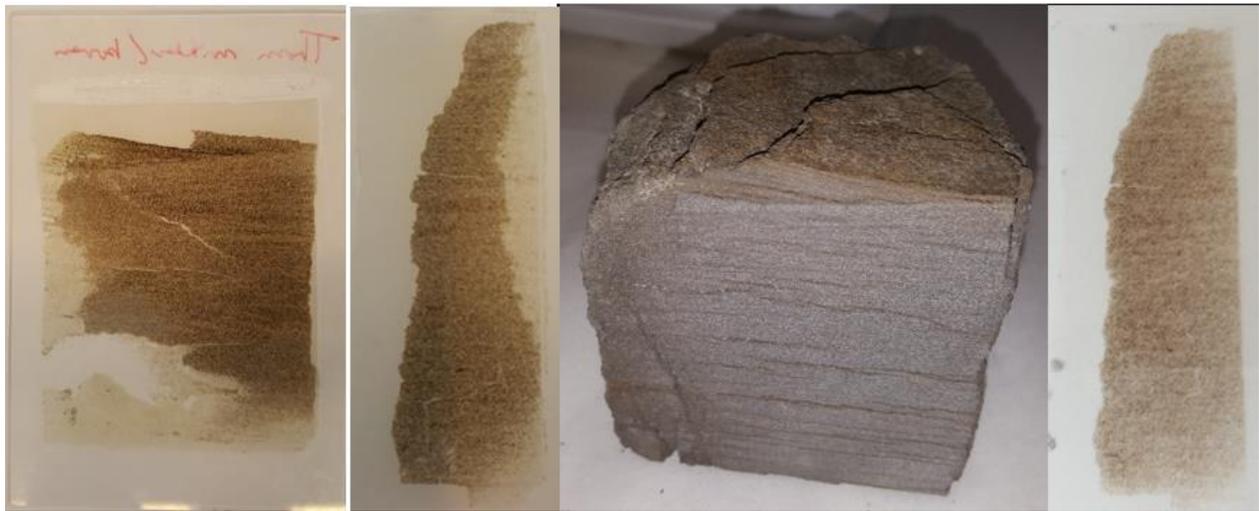
FIGURE 3: THREE THIN-SECTIONS AND CORRESPONDING ROCK SAMPLE.

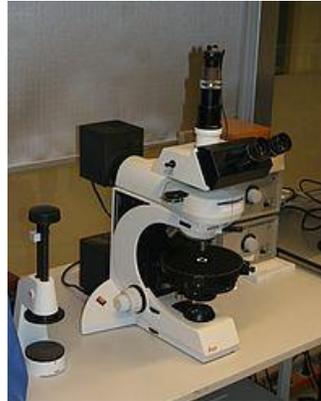
FIGURE 4: LEICA DM/LP POLARIZATION OPTICAL MICROSCOPE.

- Polarization Microscope, Leica DM/LP.
- Transmitted and Reflected light
- Digital microscope camera (Leica)

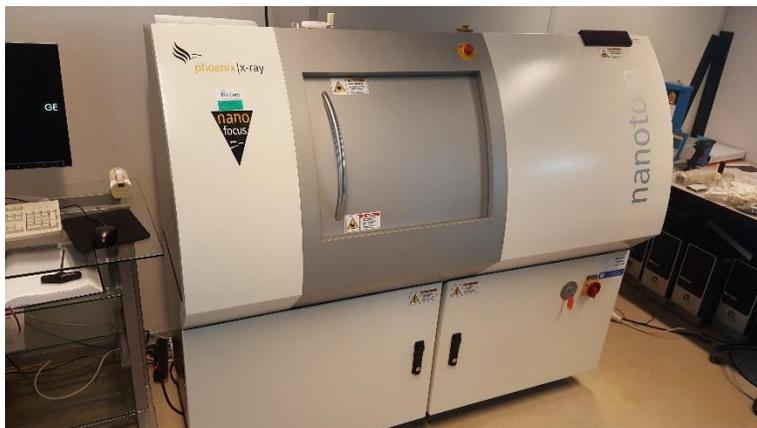
FIGURE 5: PHOENIX NANOTOM MICRO-CT SCANNER AT THE FACULTY OF GEOSCIENCE (TU DELFT).

X-ray micro-CT is used to obtain tomographic information. This information is given in the form of maps of the internal X-ray linear attenuation coefficient of a sample (Ikeda et al., 2000). For this procedure the Phoenix Nanotom

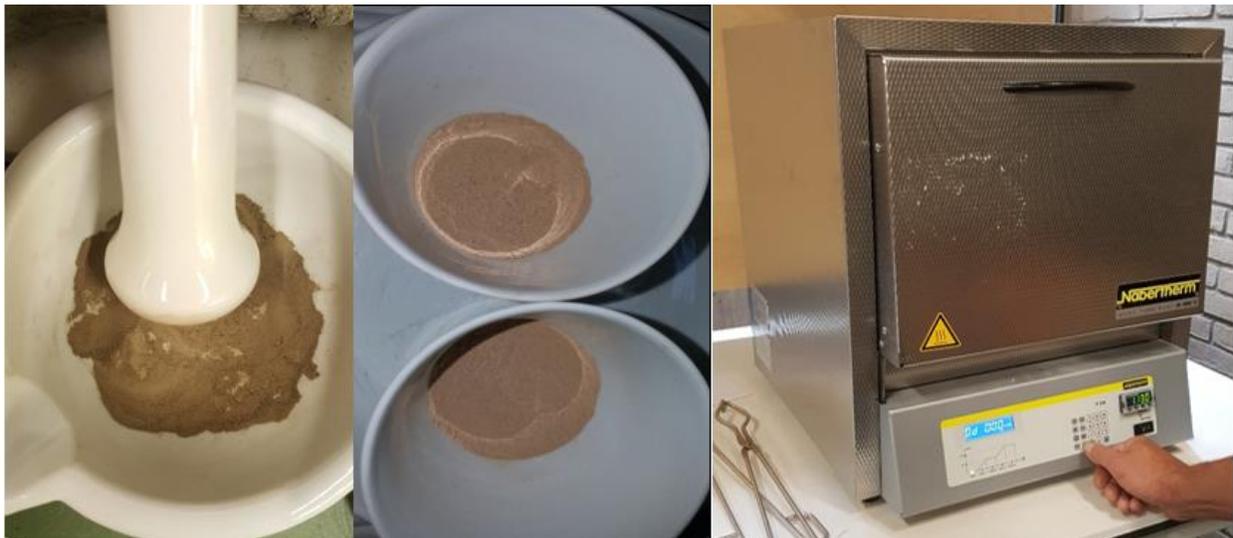
FIGURE 6: POWDERED ROCK SAMPLE (LEFT), TWO PORCELAIN DISHS WITH ROCK POWDER (CENTER) AND BURNING OVEN (RIGHT).

The two porcelain dishes with rock-powder content are put in the oven at 440 °C for four hours. After this, the dishes containing the burned soil are removed from the oven and then cooled off to room temperature. Finally the dishes with the burned soil content are weighed again.

The porcelain dishes are reheated from room temperature to 550 °C for four hours. After this the dishes containing the burned soil are removed from the oven and then cooled off to room temperature. Then again, the dishes with the burned soil content are weighed.

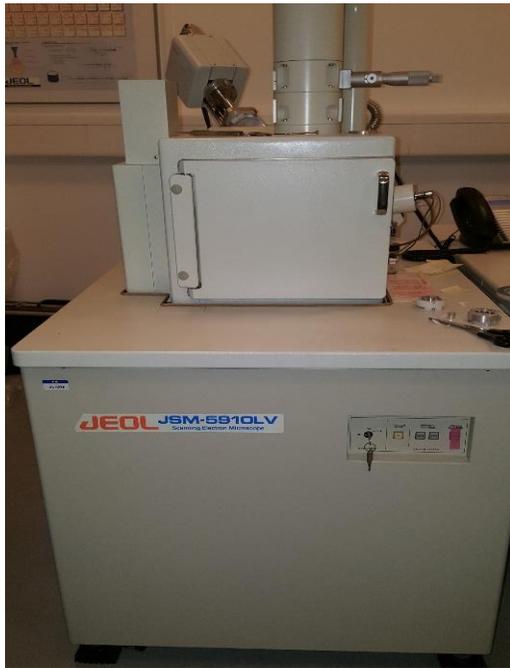
FIGURE 7: THE JEOL JSM-5910LV SCANNING ELECTRON MICROSCOPE.

When optical microscopy is not able to provide sufficient image resolution, high enough magnification or accurate enough information then SEM-analysis can be used (website: [3]). High-resolution and high-depth-of-field images of the rock-sample surface and near-surface can be obtained by using Scanning Electron Microscopy (SEM) (website: [3]). This is a widely used analytical tool because of the greatly detailed images it can provide in a fairly limited amount of time (website: [3]). The SEM can also provide elemental identification of nearly all elements of the periodic table when connected to an auxiliary Energy Dispersive X-ray Spectroscopy (EDX) (website: [3]).

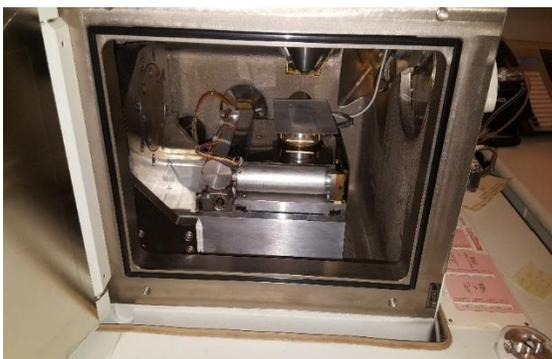
FIGURE 8: AN IMAGE OF THE SAMPLE CHAMBER WITH A THORN-SANDSTONE THIN-SECTION PLACED INSIDE.

Three thin-sections are used for SEM-analysis. The third polished thin-section is made by Jens van den Berg at the TU Delft. This thin-section is cut and then hand polished with silicium-carbide (Carborundum sic powder) of various sizes: on the first polishing table; grain “150”, the second polishing table; grain “500” and the third polishing table; grain “1000” (and possibly intermediate grain roughness). Afterwards the thin-

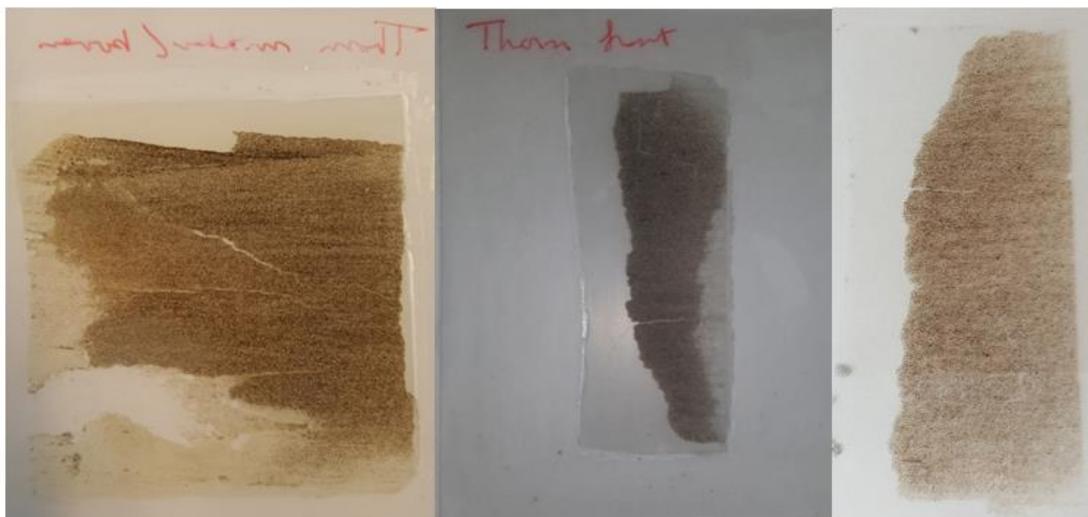
FIGURE 9: FROM LEFT TO RIGHT: THIN-SECTIONS 1, 2 AND 3. THESE THIN-SECTIONS WERE MADE FROM THE THORN-SANDSTONE BLOCK IN FIGURE 10.

The (quartz) grains are about 100 $\mu\text{m}$ . The grains on both sides of cracks, following the sedimentation layering, are coated with a unknown brown material. The more coarse grains are surrounded by a smaller amount of this material whereas the smaller grains are surrounded by more.

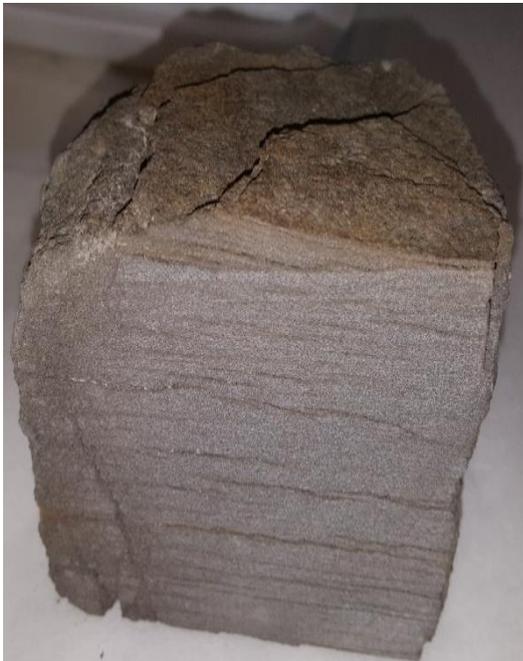
FIGURE 10: THIN-SECTIONS 1, 2 AND 3 CORRESPOND TO THIS SAMPLE.

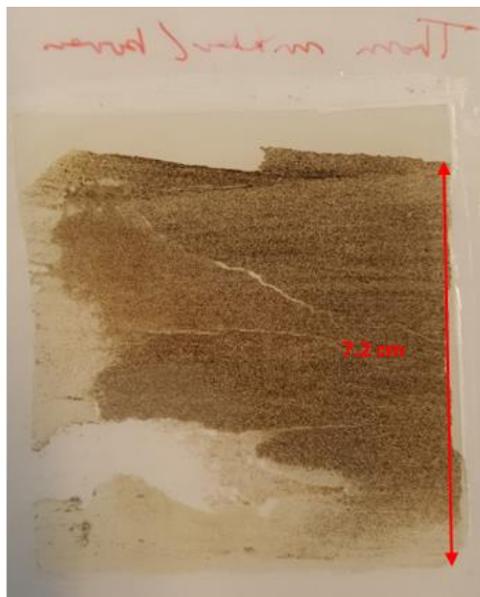
FIGURE 11: THIN-SECTION 1.

Thin-section 1 was cut perpendicular to the layering within a stone taken from the Thorn church. Only the top of the thin-section corresponds to an external surface of the stone. It can be seen that its structure is not parallel to the main layering.

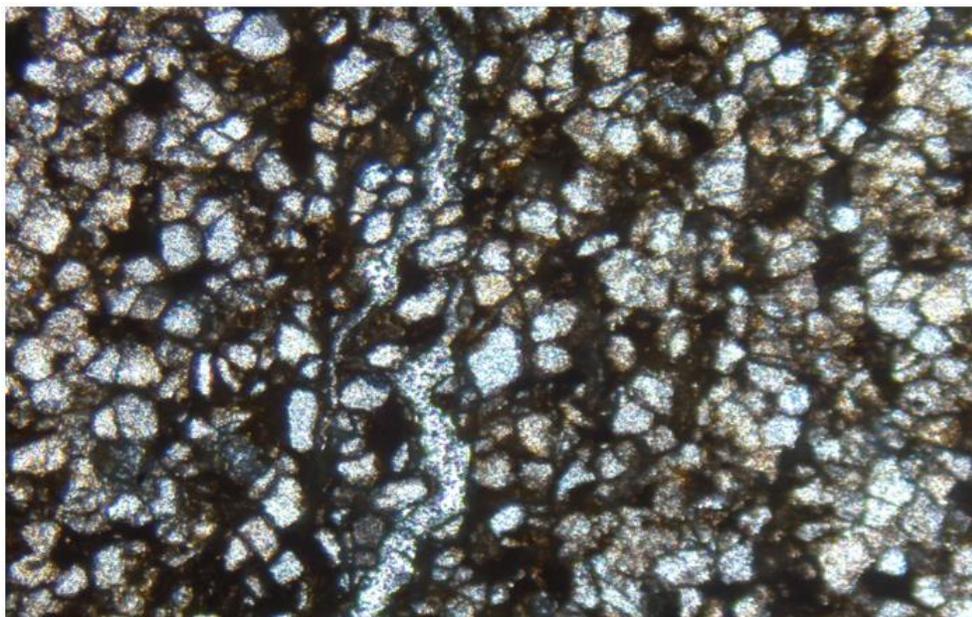
FIGURE 12: ZONES WITH SMALLER GRAINS, SURROUNDED BY BROWN MATERIAL, ARE WHERE CRACKS ARE FOUND.

The smaller cracks look to be in multiple directions whereas the larger cracks are either parallel or perpendicular to the sedimentation layering.

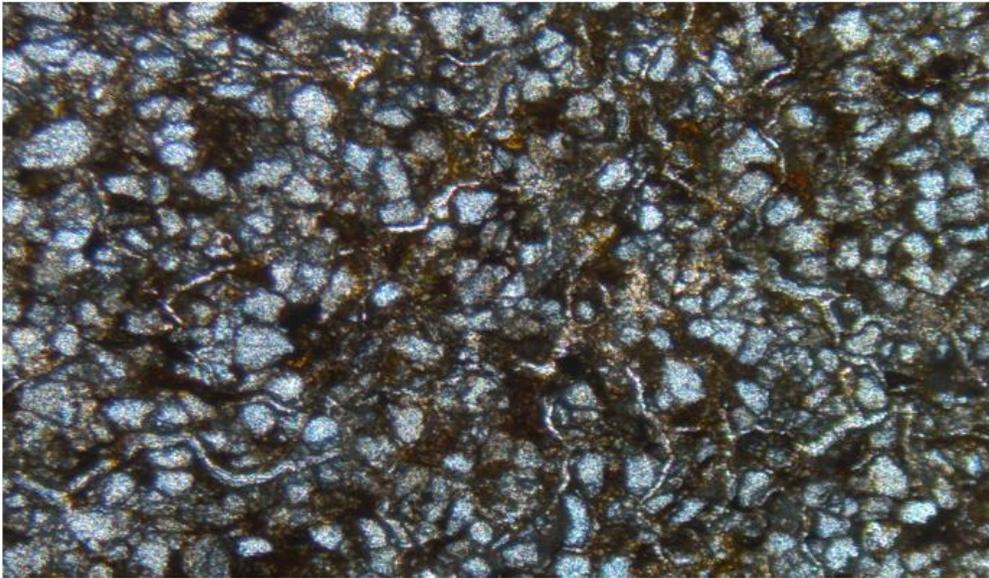
FIGURE 13: LARGE AMOUNT OF SMALL CRACKS IN MULTIPLE DIRECTIONS.

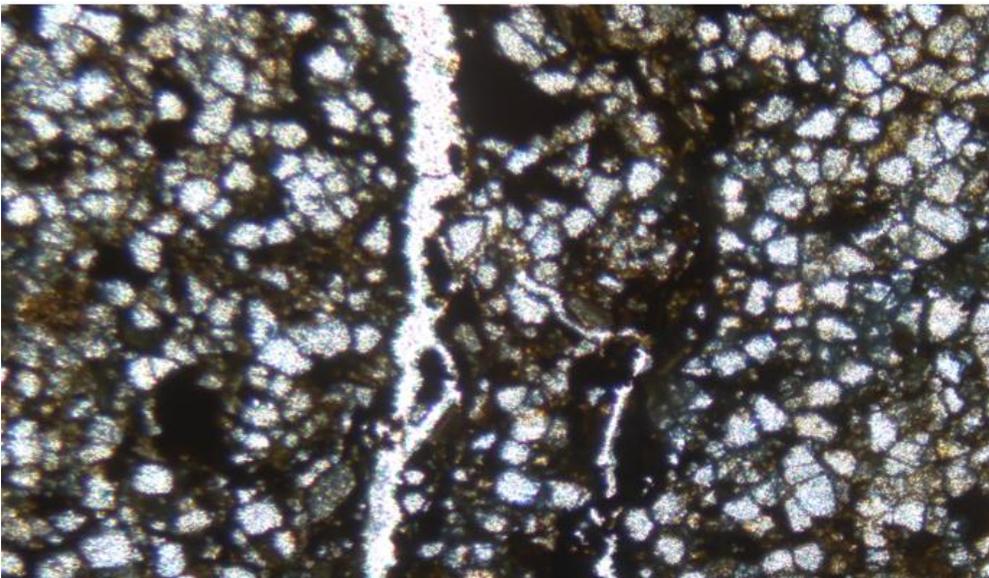
FIGURE 14: LARGE SINGULAR CRACK. THERE IS ALSO BROWN MATERIAL VISIBLE ALONG THE CRACK AND AROUND THE GRAINS.

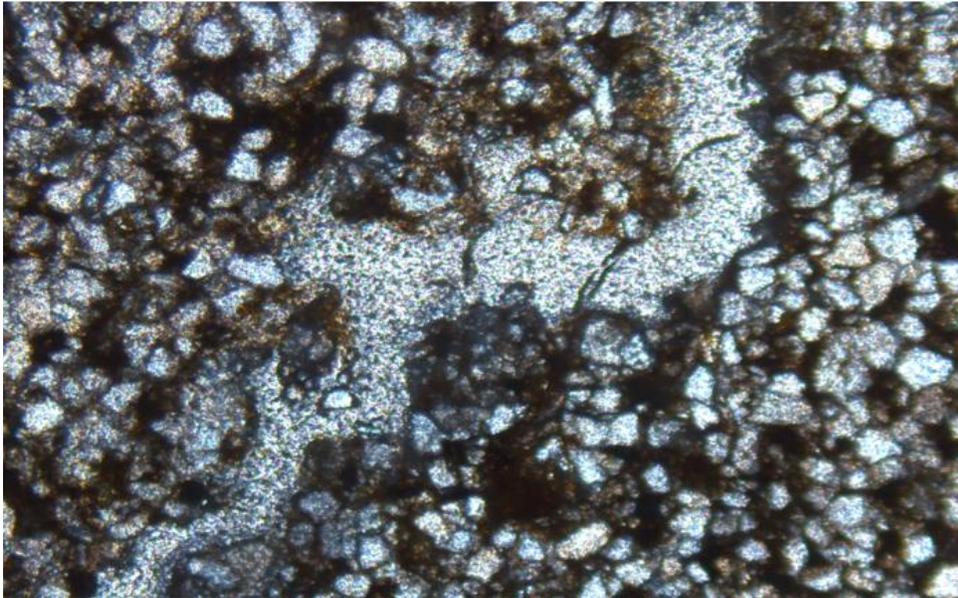
**FIGURE 15: BROAD STEP-INCLINED CRACK, DEVELOPED AT THE INTERFACE BETWEEN ZONES WITH DIFFERENT TEXTURES, WHICH FORCES ITS WAY THROUGH SEDIMENTATION LAYERS.**

Step-inclined cracks, which look to cross-cut the sedimentation layers, can also be seen in figure 15.

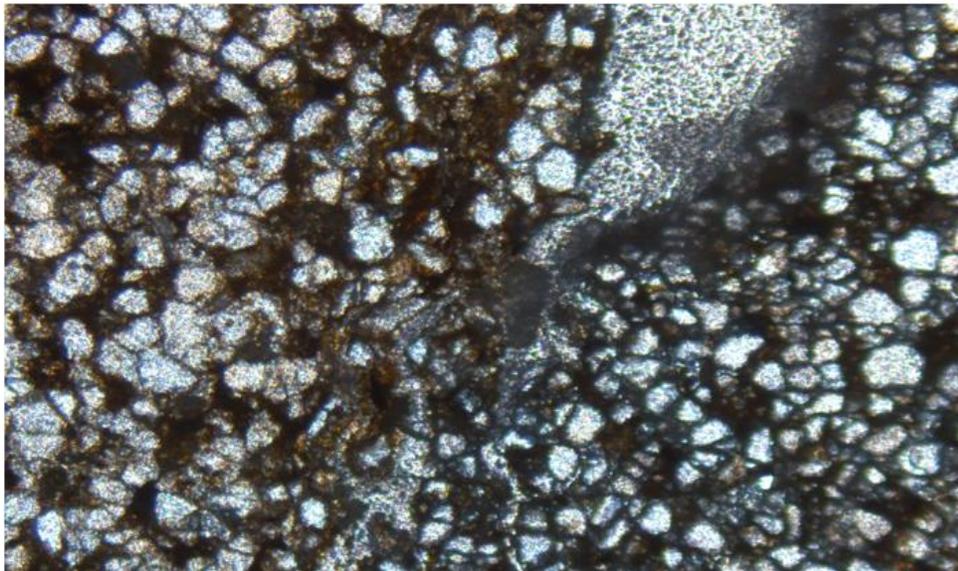
**FIGURE 16: COARSER GRAINS (LEFT SIDE OF THE IMAGE) AND LESS COARSE GRAINS (RIGHT SIDE OF THE IMAGE) ARE VISIBLE. CRACKING THEN OCCURS AT THE INTERFACE BETWEEN THESE TWO ZONES.**

Broad cracks look to have developed at the interface between sedimentation zones with different grain sizes. The cracks can then be seen to end at the cross bedding (see figure 16).

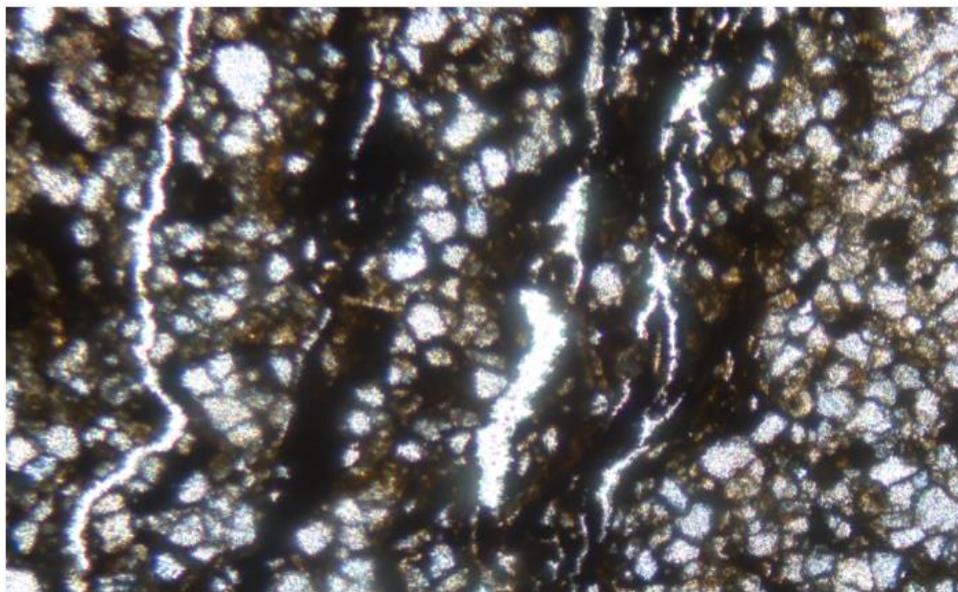
FIGURE 17: SUB-PARALLEL CRACKS VISIBLE. BROWN MATERIAL PRESENT ALONG THE CRACK AND AROUND THE GRAINS.

We also see thinner smaller cracks parallel to the sedimentation layering which converge to a larger crack. Further along the presence of more brown material, forming two bands parallel to one another, results to a bottom set of ripples in which cracks are formed (see figure 17).

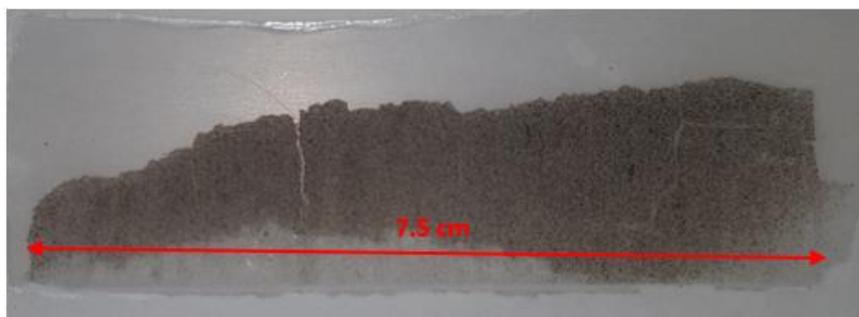
FIGURE 18: THIN-SECTION 2.

Thin-section 2 is cut perpendicular to the layering at the edge of the stone where weathering and cracking are most developed. Several types of cracks were observed. These can be categorized in a main crack parallel to sedimentation layering and many thin cracks connected to each other. The large crack with multiple linked micro-cracks, found near the sample edge, is parallel to the sedimentation and many other thinner cracks (see figure 19).

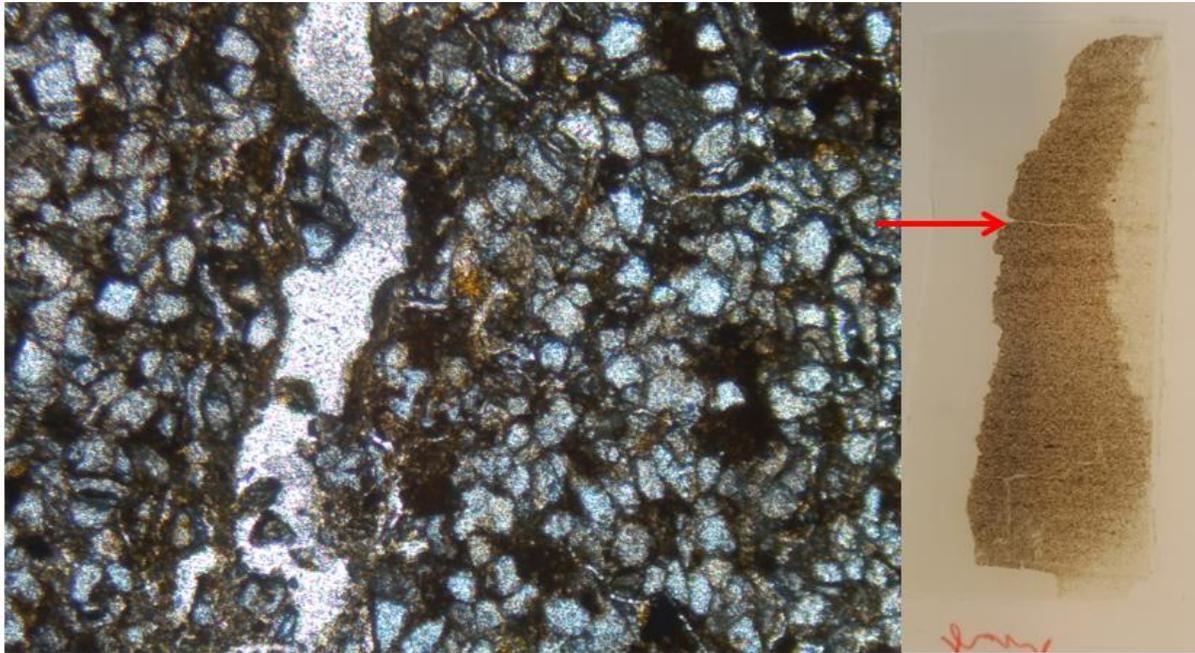
**FIGURE 19:** LARGE CRACK AT A MORE INWARD POSITION WITHIN THE THIN-SECTION (INDICATED BY THE RED ARROW) ALONG WITH MULTIPLE MICRO-CRACKS. BROWN MATERIAL ALONG THE CRACK ALSO VISIBLE.

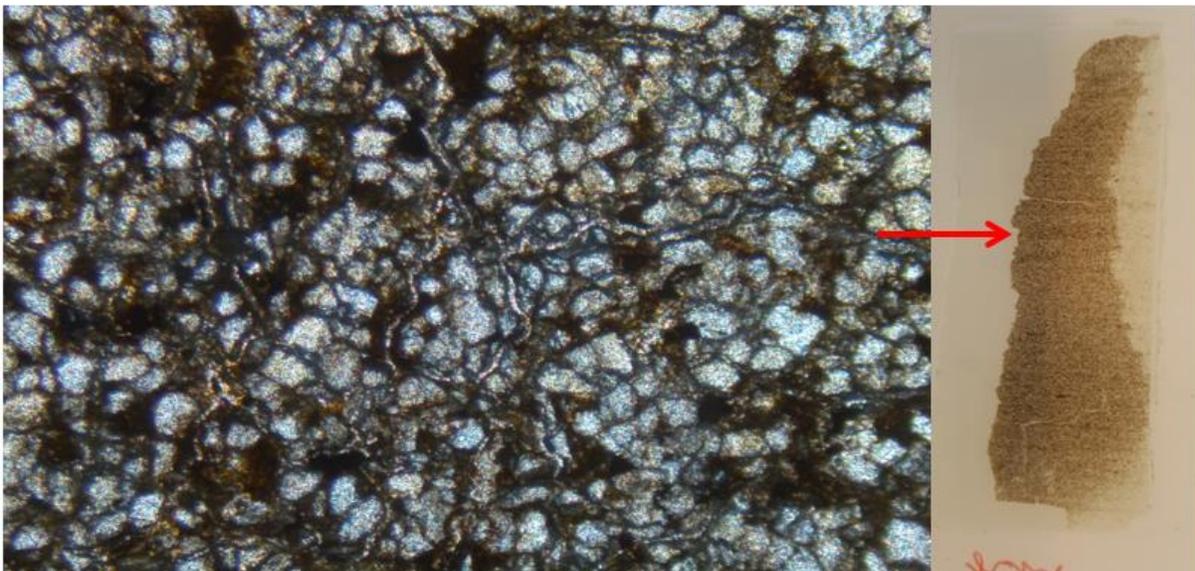
**FIGURE 20:** THE RED ARROW INDICATES THE FIRST VISIBLE BLACK BAND AND CORRESPONDING MICRO CRACKS.

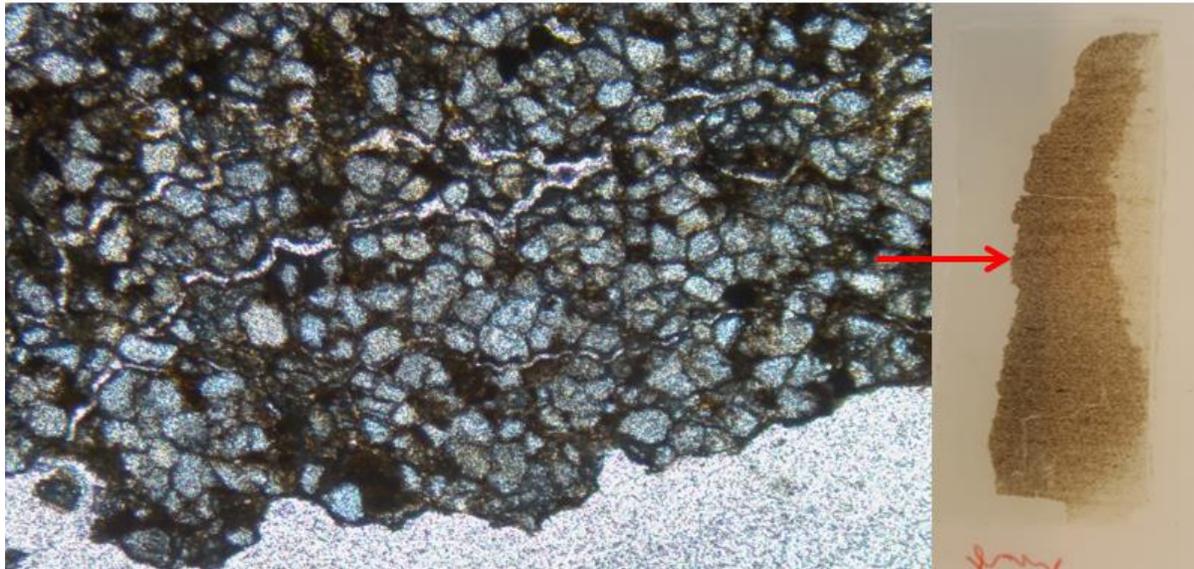
FIGURE 21: THE RED ARROW INDICATES THE SECOND VISIBLE BLACK BAND.

In the second organic band multiple cracks parallel to the sample edge can be seen (see figure 21).

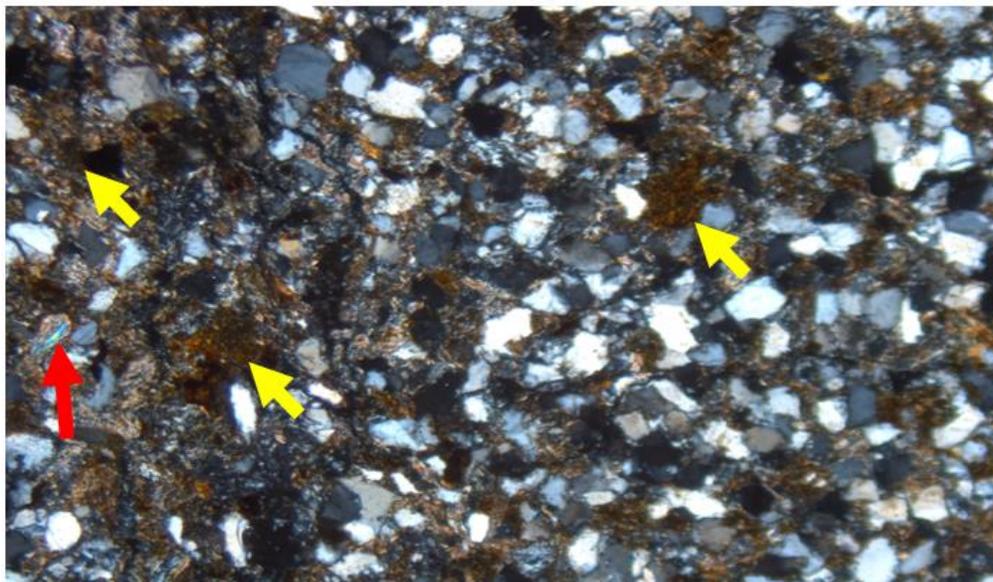
FIGURE 24: MICA (RED ARROW) AND BROWN MATERIAL (YELLOW ARROWS) VISIBLE.

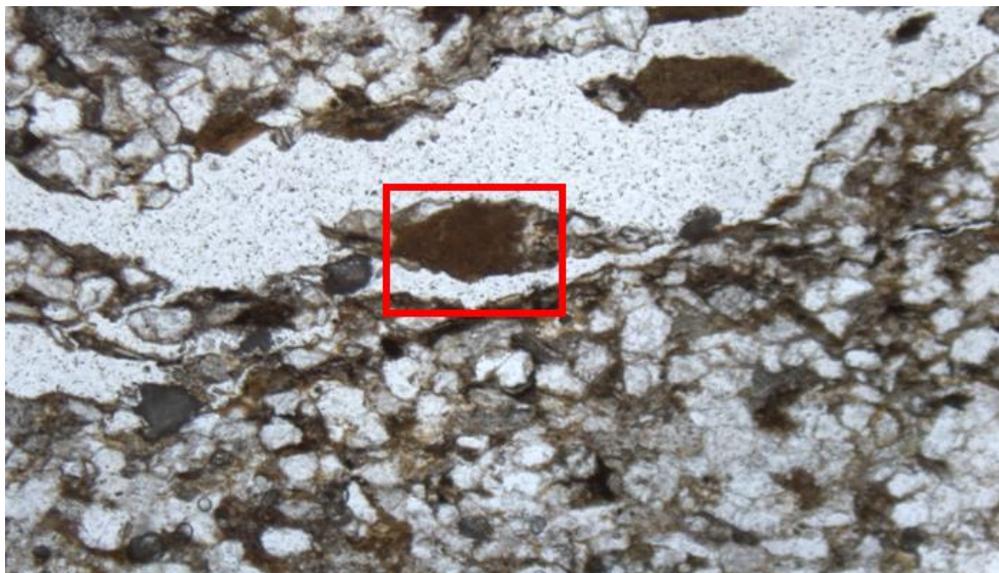
FIGURE 25: IN THIS PICTURE, TAKEN UNDER NORMAL LIGHT, THE AREA CONTAINING THE BROWN MATERIAL OF INTEREST IS INDICATED BY THE RED FRAME. FIGURE 26 GIVES A ZOOM ON THIS SPECIFIC AREA.

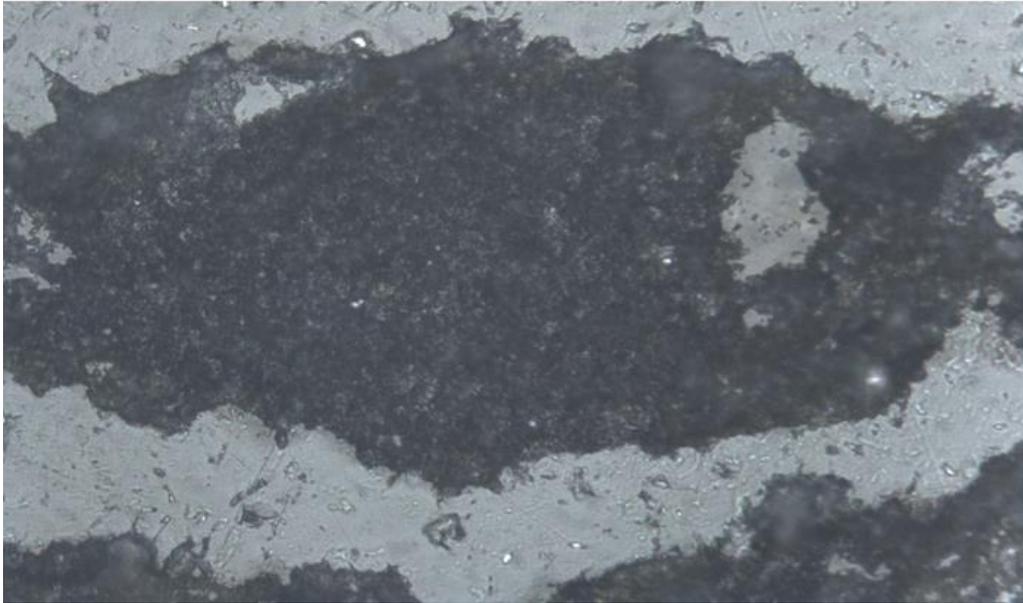
FIGURE 27: THIS IS THE SAME AREA DISPLAYED IN FIGURE 26, HOWEVER, TAKEN UNDER REFLECTED LIGHT. BY DOING SO IT CAN BE CONCLUDED THAT, UNDER THIS LIGHT, THE BROWN MATERIAL ALSO STAYS DARK COLORED. THIS MEANS THAT IT CANNOT BE AN IRON-OXIDE OR ANOTHER SPECIFIC MINERAL. THE HETEROGENEITY OF THE BROWN MATERIAL IS ALSO VISIBLE.

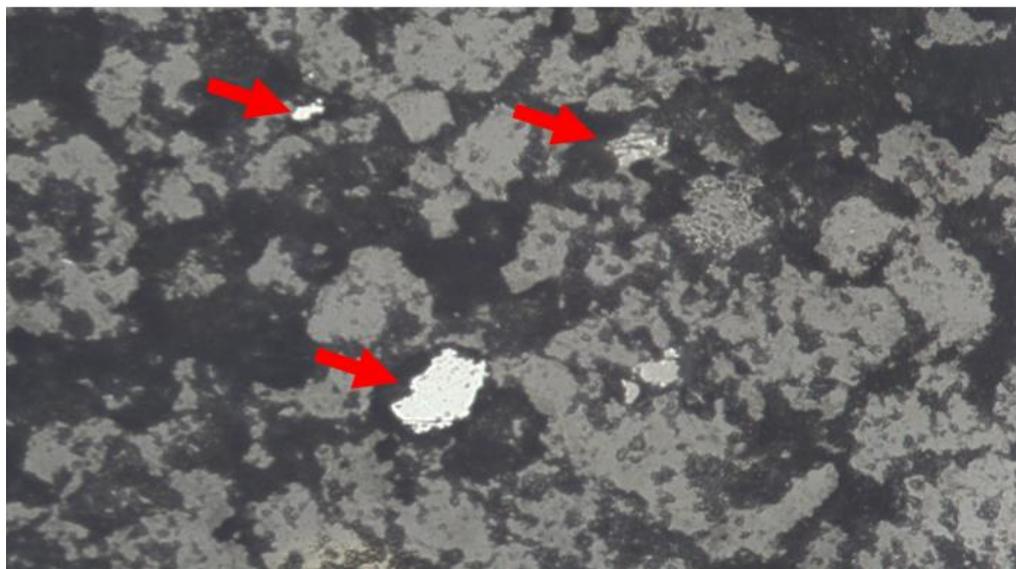
FIGURE 28: IN THIS IMAGE, TAKEN UNDER REFLECTED LIGHT, THREE GRAINS (RED ARROWS) OF AN UNKNOWN MINERAL ARE VISIBLE. TO KNOW WHICH MINERAL IS PRESENTED MORE ANALYSIS IS NEEDED.

Besides the quartz grains, mica's, cracks and large amount of brown material other minerals were also observed. This is illustrated in the following images. However, it is not possible, solely through optical analysis, to be sure what exact mineral is present. To determine this, SEM-analysis could perhaps provide the necessary information regarding the composition of the minerals.

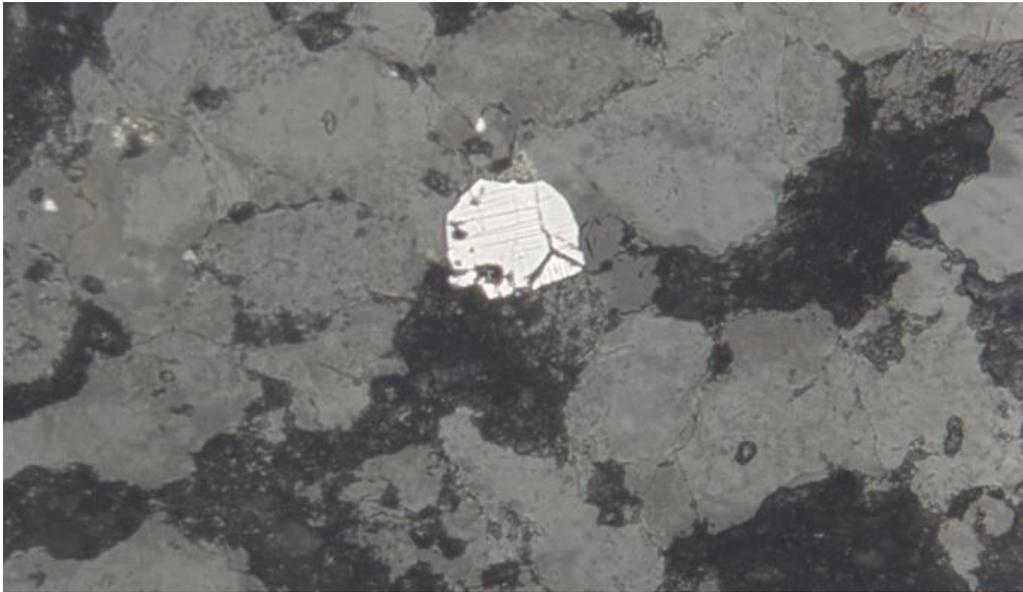
**FIGURE 30:** THIS IMAGE SHOWS AN UNKNOWN GRAIN UNDER REFLECTED LIGHT (CENTER). LAMINAR TWINNING BOUNDARIES ARE VISIBLE. THIS IS A KNOWN PROPERTY OF HEMATITE. TO BE SURE WHETHER THIS CAN BE A HEMATITE GRAIN MORE ANALYSIS ON THIS GRAIN IS NEEDED.

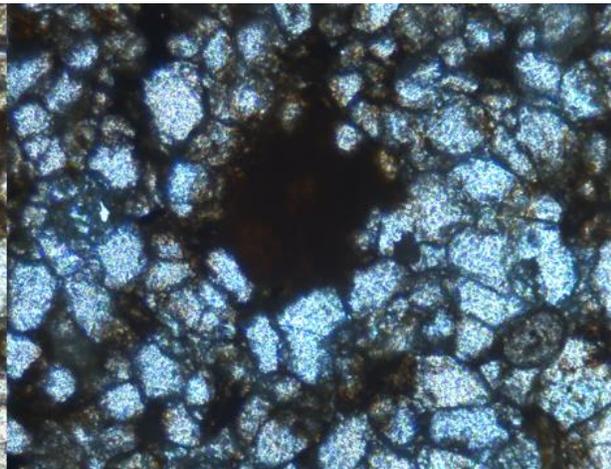
**FIGURE 32:** BLACK SPOT APPEARING UNDER REFLECTED MICROSCOPIC LIGHT (CENTER). BROWN MATERIAL BETWEEN GRAINS IS VISIBLE.

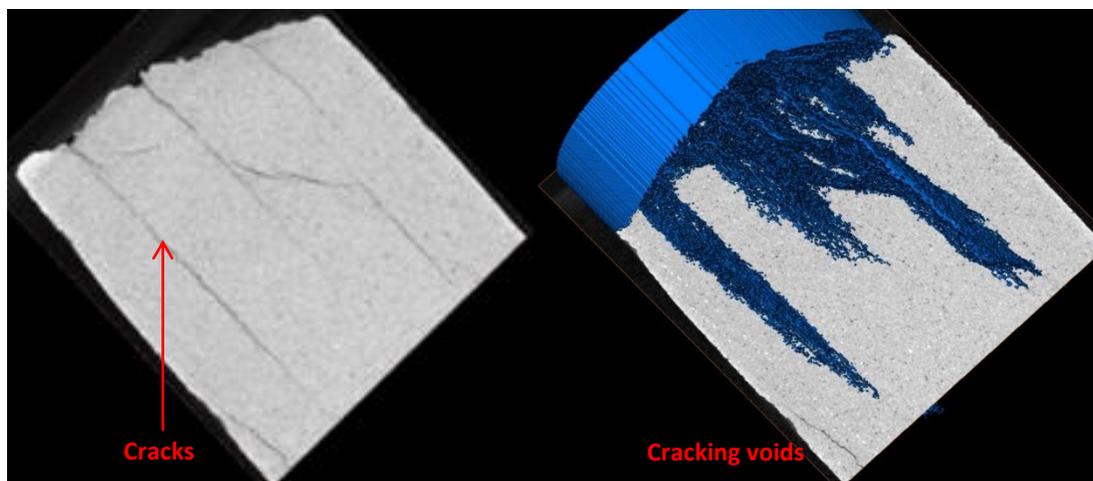
FIGURE 33: SCAN OF B3-1 TOP. SEVERAL PARALLEL SEDIMENTATION LAYERING VISIBLE INCLUDING (MICRO) CRACKS (LEFT). CRACKING VOIDS INDICATED ON THE RIGHT.

Figure 33 shows micro-CT images of the weathered part of a drilled core. Parallel sedimentation layering including cracks are visible.

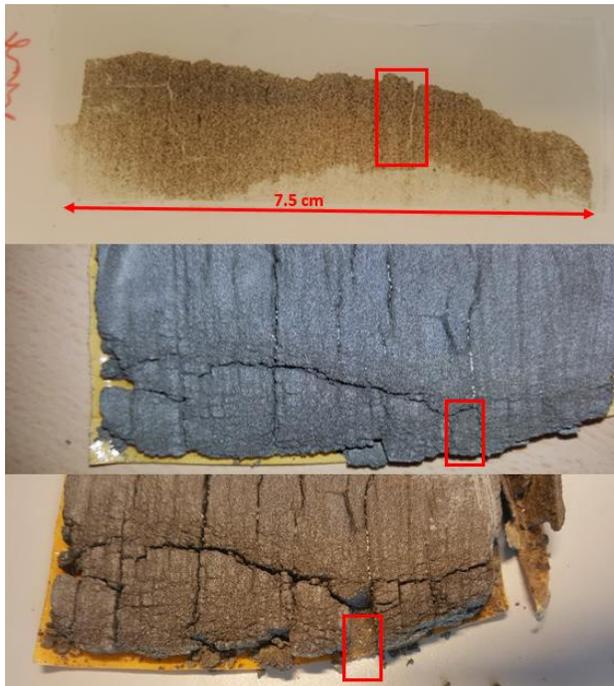
**FIGURE 34:** THIN-SECTION OBTAINED FROM SAMPLE 3 (SEE TABLE 1, APPENDIX C). SUB-SAMPLE AREA INDICATED BY THE RED FRAME. SCALE OF THE BOXED IS APPROXIMATELY 8MM X 5MM.

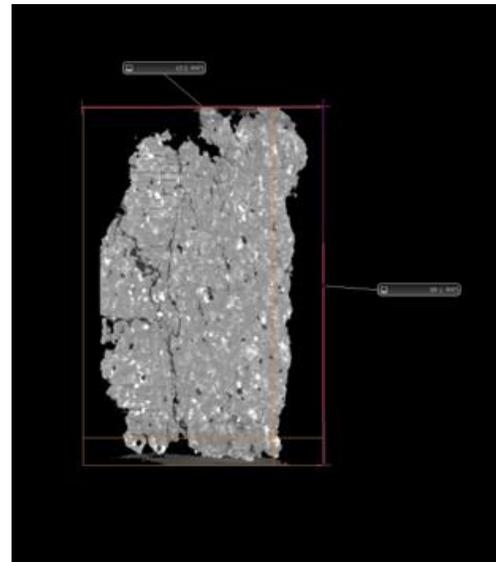
**FIGURE 35:** GRAY QUARTZ GRAINS ALONG WITH OTHER HIGHLY ATTENUATING GRAINS ARE VISIBLE. SCALE: APPROXIMATELY 8MM X 5MM.

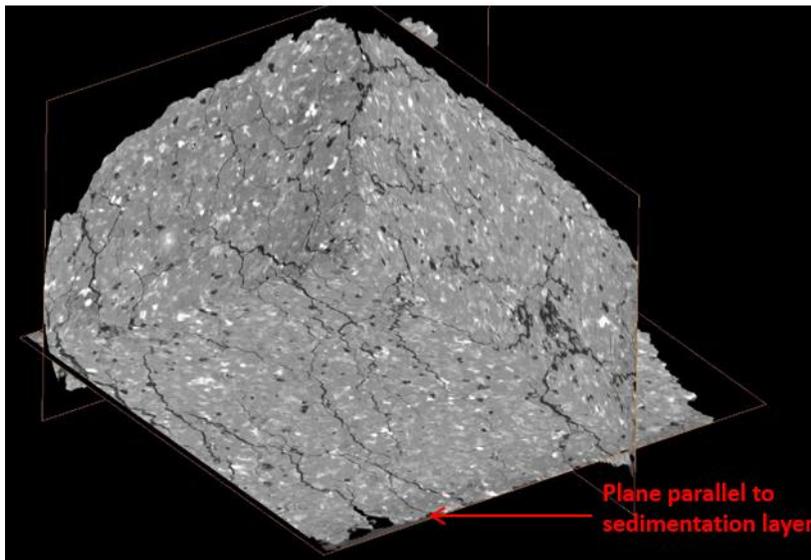
**FIGURE 36:** INTERNAL STRUCTURE OF THE ABOVE MENTIONED SUB-SAMPLE IN 3-DIMENSIONS.

Several micro-CT scans are presented below to illustrate the microstructure of the Thorn-sandstone in 3D. Observations made are described in the captions of the figures.

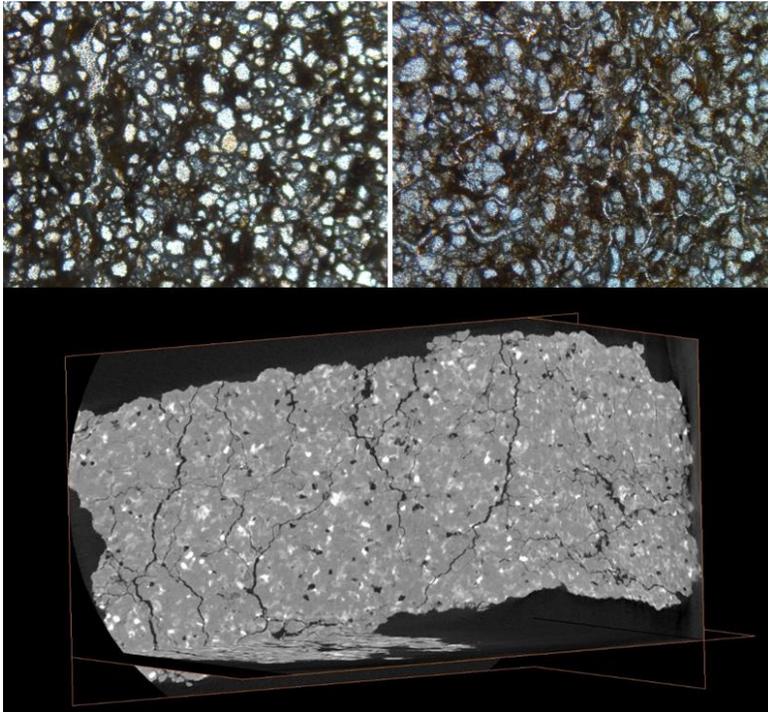
**FIGURE 37: MULTIPLE CRACKING IN SEVERAL DIRECTIONS. HIGHER (ALMOST WHITE) AND LOWER (ALMOST BLACK) ATTENUATING GRAINS ARE ALSO VISIBLE.**

The cracks observed through optical microscopic analysis can also be seen in the micro-CT images. This is shown in figure 37.

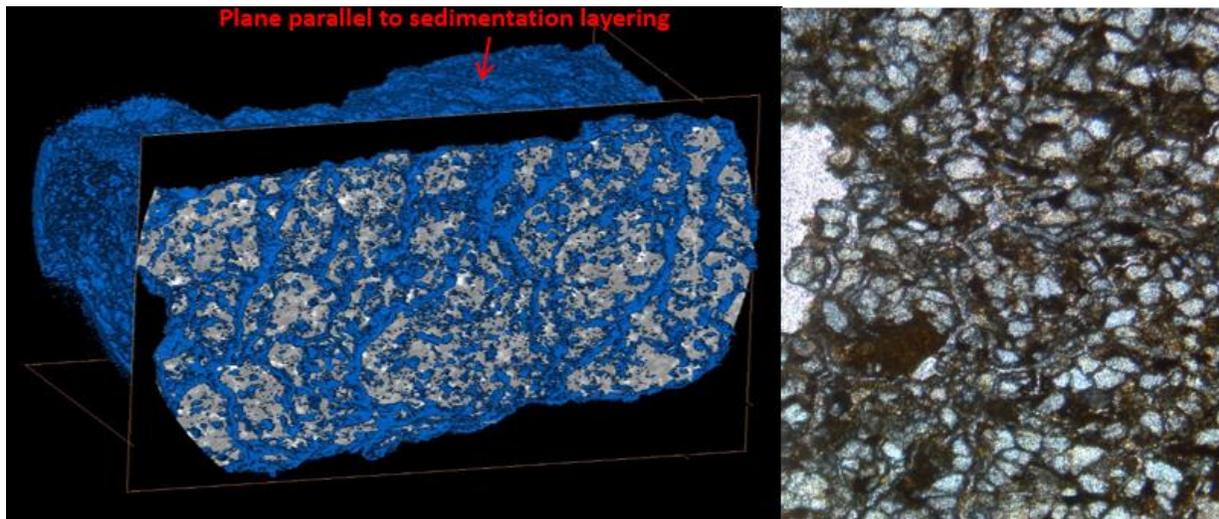
**FIGURE 38: MULTIPLE CRACKING IN ALL DIRECTIONS. MICRO-CT IMAGE (ON THE LEFT) AND OPTICAL MICROSCOPIC IMAGE OF THE SAME AREA (ON THE RIGHT).**

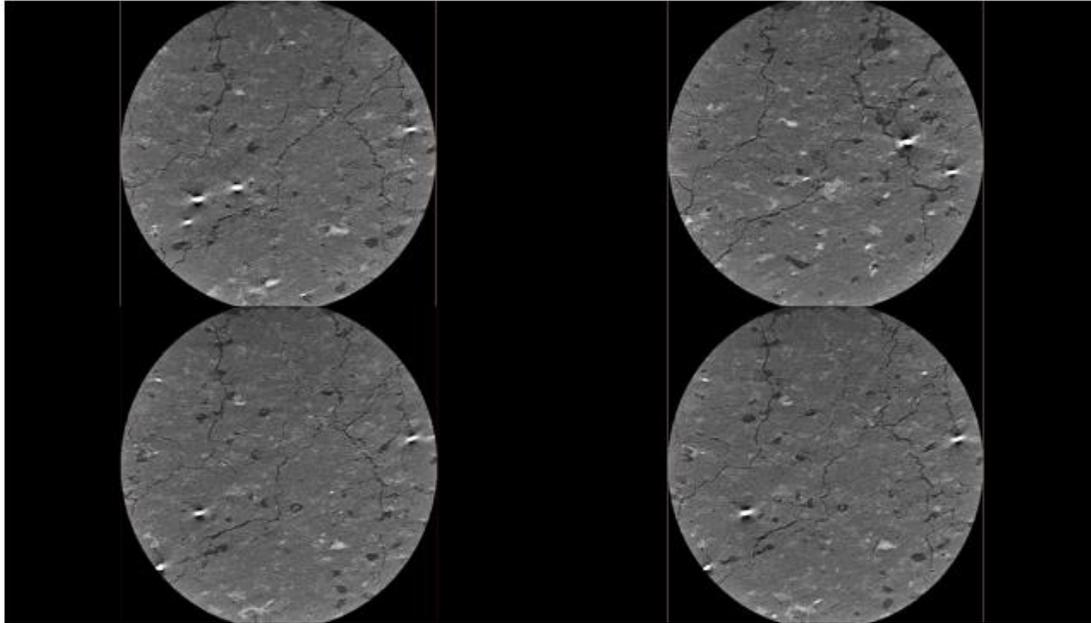
FIGURE 39: HIGHLY ATTENUATING PARTICLES (ALMOST WHITE).

A high resolution scan ( $0.0015 \times 0.0015 \times 0.0015 \text{ mm}^3$  voxel) was done on a selected area of the previous sub-sample. Very light colored, almost white, spots on micro-CT images indicate highly attenuating particles. This can be seen in figure 39.

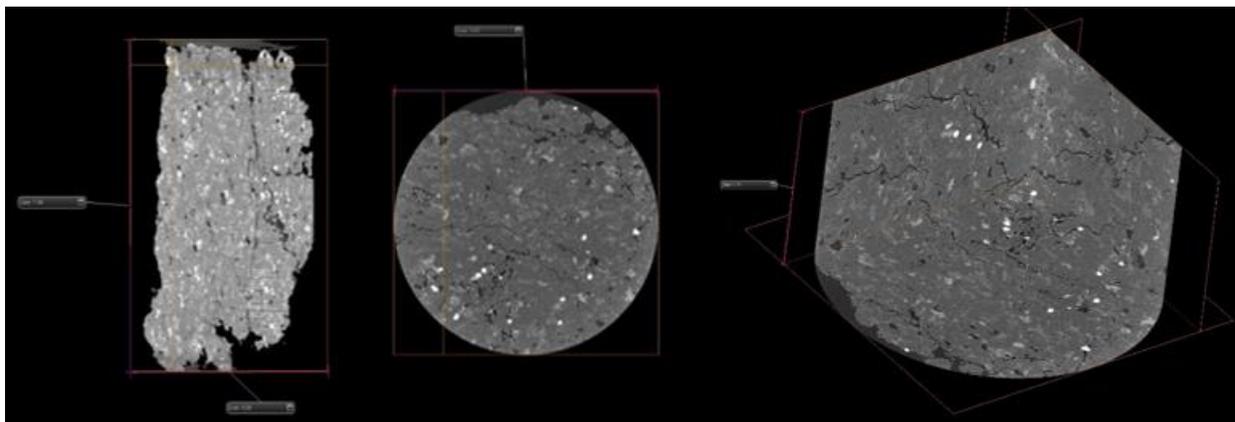
FIGURE 40: SUB-SAMPLE (LEFT) AND CORRESPONDING FLAT CYLINDER (CENTER AND RIGHT).

The next scan was done on another sub-sample taken from sample 8 (see table 1, appendix B). This was then reconstructed into the shape of a flat cylinder (dimension: diameter: 3.61 mm, height: 1.74 mm. Resolution: 0.00175 mm) (see figure 40).

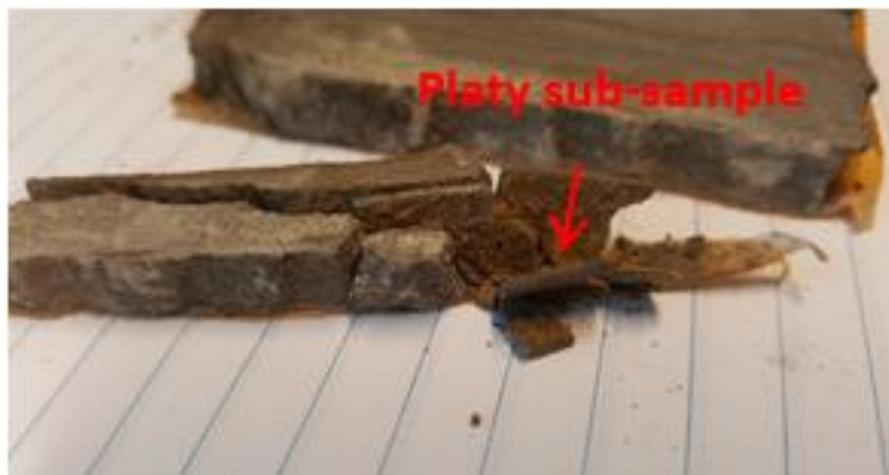
FIGURE 41: PLATY SUB-SAMPLE.

The next micro-CT scan is done on a platy sub-sample of the brown cross-bedded zone at the top of sample 8 (see figure 41). Dimension of the sub-sample is 1.20cm x 0.75cm. The images display the micro-cracking and the highly attenuating particles (figure 42 and 43).

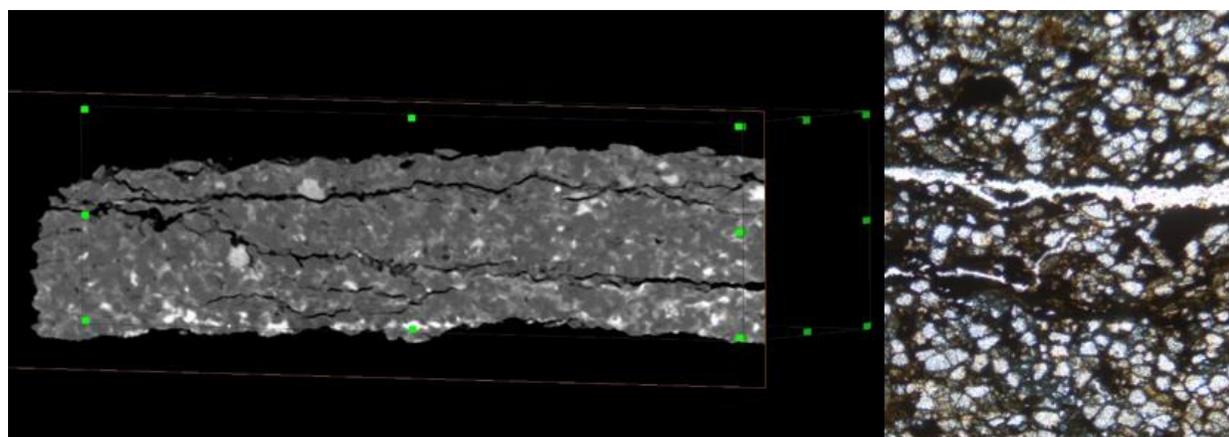
FIGURE 42: MICRO-CT (LEFT) AND OPTICAL MICROSCOPIC (RIGHT) IMAGES OF PARALLEL CRACKS WITHIN THE PLATY SUB-SAMPLE.

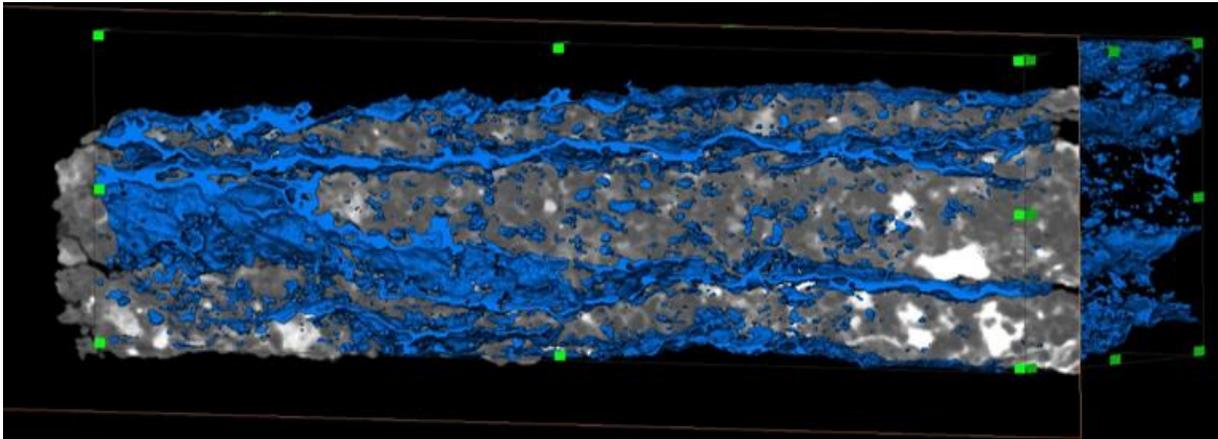
FIGURE 43: PARALLEL CRACKING VOIDS WITHIN THE PLATY SUB-SAMPLE.

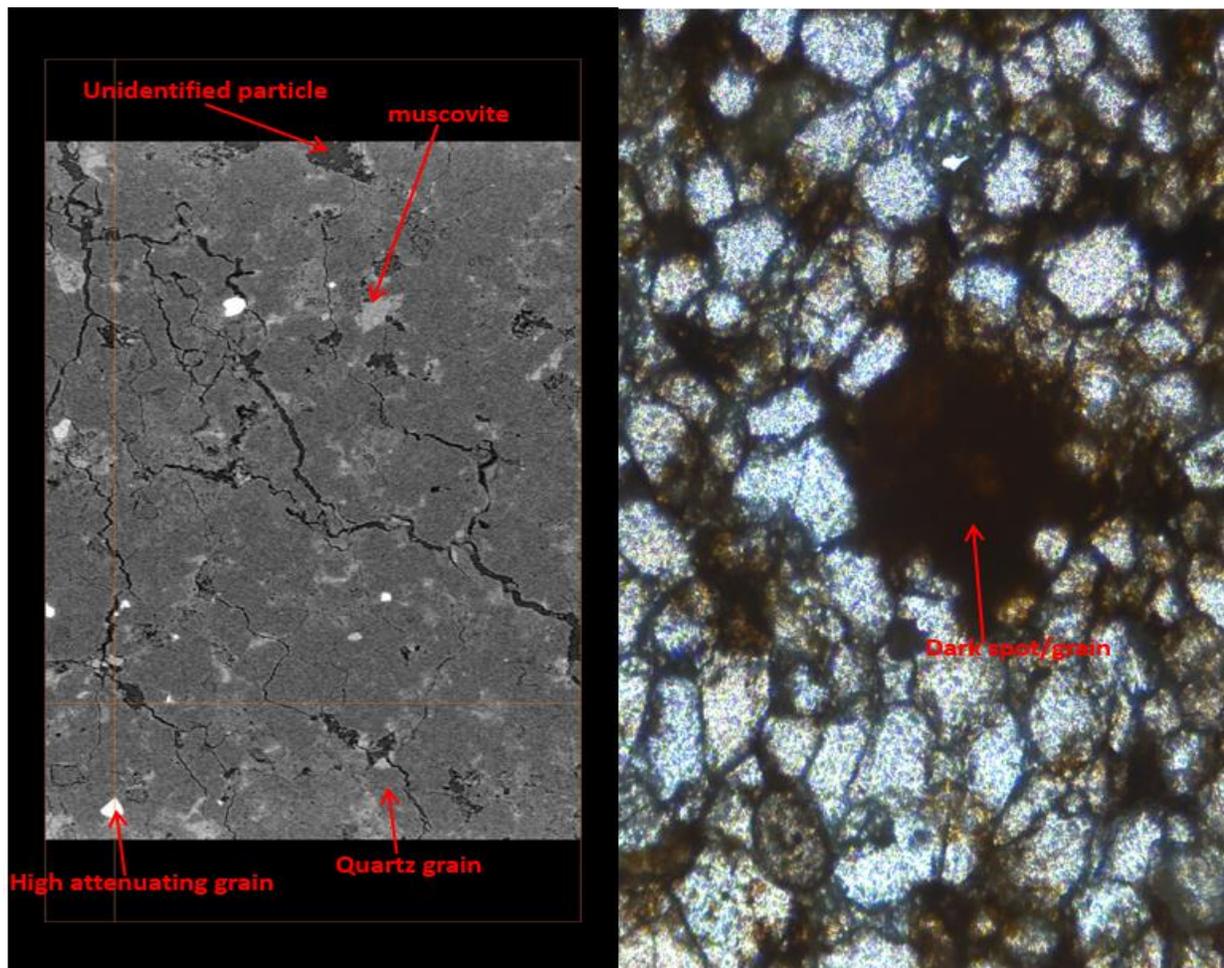
FIGURE 44: HIGHLY ATTENUATING GRAINS ON MICRO-CT IMAGE (LEFT) AND DARK SPOT ON OPTICAL MICROSCOPIC IMAGE (RIGHT).

Further analysis and testing is required to determine if the high attenuating grains are connected to the dark spots visible on the optical microscopic images as shown in figure 44.

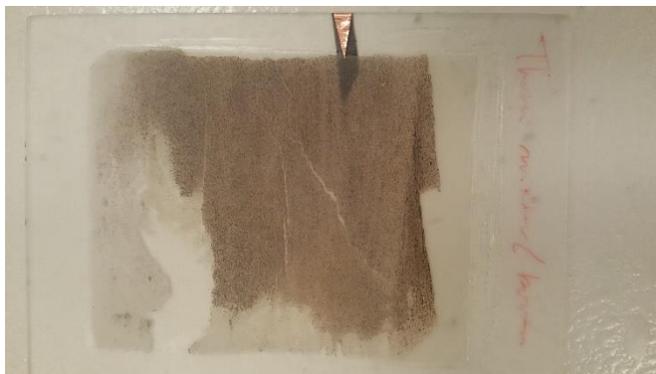
FIGURE 45: THIN-SECTION 1 WITH INDICATION ARROW.

Analysis of thin-sections 1 and 2 was focused on zones highlighted with an arrow in figure 45 and 46. Thin-section 3 was analyzed as a whole, as indicated in figure 47.

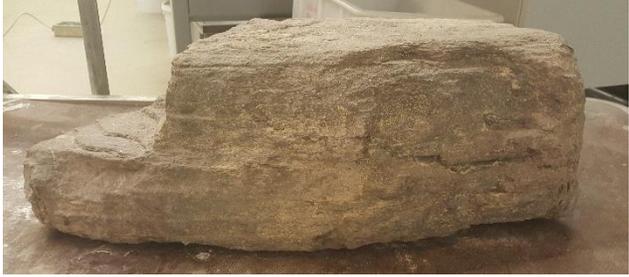
Information	Picture
Sample 1	Large block of the Thorn-sandstone. Dimension: ( x x )

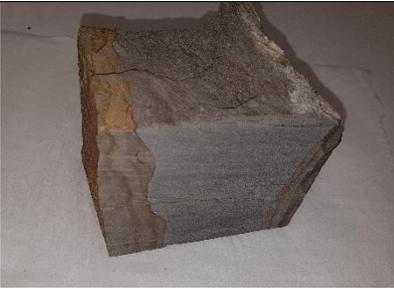
Sample 2	Block of the Thorn-sandstone. Dimension: ( x x )

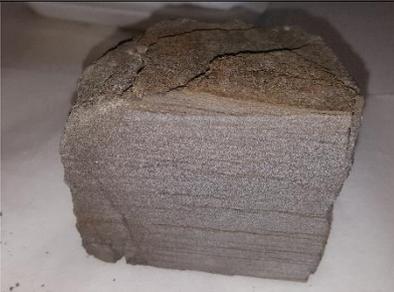
Sample 3	Block of the Thorn-sandstone. Dimension: ( x x )
