# Investigation of the processes causing the degradation of the sandstone used on the Thorn church based on mineralogical analysis.

BSc. Thesis

Faculty of Civil Engineering and Geoscience, Delft University of Technology, Geo-Engineering

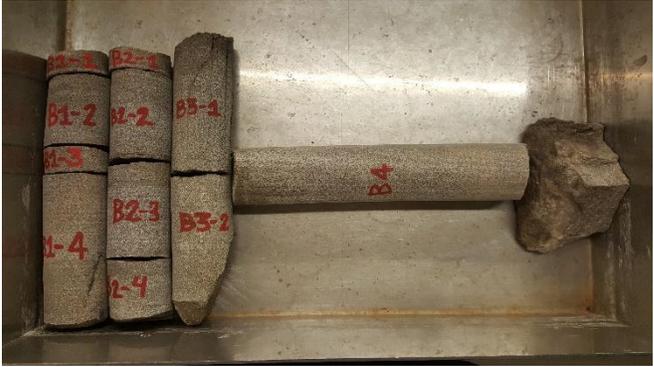
<p>Sample 4,5,6,7</p>	<p>4 cores: B1,B2,B3,B4; drilled from of sample 1.</p> <p>B1,B2: Vertically drilled</p> <p>B3,B4: Horizontally drilled</p> <p>B1,B2 and B3 broken along sedimentary boundaries.</p> <p>B4 remained whole.</p>

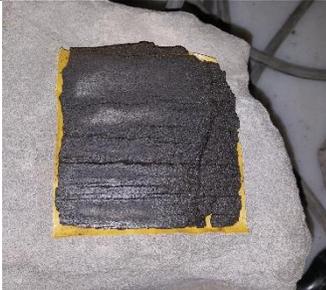
<p>Sample 8</p>	<p>This thin slab was cut from sample 3.</p> <p>Several parts have been taken out of this sample to perform micro-CT scanning. Dimension: ( x x )</p>

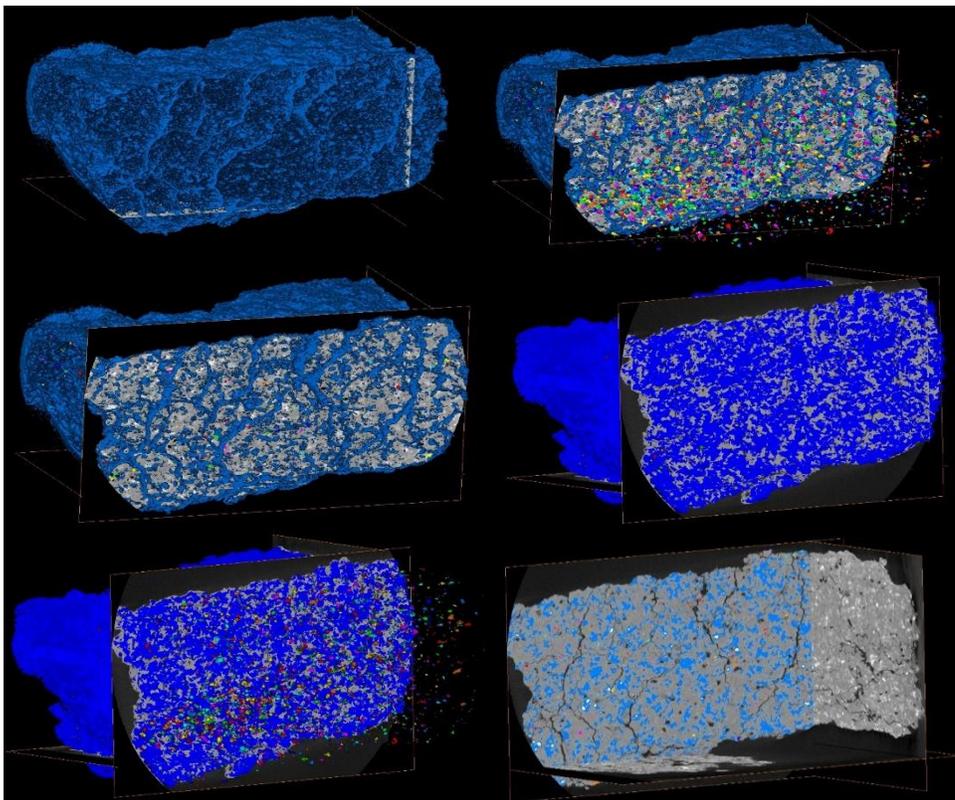
FIGURE 55: MICRO-CT IMAGES SHOWING MULTIPLE FISSURES OR CRACKS. MULTIPLE GRAINS INDICATED IN DIFFERENT COLORS ARE ALSO VISIBLE THROUGHOUT THE SAMPLE.

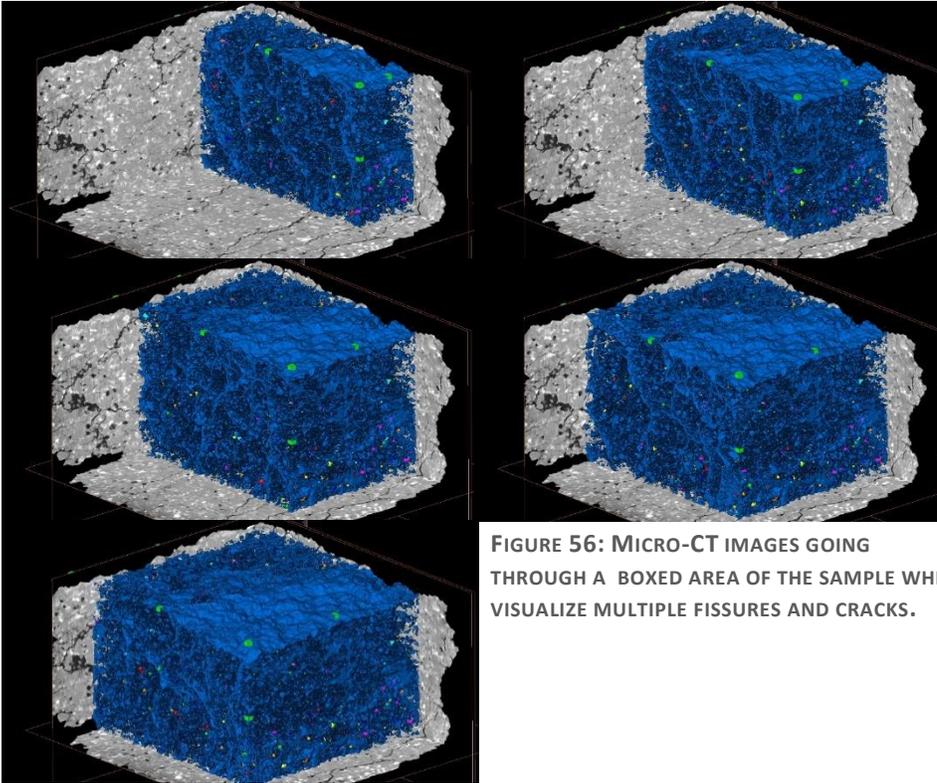
FIGURE 56: MICRO-CT IMAGES GOING THROUGH A BOXED AREA OF THE SAMPLE WHICH VISUALIZE MULTIPLE FISSURES AND CRACKS.

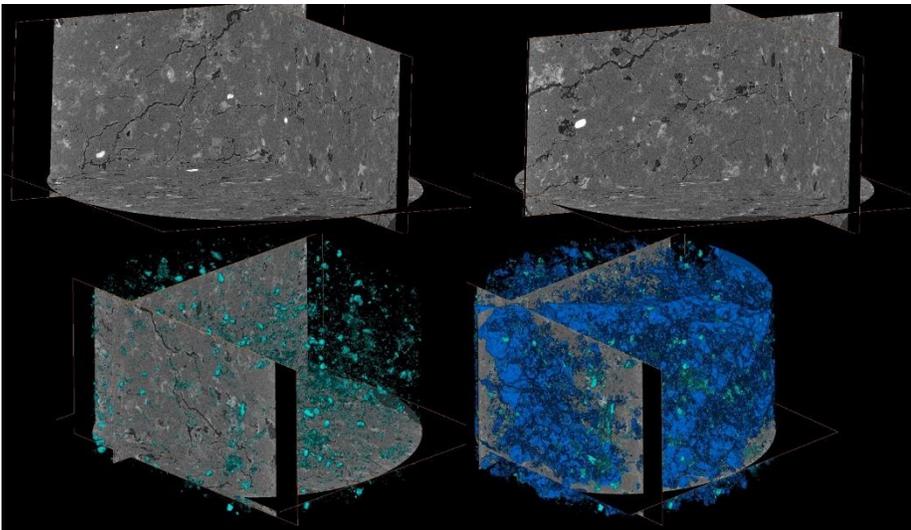
FIGURE 57: MICRO-CT IMAGES SHOWING IN 3D FROM A CIRCULAR SAMPLE IMAGE-CUT. LARGE PARTICLES (LEFT UNDER) AND FISSURES/CRACKS (RIGHT UNDER) ARE VISIBLE.
