Experimental study on deep steel-concrete composite slabs using distributed strain measurements

In partial fulfilment of the requirements for the degree of:

Master of Science
in Civil Engineering

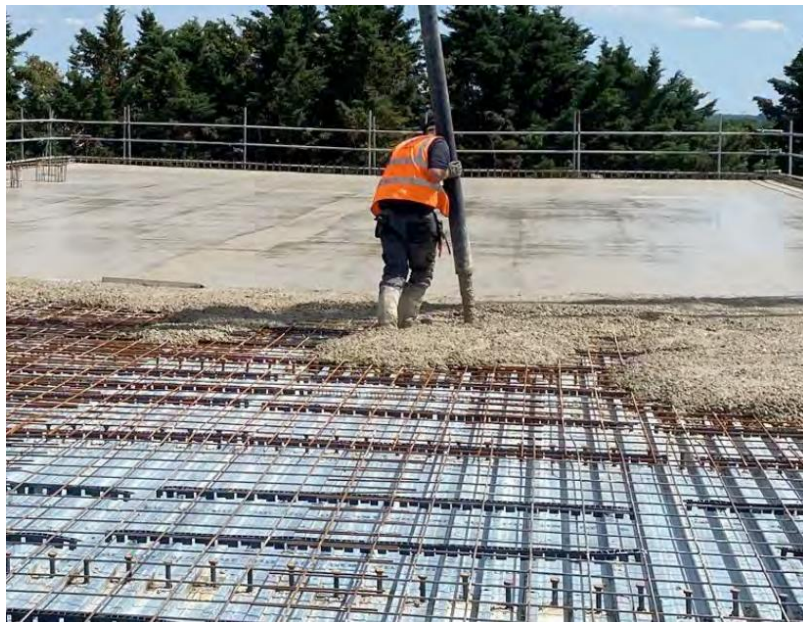
Figure 2.4. Concrete poured onto the steel sheeting [1].

The concrete can be cast onto the steel sheeting at the construction site, the steel sheeting acts as formwork, this can be seen in Figure 2.4 [1]. During the casting process, the steel sheeting has to bear the weight of the concrete as it is poured and set. There is no composite interaction between the steel and concrete until the concrete hardens.

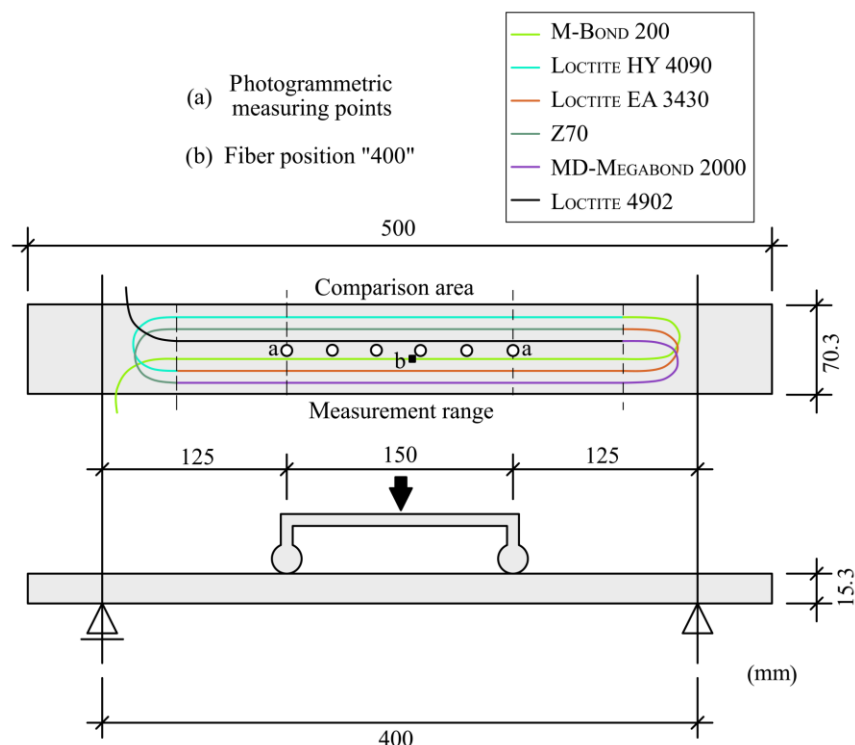
Figure 2.16. Test setup and fiber locations [17].

Three separate specimens were prepared, each with a different fiber coating. The dimensions of the specimens were 70.3 mm x 15.3 mm x 500 mm. Four-point bending tests were conducted at three different load levels. The test setup and the locations of the fibers are shown in Figure 2.16 [17].

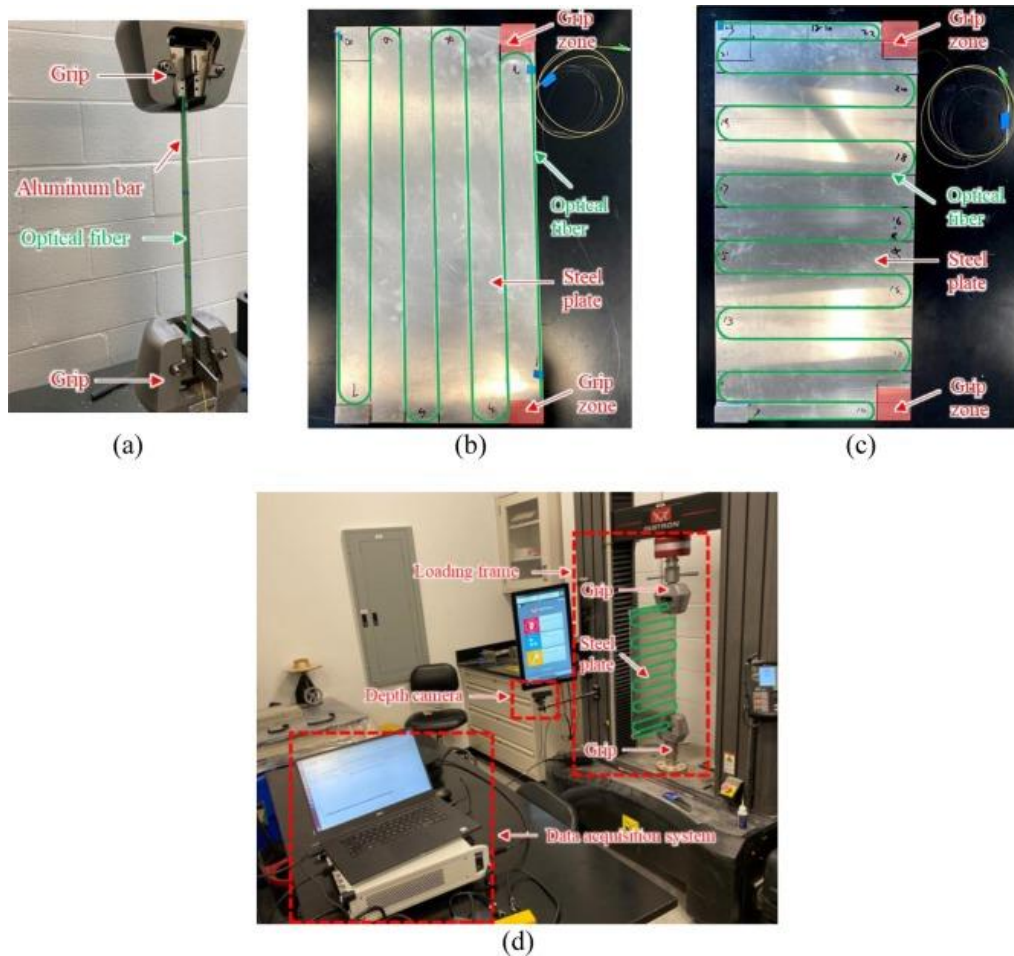
Figure 2.17. Test setup and location of the DOFs on the bar (a) and plate (b and c) [18].

Tan et al. [18] utilised distributed fiber optic sensors to detect buckling and reconstruct three-dimensional deformations. The DOFs were applied to an aluminium bar and a thin steel plate which were compressed until they buckled. The setup and location of the fibers is illustrated in Figure 2.17 [17].

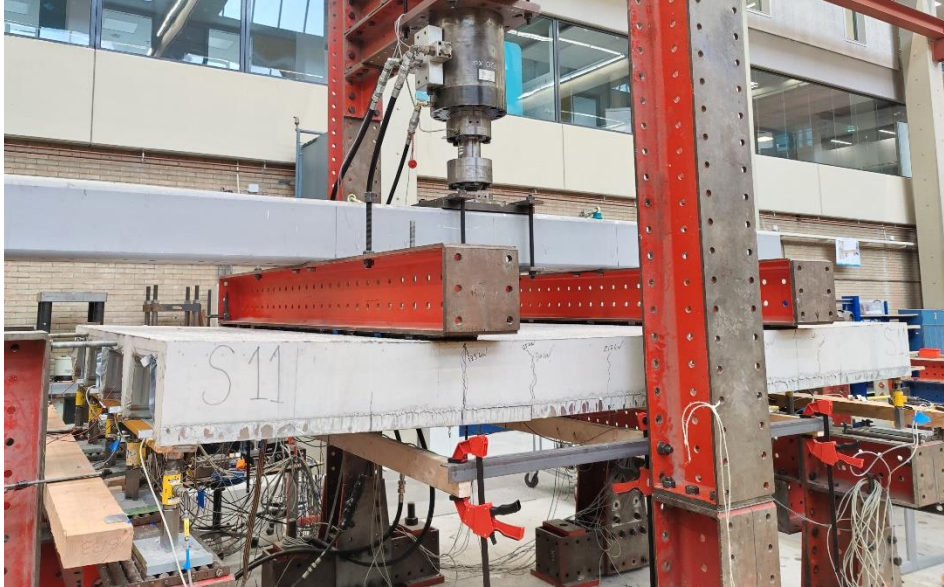
Figure 3.1. Test setup of the full-scale experiments.

For this thesis, Distributed Optical Fibers (DOFs) were applied to deep steel-concrete composite slabs that underwent a four-point bending test. The test setup used for the full-scale experiments is shown in Figure 3.1, the schematic overview of the setup, described by Eurocode 4 [4], is shown in Figure 3.2.

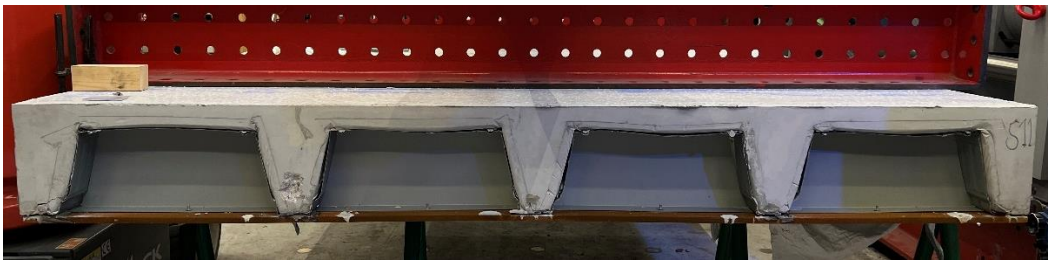
Figure 3.3. Side view of a slab.

The specimens are 2500 mm wide and have 5 ribs, however, the two ribs on the side of the slab can be considered as half a rib. This is illustrated in Figure 3.3. A schematic view of a single rib is shown in Figure 3.4 [20].

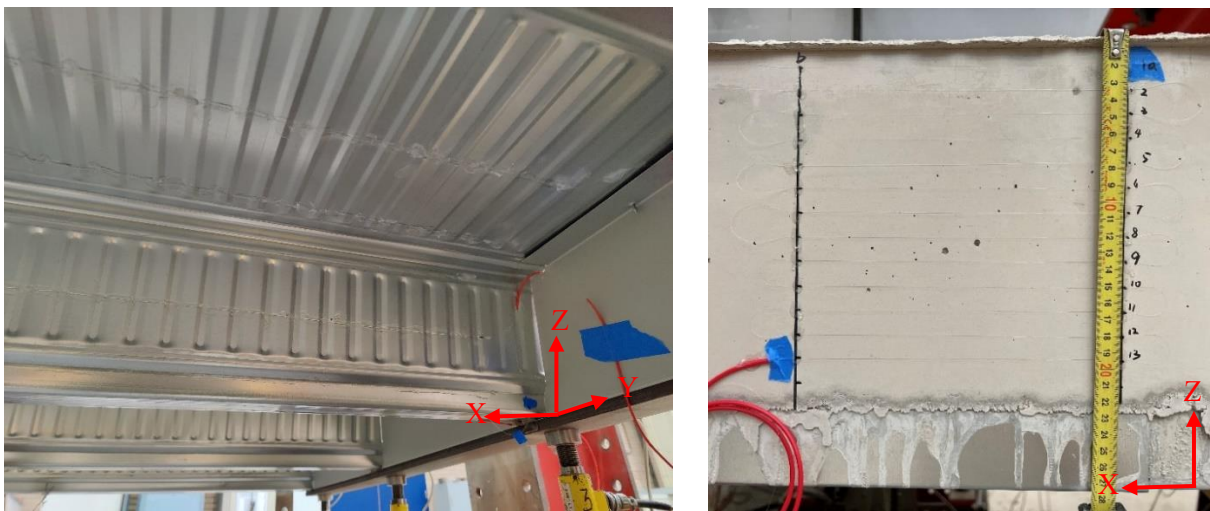
Figure 3.8. Photograph of the Steel Fibers (left) and the Concrete Fiber (right).

A photograph of the Steel Fibers is shown on the left side and the Concrete Fiber is shown on the right side.

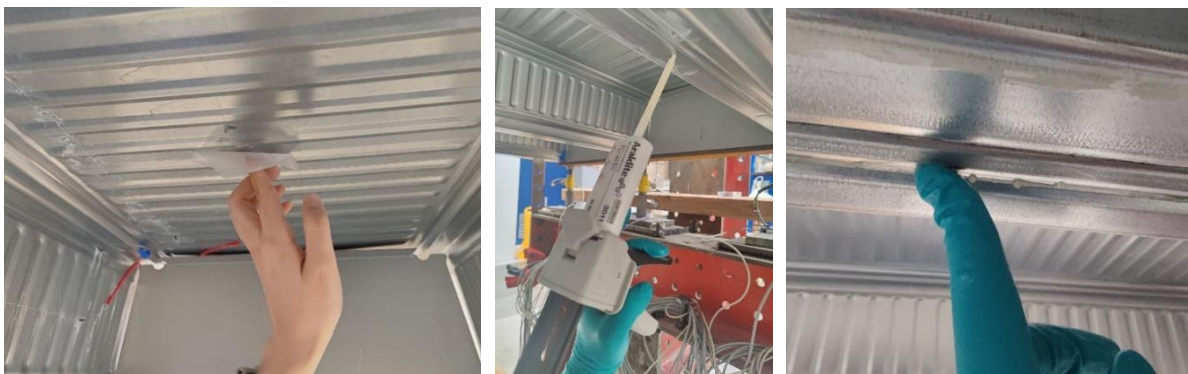
Figure 3.11. Application of two-component glue on embossments (left), application of epoxy (middle), and spreading the epoxy by hand (right).

For the embossed part of the steel sheeting, this could not be done in the same manner because the fibers have to follow the embossments. Instead, the two-component glue had to be applied in every embossment, and in between the embossments the epoxy would be applied. Figure 3.10 shows a close-up of a fiber applied over embossments, the fiber is indicated with a dashed red line. The steps taken to apply the fiber are shown in Figure 3.11.

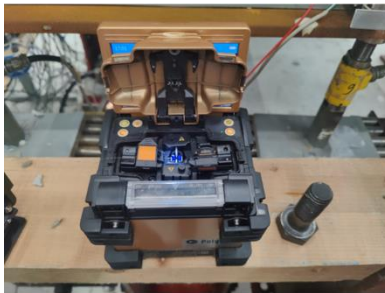
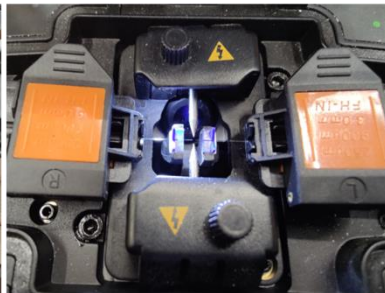
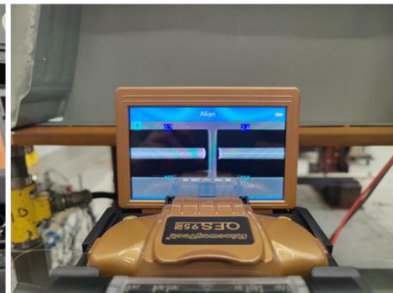
Figure 3.12. Steps of connecting the fiber to the Luna system.

After the application of the fibers, both ends have to be prepped to be connected to the Luna ODISI 6104 Series measuring system. The start of the fiber will be connected to the Luna system with a pigtail, and the end will be connected to a coreless fiber which protects the end of the fiber.

Steps a), c), and e) have been illustrated in Figure 3.12.

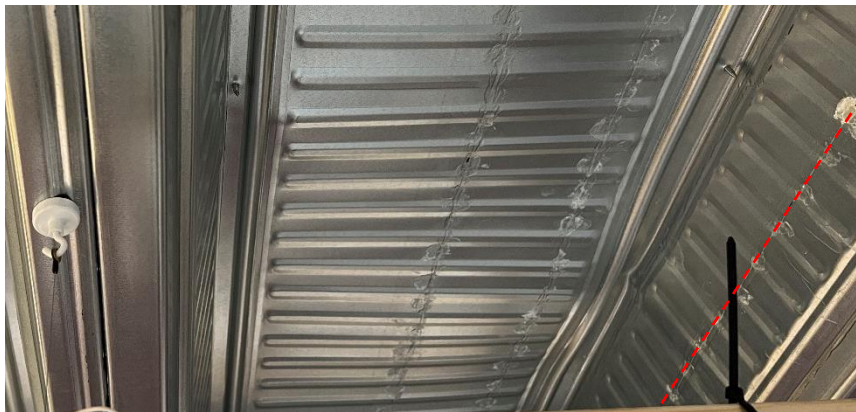
Figure 6.9. Buckling of the steel sheeting of Slab 11.

Slab 10 had a span of 3.6 meters and featured rib reinforcement along with recycled aggregate concrete. In contrast, Slab 11 lacked rib reinforcement and had normal C20/25 strength concrete. During the testing, the steel sheet of Slab 10 experienced buckling. Out of the fibers placed in the buckling zone, only Fiber 2 provided usable data because the other fibers broke. Consequently, Fiber 2's data is the only source for analysing the buckling behaviour of Slab 10. Slab 11 showed that Fiber 2 could detect buckling, although it showed indications of buckling later than the other fibers. The buckling of slab 10 is illustrated in Figure 6.9, and Fiber 2 is highlighted with a red dashed line.

The buckling shown in Figure 6.9 occurred close to the right load point. The effect of buckling on the strain of Fiber 2 is illustrated in Figure 6.10, at three load levels. These load levels are indicated in the load-displacement graph of Slab 10 in Figure 6.11.

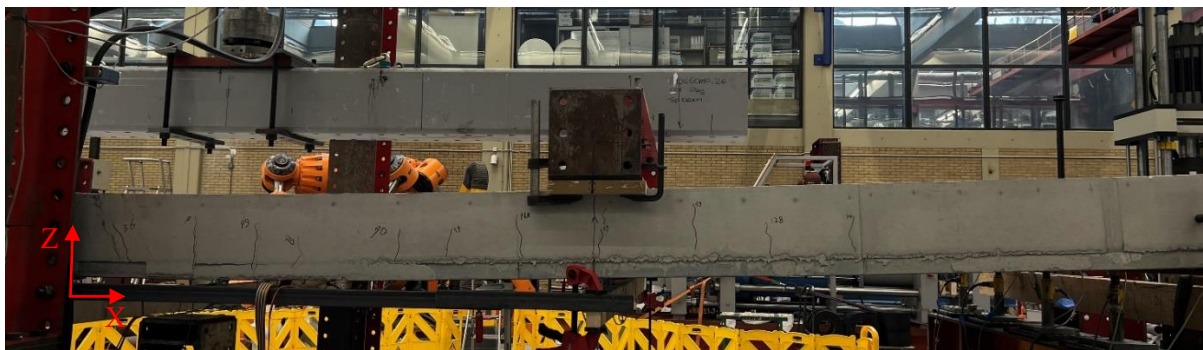
Figure 7.2. Photo of the front right side of Slab 7.

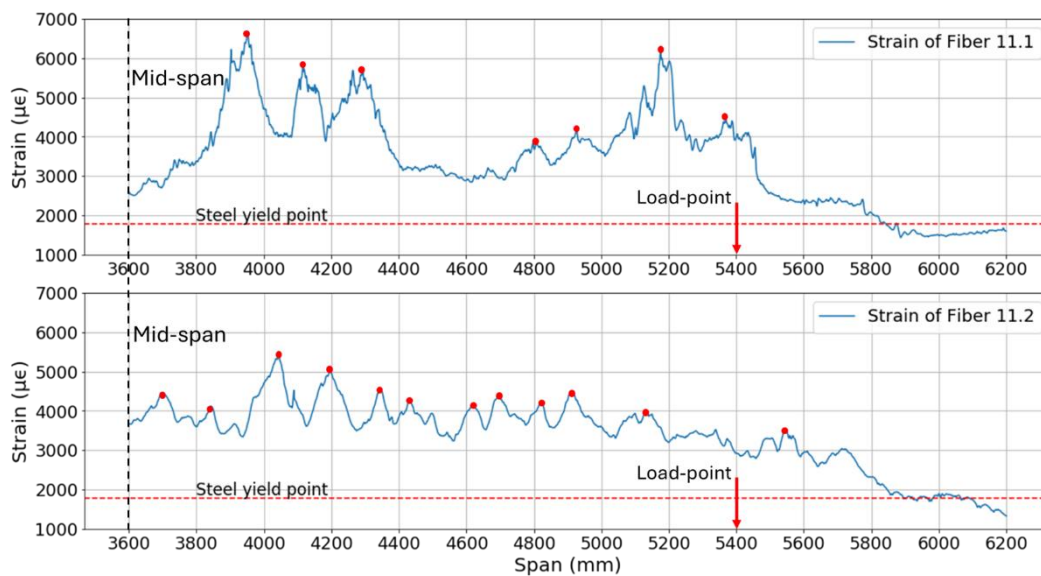
Figure 7.3. The strain data of Fiber 11.1 (top) and Fiber 11.2 (bottom) on the right side of Slab 7, at peak load.

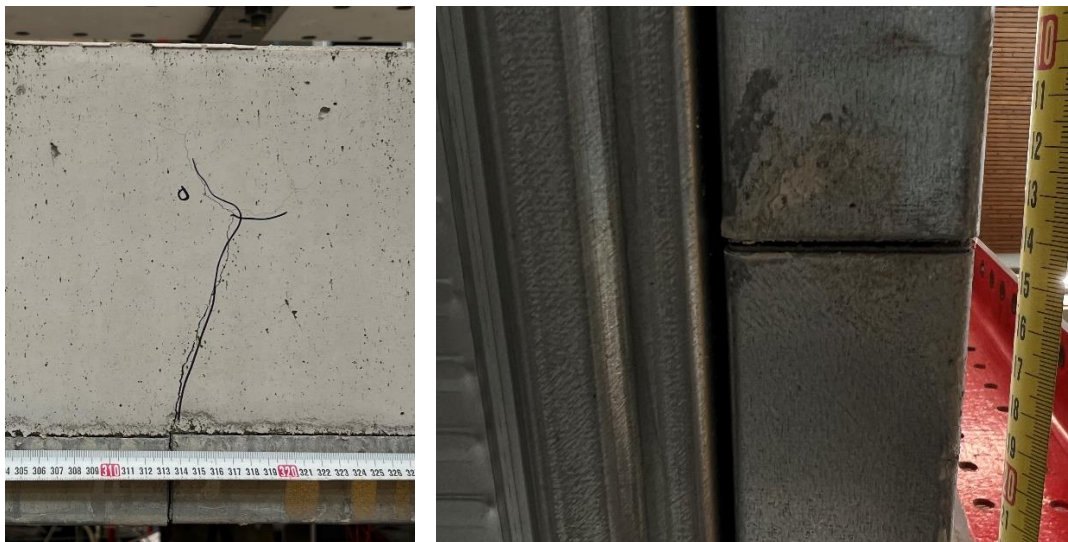
Figure 7.4. Side view (left), and bottom view (right), of the gap in the steel sheeting.

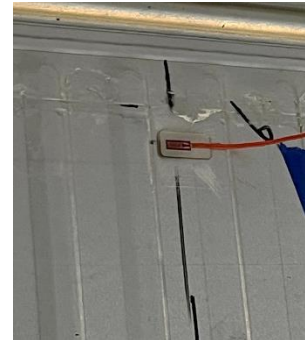
Figure B.8. The strain of Fiber 4, Slab 6, overlapping with a small part of the steel top flange (left), and a photo of the strain gauge location on the flat part of the flange (right).

Figure B.8 shows the strain of Fiber 4 over a small portion of the span, and the measurement point corresponding to the strain gauge is highlighted with an orange dot. Additionally, it shows in the photo that the strain gauge is applied slightly to the right side of the flat part of the web, this means that in the fiber data, the strain gauge is also on the right side of the flat part. The same has been done for Fiber 5 which is illustrated in Figure B.9, here the strain gauge was also moved slightly to the right side of the flat part.
