International Journal of Architectural Heritage

# A two-stage numerical analysis approach for the assessment of the settlement response of the pre-damaged historic Hoca Pasha Mosque

Korhan Deniz Dalgic, Max A.N. Hendriks, Alper Ilki & Wout Broere

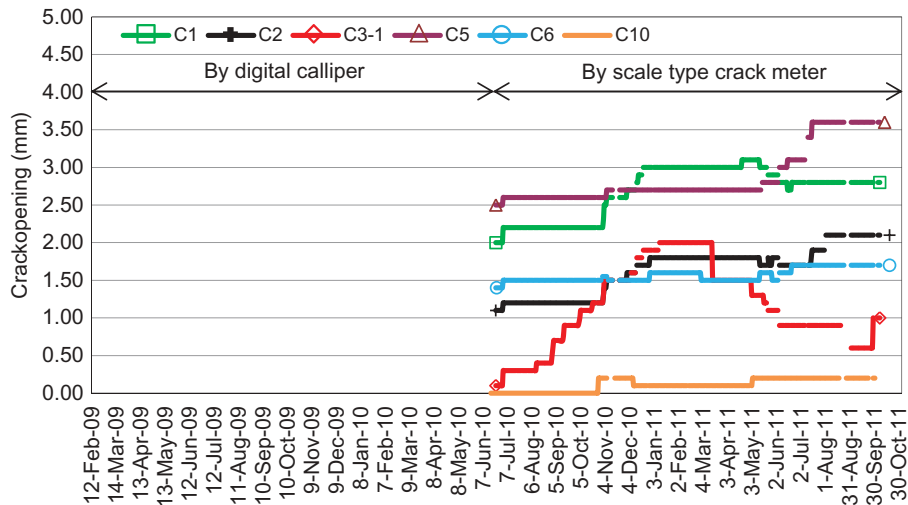
Figure 6. Opening and closures of the pre-existing localized cracks.

Figure 6 shows the variation of the widths (crack activity) of the major pre-existing localized cracks. Although a trend cannot be given for the initial data obtained by the digital callipers for the period before June 23, 2010, the final digital calliper readouts are added to the data obtained by scale type crack meters. No measurements for crack C3-2 were carried out.

Figure 6 shows that crack C3-1 widens and closes significantly during the NPFV excavations. As the mosque settlements slow down towards March 2011, a closing is observed for this crack. Another increase in the activities of C1 and C2 is noted during the top heading and medium sub-section excavations of NPFV. The C5 and C6 cracks seem to be influenced least by the NPFV excavations. However, an increase in their widths is observed as of June 2011 possibly due to the CNV excavations. Crack C10 shows minor variation throughout the excavations.

Note that the crack activities given in Figure 6 are in general agreement with the wall distortions given in Figure 8. For instance, the lowest activity in the C10 crack is in line with the lowest distortions experienced by the SE wall and the variations of the width of crack C3-1 are in line with the increases and decreases in the distortions of the NW wall. However, a direct comparison between crack activities (openings and closings) and variations of calculated wall distortions may not always be straightforward due to the following.

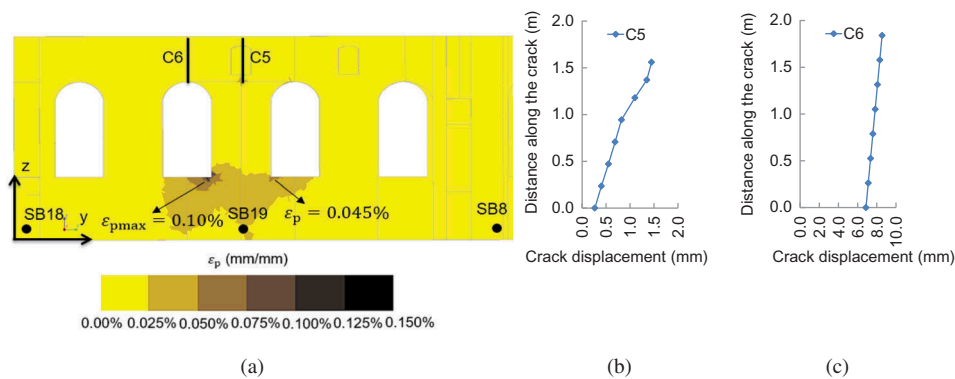
Figure 11. (a)  $\epsilon_p$  distribution in SW wall with crack interfaces and relative crack displacements of (a) C5 and (b) C6 cracks ( $E_m = 350$  MPa).

Figures 10 and 11 show the deformation and crack opening results obtained for the SW wall without and with crack interfaces (C5 and C6), respectively. In the first case, it is seen that the major principal tensile strains ( $\epsilon_p$ ) concentrate around the small niche at the upper side of the wall as well as the bottom parts of the central windows. The maximum principal tensile strain ( $\epsilon_{pmax}$ ) reaches about 0.080%. This value exceeds slightly the tensile strain range (0.038–0.060%) that was previously reported by Burhouse (1969) as the onset of visible cracking in the brick masonry walls. The presence of the C5 and C6 cracks in the second case results in a remarkable change in  $\epsilon_p$  distribution. It is seen that the C5 and C6 cracks reduce the strain levels in their vicinity, however they result in an increase in the strain levels at the bottom parts of the central windows. The maximum principal tensile strain reaches about 0.1%. In both cases, the damage class of SW wall is assessed slight damage based on the comparison made between  $\epsilon_{pmax}$  and the suggested limiting tensile strain intervals of Boscardin and Cording (1989) (see Table A1 in the Appendix).

The variation of the relative crack displacements ( $\delta_{cz}$ ) along the height of the C5 and C6 cracks are shown in Figure 11b,c, respectively. Crack C6 is opening more uniformly and widely, whereas C5 widens more at the upper part and relatively less. A direct comparison of numerical and monitored crack

openings is not straightforward due to aforementioned restrictions. Instead, making comparisons based on the summed crack openings of the two cracks makes sense. The analysis yields that the total crack opening of C5 and C6 (C5 + C6) ranges from 7–9.5 mm from the bottom to the top of the cracks. The sum of the monitored crack openings (C5+C6) (at the end of July 2011 in Figure 6) is 5.3 mm.

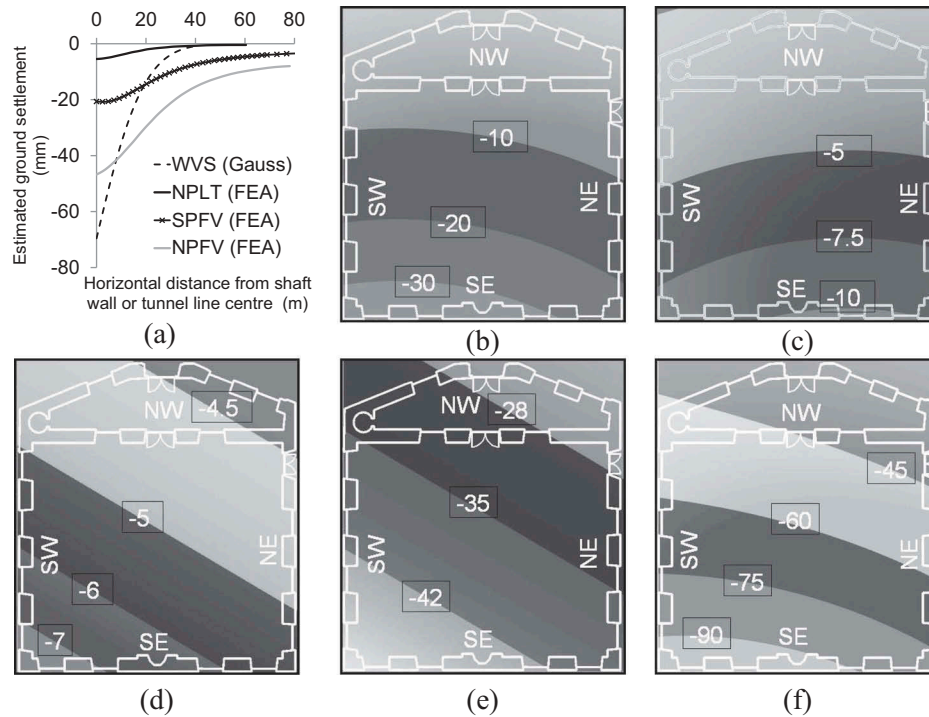
**Figure 13.** (a) Reported or derived 2D free-field ground settlement estimations which are used to produce settlement fields and 3D settlement field contours generated for (b) WVS, (c) NPLT, (d) SPFV, (e) NPFV, and (f) combination of WVS, NPLT, SPFV, and NPFV excavations.

Free-field ground settlements due to tunnel excavations were obtained from the numerical analysis results reported by the contractor company (Figure 13a) (Prediction of Ground Surface Settlement Report 2011). In these analyses, 2D plane strain conditions were considered. Man-made fill (I) and clayey silty sand (II) layers were modeled using an elasto-plastic Mohr-Coulomb model. Besides the elastic properties, anisotropic damage parameters were used to reduce the shear modulus of the greywacke (III). Damage parameters were determined through back analyses based on the monitored crown and spring line settlements of the concerned tunnels. Figures 13c–e show the contours of the settlement fields which are produced based on the numerical simulations

- (1) Although the estimated settlements are increasing towards the SE-SW corner (SB18) due to closeness of this corner to the WVS, SPFV, and NPFV excavations (see Figures 2a and 13b,d,e, a more severe settlement was measured in reality for the SE-NE corner (SB14). The reason of reading higher settlement from SB14 monitoring bolt might be due to a possible local discontinuity and stiffness difference in the relatively thick and loose man-made fill. The region has been a trade and residential center over the centuries and many archaeological relics including ancient building parts and wells have been discovered (Figure 14) (Iwano et al. 2013).

The second-stage analyses are performed using the combined 3D settlement field shown in Figure 13f and (Table 7). The Analyses 1 (reference), 2, and 3 aim to investigate the effect of the Young's modulus of the masonry. Analyses 1, 4, 5, and 6 investigate the effect of the bedding stiffness using a constant Young's modulus of the masonry. Analyses 7 and 8 study the effect of the leaving out the pre-existing crack and bedding interfaces, respectively. In analysis 9 both interfaces have been left out.
