## Indoor climate in the Rietveld Schröder house

Lubelli, Barbara; van Hees, Rob

# 5 / INDOOR CLIMATE IN THE RIETVELD SCHRÖDER HOUSE

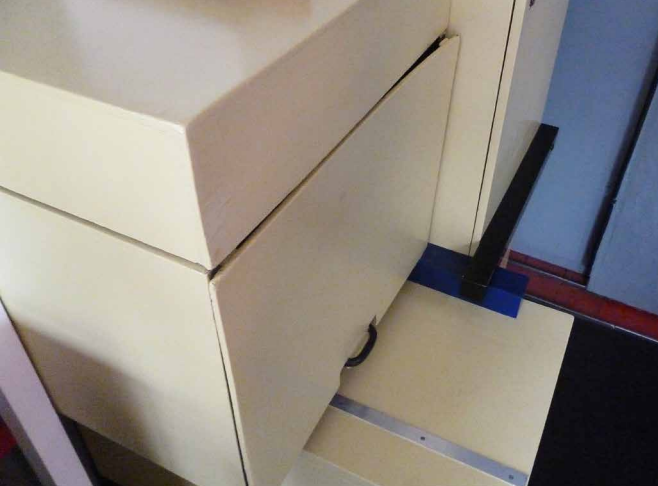
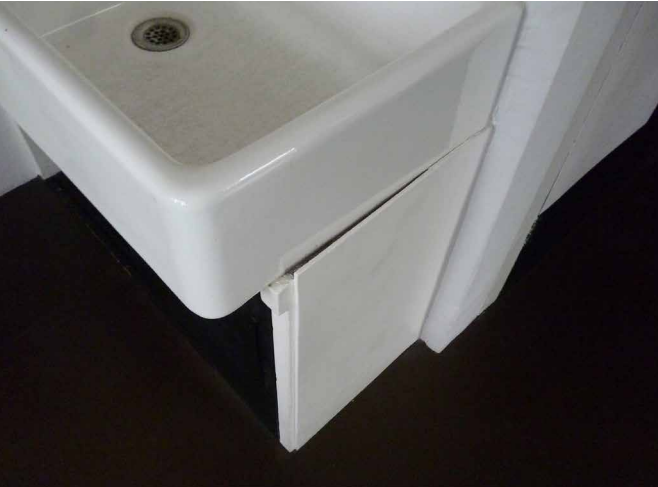
FIG. 5.2 Deformation of thin timber elements of furniture

The state of conservation of the furniture is generally good. However, some pieces of furniture, mainly the thinner parts, are visibly deformed [FIG. 5.2]. Floor finishes (carpet and linoleum) become worn due to use and are regularly replaced.

No immediate risks of biological growth or mechanical damage have been detected. The option of replacing the original pieces of furniture with copies, might still be considered if the lifetime needs to be optimized or when other risks (e.g. mechanical damage caused by visitors) need to be avoided.

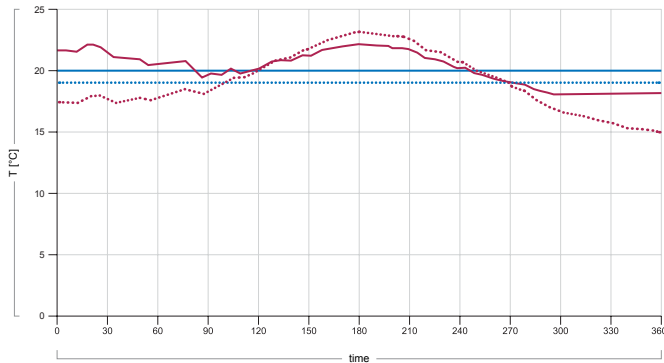
FIG. 5.4 Temperature and RH yearly and seasonal average on the ground and 1<sup>st</sup> floor.

The yearly and seasonal temperatures and RH averages on the ground and first floors are reported in figure 5.4. Based on these values it can be concluded that the average temperature and RH are higher on the ground floor than on the first floor. When daily T and RH variations are considered, larger variations are recorded for the first floor than for the ground floor. This suggests that the climate on the first floor is more affected by variations in the outdoor climate.

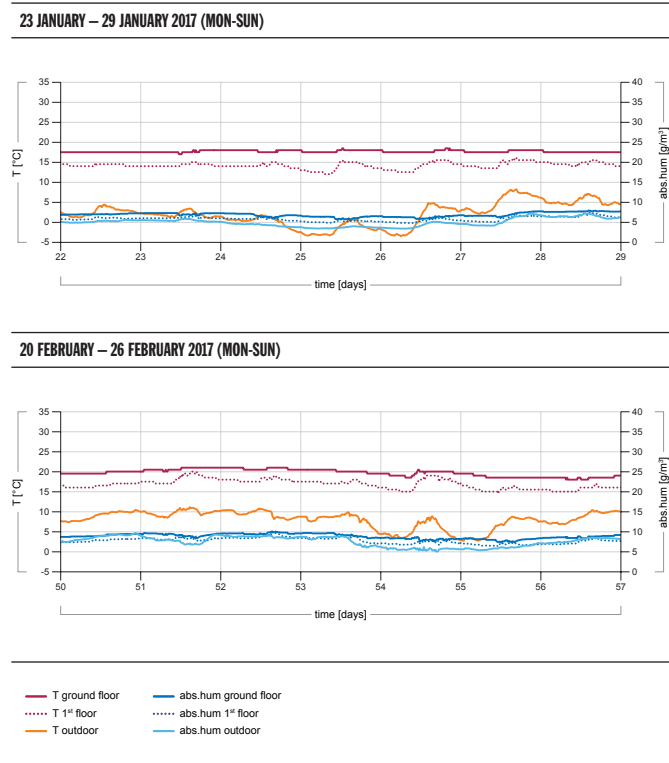
FIG. 5.6 Indoor and outdoor T and absolute humidity on ground and 1<sup>st</sup> floor during two weeks in the winter period

The presence of visitors has no evident effect on temperature and absolute humidity in the building: it is not possible to distinguish any peak in temperature and/or indoor absolute humidity during the visiting hours; not even during winter [FIG. 5.6], which might have indicated the production of heat or moisture by people. This means that ventilation nullifies any effect produced by visitors and confirms that the building is open to the outdoor climate.

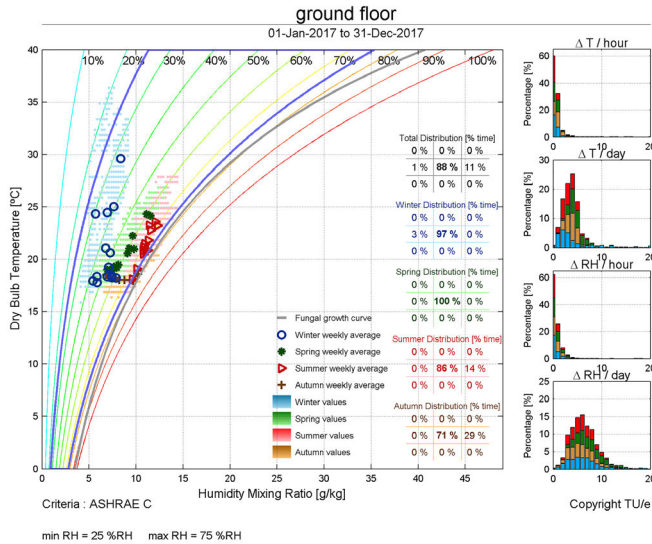
FIG. 5.8 Temperature and RH data recorded on the ground floor of the building in 2017 compared to the specifications for class C; graphical elaboration performed using the web tool available at <http://www.monumenten.bwk.tue.nl/>

The absence of surface condensation is confirmed by the measurements of the surface temperature and the calculation of the resulting RH at the surface. Despite no surface condensation being detected, high values of air RH (> 80-85% RH) might still lead to biological growth on plaster and wooden surfaces in the event of extended periods of high RH; in addition, variations in RH and temperature might lead to risks for the conservation of the building materials and furniture. These risks are further examined. First the correspondence of the indoor climate to the specifications for ASHRAE climate control class C, which is the expected class, was assessed. Figures 5.8 and 5.9 show that, when considering RH specifications, 88% and 98% (for the ground floor and first floor respectively) of RH values are within the given criteria for class C. In summer and autumn, there is still a significant percentage of values which exceeded the RH requirements; this percentage is higher for the ground floor than for the first floor. No risk of fungal growth was detected. A few temperature values exceeded 30 °C (due to malfunctioning of the heating system), while a significant number of values exceeded 25°C in the spring and summer period (mostly on the first floor). For climate control class C, according to the ASRHAE guidelines,<sup>8</sup> risks of mechanical damage are mainly present for highly vulnerable objects and for paintings, some books and some artefacts [TABLE 5.2]. However, as the ASRHAE does not further specify which type of artefacts, and the indoor climate does not fully meet the specifications for class C, it is difficult to draw conclusions as to the risks for the conservation. Another approach, which considers the response of the material to the indoor climate,<sup>9</sup> was therefore adopted (see above). Table 5.3 reports the outcome of this elaboration, performed using the web tool at <http://www.monumenten.bwk.tue.nl/>.

Based on these results it is possible to conclude that the indoor climate is safe as far as the wooden furniture is concerned; neither biological growth (germination and growth of spores) nor mechanical damage are to be expected. However, the lifetime multiplier (LM), is relatively low, especially for the ground floor, which means that the service life is lower than it would be in ideal conditions (stable 20 °C and 50% RH).

In order to reduce RH in the summer, air dehumidification should be considered. Ventilation will not be sufficient, as the absolute outdoor humidity during summer is high.
