Decay Patterns And Damage Processes Of Historic Concrete A Survey In The Netherlands

12th International Conference on Structural Analysis of Historical Constructions

DECAY PATTERNS AND DAMAGE PROCESSES OF HISTORIC CONCRETE: A SURVEY IN THE NETHERLANDS

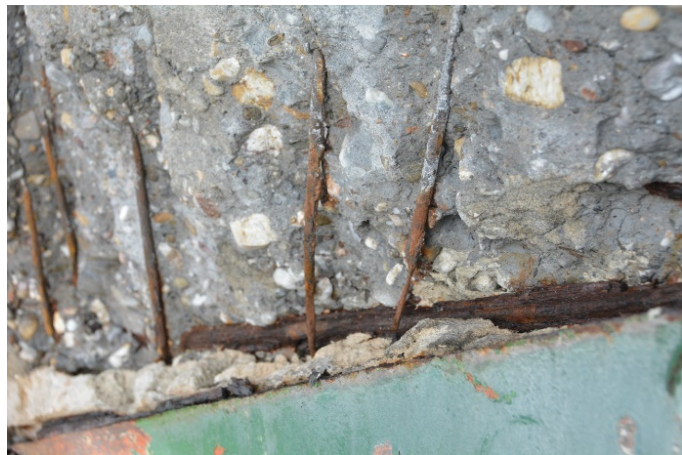
Figure 1. Loss of rebar section due to corrosion in exposed concrete beam from 1921

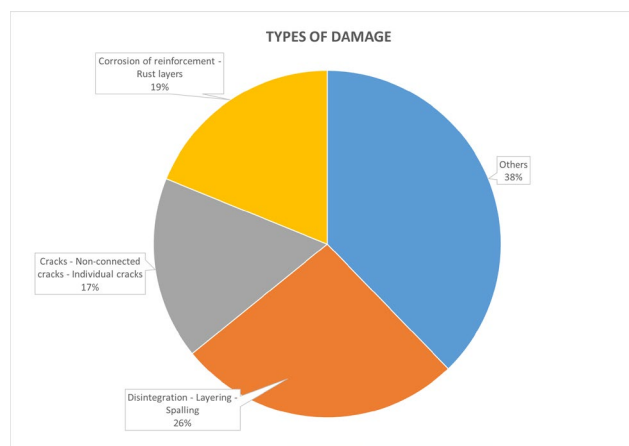
- Spalling (26%), uniform corrosion/rust layers (19%) and non-connected cracks (17%). The rest of the damage types were scattered representing 4% or less (Figure 4).
- 85% of the damages were classified as “Light”, 15% as “Medium Severe”, and 0% as Very Heavy.

Figure 4. Common types of damage

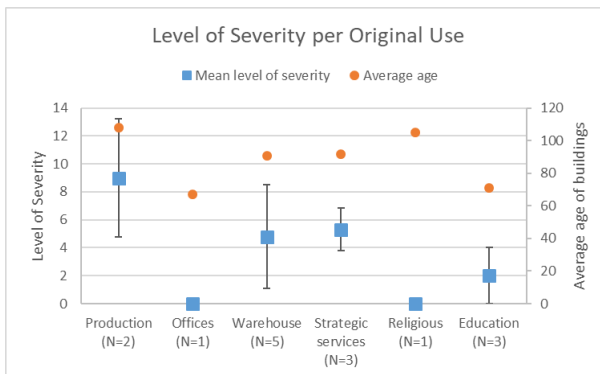
- Office, religious and education buildings had the lowest level of severity. Whereas, production, warehouses and strategic services buildings (water tower, tunnel ventilation buildings, etc.) had the highest levels (Figure 7).

Figure 7. Graph representing level of severity per original uses of the buildings. "N" denotes number of buildings; orange dots represent mean age of buildings under the same category

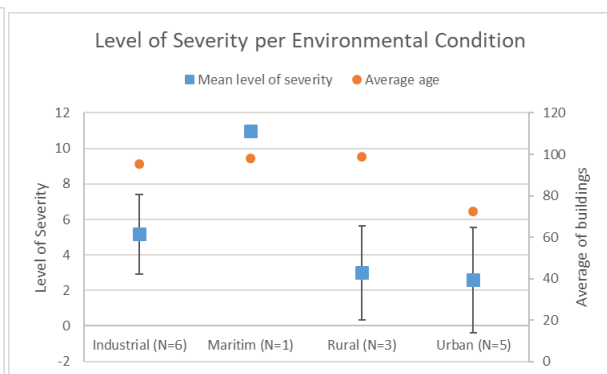
Figure 8. Graph representing level of severity per environmental condition of the buildings. "N" denotes number of buildings; orange dots represent mean age of buildings under the same category

- Damage to buildings located in maritime and industrial environment did show a higher level of severity than buildings located in urban and rural areas, all having

similar average age (Figure 8).

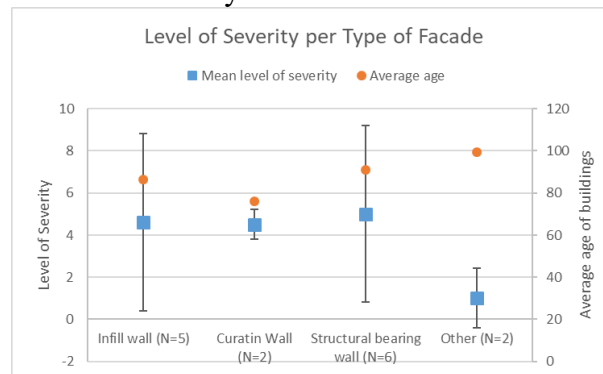
Regarding type of the façade (Figure 10), roof, and structure, there was not a clear influence on the level of severity of the damage found, as it followed the general tendency the higher the average age the higher the level of severity.

Figure 10. Level of severity per type of facade

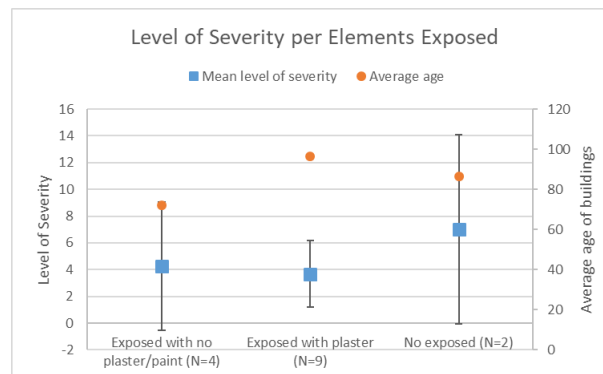
Lastly, the reinforced concrete elements exposed to the outdoors rendered with a cement plaster had on average better performance than the exposed elements with no plaster or paint (Figure 11). It is important to note that the plastered elements had higher mean age than the non-plastered elements. On the other hand, the not-exposed elements, which are protected to weather and rain, resulted in higher level of severity. The main reason for this apparently incongruent result lays in the fact that one of the two case studies under this category was a leather fabric, where water and other chemicals were likely used inside the building.

Figure 11. Level of severity per characteristics of exposed RC elements

- **External sacrificial plaster:** Exposed RC elements with a cement-based plaster exhibited better performance against corrosion and other damage processes than RC elements without additional plaster. Rendering the exposed exterior concrete was a common practice in the Netherlands until the 1930s, apparently to hide the dull and rough aspect of raw concrete [4]. This is in line with the results of the case studies, since 100% of the buildings built before 1937 had a layer of plaster applied to the external concrete surfaces. A plaster layer can provide an additional protection against the ingress of CO₂, moisture, and other soluble substances, which may lead to corrosion and other damages in the concrete [20]. However, if the corrosion has already initiated, as it may be the case in historic concrete, the corrosion will not stop but the corrosion rate may decrease [21].
