Thin-walled concrete beams with stay-in-place flexible formworks and integrated textile shear reinforcement

Lee, Minu; Mata-Falcón, Jaime; Popescu, Mariana; Kaufmann, Walter

Structural Concrete

ARTICLE

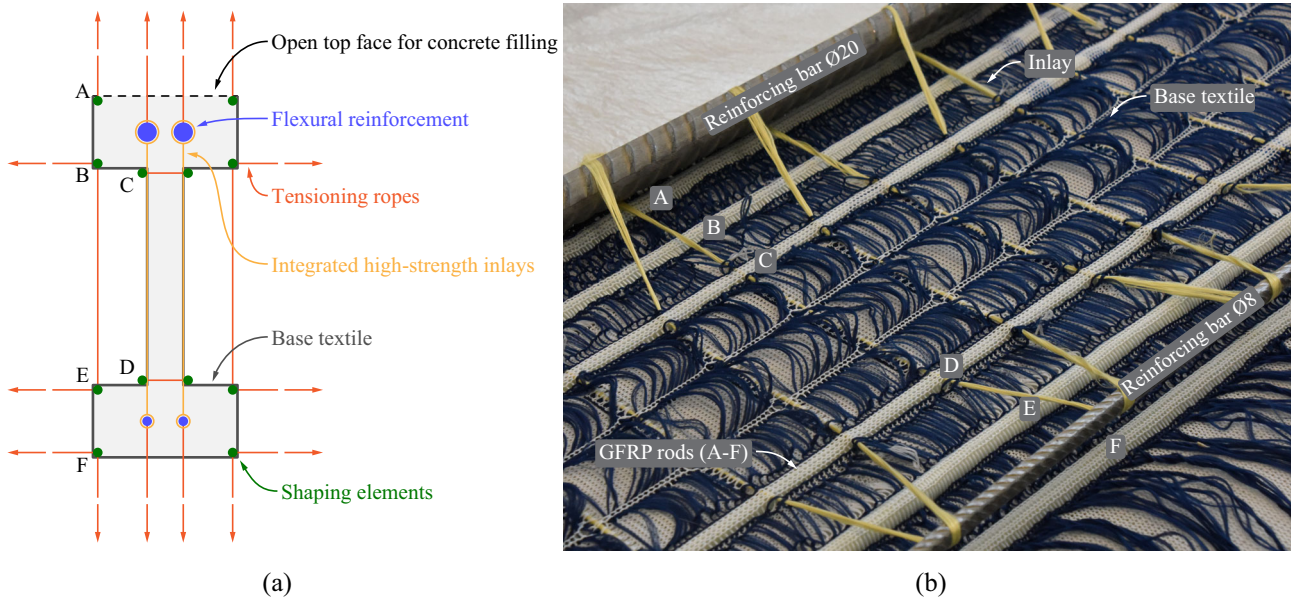
FIGURE 1 Thin-walled concrete beams from folded textiles: (a) cross section (in upside-down casting position); (b) flat textiles before tensioning with integrated flexural and textile reinforcement, and shaping elements.

This study explores an alternative method where the cross section can be formed by folding a flat textile into the desired shape, with cables or bending-active rods defining the vertices, and being tensioned using ropes in a scaffolding frame. In contrast to tubular textiles, one side of the cross section is left open (as shown in Figure 1a), allowing the concrete to be cast with the

The textile formwork was produced in one piece using a gauge 7 CNC flat-bed knitting machine (Steiger Libra 3.130). The knitting was done in the length direction of the beam, with the sectional perimeter (outline) of the beam representing the weft direction of knitting. Two polyester yarns (PES 167 t 30/2) were used to create a sheet of textile that includes longitudinal channels for the insertion of shaping rods, as described in Section 2. Straight inlay aramid yarns were automatically placed during the production process in weft direction, having the correct length and spacing. These inlays formed two continuous zig-zags side-by-side along the length of the textile, thus, connecting the longitudinal reinforcement in the bottom and top flanges of the cross section, which was inserted into these zig-zags (Figure 1b).

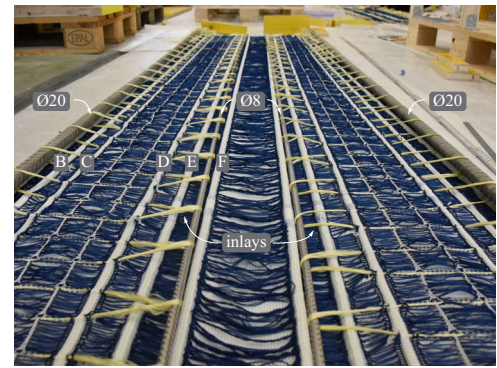
FIGURE 2 Manufacturing of thin-walled concrete beams with stay-in-place formworks and integrated textile reinforcement: (a) scaffolding frame and assembly, (b) textile before tensioning with deformed steel bars and GFRP rods threaded in inlay loops and channels within the fabric, respectively, and (c) tensioning of textile within frame.

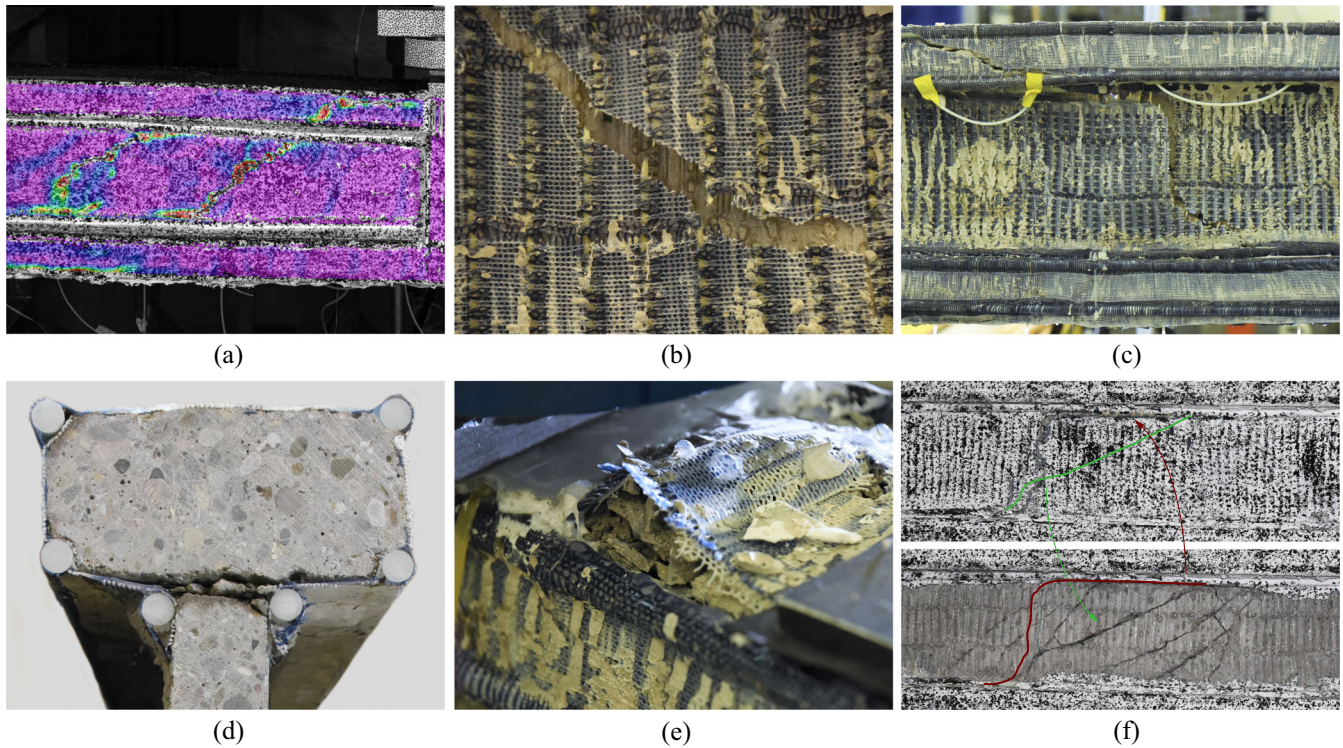
FIGURE 5 Crack and failure behavior of tested concrete beams: (a) substantial crack in textile of Specimen “ISB-T” before failure (illustrated by the measured principal tensile strain field); (b) ruptured aramid rovings in “ISB-A-s20”; (c) propagation of shear crack along web-flange interface and into compression chord; (d) cut specimen after testing (“ISB-T”); (e) concrete crushing in compression chord; (f) governing crack in the concrete (green) and failure crack in textile (red) after testing.

All beams with high-strength inlays exhibited a sudden drop of the applied force and rupture of the aramid rovings when reaching the ultimate load (Figure 5b) in the first loading cycle. The shear cracks, which formed as expected in the shorter span, propagated to the flanges, causing horizontal cracks at the web–flange interface and in the compression chord, as shown in Figure 5c,d. The failure loads increased with the transverse reinforcement ratio, as shown in Figure 6, highlighting the significant beneficial influence of the aramid inlays on the shear strength.

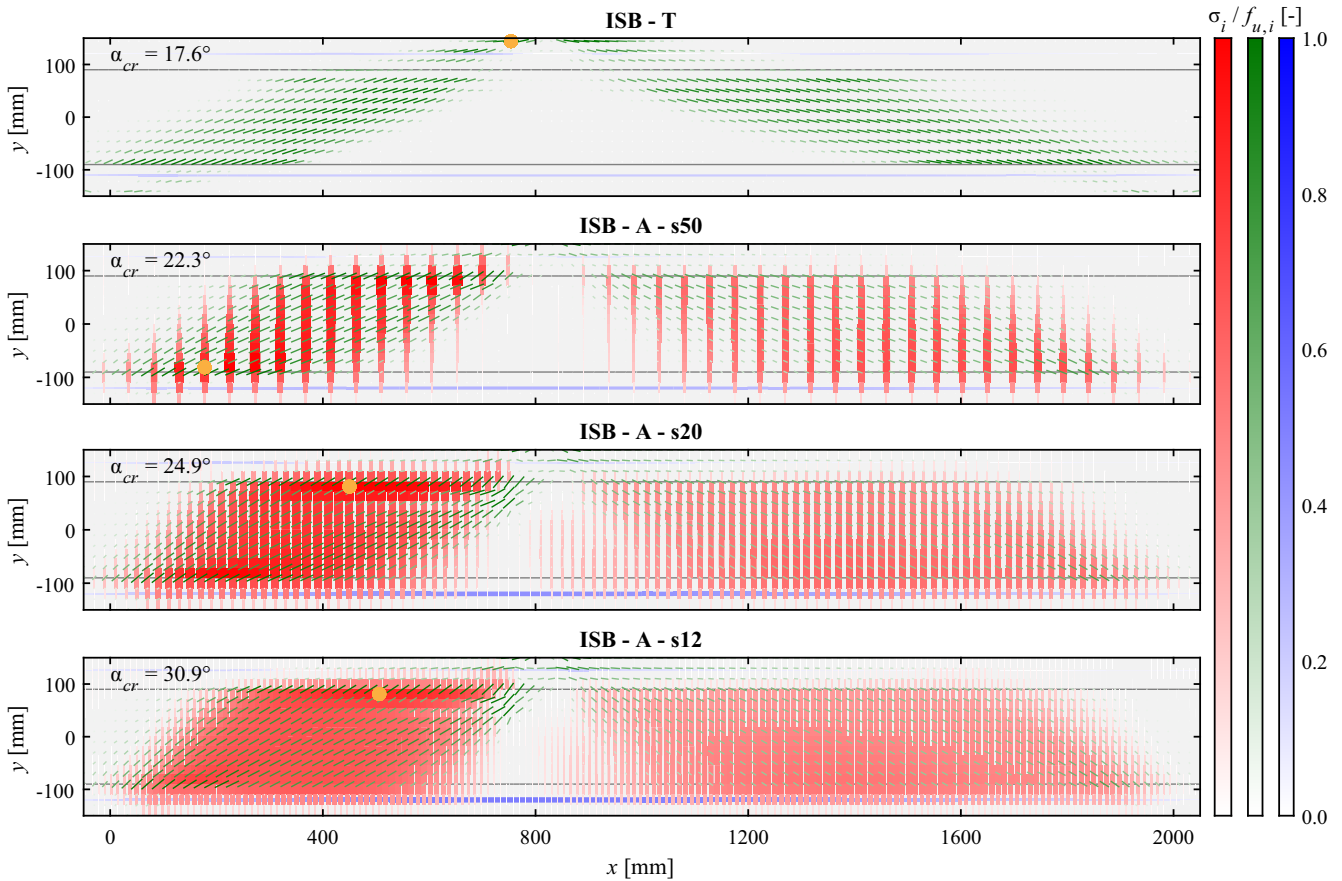
FIGURE 14 Utilizations (stress divided by effective strength, admissible stress, and yield strength, respectively) predicted with compatible stress fields for transverse aramid rovings (red), concrete (green, inclinations of lines according to principal direction), and deformed steel bars (blue), with thicknesses of reinforcement and line lengths of compressive stresses proportional to their magnitudes, and yellow dots denoting governing element (utilization = 1).

The predicted load transfer of Specimen “ISB-T” without high-strength inlays (shown in Figure 14) mainly depended on the formation of a direct strut from the load introduction to the support, which is reflected by a flat inclination of the compressive stresses. Clearly, the model assumption of stress-free, rotating cracks differs from the actual behavior due to the absence of transverse reinforcement, as observed in the experiment, where the governing shear crack exhibited a steeper inclination and hardly any flatter cracks formed. The failure eventually
