Research paper

# Modelling masonry façade cracking induced by non-uniform temperature gradients with soil-structure interaction

Clay masonry  
Light damage  
Cracks  
Vulnerability  
Temperature-effects  
Insolation

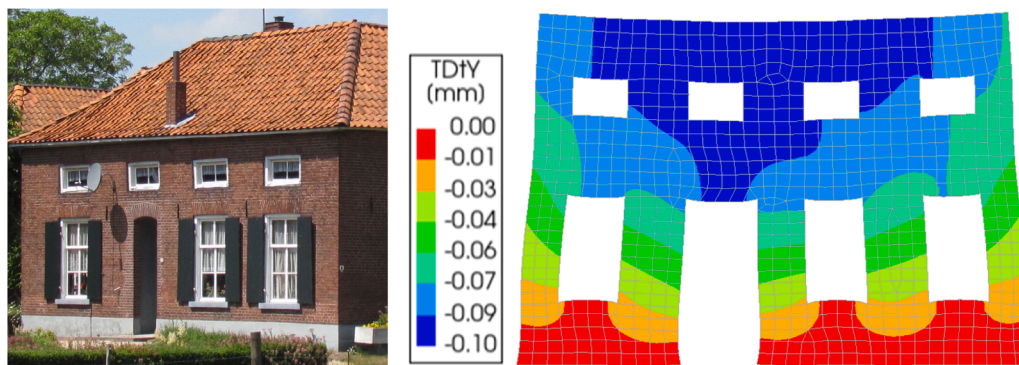
Fig. 1. Example of a recognised historical masonry façade in the Netherlands, left. Right, a 2D model of the front façade subjected to a horizontal strain at the base and showing its exaggerated deformed shape with a contour colouring of vertical displacements. This façade inspires a few of the façade geometries studied in this work.

restraining effect on the façades. The model is thus built up as presented in Fig. 7 (and later Fig. 10). The masonry façade, with unreinforced masonry foundations and interlocked transversal masonry walls, is placed atop a layered soil block, of which three variations are analysed: a fully sandy profile (labelled Soil #6 in reference to a study with representative Dutch soil profiles [64]), a clay-peat-sandy profile (Soil #9) and a clayey-sandy profile (Soil #0) with a stiffness value (at the foundation) in between that of the other two profiles. The illustrated façade corresponds to that of the historic building introduced in Fig. 1.

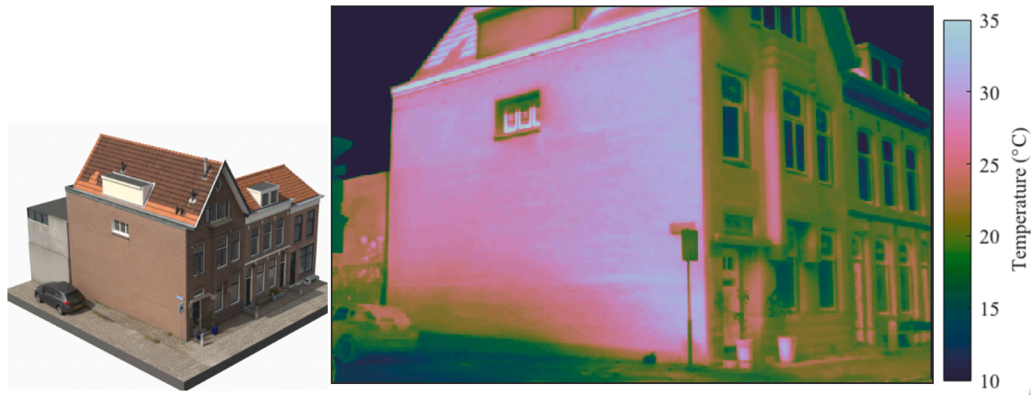
Fig. 2. Temperature on a façade from a thermographic image. The photograph shows a different temperature between neighbouring walls and a stark temperature decrease where the façade is in the shadow. Own images, see also [69].

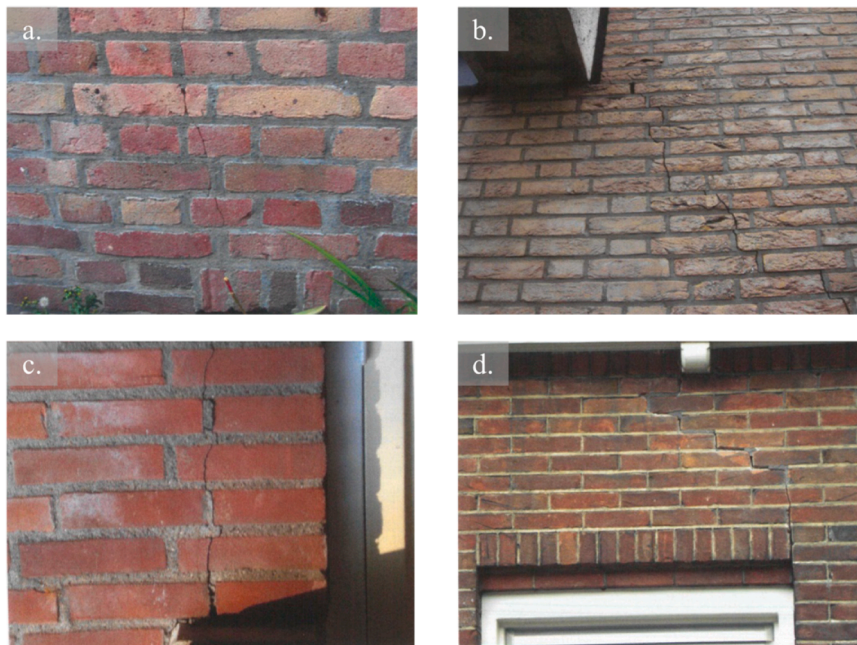
Fig. 3. Photographs of cracks in bare masonry walls. (a) Small crack narrower than 0.5 mm; (b) crack approximately 2 mm wide; (c) crack narrower than 2 mm; and (d) wider than 5 mm. Adapted from SBR [60].

The cracking behaviour of masonry façades is more complex, though cracks are a common expression of damage in masonry; see Fig. 3. The wider the crack, the more severe the damage may be categorised. Cracks on façades do not always correspond to structural damage but will still compromise the watertightness of the structure and its aesthetics, potentially affecting the perception of safety of its users [61]. When several cracks are present, determining the damage severity is more cumbersome; in this study, the damage parameter  $\Psi$  is used. The parameter summarises crack-based damage in masonry by considering the number of cracks ( $n$ ), and the cracks' width ( $c_i$ ) and length ( $L_i$ ) as per

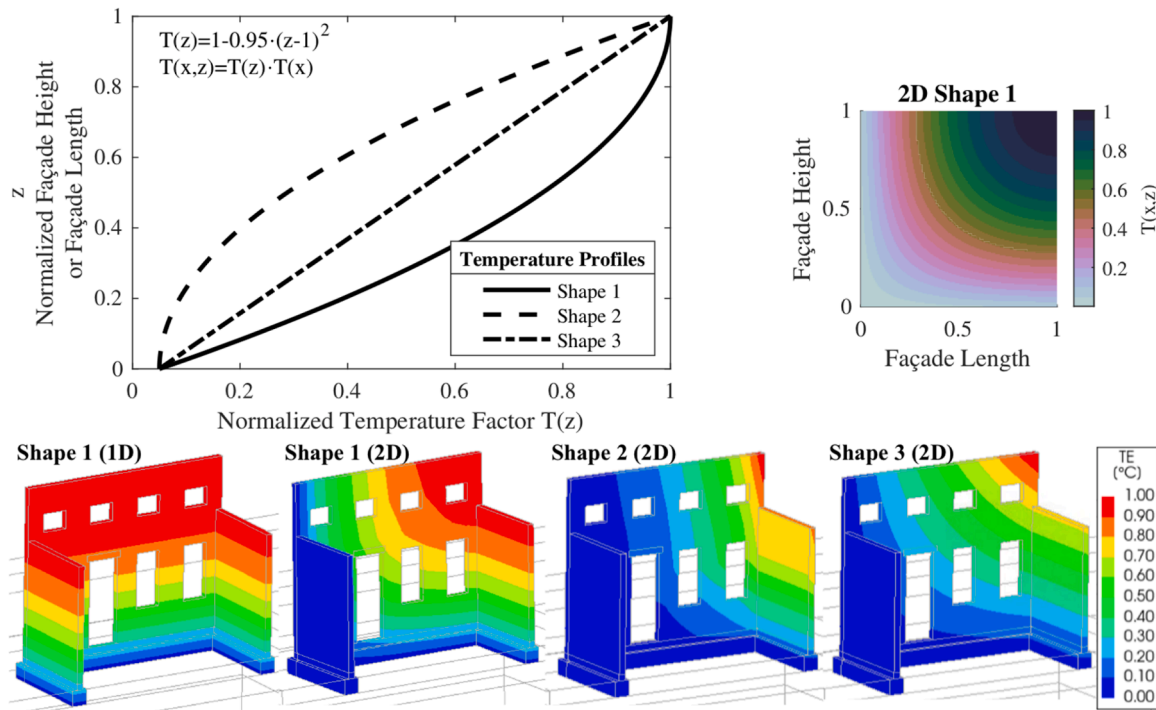
**Fig. 8.** Temperature profiles or gradient shapes on a façade. Three functions are applied vertically or horizontally to produce four distinct gradient shapes.

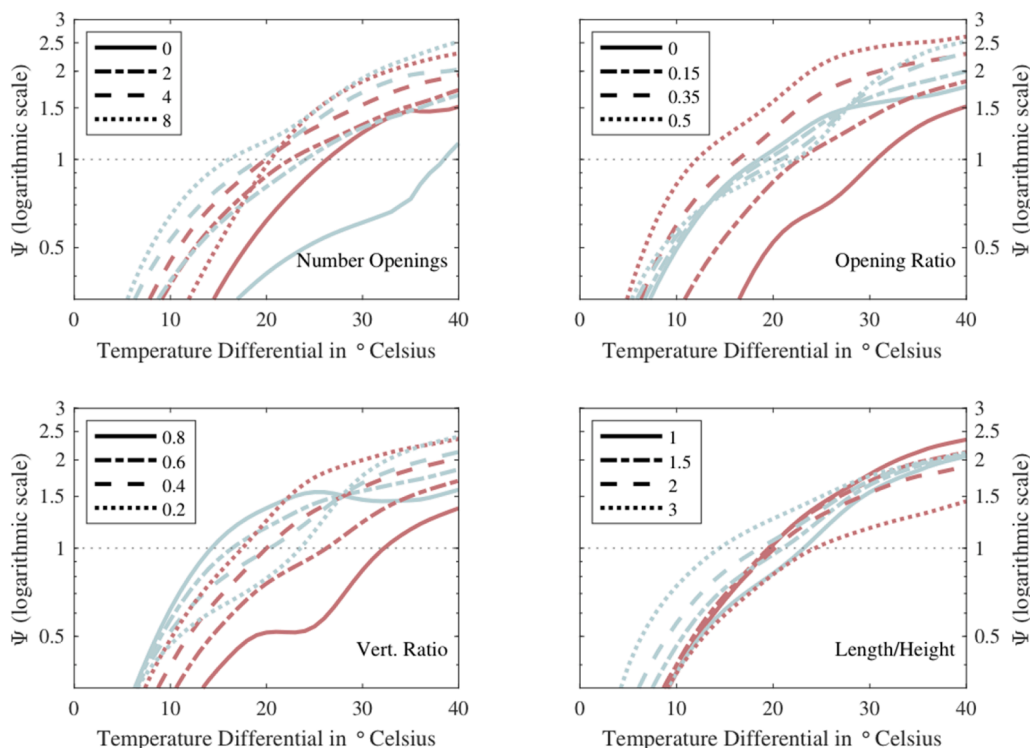
Fig. 15. Segregation by geometric properties. The curves are the means of all the façades, soils, materials, etc. but are limited to the 2D Type 1 temperature profiles.

Other interesting comparisons concern the geometrical features of the façades. Fig. 15 segregate the average of the results by the number of openings, opening ratio, vertical masonry ratio, and length/height ratio. Most behave as expected, though their quantifiable influence on the response for  $\Psi=1$  is a key outcome of this figure. The more openings a façade has, the more vulnerable it is to temperature effects. Indeed, the curves for zero openings are 10 °C to 25 °C less vulnerable than those with eight openings. Cooling temperature shapes are more affected by the number of openings than warming profiles. The opposite is true when considering the opening ratio; in this case warming profiles are most affected by a different opening ratio. However, the expected outcome, that a higher ratio of openings, up to 50 % of the façade dedicated to openings illustrated in the figure, will reach visible damage 20 °C earlier than a façade with no openings, and that the other two ratios fall in between, is shown. For the cooling profiles, the opening

ratio seems irrelevant regarding damage sensitivity. While the two graphs (number of openings and opening ratio) are related, the comparisons with the opening ratio are made between façades with similar number of openings to only contrast the parameter of opening ratio.

Finally, Fig. 15 compares the length over height ratio. Longer façades, with a higher L/H ratio, seem more vulnerable for cooling and less for warming gradients. However, from the four geometrical features presented, the L/H is the least influential one. This stands in contrast to damage from settlement actions for which the L/H is the most influential parameter [65].

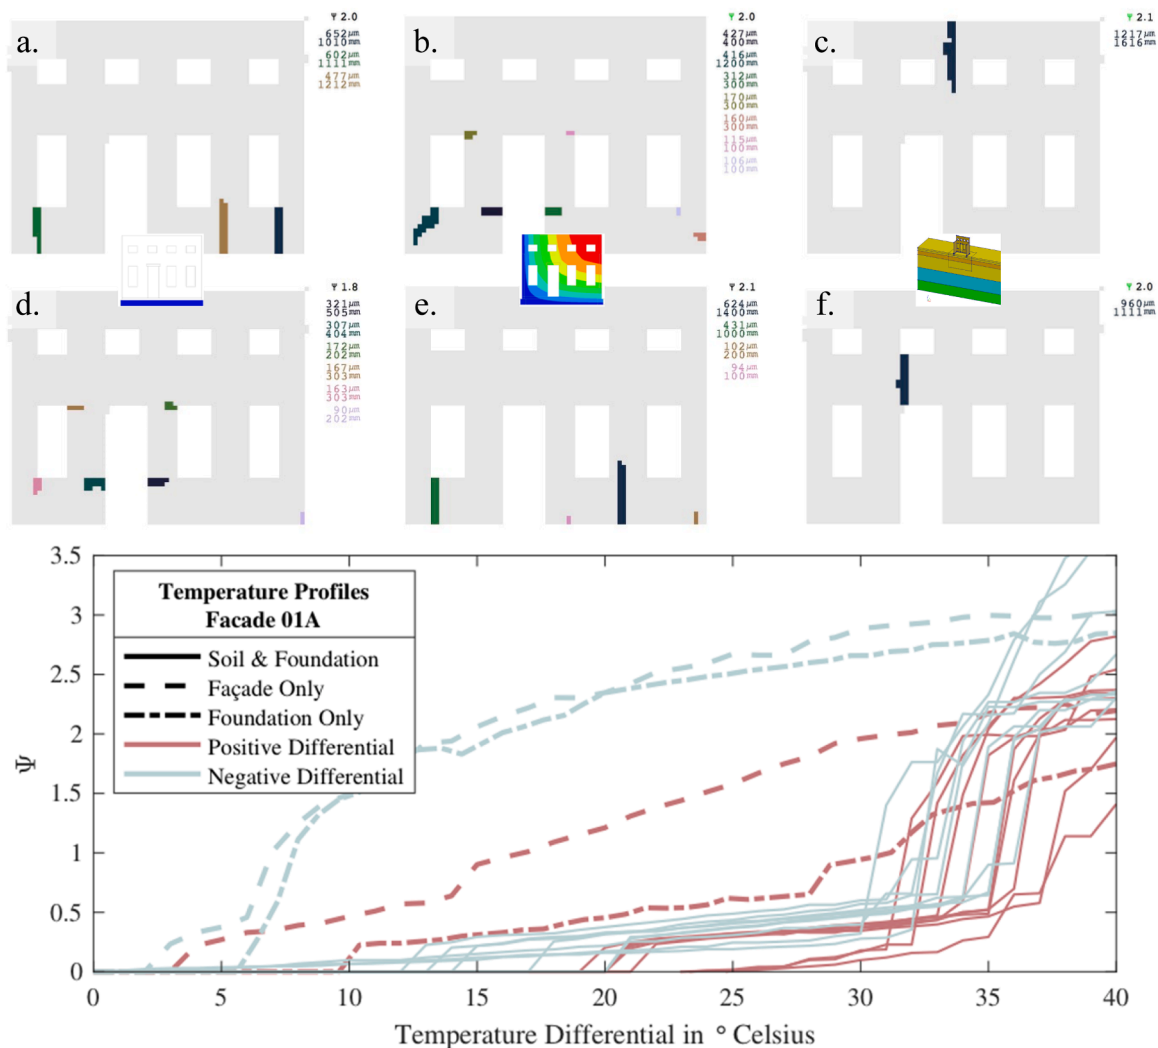
Fig. 16. Comparison for F01A with or without soil, temperature at the foundation or at the façade. See Fig. 9. Top row (a-c): temperature increase; bottom row (d-f): temperature decrease. Left column (a, d): temperature change applied to the foundation only; middle column (b, e): temperature change applied uniformly to the façade only; right column (c, f): temperature gradient applied to façade and foundation.

For façade 1A only, additional comparisons were made against two situations that do not consider the presence of the soil, and which use a uniform temperature variation. This is a more common approach to modelling temperature effects; Fig. 16 demonstrates that it results in significantly more damage for this façade and might be overly conservative. Consider the crack patterns first. These correspond to the

cracking situation at damage intensities around  $\Psi \approx 2$ . Yet the approaches with uniform temperature variations reached this state 20 °C earlier than the method proposed herein and display a larger number of cracks distributed throughout the façade. In contrast, damage for the façade, only restrained by the soil and experiencing a gradual temperature variation, is concentrated in a single crack for both positive and negative temperature gradients.

The crack patterns are consistent with the modelled situation. When the foundation is warmed up (a), it expands, which forces the façade on top of it to expand as well leading to tensile stresses in the horizontal direction and ultimately vertical cracking. Similarly, when the façade cools (e) but the foundation is unaffected by a temperature change, the façade, trying to contract, will develop horizontal tension and crack vertically. In the opposite situation, when the foundation cools (d) or the façade warms (b), the associated contraction and expansion are prevented by the façade or foundation, respectively. In these cases, the façade is forced to contract (d) or prevented from expanding (b). The masonry piers in between the openings are charged with transferring this deformation (d) or restraint (b) to the top of the façade via a shearing action. This results in rocking failure [66] of the piers with horizontal cracks at their top and bottom. The behaviour of the situation with a gradient temperature change (c and f) is more complex and was analysed in Fig. 12. However, the single crack appears towards the top of the façade instead of at the bottom region as with the other two approaches.

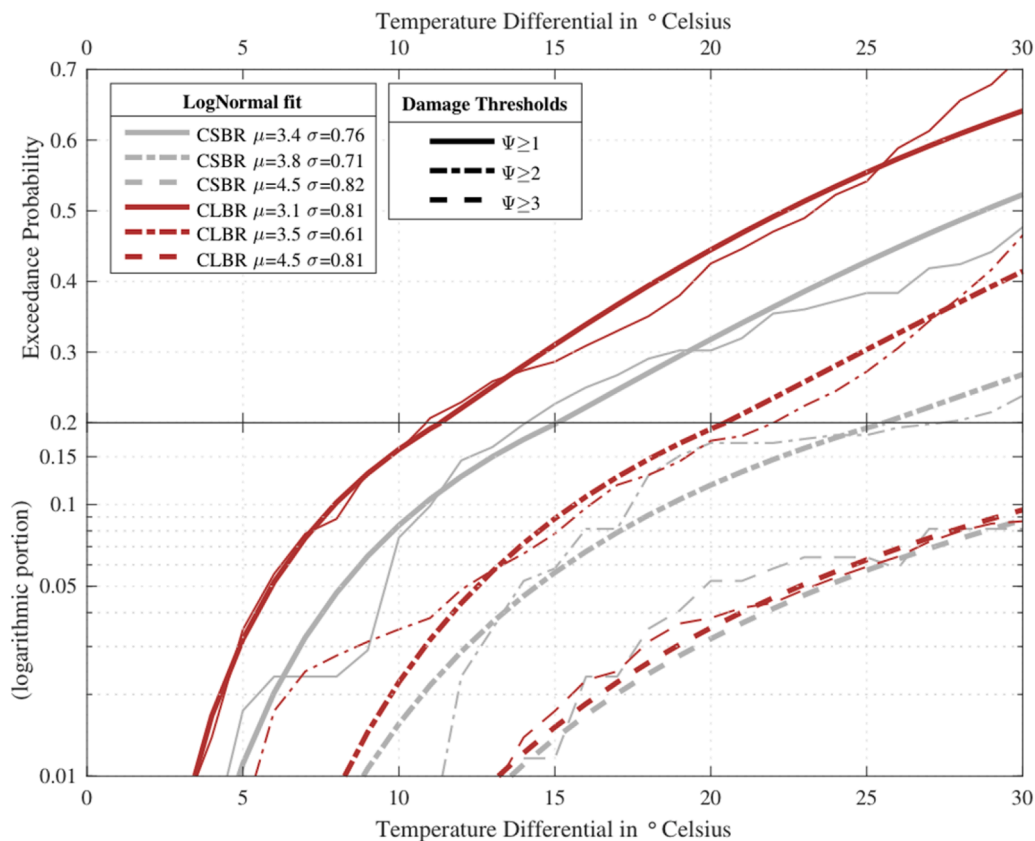
Fig. 17. Exceedance probability. CaSi vs Clay. The data between 10 °C and 25 °C is weighted twice for the lognormal fit (bold lines).

Finally, with Fig. 17, we take advantage of the large number of model results to determine fragility-like exceedance curves. These are elaborated by counting the number of models that, at a given temperature differential, exceed certain thresholds of damage. The curves consider both positive and temperature profiles and are segregated by façade general typology, with the reinforced (CSBR) and unreinforced (CLBR) foundations. The results are fitted to a log-normal distribution as is common practice for fragility curves [67]. This also helps to produce

smoother curves in regions where there are few results such as at the very low bottom of the graph. Note that the lower portion of the graph is plotted with a logarithmic scale precisely to better display the very low probabilities of damage.

For temperature differentials, where one point on the façade differs in temperature to another on the opposite corner, of about 5 °C the probability of reaching or exceeding visible damage ( $\Psi=1$ ) is 2 %, which can be considered very low [68]. A temperature differential of 22 °C is needed for visible damage to be expected (50 % probability) for buildings on unreinforced foundations and of 28 °C for buildings on reinforced foundations. Exceeding light damage ( $\Psi \geq 3$ ) is not expected, in fact, for both types of masonry, the probability of exceeding light damage is below 10 % even for the 30 °C differential considered in this study. The probability of clearly visible damage with cracks of about 1 mm in width ( $\Psi=2$ ) is 2 % at 10 °C for unreinforced masonry and slightly lower for reinforced foundations.
