# Investigation on the attenuation trend of Acoustic Emission in reinforced concrete structures

Yubo Sun 4614887

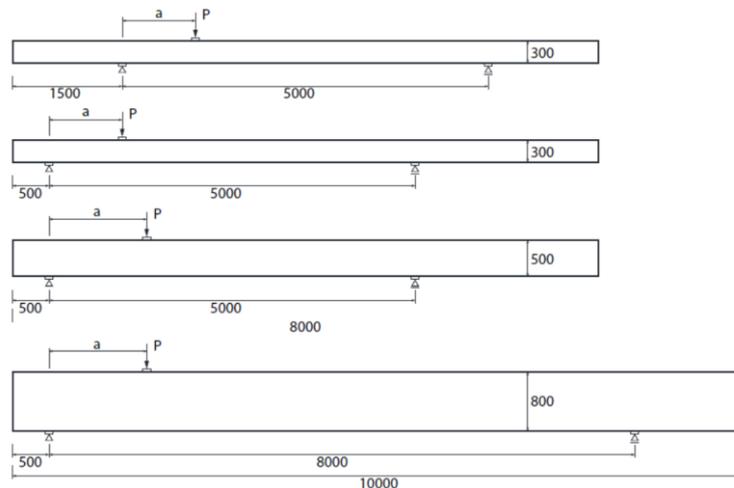
**Fig. 2.2.1 Configurations of the boundary conditions of the tests**

In all the tests, the specimens are simply supported, and the positions of supports are shown in Fig. 2.2.1. The position of point loads varies in tests to find out the expected failure modes, which is expressed by the distance from one of the supports (distance  $a$ ) in the figure. A long cantilever was left out of the longer end support so that the two ends of each specimen could be tested separately.

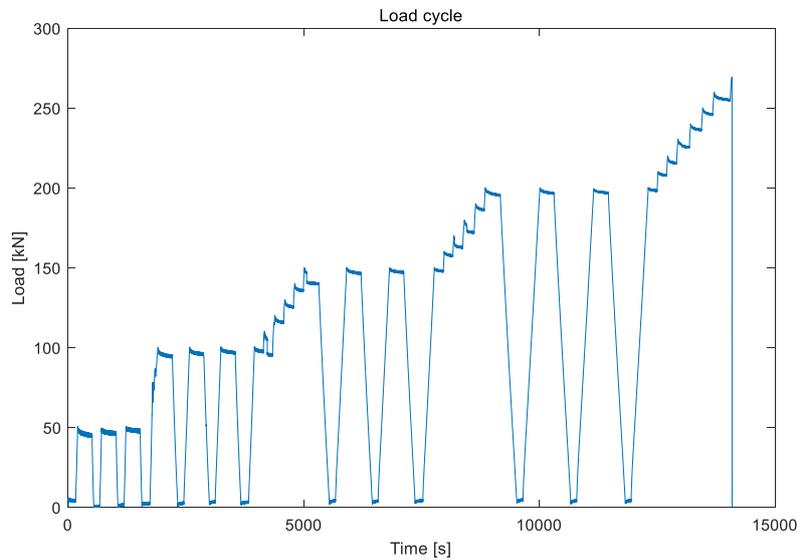
**Fig. 2.2.3** Load cycles

AE and LVDT measurements are introduced in tested specimens, layouts could be found in *Appendix I*. For this study load cycles are performed for Acoustic Emission measurements (Fig. 2.2.3).

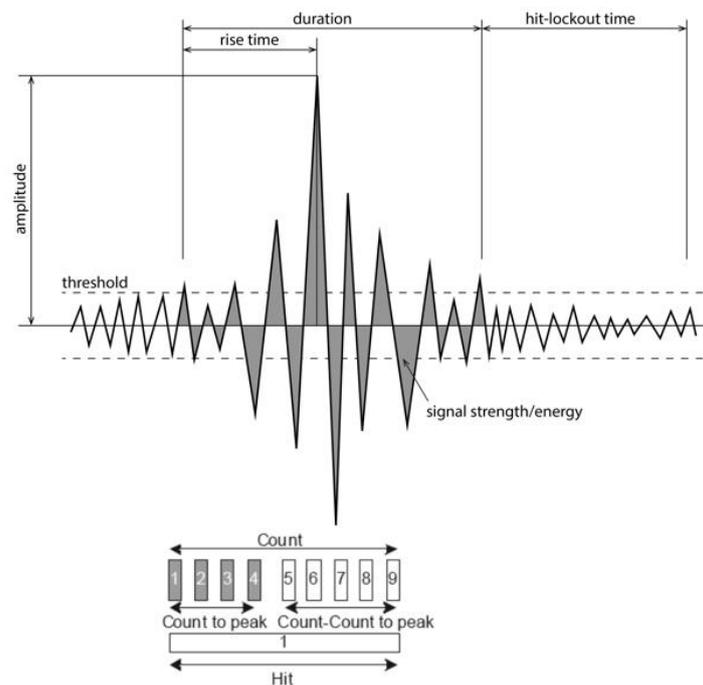
**Fig. 2.2.4 Conventional AE signal features**

Elastic waves generated by fracture phenomena is detected by AE sensors as electrical signals (AE signals). Therefore, characteristics of AE parameters are studied to reveal the physical phenomena of cracking. In what follows, signal parameters (shown in Fig. 2.2.4) most widely used are explained from definitions (ISO 12716 2001) [3].

- Hit: a signal that exceed the threshold and causes a system channel to accumulate data. It is frequently used to show the AE activity with counted number for a period or accumulated numbers.
- Count: the number of times within the duration, where one signal strength exceeds a present threshold.
- Amplitude: a peak voltage of the signal waveform is usually assigned, which is closely related to the magnitude of source event.
- Duration: a time interval between the triggered time of one AE signal and the time of disappearance is assigned.
- Rise time: a time interval between the triggering time of AE signal and the time of the peak amplitude is assigned.
- Signal strength: a measured area under the rectified signal envelope.
- Average frequency: a calculated feature obtained from *Count* divided by *Duration*, which determines an average frequency over one AE hit.

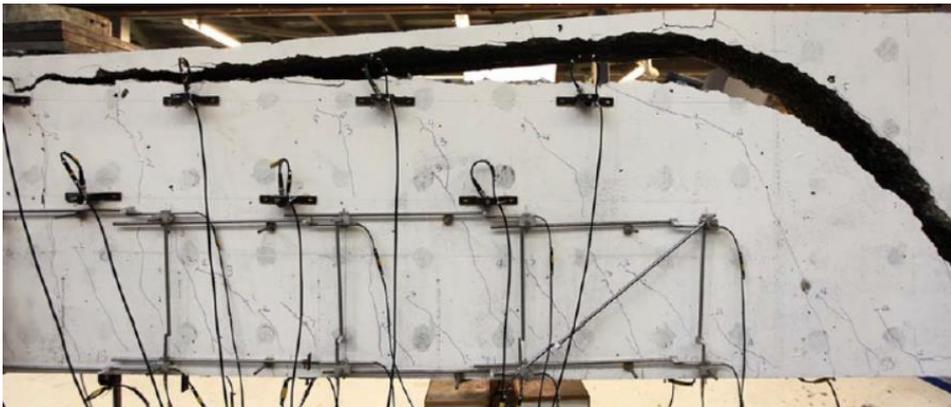
**Fig. 2.2.6 AE and LVDT grid**

Crack openings are measured by LVDT grid shown in Fig. 2.2.6. Elongation of specific part of concrete specimen could be measured so that the crack openings could be tracked.

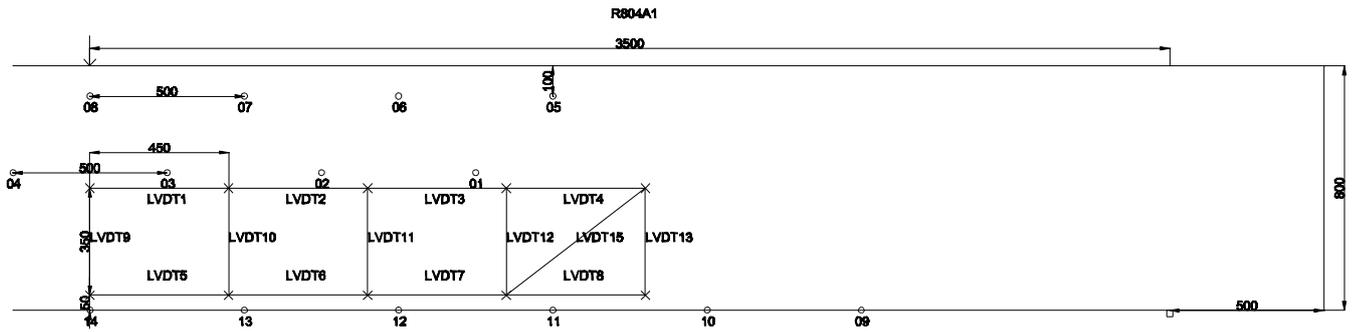
Fig. 3.3.1 AE layout of R804A1

Therefore, in this study, the CSS detected by AE sensor located at the bottom surface of specimen closest to loading point is regarded as Fictitious Source. For instance, AE layout of specimen R804A1 is given in Fig. 3.3.1. The AE sensors (No.1 – No.14) are divided into three rows and installed on the surface of concrete beam, and AE signals of 14 channels are recorded in computer memories. In this test, the first flexural crack is expected to occur at the position where external load is applied at the bottom of the beam and propagate upward due to the longest lever arm according to the support position. It is obvious that AE sensor No.14 is the closest one to the first crack and the attenuation is smallest, and therefore, AE signal recorded in channel 14 is selected as the Fictitious  $G_0$ .

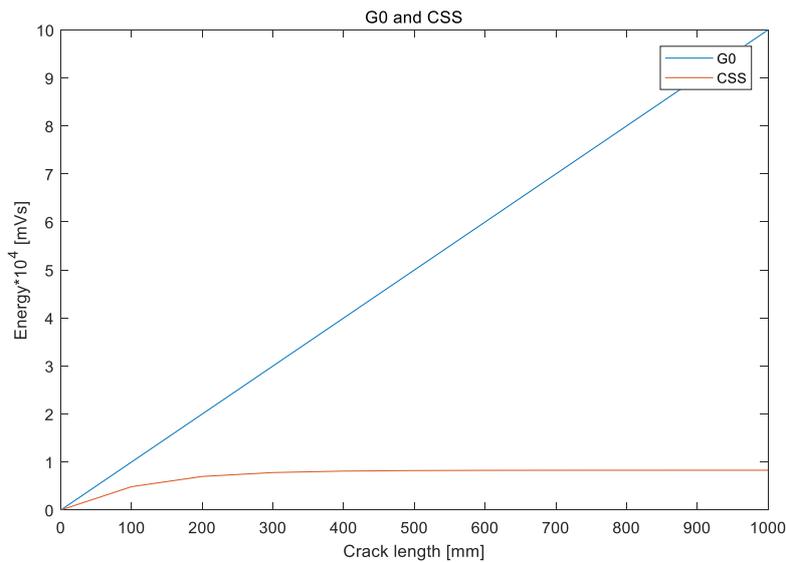
**Fig. 4.2.2 Comparison between CSS and G0**

Result is plotted in Fig. 4.2.2 (unknown constants are assumed to be 1), and it is obvious that after crack has grown to a certain length the CSS detected by a single AE sensor nearly approaches a constant while the total amount of energy release of a crack increases linearly as crack propagates.

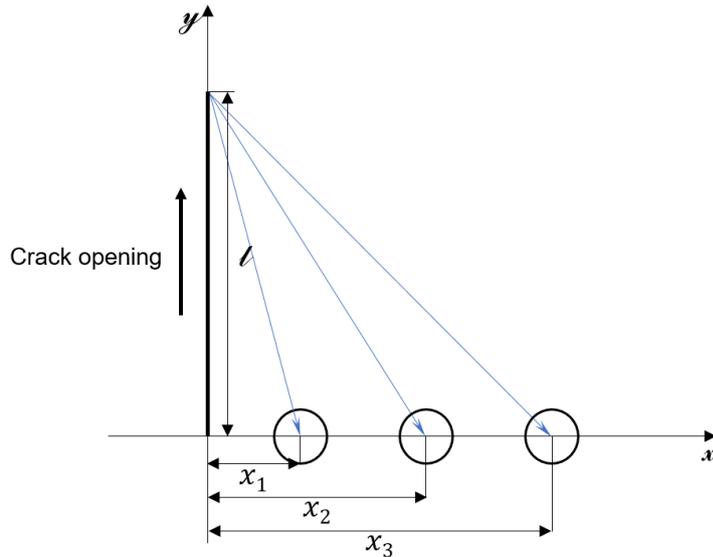
**Fig. 4.2.3 Simplified model of horizontal distance model**

Here, the attenuation factor of signal strength is given as a function of distance  $A(x) = A_0 e^{-\sqrt{x^2+y^2}}$ , and  $\sqrt{x^2 + y^2}$  is the distance between AE sensor and crack front.

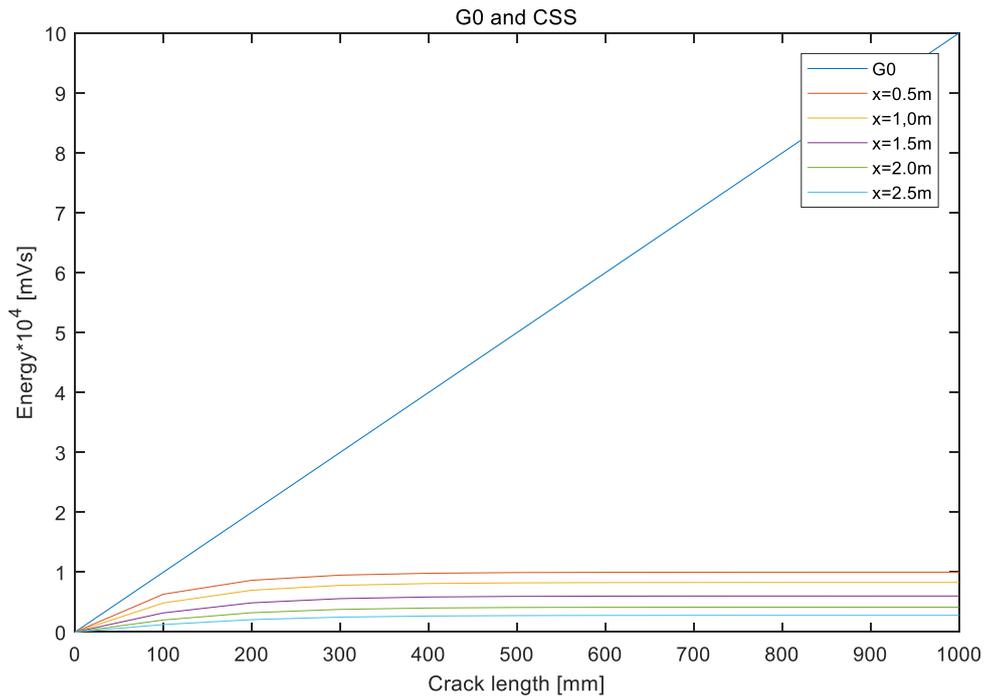
Fig. 4.2.4 CSS of a single sensor versus Horizontal distance

Setting the horizontal distance  $x = 0.5, 1.0, 1.5$  and  $2.0$  m respectively, CSS of each sensor against crack length is plotted in Fig. 4.2.4. An obvious decrease in CSS is observed with the increase of horizontal distance. The result shows that as the horizontal distance between sensor and crack increases, CSS detected by a single AE sensor would decrease since the propagating distance is longer and more energy is dissipated.

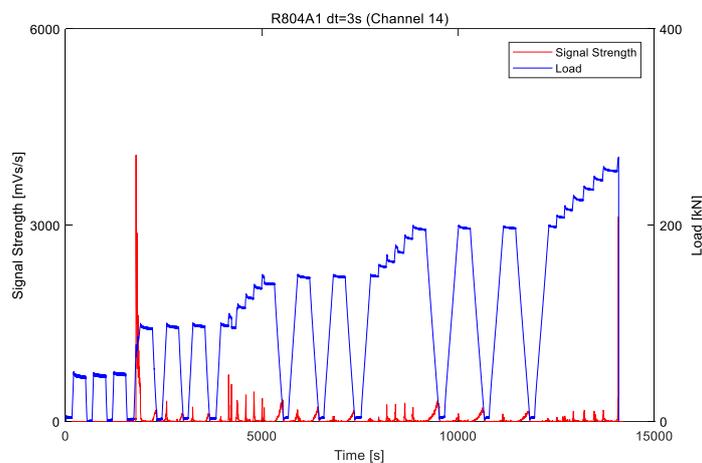
**Fig. 4.3.2 Load-time and SS-time curve of R804A1 (Channel 14  $dt=3s$ )**

It is obvious that there is a high concentration of AE impulse within loading phase. Since AE signals are detected at discrete points in time, this graph could not show the amount of energy release accurately. To solve this problem, a modified graph is shown in Fig. 4.3.2 by summing up and plotting the AE signal strength in every three seconds ( $dt=3s$ ). An obvious energy release phenomenon is observed in loading phase. The occurrence of peak values of signal strength are always accompanied with a significant drop of slope in loading curve, which represents the generation of a crack. On the other hand, however, energy release phenomenon is also observed at the end of unloading phase, which is suspected to be induced by crack closing or friction. Energy induced by these kinds of mechanisms should not be accounted into the amount of energy release in crack opening. Therefore, the time period of CSS is strictly limited within the loading phase where the first crack occurs and grow to full length. In addition, noises introduced by other mechanisms such as rubbing of crack surfaces during crack closure, debonding of the reinforcing steel from the surrounding concrete, and environmental noises should always be avoided. Unloading where other mechanisms would be dominant are excluded.

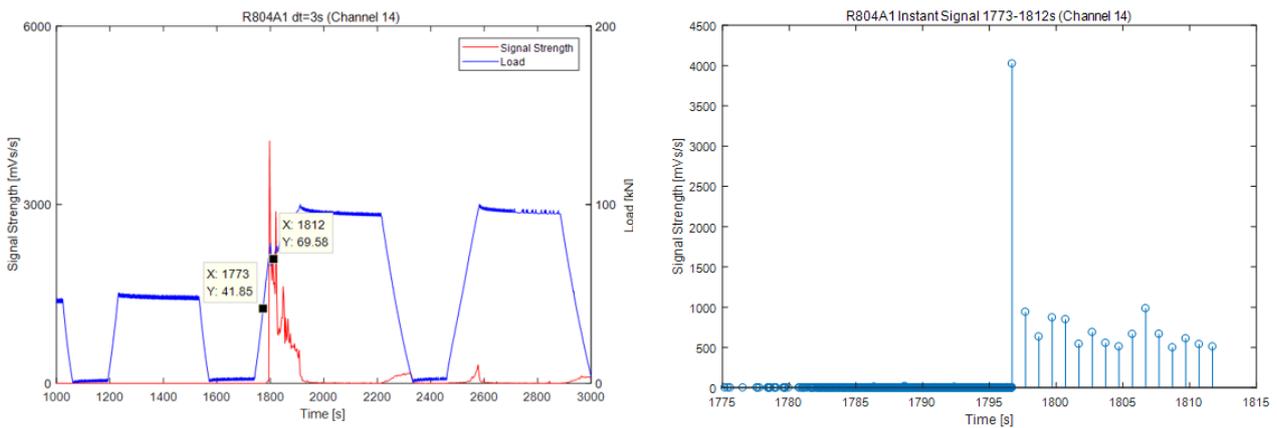
Fig. 4.3.3 1773-1812s R804A1 (Channel14 dt=3s)

Zooming in to examine loading phase, shown in Fig. 4.3.3, the time period where the first SS peak occurs is taking out individually to account for the amount of energy release in the first main flexural crack. However, an obvious overlap of SS peaks is observed, which means several cracks are growing together and affecting each other in AE signals. This kind of phenomena occurs in several tests because the crack pattern is hard to predict. The solution is to separate each peak in loading history and only the first peak is selected to account for the 1<sup>st</sup> main flexural crack. By summing up all signal strength in channel 14 from 1773s to 1812s (Fig. 4.3.3), the CSS is 14239 mVs. As a matter of fact,  $G_0$  should be little bit greater than CCS of AE14 since there is an attenuation while the signal wave travels from crack front to the position of AE sensor.

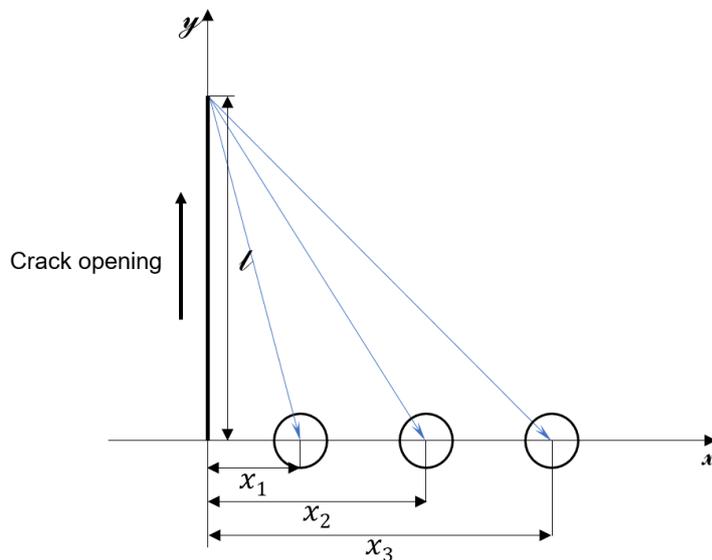
Fig. 5.1.1 Simplified model of horizontal distance model

As mentioned before, horizontal distance between AE sensor and crack is an important factor affecting CSS detected by a single sensor. In this chapter, CSS of several sensors installed in the same row with different horizontal distance are compared to each other to find attenuation (Fig. 5.1.1).

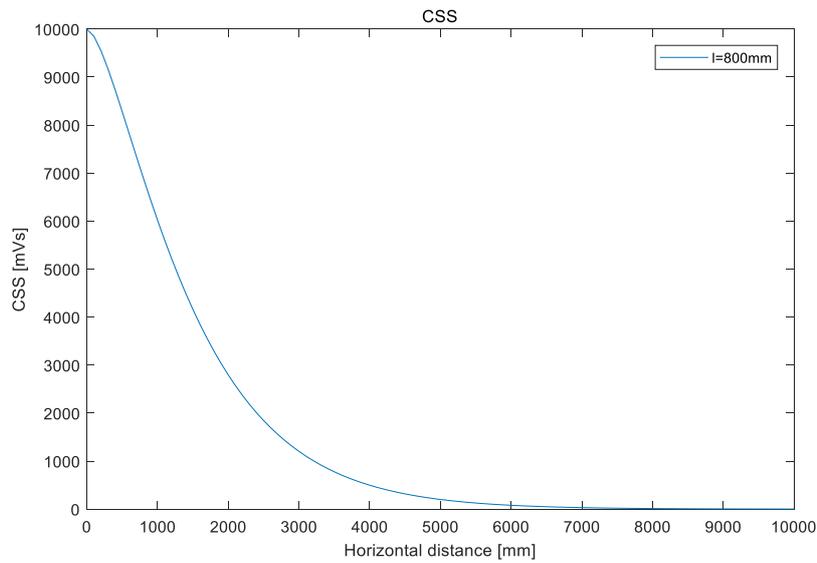
**Fig. 5.1.2 CSS of different sensors versus Horizontal distance**

CSS of different sensors in a row are plotted against distance in Fig. 5.1.2. A significant attenuation of CSS is observed as horizontal distance between AE sensors and crack increases. CSS drops rapidly at the beginning, and while the horizontal distance is big enough, almost no signal would be detected by AE sensor. The phenomena unambiguously illustrate that as the horizontal distance increases, crack length is no longer the dominant factor affecting CSS, since the vertical length of crack is negligible comparing with horizontal distance.

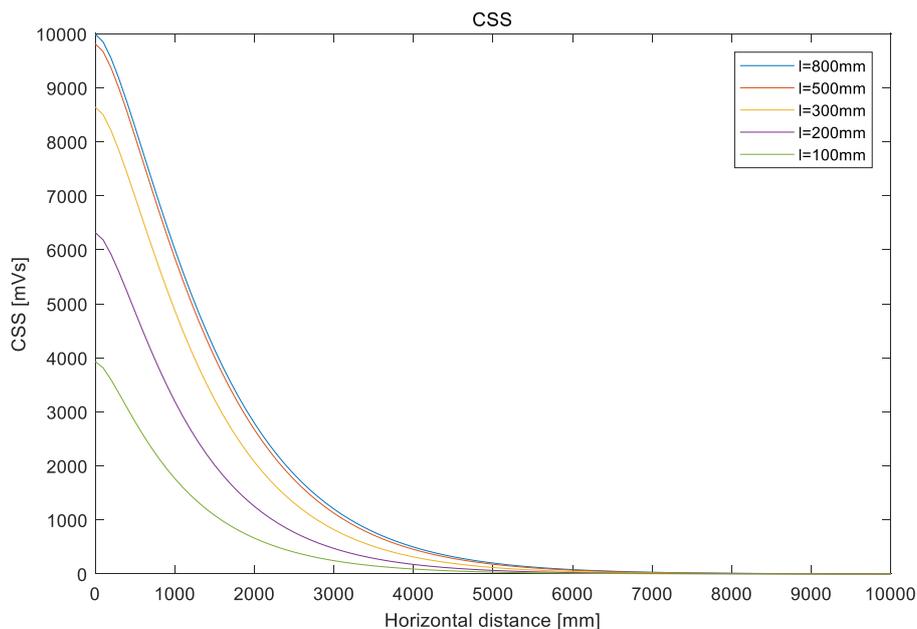
**Fig. 5.1.3 CSS versus Horizontal distance (different crack length)**

Crack length may also affect the attenuation. Setting crack length  $l=800, 500, 300, 200$  and  $100\text{mm}$  respectively (Fig. 5.1.3). While the crack length decreases to 1/8 of initial length, approximately only 40% percent energy is detected. In horizontal direction, a quite clear attenuation is observed in each crack length. After the horizontal distance increasing to approximately  $6000\text{mm}$ , CSS of each case almost decrease to zero.

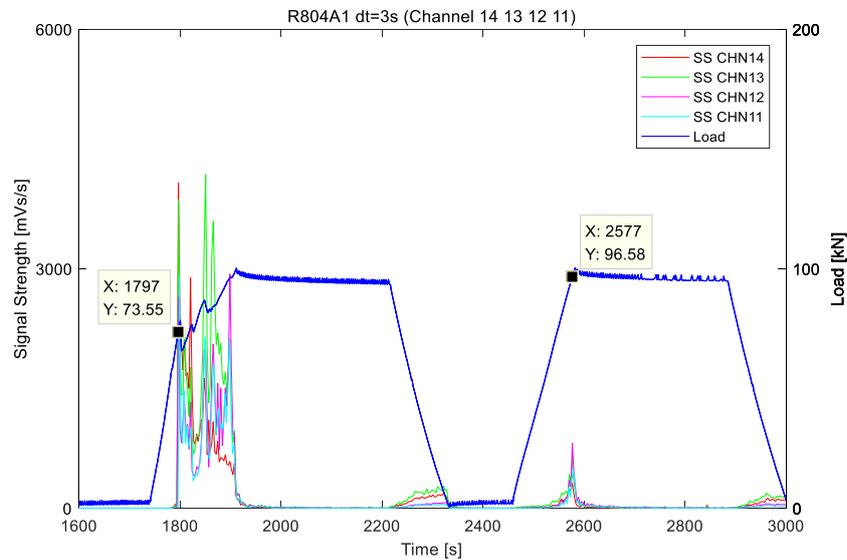
**Fig. 5.2.1 Load and Signal strength against Time (R804A1)**

In test R804A1, for instance, AE signals detected by sensors 14, 13, 12 and 11 are plotted against time in the same graph as shown in Fig. 5.2.1 (time period 1600-250s). It is quite clear that there is no distinct time delay of peak values in different channels, only the peak signal strength of each channel varies. Several cracks propagate almost together according to this graph, which is quite hard to distinguish.

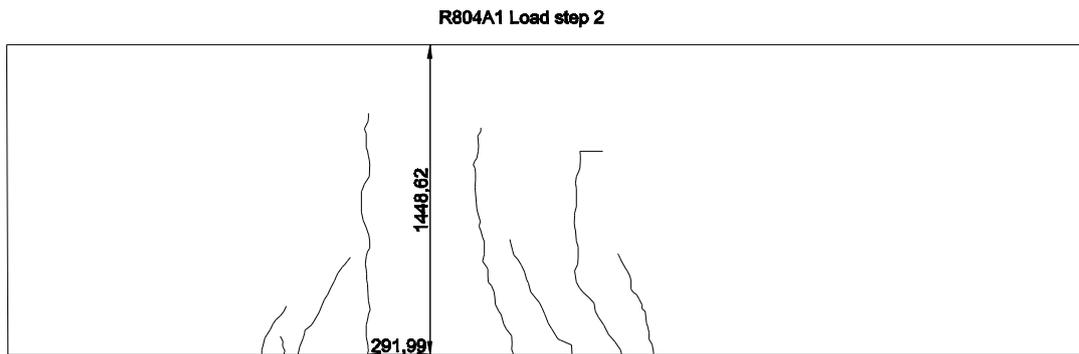
Fig. 5.2.4 Crack pattern of R804A1 load step 2

Crack pattern of load step 2 of R804A1 is given in Fig. 5.2.4, the 1<sup>st</sup> main flexural crack is located to the left of loading point, which it is not detected by LVDT6. According to Fig. 5.2.5, energy release of the first crack is in the time-period 1773-1812s, and CCS within this period detected by each sensor is given in Table. 5.2.1.2.

According to the crack pattern of R804A1 in load step 2 and 3 (shown in Fig. 5.4.1 and Fig. 5.4.2 respectively), the length of crack path in uncracked specimen is  $\frac{1127.72 \cdot 800}{1448.62} = 622.78$  mm (approximately 600mm level), and the length of crack path in cracked specimen is  $\frac{419.55 \cdot 800}{1461.38} = 229.67$  mm (approximately 200mm level). Comparison between theoretical results and curve fitting results is given in Fig. 5.4.3 and Fig. 5.4.4.

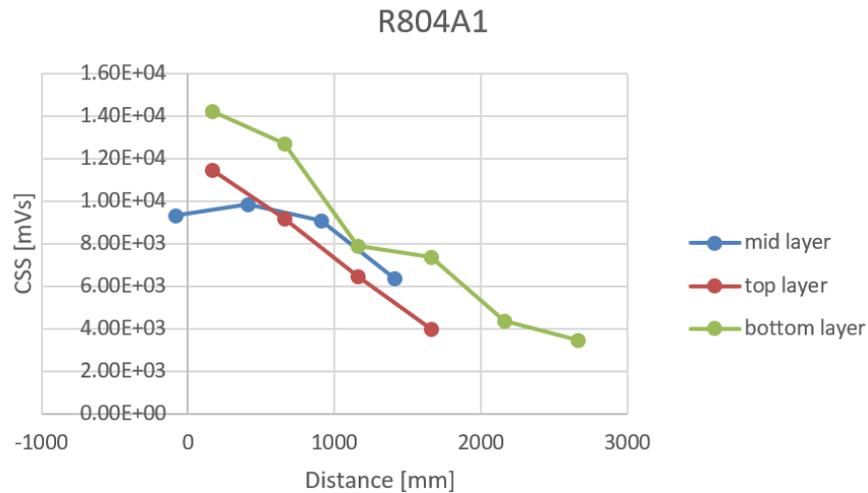
Fig. 5.2.6 CCS-Distance R804A1 (uncracked)

According to AE grid, sensors are divided into three layers, and attenuation of each AE row could be investigated. CCS against time is plotted in Fig. 5.2.6 in three groups. An obvious attenuation is observed in each layer as horizontal distance increases.

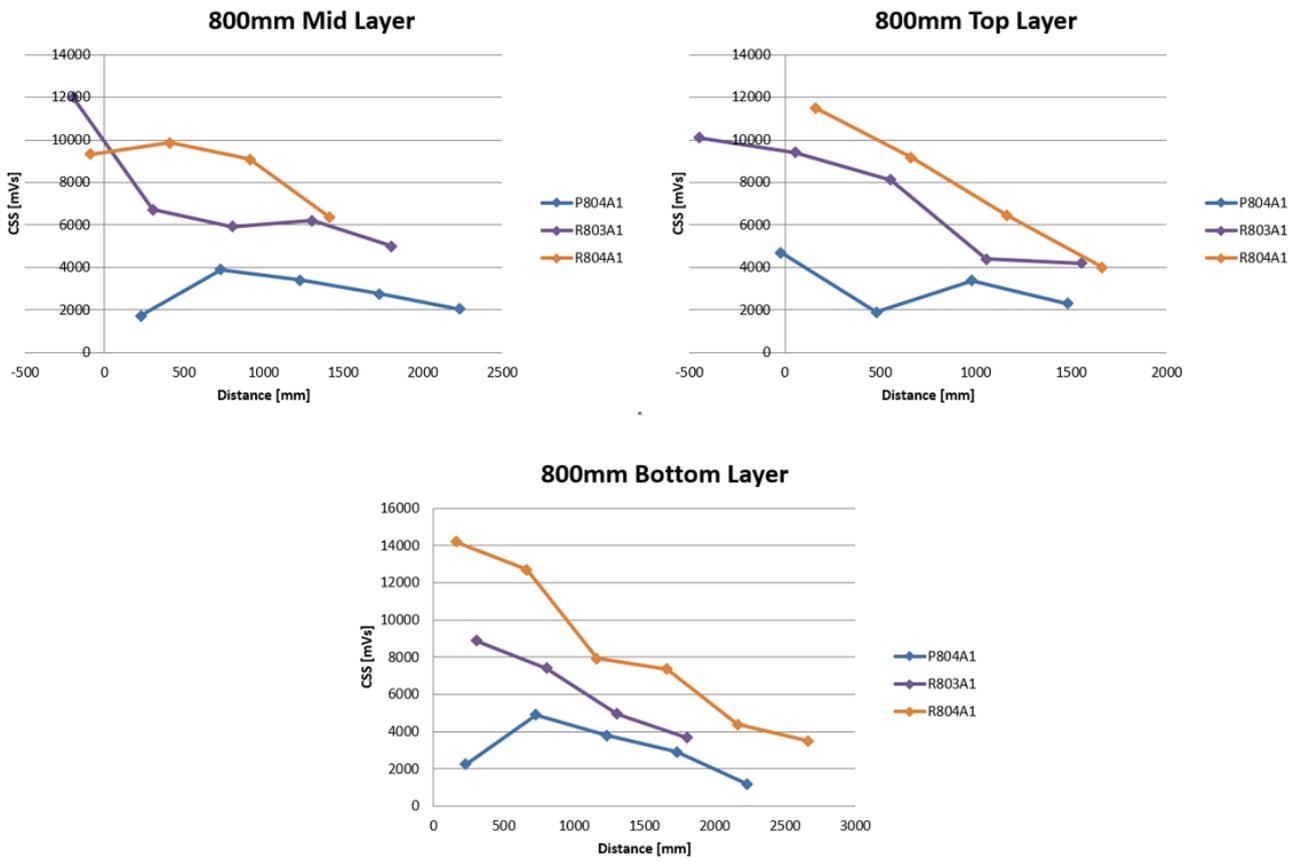
Fig. 5.2.7 CSS of 800 mm beam in different layers (uncracked)

CSS are plotted in three layers against distance since different factors would be dominant, as shown in Fig. 5.2.7. The factor  $G_0$  could be estimated by reading the signal strength of AE sensor closest to the crack. According to figures above,  $G_0$  of bottom layer is always higher than mid layer and top layer. The bottom layer AE sensors would be more affected by those newly generated cracks on bottom surface of specimen, which would increase the total amount of energy release, and therefore the CCS of bottom layers are higher. Besides, CSS of top layer is expected to be the lowest since the propagating distance is the longest, however, it's also interesting to find that there is no apparent difference between CSS of mid layer and top layer. It is suspected that the reflection of AE signals from top surface of specimen may affect the signal strength of top layer.

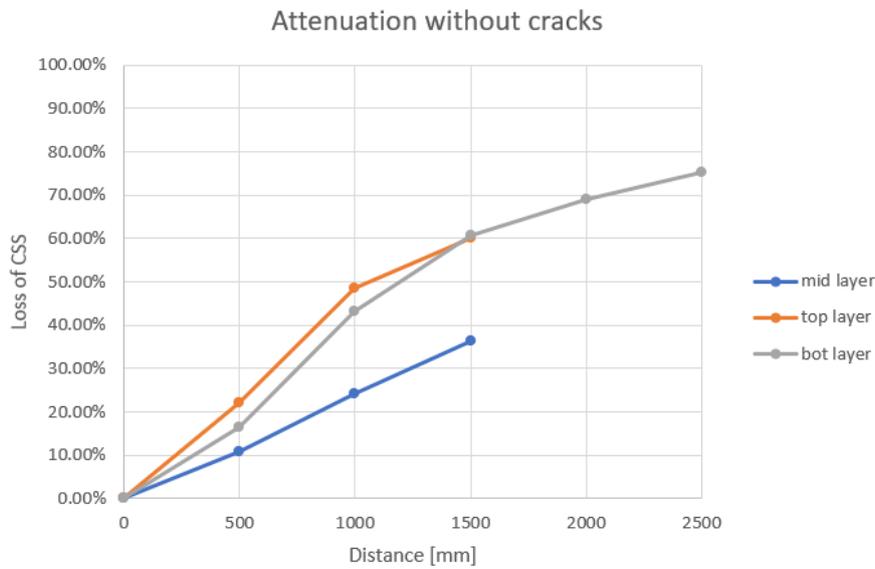
**Fig. 5.2.9 Averaged attenuation of 800 mm beam in different layers (uncracked)**

It's obvious in the figure that attenuation of top layer and bottom layer are higher than mid layer. However, this might be caused by different mechanisms. In bottom surface of specimen, there are many existing and newly generated cracks which would increase energy dissipation, and therefore the attenuation in bottom layer would be higher. As for top layer, the propagating distance would be dominating since bottom-initiated cracks have to travel farther to be detected by a top layer sensor than a mid-layer sensor. Finally, it is hard to tell whether the attenuation of top layer or bottom layer is higher since CSS would be affected by many factors and data derived from tests is limited.

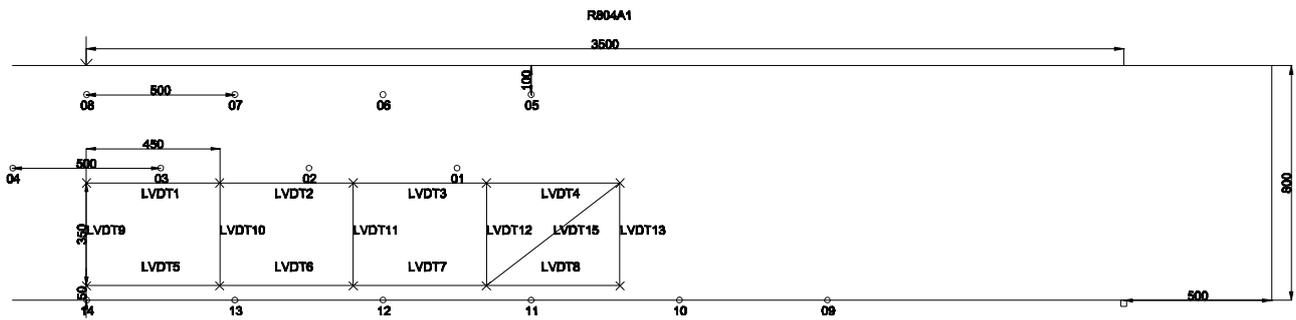
Fig. 5.2.11 LVDT layout of R804A1

A crack detected by the LVDT farthest from loading point is selected to make sure that there are sufficient sensors working in the cracked zone. For instance, according to LVDT layout of R804A1 (shown in Fig. 5.2.11), the crack detected by LVDT8 is selected to be investigated. Cracks occurred prior to this one which were detected by LVDTs on left side are regarded as target cracks affecting attenuation of CSS.

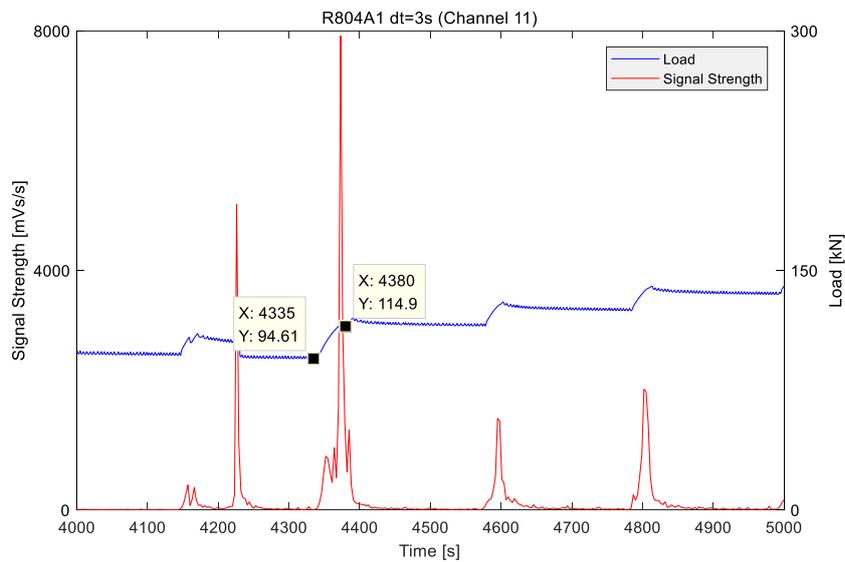
Fig. 5.2.13 Load and Signal strength against Time (R804A1 CHN11)

Zooming in signal strength plot of AE11 (Fig. 5.2.13), peak value of signal strength at load level 115.8kN is in time period 4335-4380s. CSS of other AE sensors within this period is given in Table. 5.2.2.2.

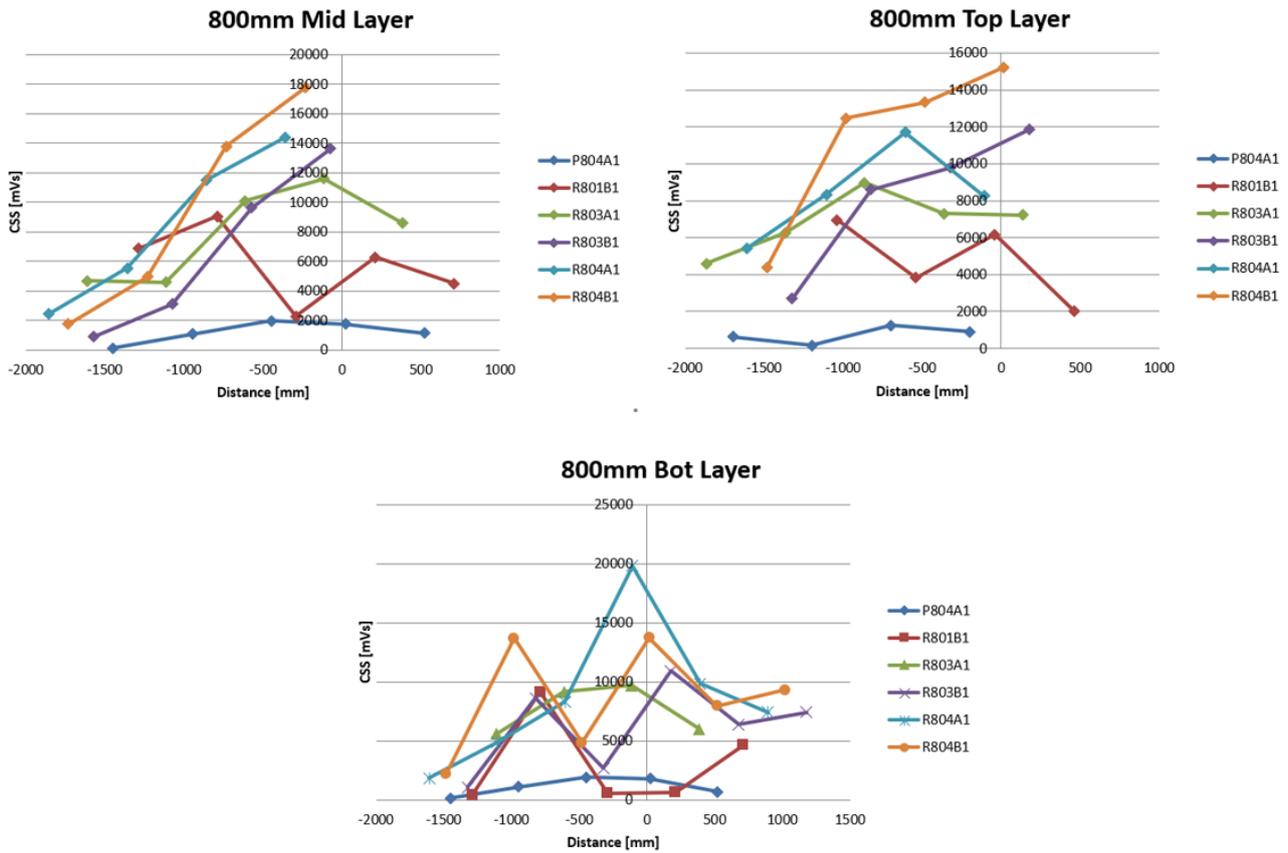
Fig. 5.2.15 CSS of 800 mm beam in different layers (cracked)

CSS are plotted in three layers against distance as shown in Fig. 5.2.15. The factor  $G_0$  could be estimated by reading the signal strength of AE sensor closest to the crack. According to figures,  $G_0$  of bottom layer is higher than mid layer and top layer since bottom layer AE sensors would be more affected by newly generated cracks on bottom surface of specimen. In general, however, the attenuation in cracked concrete structure is not that characteristic since several cracks may propagate simultaneously, as shown in figures that sub-peaks occur at somewhere far away from main crack.

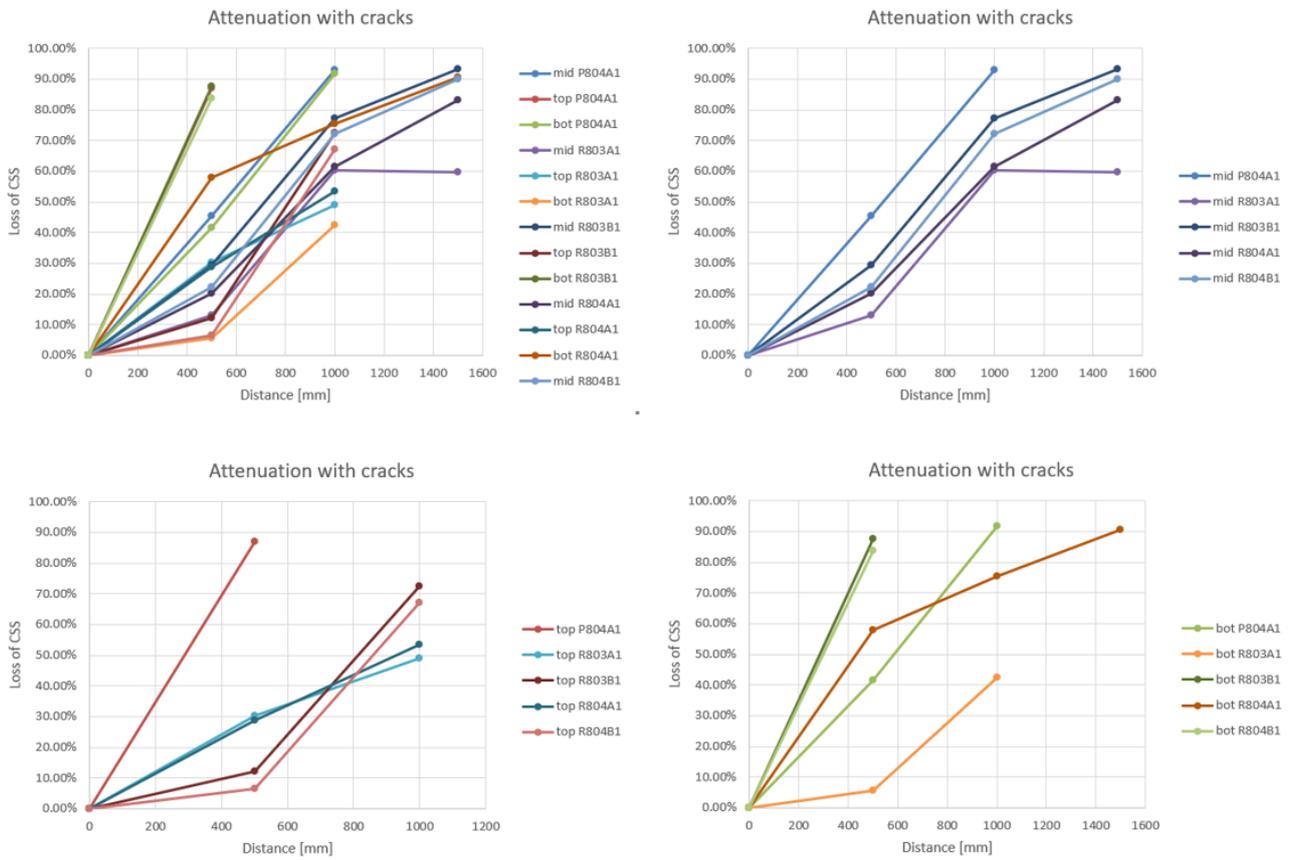
Fig. 5.2.16 Attenuation of 800 mm beam in different layers (cracked)

At a horizontal distance from 0 to 500 mm the attenuation trend is the same as that observed in uncracked structures. However, the attenuation in greater distance would be hard to predict since the existing crack would significantly affect CSS detected by sensors, and crack pattern varies with each beam.

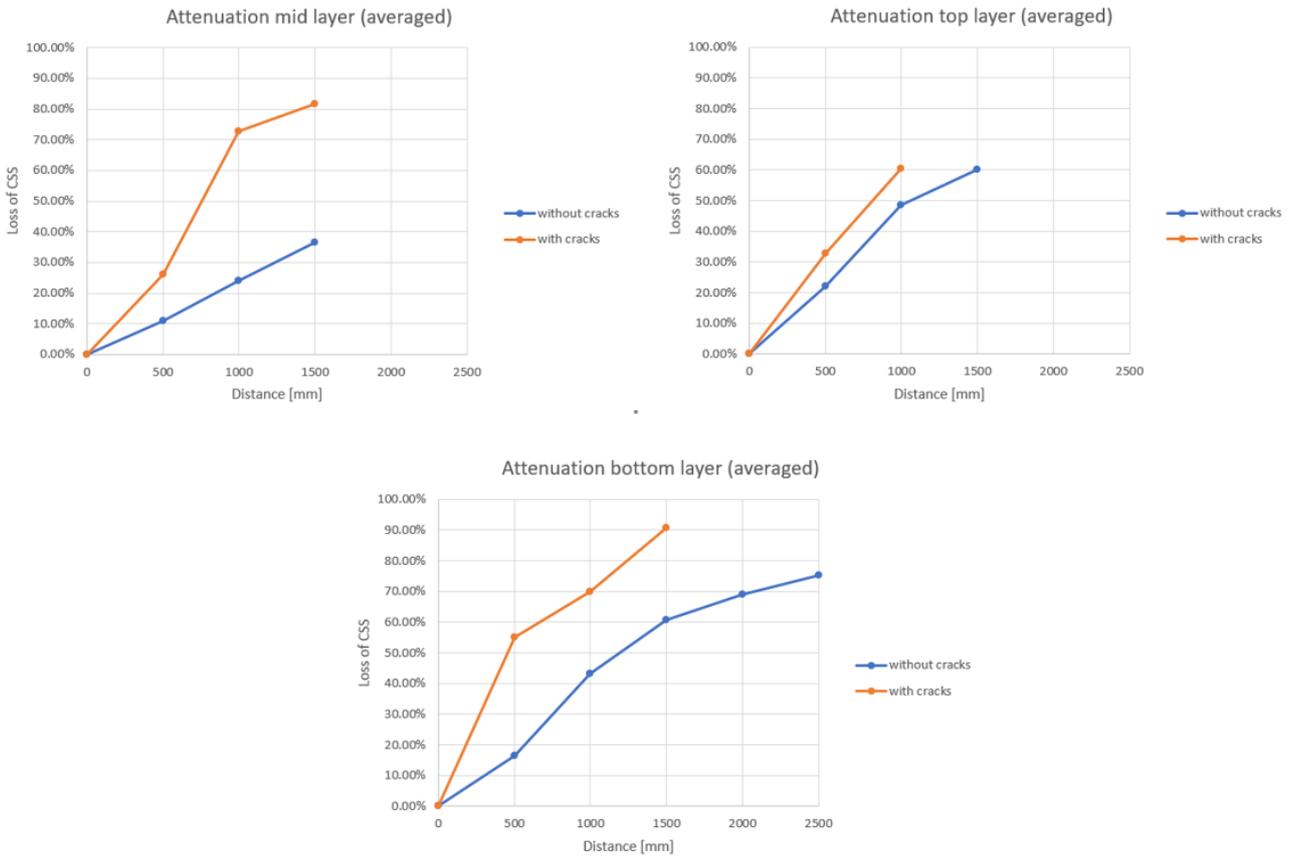
Fig. 5.3.1 Attenuation in cracked and uncracked structures

The difference of attenuation between cracked and uncracked structures are given in Fig. 5.3.1, it is quite obvious that the attenuation of cracked structures is much higher than uncracked structures in all three layers. On the other hand, the difference in top layer is not that great since the propagating distance plays an important role in attenuation as well. In general, the existing cracks would result in significant energy dissipation and decrease in CSS.

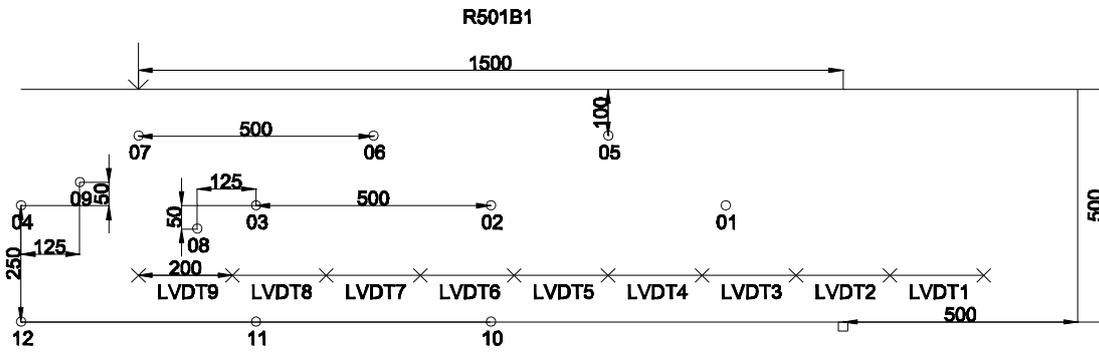
Fig.A2. 1 LVDT and AE grid (R501B1)

Only one test of 500mm beam is conducted named R501B1, however, it's very interesting to focus on this specific test result since a dense array of AE sensors are installed at the bottom of the specimen (as shown in Fig.A2. 1). Therefore, cracks could be located accurately, and it's easier to tell energy detected by different sensors are released by which crack as well. Top layer sensors are AE sensors 05-07 installed at 50 mm from the top surface of specimen, while the bottom layer sensors are AE sensors 10-12, arranged at the bottom surface of specimen. Mid layer sensors are AE sensors AE 01-04 and 08, 09, they are installed in the central axis of the beam. AE08 and AE09 are slightly adjusted 50 mm upward and downward in vertical direction respectively as shown in Fig.A2. 1.

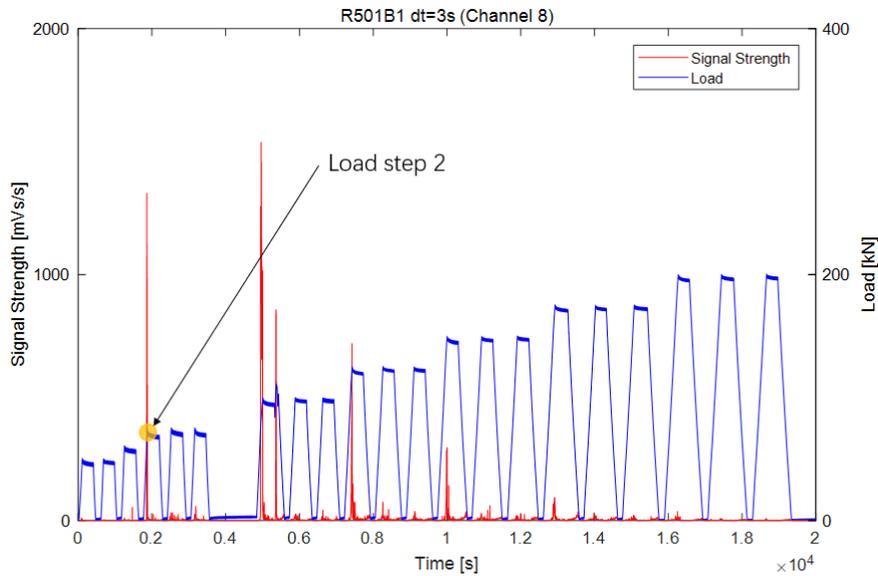
**Fig.A2. 2 Load and Signal strength against Time (R501B1)**

In Table.A2. 1, by comparing Load-crack width plot and corresponding AE plot, it is obvious that at the same load level, each crack opening detected by LVDT is accompanied with a peak value of

signal strength detected by AE sensor, which proves again that the crack propagation could be monitored by AE sensors.

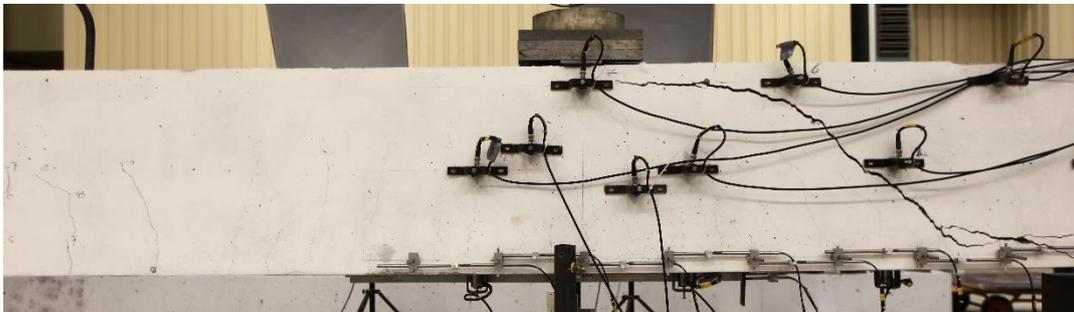
**Fig.A2. 3 Crack pattern of R501B1**

The crack pattern of R501B1 is given in Fig.A2. 3 and Fig.A2. 4, the 1<sup>st</sup> major flexural crack is located approximately 179.11 mm to the left of loading point, which it is not detected by LVDT9. According to Fig.A2. 5, energy release of the first crack is in the time-period 1800-1980s, and CCS within this period detected by each sensor is given in Table.A2. 2.

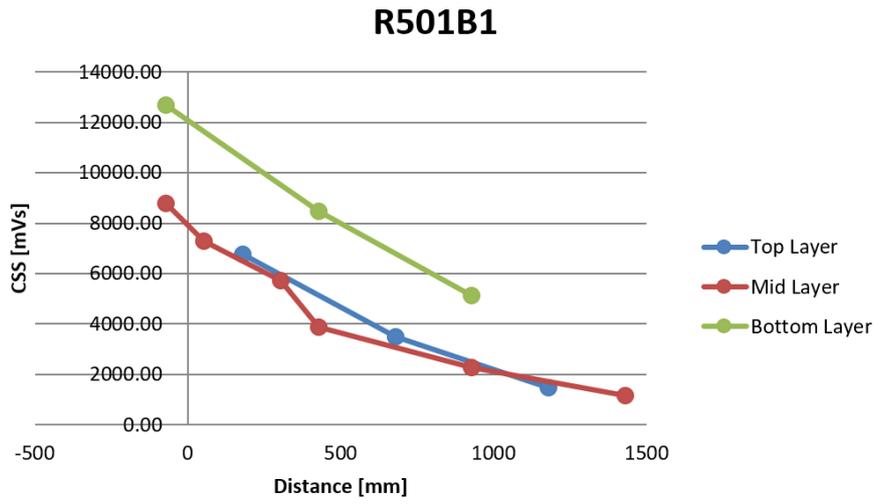
Fig.A2. 6 CCS-Distance R501B1

By dividing the AE sensors into three groups, CCS against time is plotted in Fig.A2. 6, and the trends of attenuation is quite clear as the distance between AE sensors and crack increases.

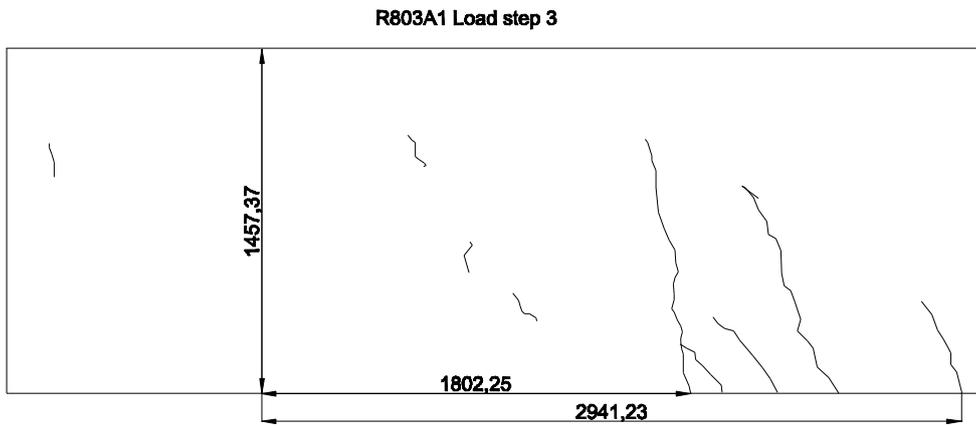
Fig.A3. 5 Crack pattern of load step 3

Crack pattern of load step 3 is shown in Fig.A3. 5. CCS of each sensor against horizontal distance is plotted in Fig.A3. 6

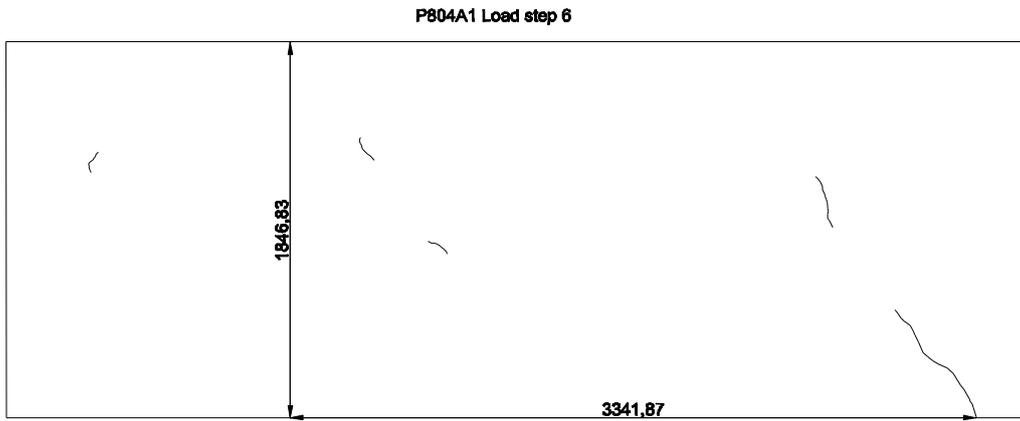
Fig.A3. 8 Crack pattern of load step 6

Crack pattern of load step 6 is shown in Fig.A3. 8. CCS of each sensor against horizontal distance is plotted in Fig.A3. 9.
