GAS PATH ANALYSIS AS A TOOL FOR THE PREDICTIVE MAINTENANCE OF THE HONEYWELL 331-500 AUXILIARY POWER UNIT

Gas Path Analysis as a Tool for the Predictive Maintenance of the Honeywell 331-500 Auxiliary Power Unit

Master of Science in Mechanical Engineering

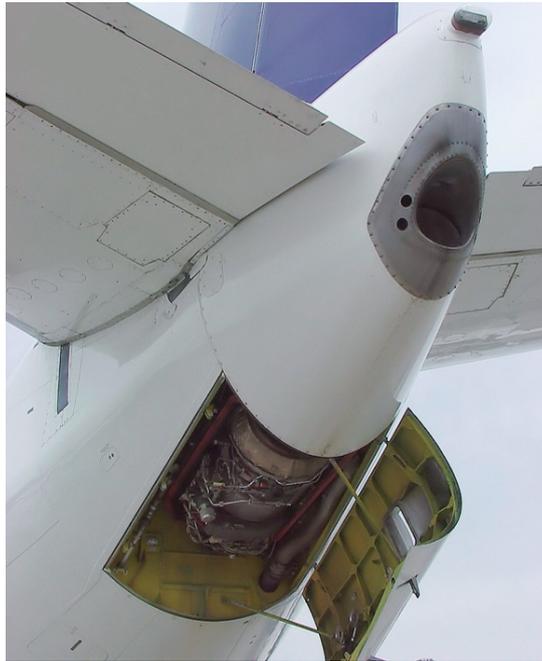
Figure 1.1: The tail of the Boeing 737-300 showing the APU and its exhaust outlet [4].

An APU is a single-shaft, constant-speed, gas turbine. As shown in Figure 1.1, it is located inside the tail of the aircraft and its function is to supply both bleed air and electrical power. Bleed air is used to start the aircraft's main engines and meet cabin air demand while electrical power is used for flight controls. In the absence of ground power units and air starters, the APU may be the only power source of the aircraft. Additionally, in the unlikely event of in-flight engine shutdown or failure, the APU can supply both electrical power and air flow.

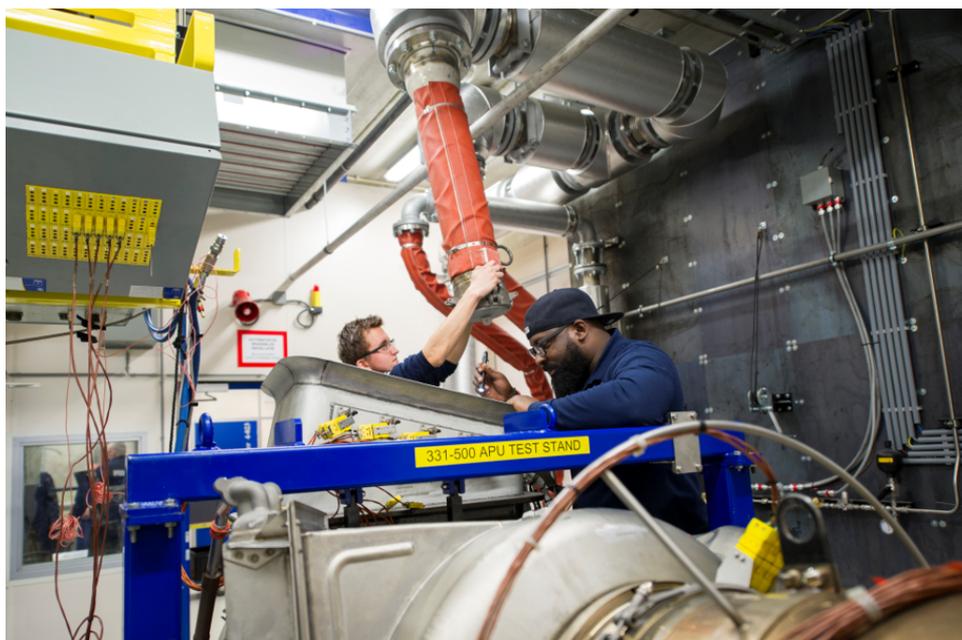
Figure 1.5: The preparation of a Honeywell 331-50 APU for testing at EPCOR.

conditions such as idle and Main Engine Start (MES), a high power condition. As detailed later in section 5, this test cell data is used to determine the design point performance of the Honeywell 331-500 APU. The preparation of a 331-500 for testing at EPCOR is shown below in Figure 1.5.

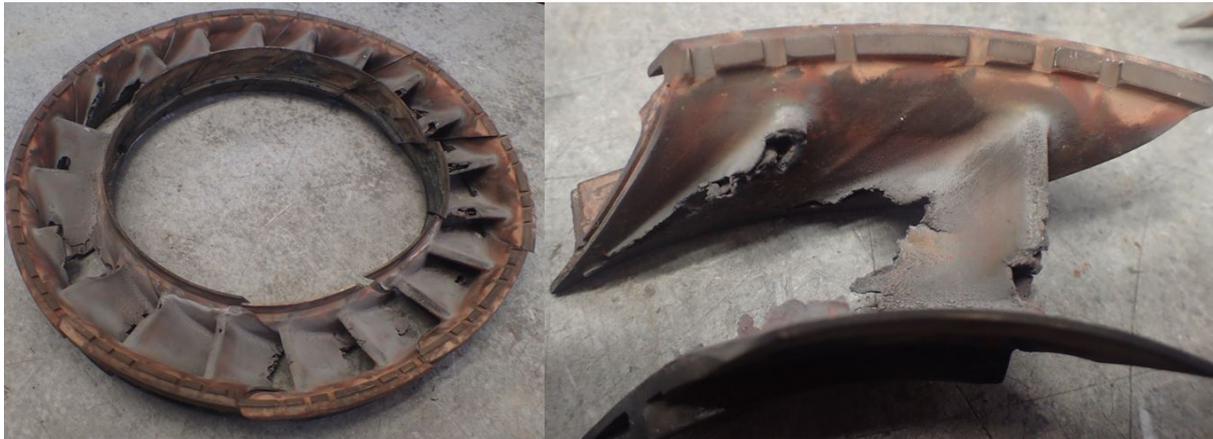
Figure 2.2: The first stage NGV assembly of the turbine of a 331-500 showing extensive corrosion and damage.

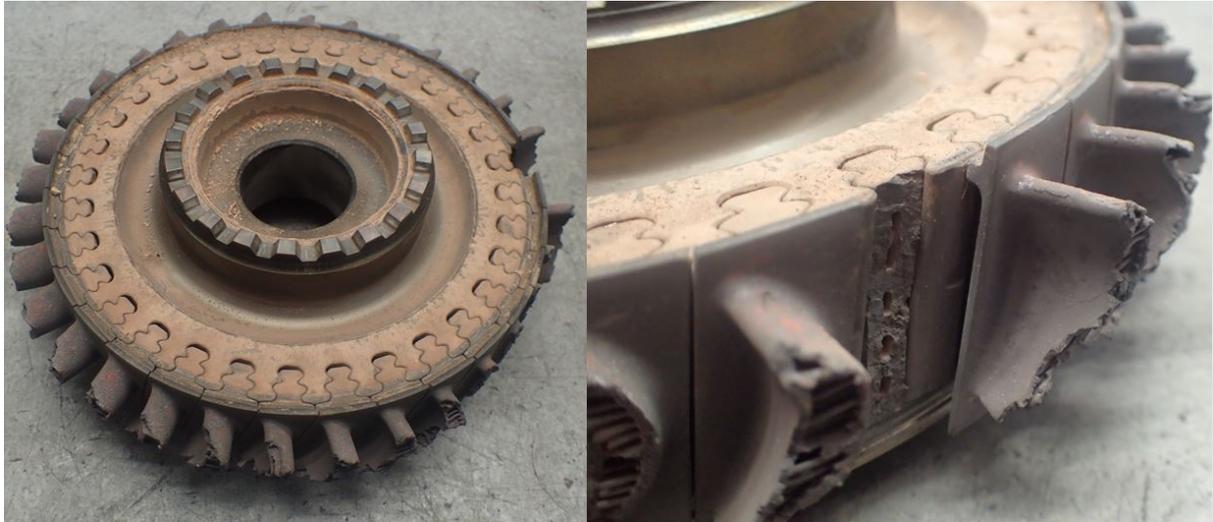
Figure 2.4: First stage turbine rotor of a 331-500 after T1 blade failure showing extensive impact damage.

release. This imbalance causes blade tip/casing rub and accelerated wear of the compressor impellers. Photos of various components after T1 blade failure are shown below in Figures 2.4 to 2.7.

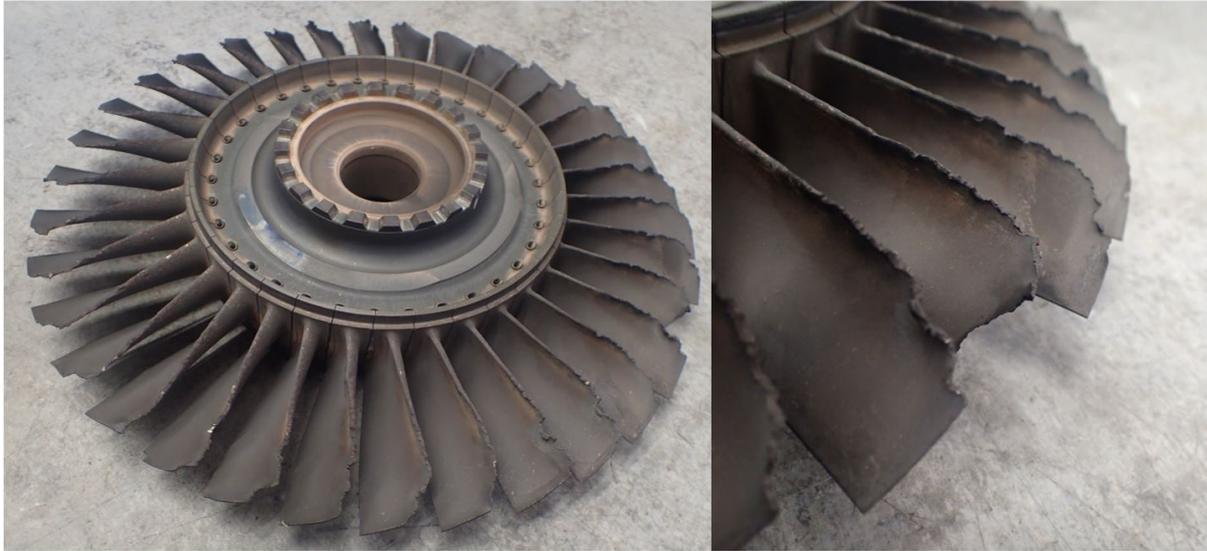
Figure 2.6: Third stage turbine rotor of a 331-500 after T1 blade failure showing extensive impact damage.

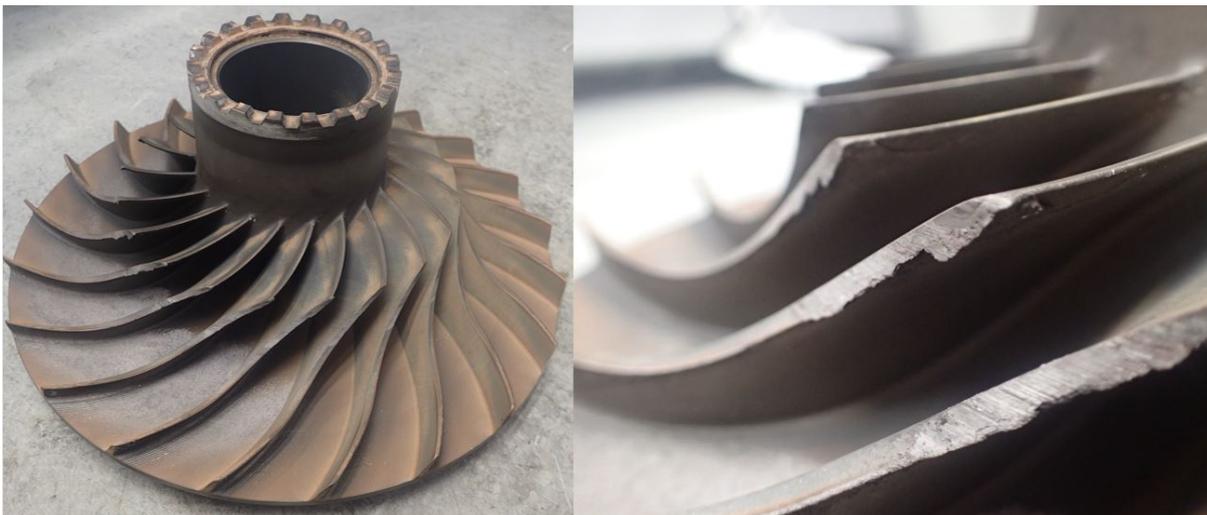
Figure 2.7: Second stage compressor impeller of the 331-500 after T1 blade failure showing heavy abrasion of the contours.

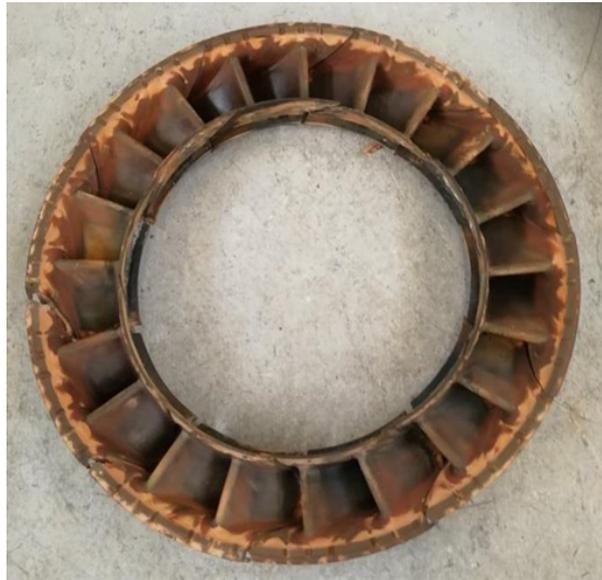
Figure 5.5: Assembled first stage NGV of the Honeywell 331-500 APU.

To determine the PR of the machine, the turbine throat is measured. As mentioned previously, the throat area is the summation of the minimum area between each stator vane, or NGV. The first stage NGV assembly of the 331-500 turbine, consisting of 20 nozzle segments that are joined together, is shown below in Figure 5.5. A 3-D scan of one of the nozzle segments is completed and the throat area computed through the use of the CATIA computer-aided design program. As shown in Figure 5.6, the surface of each nozzle is curved thereby making it difficult to calculate the throat area. With an estimated error of $\pm 5\%$, the value of the throat area was determined to be approximately 4000 mm^2 .

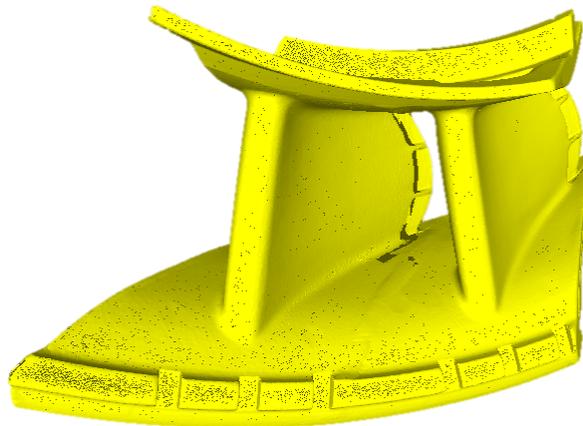
Figure 5.6: 3-D scan of a single nozzle segment from the first stage NGV of the Honeywell 331-500.

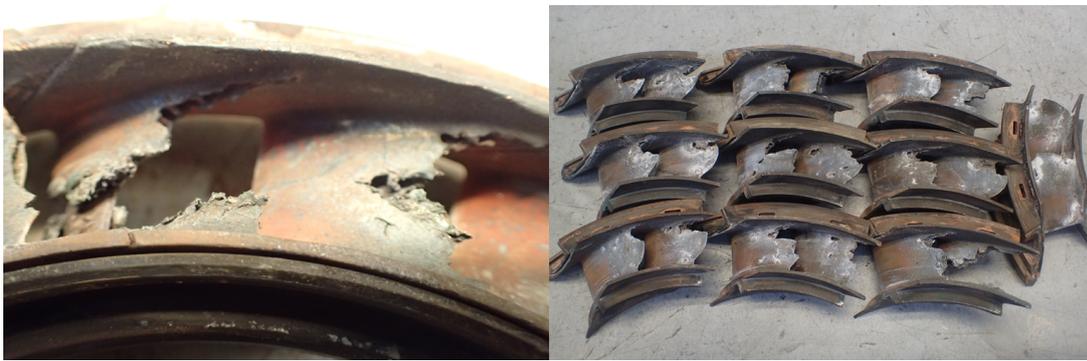
Figure 8.5: Deterioration in the first stage NGV after T1 blade failure for APUs 1602 (left) and 1552 (right).

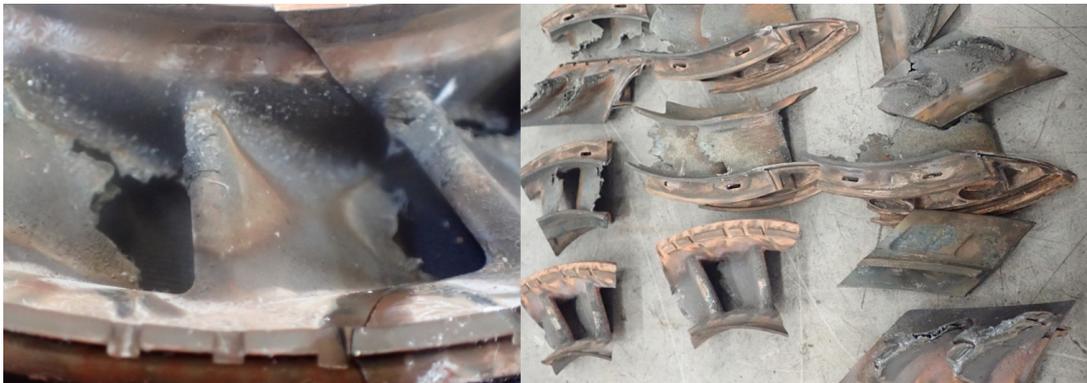
Figure 8.6: Deterioration in the first stage NGV after T1 blade failure for APUs 1608 (left) and 1308 (right).

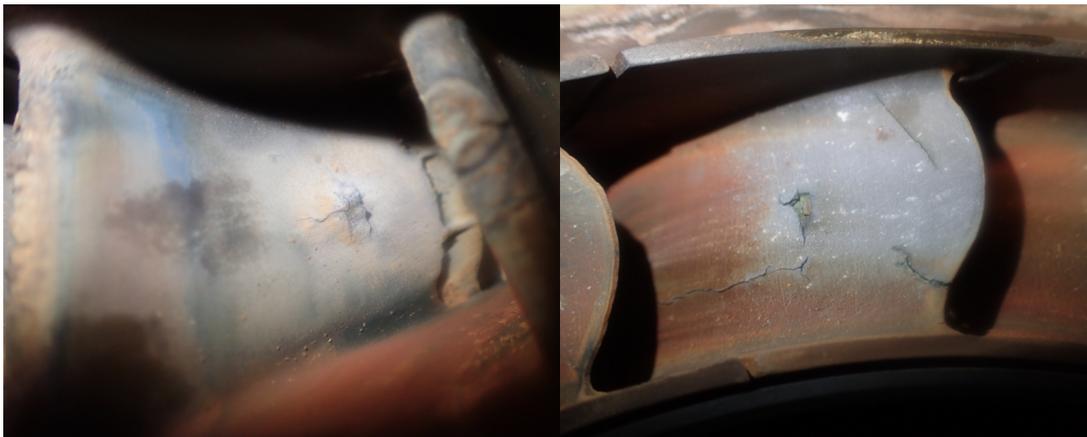
Figure 8.9: Deterioration in the first stage NGV of APU 1710 after removal due to high time.

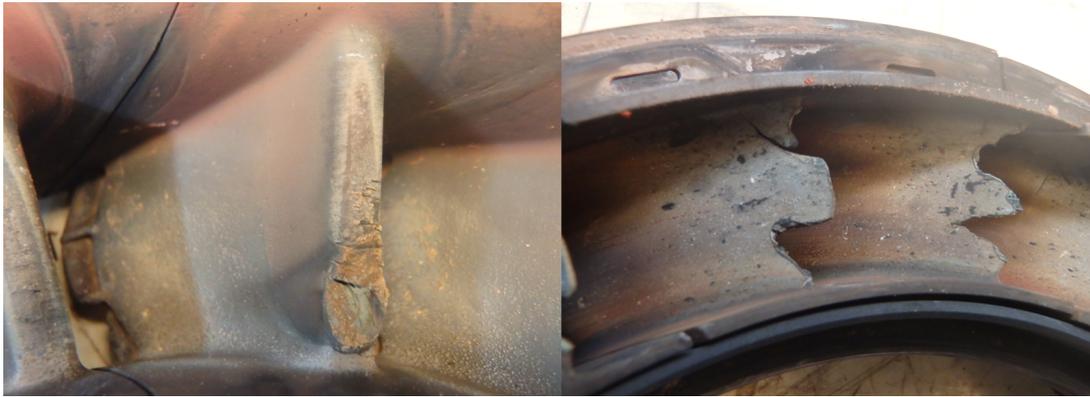
Figure 8.10: Deterioration in the first stage NGV of APU 1925 after removal due to high time.

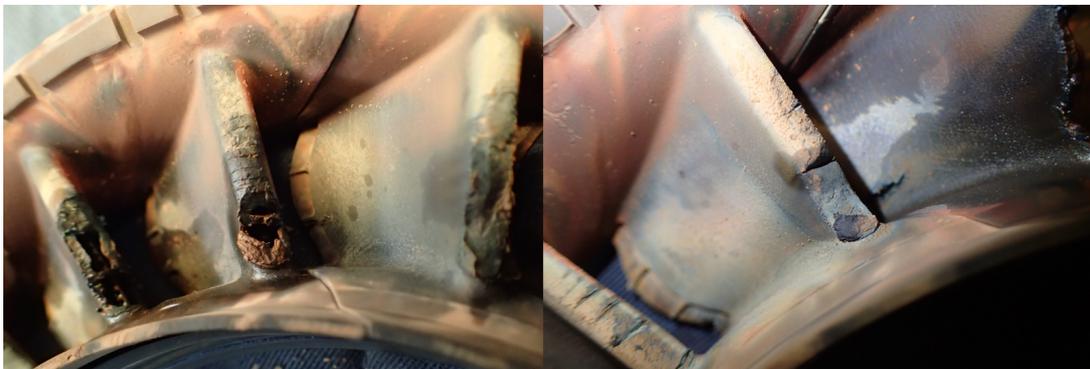
Figure 8.11: Deterioration in the first stage NGV of APU 1835 after removal due to high time.

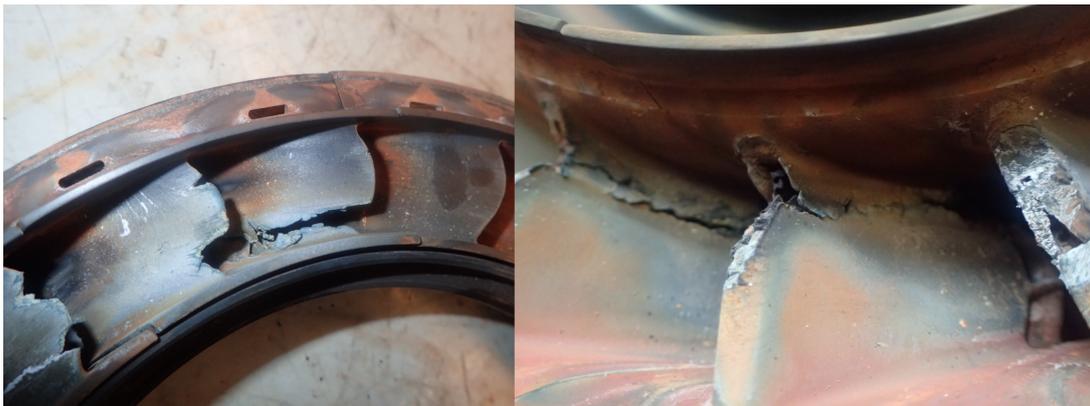
Figure 8.12: Deterioration in the first stage NGV of APU 1465 after removal due to high time

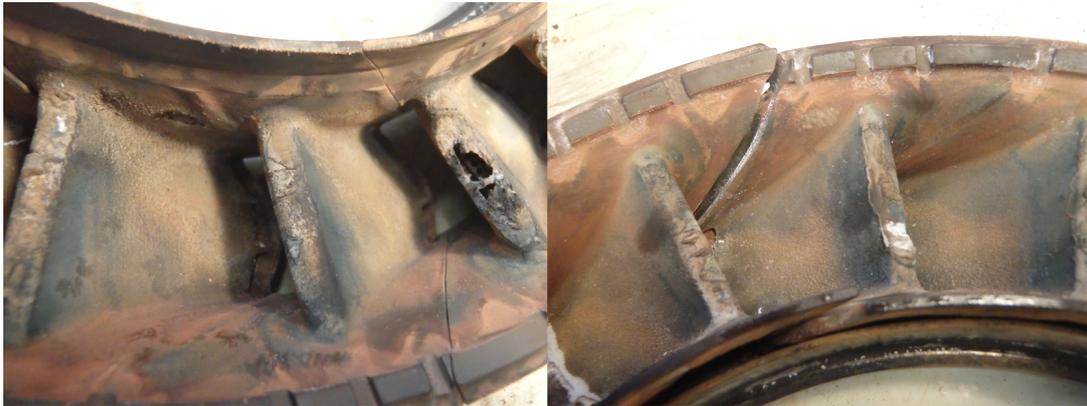
Figure 8.13: Deterioration in the first stage NGV of APU 1466 after removal due to high time.

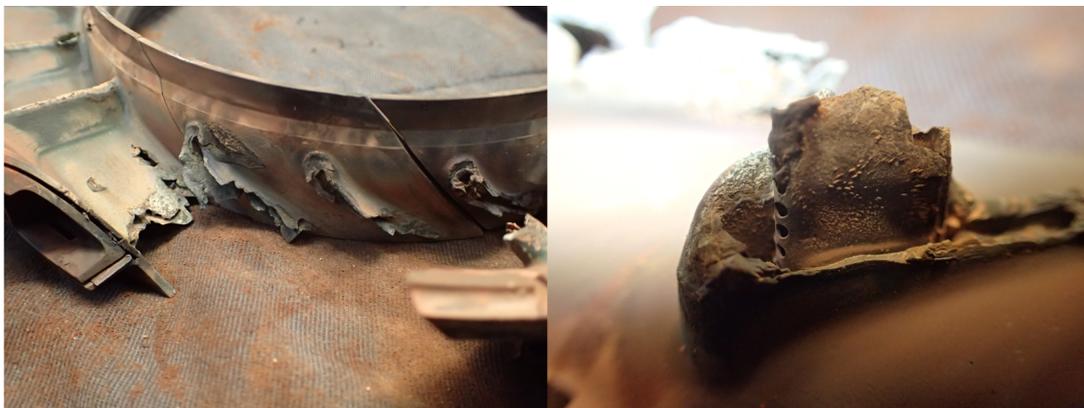
Figure 8.16: Deterioration in the first stage NGV of APU 1590 after removal due to high time.
