STRENGTH OF THE LANDWARD SLOPES OF SEA DIKES IN VIET NAM

H.T. Le¹, H.J. Verhagen², J.W. van der Meer³ and V.M. Cat⁴

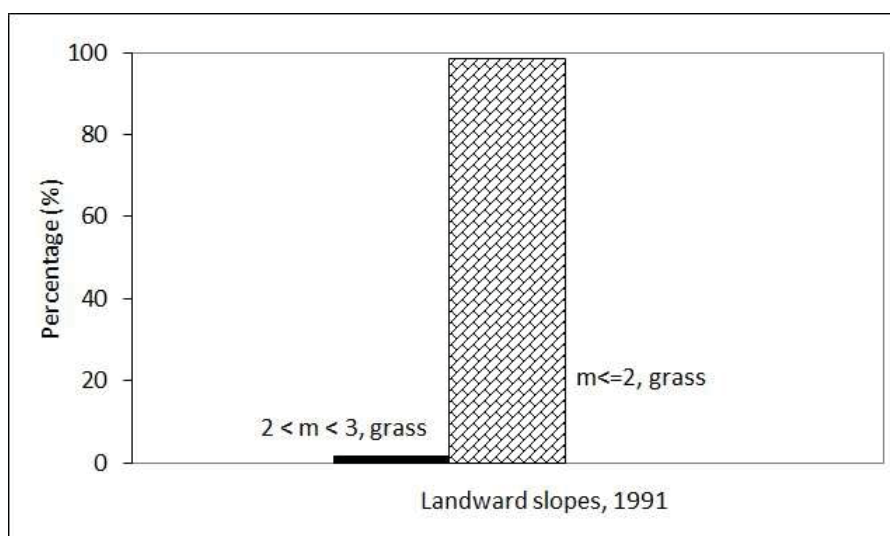
The sea dike systems have been built up and upgraded from year to year, however due to budget limitation and the present design guideline, priority is always given to the seaward slopes and recently the crest. Up to 1991, all landward slopes were covered with grass and about 98% of which were not gentler than 1:2, see Figure 2.

Fig. 2. Protection of the landward slope of the sea dikes in the north of Viet Nam, 1991.

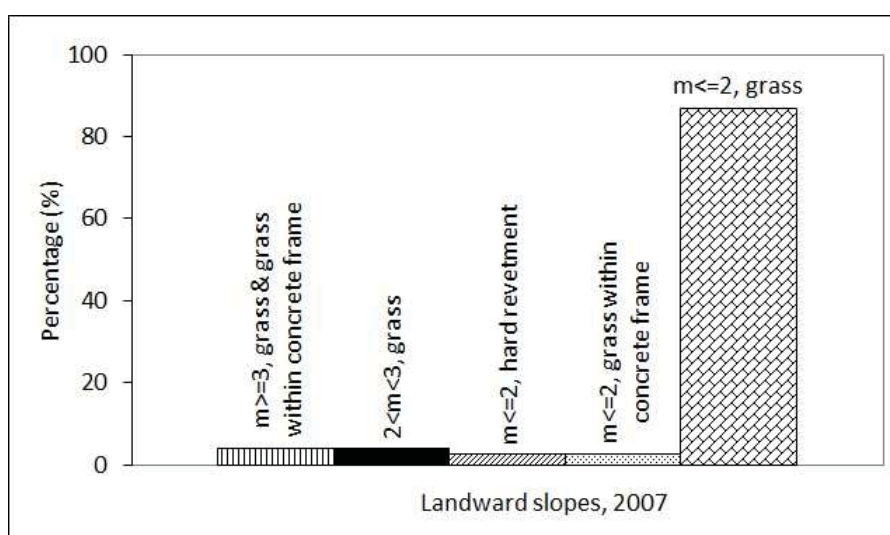
In 2007, several different measures of protection could be found on the landward slope such as grass within concrete frames or hard revetment constructed by concrete blocks (less than 3%). More than 90% of the landward slopes were not gentler than 1:2 and there was only 4% gentler than 1:3, see Figure 3. It was also reported that landward slopes were even shortened in order to enlarge the rice field areas of local farmers. These data indicate that the landward slope have been remained both the steepness and material in the last decades. In the Netherlands, after 1953, sea dikes have been designed with gentle landward slopes in the order of 1:3 or smaller, as steep slopes might fail by a deep slip circle what were recorded in the past.

Fig. 3. Protection of the landward slope of the sea dikes in the north of Viet Nam, 2007.

Statistic data shows that more than 90% of the landward slopes in the north of Viet Nam is steeper than 1:3 and mainly covered with grass. To reduce the likelihood of a slip circle it is recommended to apply a steepness of 1:3 or gentler to the landward slopes of new dikes or dikes which are upgraded.

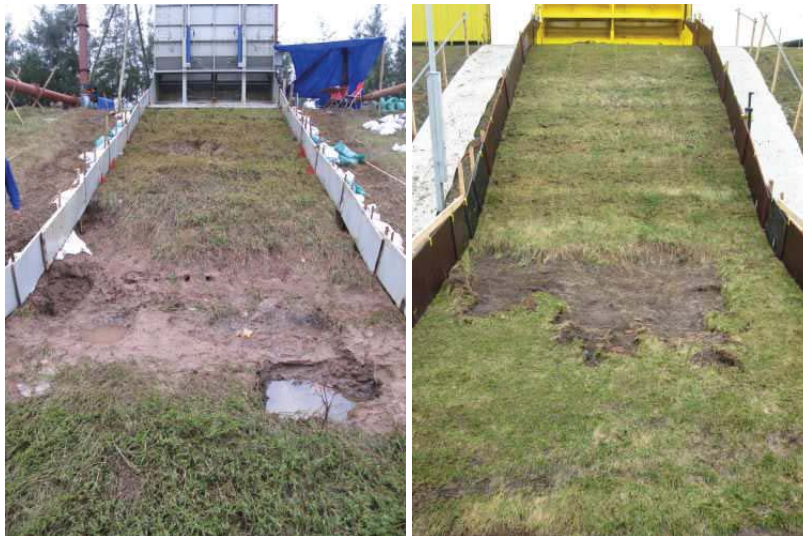
At the first section in Think Long, erosion happened under discharge of 40 l/s per m at the transition between the slope and the horizontal toe where the cover of Bermuda grass and Ray grass were poorer than on the higher part of the slope, Figure 5. At this area soil was more directly exposed to overtopping flow which was enhanced due to the rough guidance in the flow course. At the first section at Afsluitdijk, initial damage occurred at a small irregularity at the dike toe during the discharge of 10 l/s per m. Maximum overtopping rate applied at these two sections were 70 and 75 l/s per m, respectively, the dike however did not fail at the end of the tests.

Fig. 5. Damages at transition between the steep part and the horizontal toe, left: Think Long dike and right: Afsluitdijk.

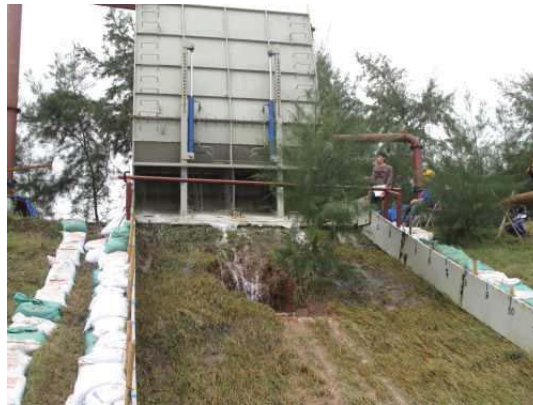
Fig. 6. Damage at a tree on the grass slope, Thinh Long dike, Nam Dinh province.

Sometimes due to different reasons, objects such as tree, fence, and even staircase are located on the dike slopes. At the second section of the Thinh Long dike and also the second section of the Vechtdijk, a tree with trunk of 7 cm and 80 cm wide alternatively were present. The areas around these trees were quickly damaged at small discharge of 10 and 5 l/s per m, Figure 6. The Casuarina tree at the former section collapsed at overtopping rate of 20 l/s per m while a discharge of 50 l/s per m caused large erosion around the 80-cm-trunk tree on the Vechtdijk. It was observed that flow tended to concentrate along both sides of the staircase on the third Afsluitdijk section resulting early erosion under a discharge of 10 l/s per m. The staircase was damaged considerably when higher rates of overtopping were applied. Test was finished at 75 l/s per m, a hole depth of 1 m was measured, the dike core however was not reached yet.

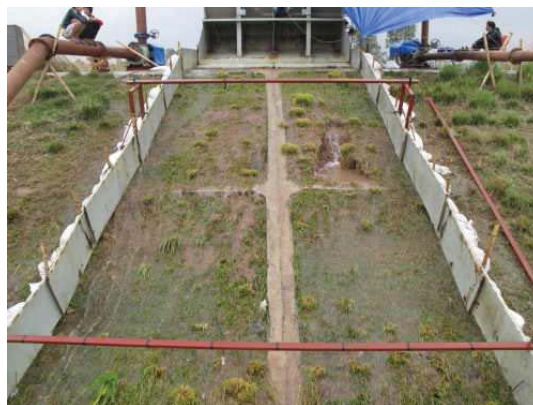
Fig. 7. Damages initiated at existing holes, Thai Thuy dike, Thai Binh province.

It is hardly possible to prevent a grass cover from being eroded or damaged, causing factors can be activities of animals and activities of dike maintenance and dike inspection. At test sections of Boonweg, Kattendijk, Afsluitdijk, Vechtdijk, erosions were first recognized at the existing damaged points which were induced by mice and moles or by tractor tires. Some small size holes were the starting points of damage development at sections tested in both Thinh Long and Thai Thuy, Figure 7. Later on, holes seemed likely to extend larger from these initial weak points resulting severe damages of the dike slopes.

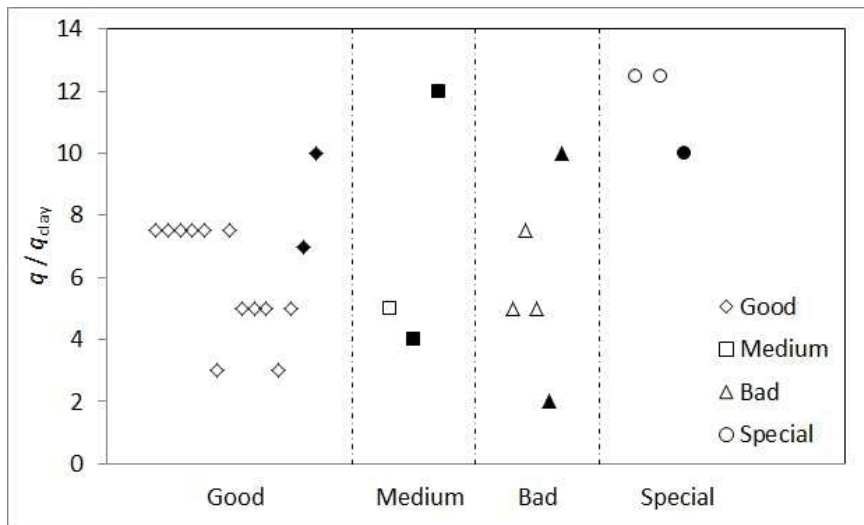
Fig. 6. Strength of various dike slopes in comparison with a bare clay slope, classification based on grass quality.

The grass quality of 23 sections is classified as Good, Medium and Bad. Figure 6 shows the dimensionless maximum overtopping discharges of these sections and also three special sections including an open asphalt concrete, an elastocoast in Kattendijke and a Vetiver grass cover in Do Son. Bad or Medium quality do not show very clear difference in strength compared to Good quality. The average strength of the Medium category is even higher than that of the Good category, 7.00 compared to 6.29, see Table 3. By comparing Figure 5 and 6, it can be seen that data points generally scatter more widely in Figure 6 than in Figure 5. Besides, the squared variance σ^2 of q / q_{clay} are calculated for two ways of classification and given in Table 3. Classification based on grass quality gives larger values of σ^2 than those derived from slope specification: 3.67, 12.67, 7.24 and 1.39 compared to 1.06, 3.98, 2.00 and 1.39. As we have seen, slope classification based on grass quality is likely not reliable and appropriate for practical application.
