Authenticity in Delft

How important is authenticity in maintaining the heritage of a city? Focusing on three buildings the old city of Delft.

AR2A011 - Architectural History Thesis
Architecture

Technische Universiteit Delft
14 april 2025

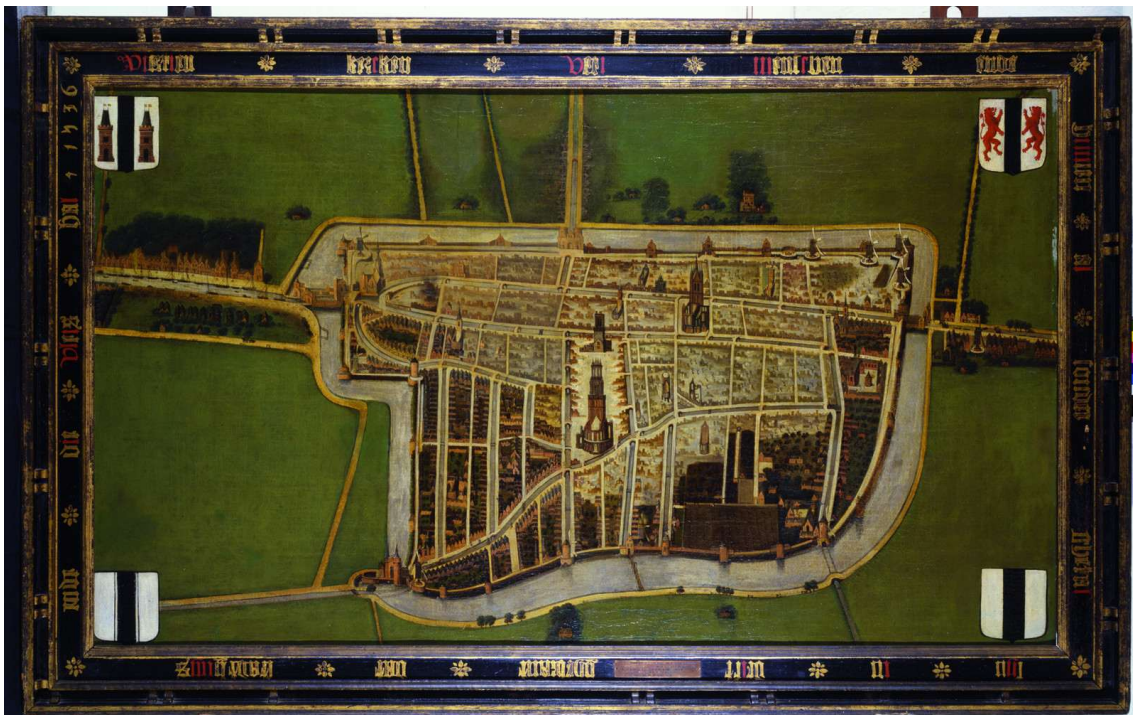
Delft originated in the Middle Ages, and though some monuments still date from that time, most were not left unscathed during the great city fire of 1536. The cause of the fire is uncertain, but most likely a lightning strike in the tower of the Nieuwe Kerk. About three quarters of the city were destroyed (figure 1).

Fig 1: Map of Delft after the city fire (CanonvanNederland)

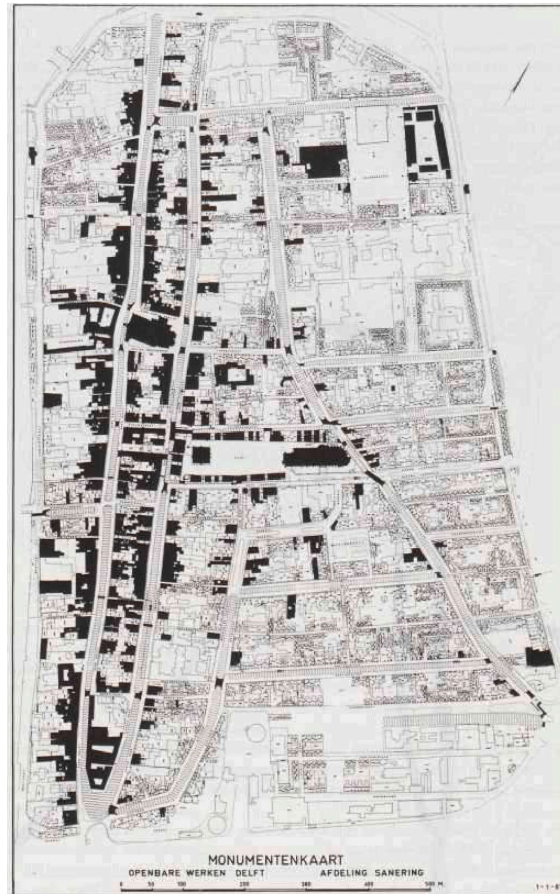
Even after this period of growth, the original structure of the city with its basis of canals and waterways can be found in the monuments of the present day (figure 2). This reverts back to the statement that monuments connect the city and its history, as the original structure can never be discarded.

Fig 2: Monuments of Delft (Raue, 1975)

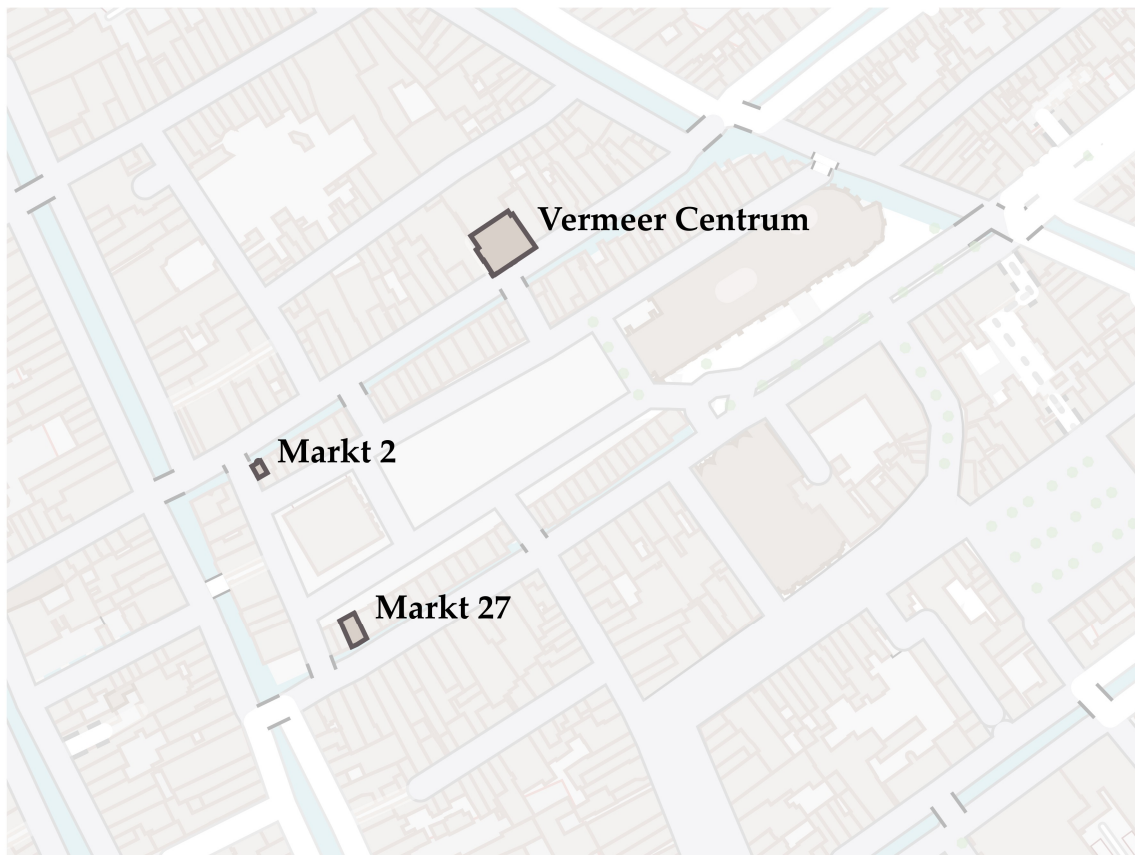
Figure 3: Case Studies highlighted

In order to apply the theory of heritage and authenticity to the city of Delft, three case studies have been chosen that will be analyzed in this chapter. The aim is to understand three types of heritage that can be found within 100 meters of each other in the city center of Delft. The first building has been reconstructed, the second building is 'authentic' in the sense that it has not been reconstructed or rebuilt, and the last building has been completely rebuilt after being demolished. Because the initial idea of authenticity of these buildings differs much, the case studies will provide diverse angles on authenticity and its effect on the heritage in Delft.

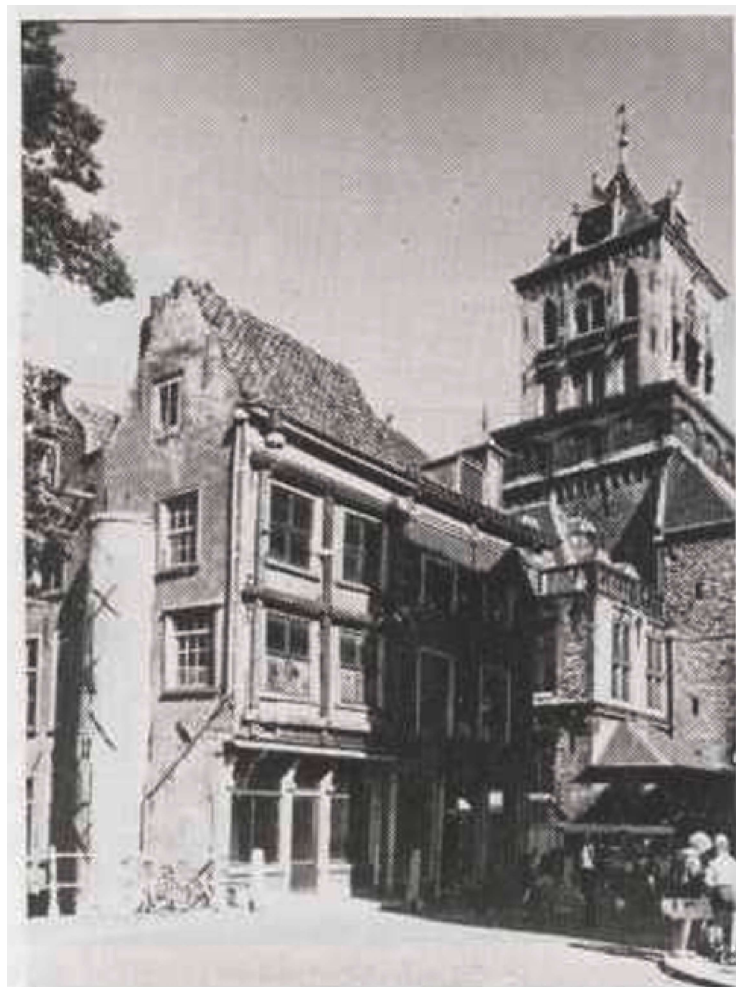
In 1839, the facades were modernized with a cornice facade, and new windows and frames. The building had a sober light gray plastered appearance. After a century, the building showed signs of wear and had to be restored (figure 4). In 1962, both Markt 2 and 4 were bought by association Hendrick de Keyser, who made plans for the restoration of the dilapidated buildings. The history of the architecture led the restoration and Markt 2 was reconstructed to look like the 16th century version (figure 5). This was done by the architecture firm J.H. Kooreman and J.J. Raue between 1965 and 1966. An accurate reconstruction was possible due to construction traces on the building, as well as a detailed painting from 1836 of the original building (figure 6). Of the reconstructed building, only the consoles in the lower facade are original. (AchterdegevelsvanDelft)

Figure 4: De Kaerskorff in 1839 (Raue, 1975)

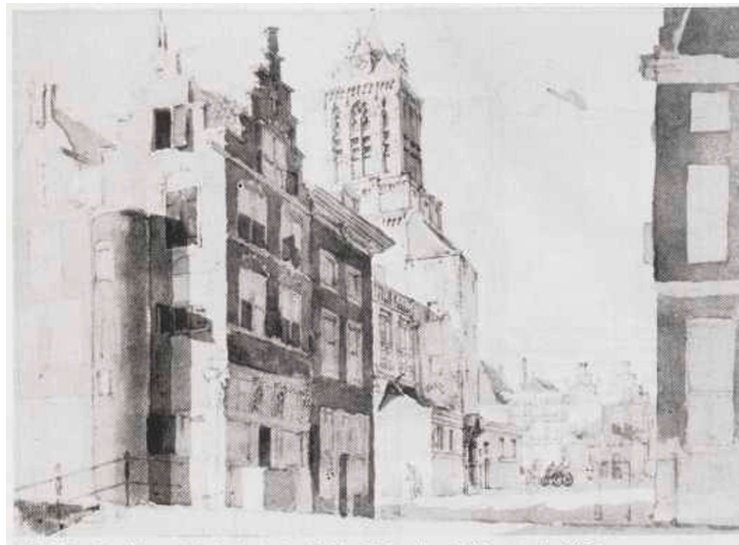
Figure 5: Painting of original house (J. Oltmans, 1836)

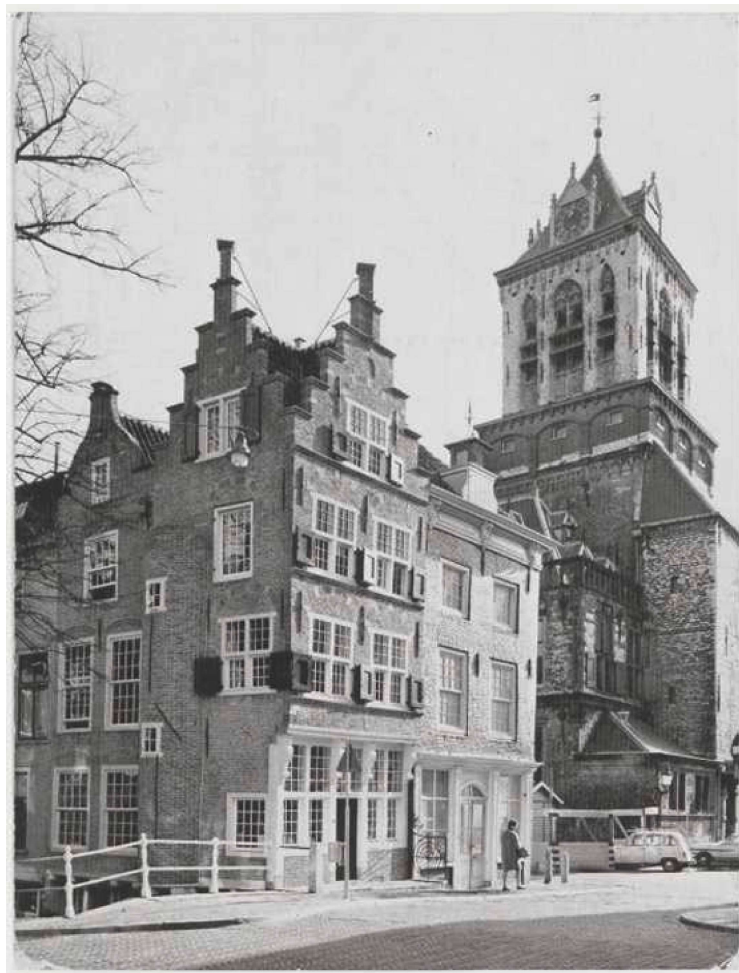
Figure 6: De Kaerskorff after renovation in 1966 (Raue, 1975)

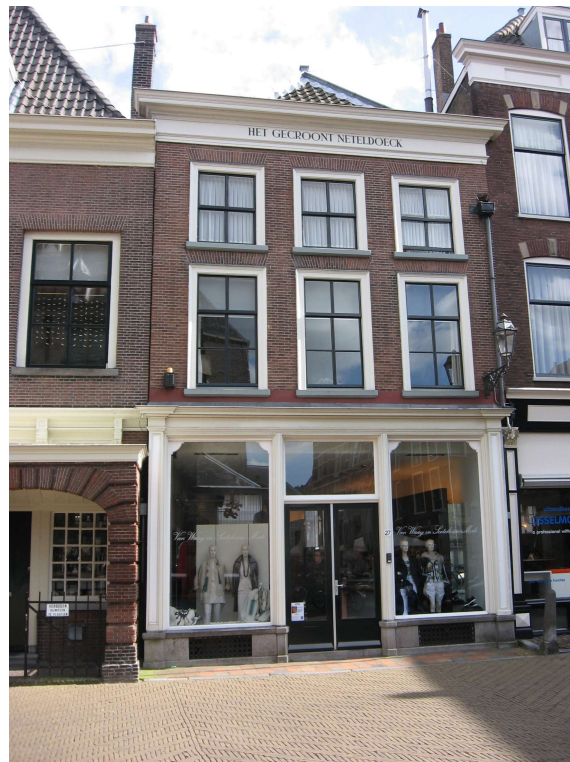
The original building of Markt 27 was a wooden house, that was burned down during the city fire in 1536. It was later rebuilt fully in stone (figure 7) The only other renovation the building knows happened around 1888, when a contractor and carpenter bought the house. He only made some minor changes to improve the state of the architecture (Achter de Gevels van Delft).

Figure 7: Markt 27

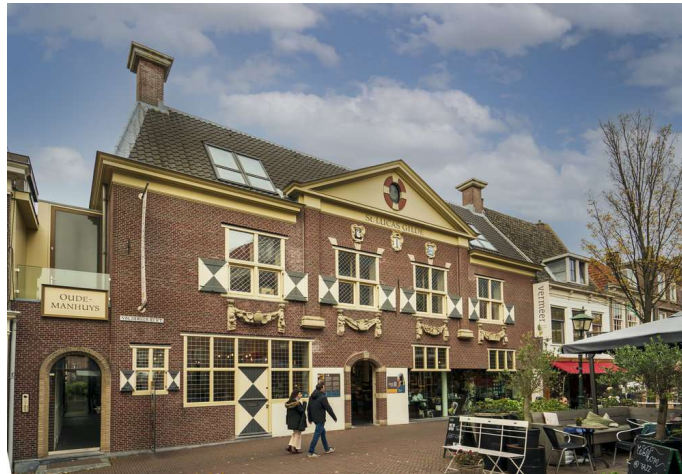
The Vermeer Centrum, now a museum for the painter Johannes Vermeer, used to be the St. Lucasgildehuis between 1661 and 1876. During the 1950's, the building was completely removed to make space for a school. It is only since 2007 that the building has been reconstructed to look like the old St. Lucasgildehuis and used as a museum (figure 8). This reconstruction was done by architecture firm Molenaar & Van Winden. There were several reasons to go through with reconstructing the facade to look like the original facade from the 17th century. The exact location of the original building was available, there was enough trustworthy information about the history and architecture of the original building, and the contractor was experienced with reconstruction. None of the original blueprints were available, but the architects did have an old photograph from the building in 1876 that included adjacent buildings that still exist that helped with figuring out the exact sizes of all the aspects of the facade (figure 9). The original stone decorations of the facade turned out to be used for the facade of the Rijksmuseum in Amsterdam (figure 10), so these were used to make exact replicas for the new building in Delft. (Achter de Gevels van Delft)

Figure 8: SE facade of Vermeer Centrum (Delft media)

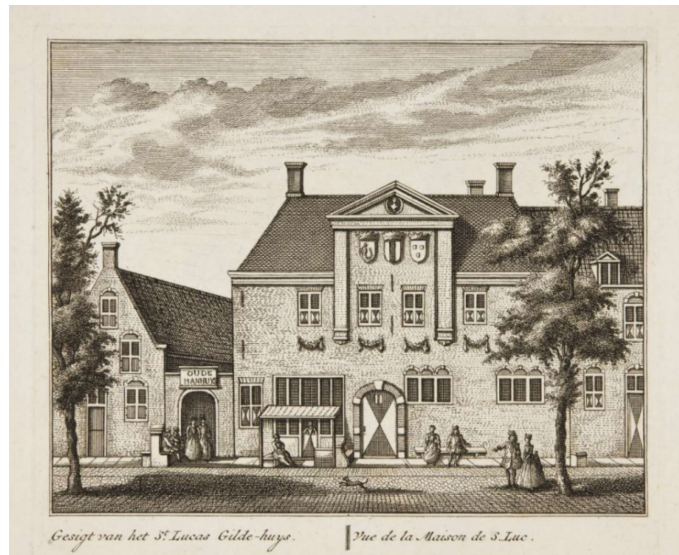
Figure 9: Photograph of St. Lucas Gilde (delftsaardewerk.nl)

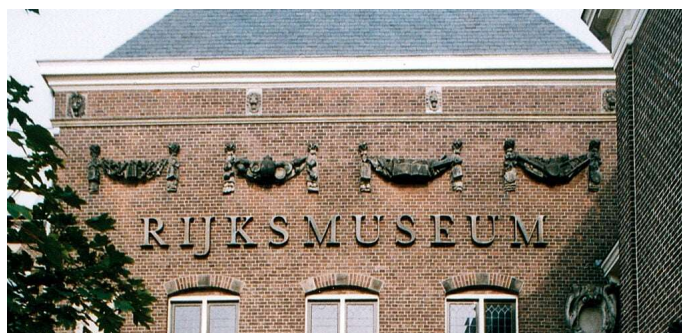
Figure 10: Original stone decorations on Rijksmuseum (De Haan, 2022)

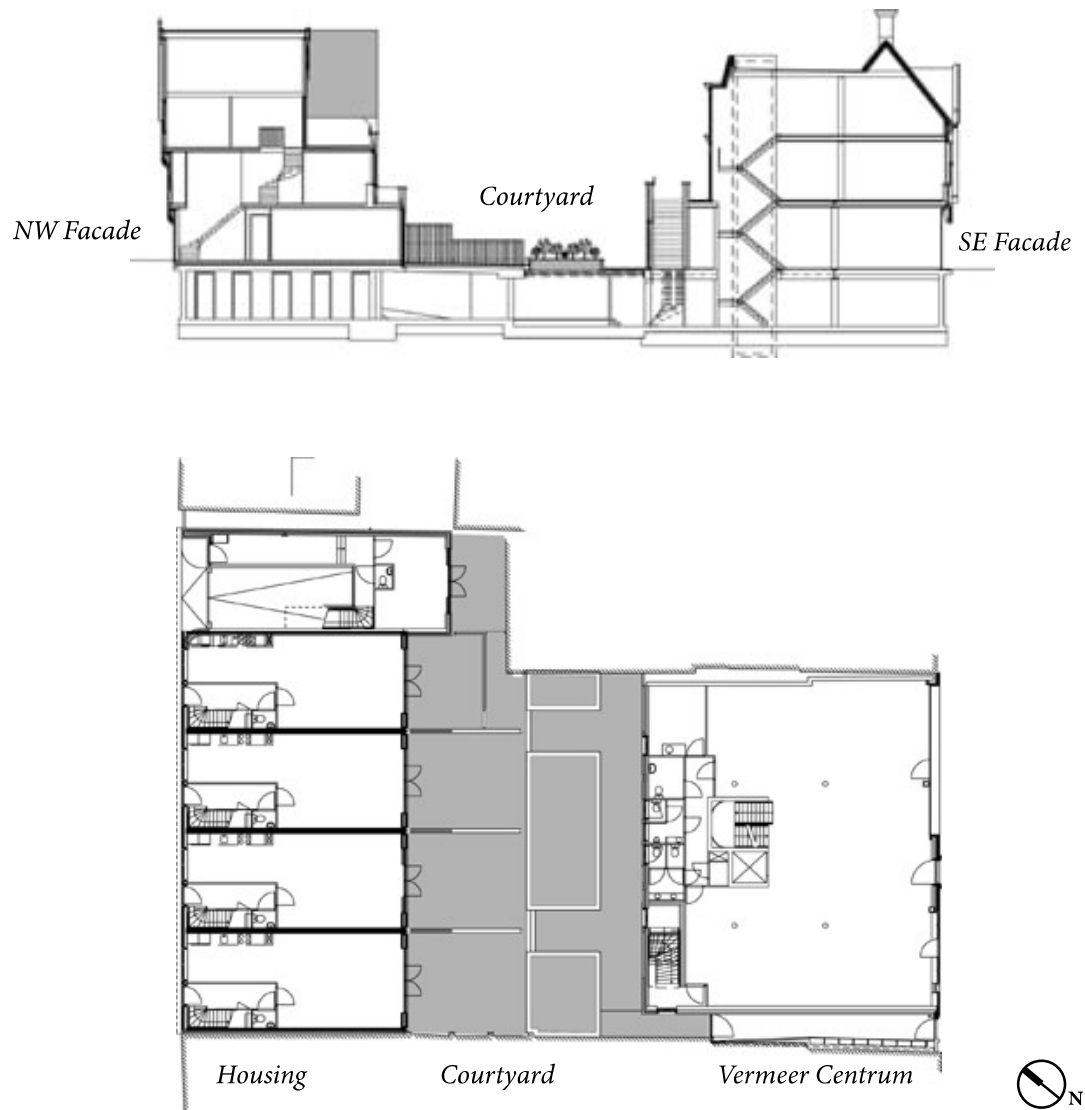
Apart from the perfectly reconstructed facade, the building itself does not resemble the original. The top two floors have a housing function, and the ground floor can also be used as a shop (figure 11). The in-

side of the building used to have a large lofted space that referred in contours and sizing to an old chapel that used to be at that location before the St. Lucasgildehuis. The space has however been closed when building the museum. The construction of the inside of the building is also simply made from concrete.

Figure 11: Plans of Vermeer Centrum

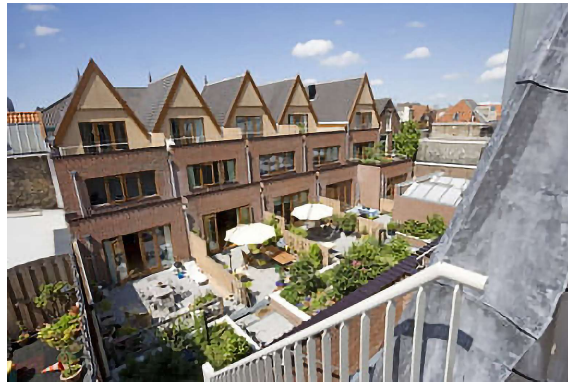
The courtyard of the building was completely redesigned as well (figure 12). It is a reference to the old courtyard that used to be there and functions as common outside space for the surrounding houses. These surrounding houses have a wooden facade (figure 13), that refer to the old wooden buildings of Delft from the middle ages, that were burned down during the city fire of 1536 (figure 14). The facades do know modern elements as well, that can be found in the structure and sizing of the layers of wood, as well as the accountance for cars in the edges of the facades. (Achter de Gevels van Delft)

Figure 12: Courtyard of Vermeer Centrum (architectuur.nl)

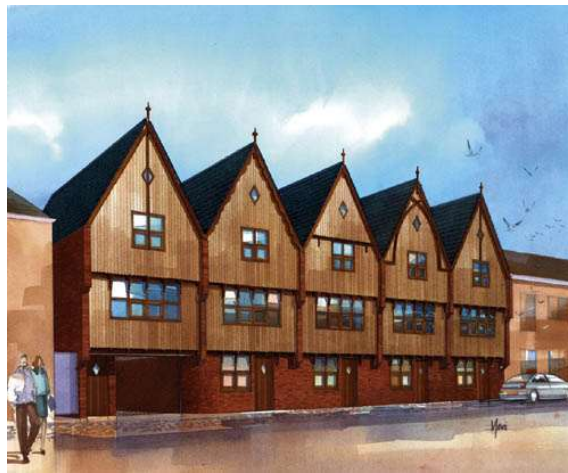
Figure 13: NW facade of Vermeer Centrum (www.architectuur.org)
