The decline of timber construction practices in North-Holland, The Netherlands

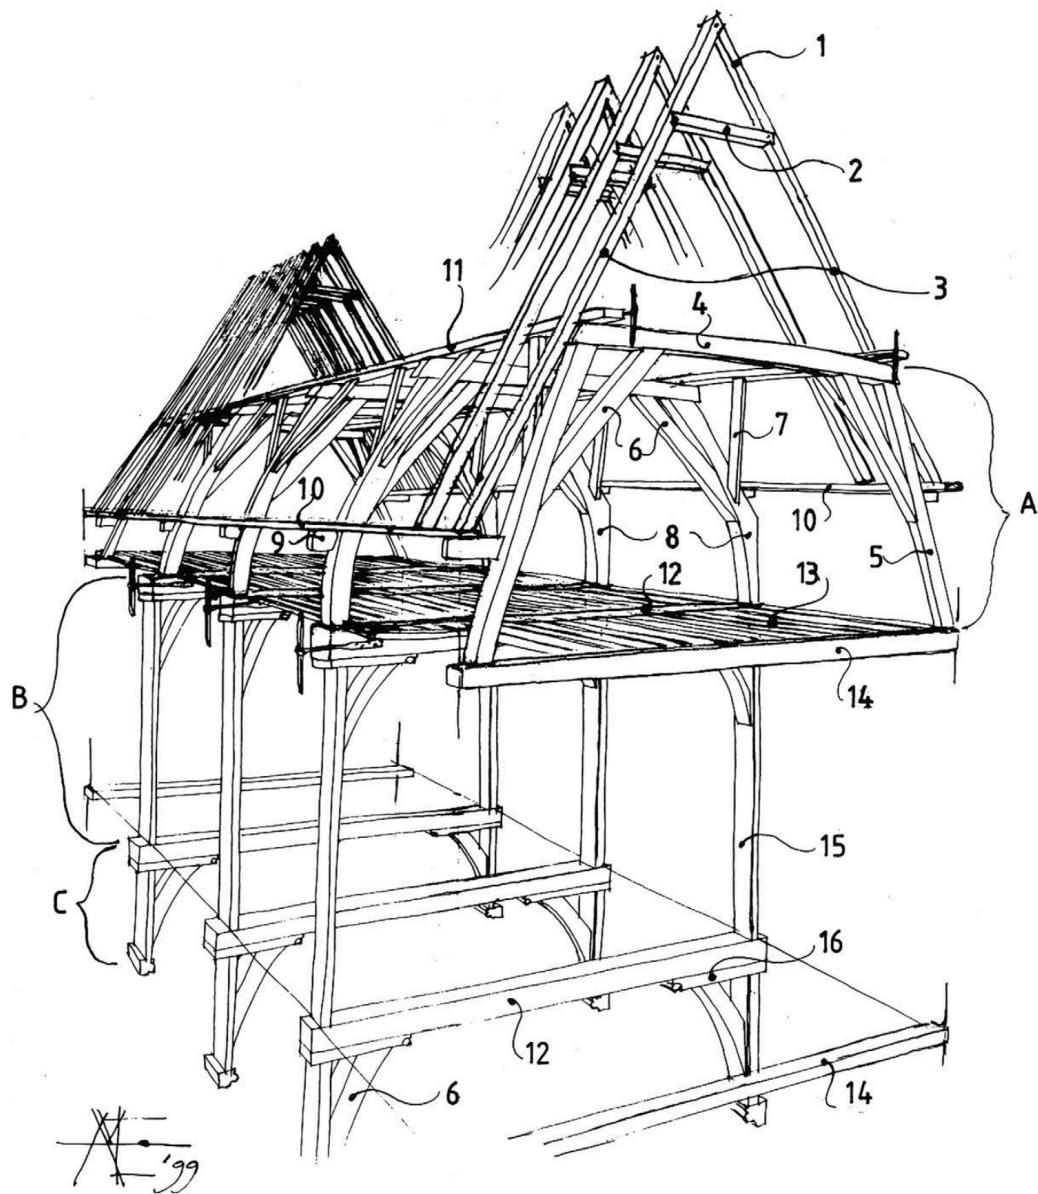
Fig. 2. Late Medieval timber-framed house (drawing Albert van Engelenhoven/Municipality of Dordrecht 1999) (van Tussenbroek, 2017).

As van Tussenbroek (2017, p. 46) states, the most important element of nearly all Dutch timber-framed town houses is the repetition of cross frames¹. These cross frames, (titled 'B' in figure 2) are made up of two posts² and a beam³, connected with mortise and tenon joints⁴ and often reinforced with braces⁵ and sole plates⁶ (visible in figure 3). This principle of cross frames that carry the floors and roof also applies to the example of Begijnhof 34 (figure 4), as can be seen in figure 5. Trusses⁷, that show a great resemblance to the cross frames mentioned above, but are slightly less wide, are placed on top of the cross frames to support the roof. The posts of these trusses, also called principals⁸, are made of oak that has grown in a curved shape so that these elements can be placed closer to the side walls (Stenvert et al., 2007, p. 158). These trusses are connected by longitudinal beams on which the rafters⁹ (titled '1' in figure 2) are placed.

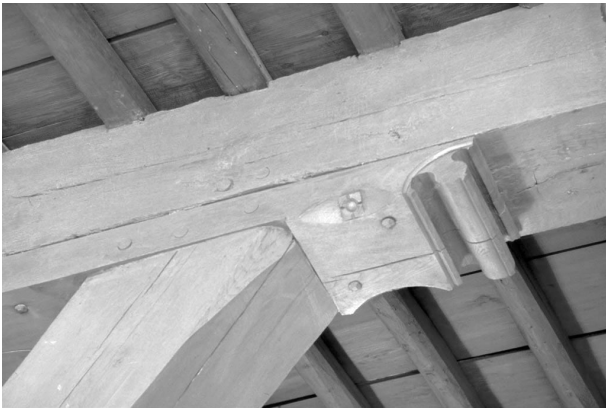
Fig. 3. Part of beam brace and decorated sole plate of Begijnhof 34 (Schoonenberg, n.d.).

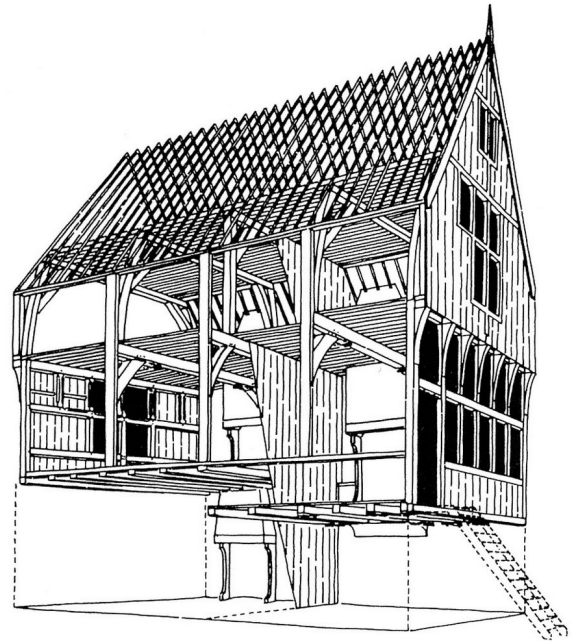
Fig. 5. Reconstruction of the timber frame by Henk Zantkuijl (Amsterdam Monumentenstad, Database Van De Amsterdamse Grachtengordel, 2020).

In the drawing of the timber frame by Henk Zantkuijkl, the structure appears to be floating. This is due to the fact that the ground floor walls were actually constructed out of brick as it proofed more suitable with the humid subsoil. As I. R. Meischke (1969) proposes, this house can be described as a supported timber-framed house. Alongside these supported timber-framed houses, self-supporting timber-framed houses, which lacked the brick ground-floor walls were also commonly found in Amsterdam. Thin brick side walls, anchored to the timber structure, are also used in Begijnhof 34 in order to provide horizontal stability. (Glaudemans & Smit, n.d.). The nature of these side walls show how the transition to the use of more brick in Amsterdam was already unfolding during the construction of Begijnhof 34. Before this transition, most side walls would have been constructed using timber wind braces¹⁰, rails¹¹ and siding¹² between the cross frames (figure 6).

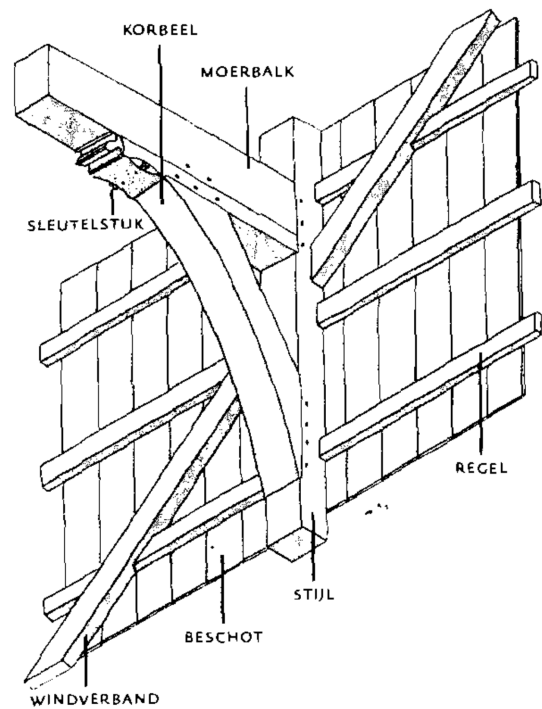
Fig. 6. Reconstruction of a part of the timber frame at Warmoesstraat 96 by Ronald Glaudemans (Glaudemans & Smit, n.d.).

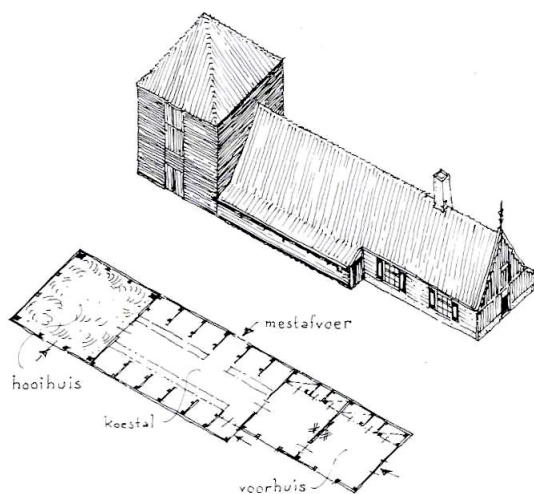
Fig. 7. Isometric projection and ground-floor plan (Hooihuisboerderij, n.d.).

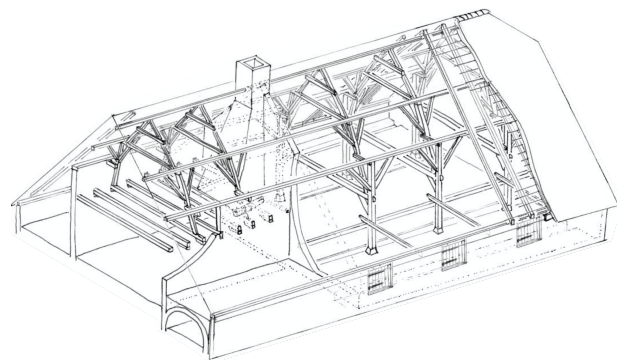
Fig. 8. Timber-framed construction of an aisled hall house (Rijksdienst voor het Cultureel Erfgoed, 2015).

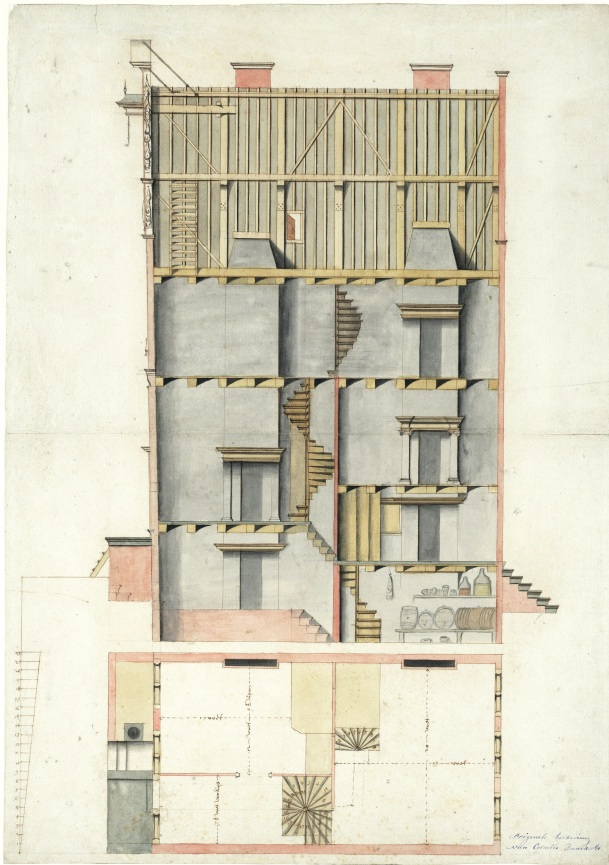
Fig. 11. Section and ground-floor plan by Cornelis Danckerts of unknown house in Amsterdam (no scale) (Danckerts & Stadsarchief Amsterdam, 1678).

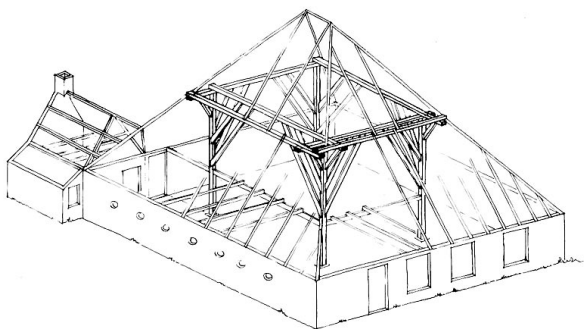
Fig. 14 Isometric projection of the common timber frame (Constructie Van Een Stolpboerderij, n.d.).

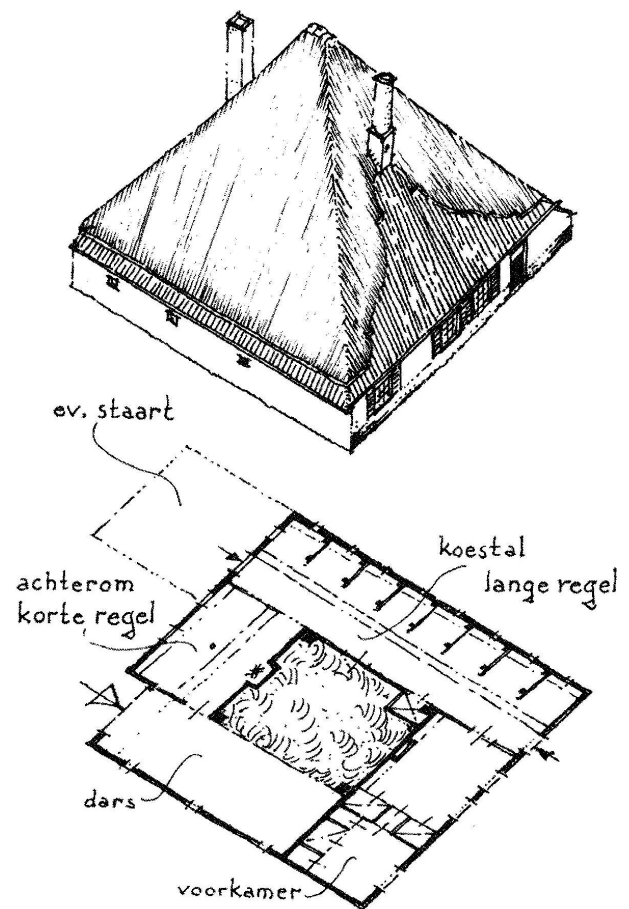
Fig. 15. Isometric projection and ground-floor plan (Noord-Hollandse normaalstolp, n.d.).

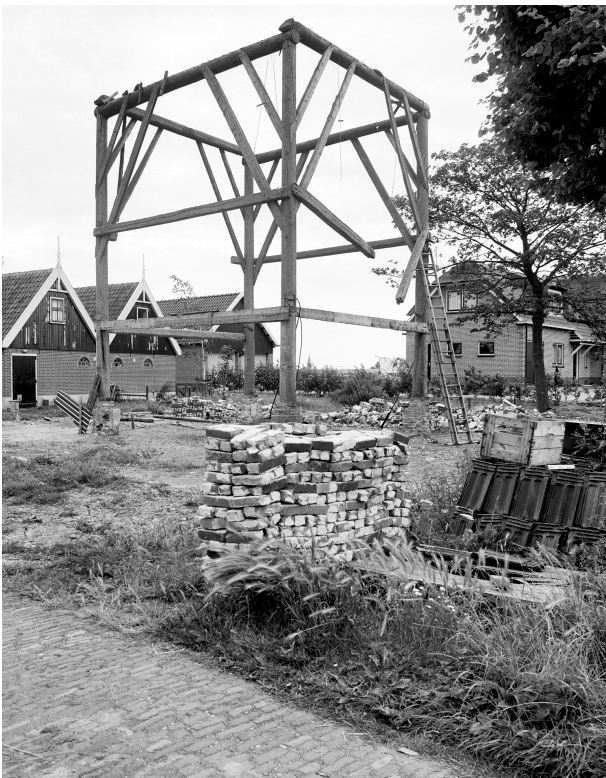
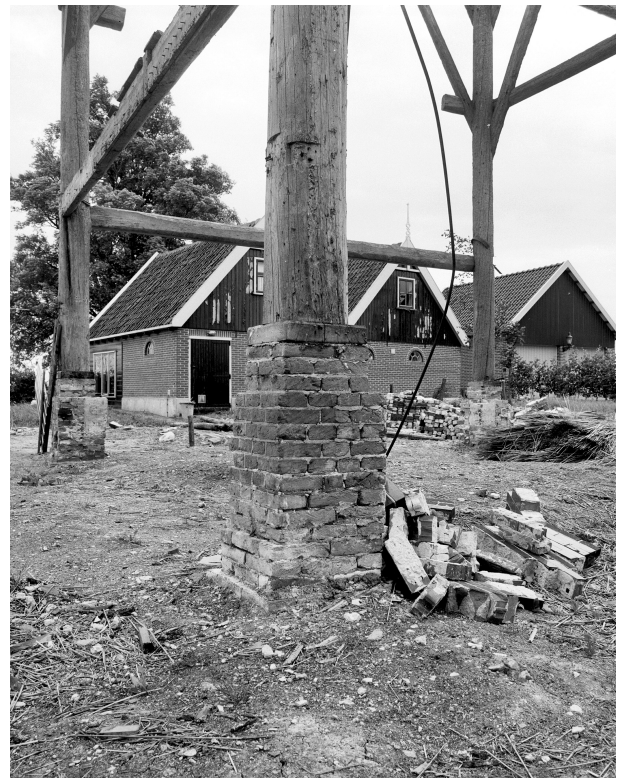
Fig. 17. Remaining central timber frame and brick footings of an unknown Stolpboerderij (Dukker, 1986).

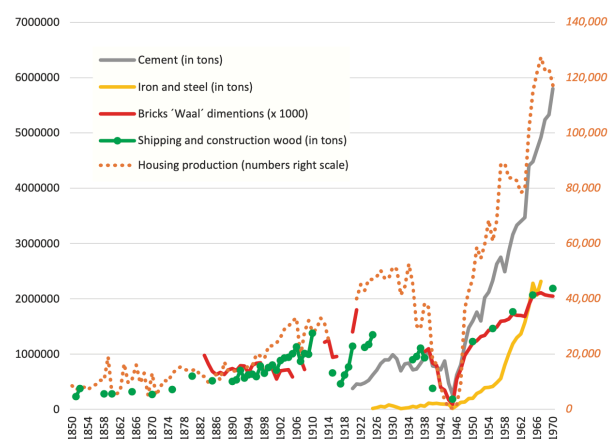
Fig. 18. Utilization of construction materials and housing production in the Netherlands, 1850–1970 (Lintsen et al., 2018, p. 311).

Another interesting example however, is the slightly older and lower Frankendaal neighborhood in Watergraafsmeer. This neighborhood consists of 792 duplex houses; consisting of two apartments stacked on top of each other that were to be combined when the housing shortage was over (Zijlstra, 2002). The way in which they were constructed is exemplary for the then prevalent industrialization of the construction process. The introduction of mass production and prefabrication was expected to lead to a cost-, work- and time reduction in the construction process (De Wederopbouw: Architectuur En Stedenbouw, n.d.). The 'new' construction-materials, being concrete and steel, which had previously mostly been used for small elements such as balconies and lintels (see chapter 2.1), now took up an important role in construction. The term 'system construction'¹⁵ is often associated with the dutch post-war reconstruction as more than 400.000 of dwellings constructed between 1950 en 1979 have been built using on of the many mass-produced systems (De Wederopbouw: Architectuur En Stedenbouw, n.d.). The section in figure 20 clearly illustrates this revolution in construction methods. In a substantial part of the Frankendaal neighborhood, the Dotremont-Ten Bosch was used; a system which is characterized by its use of notched concrete columns and beams as its main constructive elements as seen in figure 19 (Zijlstra, 2002). The use of timber was now quickly reduced to the fabrication of window frames and floor planks. Partially owing to the strong national coordination, dwellings were built at a rate previously unknown. Combined with the aforementioned revolution in construction practices and the creation of large infrastructural works, this led to an enormous increase in the yearly use of concrete and steel (figure 18) (Lintsen et al., 2018, p. 310).

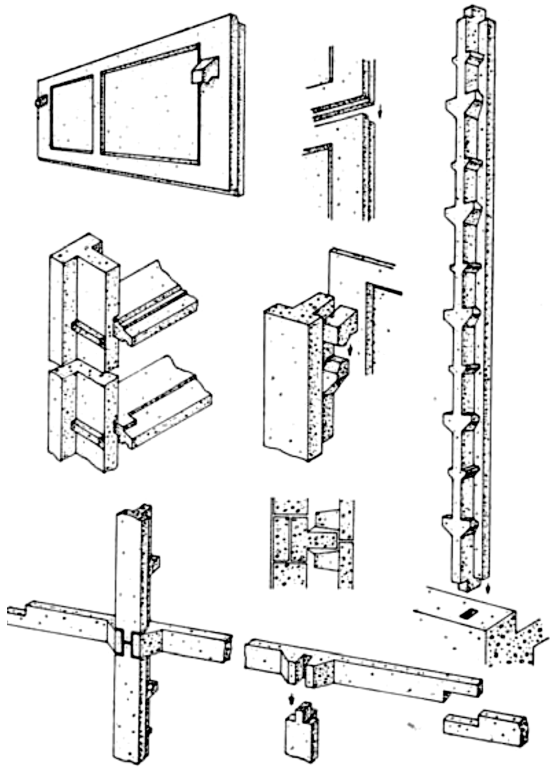
Fig. 19. Schematic drawings of the systemized construction elements as applied in the Frankendaal duplex houses (Kwantes, 1952).

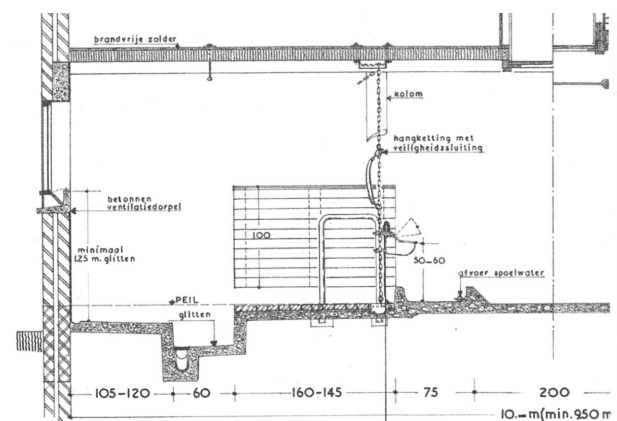
Fig. 23. Standardized section by the BWB (no scale) (Elpers, 2019).

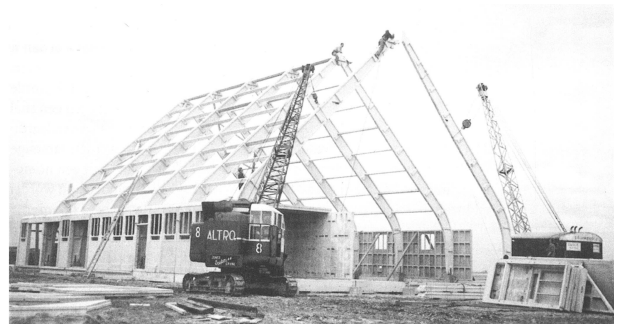
Fig. 25. Constructing a barn in the Noord-oostpolder (Elpers, 2019).

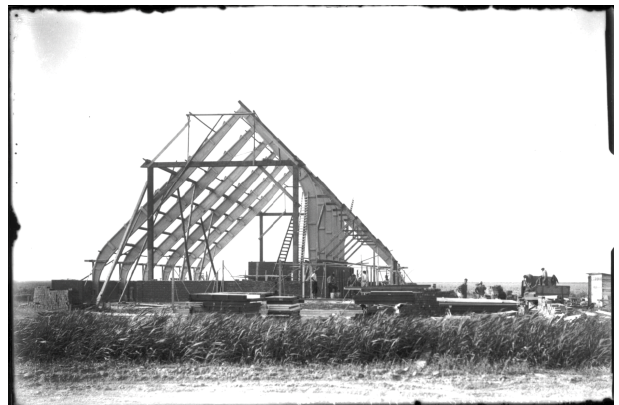
Fig. 26. Laminated timber truss construction on Texel (Eelman, 2021).
