# **Dutch Buildings Flood Fragility** Masonry Wall Experiments at Flood Proof Holland

Report number C71H14-01

# **DUTCH BUILDINGS' FLOOD FRAGILITY**

Masonry Wall Experiments at Flood Proof Holland

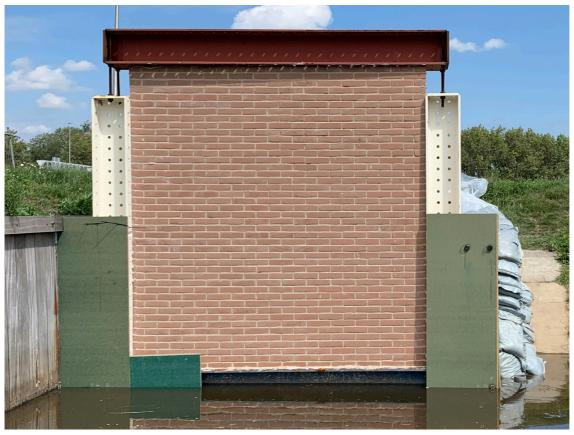
Figure 1. Masonry wall in steel testing rig with water level at -15cm.

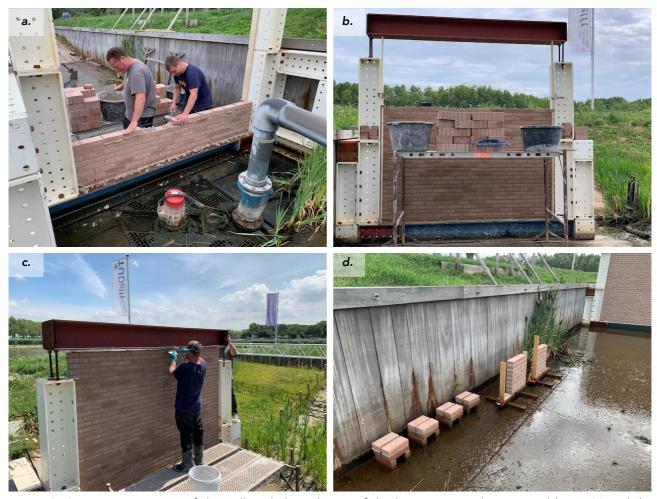
Figure 8. Construction process of the wall, including glueing of the last course to the top steel beam (c) and the companion specimens (d).

The masonry wall was constructed on June 15th 2020 by a professional mason who had built many masonry samples tested in the Stevin Laboratory. The fired-clay bricks of 'waalformaat' of 210 mm in length, 50 mm in height and 100 mm in thickness, were laid in a stretcher bond pattern with half overlap and 10 mm joints, resulting in a single-wythe wall 100 mm thick. The wall was built 12 bricks wide (2630 mm approx.) and 44 courses tall (2630 mm approx.). The first and last courses were glued to the boundary steel beams using a two-component epoxy glue, while the lateral sides of the wall were placed dry against the steel columns. The mortar was acquired pre-mixed with a recipe consisting of cement and hydrated lime as cementitious components, and fine sand. The final product had a ratio in weight of approximately 1.3:5.5:1 of cementitious aggregates, sand, and water; however, the water quantity was tuned by the mason on site to compensate for the sunny and windy construction conditions. Hence, two compression wallets (2 bricks wide and 8 courses high) and 6 bond-wrench couplets were constructed to later establish any deviations between the material properties of the masonry built at Flood Proof Holland, and the masonry built in the laboratory (see Figure 8.d). The companion samples were left to harden next to the wall for a period of eight weeks before being taken to the laboratory for testing so that they would resemble the wall properties as much as possible.

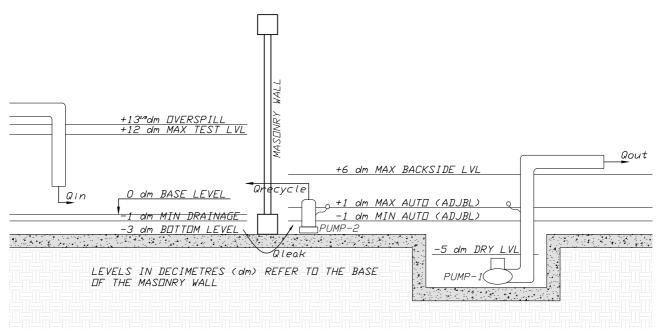
Figure 4. Scheme of water levels.

The water level was controlled by opening the shutter valve from the main basin and allowing the basin to fill with water. Water leaking to behind the wall through the small gaps around the frame was automatically returned to the basin by a small pump; see 'pump 2' on the scheme in Figure 4. If the water level at the backside of the wall became too high, the large pump was engaged to keep the water at the desired level, avoiding the compensation of the hydrostatic pressure from the inside of the wall which would, in most cases, create a less unfavourable situation. A pipe with a plug was also installed to drain the basin at the end of the test.

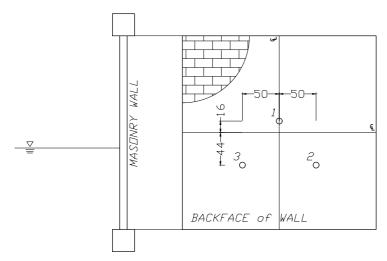
Figure 5. Position of the potentiometers referenced to the centre of the back face of the masonry wall. These sensors measure the out-of-plane displacement, i.e. the displacement perpendicular to the face of the wall.

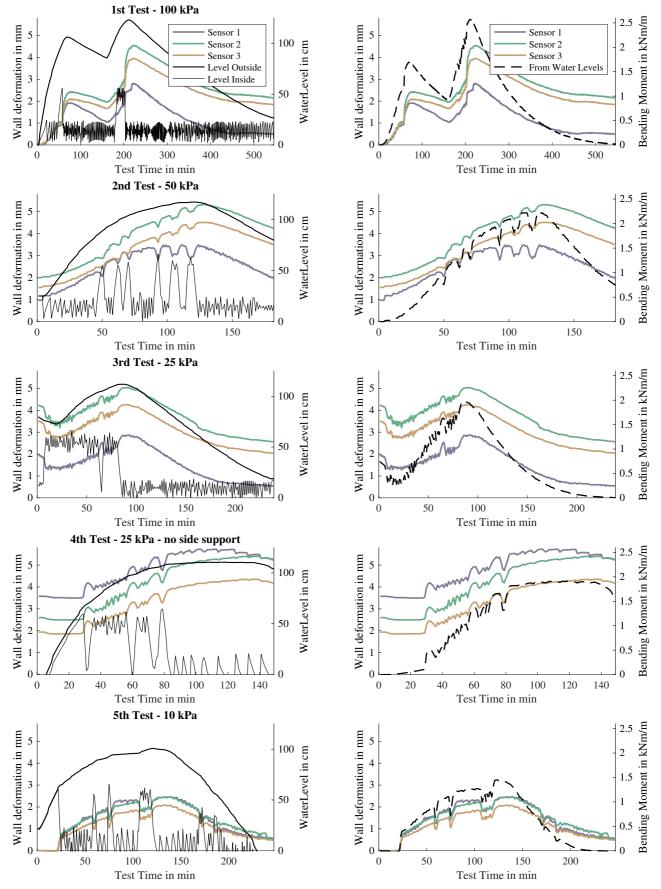
Figure 6. Water levels, sensor deformation, and derived bending moment (from water levels) against test time for the five different tests. The bending moment is derived from the water levels present and is an indication of the severity of the load.

The deformation measured by the sensors placed on the wall was captured next to the water levels so as to obtain a relationship between the hydrostatic pressure on the wall and its deformation. Furthermore, the combination of water in front and behind the wall can be observed as an applied bending moment, which offers a clearer relationship to wall deformation. These are depicted in Figure 6. The chronological progress of the test is presented on the horizontal axes and reveals the speed at which the basin was filled and subsequently emptied. As the outer water level rose, a clear deformation was measured by the wall deflectometers; see graphs on the left. This trend is even more evident when the water levels are converted to an equivalent bending moment on the wall, presented in the graphs on the right. Note that the exerted moment is not directly related to the internal bending moment developed in the wall; this is explored later on. The relationship between the outer water level and the deformation of the wall is better illustrated in Figure 7, where the outer water level at times of a near-zero inner water level is plotted against the wall deformation measured by the 3 deflectometers. These graphs also reveal increased wall deformation at high water levels. After the first test, a residual wall deformation is present; this may be linked to permanent damage in the wall or, most likely, an initial deformation of the testing rig as it settles to the lateral loading. The accumulated deformation persists over the test, with one test beginning where the previous ended; the initial point is marked with an 'x'. Note that some tests, like the 1st and 3rd tests, present a horizontal line marking deformation of the sensors at a constant water level. This occurs at high and low water levels, and in both cases, is linked to a long-term presence of the water. At high water levels, this could be attributed to a plastic deformation of the wall, while at lower water levels, the deformation of the sensors is more likely related to temperature, wind or rain effects as the testing setup is left exposed to the environment over night. Consequently, the lower plateaus in Figure 7 should not be disregarded. Additionally, the sensors were reset directly before the fifth test.

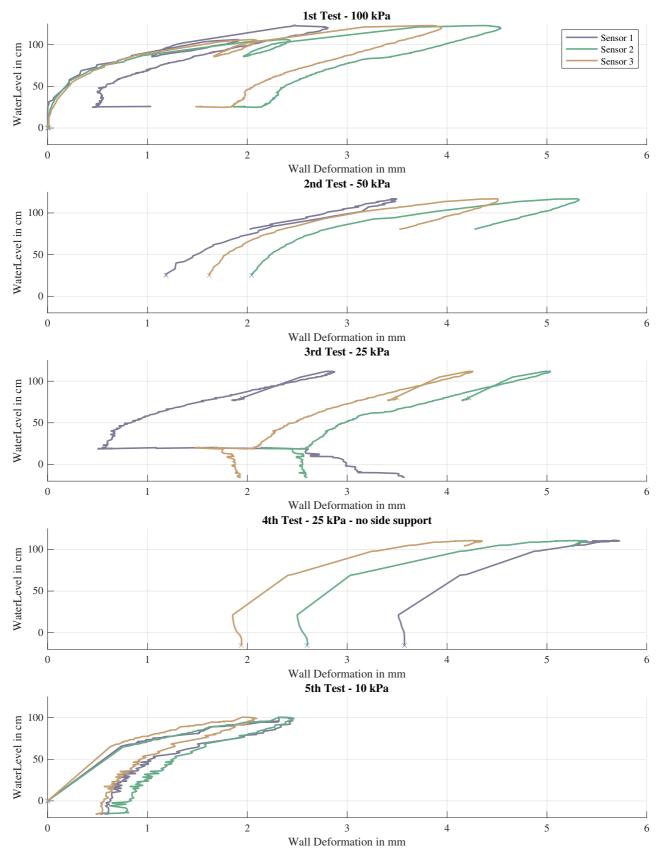
Figure 7. Water level against wall deformation.

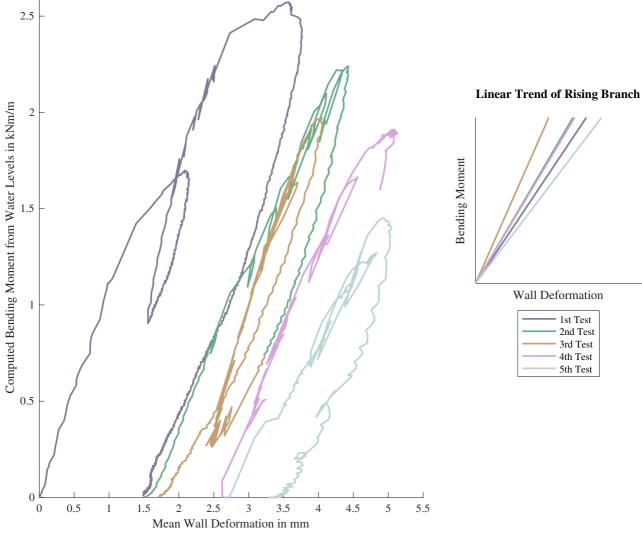
Figure 8. Bending-moment against wall deformation.

Furthermore, the equivalent bending moment applied by the water levels can also be plotted against the wall deformation averaged from the three sensors; this is illustrated in Figure 8. Here, the fifth test is shifted to the end of the fourth test, yet the other values are left untouched. This reveals an increasing, accumulated deformation during the tests, with most of the residual deformation occurring during the first test. Sustained water levels also lead to an increase in deformation. In this light, the rate at which the water level was increased seems to be reflected in the absolute deformation measured. Hence, the stiffness of the indicative force-displacement curve presented in Figure 8 may not be representative of the stiffness of the wall when subjected to the hydrostatic pressure. Nonetheless, comparing the first and fifth test, where the water level was raised much faster for the fifth test, does hint at a reduced stiffness of the wall at the later test. This is summarised in Figure 8, right, where a simple linear fit to the rising branch of the data is made. The lower stiffness of the later test would be attributable to the progressive degradation and damage of the wall.

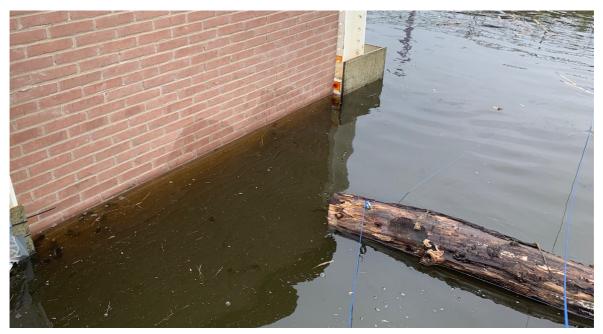
Figure 9. Tree log floating in front of the wall.

Two types of debris experiments were performed. The first consisted of a floating tree log, about 3 metres in length, 30 cm in diameter and about 80 kg of mass, which was rammed against the wall; see Figure 9. The log was accelerated in the water and given a trajectory perpendicular to the centre of wall; at the moment of impact, the speed of the log was varied between 0.5 and 1.8 m/s over 18 collisions. The wall deformation was measured before and after each impact. The log was to represent "soft" debris floating in flood waters.

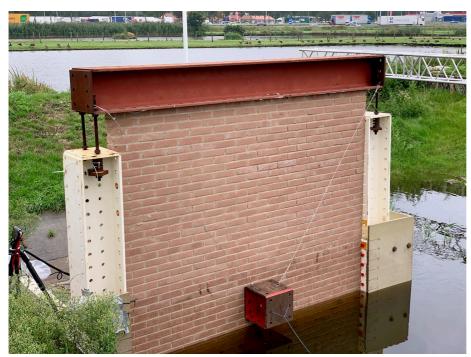
Figure 10. Object swinging against the wall to simulate 'hard' debris.

Secondly, a heavy object, a 30 cm steel cube of 40 kg, was hung from the top of the frame suspended slightly above the water line. This object was to mimic "hard" debris in the water such as cars or metal boats. The object was pulled perpendicularly to the wall and left to swing back to collide with the wall. The potential energy of the object is converted to kinetic energy by the swinging action, which is then absorbed by the wall and the testing rig and transformed into damage or released as dissipating vibrations.

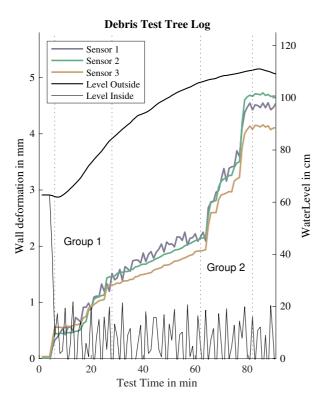
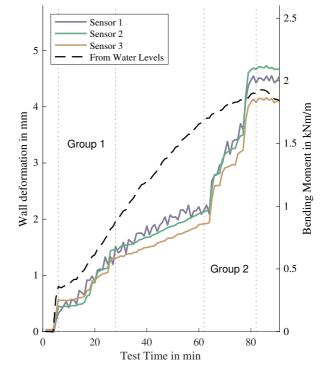
Figure 11. Deformation of the wall after impacts.

While the deformation of the wall during the collision couldn't be recorded accurately, the deformation after each impact can be observed in Figure 11. Here, the water level rises between 90 and 110 cm; two groups of impacts were conducted at a lower (Group 1) and higher (Group 2) water level as depicted by the dotted lines in Figure 11. Here, many of the collisions can be identified by a spike in the wall deformation. This can be contrasted to the middle section of the graphs where no impacts took place and where the rate of increase of the sensor deformation is thus reasonably smooth and only reflects the pump cycles to control the leakage flow. The later impacts, at a higher hydrostatic pressure, led to considerable jumps of up to 0.4 mm in out-of-plane deformation of the wall. Overall, an additional 2 mm of deformation can be attributed to the collisions. This deformation was also not recuperated by the wall when the water was drained.

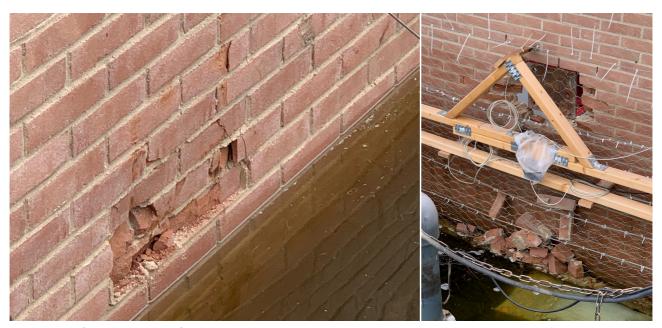
Figure 12. Left, local damage of the bricks led to a hole in the wall, right. The broken and displaced bricks were trapped by the steel net.

About 105 hits of varying velocity were necessary to create the hole in the wall seen on Figure 12. The impacts reached up to 3 m/s (as measured from the video frames), with an energy of about 180 Joules. In comparison, the impacts with the log reached only 90 J of energy. Moreover, the stiff steel cube transferred most of the impact energy to the wall while the soft log also dissipated some of the impact energy itself. The energy of the impact was observed to be dissipated by elastic damping of the frame and the wall, hydrodynamic damping due to the displacement of the water with the wall, permanent deformations in the masonry and opening of cracks, and sound.

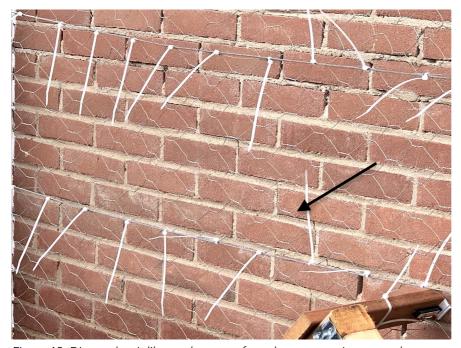
Figure 13. Diagonal stair-like crack pattern from the centre going upwards.

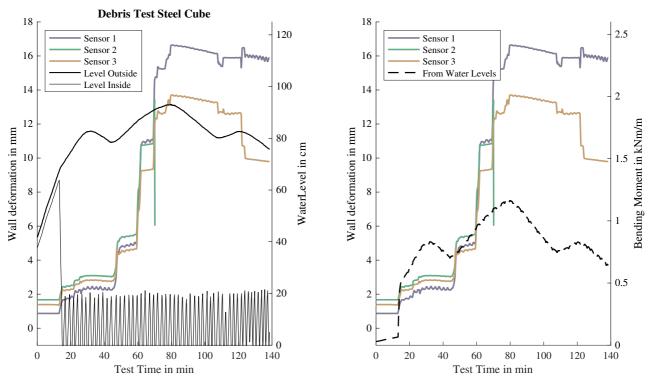
Figure 14. Deformation measured by the out-of-plane deflectometers under relatively-constant water level difference. Note that Sensor 2 dropped out halfway through the test when a large displacement took place.

The cube impacts resulted in large deformations measured by the displacement sensors, ultimately reaching and exceeding their measuring range. About 80 min into the test, the majority of the impact energy started to be consumed by the local damage of the bricks which led to a halt of the increase in wall displacement as can be observed in Figure 14. Note also that this is the residual, permanent deformation left by the impact of the debris mimic; the maximum, transitory deformation at the moment of impact was much larger but could not be recorded by the slow sensors. This transitory deformation created small ripples in the water as the wall deformed backwards and bounced back forward.

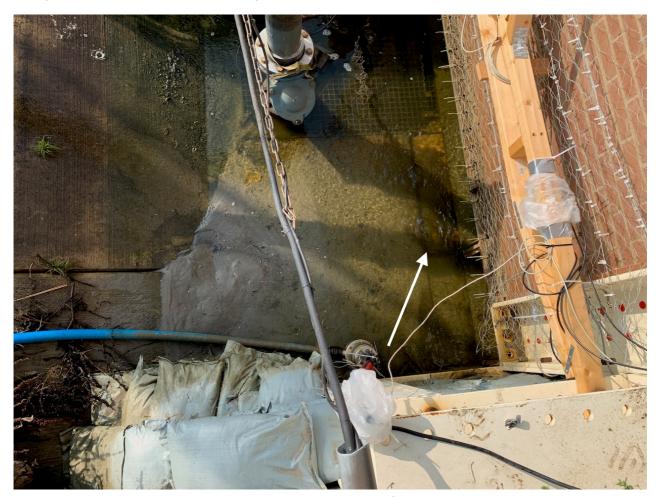
Figure 15. Small concrete tile (indicated with arrow) and sand scoured from underneath it.

Leakage around the wall and the testing rig is unavoidable and preparations to minimise it were carried out before the experiments. As long as the volume of water leaking to the backside of the wall was significantly smaller than the inflow of water to the basin, leakage would not be a problem. The measures taken to control leakage such as plugging the bolt openings in the steel frame and placing timber boards in front of it, including an impermeable layer in the dike of sandbags, and sealing all the joints with silicone were effective in minimising leakage. However, the gaps between the large concrete plates that make out the floor of the basin were underestimated. These gaps were also sealed underneath the steel frame and around it, but water ended up forcing its way through these gaps by flowing longer distances underneath the plates. This phenomenon, called piping, worsened as the test progressed. In particular, a small concrete tile, located close to the pit of the pump and smaller than the other plates to accommodate the pit, became the outlet of the piping flow; see Figure 15. The sand underneath this tile was carried by the water flow and deposited nearby. Once enough sand had been removed, the tile sunk and the water started flowing underneath the steel frame and over the tile which stopped the transport of sand.

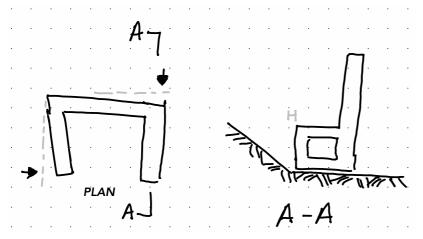
Figure 16. Scheme showing displacements of the frame due to the hydrostatic pressure.

Furthermore, it was interesting to observe that the entire testing rig was slowly displaced by the pressure of the water. The legs of the steel rig were placed about 5 cm from the edge of the slope of the basin made from concrete plates. The sliding stability of the rig was guaranteed by the weight of the additional sandbags; however, the flow underneath the steel rig may have reduced the friction at the bottom of the frame and allowed it to slide until the legs came into contact with the concrete plates. This displacement can be observed in Figure 16 where the original position of the rig can be traced back to the sealant line. Similarly, the side of the frame was bent inwards until the bolted connection was fully activated. This can be observed by the gap formed between the sandbags placed in front of the timbers boards at the side of the rig. The additional weight of the sandbag dike and the lack of underflow on this side of the rig seemed to have prevented it from sliding. These displacements are illustrated in Figure 17.

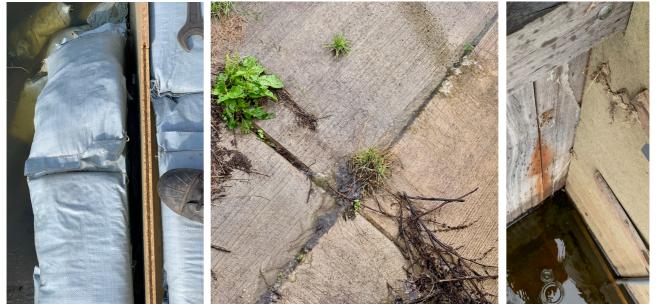
Figure 17. From left to right: gap in the dike, water flowing out of the concrete gaps, and sliding back of the frame.

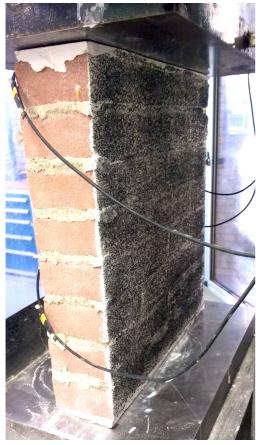
Figure 19. Wallet for a compression test in the testing rig. The front face of the wallet appears painted for monitoring with photogrammetry.

Different sizes are prescribed for the masonry wallet by various guidelines. The single-wythe wallet eight courses high and two courses wide has become the standard for the 'waalformaat' brick size and is thus comparable to the masonry already assayed in the lab. The wallet is placed on top of a rigid plate that is moved upwards by a hydraulically-operated jack against a rigid top plate. This produces a compressive stress in the masonry. The compressive strain is increased at a constant rate until a peak in the applied force is evident; this corresponds to the compressive strength of the masonry. The stress-strain relationship is then employed to compute the Young's modulus of the material. The test can be continued until the specimen fails in crushing; the total energy employed to reach failure is used to calculate the compressive fracture energy of the masonry.

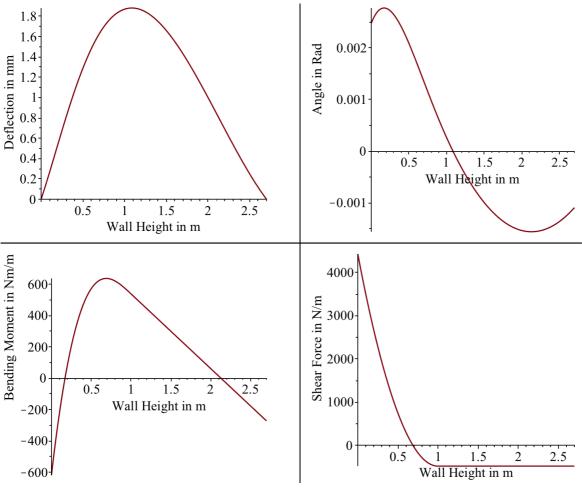
Figure 21. Deflection, line rotation, bending moment and shear force against wall height for a water depth of 1m (a=1).

It can be observed how the maximum deflection doesn't occur at the centre height of the wall but is slightly offset towards the bottom; this is due to the hydrostatic pressure which is only applied on the bottom portion of the wall and is greatest at the very bottom. For 100 cm of hydrostatic pressure, the model predicts a maximum deflection of 1.8 mm and bending moment of 600 Nm/m. With the rotational stiffness of the supports, the negative and positive bending moments are similar. Also, the rotational angle at the support is far from zero, suggesting that the rotational stiffness included is not sufficient to provide a perfect double-clamped condition. The model, expressed symbolically, can be evaluated using zero rotational stiffness which leads to an unrealistic deflection of 4.4mm. Then, at infinite stiffness, the deflection decreases to 0.65mm. The stiffness chosen is that of the web of the steel beam when a moment is applied at its top and its bottom is perfectly fixed to the bottom flange; it seems, when comparing the deflection of the model and the experimental values, that the rotational stiffness so selected is well fitting as a rotational constraint. Moreover, the similar positive and negative bending moments that result from this configuration are efficient in the sense that the wall is capable of remaining in the linear-elastic regime without one of the two locations failing first. This gave, unknowingly, a higher LE capacity to the wall.

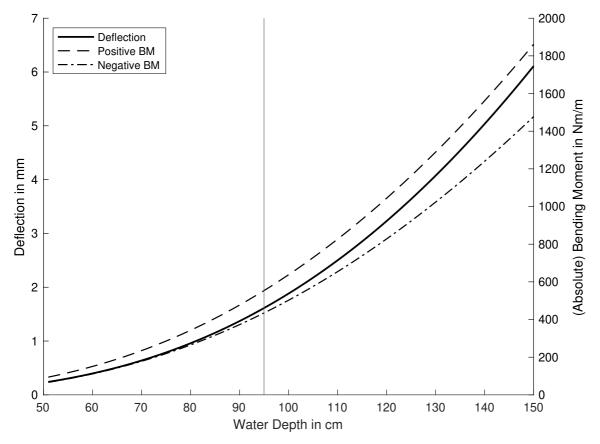
Figure 22. Maximum deflection, positive and negative (at supports) bending moments for various water depth values.

Furthermore, Figure 22 depicts the situation of an increasing water depth in front of the wall; the vertical line, at 95 cm, marks the point at which the bending moment exceeds the strength of the wall. Of course, the linear-elastic analytical model does not consider this effect. Later, in section 3.4, a comparison to the experimental values is made. Finally, Figure 23 presents a similar picture but including the deflection of the wall over its entire height.

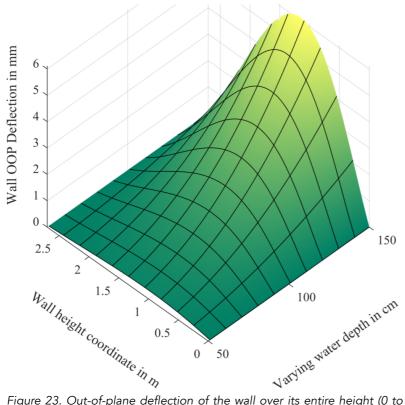
Figure 23. Out-of-plane deflection of the wall over its entire height (0 to 2.7m) for one-way bending under increasing water depth (50 to 150 cm).

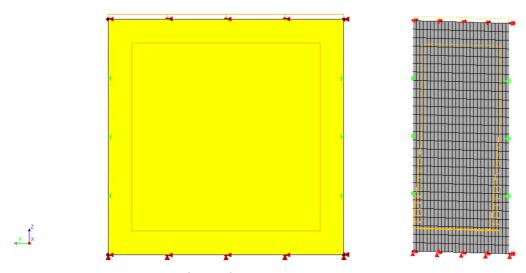
Figure 24. Boundaries and loads for the finite element models. Right, 3D view in perspective to show perpendicular hydrostatic pressure.

Additional models use the finite element method, where the wall is subdivided into small sections or rectangles connected via nodes. Both linear and non-linear FE models have a similar configuration with the exception that the non-linear models employ a non-linear material model for the wall; in both cases the material model is isotropic and follows the continuum approach. All FE models, as illustrated in Figure 24, are simply supported on all three directions at the bottom and on both horizontal directions at the top. Furthermore, a rotational spring, which limits the in-plane rotation at both top and bottom boundaries, is included in the models to consider the influence of the steel beams which provide some rotational restraint. Additionally, both lateral boundaries are connected to a boundary interface which limits the horizontal deformation perpendicular to the wall. The stiffness of this interface is zero for the one-way bending models, and 35 MN/m³ for the two-way bending models representing the flexibility of the timber supports. A line load, mimicking the weight of the steel beam and the applied vertical stress, is included at the top, while, on the face of the wall, a triangular, hydrostatic pressure is applied, as depicted on the right of Figure 24. This illustration also shows the mesh of the model with 27x27 elements of 100mm by 100mm. The basic properties of the models are shown earlier in Table 4.

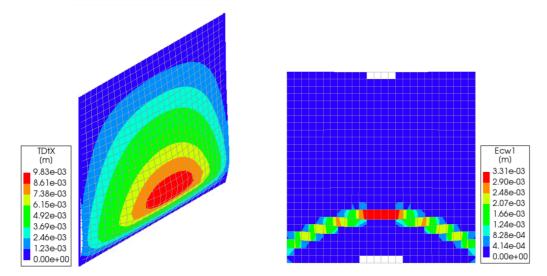
Figure 27. Two-way bending at a water depth of 130 cm.

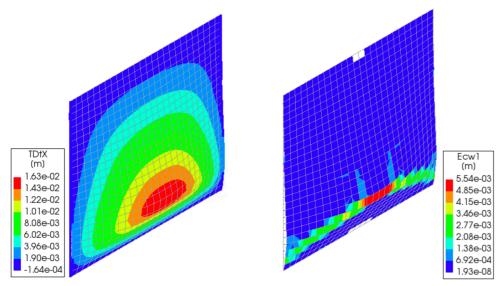
Figure 28. Two-way bending at a water depth of 140 cm.

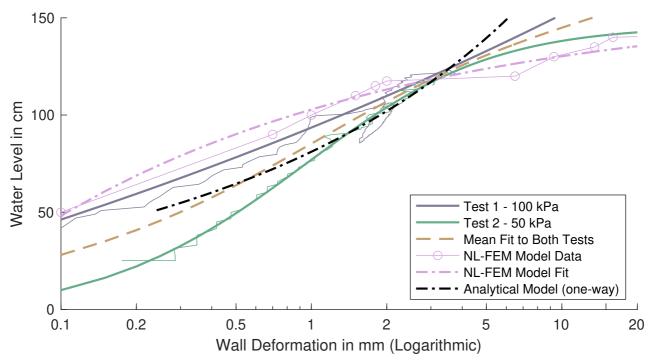
Figure 29. Comparison between Model D and experimental data.

The experiments and the models reveal that the wall was always restrained in two directions, ergo, from all four boundaries. Even when the timber restraints where removed, the wall continued being attached to the side columns. The masonry had been placed flush with the columns but had not been attached to the steel in any way; only a silicone sealant was used to prevent water seeping at the sides. This sealant does not have the capacity to support the masonry, especially with the forces capable of shifting the testing rig backwards. Consequently, a different effect must be responsible for the support of the wall at the sides and the failure to achieve both two- and one-way bending in the experiment. One hypothesis is that the pressure of the water on the side of the testing rig exerted a horizontally-compressive force on the masonry and that this force, together with the friction between steel and masonry managed to affix the sides of the wall in place. However, a modified non-linear model, where the side interfaces where made non-linear to include friction, reveals that the lateral force would have had to be much higher than what the entire pressure on the side of the setup could generate. Another explanation lays in the shifting of the frame. Figure 16 illustrates how the testing rig was displaced due to the hydrostatic pressure; this displacement could be linked to a mechanism that grasped the masonry in place. Furthermore, the hygro/thermal expansion and contraction of the frame together with that of the masonry could play a role even if the expansion coefficient of steel is higher than that of masonry and the testing period was noticeable warmer than the construction period. Finally, the out-of-plane deflection causes an horizontal arching phenomenon in the wall which adds a horizontally-compressive force; however, this confining force needs to be countered and there are no rigid elements to provide such confinement. All in all, future wall tests should incorporate a five millimetre rubber seal to prevent the masonry becoming fixed to the steel frame at the side boundaries.

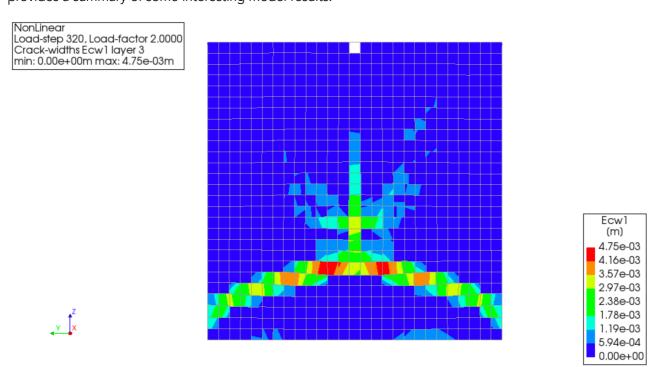
Figure 30. Debris collision on pre-damaged masonry wall (at 130 cm waterdepth) simultaneous with 100 cm of water depth using Model D. The point of impact is identifiable by the cross-like crack pattern.

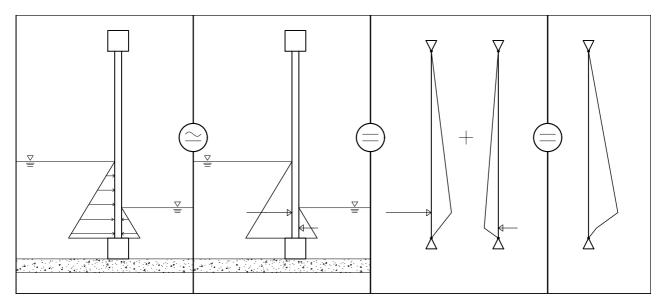
Figure A.1. Equivalent bending moment from water levels.

Following the scheme presented in Figure A.1: Firstly, the pressure applied to the the wall as a result of a water depth in front and behind the wall is schematised. Secondly, the distributed, triangular pressure is approximated to a point load located at two-thirds the depth measured from the surface of the water. Each point load produces a known, linear bending moment as depicted in the third box. Fourthly, under the principle of linear superposition, the two bending moment lines can be subtracted to produce an equivalent bending moment line from where the maximum equivalent bending moment can be observed.

It must be emphasised that this is an approximation since the hydrostatic pressure leads to a more complex moment line than depicted here; yet, due to the sensitivity of the model boundaries and other parameters, this approximation is a reasonable estimation of the severity of the load when water is present both in front and behind the wall.
