In-Plane Behaviour of Unreinforced Masonry Strengthened with a Structural Glass Window

A Proof of Concept

Gaggero, Maria B.; Korswagen, Paul A.; Esposito, Rita; Rots, Jan G.

Buildings

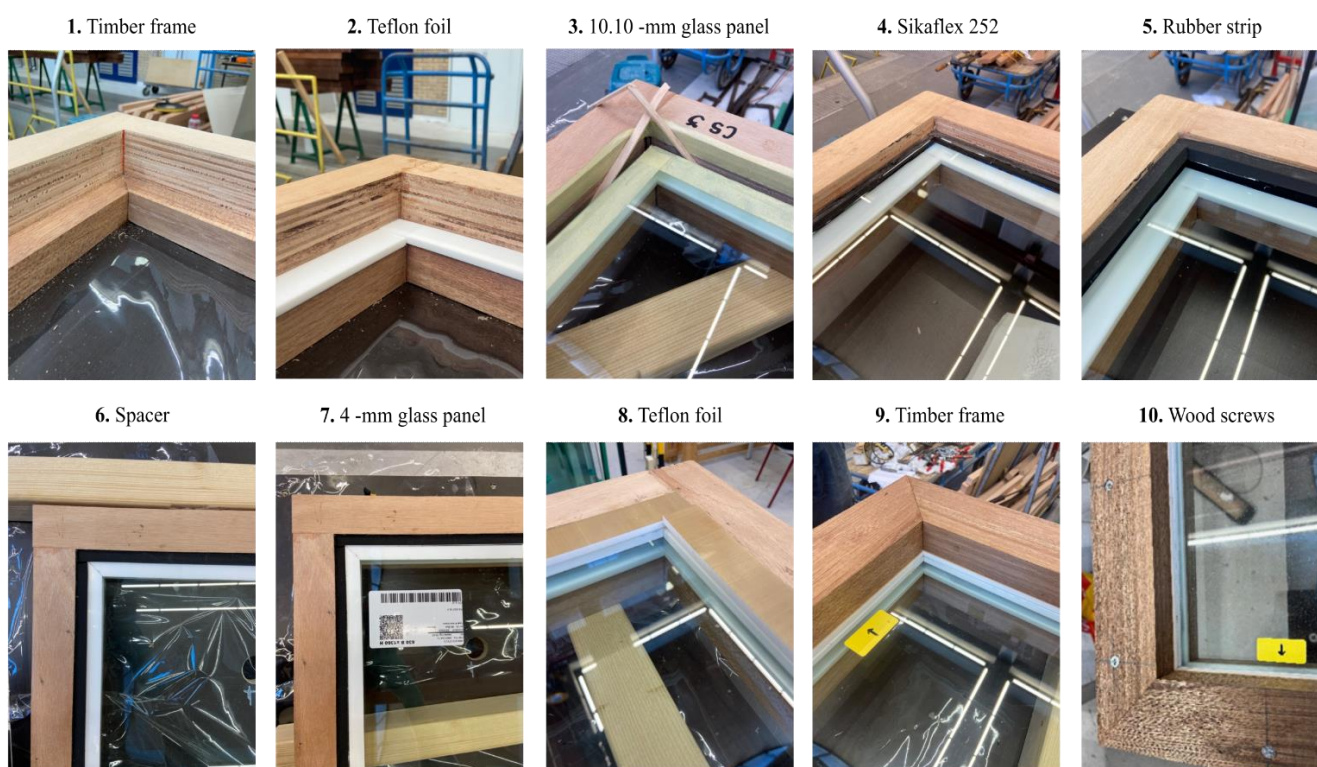
Figure 2. Overview of the structural glass window construction.

The construction of the window prototype was performed at TU Delft Macrolab/Stevin laboratory following the procedure reported in Figure 2.

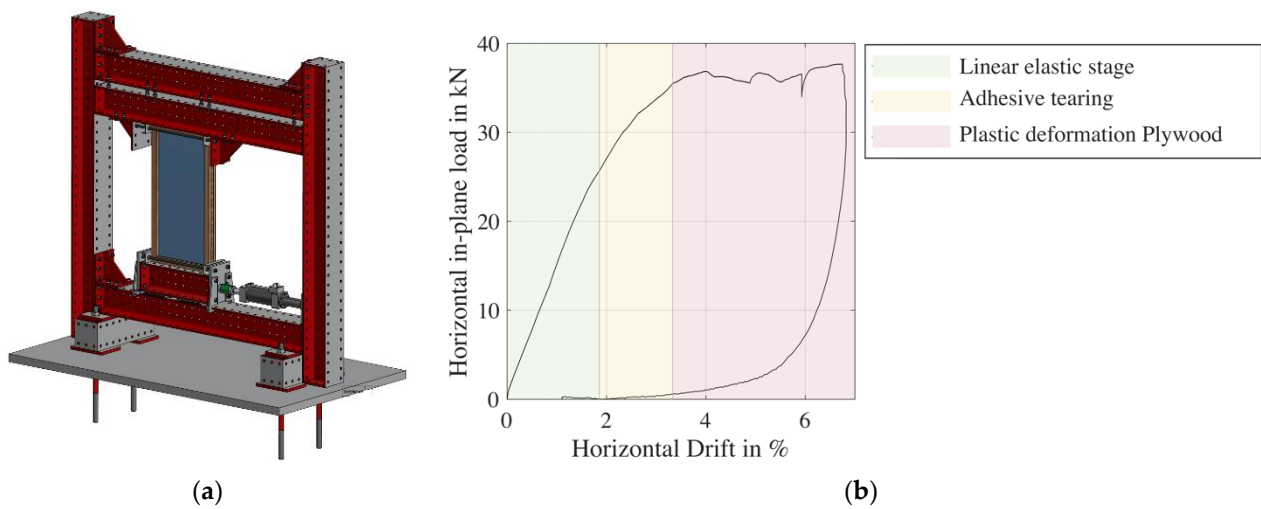
Figure 3. In-plane test on the standalone window: (a) test set-up, (b) obtained capacity curve.

To understand the behaviour of the window prototype and evaluate its capacity, a quasi-static in-plane test on the standalone prototype was performed (Figure 3a). During the test, the window was loaded in a double clamp configuration by imposing a displacement at its bottom right corner while its top part remained fixed. The resulting capacity curve

(Figure 3b), expressed as horizontal in-plane load vs. horizontal drift, showed elasto-plastic behaviour that can be divided into three subsequent phases as follows. In the first stage, the load was transferred through the adhesive without tearing, leading to a linear elastic behaviour of the window. The linear elastic stage is depicted in green and is followed by a second stage in which tearing of the adhesive occurs. Tearing of the adhesive started at a drift of 1.9% and concluded at 3.3% when direct contact between the glass panel and the wooden frame occurred after crushing of the adhesive. During the last phase, the glass panel rotated inside the wooden frame compressing and deforming the horizontal plywood elements. At the end of the test, these plywood elements showed residual plastic deformation with a glass penetration of around 10 mm.

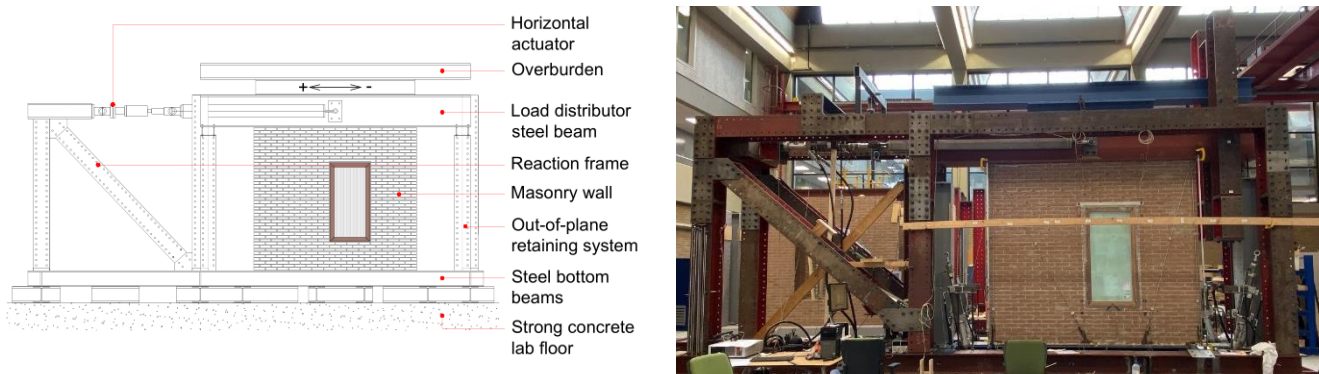
Figure 6. In-plane test set-up looking at the back of the wall (without DIC pattern).

The set-up adopted for lateral loading of both full-scale walls is shown in Figure 6. It consists of a steel frame, anchored at the stiff laboratory floor, in which the wall is settled. In particular, the bottom steel beam on which the specimen is built is connected to the bottom cross-beams of the steel frame to prevent uplift. Instead, the top beam, glued after construction to the last masonry course, is connected to a 100-kN hydraulic jack to induce the prescribed horizontal displacement to the specimen. The weight of the top beams results in a constant overburden of 0.12 MPa that mimics the load of ground-floor walls of typical two-story Dutch houses. The test is performed in a cantilever configuration, with the top beam free to displace and rotate in plane. During the test, the wall was monitored through digital image correlation (DIC) on the front side and sensors on the back side.

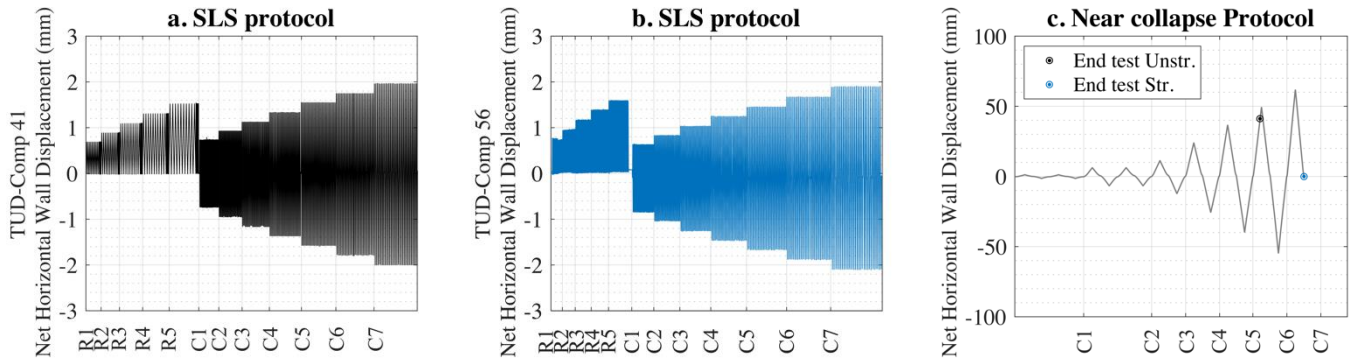
Figure 7. Loading protocol: (a) SLS part unstrengthened wall; (b) SLS part strengthened wall; (c) ULS part for both walls.

The walls were tested under a displacement-controlled procedure following a cyclically increased loading protocol (Figure 7). The protocol comprised a first part up to the serviceability limit state (SLS), and a second part up to ultimate limit states (ULS). The SLS part of the protocol was defined by Korswagen et al. [4,5,10] to investigate the initialization and propagation of cracks induced by repeated low vibration levels, typical of the light earthquakes in Groningen (The Netherlands). The ULS part of the protocol was representative of an expected Groningen-type earthquake and was derived by Mariani [11]. The SLS part consisted of a first repetitive part with 5 incremental steps and a subsequent (two-way) cyclic part with 7 incremental steps. For the two walls, the repetitive part of the SLS protocol was slightly different in terms of the number of repetitions per displacement

step that were implemented: while, in the strengthened wall, 30 repetitions with the same loading rate (0.125 mm/s) were applied, in the unstrengthened wall, 20 repetitions were applied with two different loading rates (the first 10 repetitions at 0.0125 mm/s and the last 10 at 0.125 mm/s).

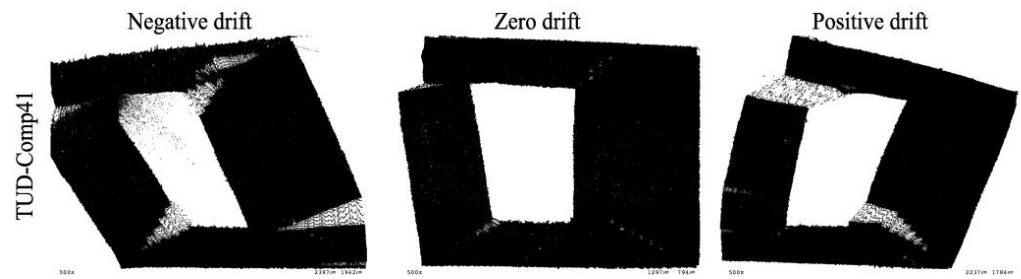
Figure 9. Deformed shape, magnified 500 times, of the unstrengthened wall (TUD-Comp41) resulting from the SLS protocol at a displacement of 2.125 mm (0.085% drift) [5].

Considering the unstrengthened case, a maximum base shear force of +22.1 kN (at 1.28 mm displacement, 0.05% drift) and −19.5 kN (at −7.0 mm displacement, 0.26% drift) was obtained, with an initial stiffness of 37.6 kN/mm, evaluated in the first repetition of the protocol at 40% of the maximum force (8.3 kN). The ultimate displacement, evaluated at a residual capacity of 80%, was 40 mm (1.6/−1.5% drift). No significant out-of-plane displacements were reached during the test as the maximum displacement was 8 mm (8% of the wall thickness). The onset of cracking occurred at the first repetition of the protocol with the horizontal crack at the bottom left side of the short pier (Crack 2 in Figure 8b) and at the top left corner of the window opening (Crack 7 in Figure 8b). The evolution of the crack pattern resulted mainly in diagonal cracks from the window corners, causing a rocking behavior of the piers and sliding of the masonry portion above the window opening and the larger pier with respect to the rest (Figure 10).

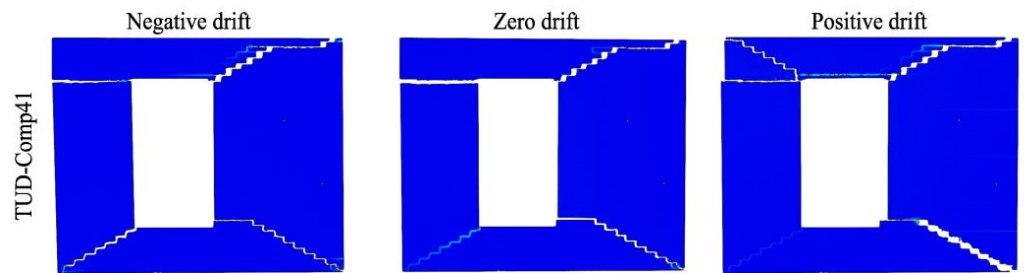
Figure 10. Failure mechanism of the unstrengthened wall (TUD-Comp41) resulting from the ULS protocol at a displacement of 40 mm (1.6/−1.5% drift).

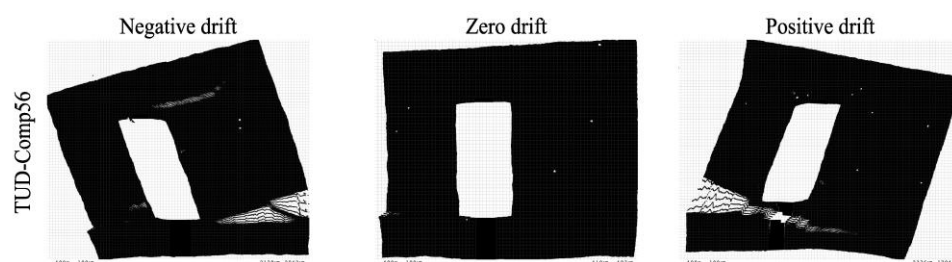
Figure 12. Deformed shape plots (500 times magnified) of the strengthened wall (TUD-Comp56) resulting from the SLS protocol at a displacement of 2.125 mm (0.085% drift).

Considering the strengthened case, a maximum base shear force of +23.9 kN (at 1.58 mm displacement, 0.06% drift) and −25 kN (−3.9 mm displacement, 0.14% drift) was obtained, with an initial stiffness of 44.6 kN/mm, evaluated in the first repetition of the protocol at 40% of the maximum force (9.6 kN). The onset of cracking occurred at the first repetition of the protocol with the two horizontal cracks at the bottom left side of the pier of lower length (Crack 1 and Crack 2 in Figure 11b). The evolution of the crack pattern resulted in two diagonal cracks at the masonry portion below the window opening. The latter cracks grew through the entire length of the wall, leading to rocking of the masonry portion above the aforementioned cracks as a whole piece (Figure 13). The test was stopped before reaching the ultimate displacement when the complete rocking mechanism was confirmed, i.e., at approximately 60 mm (corresponding to a drift of 2.3/−2.0%) and a residual capacity of 90% and 96%, respectively, in the positive and negative directions. Although leading to an underestimation of the ultimate displacement, the latter position is herein considered as the ultimate to allow future investigations of the specimen in a different boundary condition that might better force the glass panel to activate. In fact, with the presented cantilever configuration, no contact between the glass panel and timber frame was observed during the test: the maximum relative displacement, measured from the DIC at the end of the test, was −0.4 mm in both loading directions. The window remained in the linear elastic stage (Figure 3b) for the entire duration of the test: maximum wall drift in the first and second stages of the protocol was 0.1% and 2%, respectively. Regarding the

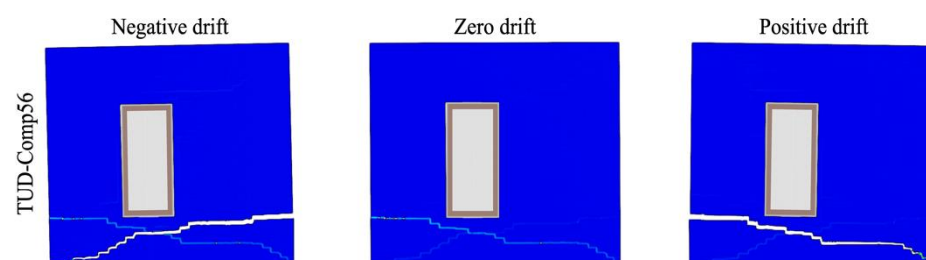
Figure 13. Failure mechanism of the strengthened wall (TUD-Comp56) resulting from the ULS protocol at a displacement of 60 mm (2.3/−2.0%).

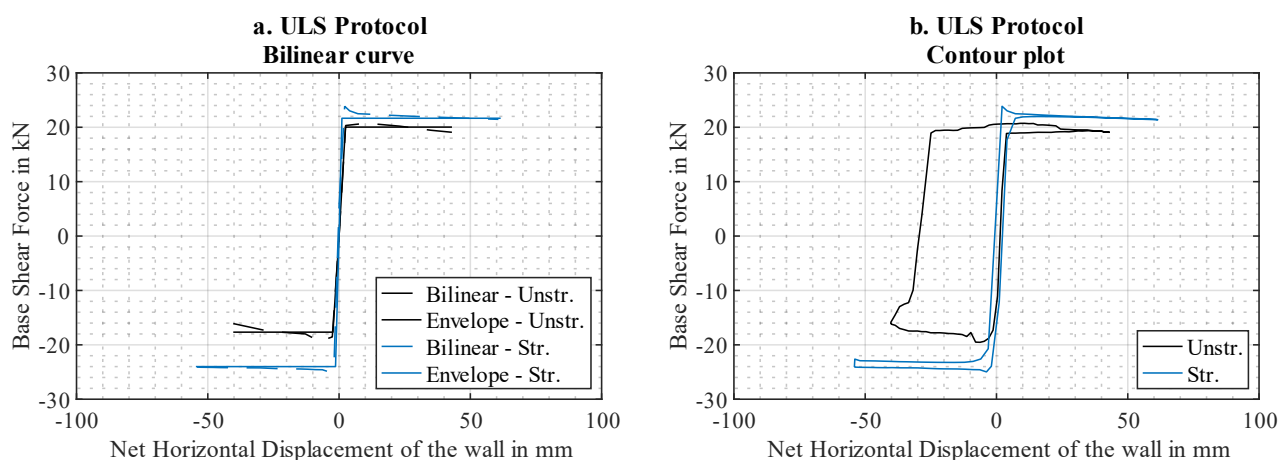
Figure 15. Performance during the ULS protocol: (a) equivalent bilinear curve and (b) contour plot.

Figure 15a shows the equivalent bilinear curve computed according to the formulation of Magenes et al. [13] with the parameters listed in Table 2, while Figure 15b shows the contour plot to visualize the amount of energy released during the test, i.e., the enclosed area. By comparing the equivalent bilinear curves, a substantial increment in terms of stiffness (+142%, +136%), ultimate displacement (+43%, +35%), maximum base shear force (+8%, +36%), and ductility (+220%, +135%) was obtained in the strengthened configuration. However, the latter showed a substantial decrease in terms of dissipated energy (−83%) that can probably be attributed to the different failure mechanisms observed. In fact, while the strengthened wall showed only rocking, the unstrengthened one also showed sliding. In addition, the horizontal displacements reached during the tests were not sufficient for the adhesive to tear, and, therefore, for including the additional dissipation source through friction and crushing of the timber.
