Digital Twin as Circularity Enabler of Façades in Maintenance

A Research into How a Digital Twin can Facilitate the Circular
Maintenance of Façades

Title of Research proposal: Digital Twin as Circularity Enabler of Façades in Maintenance.
A Research into How A Digital Twin Can Facilitate the Circularity Maintenance of Façades
Domain: Design and Construction Management (DCM)
Course: AR3R010 MSc 3 Graduation Laboratory
1st Mentor: Dr. Ir. A. (Alexander) Koutamanis | MBE | DCM
2nd Mentor: Ir. B. (Berna) Torun | Electrical Engineering Mathematics & Computer Science, Applied Mathematics | Numeral Mathematics
Document: Master's Thesis
Date: 6 July 2020

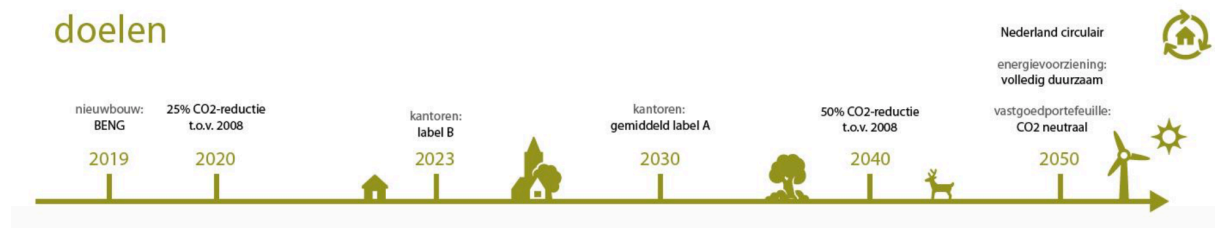
Fig. 10 Roadmap sustainability goals RVB (Rijksvastgoedbedrijf, Nd.)

In 2050 significant sustainability goals must be achieved. The aim is to adhere the aim of the government and the European Union to be 100% circular in 2050. Figure 10 depicts the roadmap on how to achieve the goals. The entire real estate portfolio is sustainable and CO² neutral in 2050. In 2030, the RVB aims to partly carry out circular maintenance as an organisation. This entails smaller tasks such as maintenance tasks which produce short-term output to feed the still developing knowledge. From 2019 all newly built governmental buildings must be nearly energy neutral (Rijksvastgoedbedrijf, n.d.).

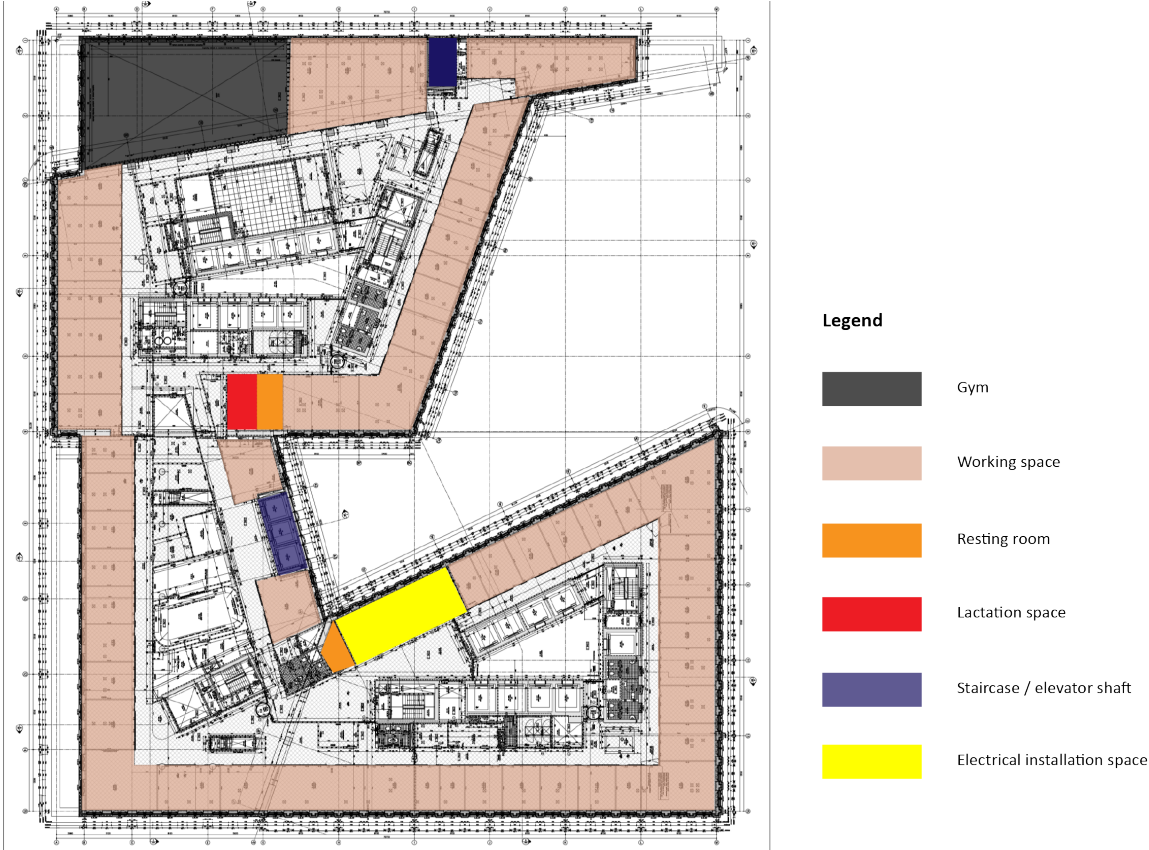
Fig. 13 Floorplan 6th floor JuBi Towers and corresponding functions near the façade (BIM-model JuBi towers)

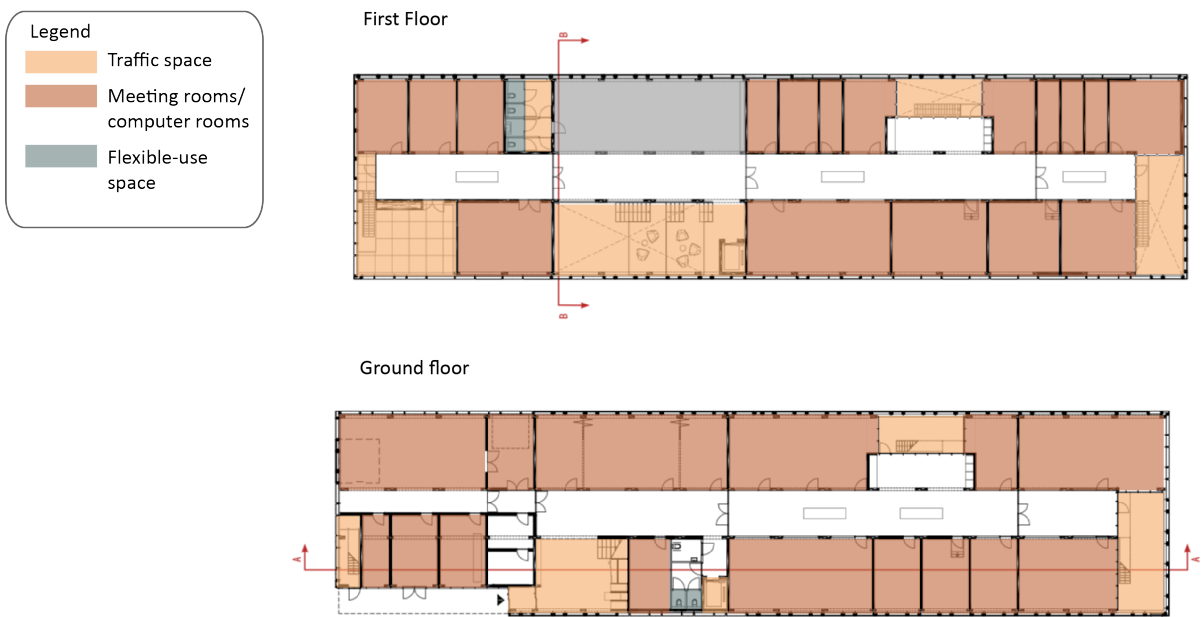
Fig 25. Floorplan ground floor and 1st floor GRC, and corresponding functions near the façade (X)
