KATOENVEEM

MSc III Heritage & Architecture

Architectural & Building Technology Analysis

07/04/2017

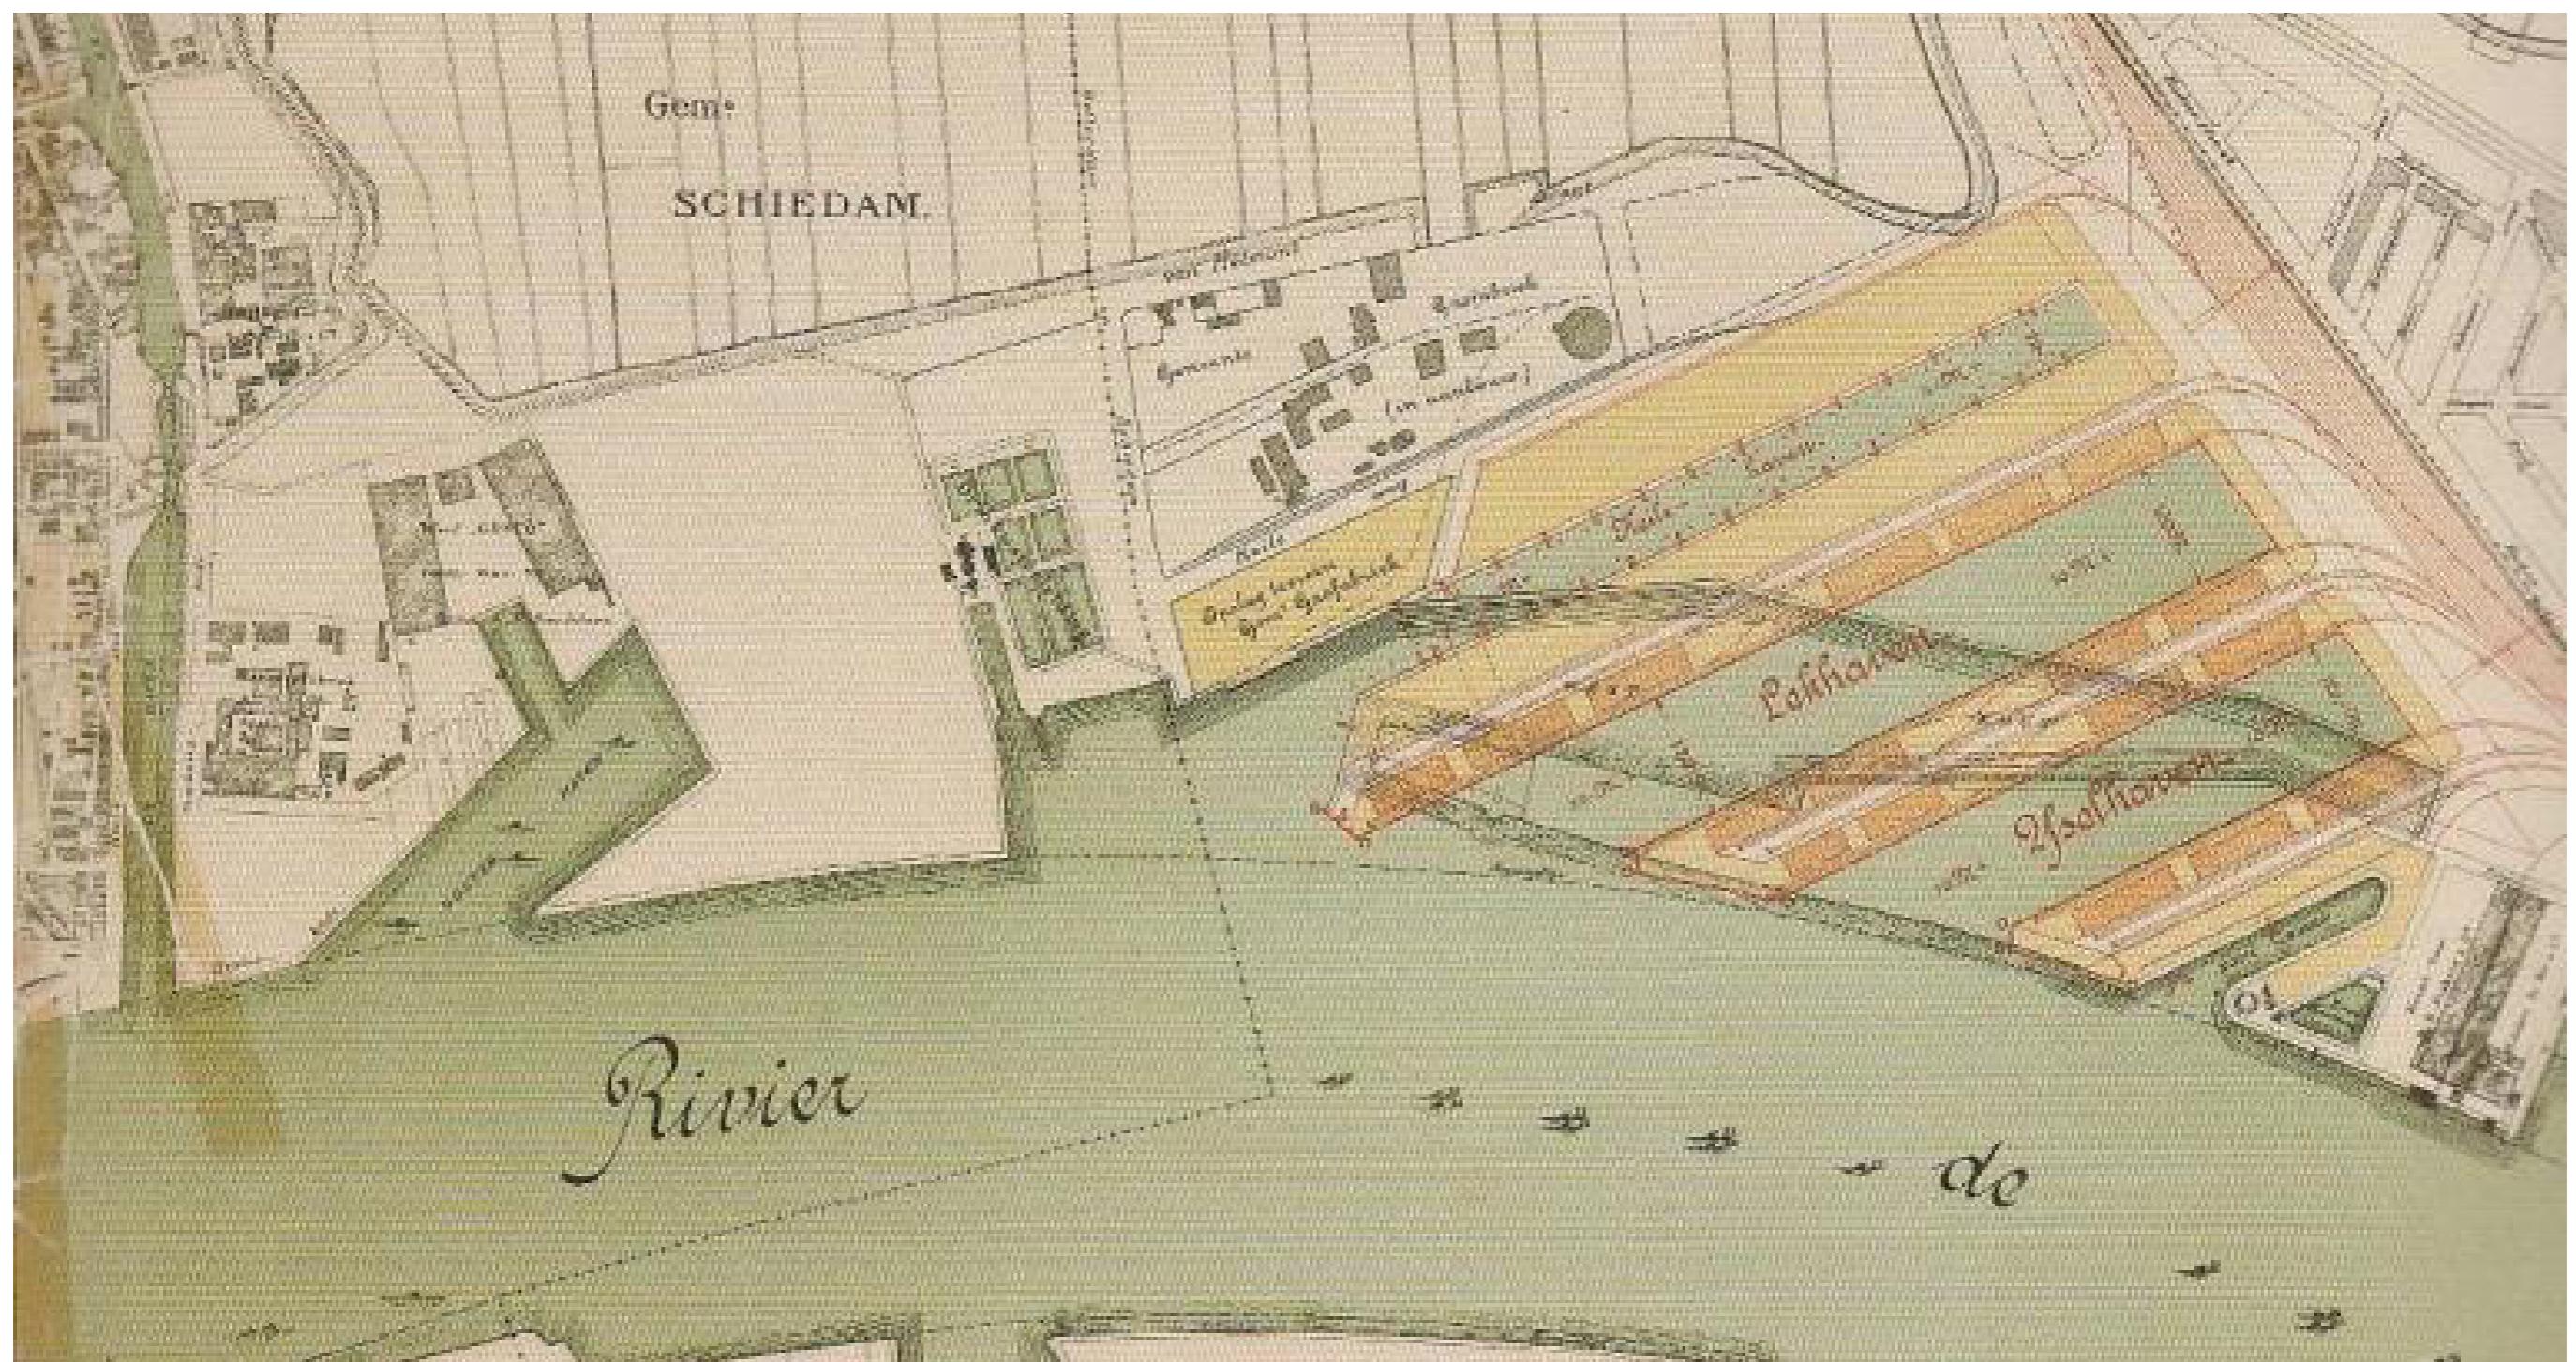
design drawing Vierhavens by unknown
Daalder R. & Ter Bruggen J. (2008). Havens van Amsterdam en Rotterdam sinds 1870. Den Bosch:
Walburg Pers.

on the previous page you can see the design drawing of the Vierhavens area. You can also see the former shorelines. In the illustration above you can see the site in red and the waterway situation around 1930. On the illustration next to it you can see the situation at the moment (2017). You can see that the structure has hardly changed. However one harbor on the left side has been closed and all harbors except one on the right side have been shortened, but why? After the war the trade in petrol became much more important for Rot-

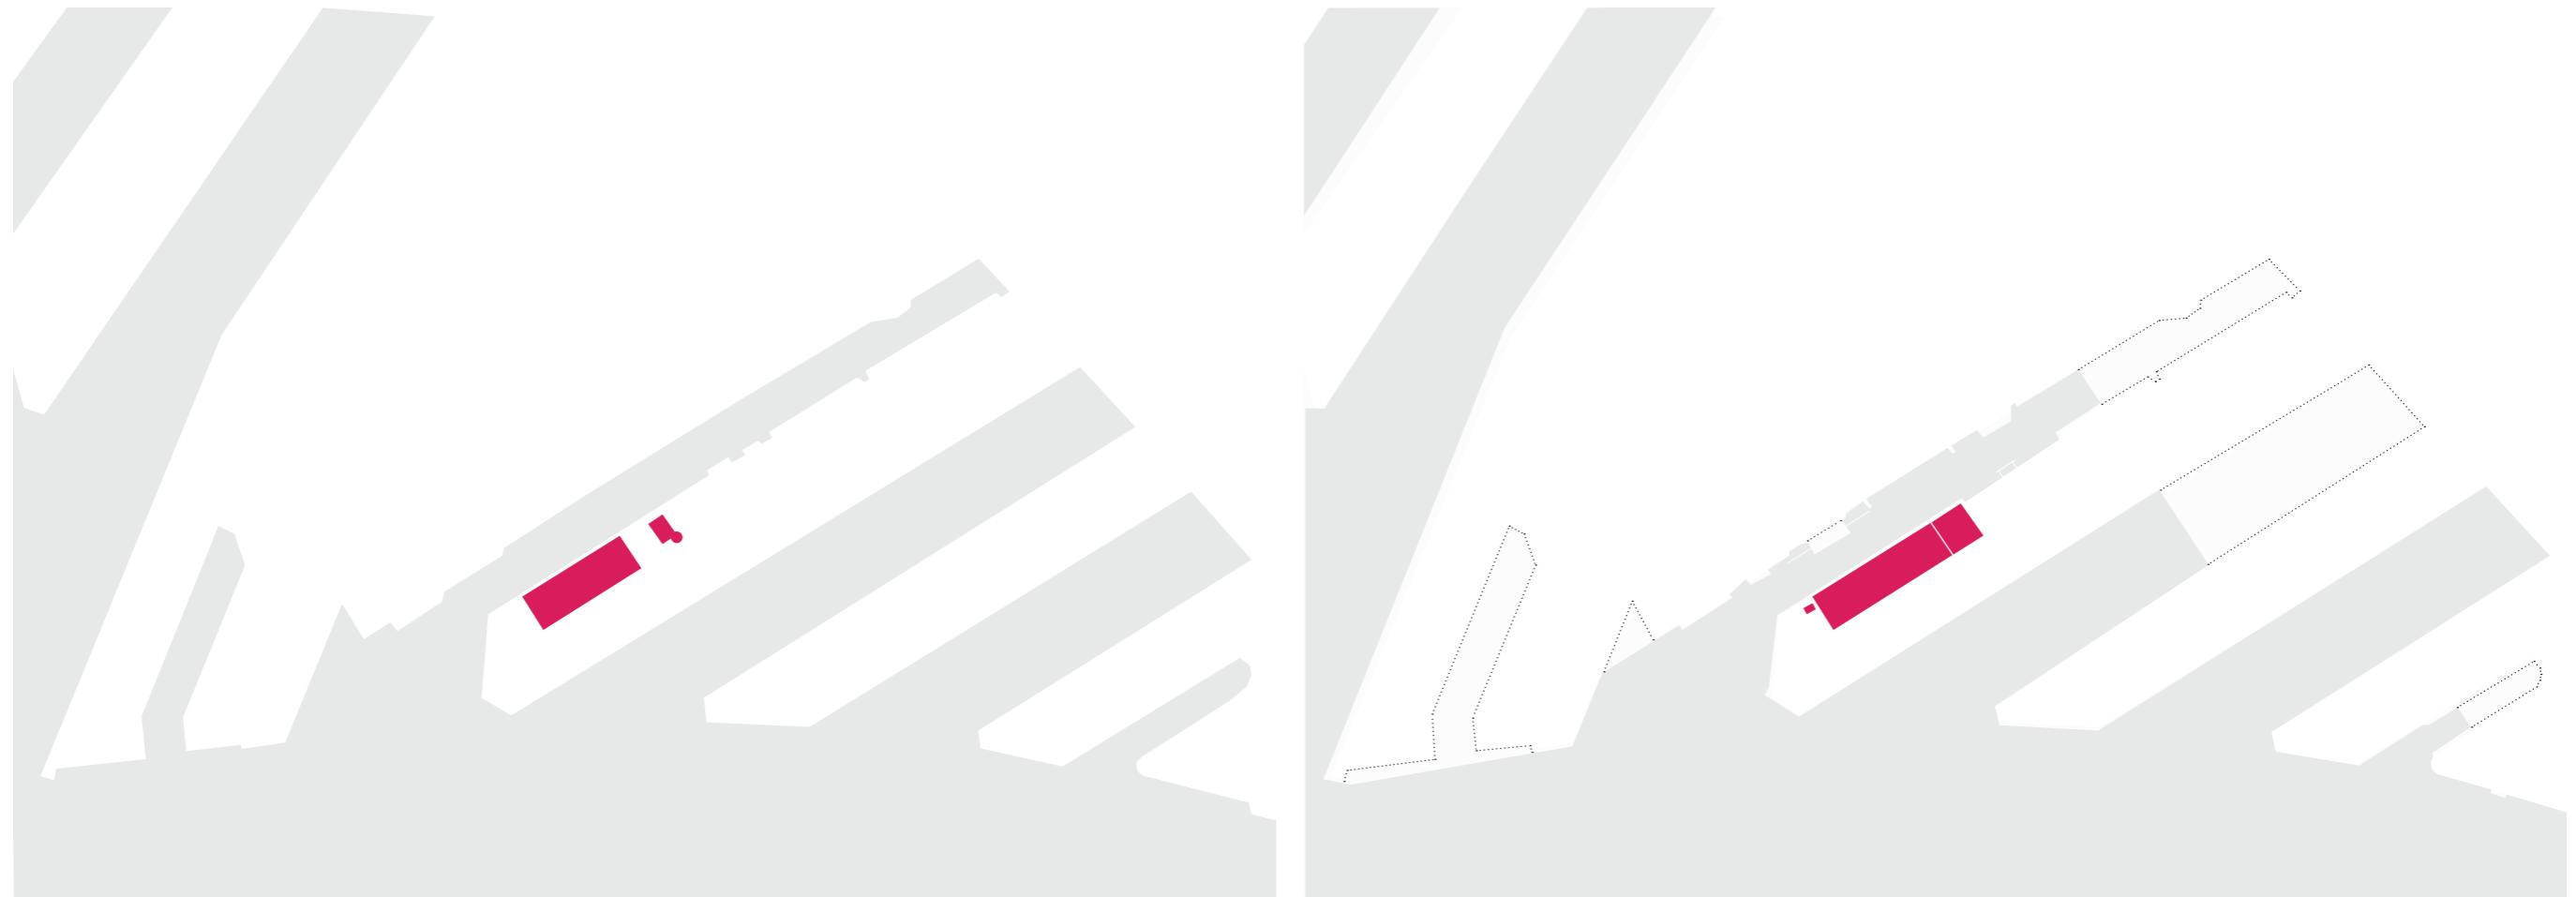
WATERWAY DEVELOPMENT 1:10.000

waterways 1930-2017 by joost van den berge
 Daalder R. & Ter Bruggen J. (2008). Havens van Amsterdam en Rotterdam sinds 1870. Den Bosch: Walburg Pers.

- Katoenveem
- water
- former water

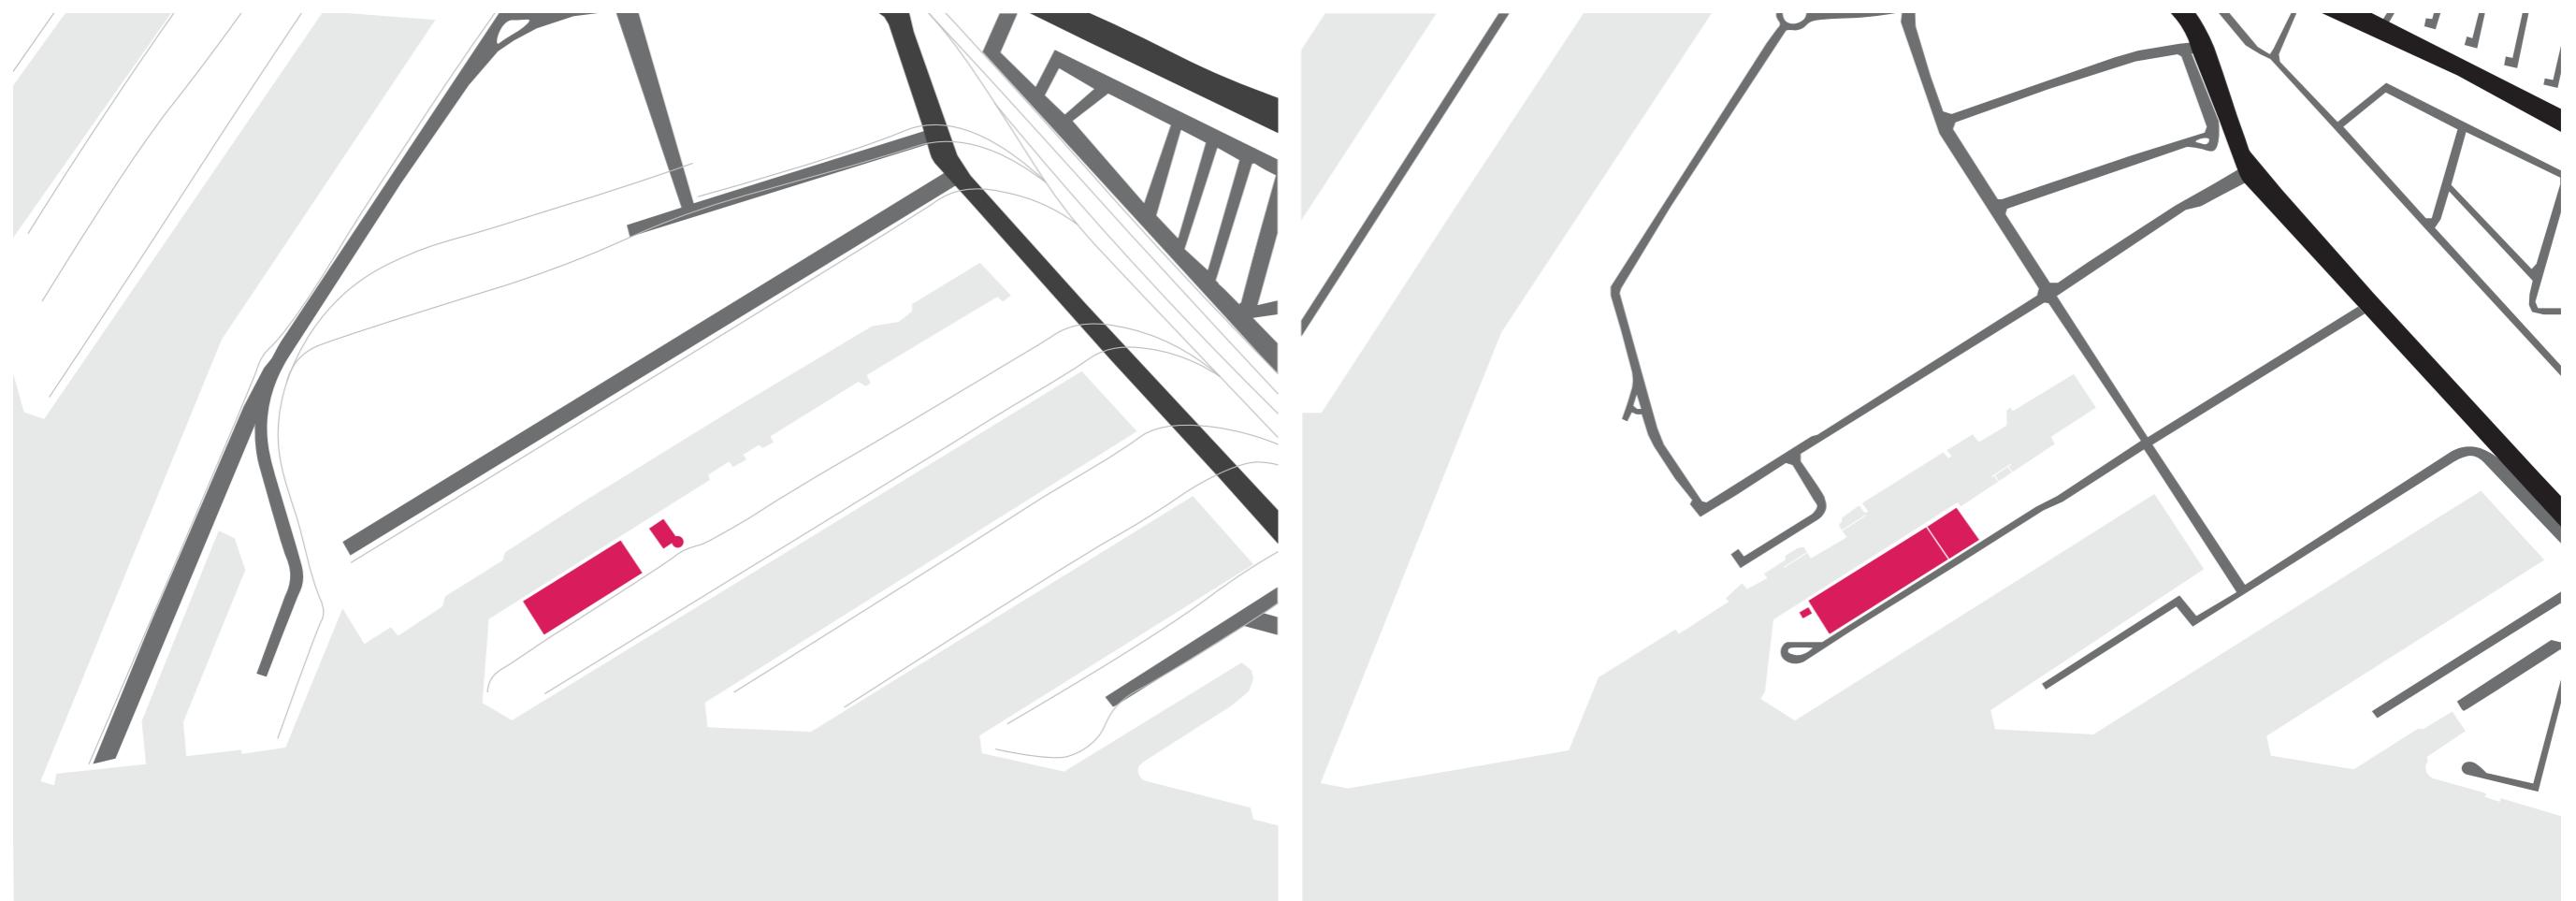
infrastructure 1930-2017 by joost van den berge
 Daalder R. & Ter Bruggen J. (2008). Havens van Amsterdam en Rotterdam sinds 1870. Den Bosch: Walburg Pers.

- Katoenveem
- water
- small road (2 lanes)
- large road (4 lanes)
- railroad

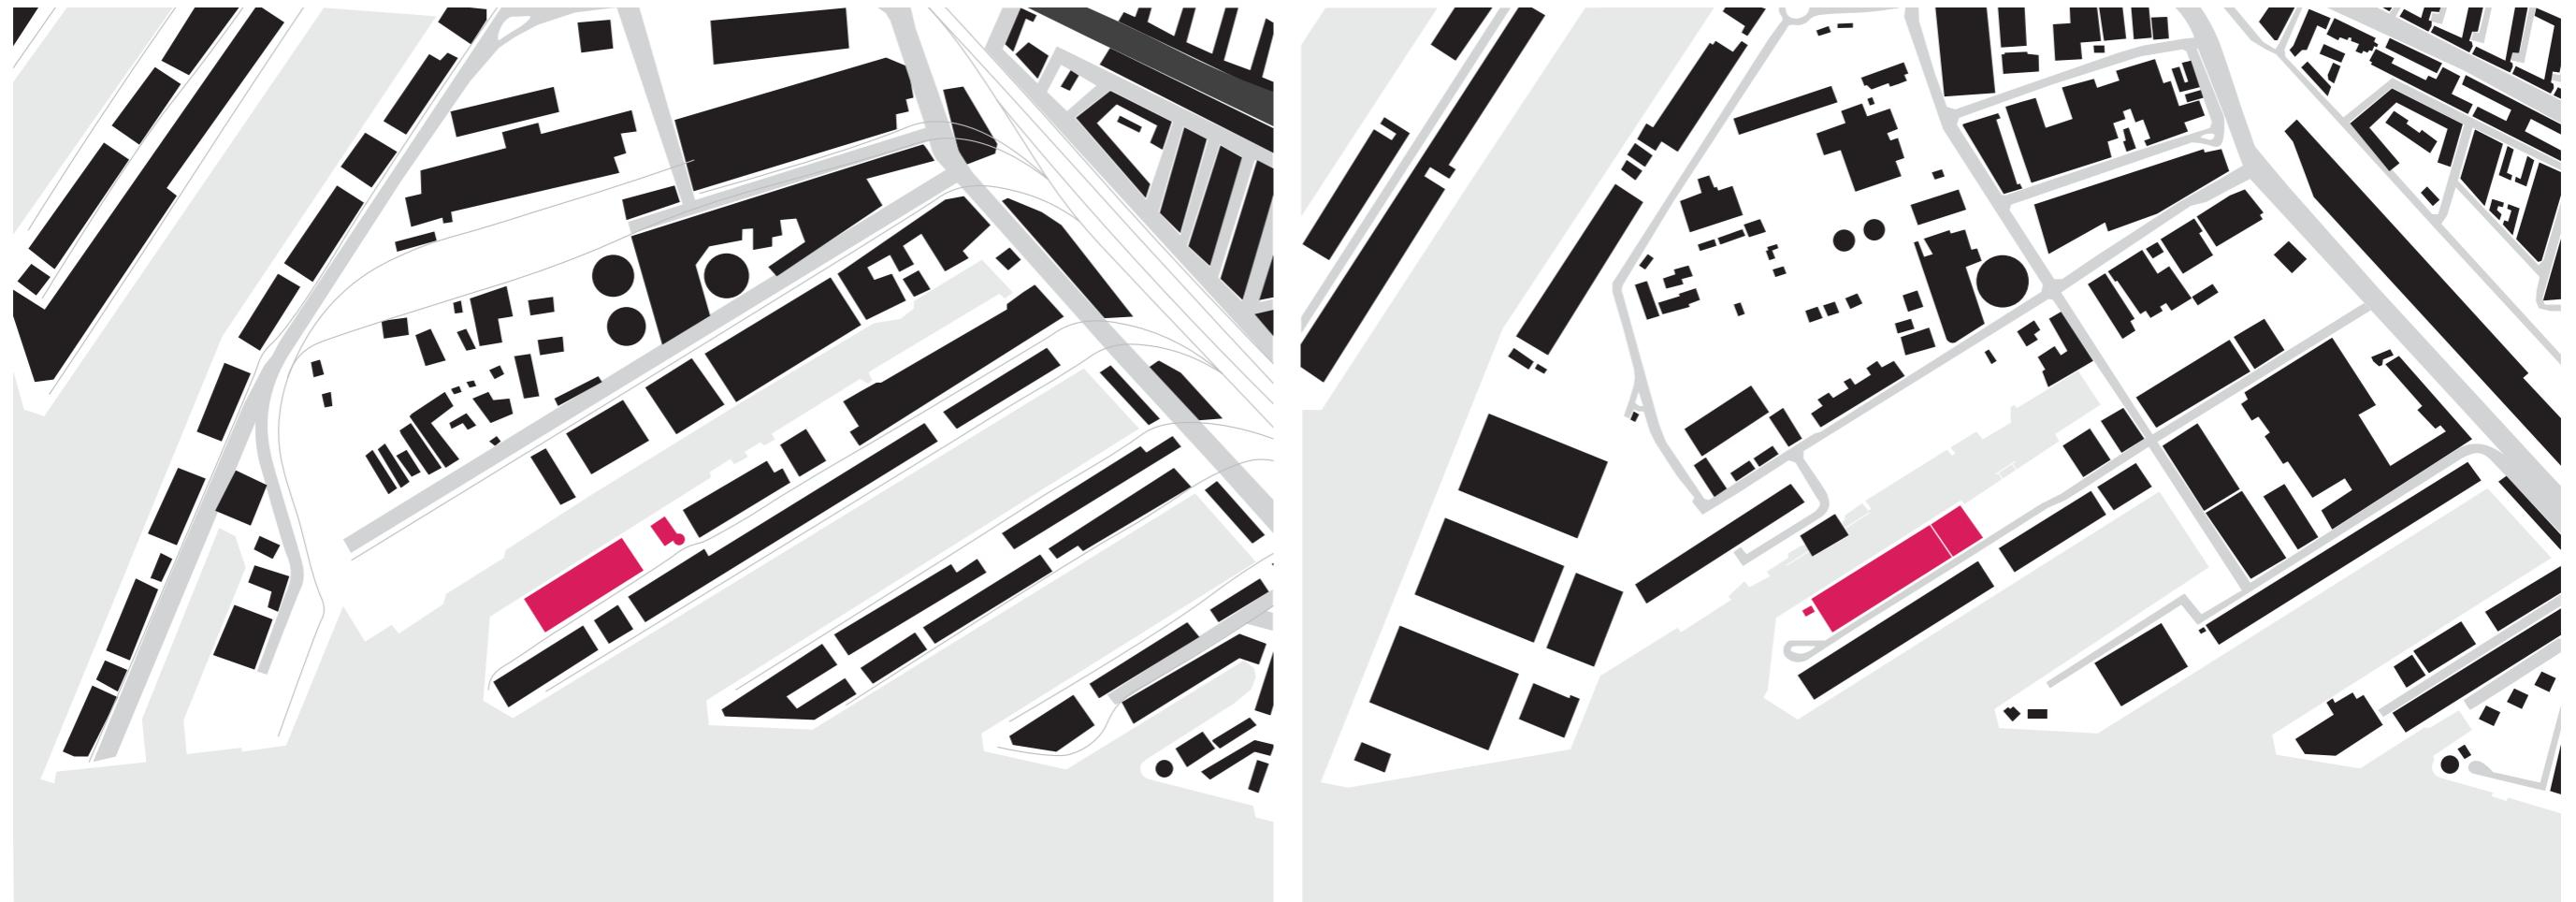
BUILT ENVIRONMENT 1:10.000

built environment 1930-2017 by joost van den berge
 Daalder R. & Ter Bruggen J. (2008). Havens van Amsterdam en Rotterdam sinds 1870. Den Bosch: Walburg Pers.

■	Katoenveem
■	water
■	roads
■	built structures

The other thing we found is that the area is not extremely more empty than it was in the beginning or before; as you can see in the illustrations. The area in 1930 was not that more dense than it is now but large open spaces at that time were also used much more than at the moment. Large open spaces in the illustration were in that time mainly used for storage, as construction site or as a spot for temporary buildings/structures. Now the open spaces in the area are mostly empty paved area's or grassland with no clear purpose or function so it is perceived much less dense.

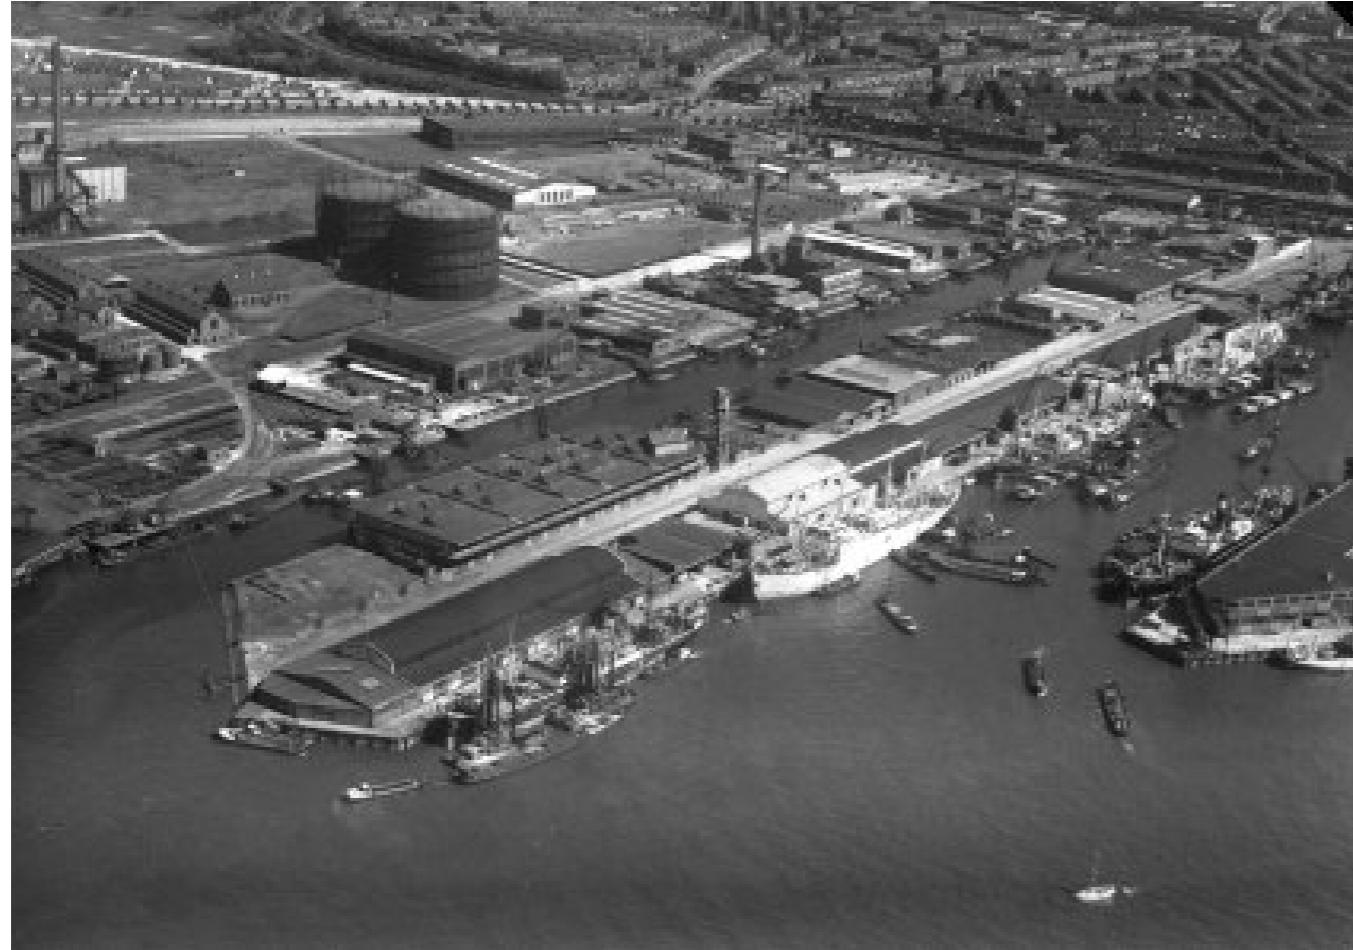
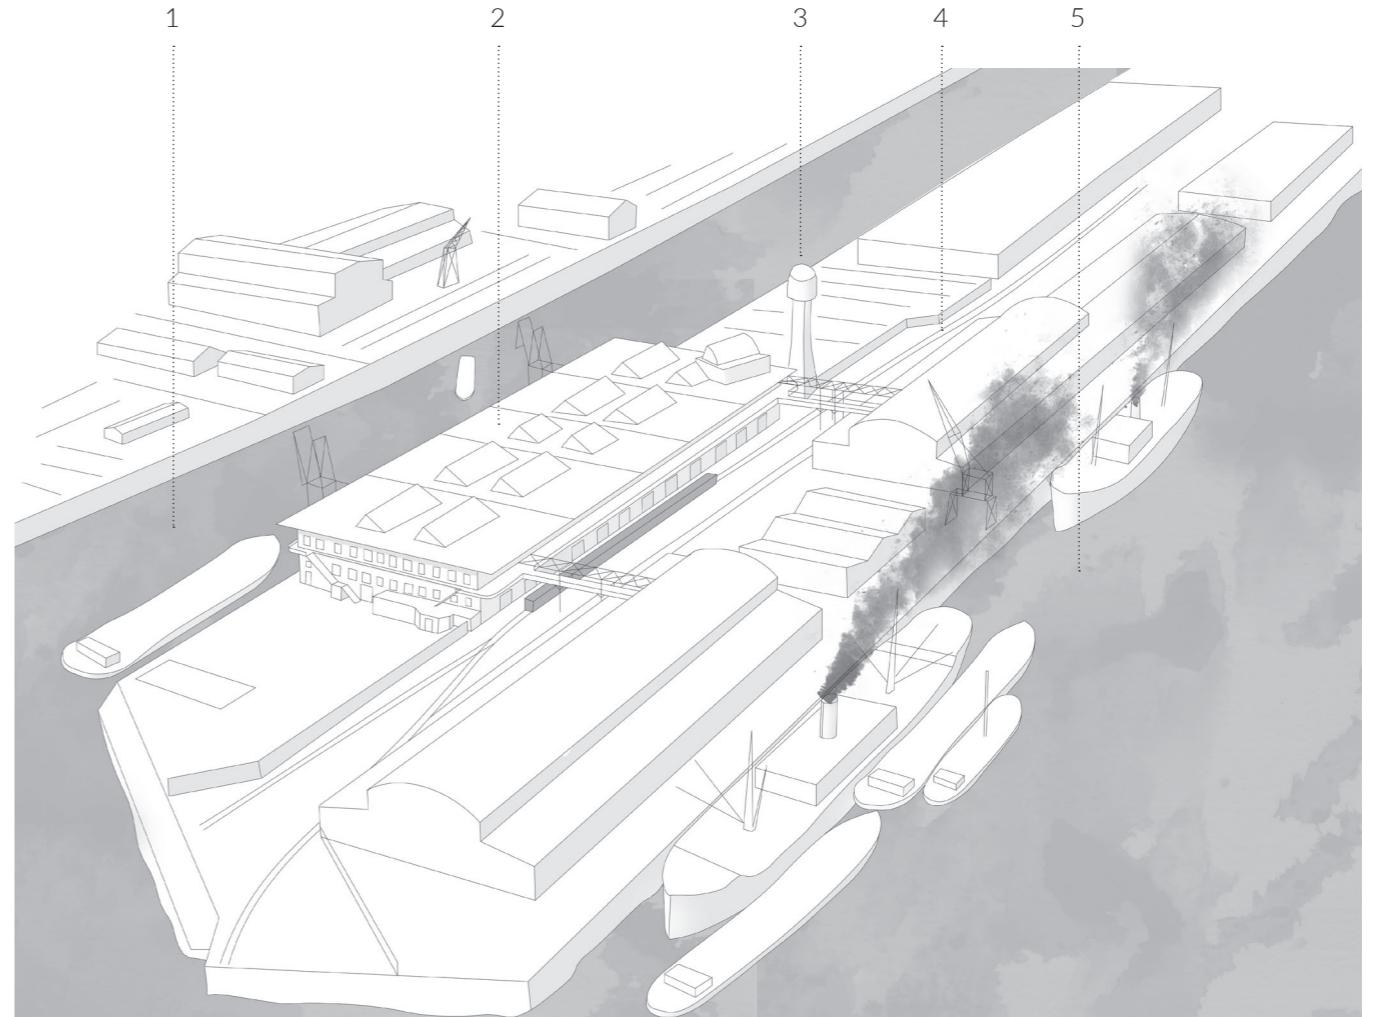
keilepier 1930 by joost van den berge

5. Large and deep ships could only reach Katoenveem by entering the Lekharbour and load their goods into the two temporary warehouses of the Holland America Line; New Orleans and Galveston (seeable on the left picture) where the chain of transshipment continued by steel bridges to Katoenveem.

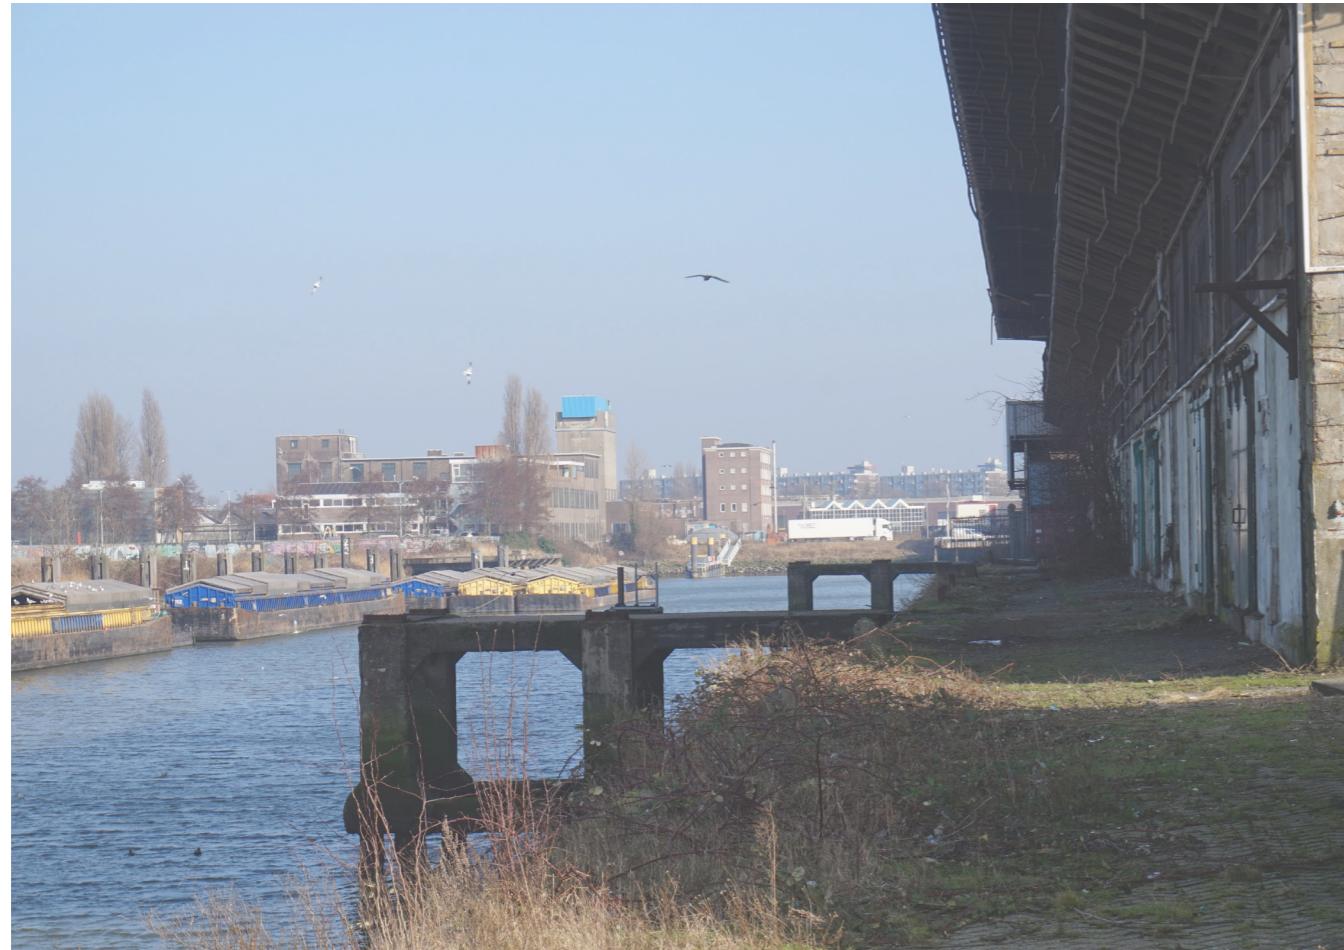
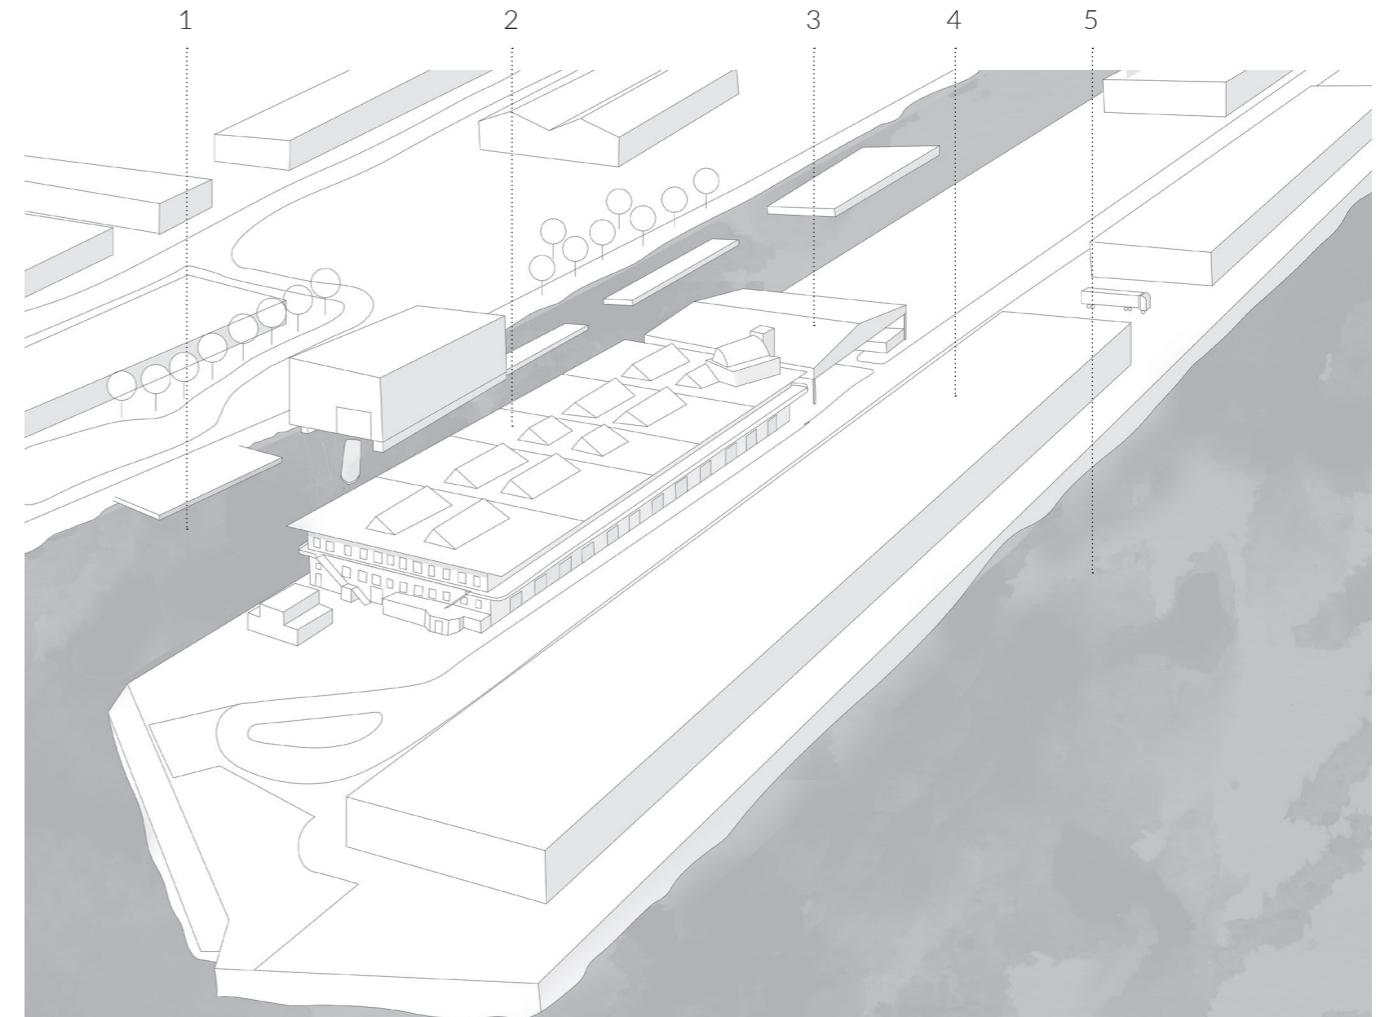
keilepier 2017 by joost van den berge

4. Quite early on the warehouses of the Holland America Line were demolished and replaced decades ago by a distribution centre. The same happened with the rail-tracks which have been replaced by a wide road which ends at the end of the pier with a roundabout.

5. The Lekharbour has become much more quiet than it once was. However It is still quite in use by the harbour company as a harbour for pilot ships and by large ships for transshipment with the large warehouses next to Katoenveem. This harbor still works in somewhat the same way as it once did.

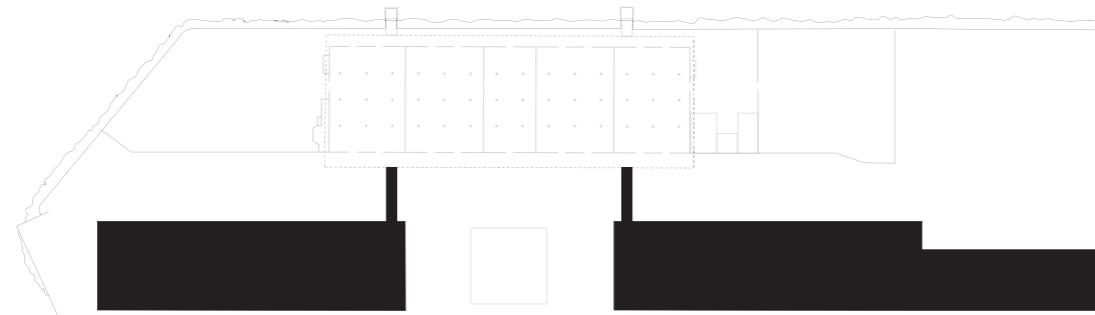
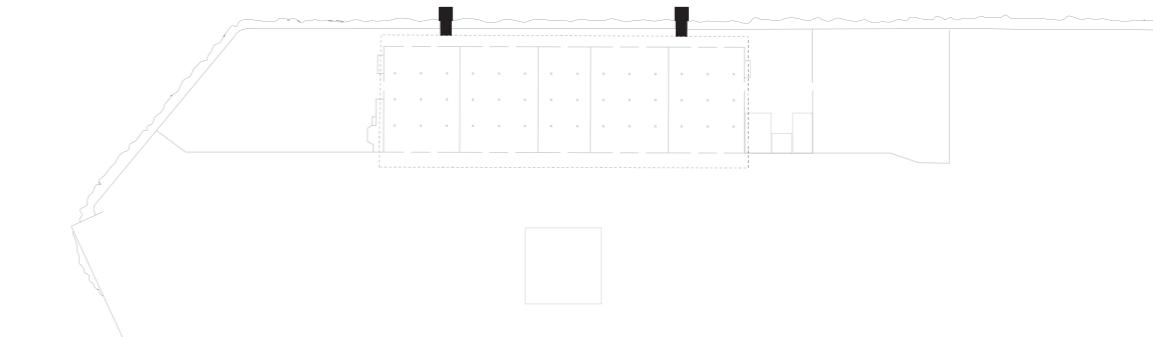
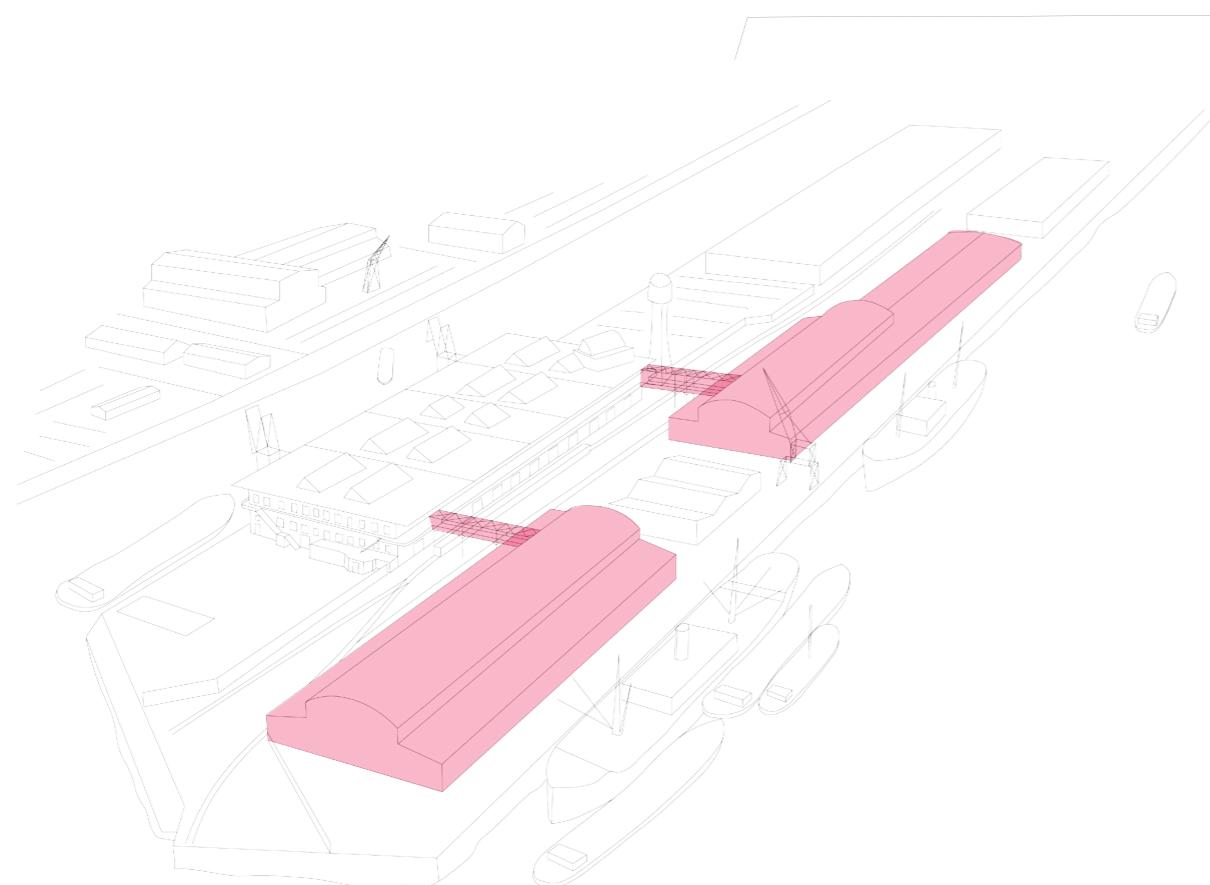
chronomaps Katoenveemsite by Joost van den Berge

1931 - the two warehouses of the Holland America Line are demolished which lead to changes in ways of transshipment. This will be more elaborated in the chapter about organisation and use

1964 - the two cranes of the Katoenveem on the Keilehaven are directly removed after the Katoenveem closure because of deterioration and the loss of function

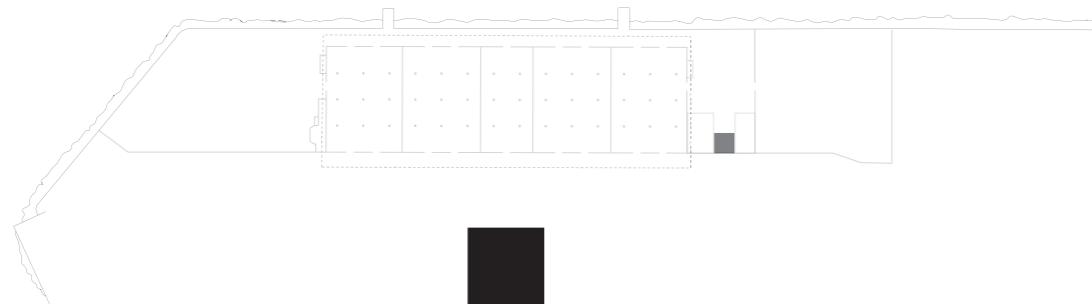
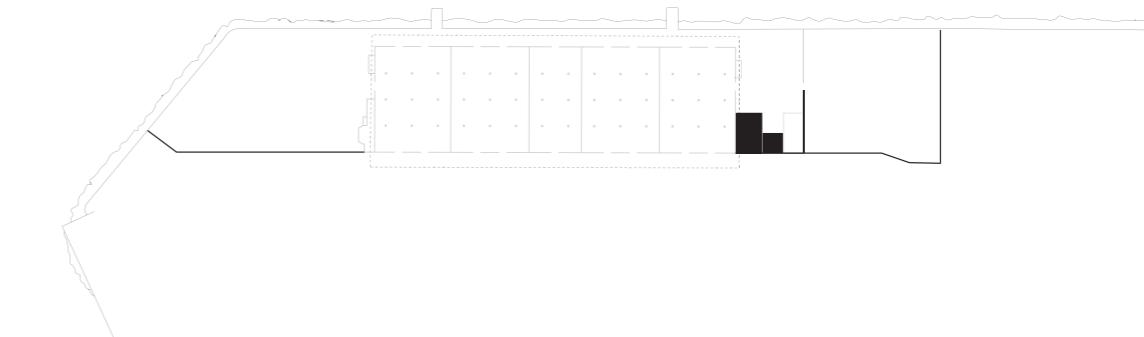
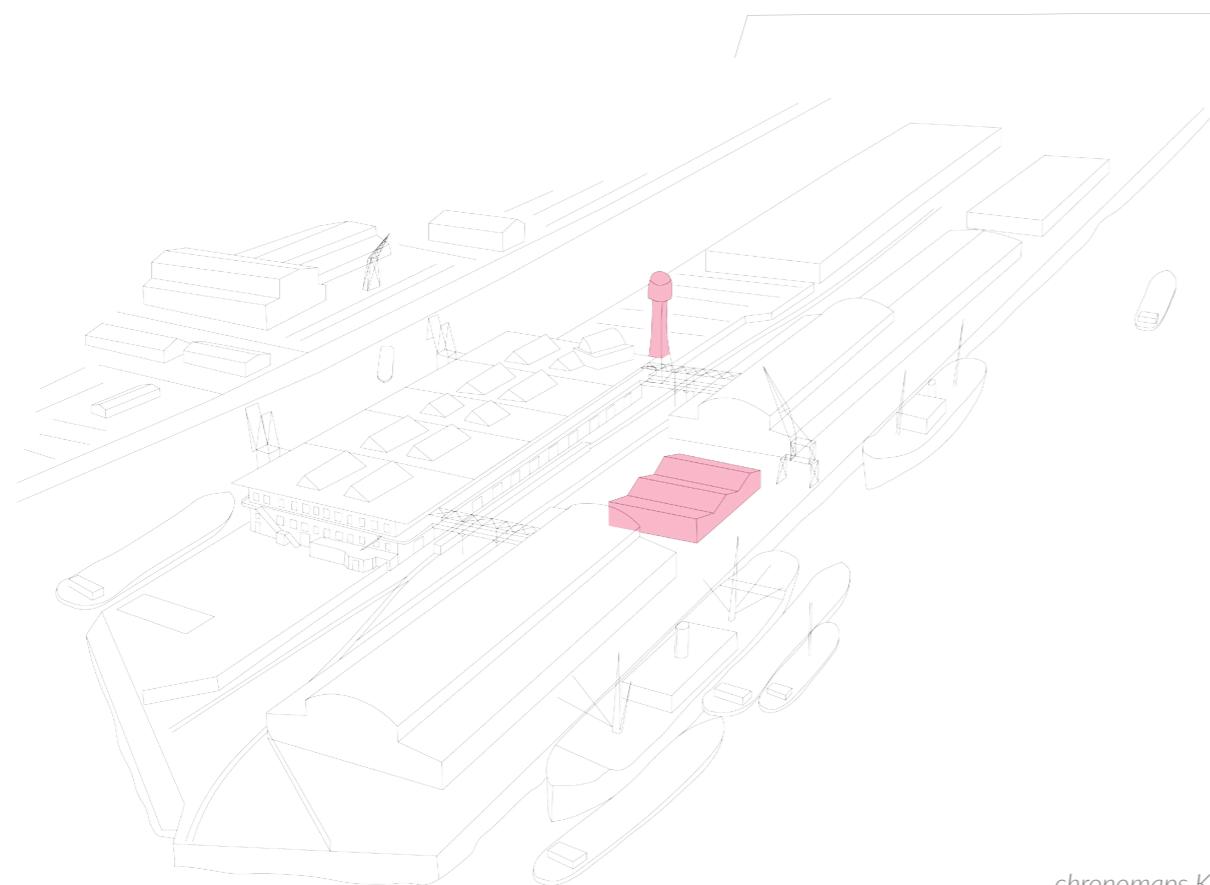
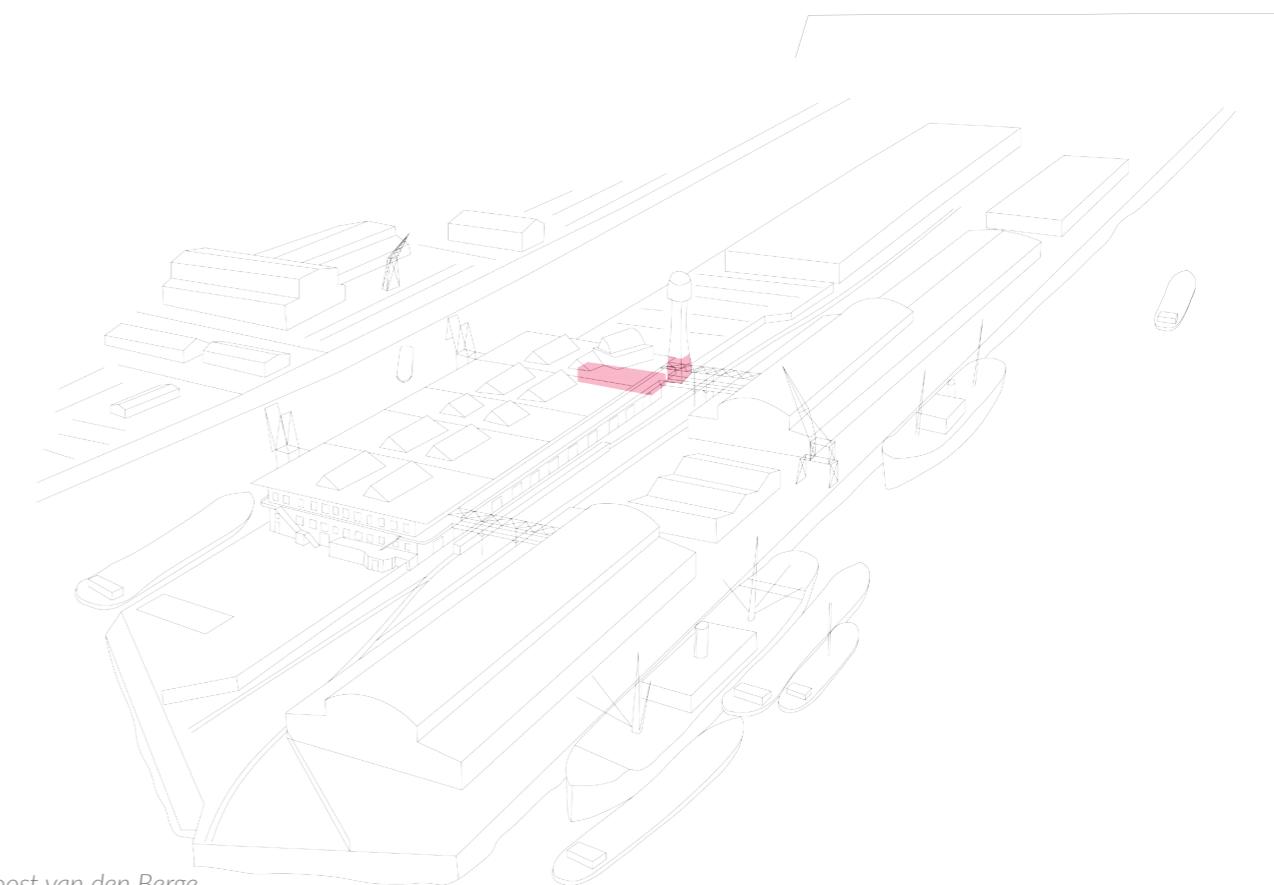
chronomaps Katoenveemsite by Joost van den Berge

1966 - the top of the watertower and the remaining sheds are removed because of deterioration and being out of use since the closure of the building

1988 - the base of the watertower, most surrounding walls of the complex and the directors office are removed as well because of deterioration and being out of use since the closure of the building
