KATOENVEEM

MSc III Heritage & Architecture

Architectural & Building Technology Analysis

07/04/2017

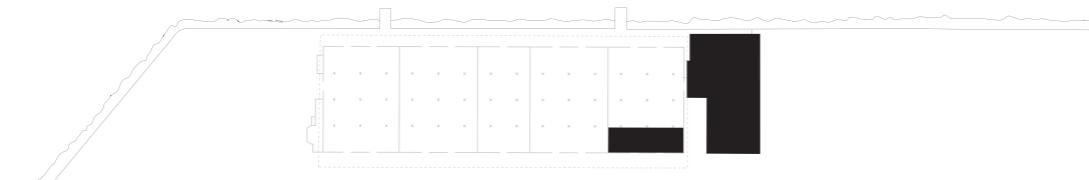
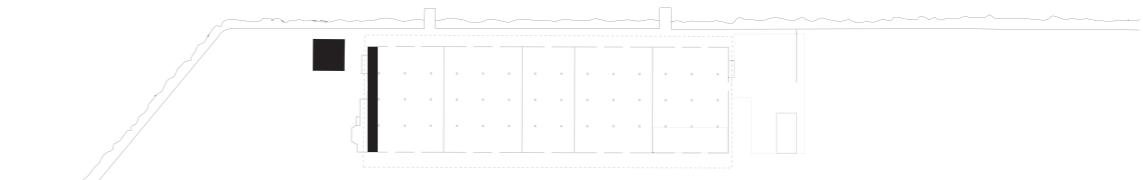
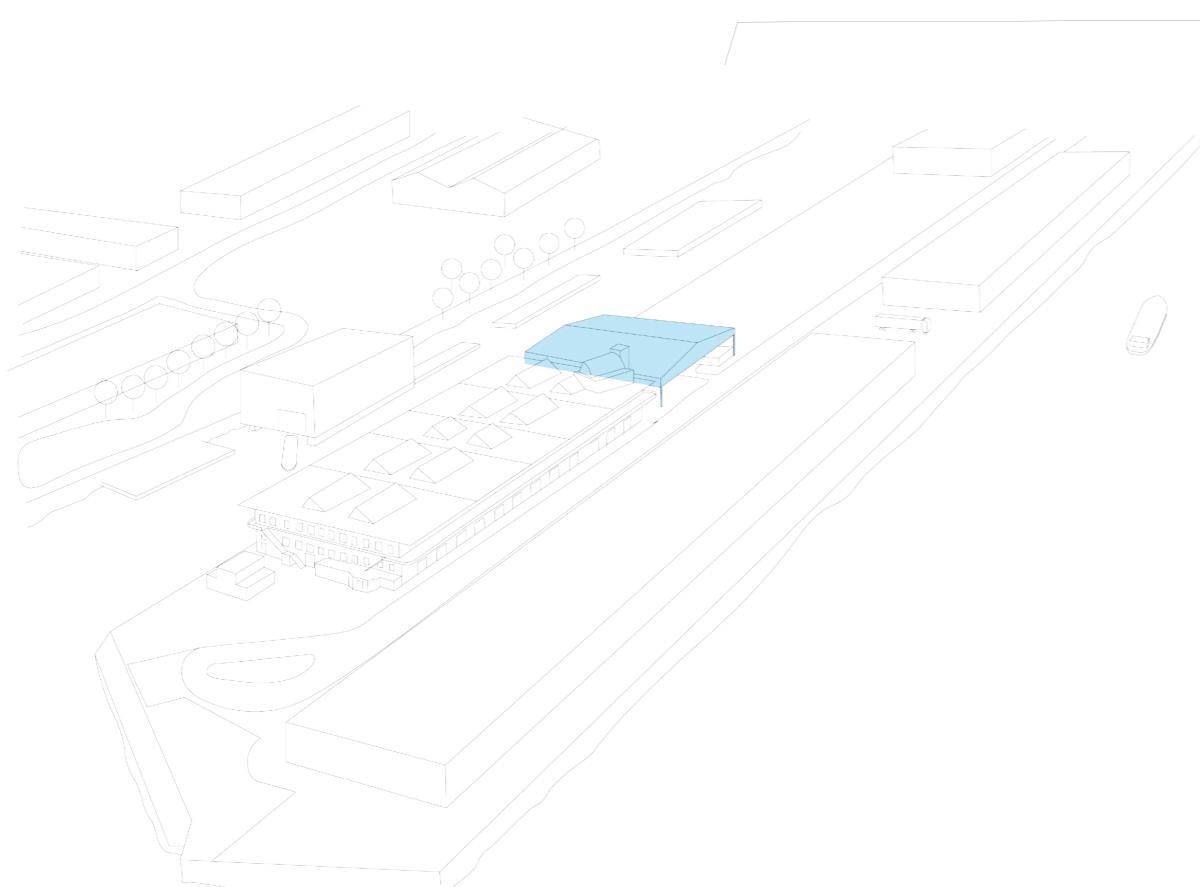
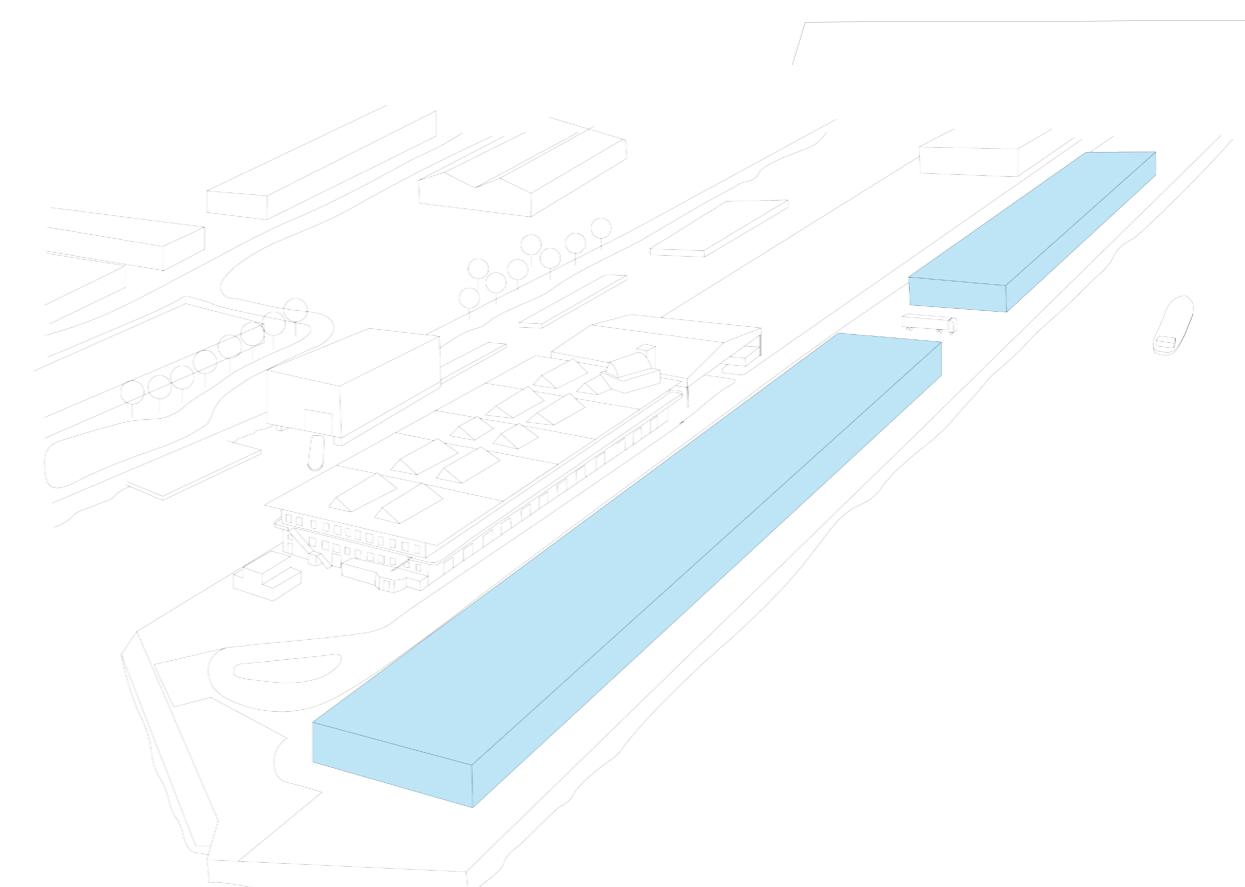
chronomaps Katoenveemsite by Joost van den Berge

1991- a new roof for outside storage and some structures are built in the Katoenveem
 1997 - 2017 new warehouses are built to accommodate the transshipment of fruit from ships to trucks and atelier van Lieshout starts an office in the Katoenveem
 sources:

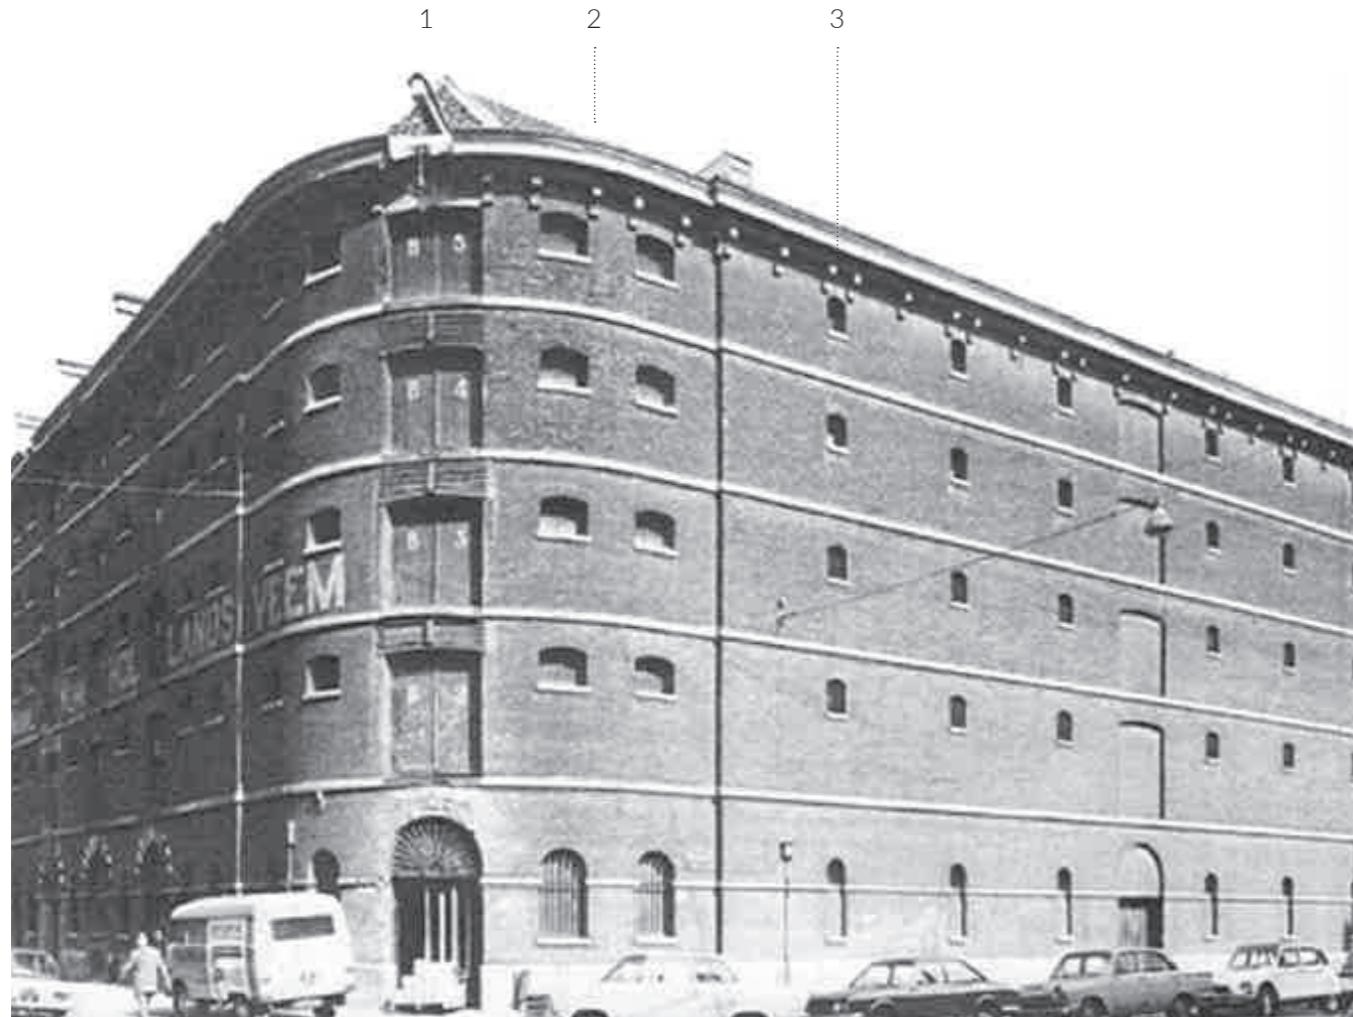
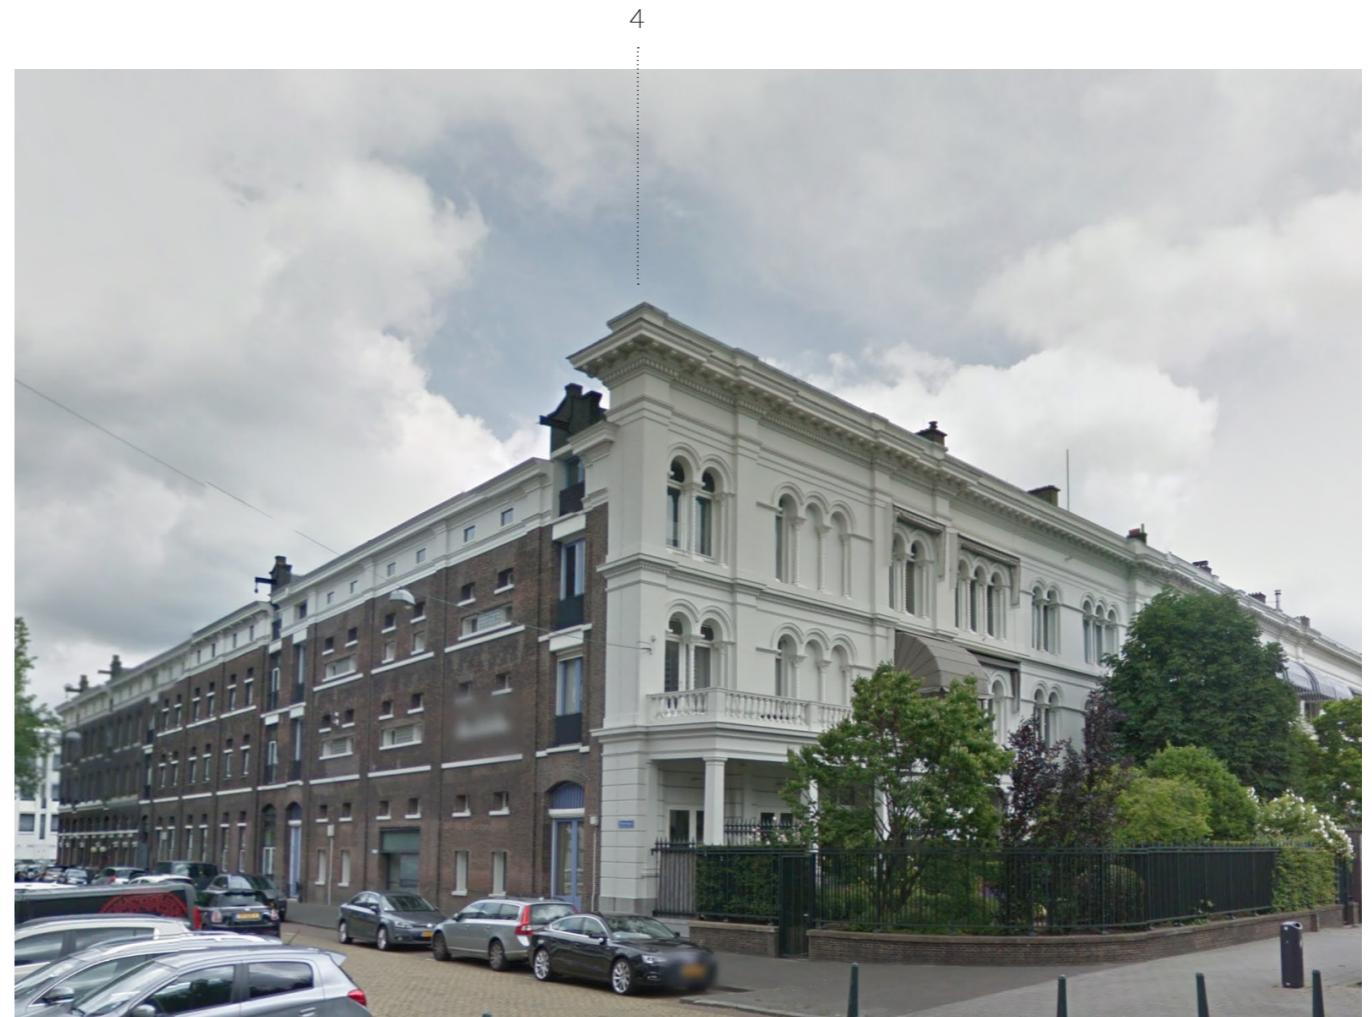
Nieuwe Werk warehouses by unknown
de Winter P. (1982) Havenarchitectuur, een inventarisatie van industriële gebouwen in het Rotterdamse havengebied. Rotterdam: Rotterdamse Kunststichting Uitgeverij

- first warehouse in the Harbour of Rotterdam
- before the World War I the biggest warehouse of Rotterdam
- 1. lyres used for transhipping
- 2. use of classical ornaments/decorations
- 3. small windows
- 4. warehouse behind a dwelling façade (schijngevel)

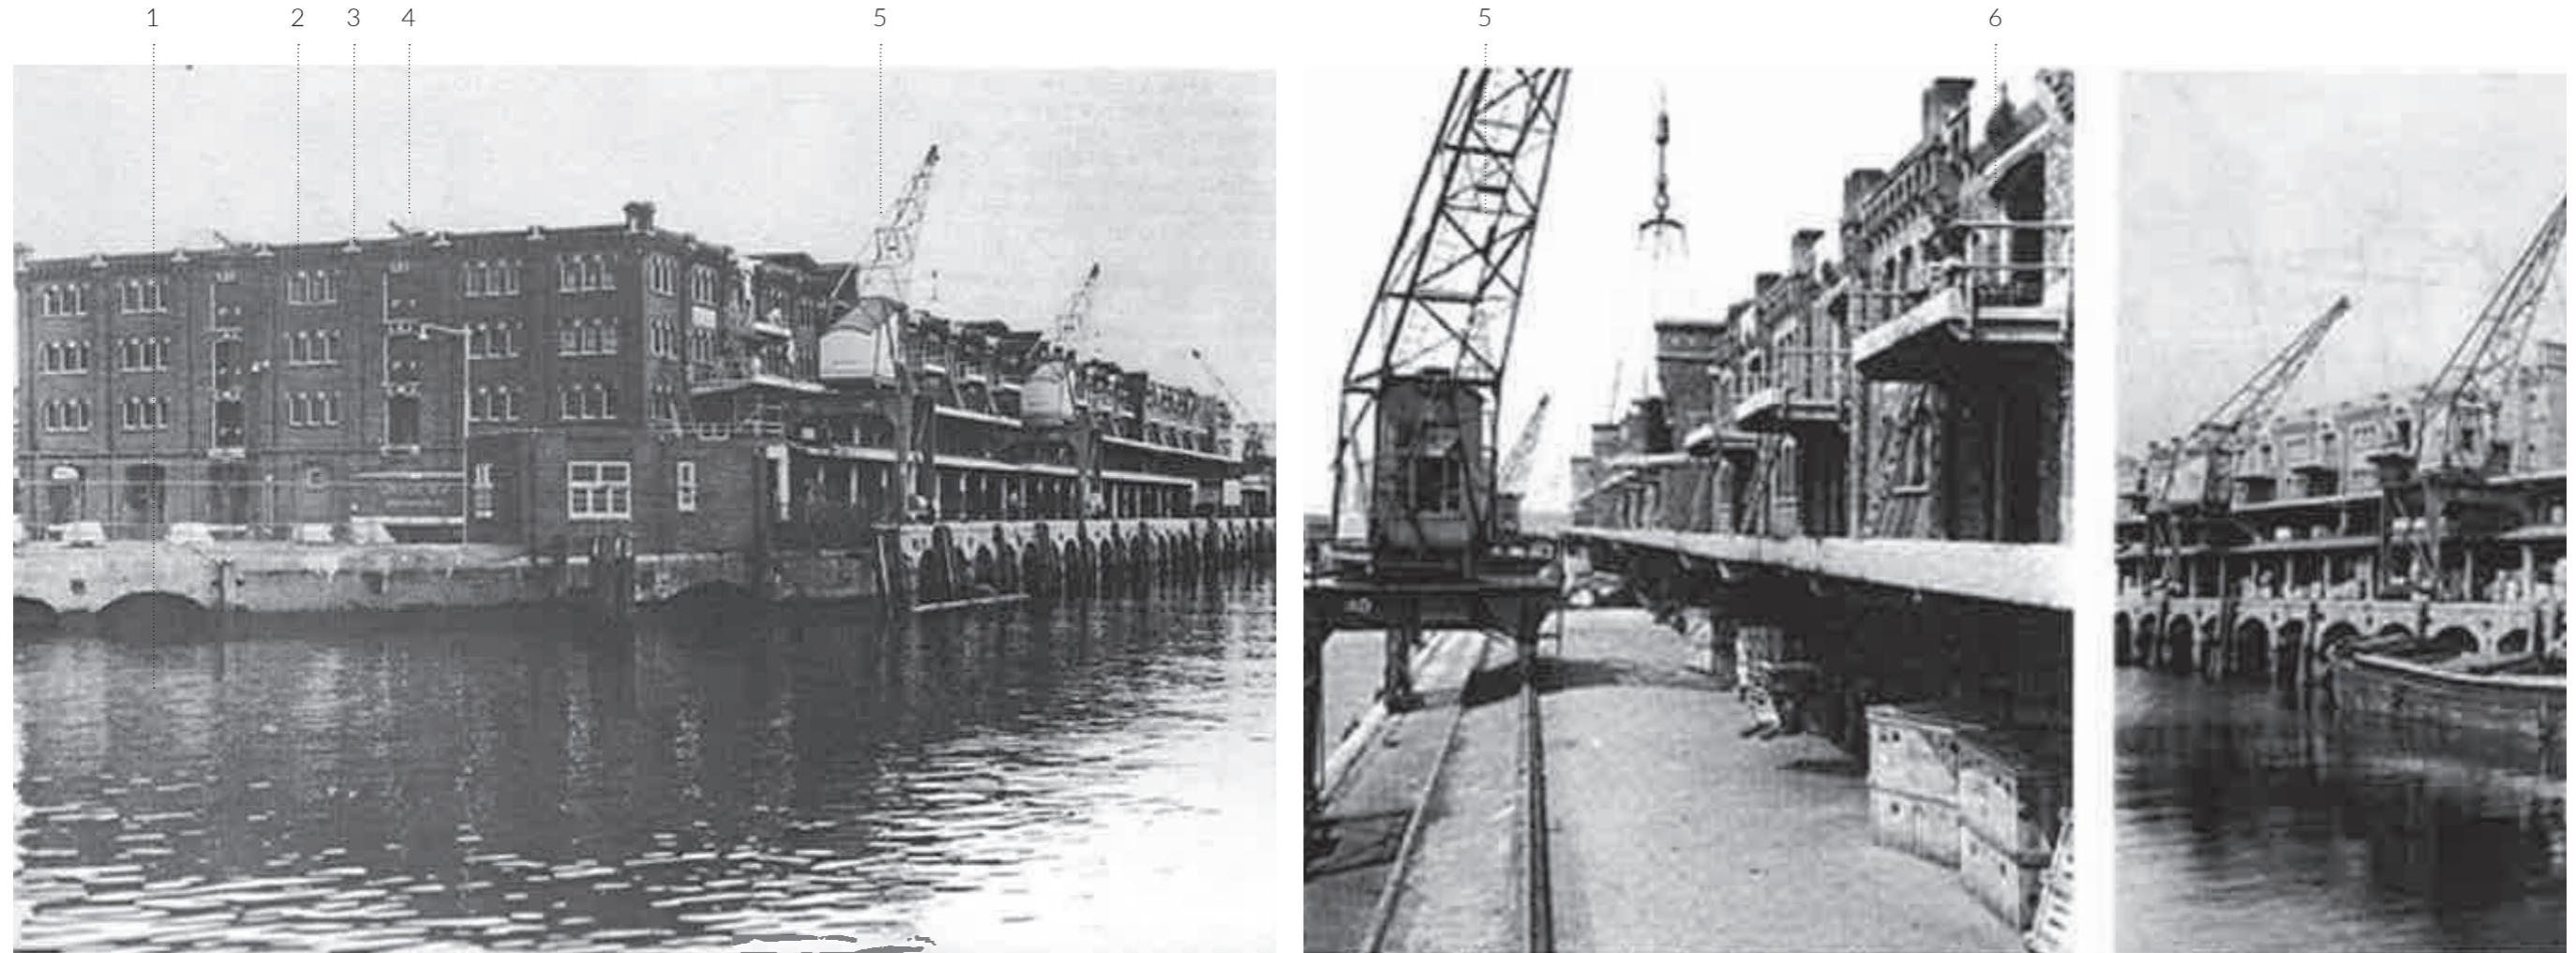
Vrij Entrepot, de Vijf werelddelen warehouse by Th. J. Stieltjes
 de Winter P. (1982) Havenarchitectuur, een inventarisatie van industriële gebouwen in het Rotterdamse havengebied. Rotterdam: Rotterdamse Kunststichting Uitgeverij

- most modern warehouse at that time
- 1. location close to the water
- 2. small windows
- 3. use of ornaments
- 4. lyres used for transhipping
- 5. use of cranes and overhang for efficient transhipping
- 6. cast iron structure and railings

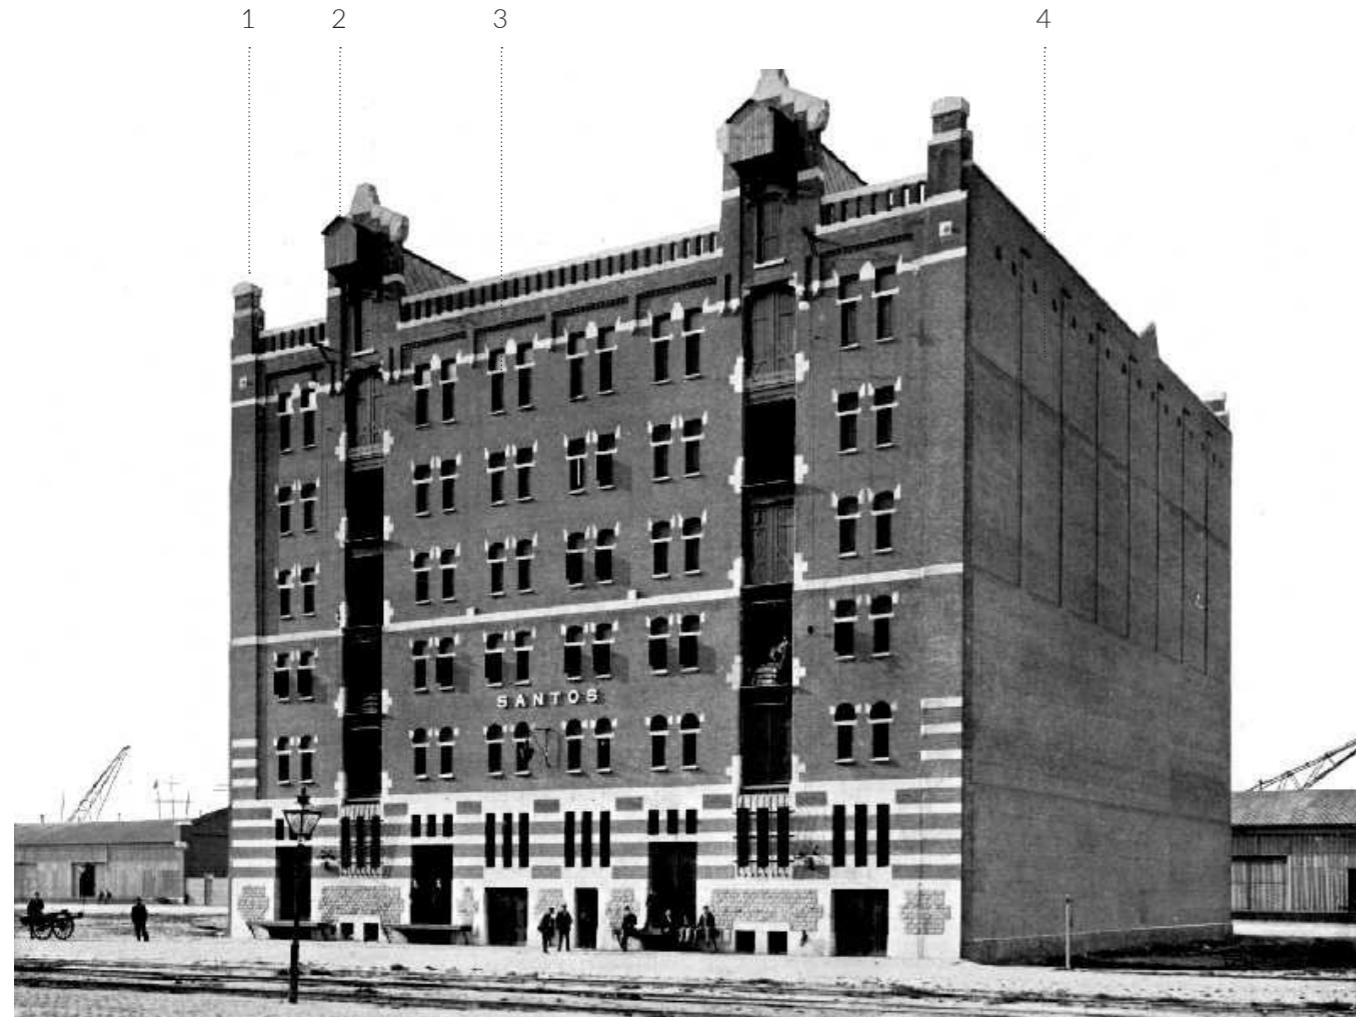
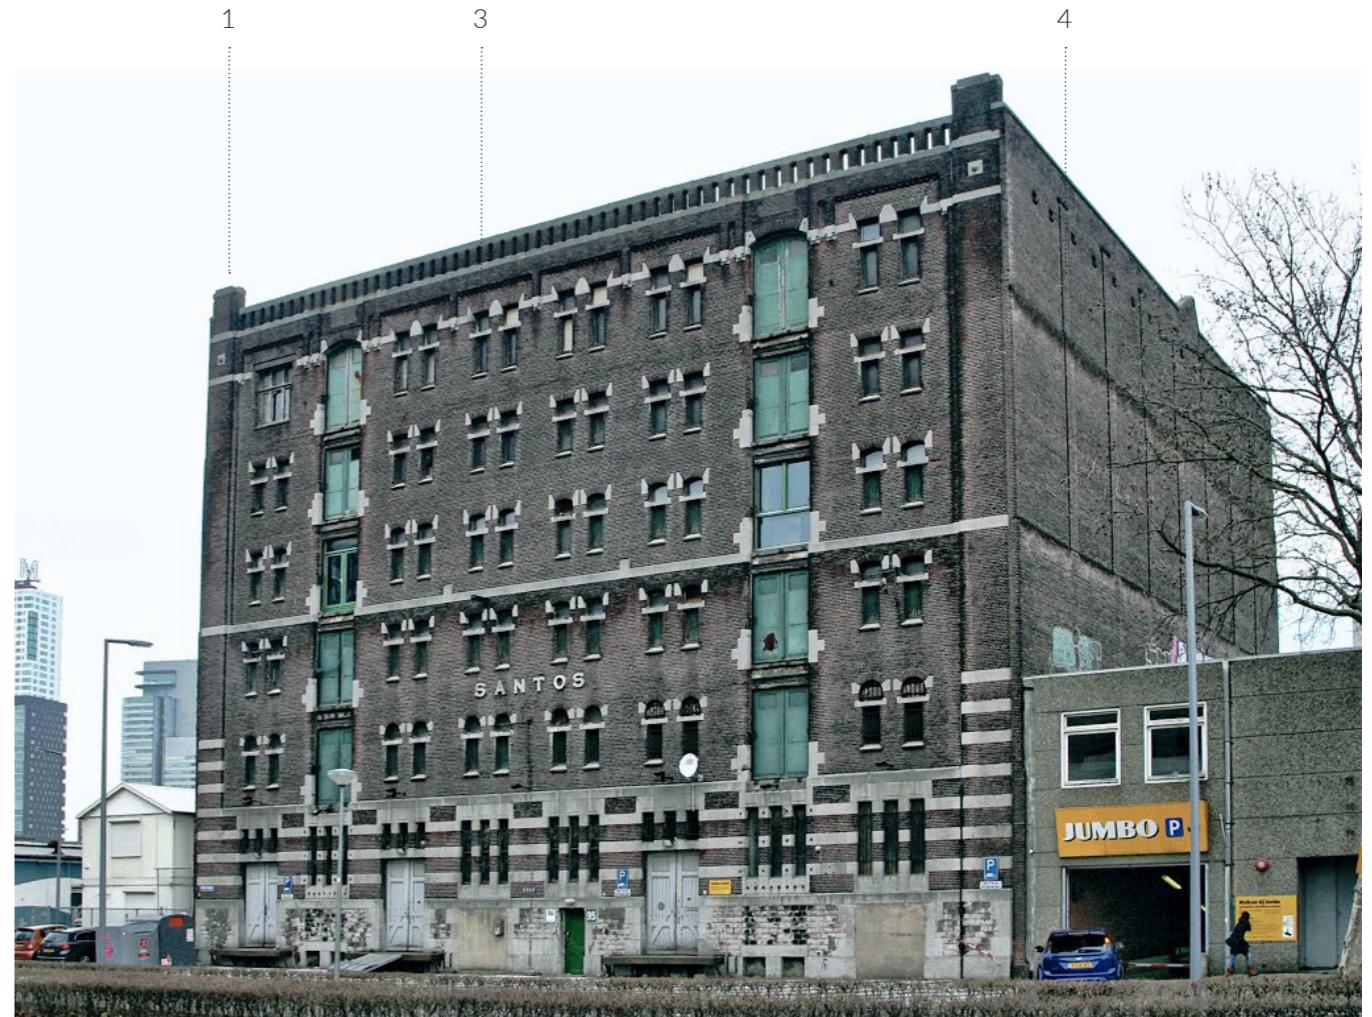
warehouse Santos by J.J. Kanters

This warehouse by Katoenveem's architect J.J. Kanters was built in 1903 on the south side of the Rijnhaven. The six story building was for a long time the highest warehouse in Rotterdam. The building was used for storage of coffee. The structure consists of revived cast iron columns on an outline of 4,22m by 5,3m. The foundation rests on a big number of wooden piles. All the floors consists of wooden beams and wooden boards, the ground floor however is built up out of concrete. This building seems to be a clear example of the transition of use in material in structure and building as

- tallest warehouse at that time in Rotterdam
 - no overhang
 - use of two types of construction, cast iron and reinforced concrete
1. use of ornaments and decoration
 2. cranes/lyres on the roof
 3. small windows (the same as Katoenveem and the Vrij Entrepot)
 4. brick facades with hardstone lintels

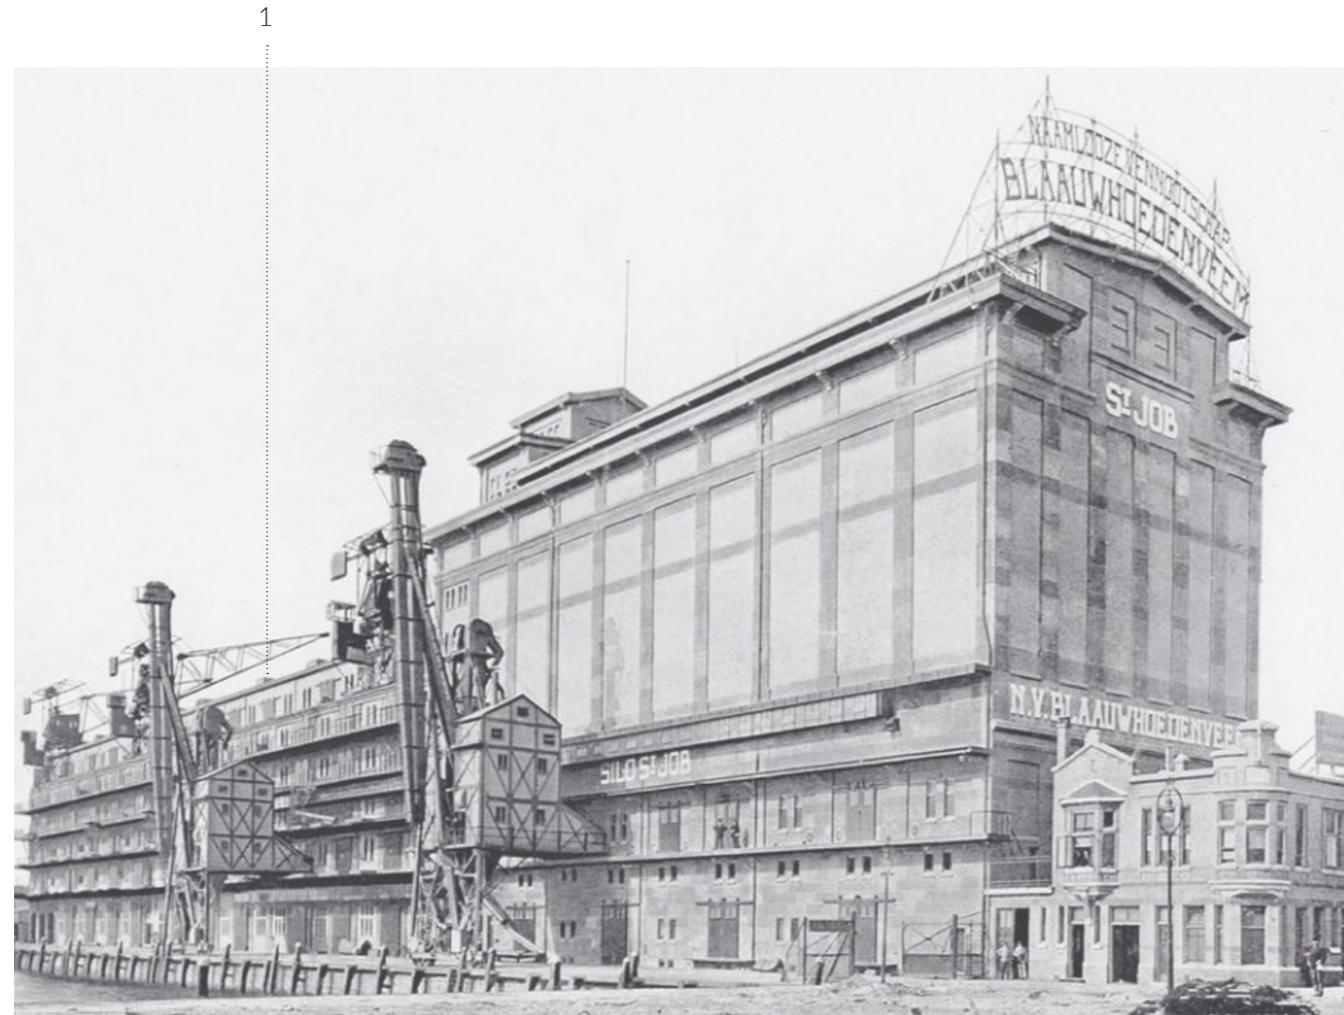
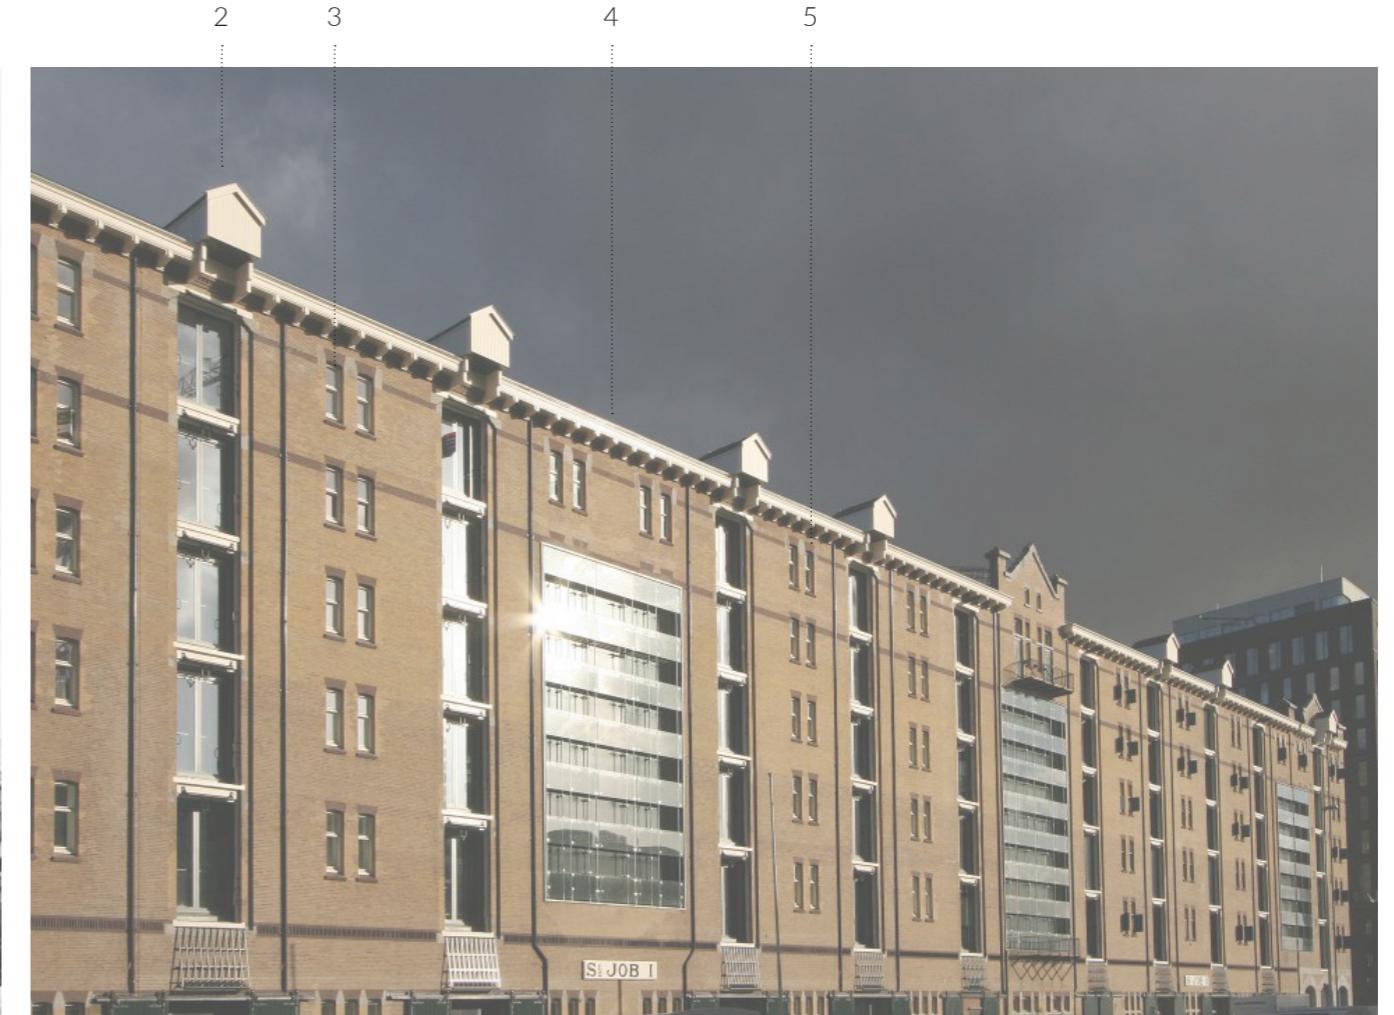
warehouse St Jobsveem by J.J. Kanters

1. use of concrete and steel structures (hennebique)
2. use of cranes and trapezium shaped overhangs for efficient transhipment (similar as Santos)
3. small duet windows
4. clearly horizontal character and lines
5. less and less use of ornaments besides above windows and building edges like roof

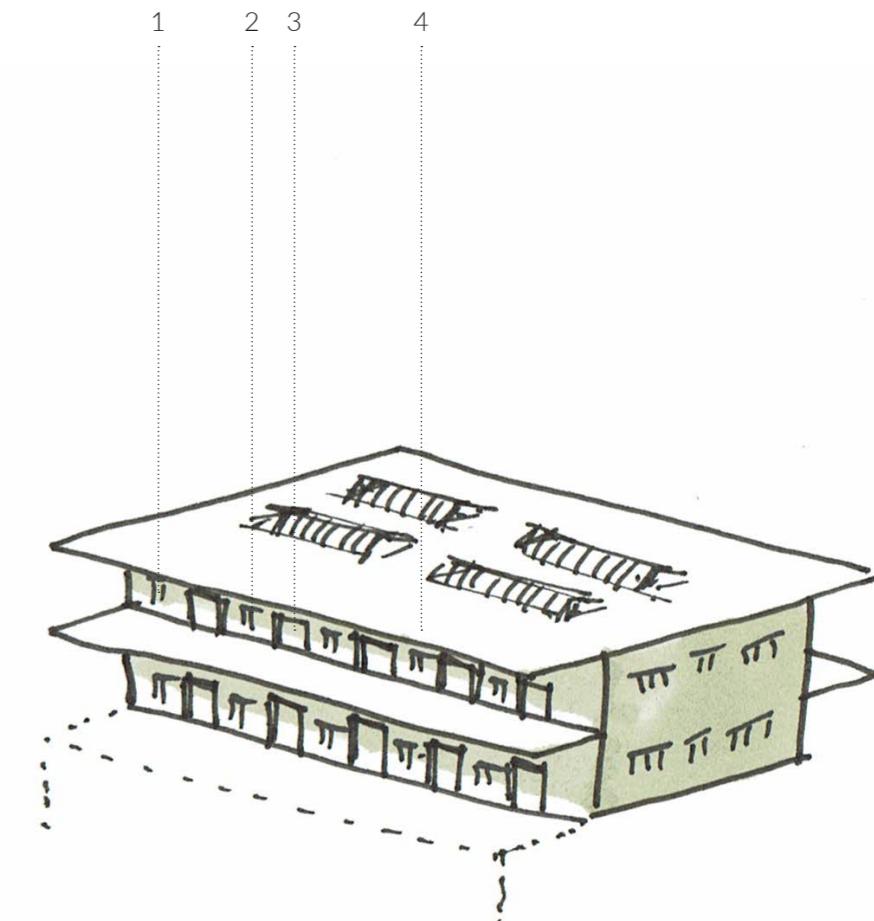
Katoenveem 1920

warehouses designed by J.J. Kanters in Rotterdam

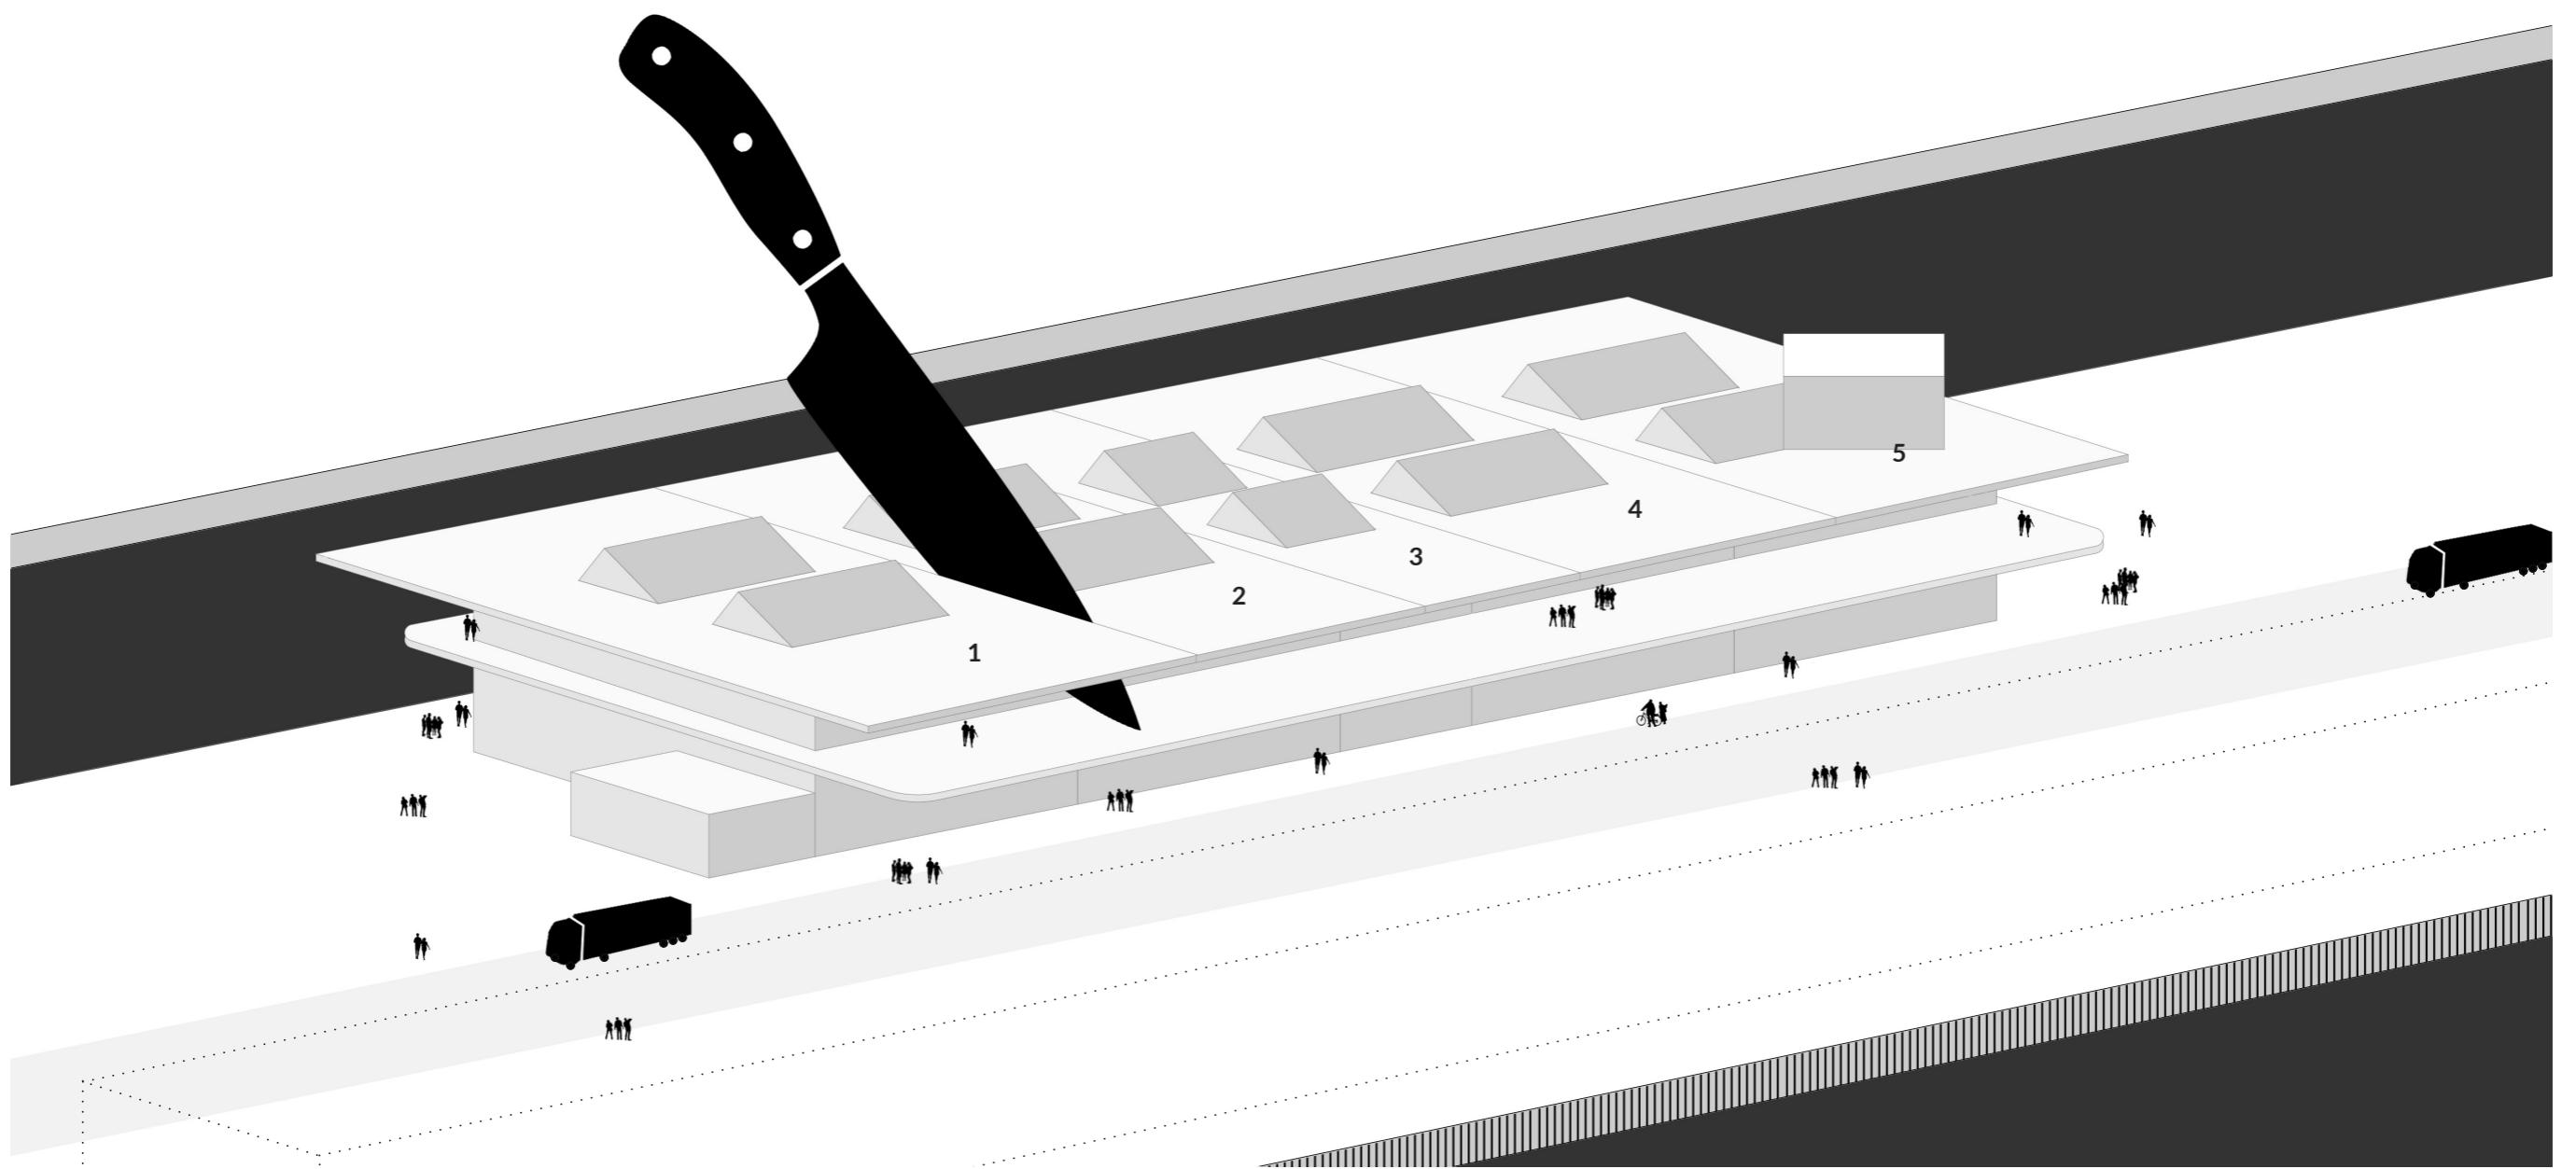
mass study & scale Katoenveem by joost van den berge

here you can clearly see the enormous scale and oblong mass of the Katoenveem. The large horizontal and rectangular building seems to be one block but actually is sliced into 5 pieces (see numbers) for fire protection, division in quality and act as dilation for expansion and shrinkage of the large concrete masses. The 5 volumes all have the same measurements except the middle one, which is less wide.

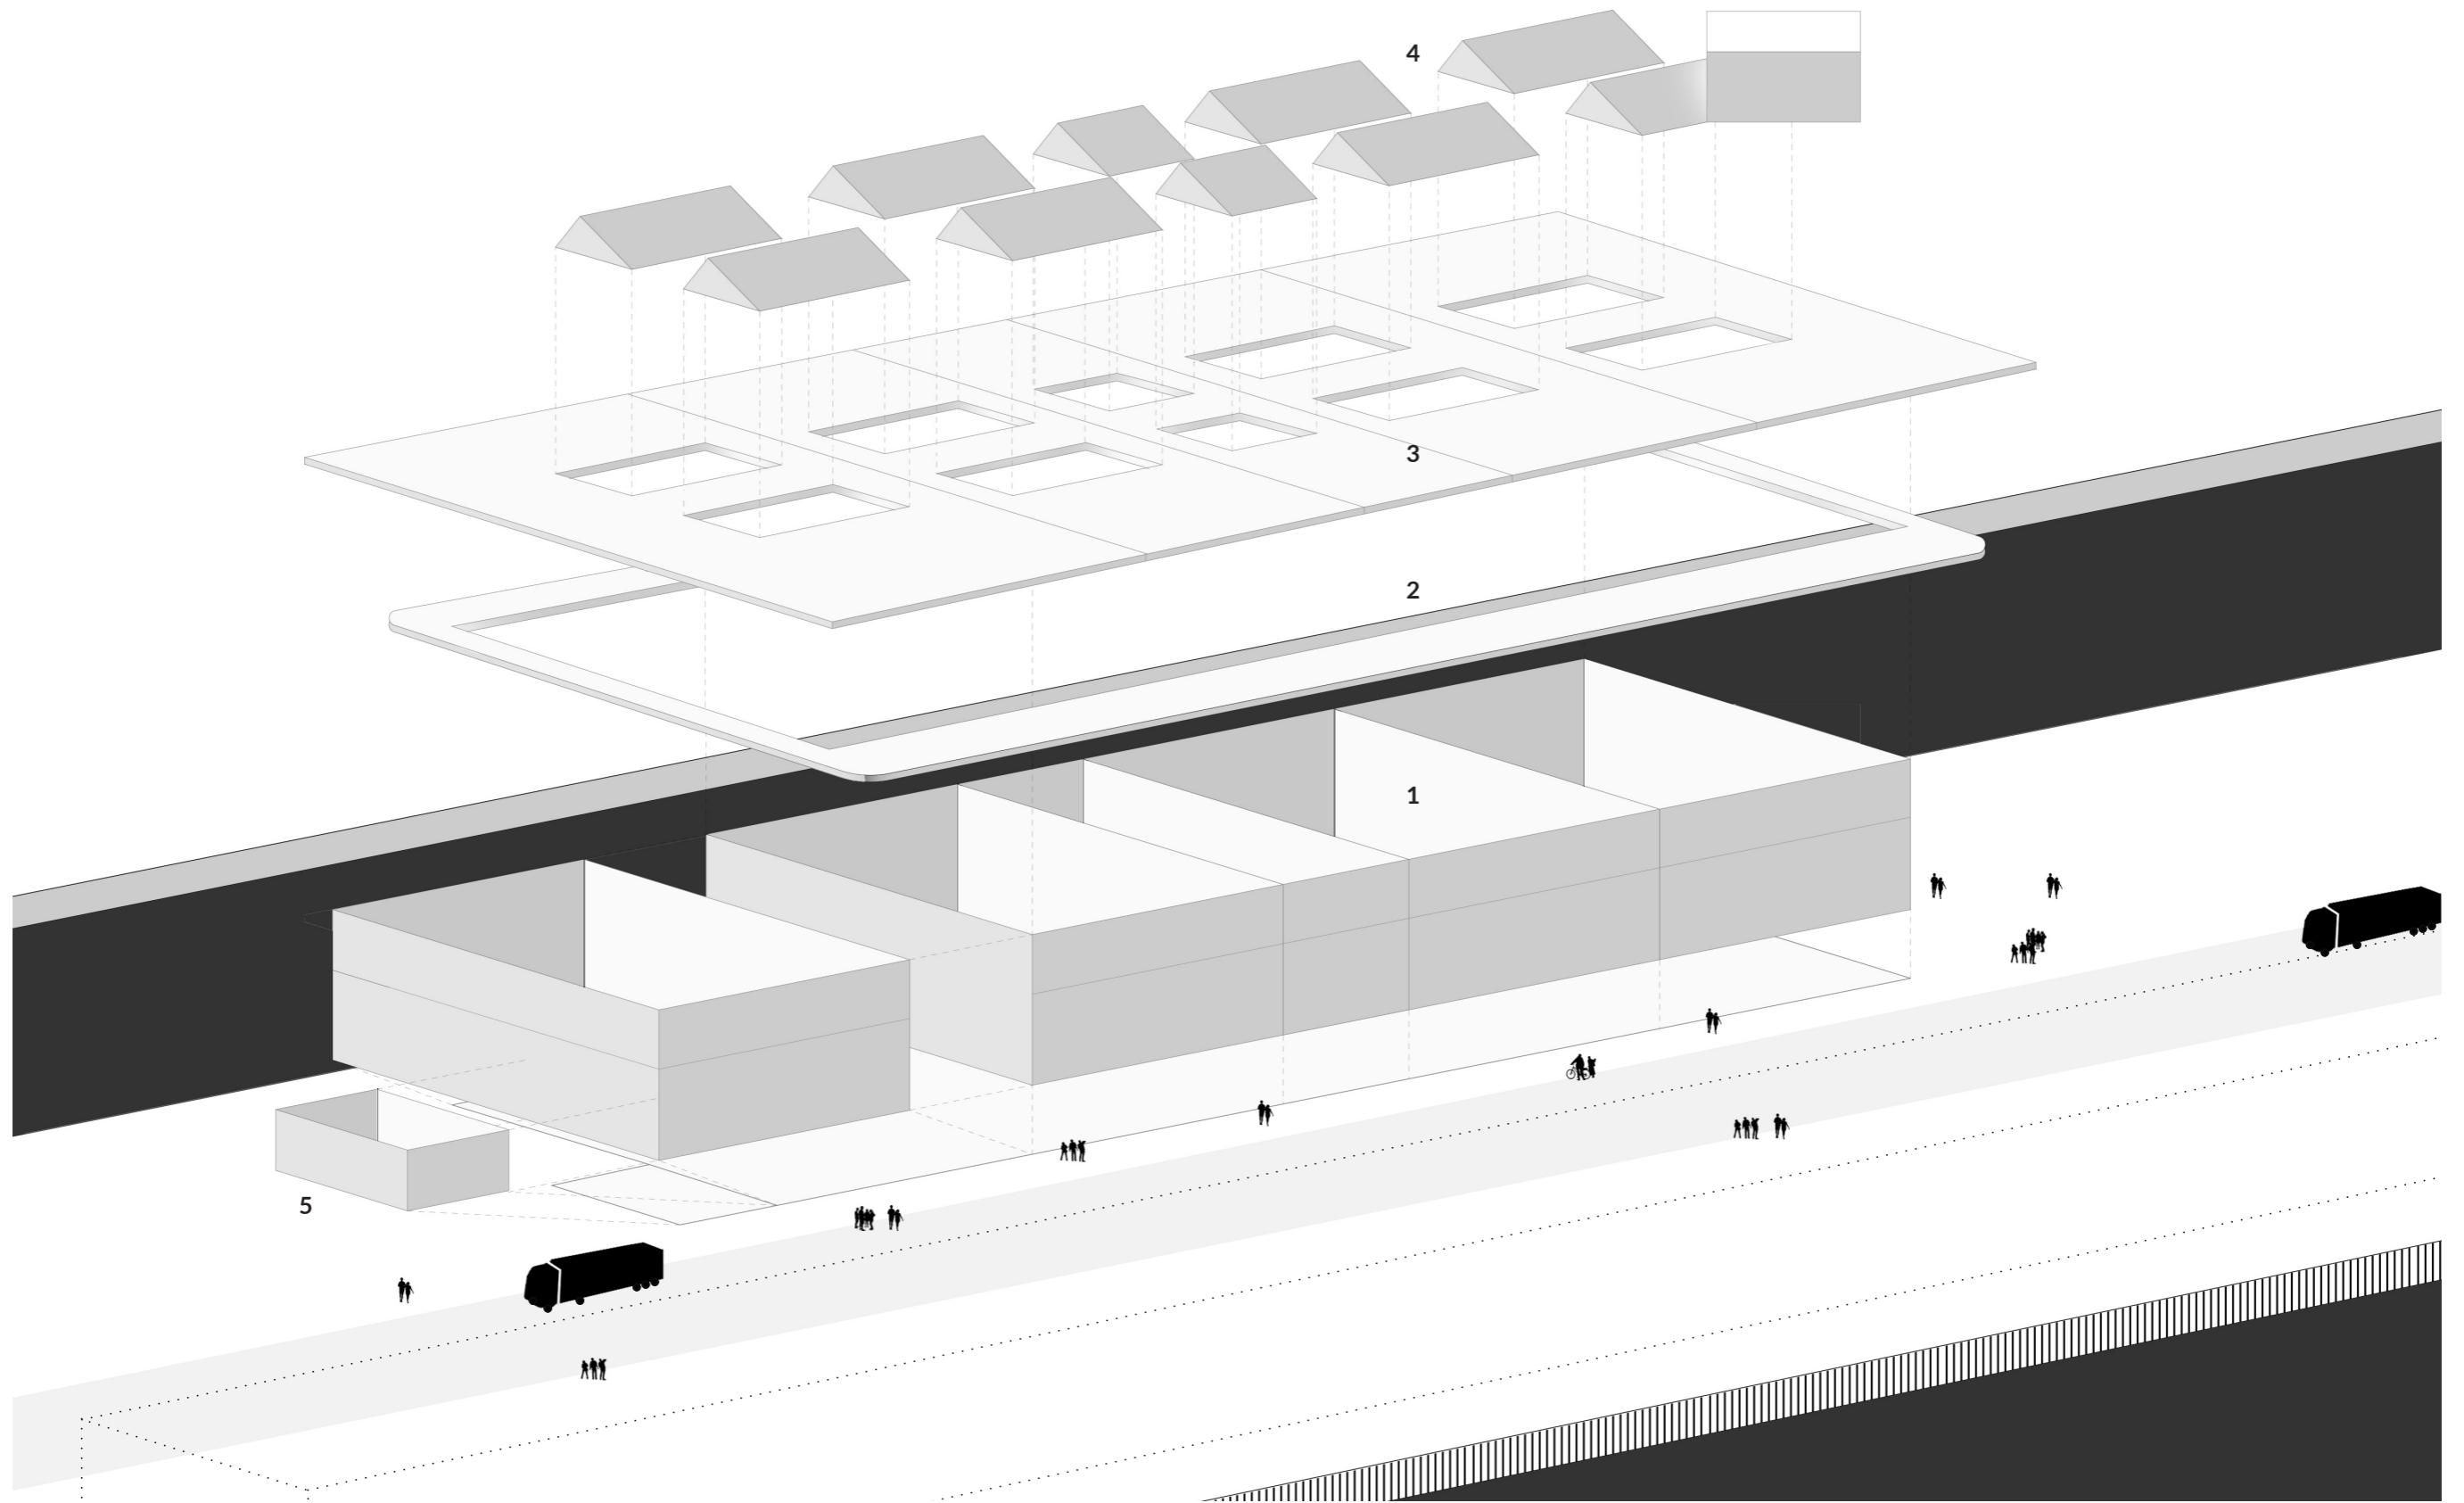
mass study, scale & exploded view Katoenveem by joost van den berge

When you would explode the building in it's main elements you could clearly see the five compartments (1), the gallery as one element (2), the roof, also cut up in five pieces, with holes for skylights (3) and the skylights themselves (4).
