KATOENVEEM

MSc III Heritage & Architecture

Architectural & Building Technology Analysis

07/04/2017

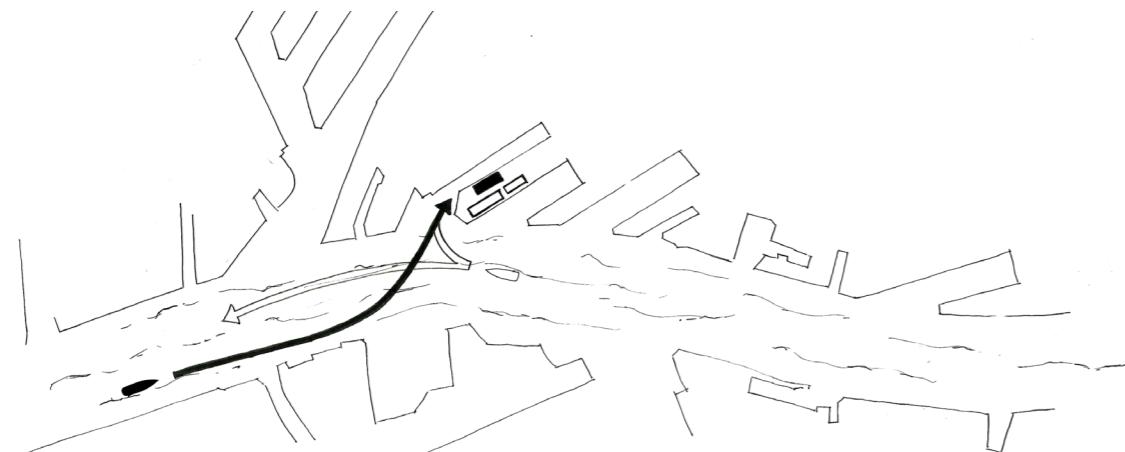
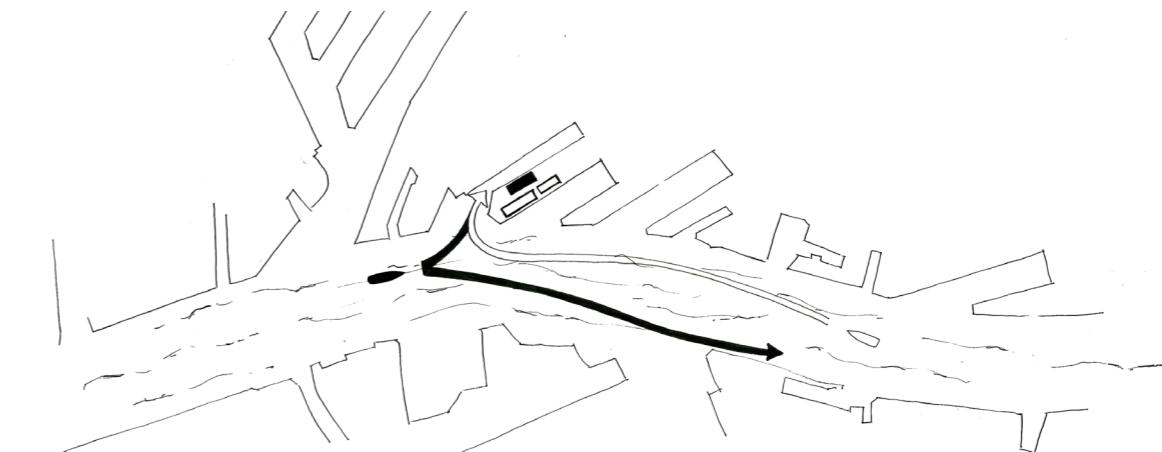
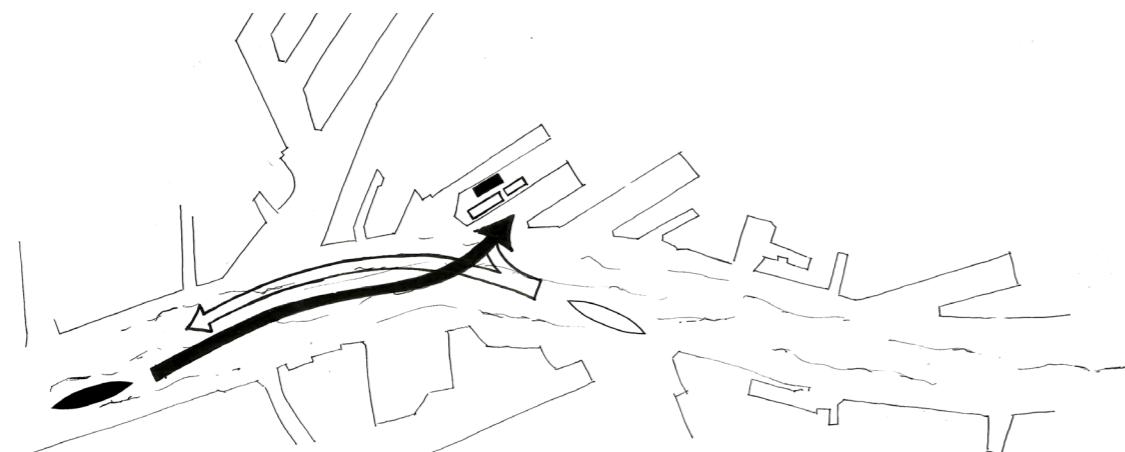
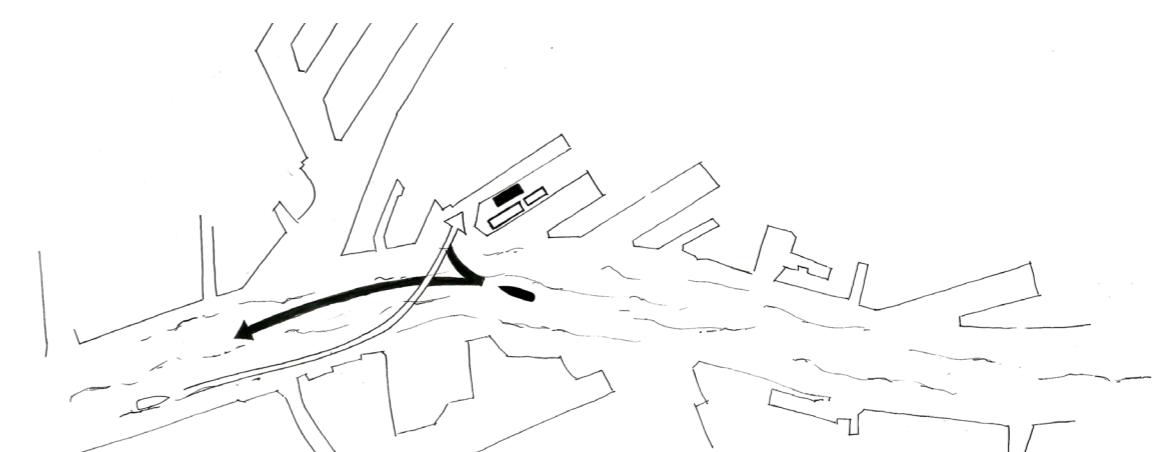
England > Keilehaven > Katoenveem

Katoenveem > Keilehaven > Hinterlands

England > Lekhaven > Warehouse Galveston or New Orleans > Katoenveem

Katoenveem > Keilehaven > Bremen / Belgium

illustration 1 Waterway system: Maas river by Audrey Loef
(own illustration according to M. Enderman and R. Stenvert, (2005). Bouwhistorische verkenning Katoenveem, Keilestraat 39 Rotterdam, Utrecht, p 6-7)

- Arrival route
- ↗ Departure route
- Katoenveem warehouse
- Temporary warehouse "New Orleans" and "Galveston"

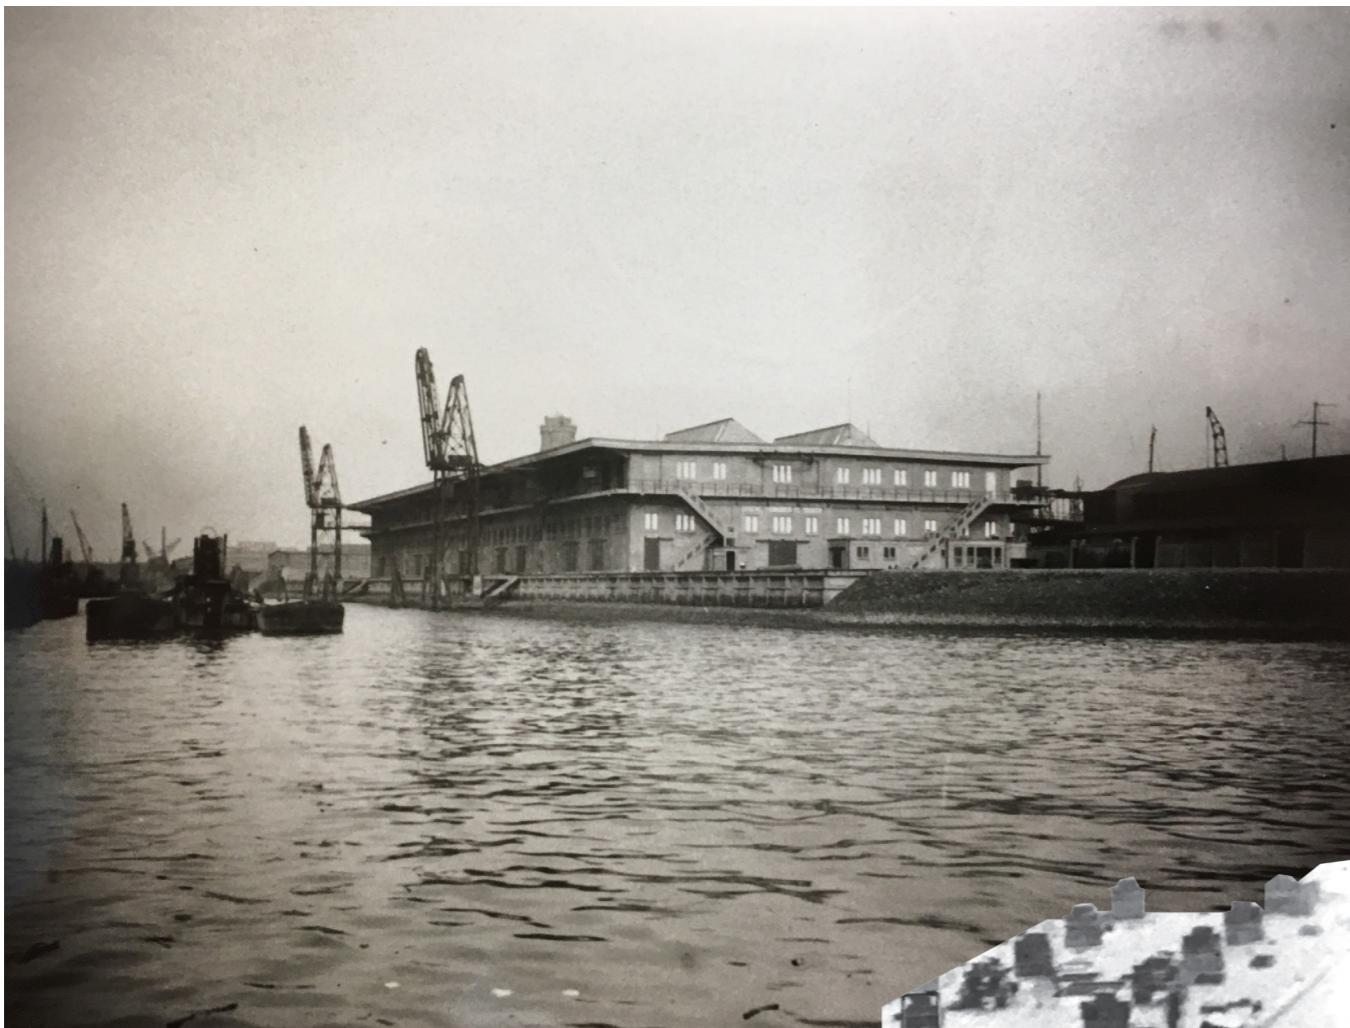
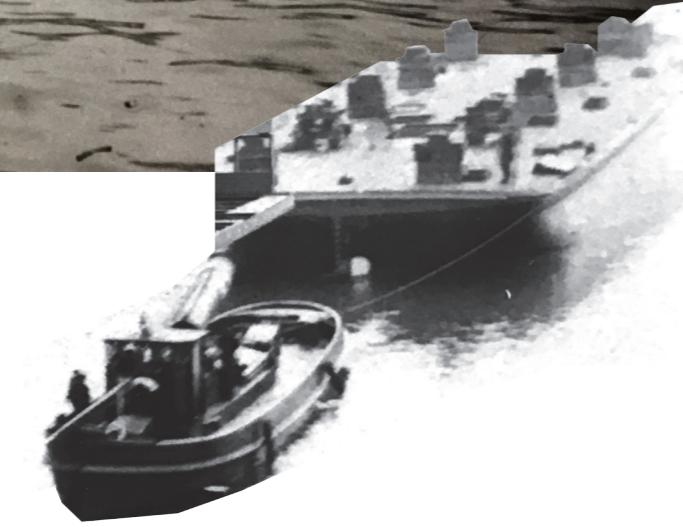
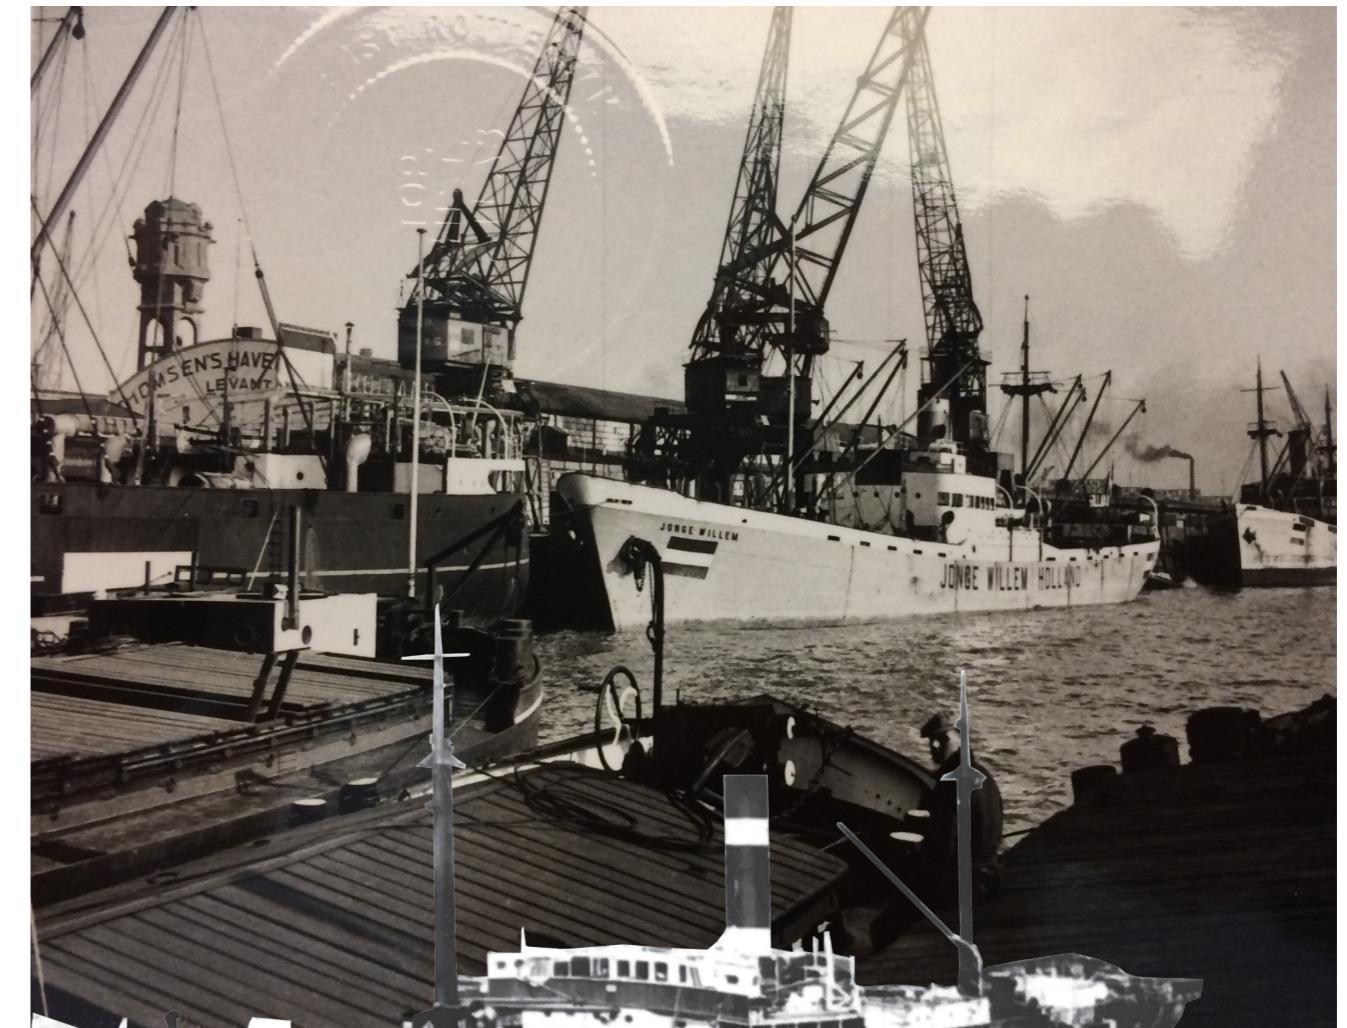
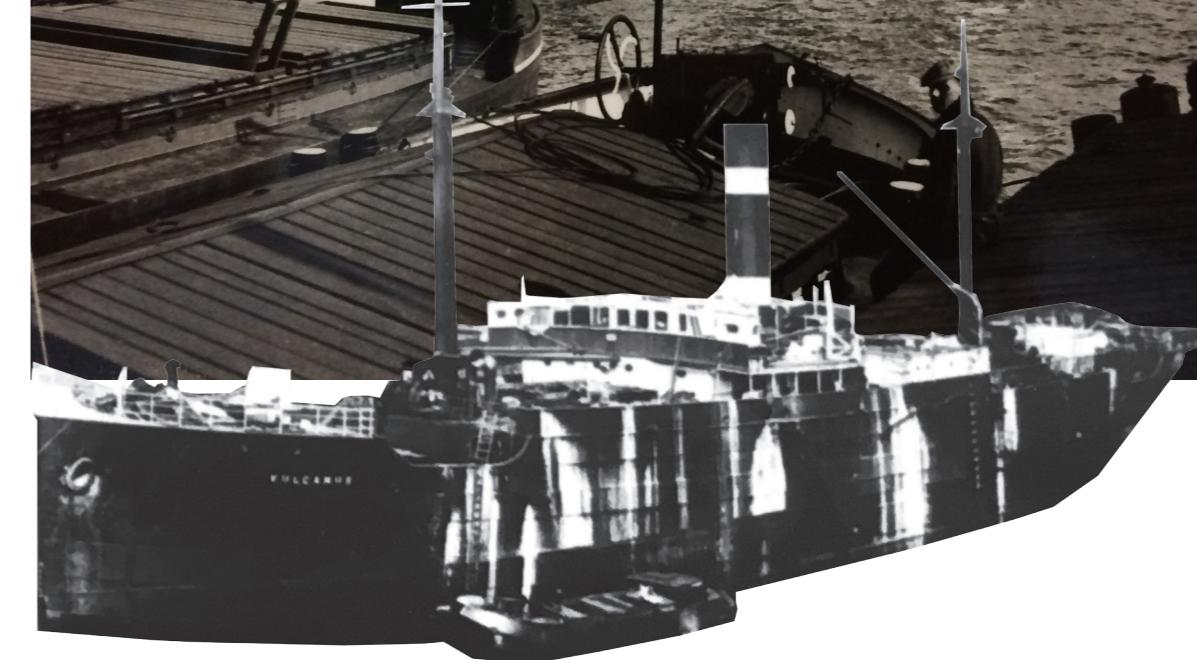
illustration 2.1 Keilehaven 1933 and barge by Audrey Loef
illustration 2.2 Lekhaven 1940 and importsteamer Holland America Line by Audrey Loef
(own illustration according to Images Gemeentelijke Archiefdienst Rotterdam)

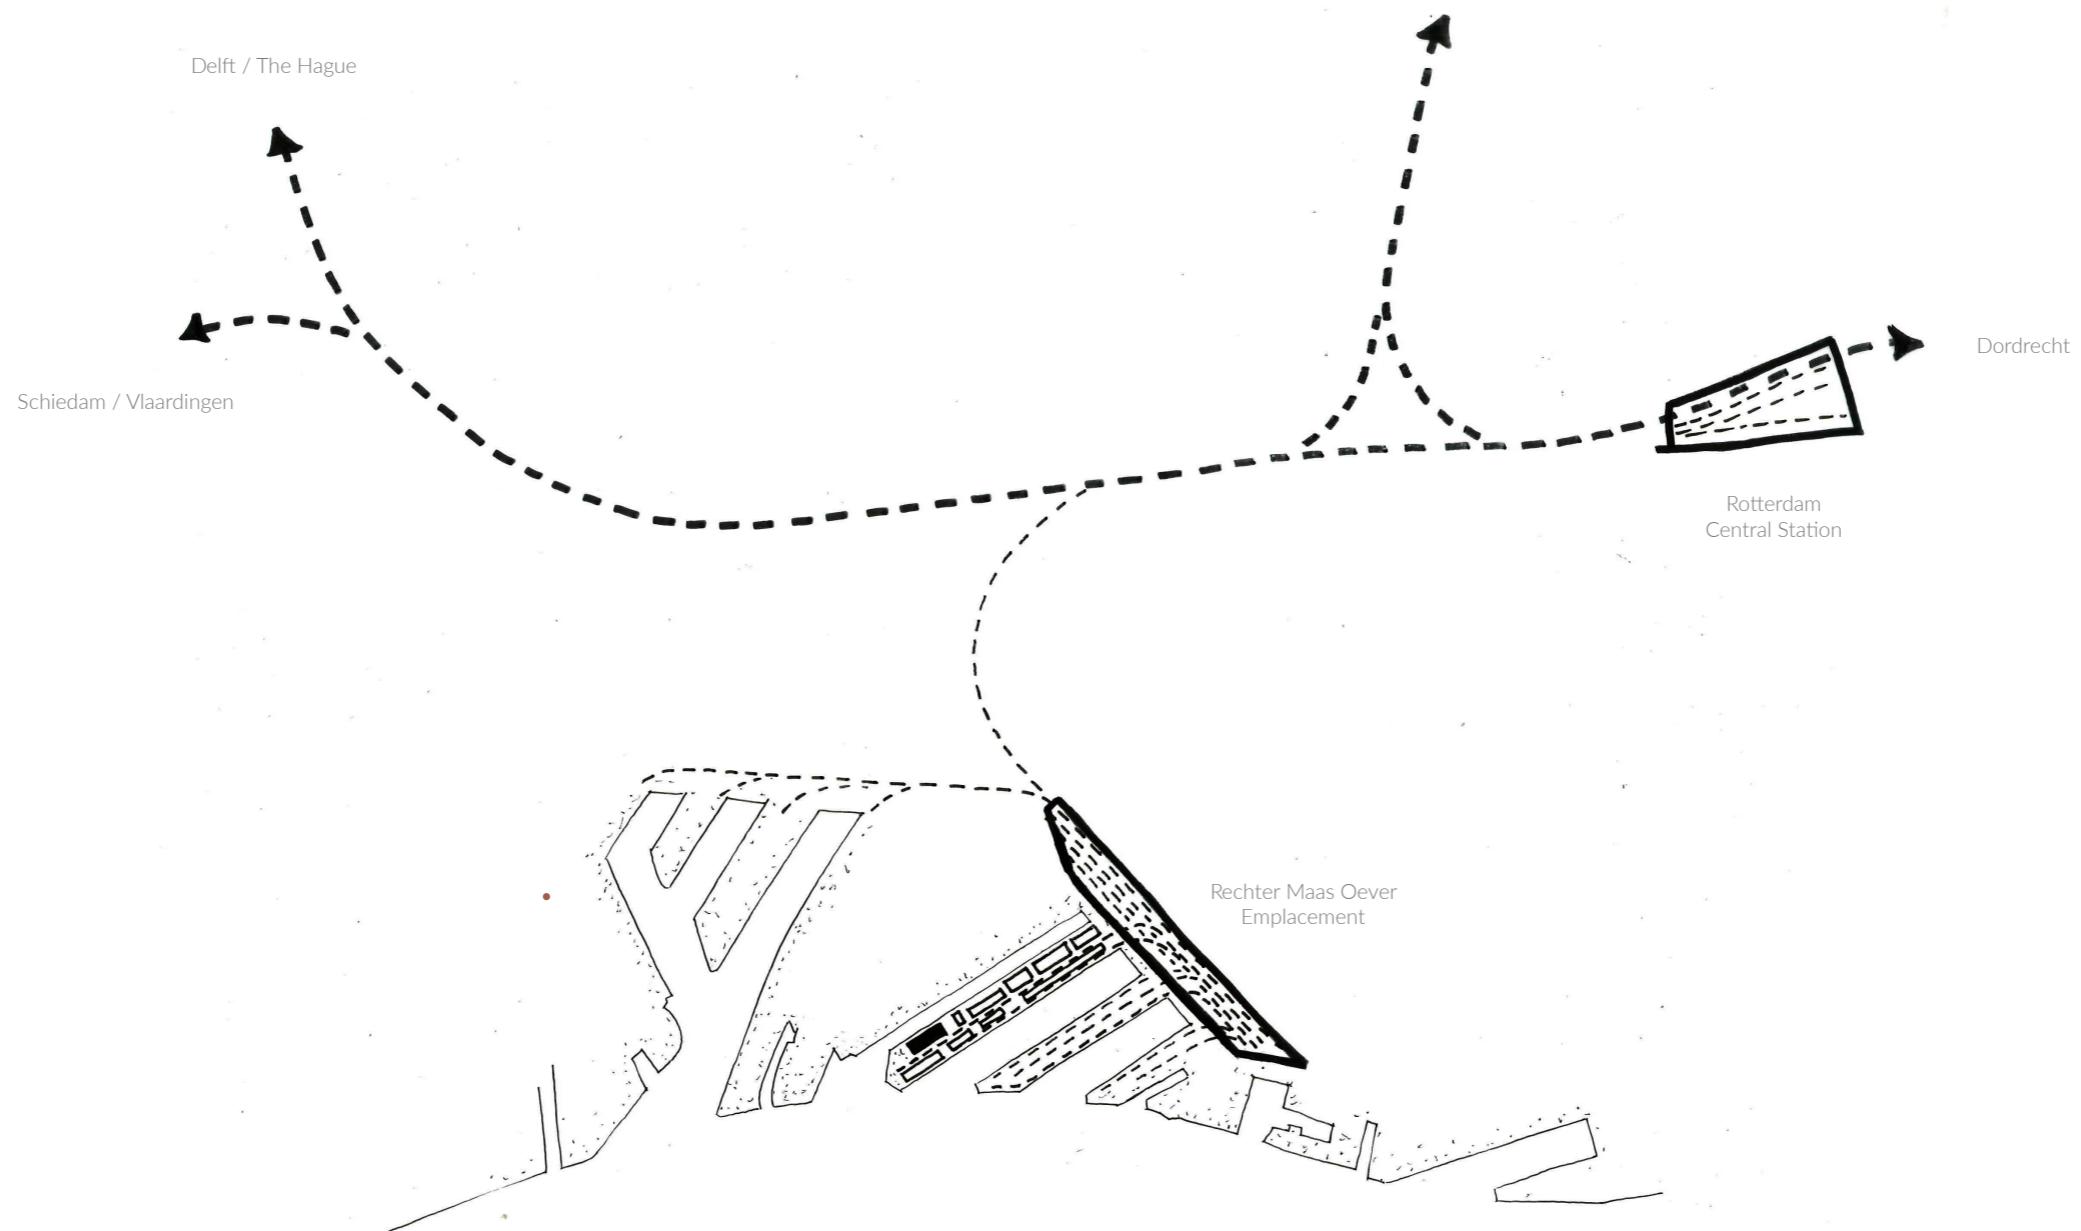
Illustration 3 Harbour railway system by Audrey Loef

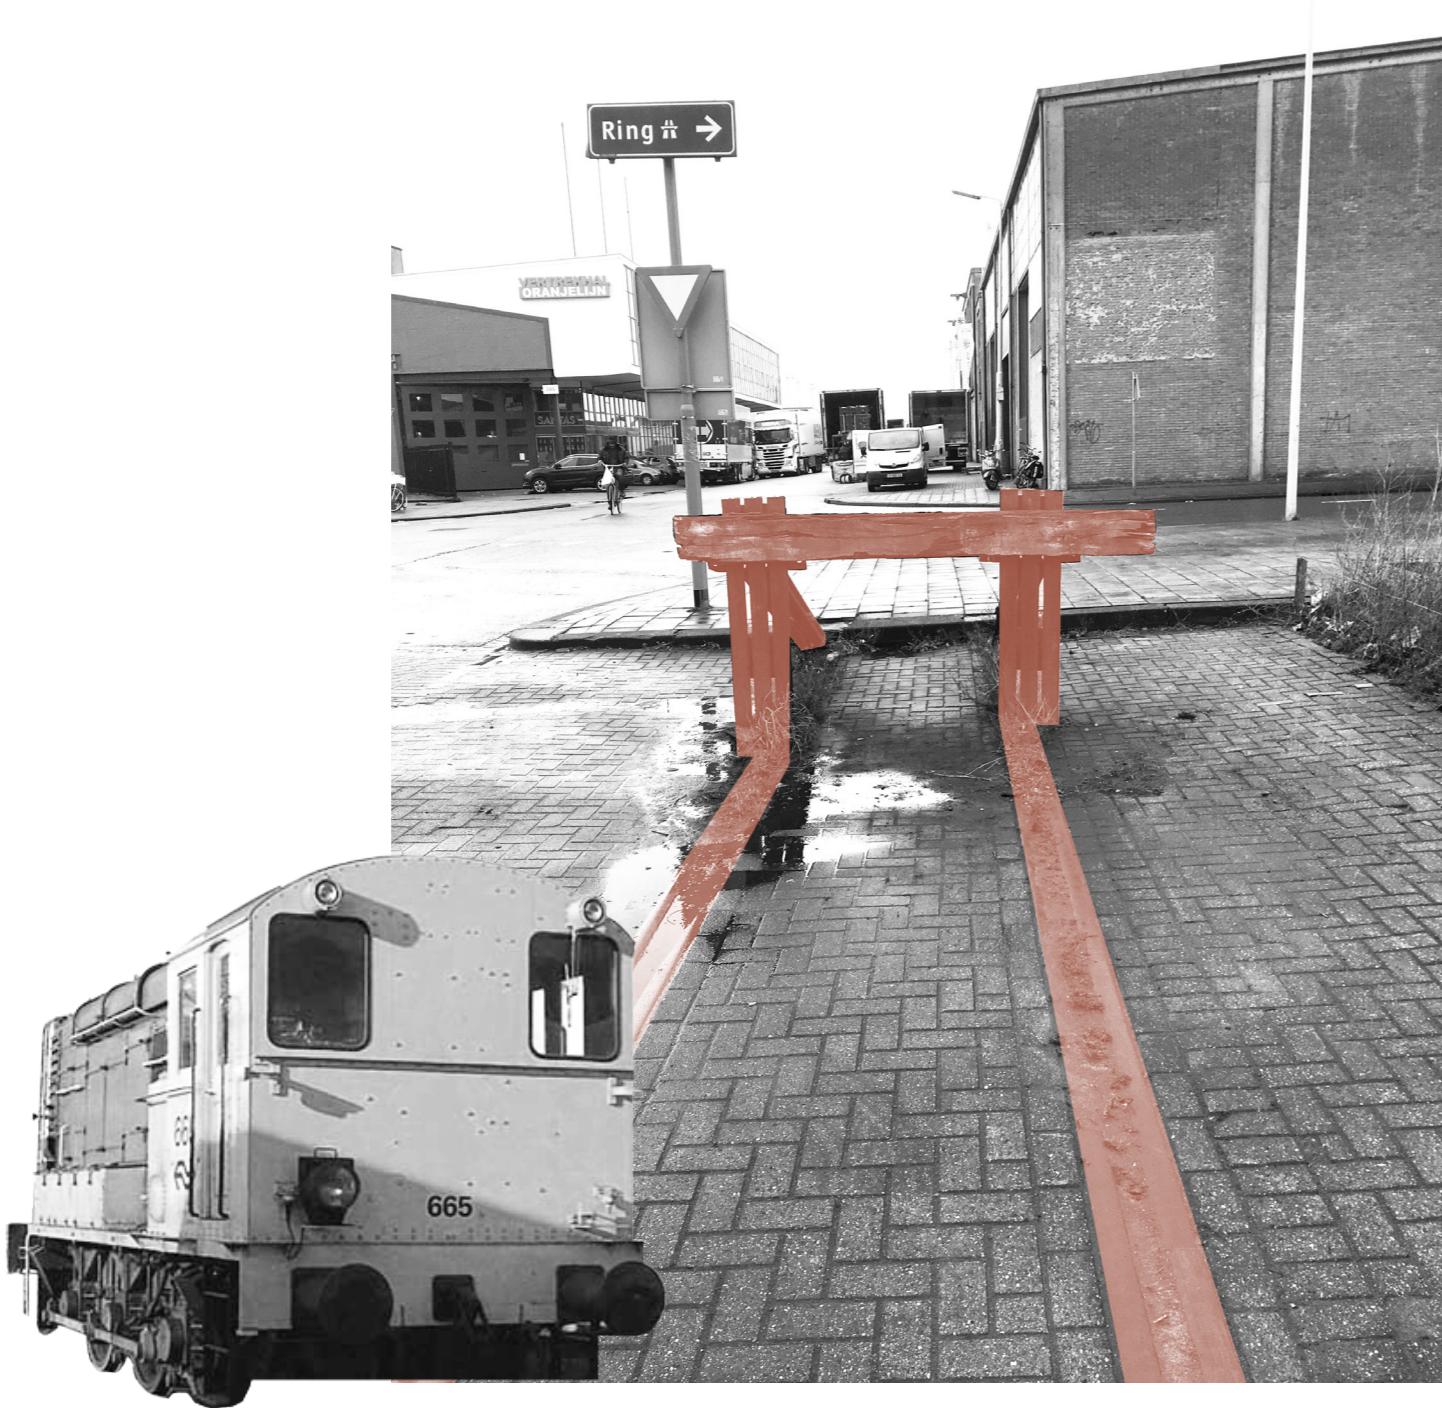
illustration 4.1 Present trace of RMO Railtrack 2017 and goodtrain by Audrey Loef

illustration 4.2 Keilestraat 1919
(own illustration according to Images Gemeentelijke Archiefdienst Rotterdam)

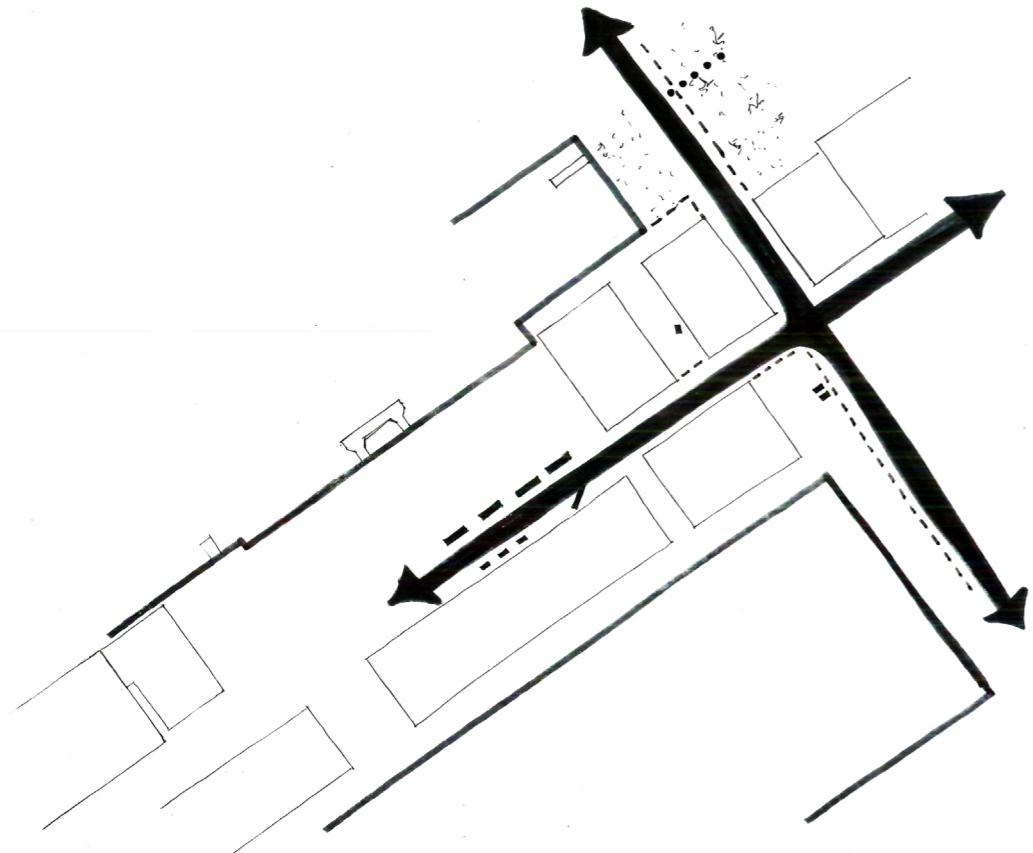
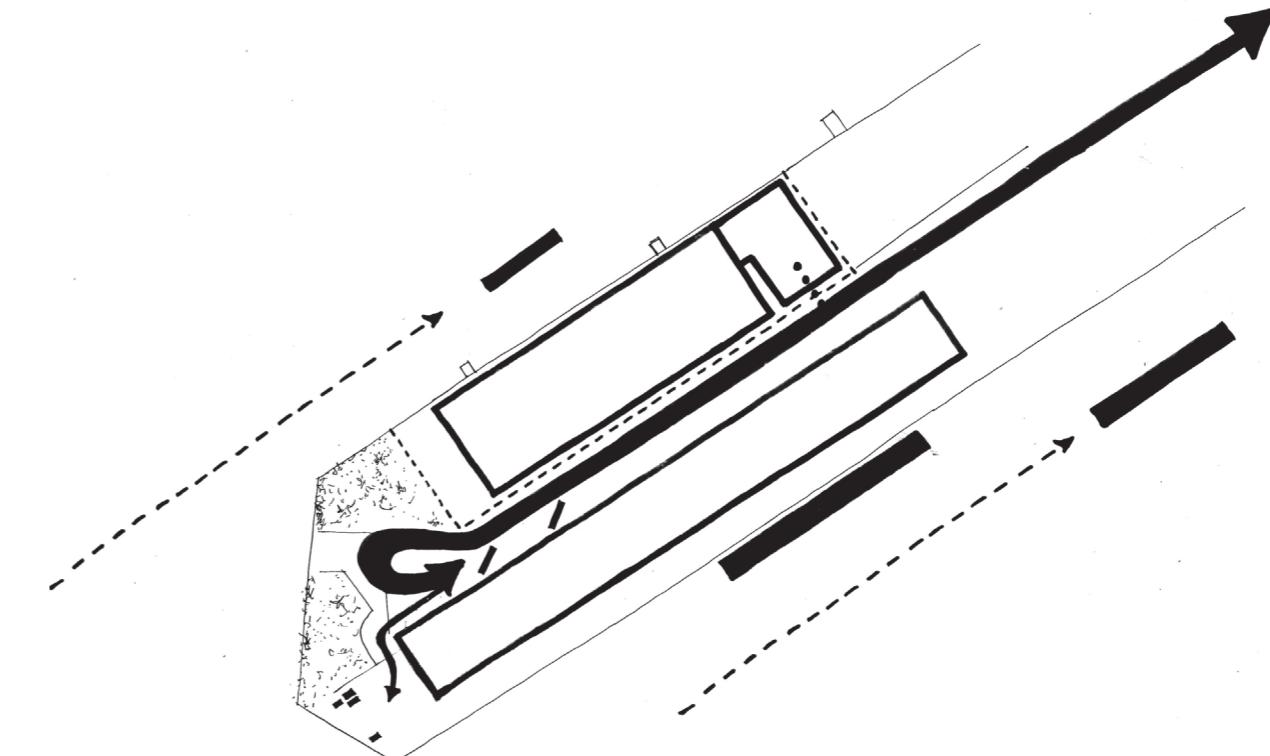
illustration 7.1 Current approach Merwevierhaven - Keilestraat

illustration 7.2 Current approach site

While arriving close to the Keilestraat a crossing of the street marks the entrance of the pier, which is enhanced by the line of the water. Along the route different scales of approach are present, to walk, to cycle and to drive. While this main route to enter the pier is marked by trucks, it is the only physical route of entering the site. Ways to cycle and paths to walk are not represented (ill. 7.1).

The site is marked by the end of the pier and trucks are still active next to the building which faces Katoenveem. A roundabout leads back after overlooking the dynamics of the ships. Katoenveem is closed off towards its surrounding because of a fence around the site of the ensemble (ill. 7.2).

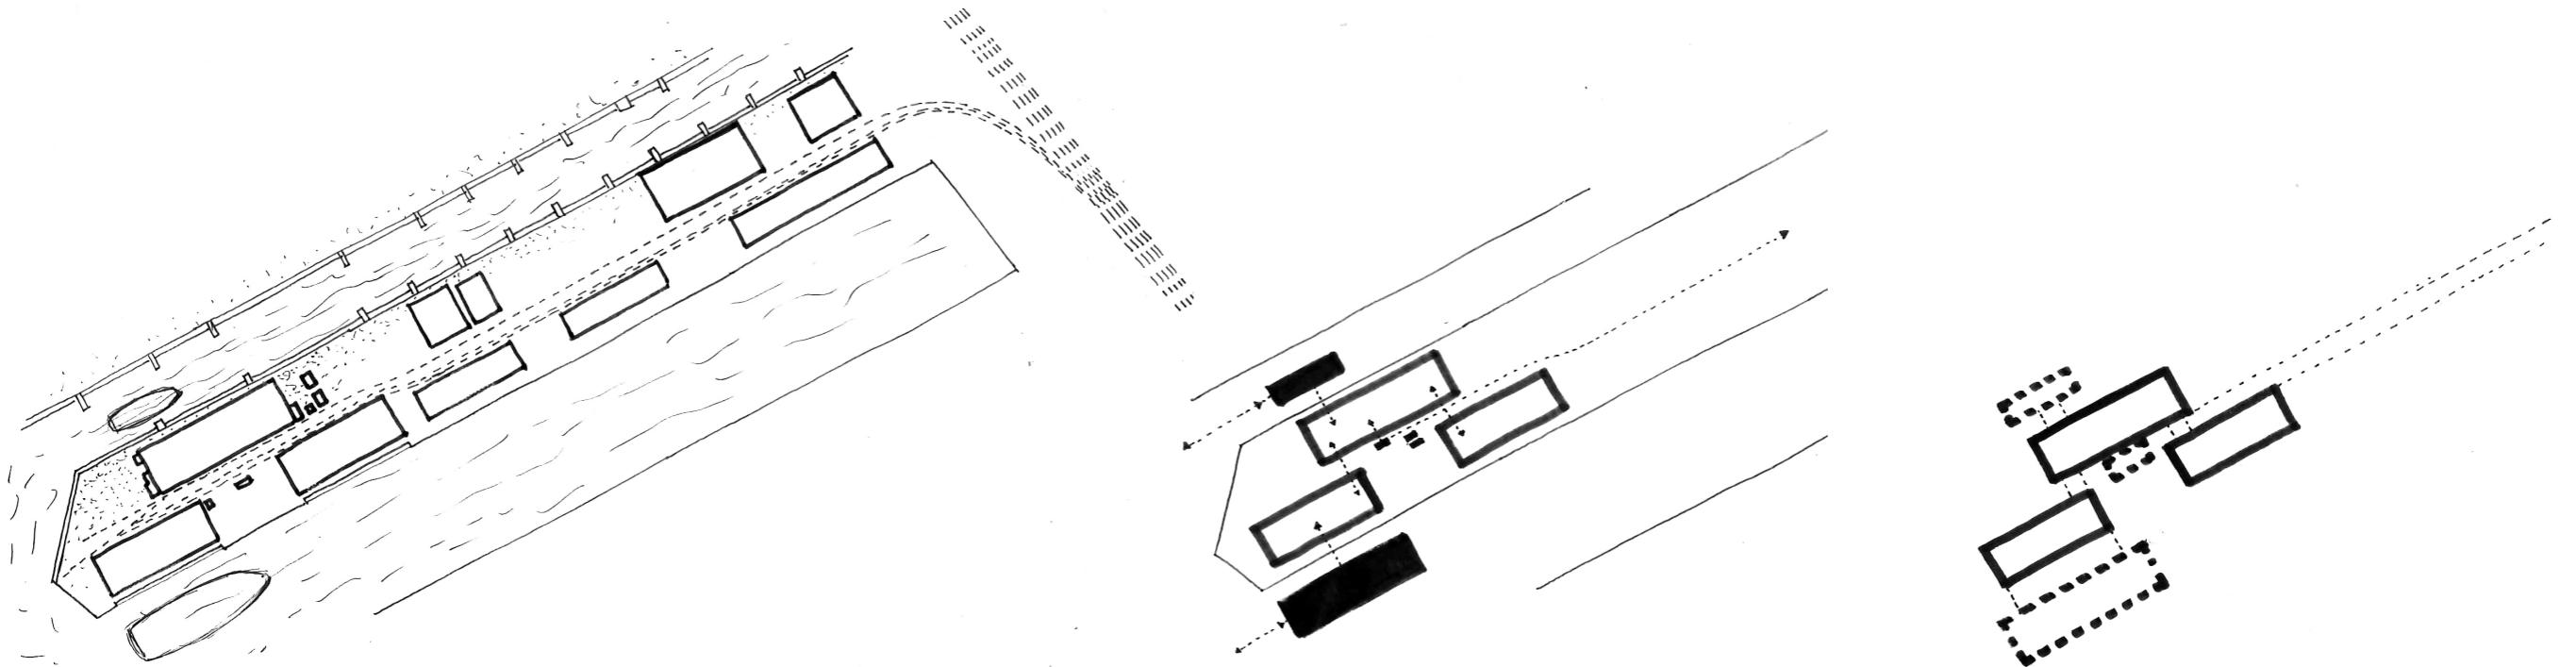
illustration 8.1 organisational situation in plan

illustration 8.2 process of storage and transport in plan

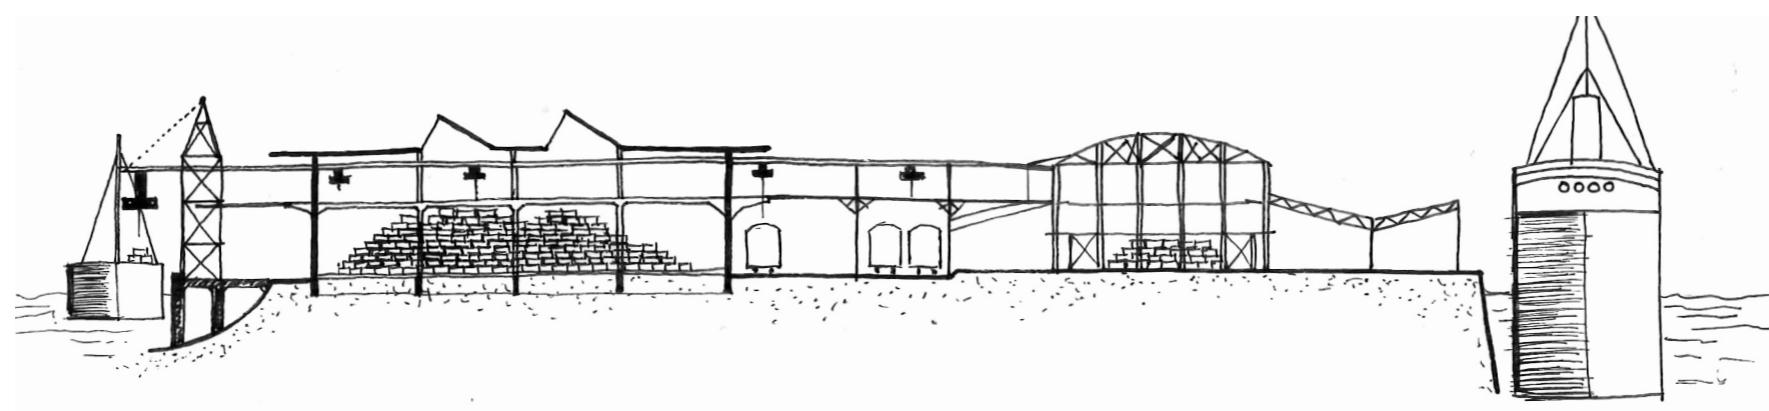
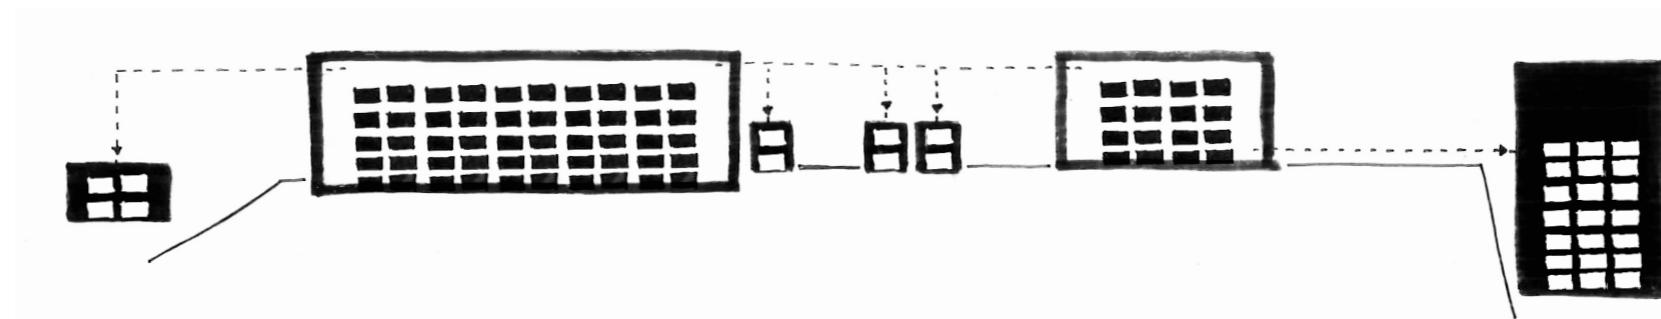
illustration 8.4 organisational situation in cross section

illustration 8.5 process of storage and transport in cross section

illustration 8.6 types of move in cross section

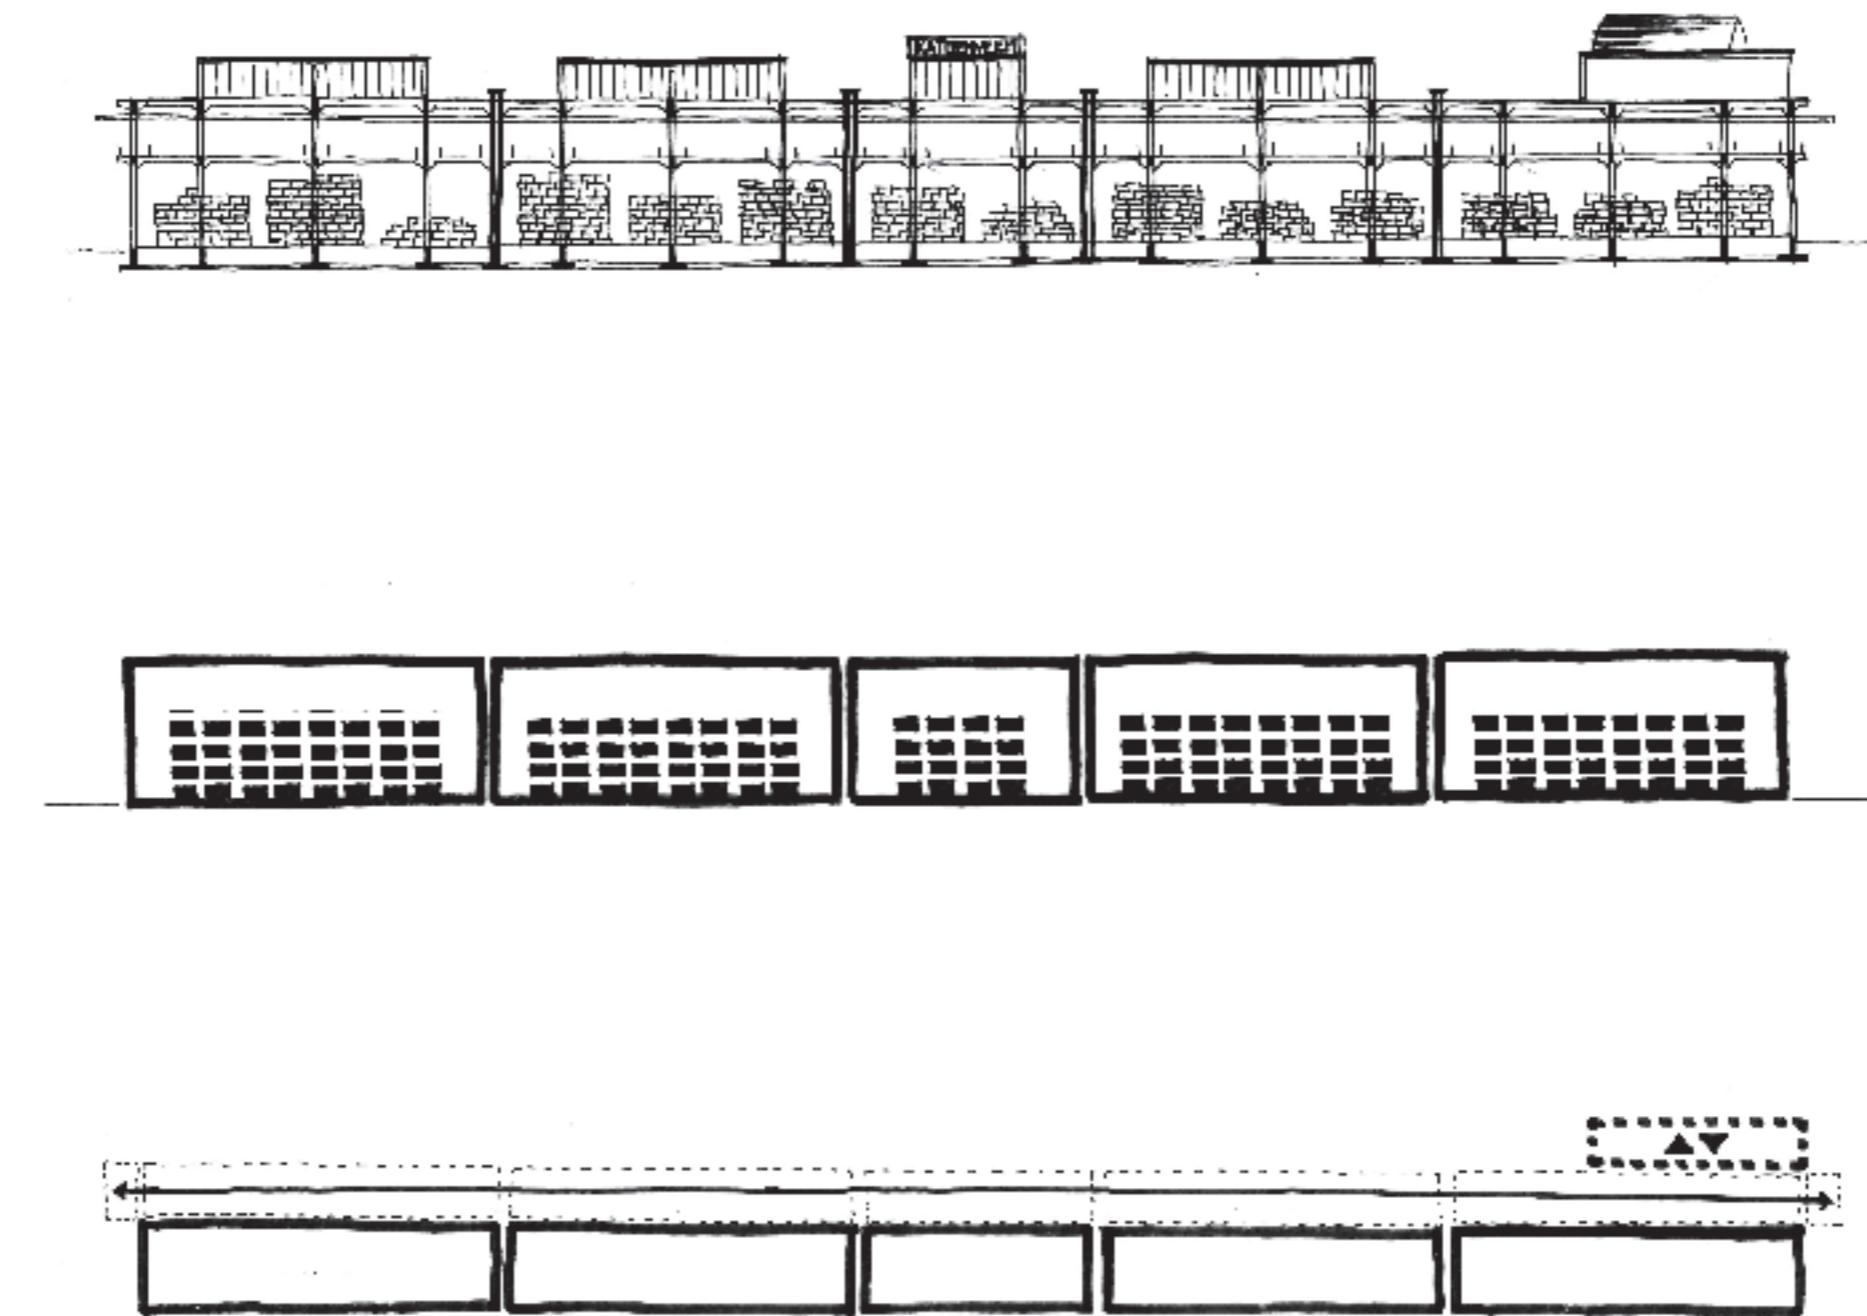
illustration 8.7 organisational situation in longitudinal section

illustration 8.8 process of storage and transport in longitudinal section

illustration 8.9 types of move in longitudinal section

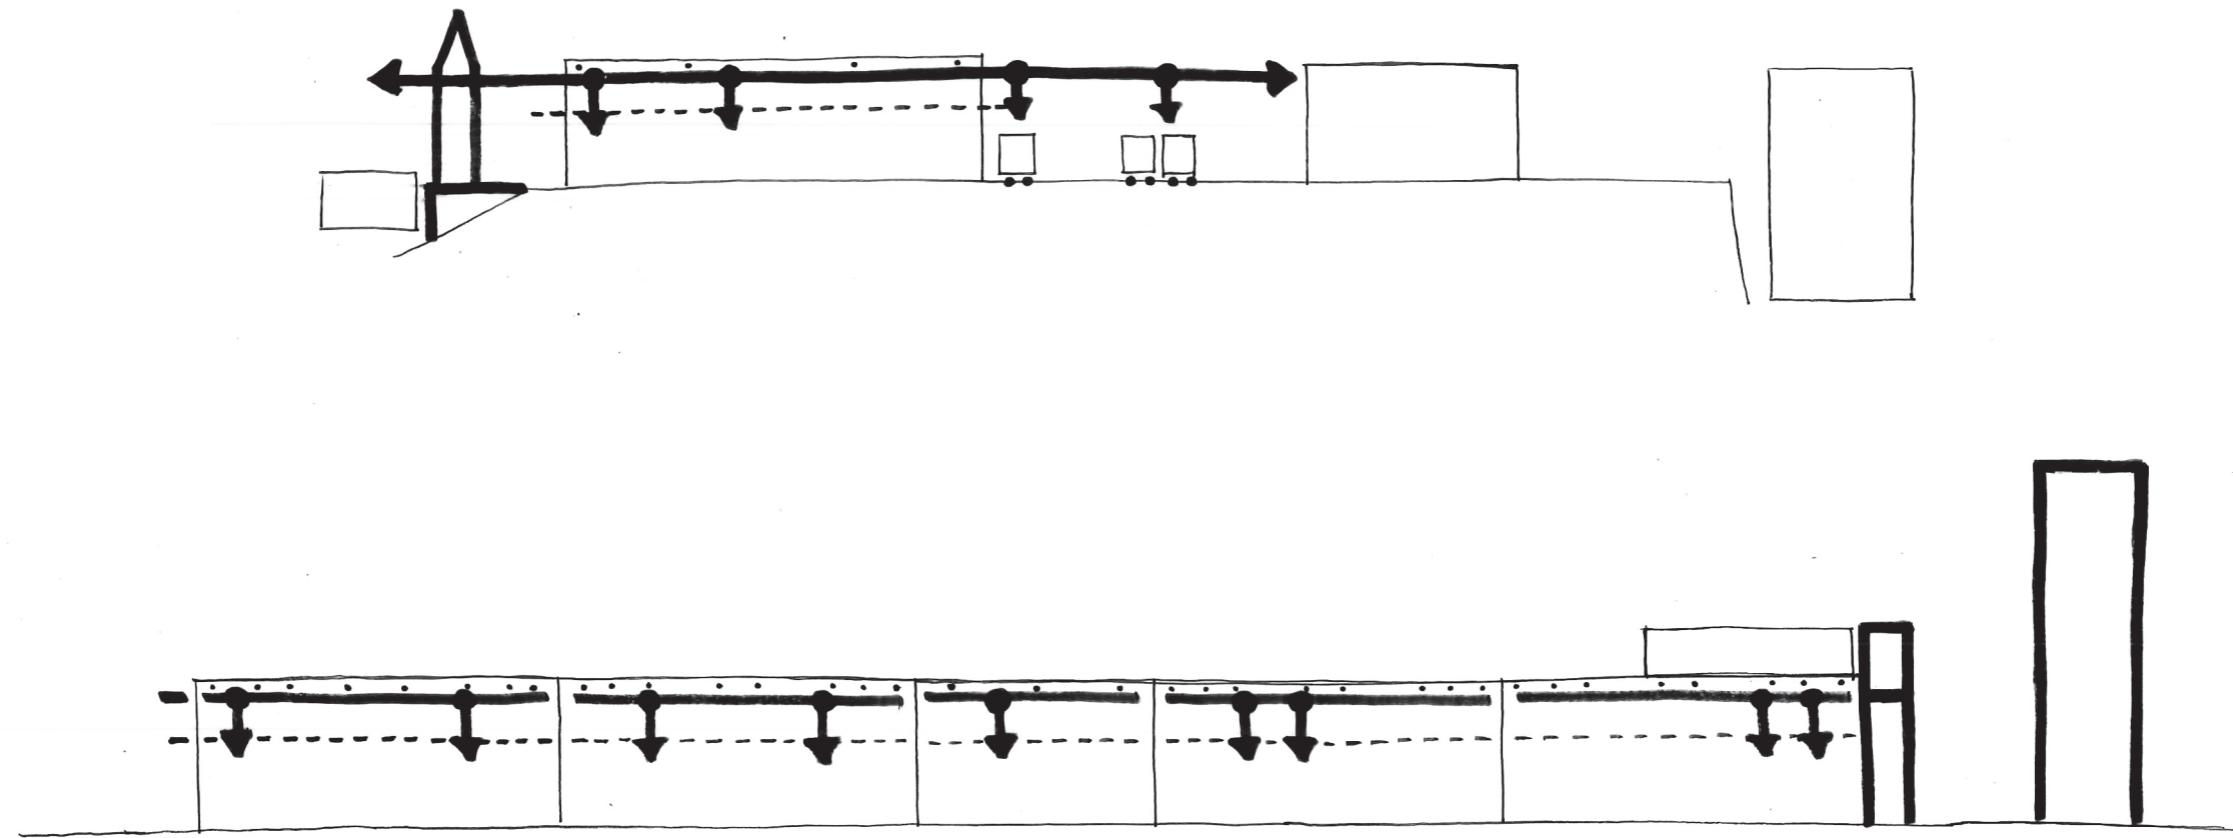
illustration 9.1 services of move in cross section
 illustration 9.2 services of move in longitudinal section
 by Audrey Loef (own illustration)
