KATOENVEEM

MSc III Heritage & Architecture

Architectural & Building Technology Analysis

07/04/2017

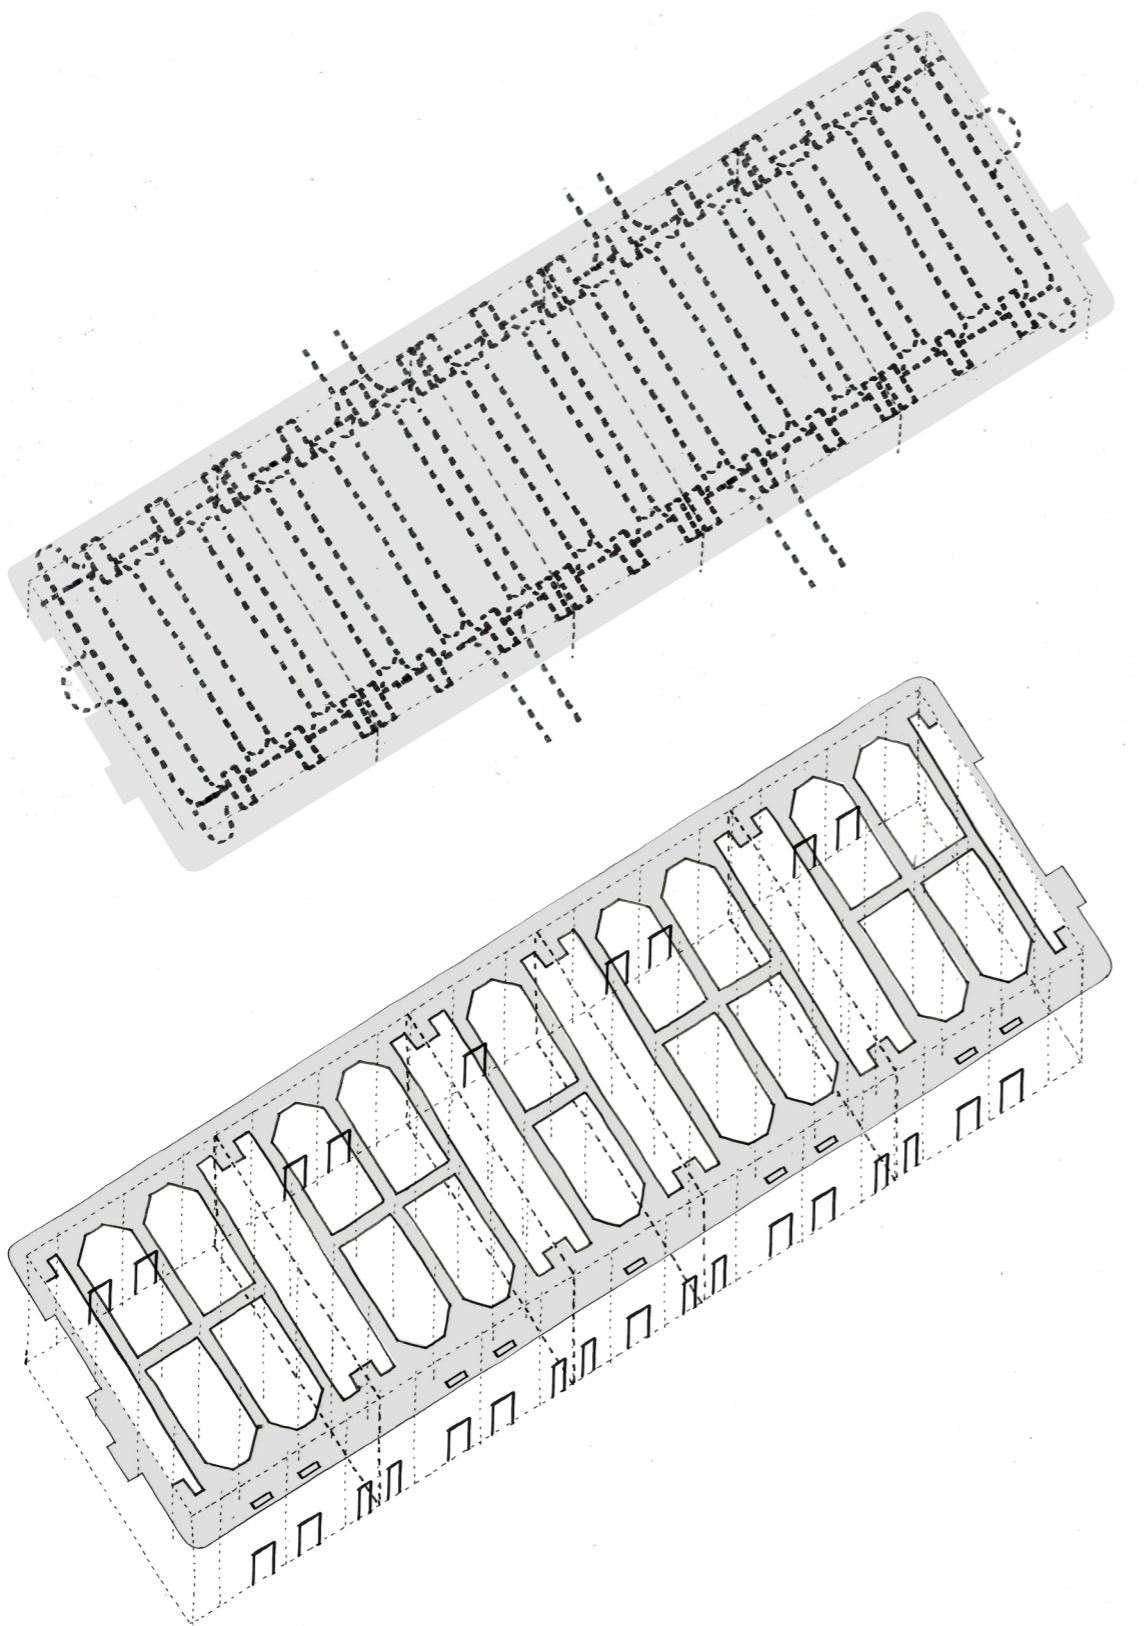
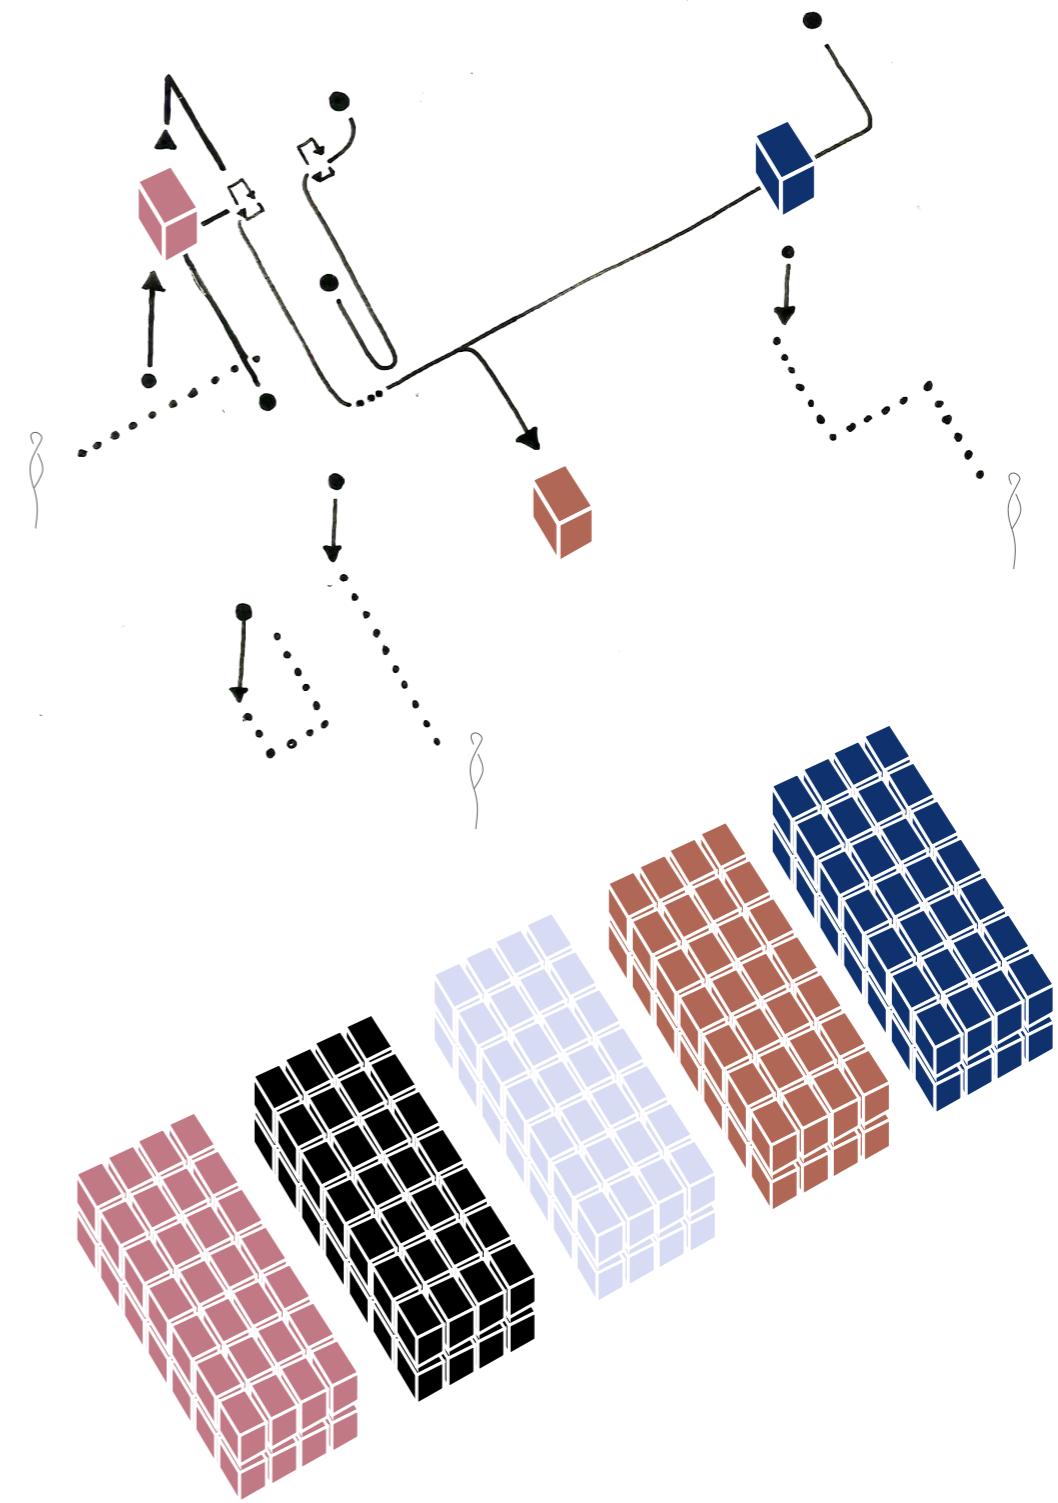
illustration 10 interaction between construction and the movement of services by Audrey Loef
(own illustration)

We can see that these services guided the cotton through the building by different routes to reach the specified area of stored cotton (ill. 10).

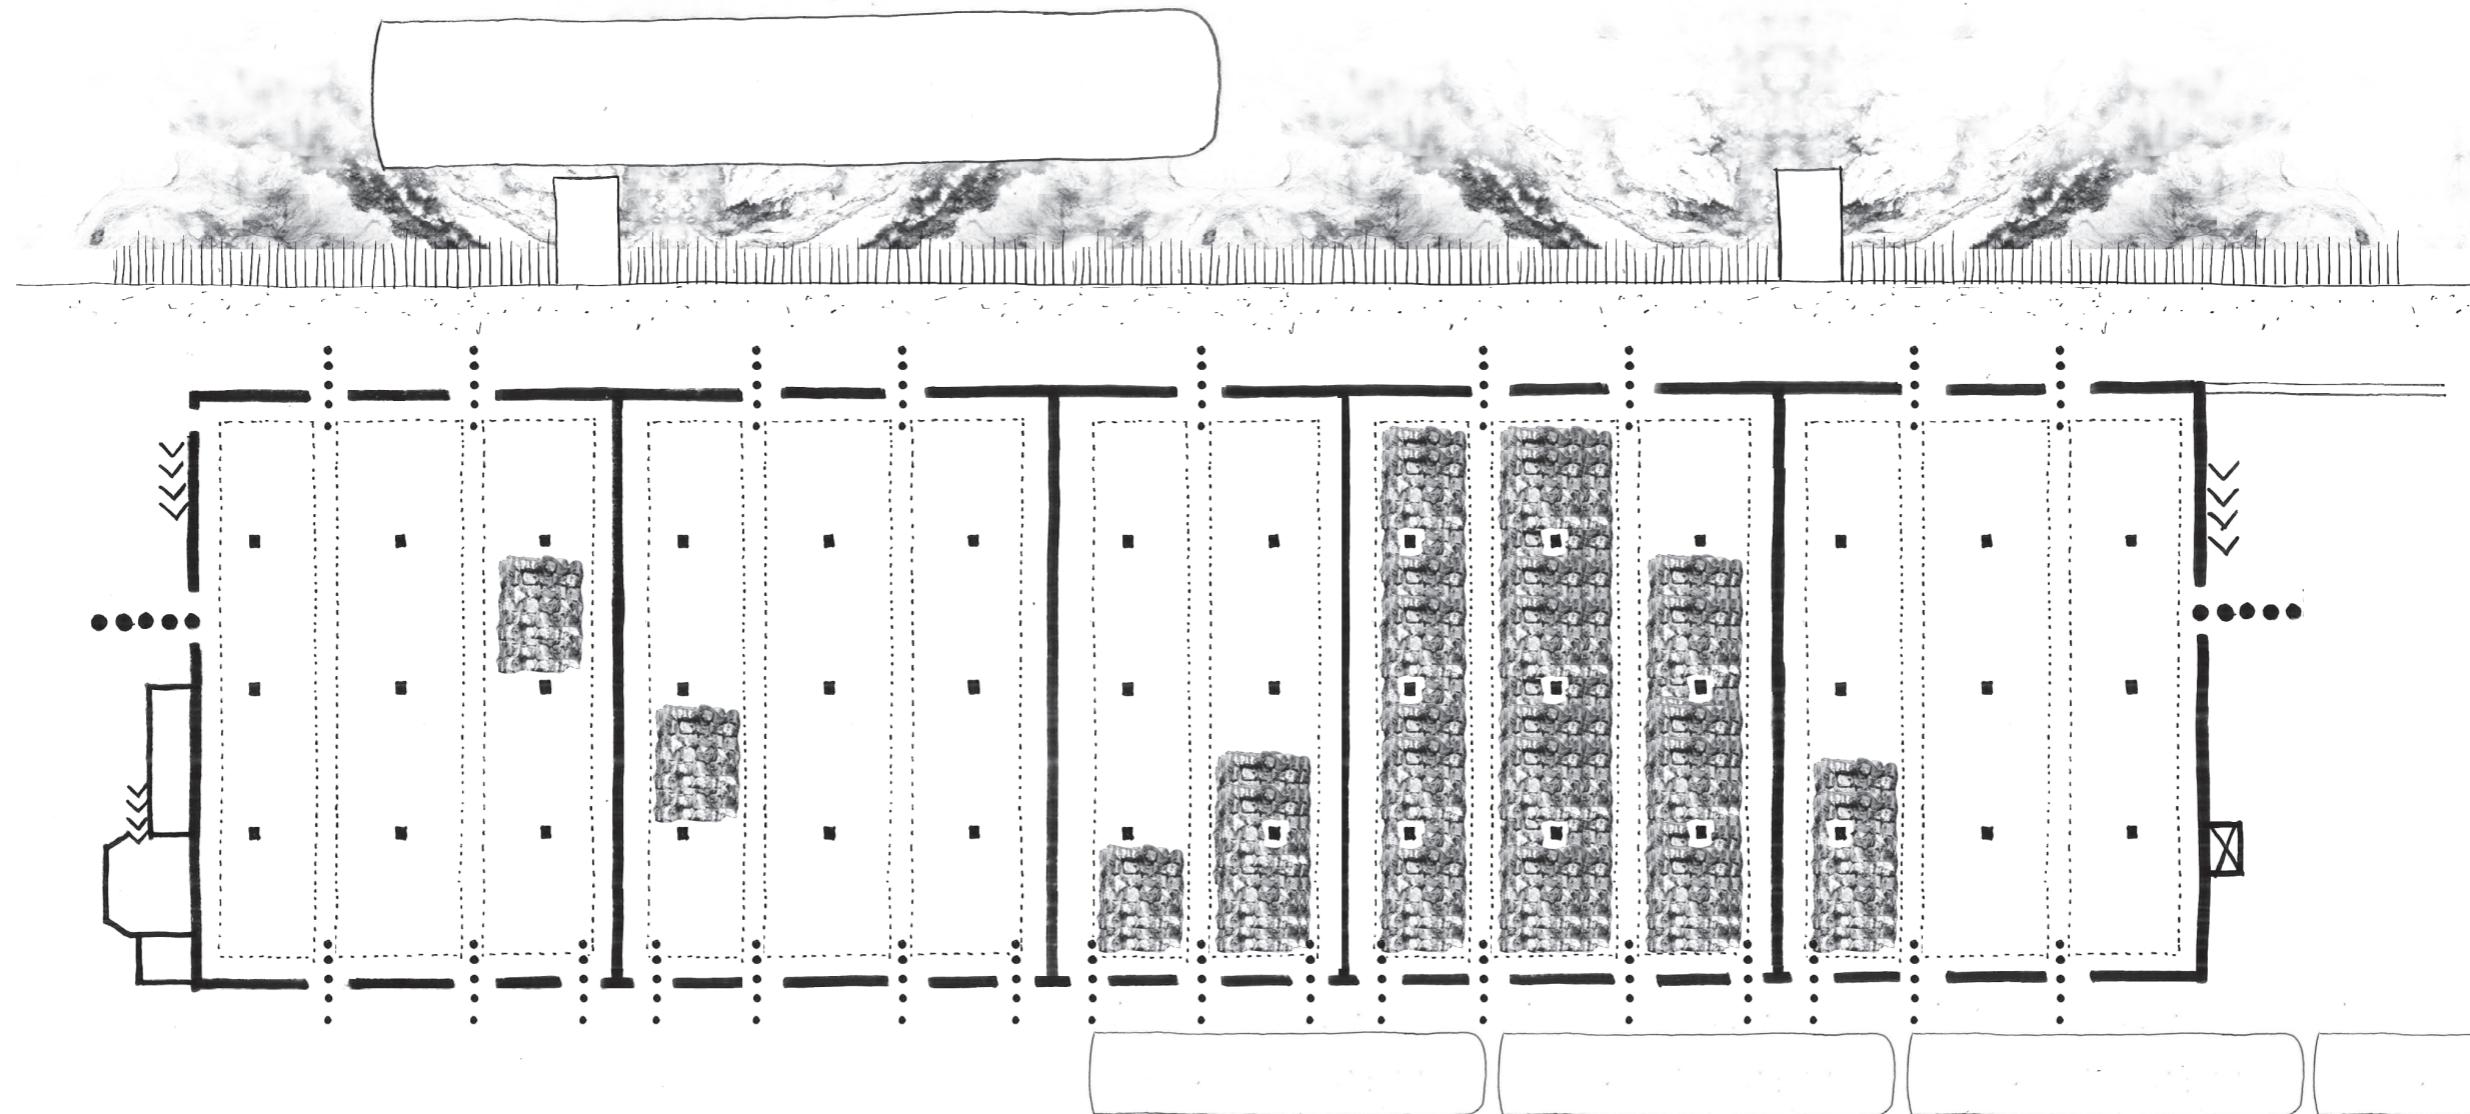
illustration 11.1 organisation and use of the ground floor by Audrey Loef
(own illustration according to plans by Huis in 't Veld, J.)

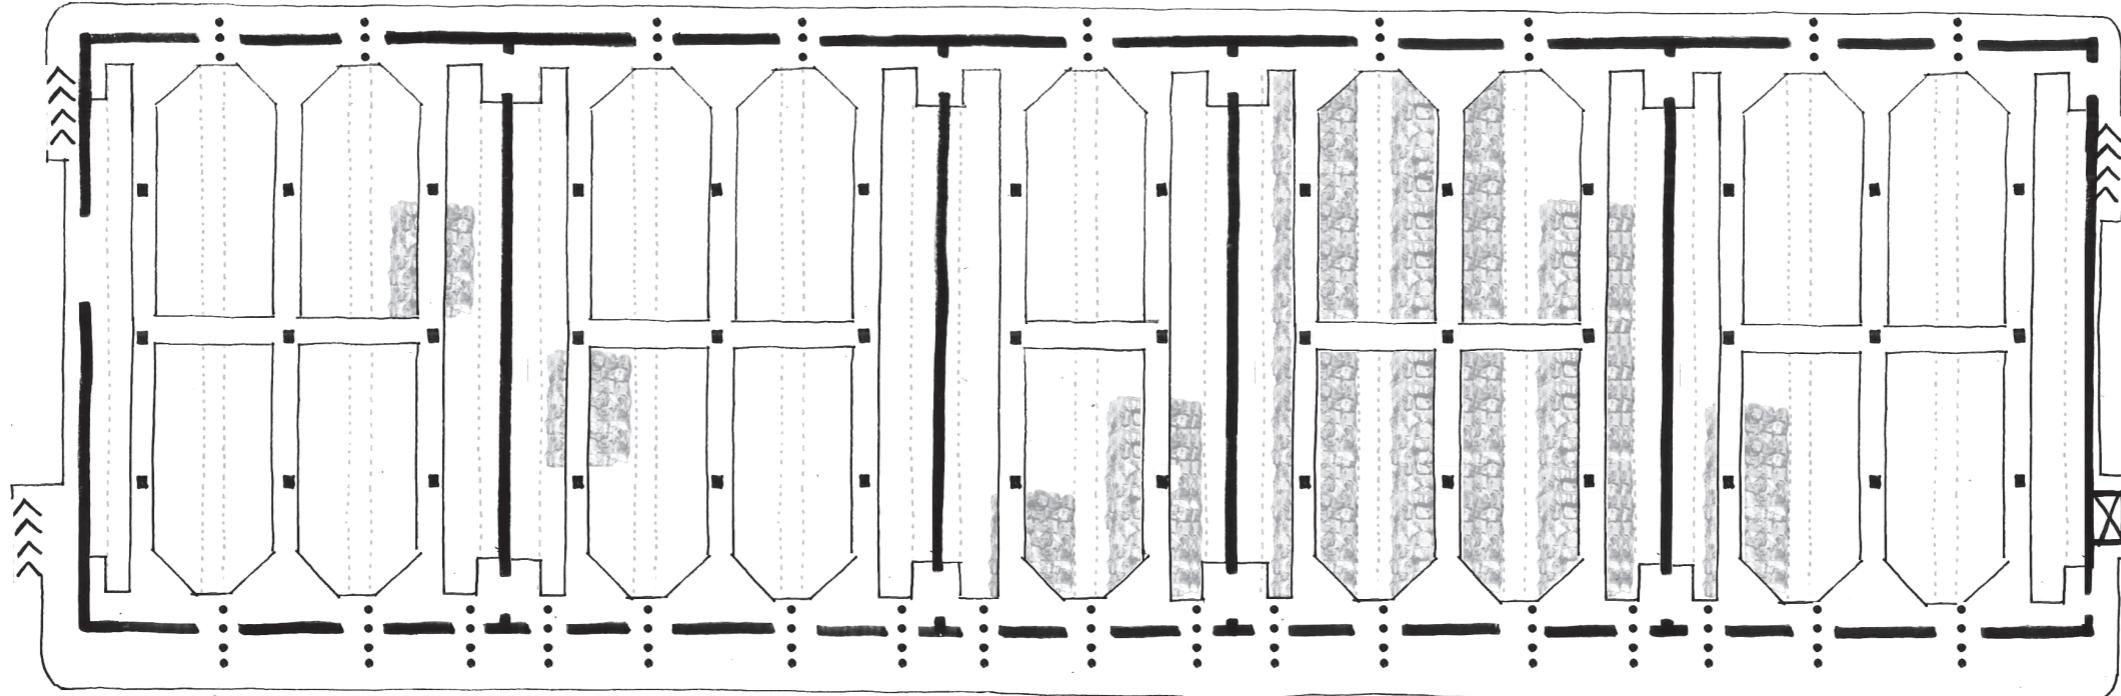
illustration 11.2 organisation and use of the first floor
illustration 11.3 tiling to indicate zoning on ground floor
by Audrey Loef (own photograph and illustration according to plans by Huis in 't Veld, J.)

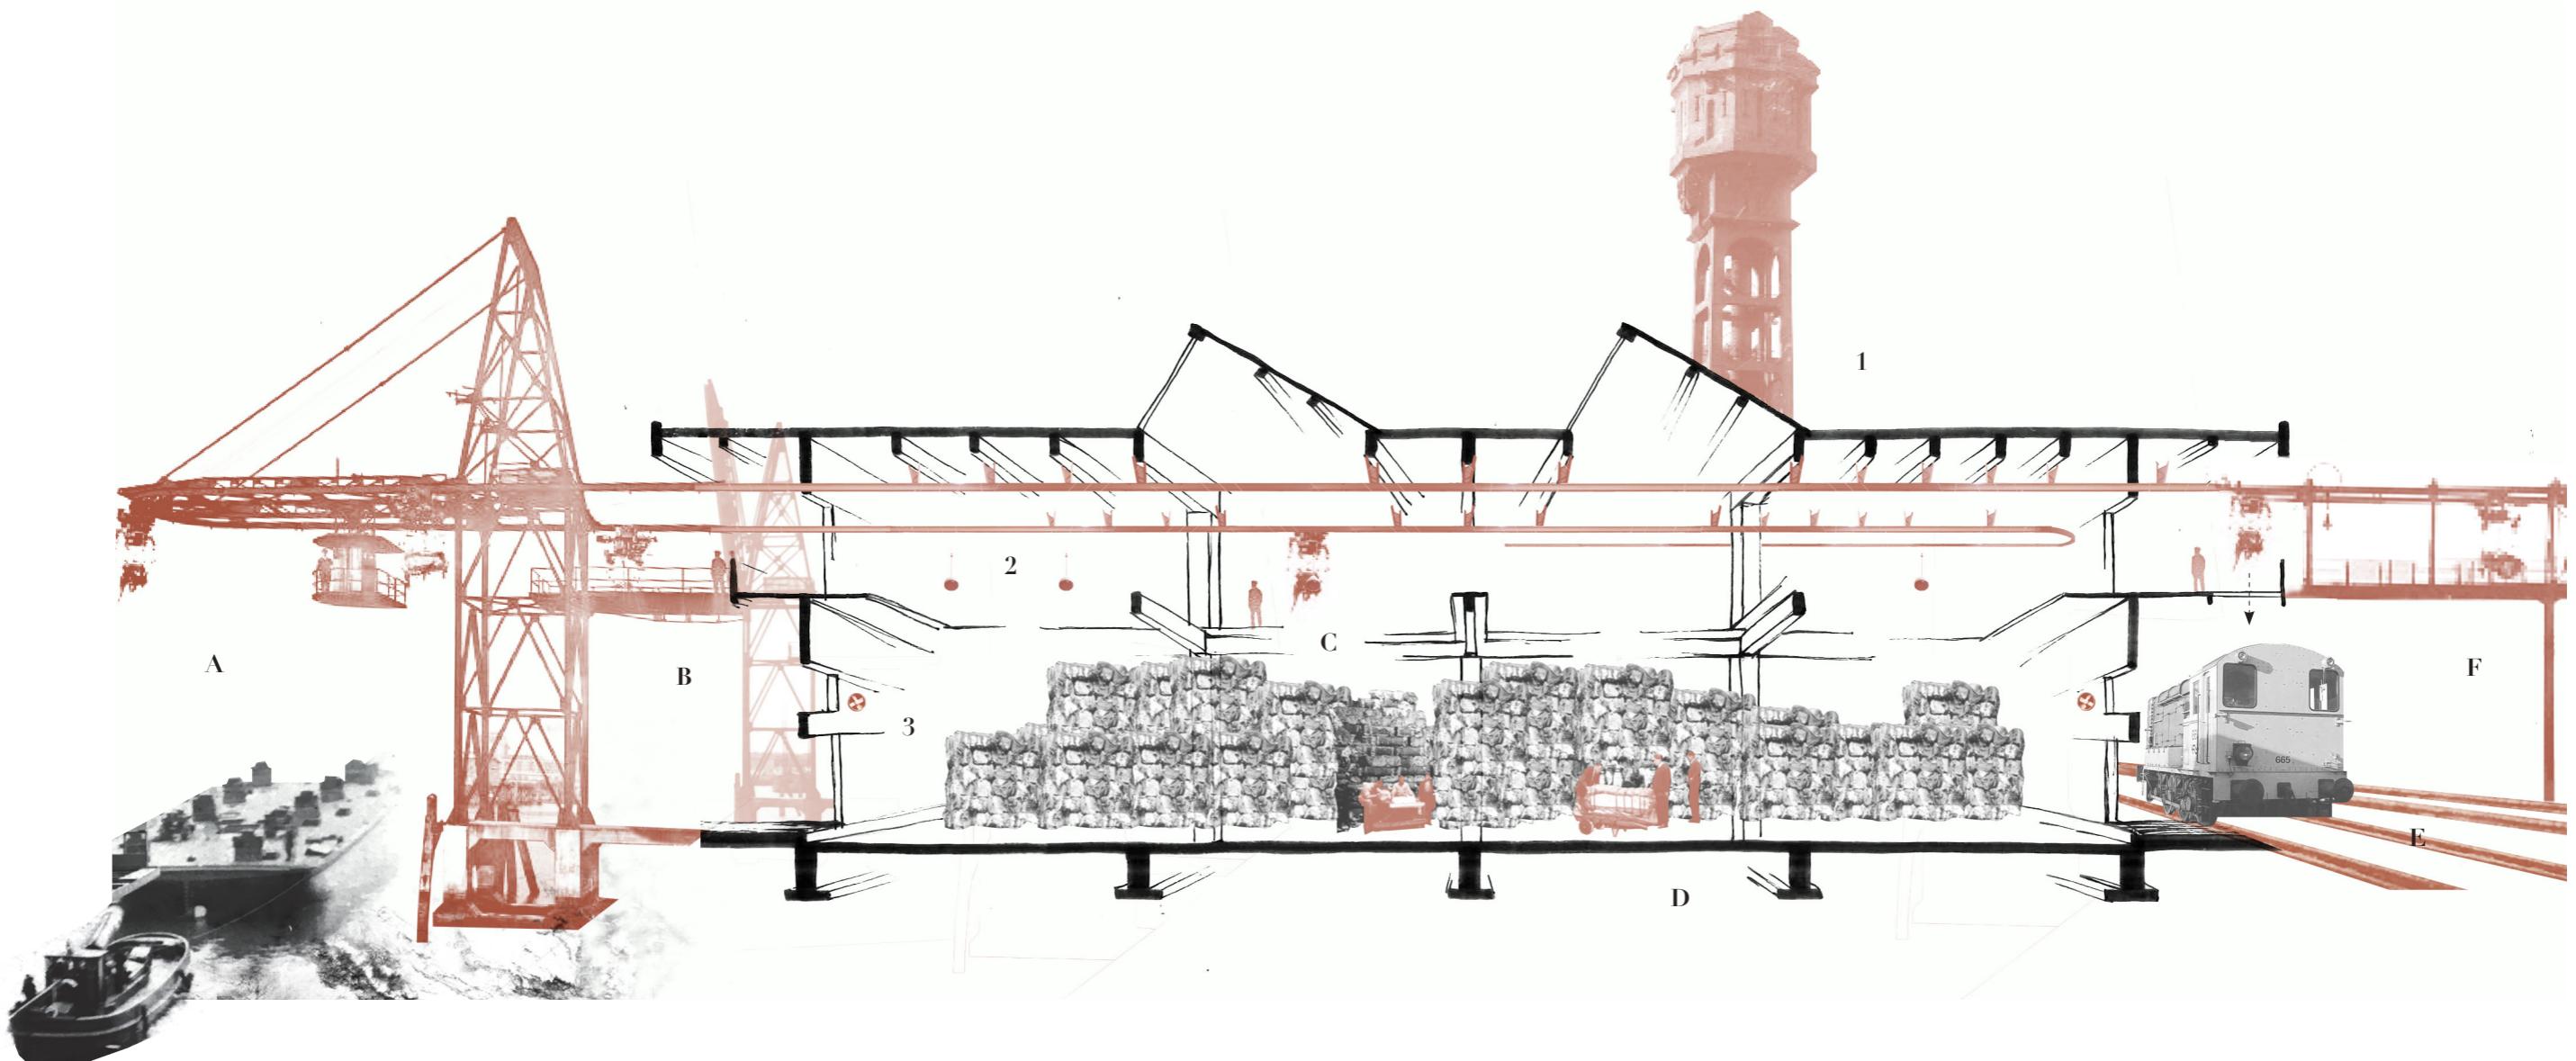
illustration 12 Impression of past functionality of the building in section by Audrey Loef
(own illustration according to The pioneer for the shipping and trade of the Netherlands and her colonies (1919) nr. 3 march, 66-69)

which was an innovative improvement. It required a water tower to keep the supply of pressured water constant along with tanks and electric pumps (1). Moveable armatures (2) provided light in every corner of the building in dusk or night periods of work. Fans rotated by wind (3) gave a soft natural breeze (?).

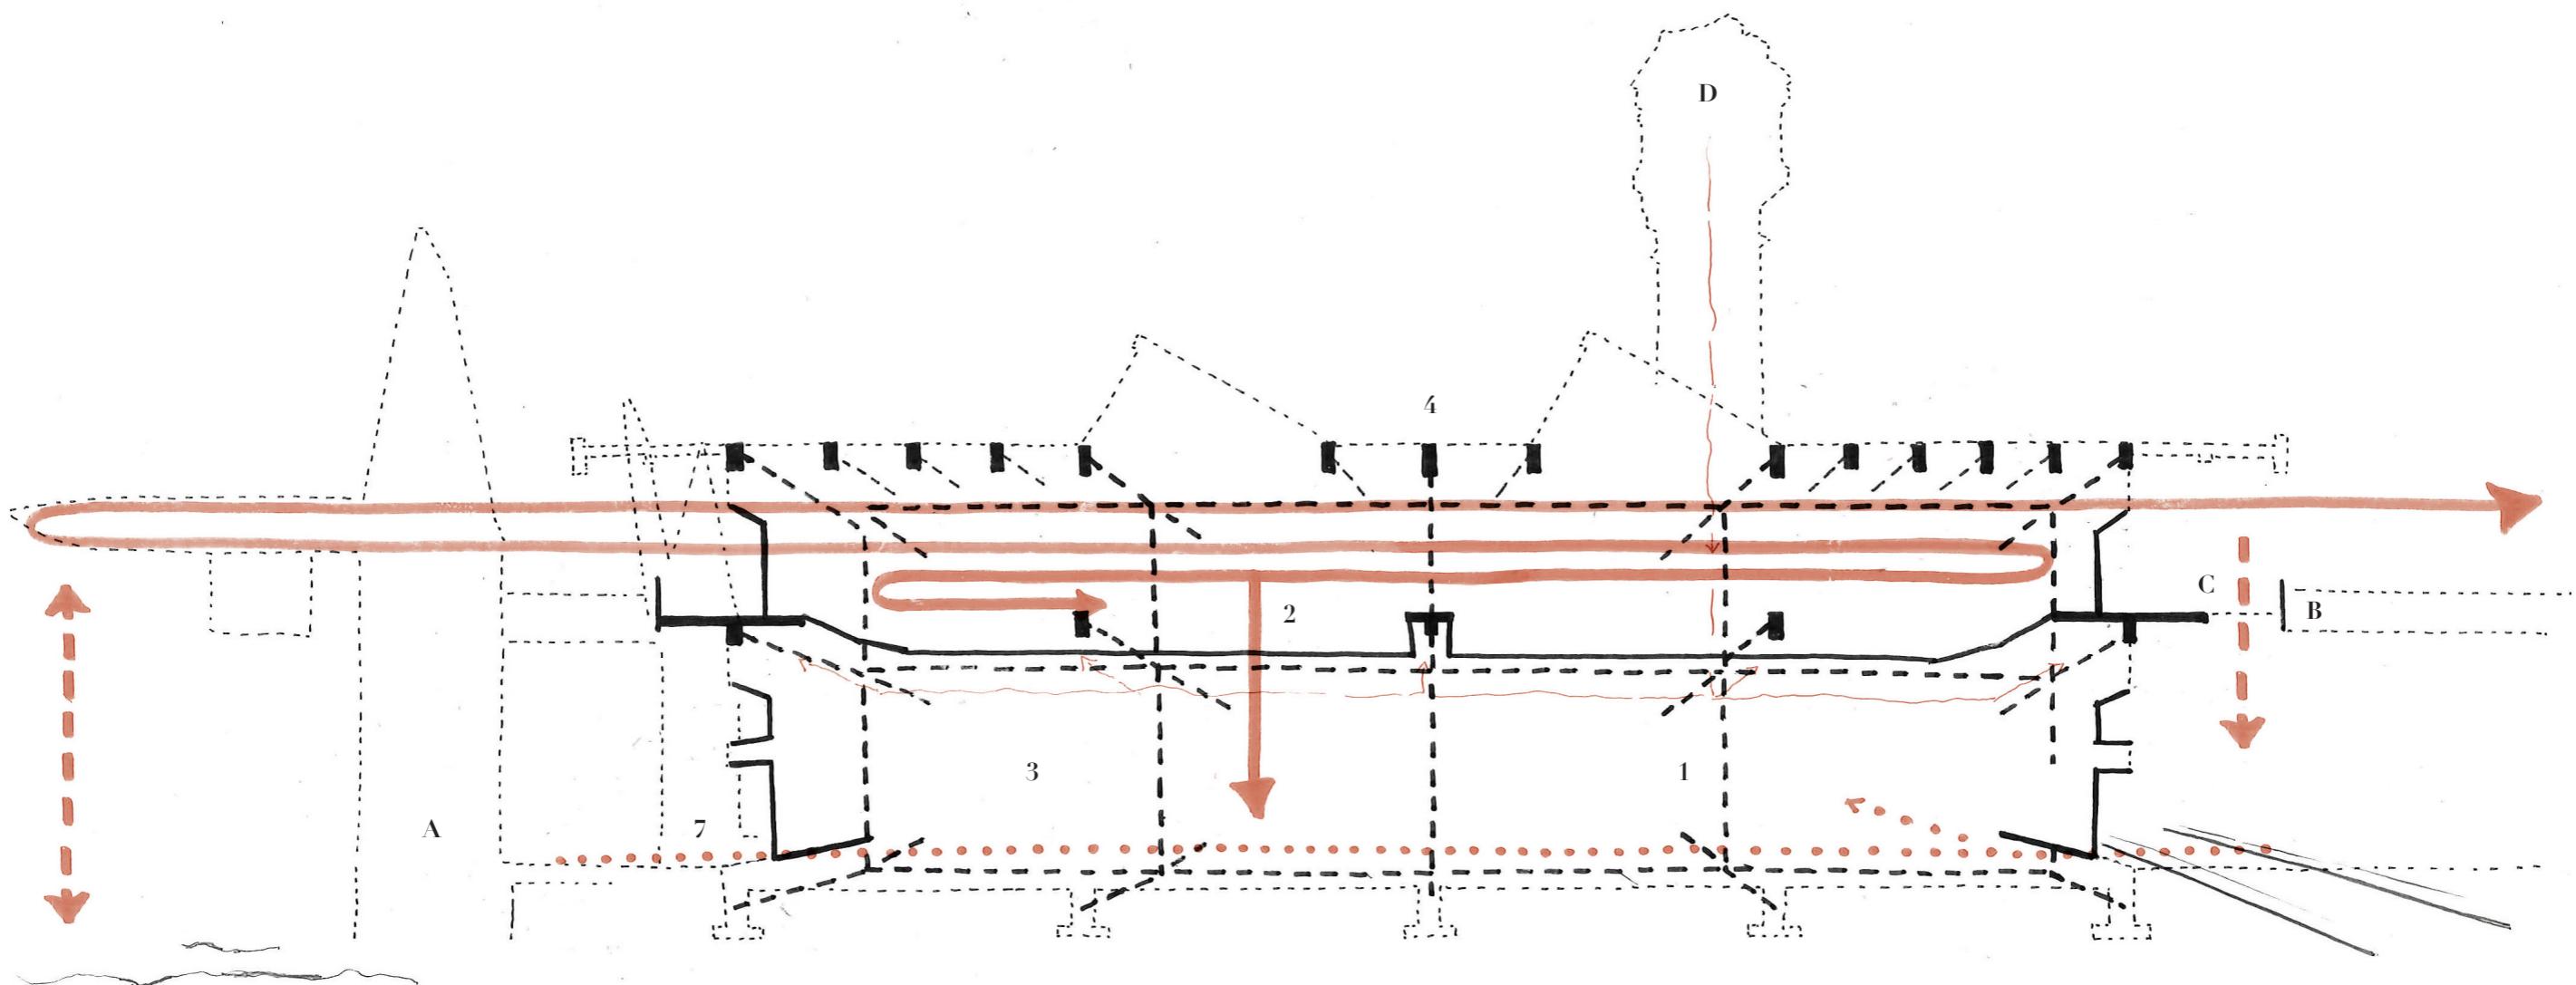
illustration 13.1 interventions on building scale to serve the functionality by Audrey Loef
(own illustration)

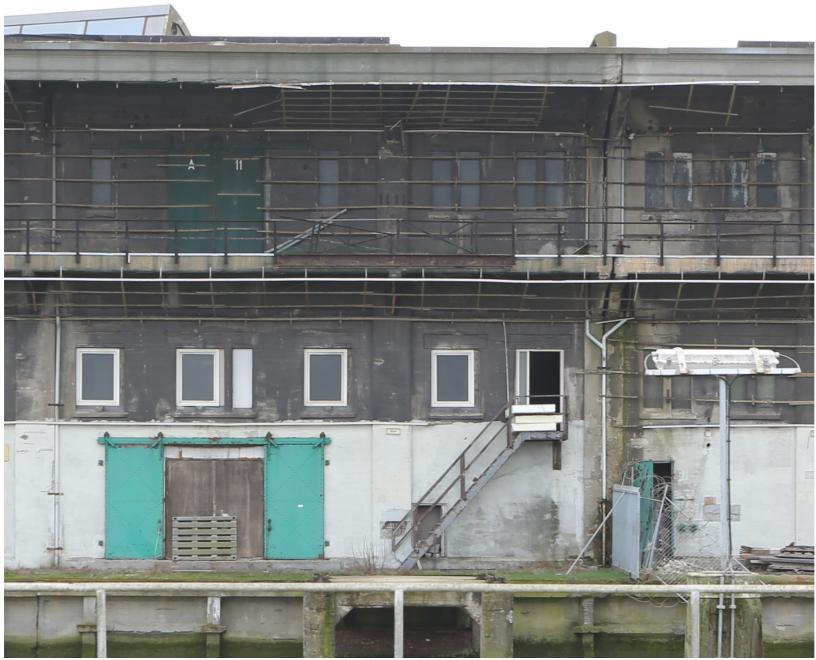
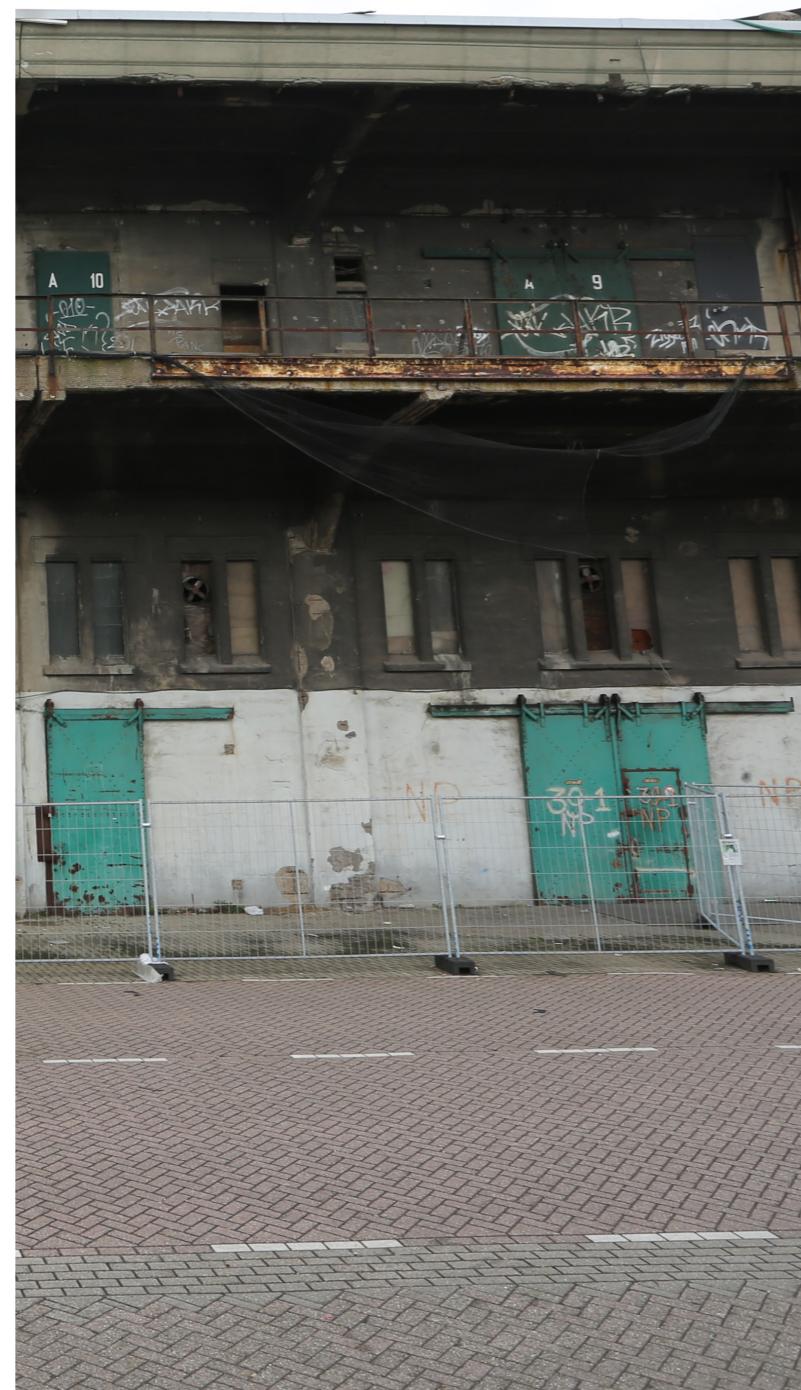
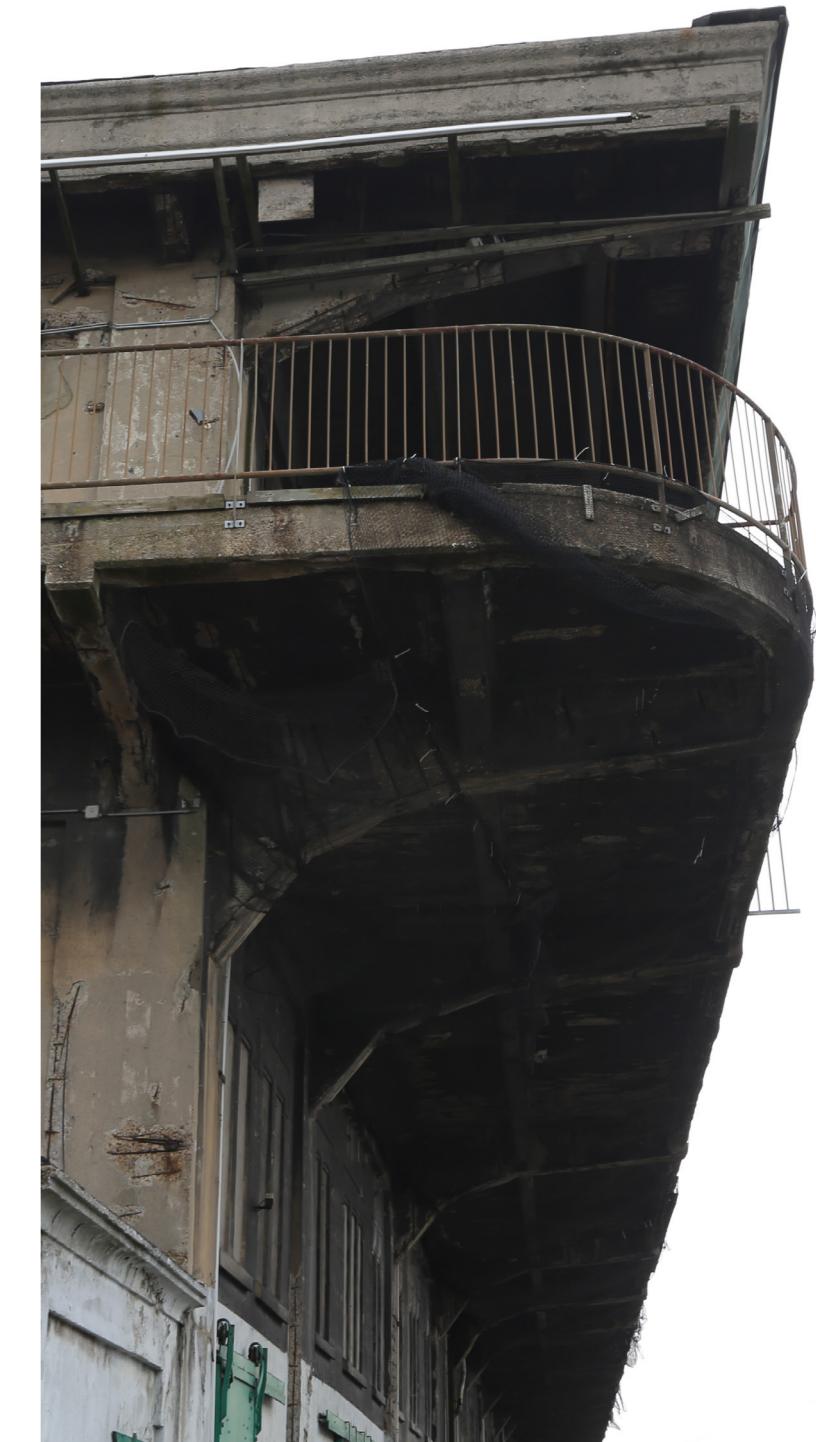
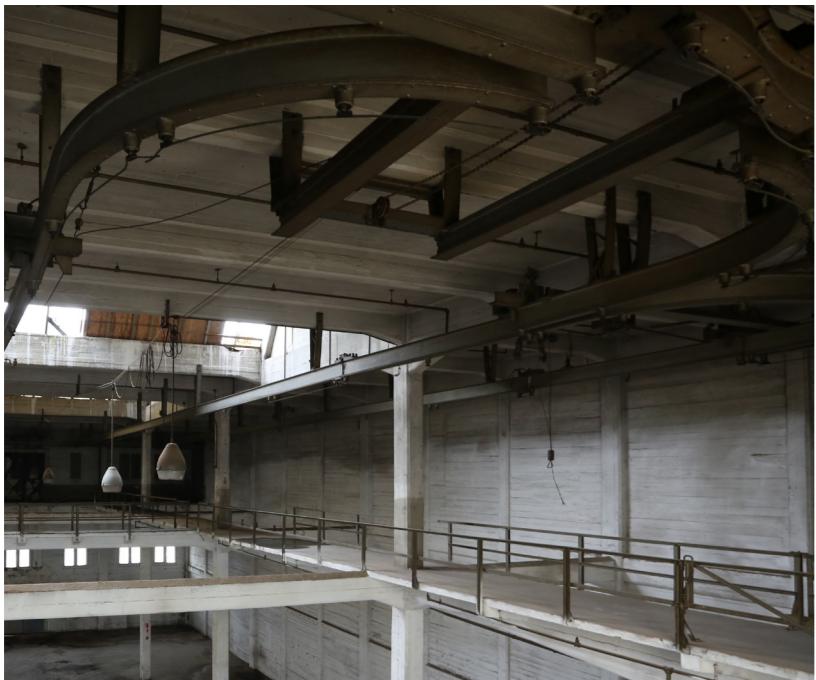
illustration 13.2 Traces of the added structures onto the galleries, carriage of the conveyor system and holes in the balconies to transfer towards goods-trains by Audrey Loef
(own illustration according to photographs by Xihao Yi)

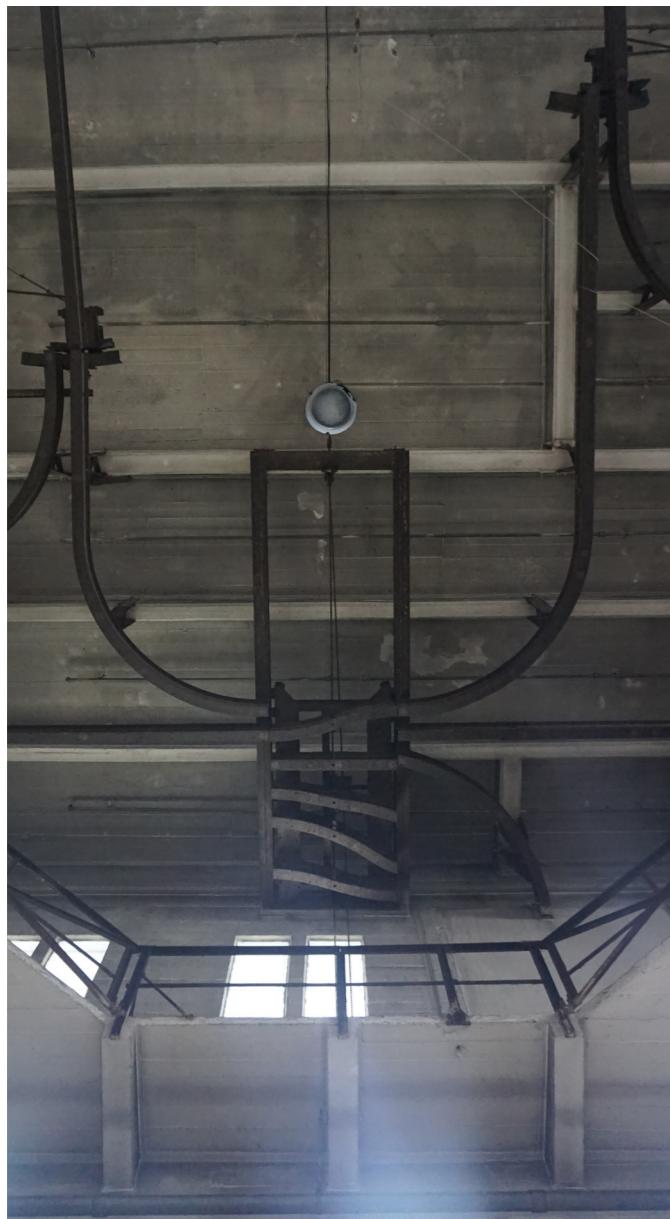
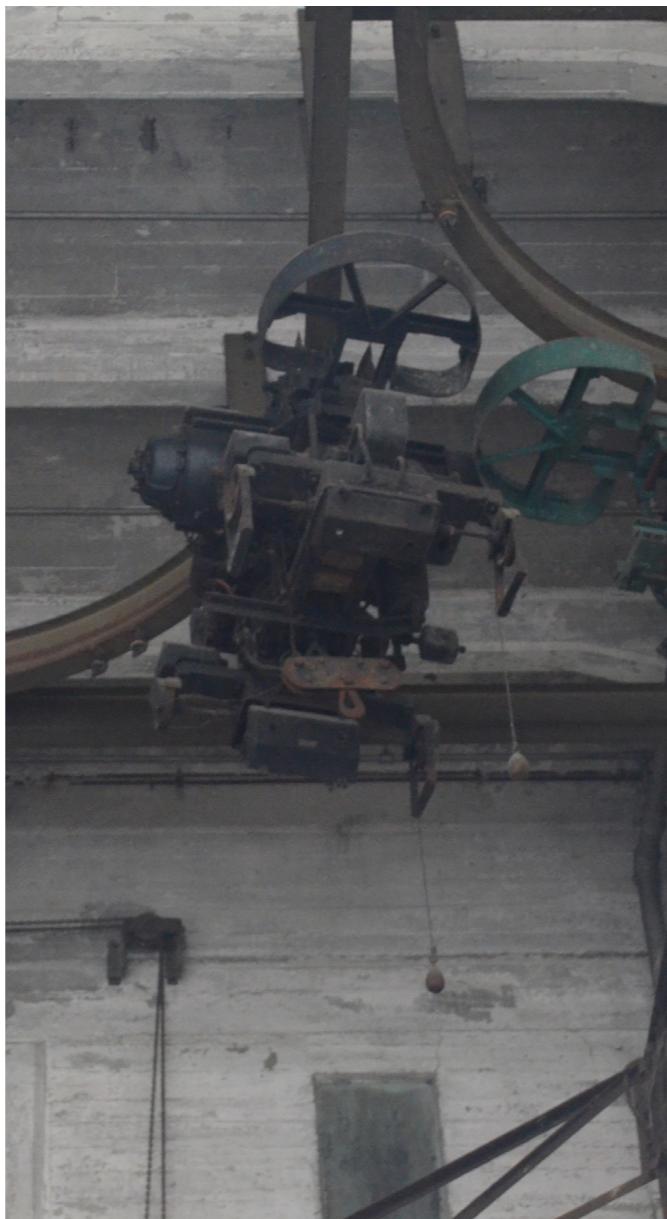
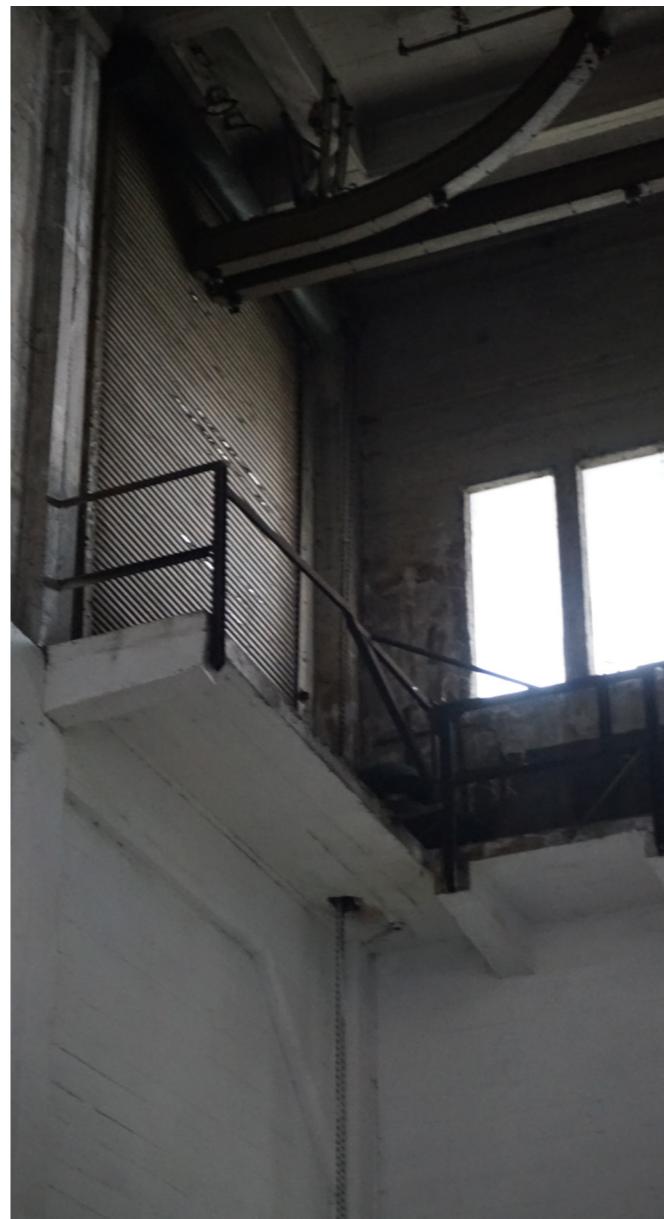
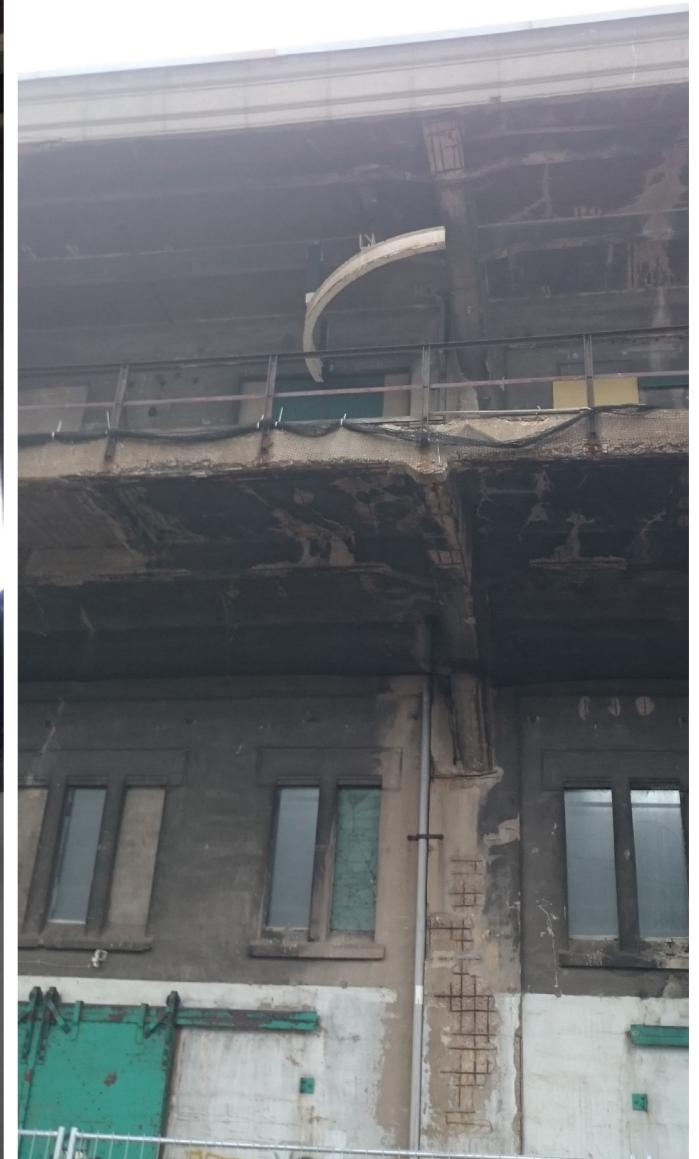
illustration 2,3,4&5 by Elmer
(source: personal photographs)

These images show the conveyor system as it currently is in the Katoenveem. The second image shows a actual traveller of which several still remain inside the building. These travellers were powered via electrical cables that ran underneath the I-beams. In most places this electrical system is no longer in place. However the I-beams themselves are still in the original place.

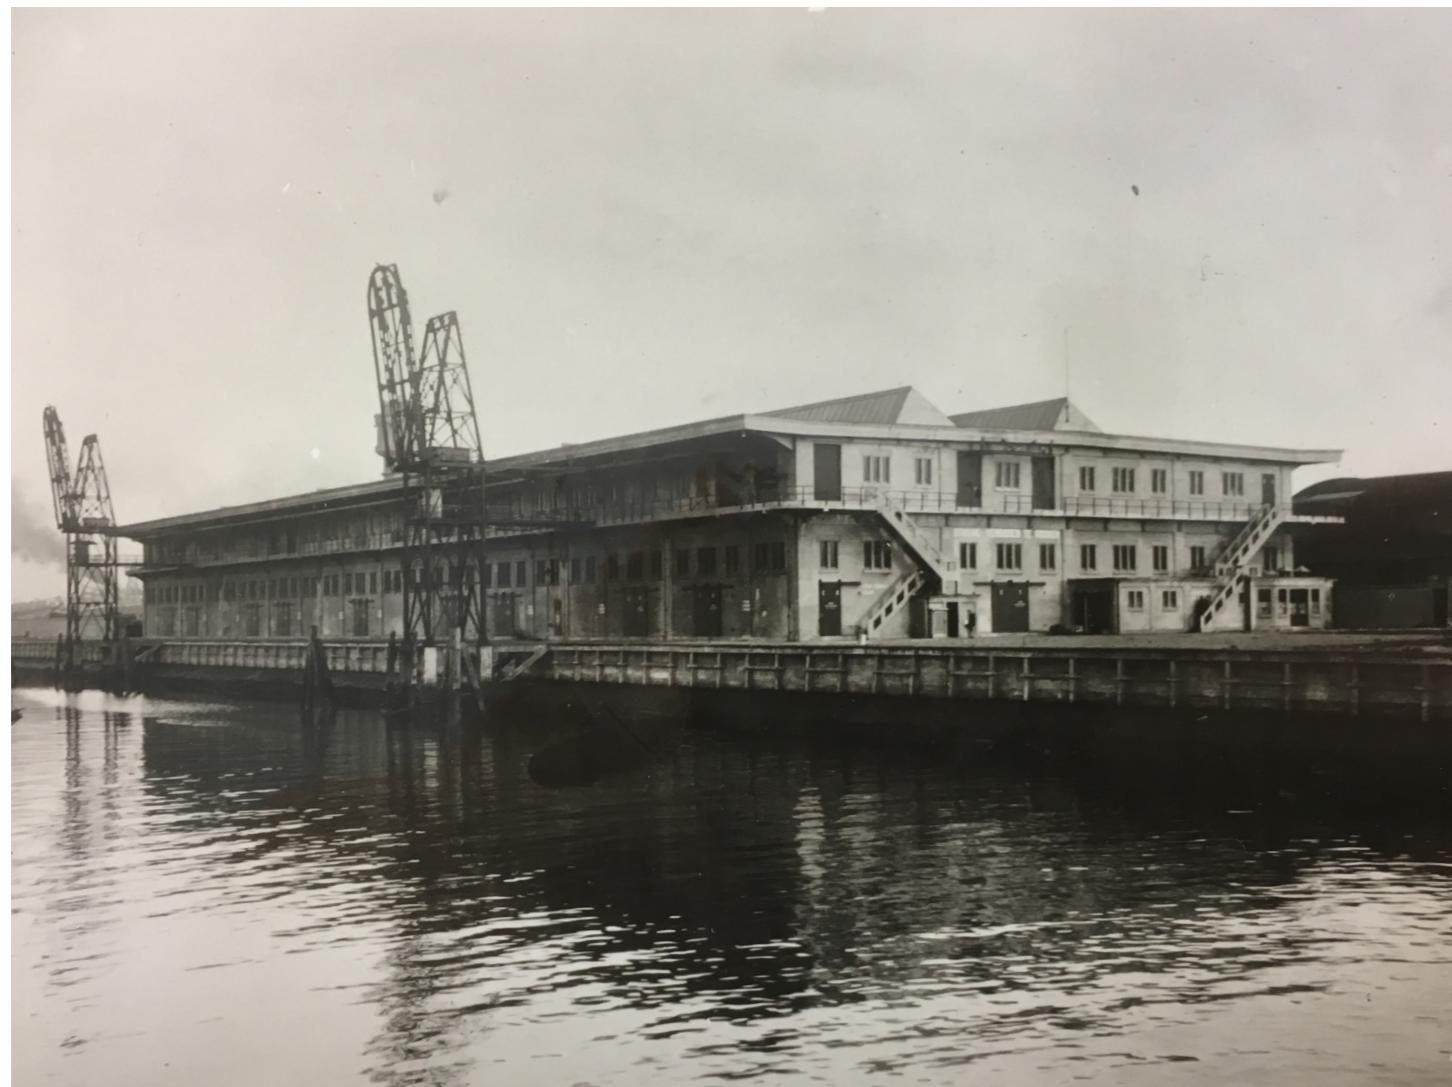
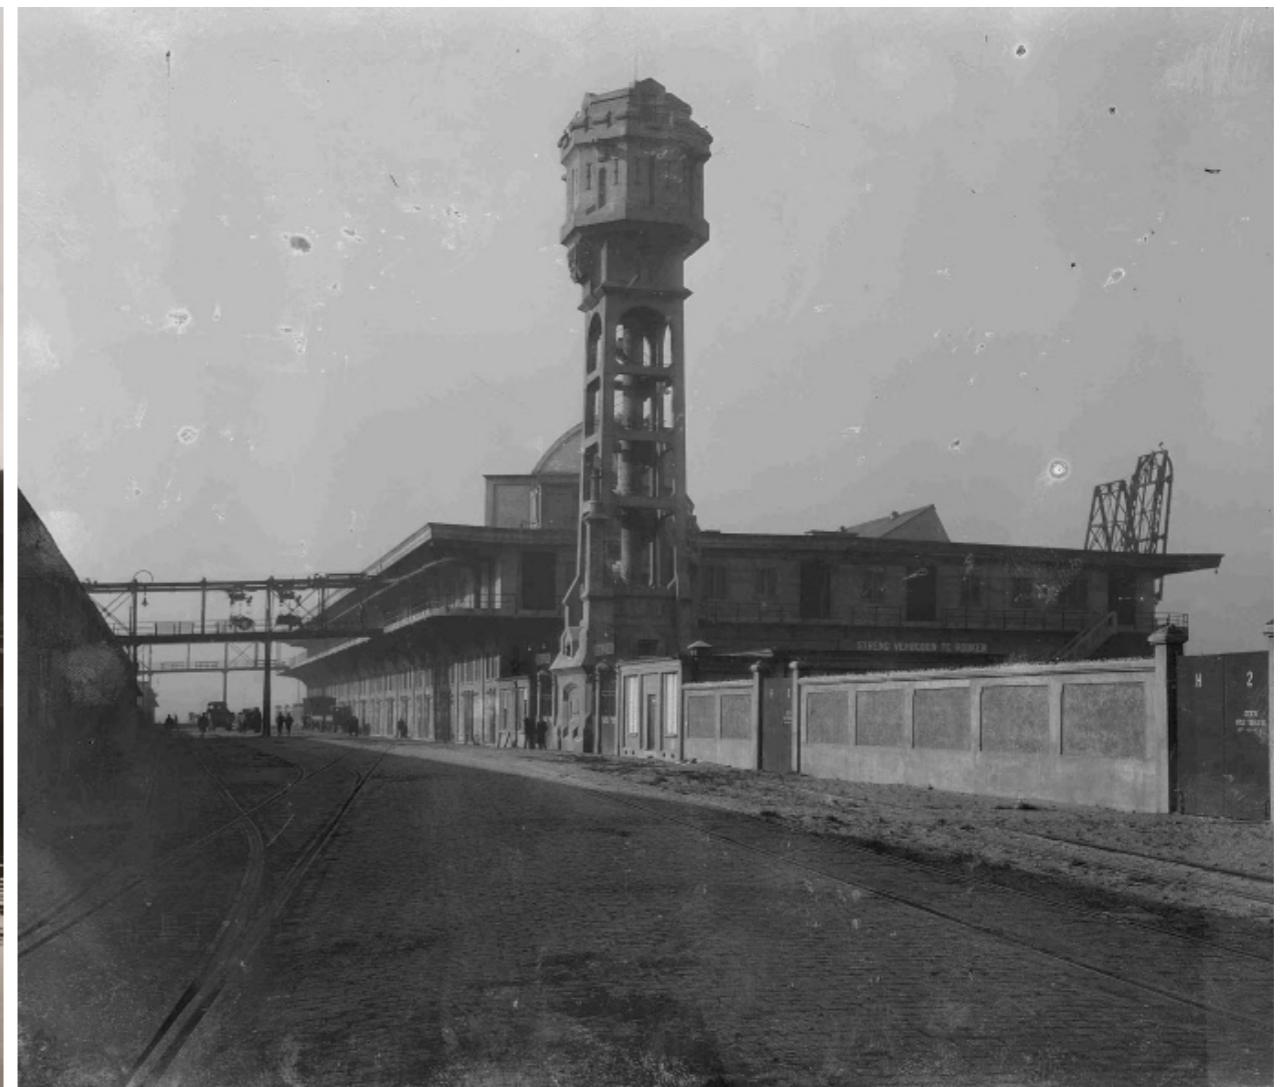
Photographs showing the original state of the conveyor system
(Images owned by Municipal Archive Rotterdam)

On the next page, two original photograph taken shortly after completion in 1920, show the original state of the conveyor system.
