KATOENVEEM

MSc III Heritage & Architecture

Architectural & Building Technology Analysis

07/04/2017

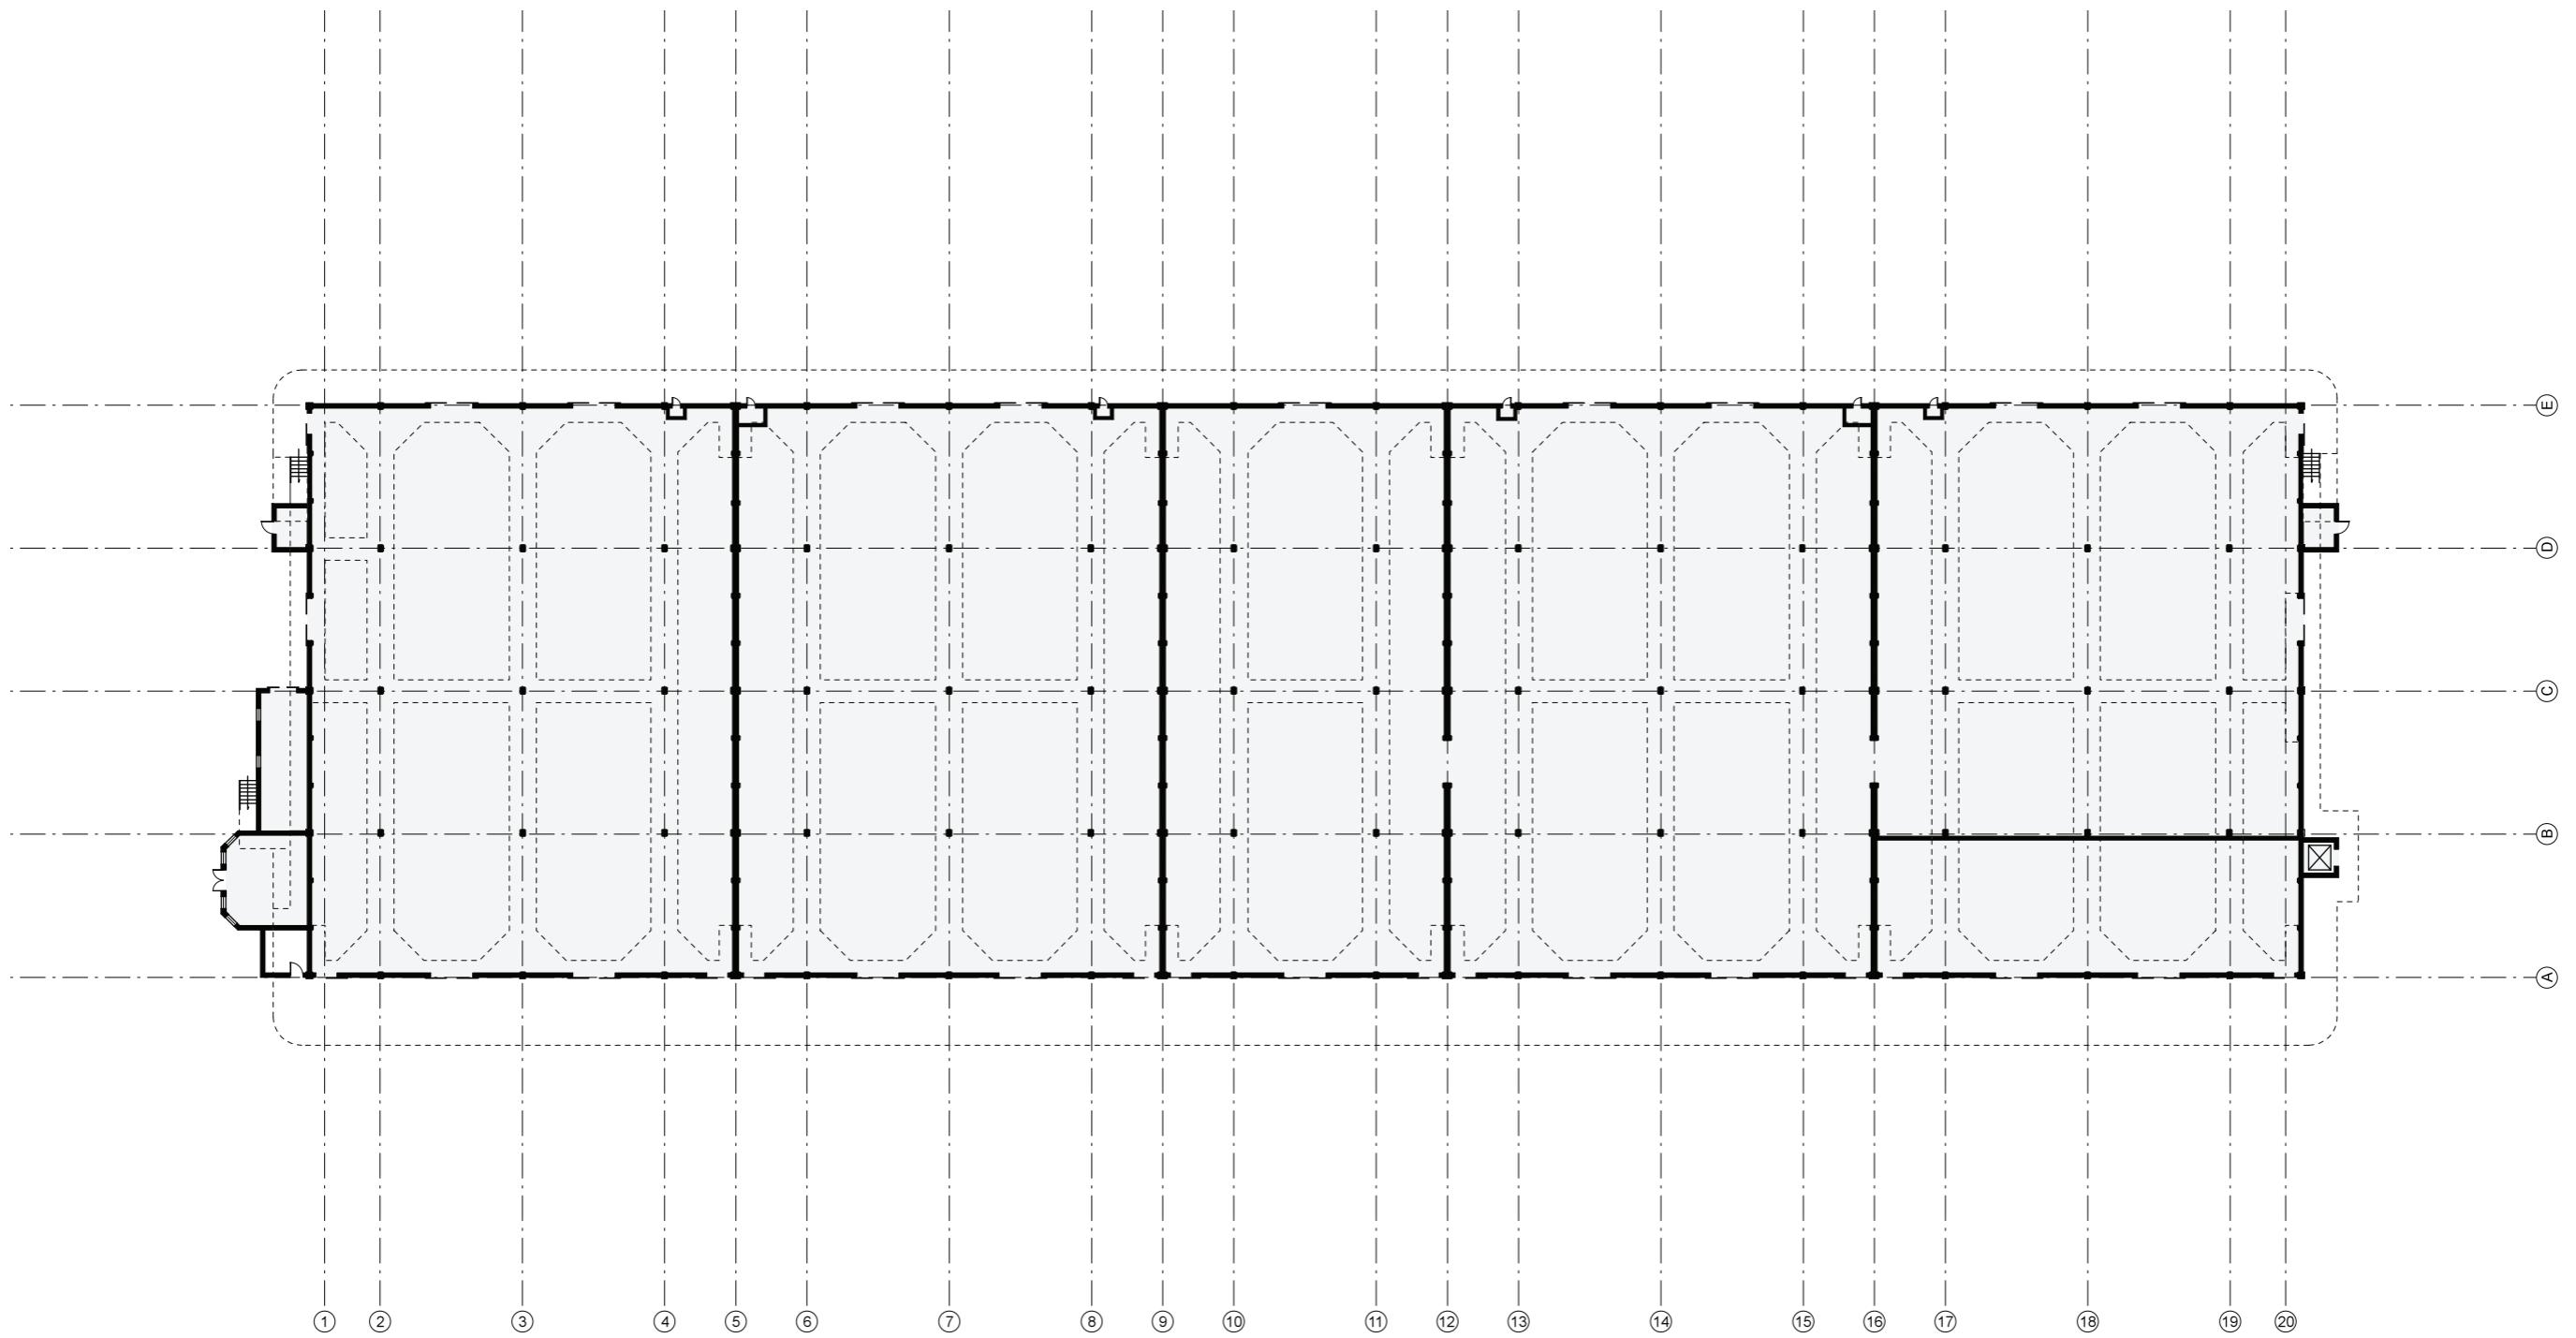
ground floor plan by Jan Huis in 't Veld
(own illustration)

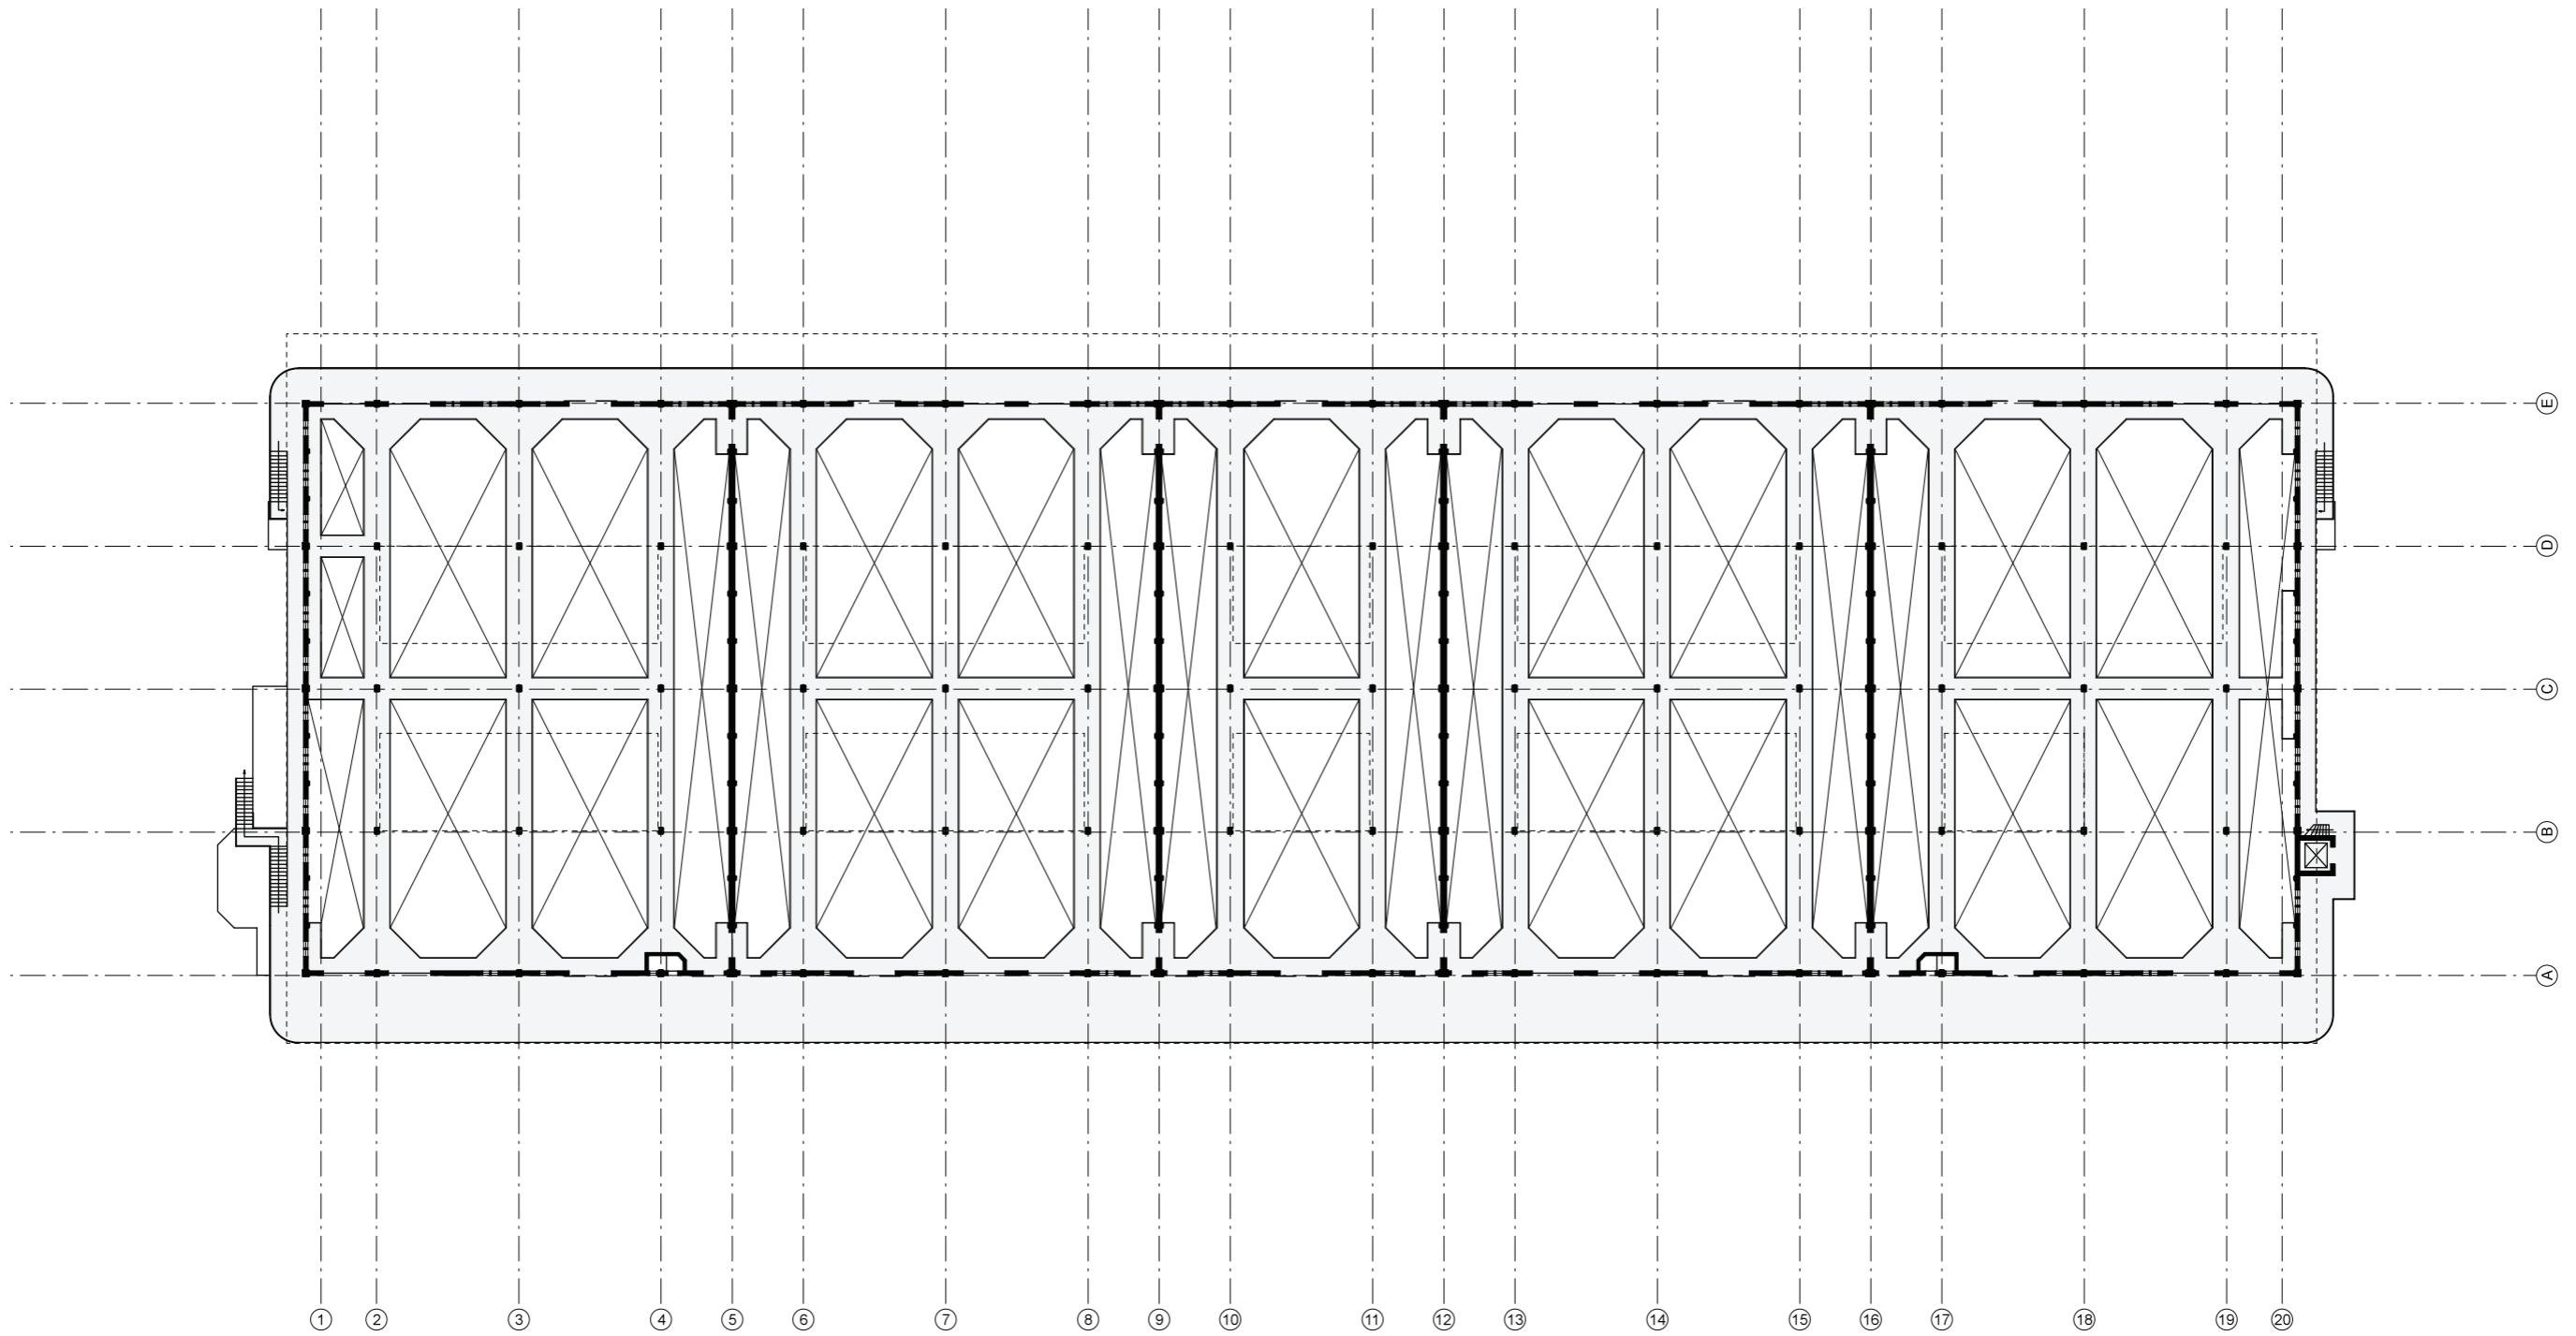
first floor plan by Jan Huis in 't Veld
(own illustration)

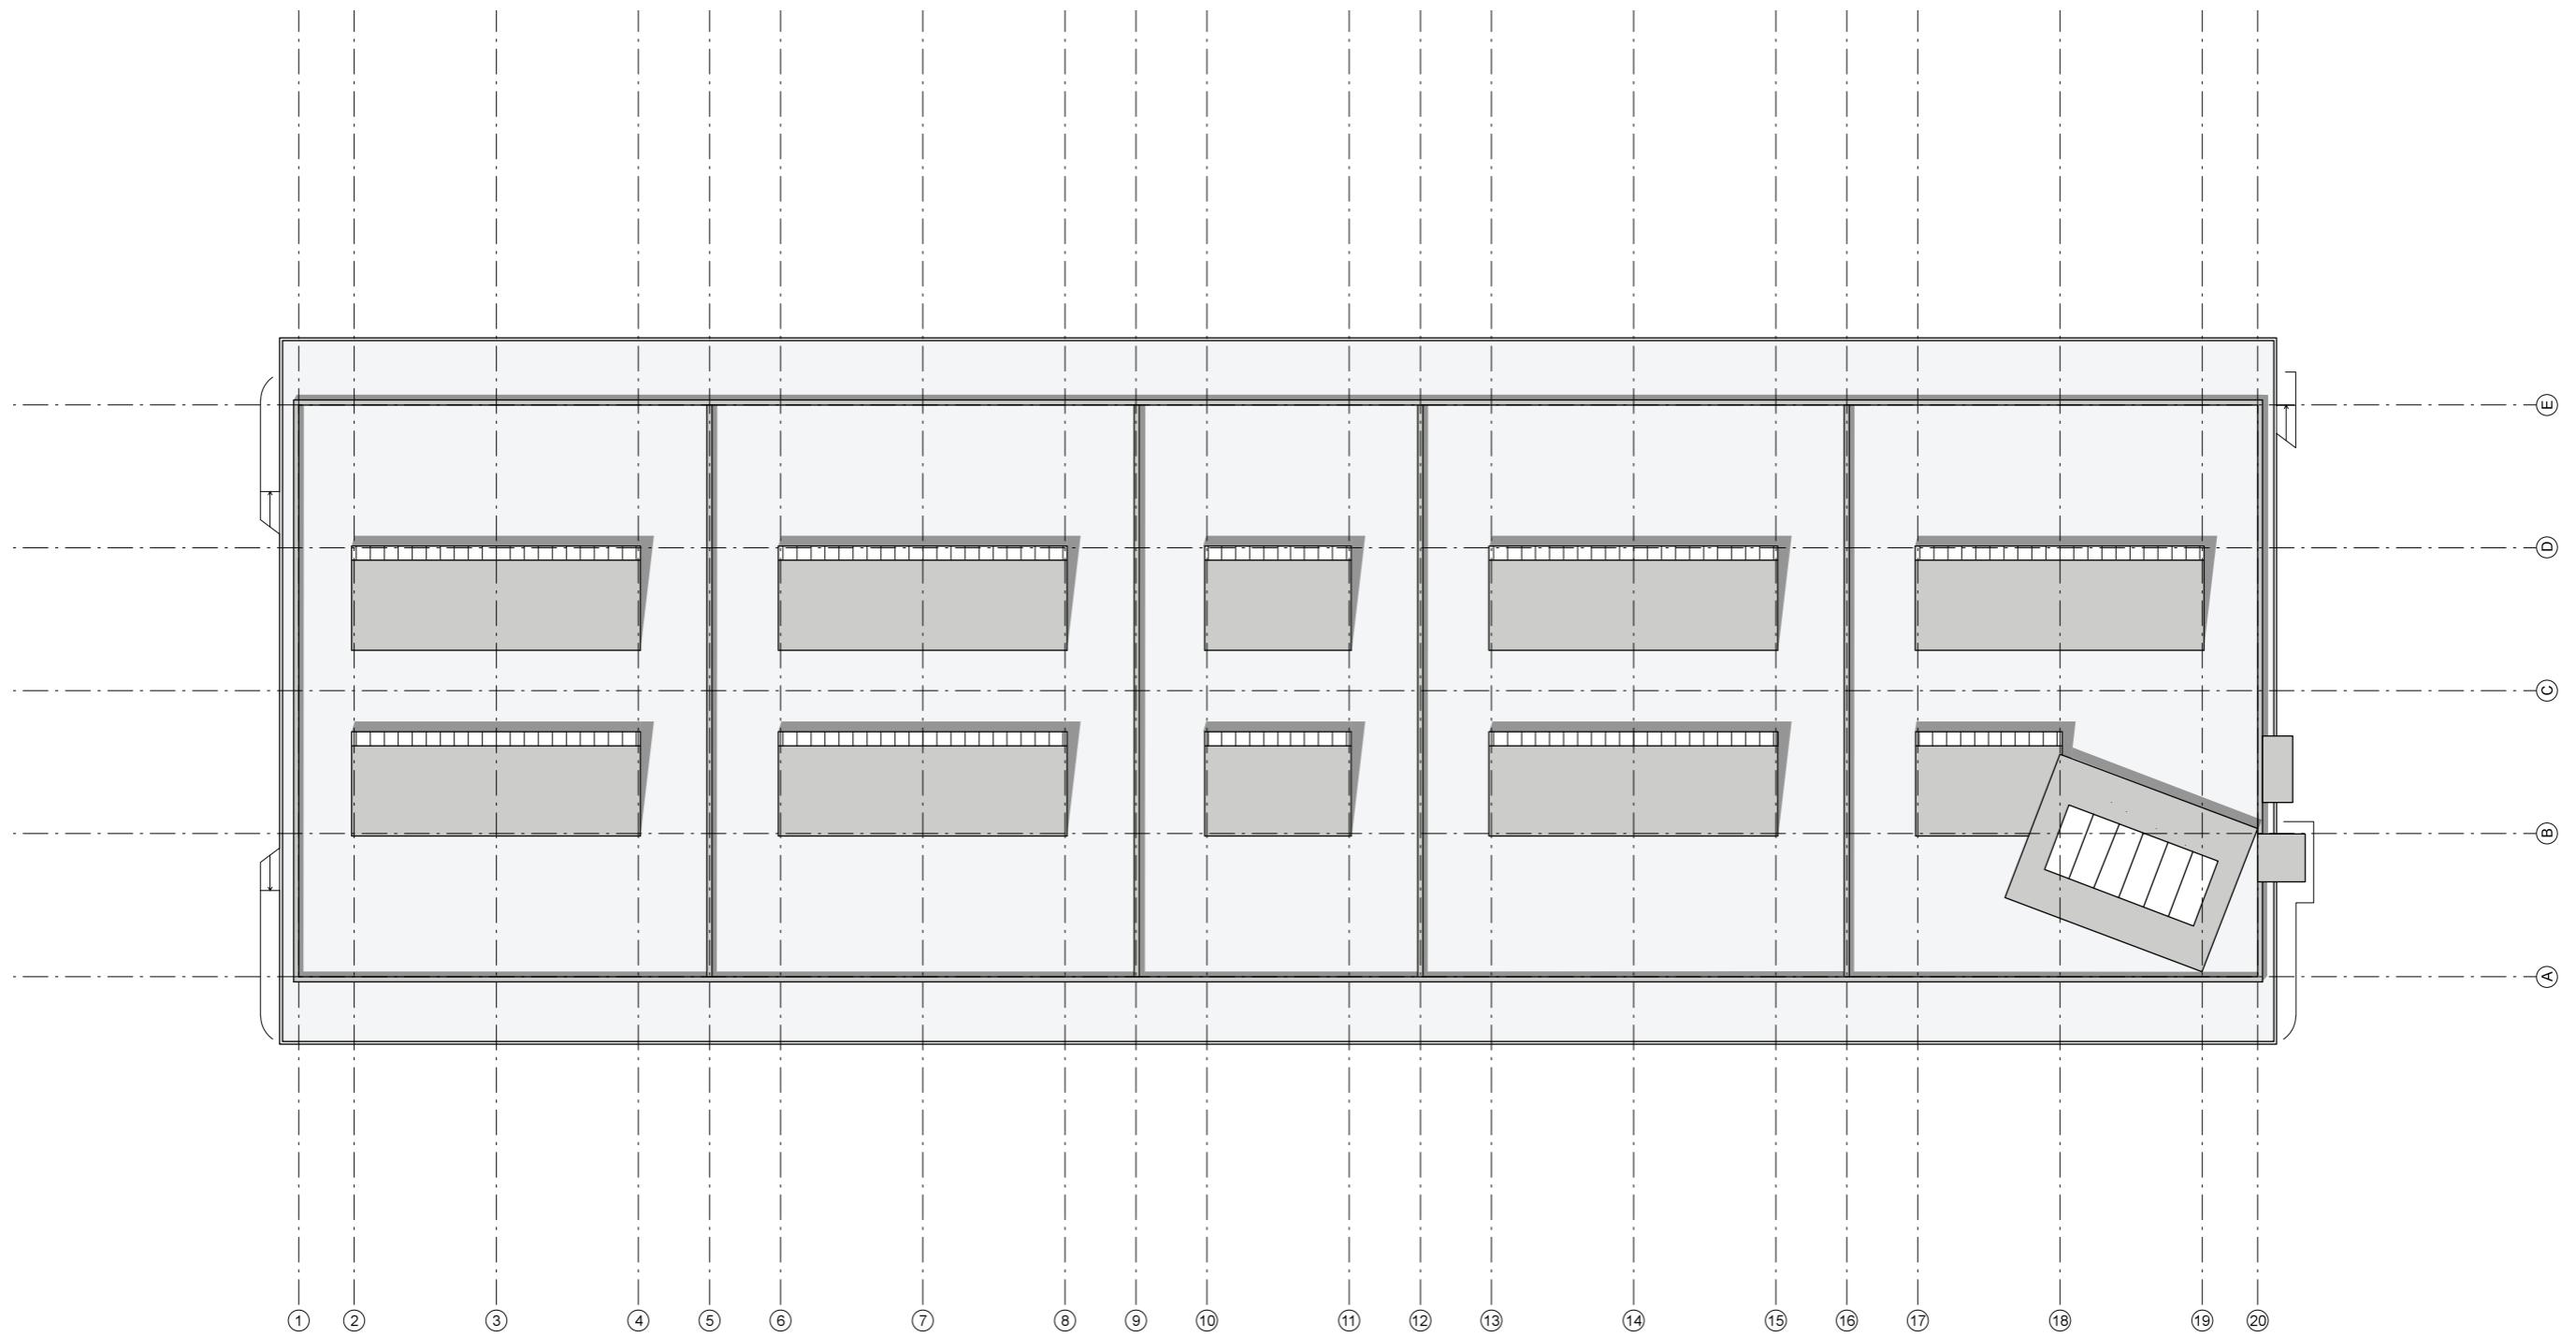
roof plan by Jan Huis in 't Veld
(own illustration)

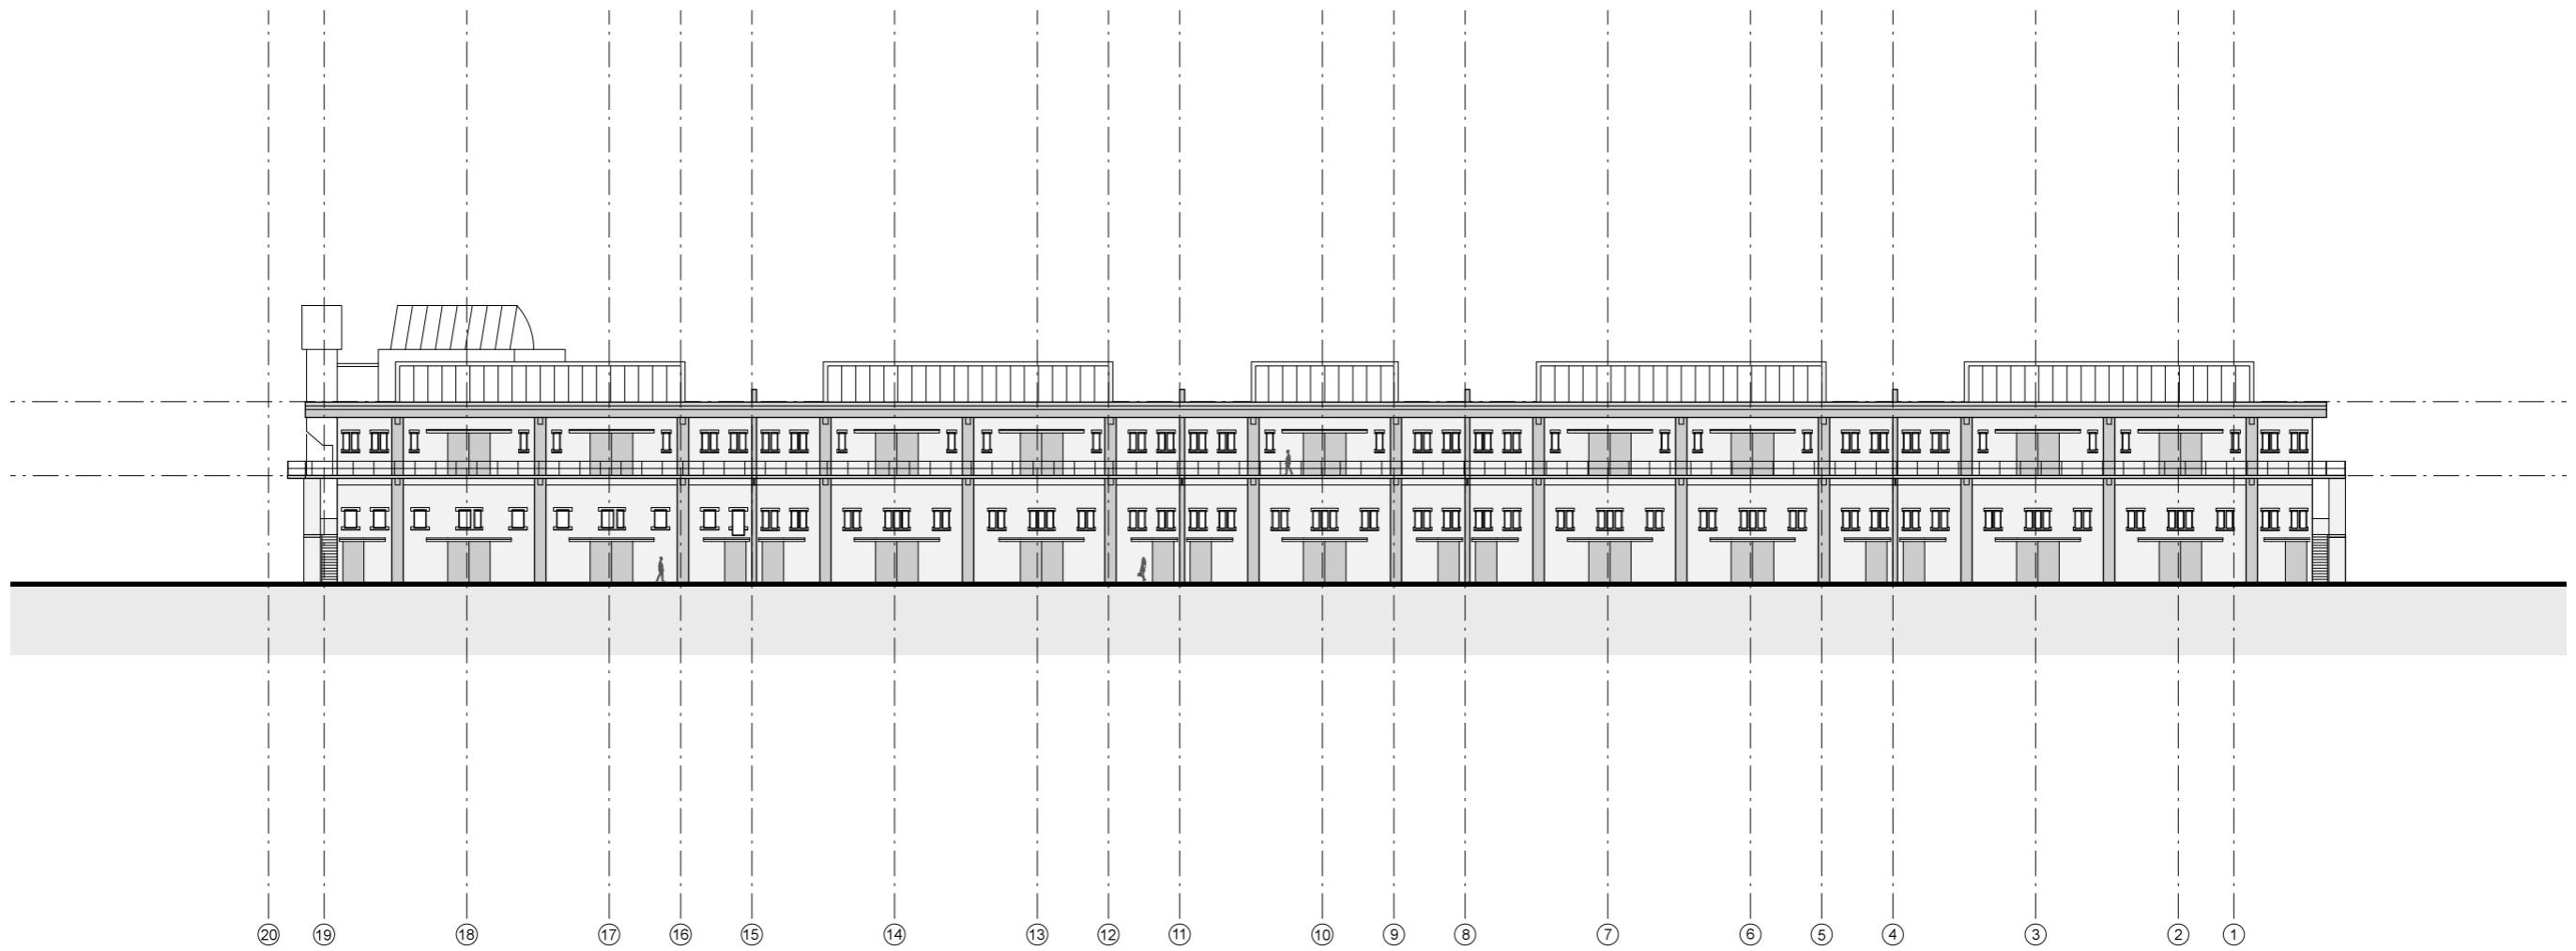
*north facade elevation by Jan Huis in 't Veld
(own illustration)*

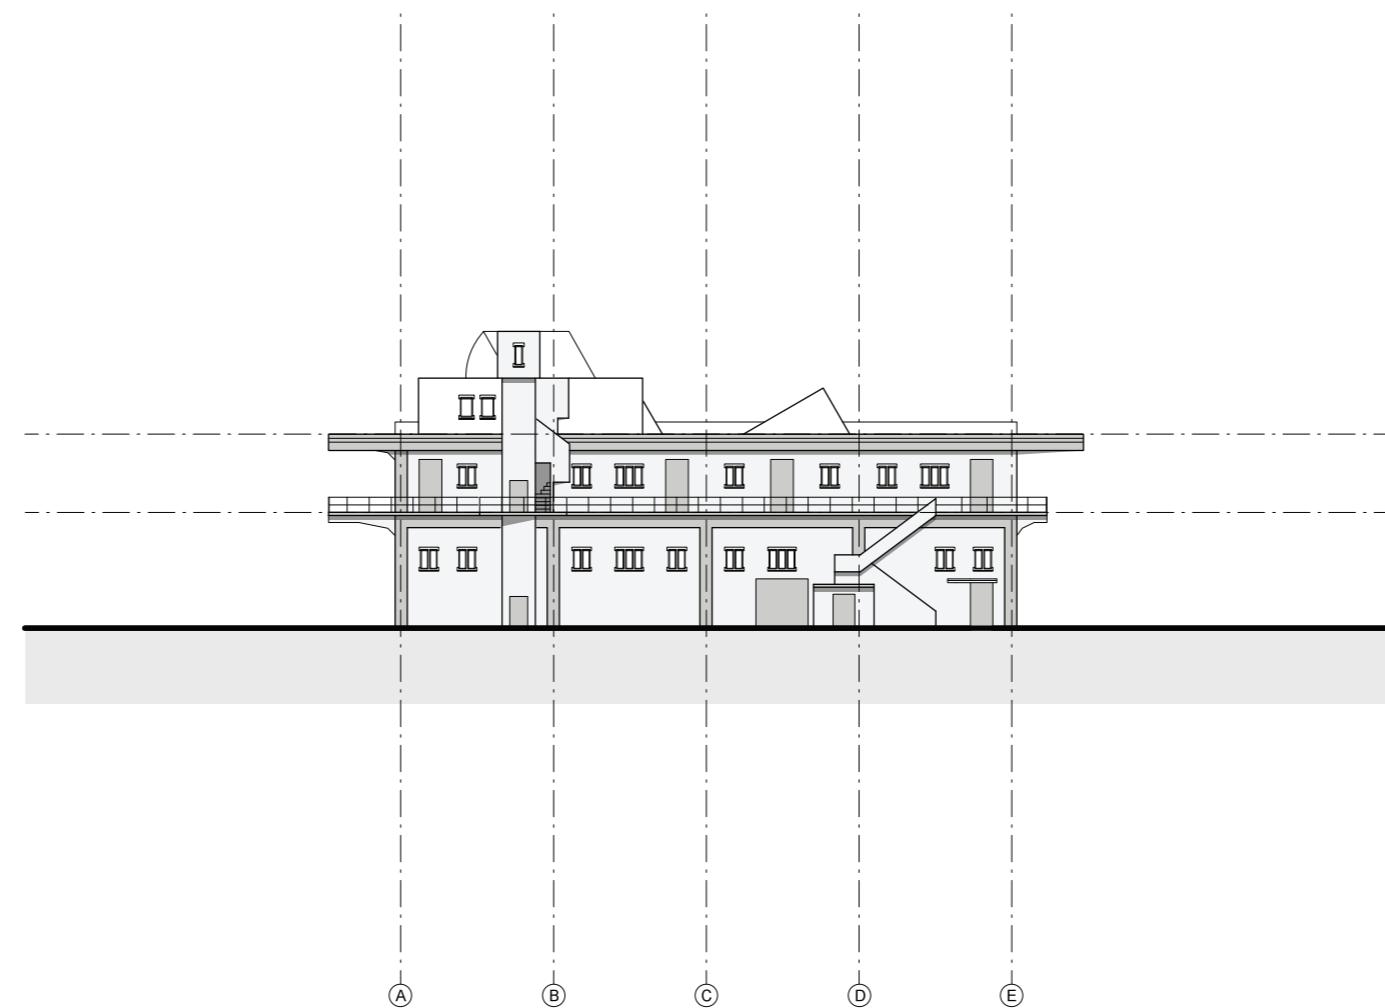
*east facade elevation by Jan Huis in 't Veld
(own illustration)*

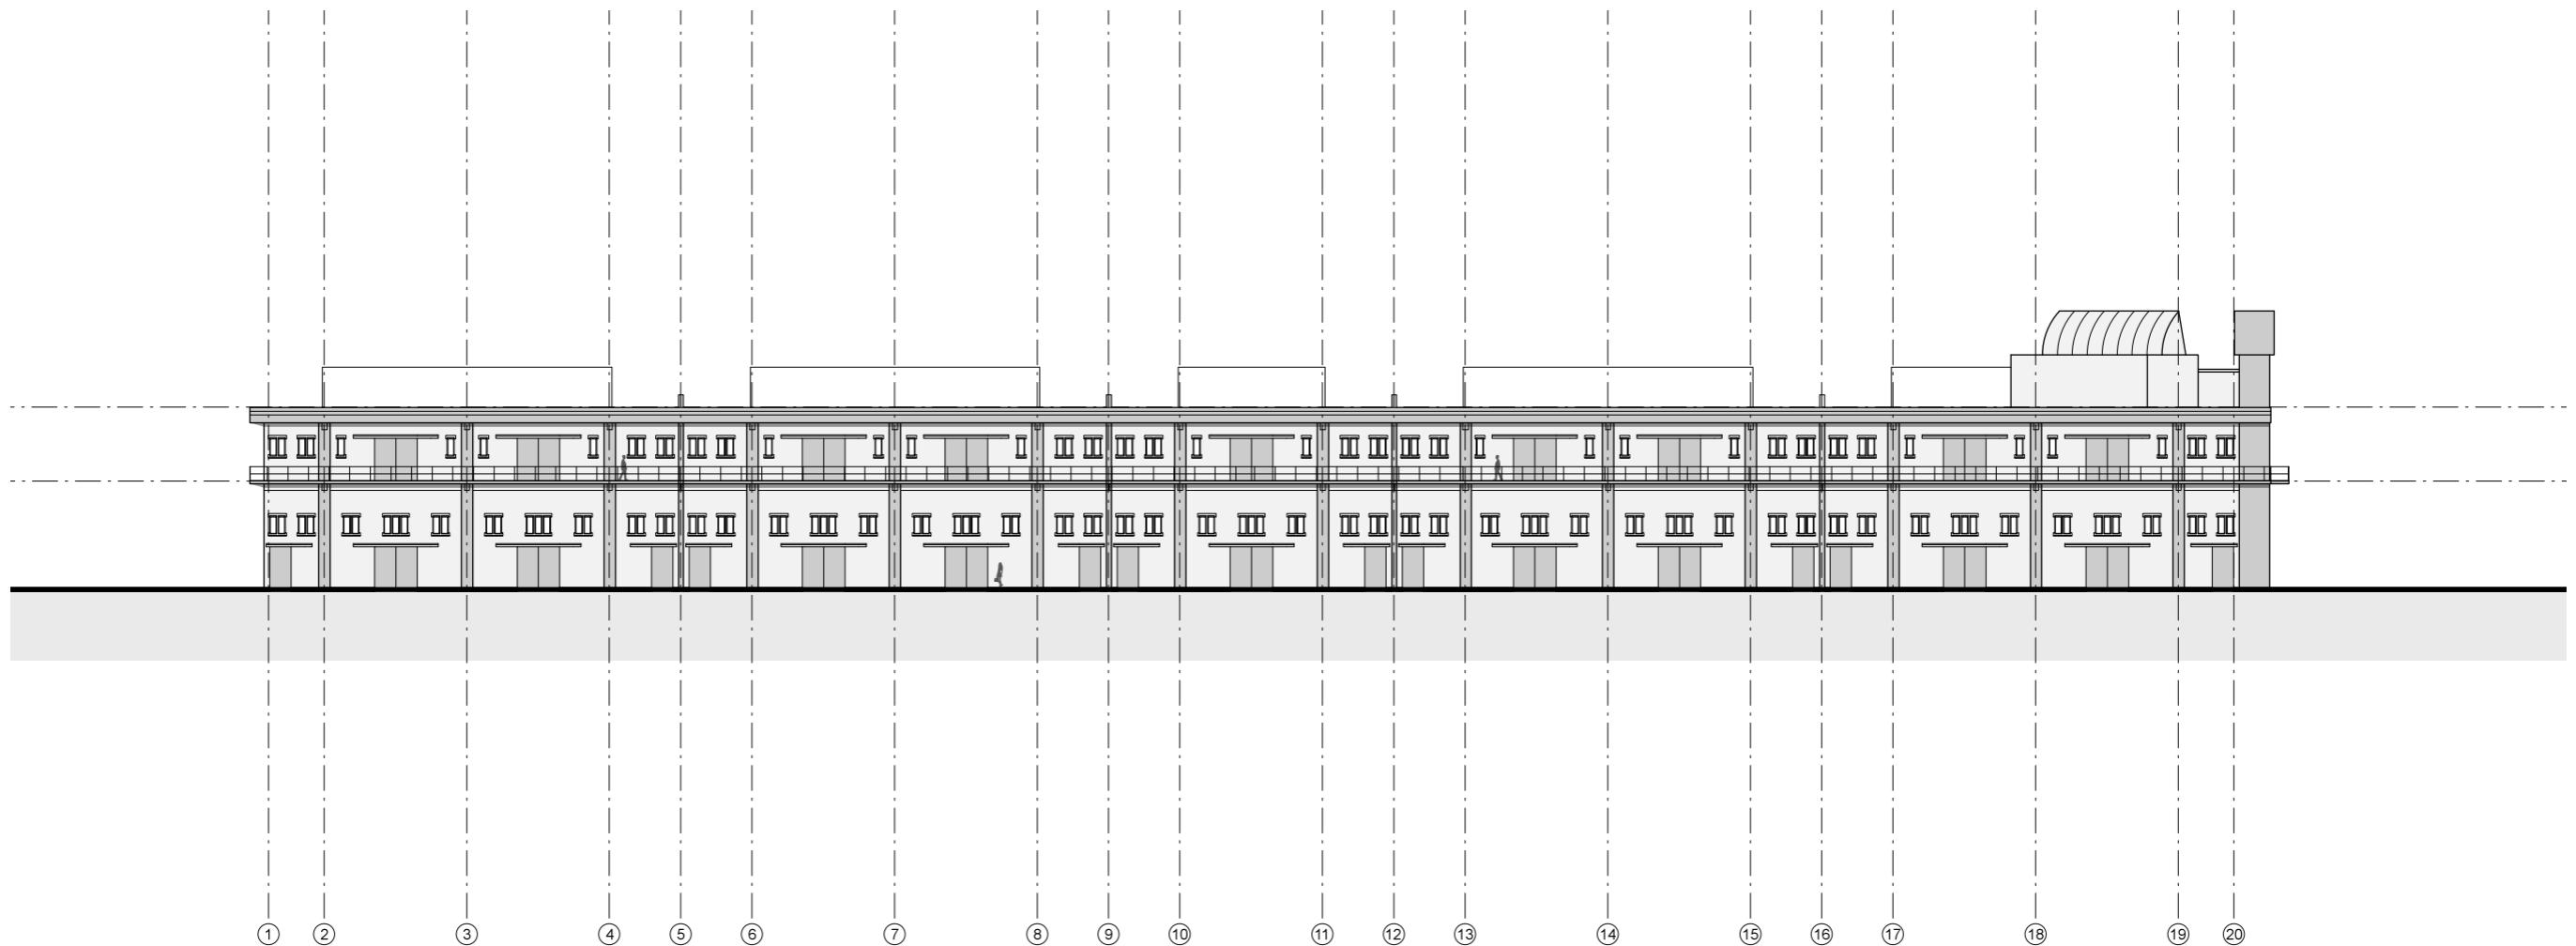
south facade elevation by Jan Huis in 't Veld
(own illustration)

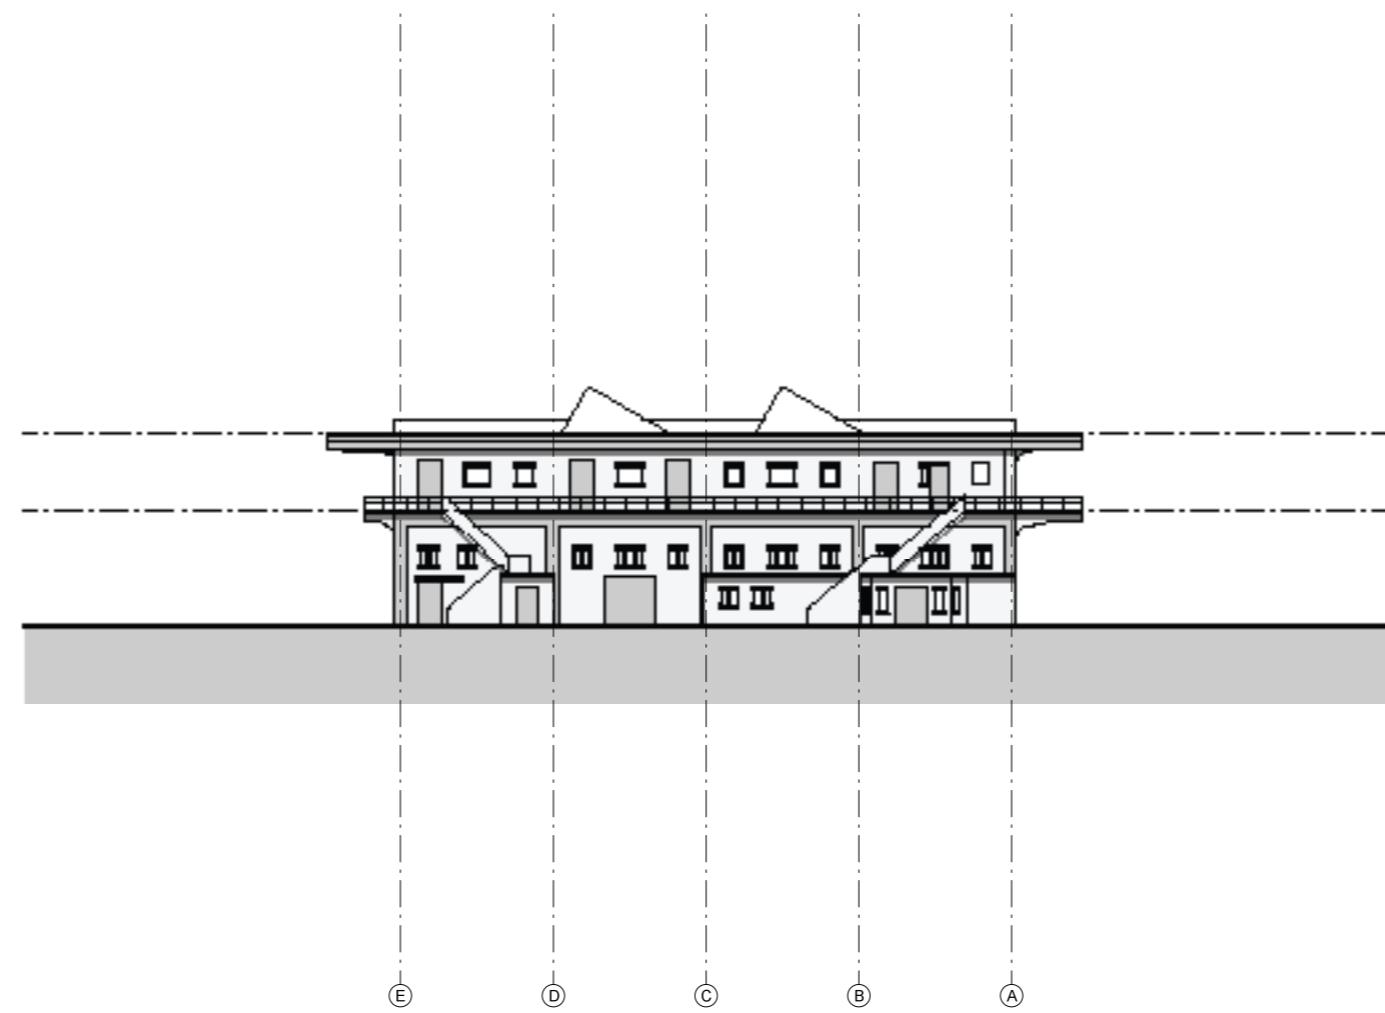
*west facade elevation by Jan Huis in 't Veld
(own illustration)*

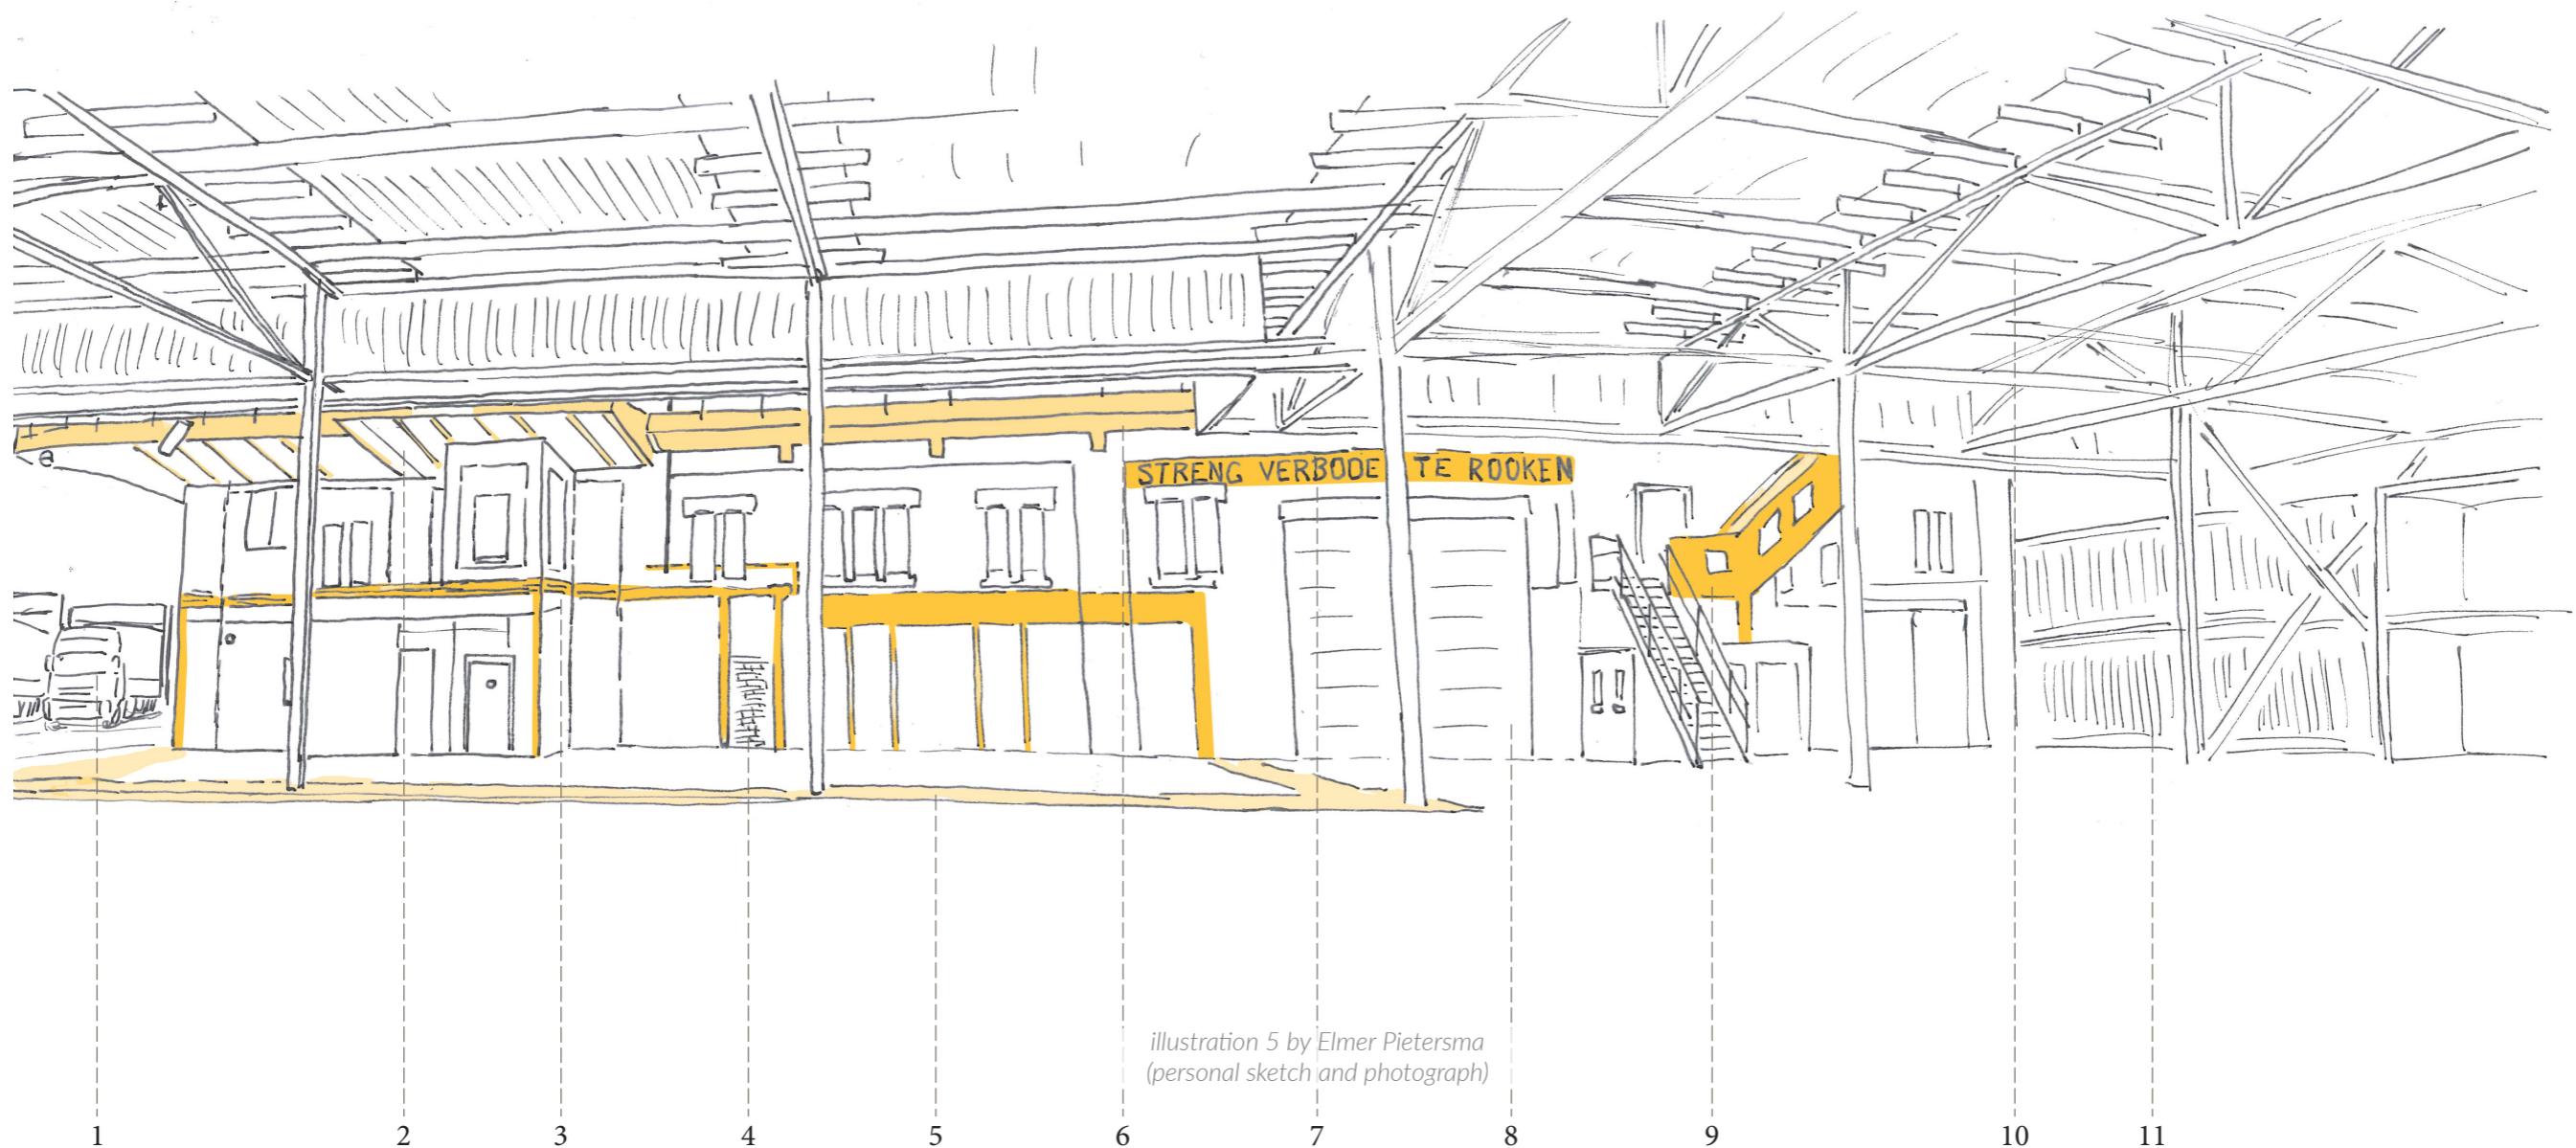
KATOENVEEM - MAIN ENTRANCE

The current main entrance of the entire warehouse is the roller door on the northern end of the building. All the other doors have been bolted up to prevent squatters of entering.

At number nine, one of the original concrete stairs is visible. It is in a very bad shape, the bottom part has already been replaced by a new, metal staircase.

1. Fruit transhipment warehouse
2. Traces of boarding that used to protect the skin
3. Traces of the removed directors office
4. Bricked up entrance
5. Traces of the removed directors office
6. Still present white boarding to protect the skin
7. Original warning against smoking
8. Roller door giving acces to the warehouse
9. Original but broken, concrete stairs.
10. Metal roofing added in 1991
11. Shipping containers blocking the view to the har-
