KATOENVEEM

MSc III Heritage & Architecture

Architectural & Building Technology Analysis

07/04/2017

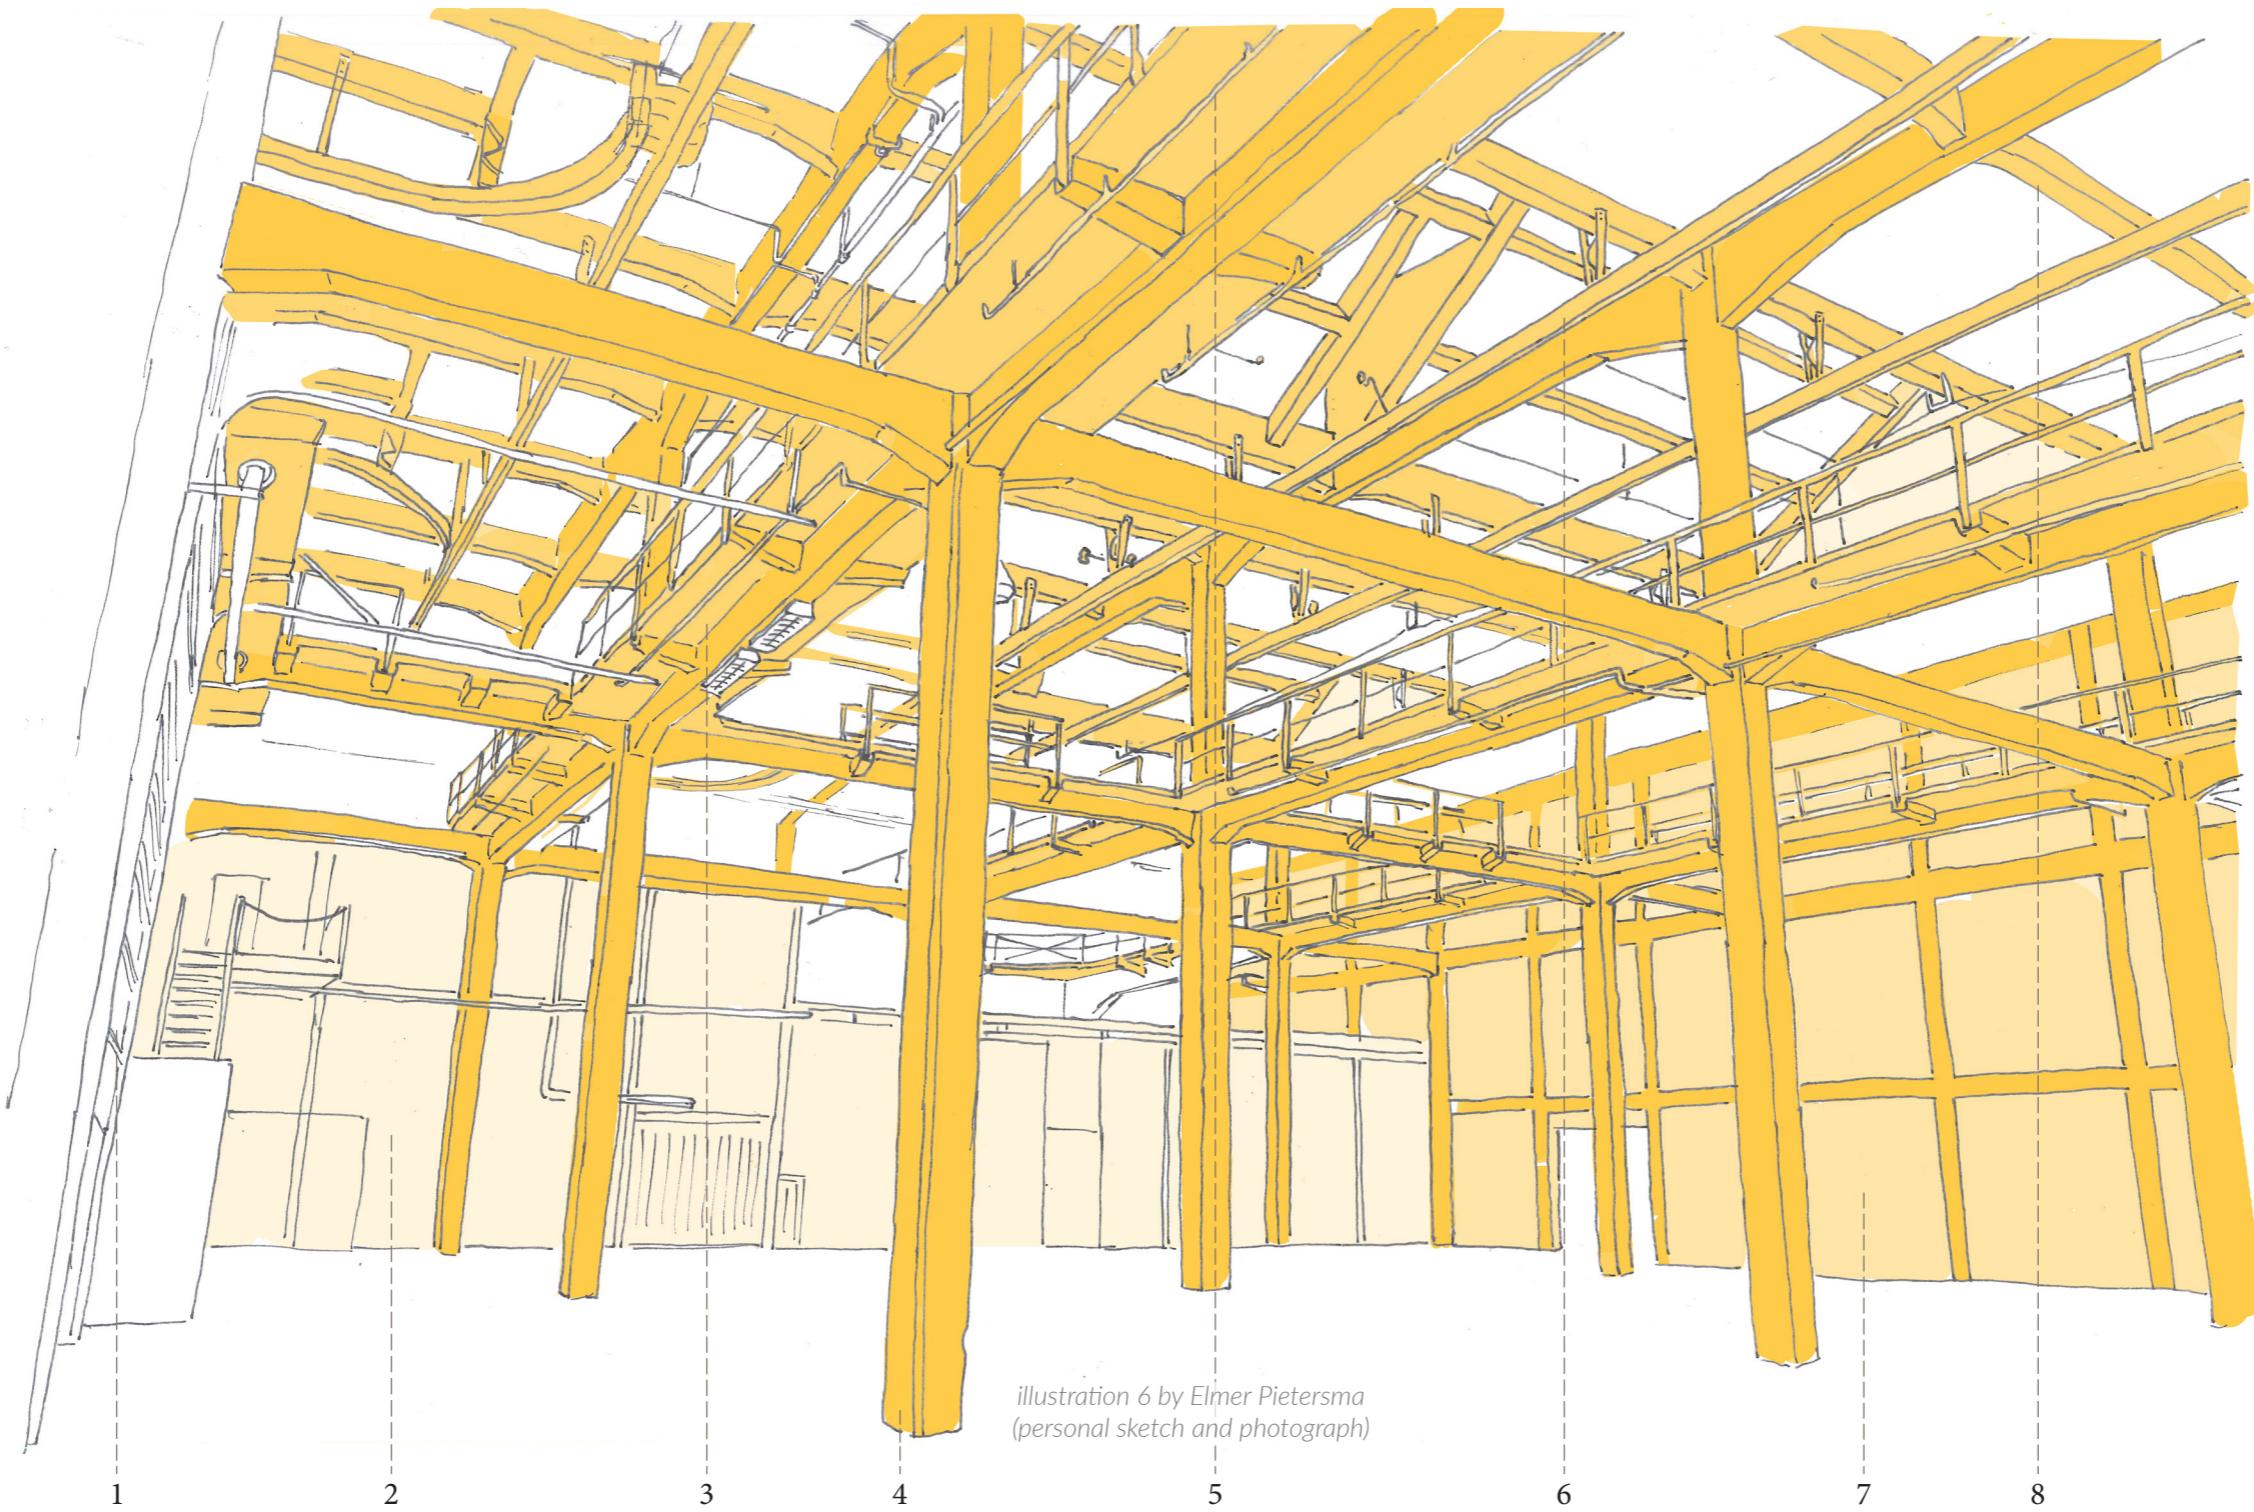
INSIDE THE KATOENVEEM

This sketch shows the interior of the warehouse. As is clearly seen at first glance; there is a lot going on. There is a complex network of construction, walkways, installations and roof beams obscuring the room. Due to the complexity of the image it is easy to forget the size of the space, the walkways start at a height of seven and a half metres, allowing for a grand and open ground floor area.

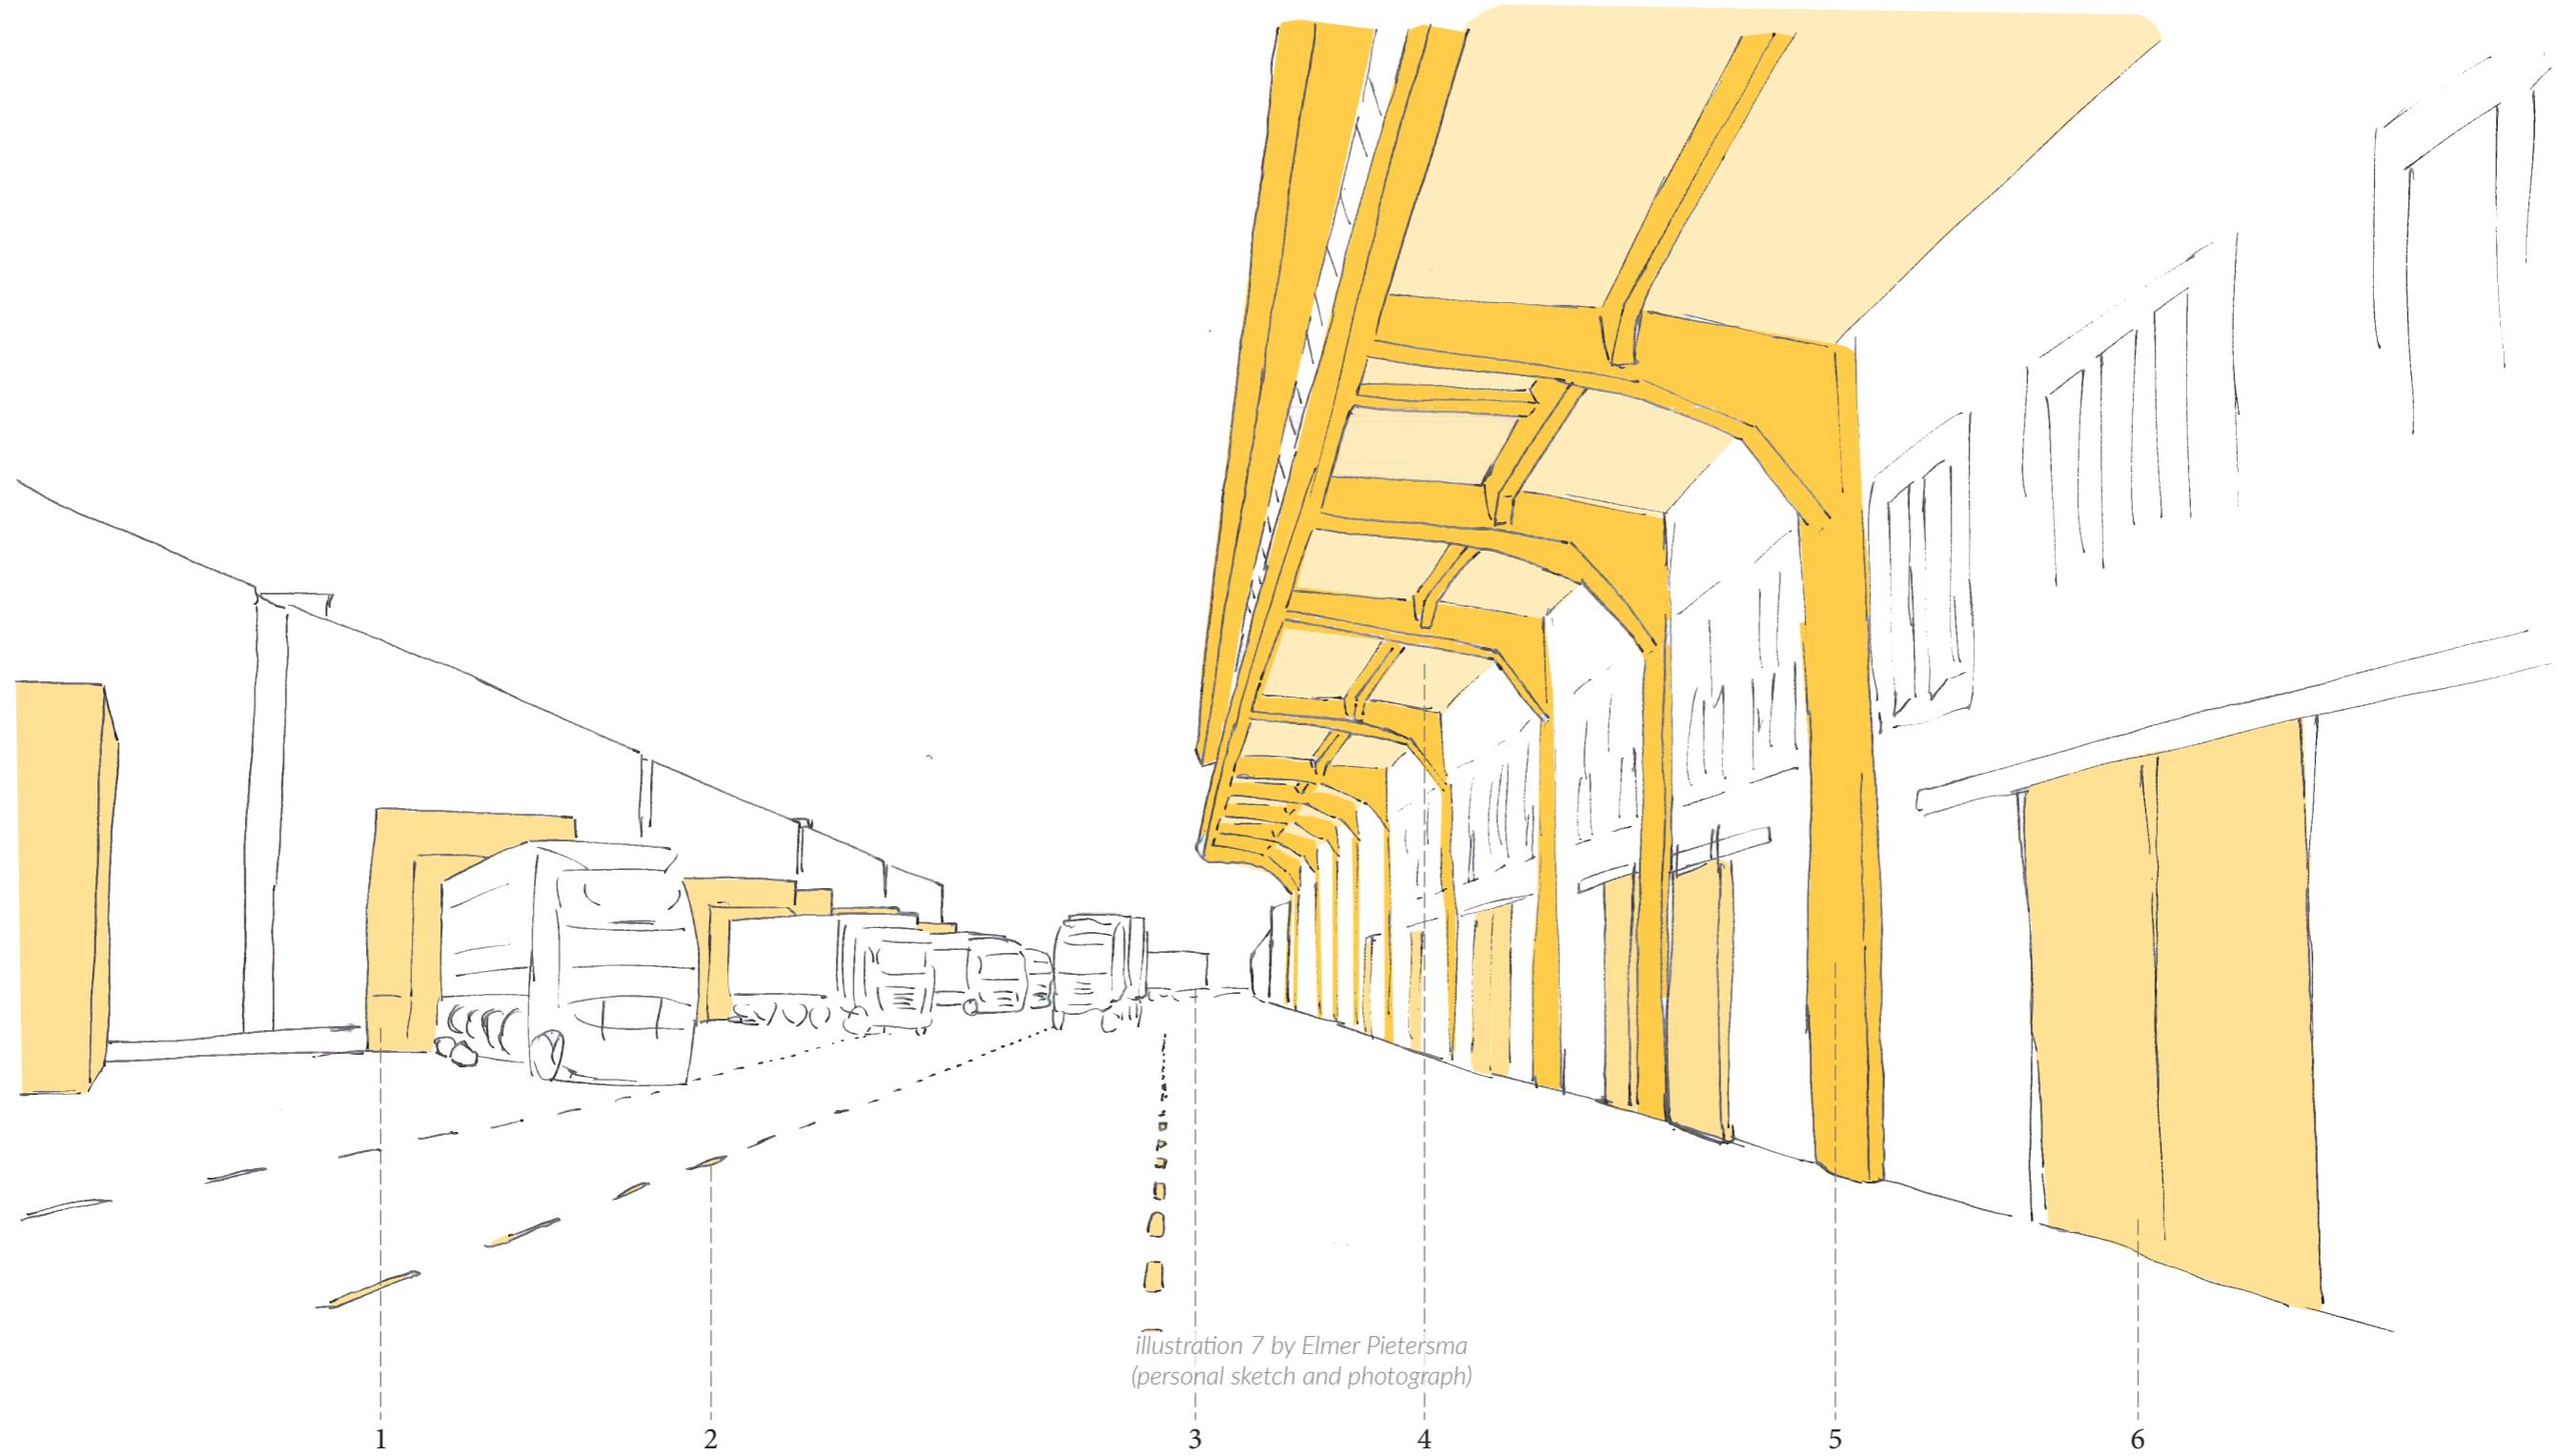
KEILEWEG 3

The current state of this balcony is very poor; it is due to the degradation of this balcony and especially the falling off of concrete is the reason this building is no longer safe to use. As a safety measure netting has been added along the entire underside of the balcony.

The yellowed sliding doors on the right side, are the original metal doors that were installed nearly a hundred years ago. Although they show clear signs of rust they are in relatively good state.

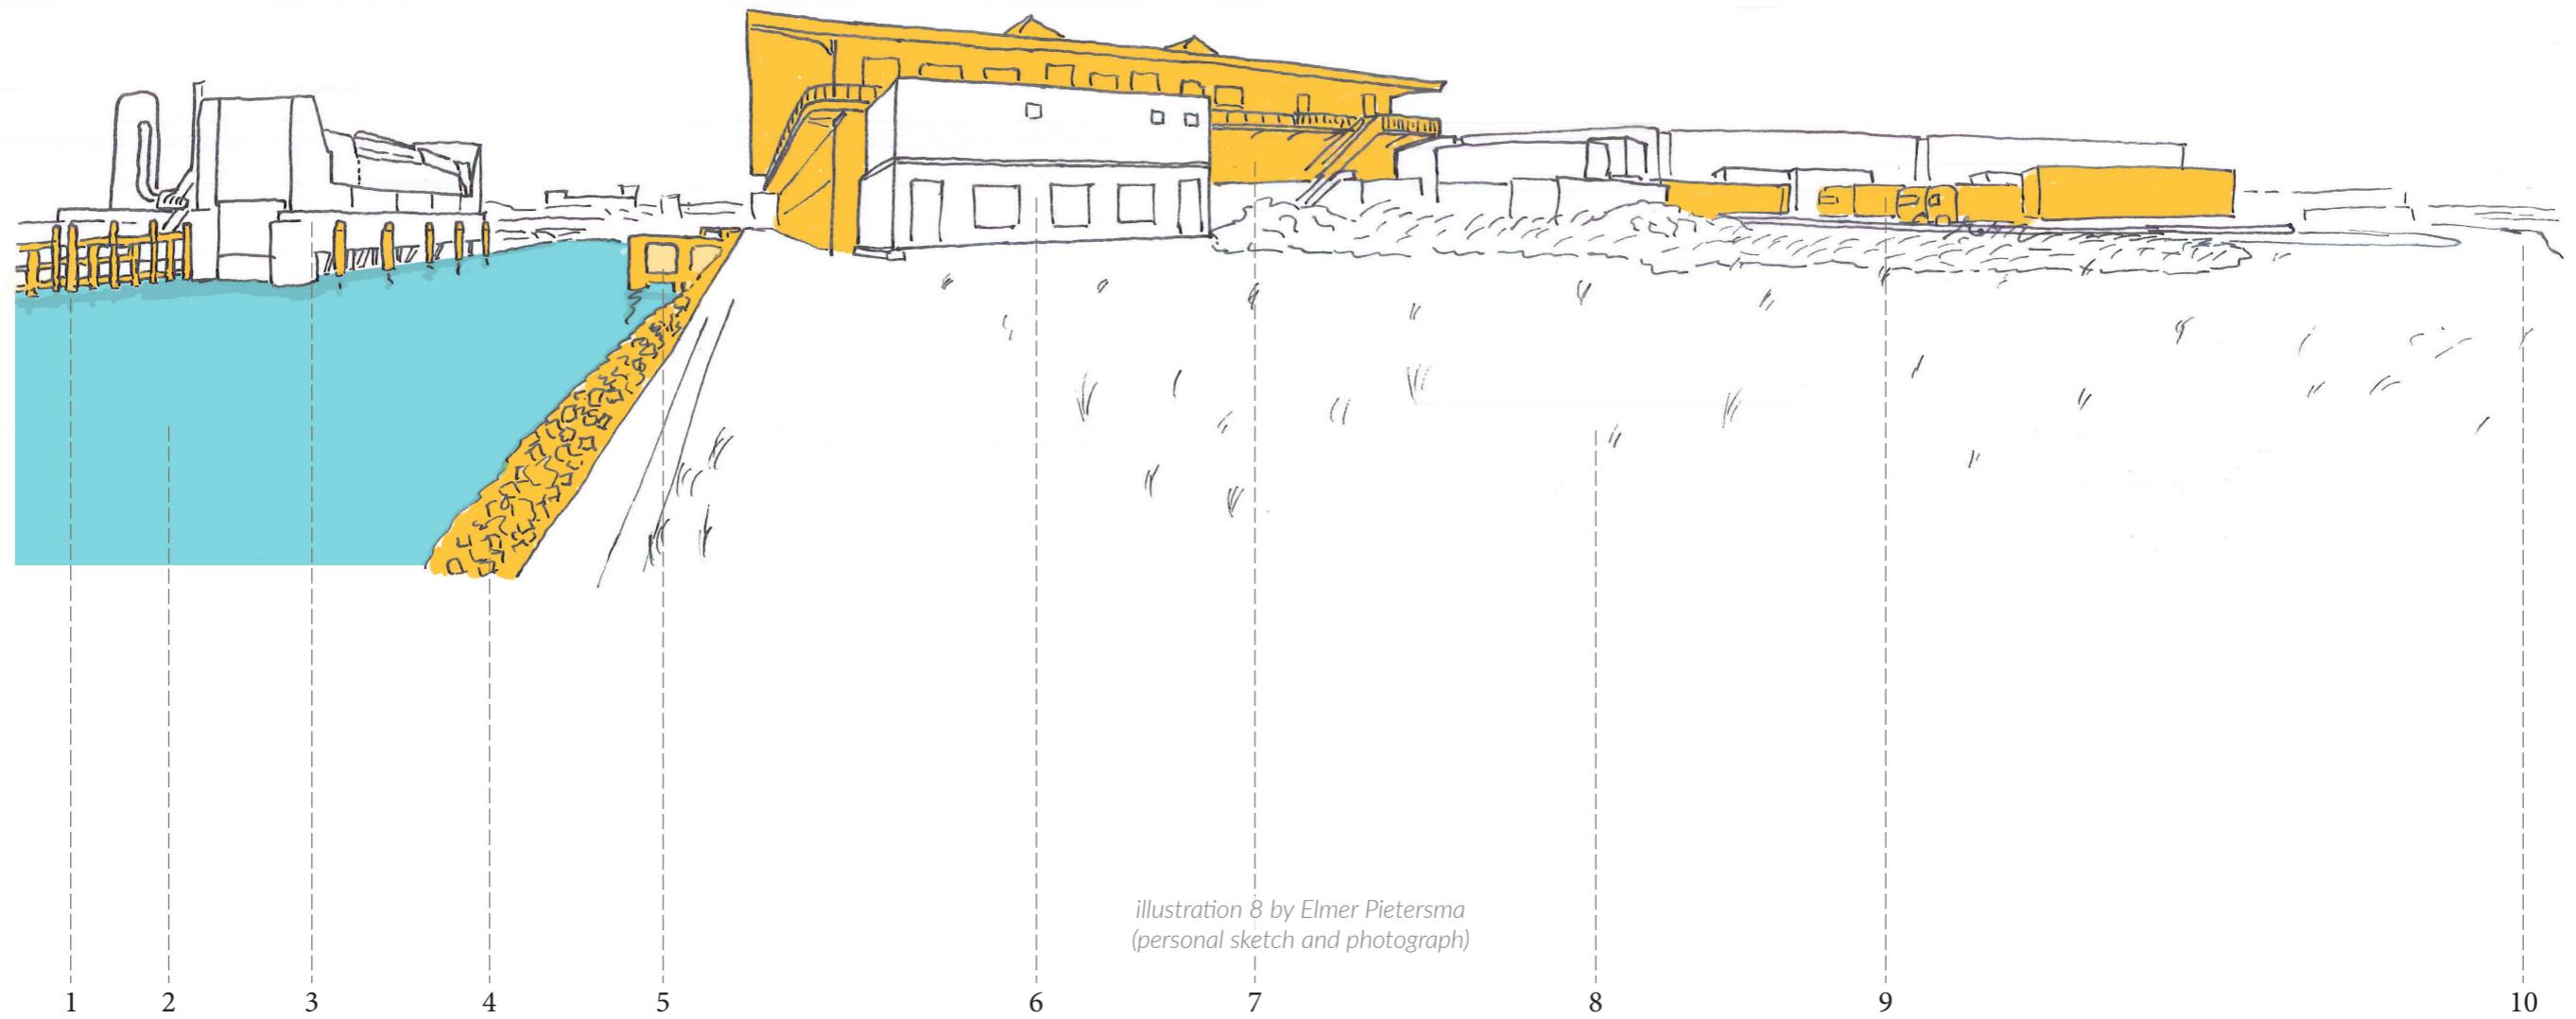
END OF THE PIER

At five, the original foundation of the two cranes is visible. This is the position of the dismantled cranes that used to connect the interior conveyor system to the ships that docked next to the building (more on that later).

1. Wooden posts to guide the ships
2. The Keilehaven
3. Industrial ship cleaning facility
4. Breakwater
5. Foundation of the demolished cranes
6. Derelict barracks and containers
7. Katoenveem
8. Empty grass field
9. Fruit transhipment warehouse

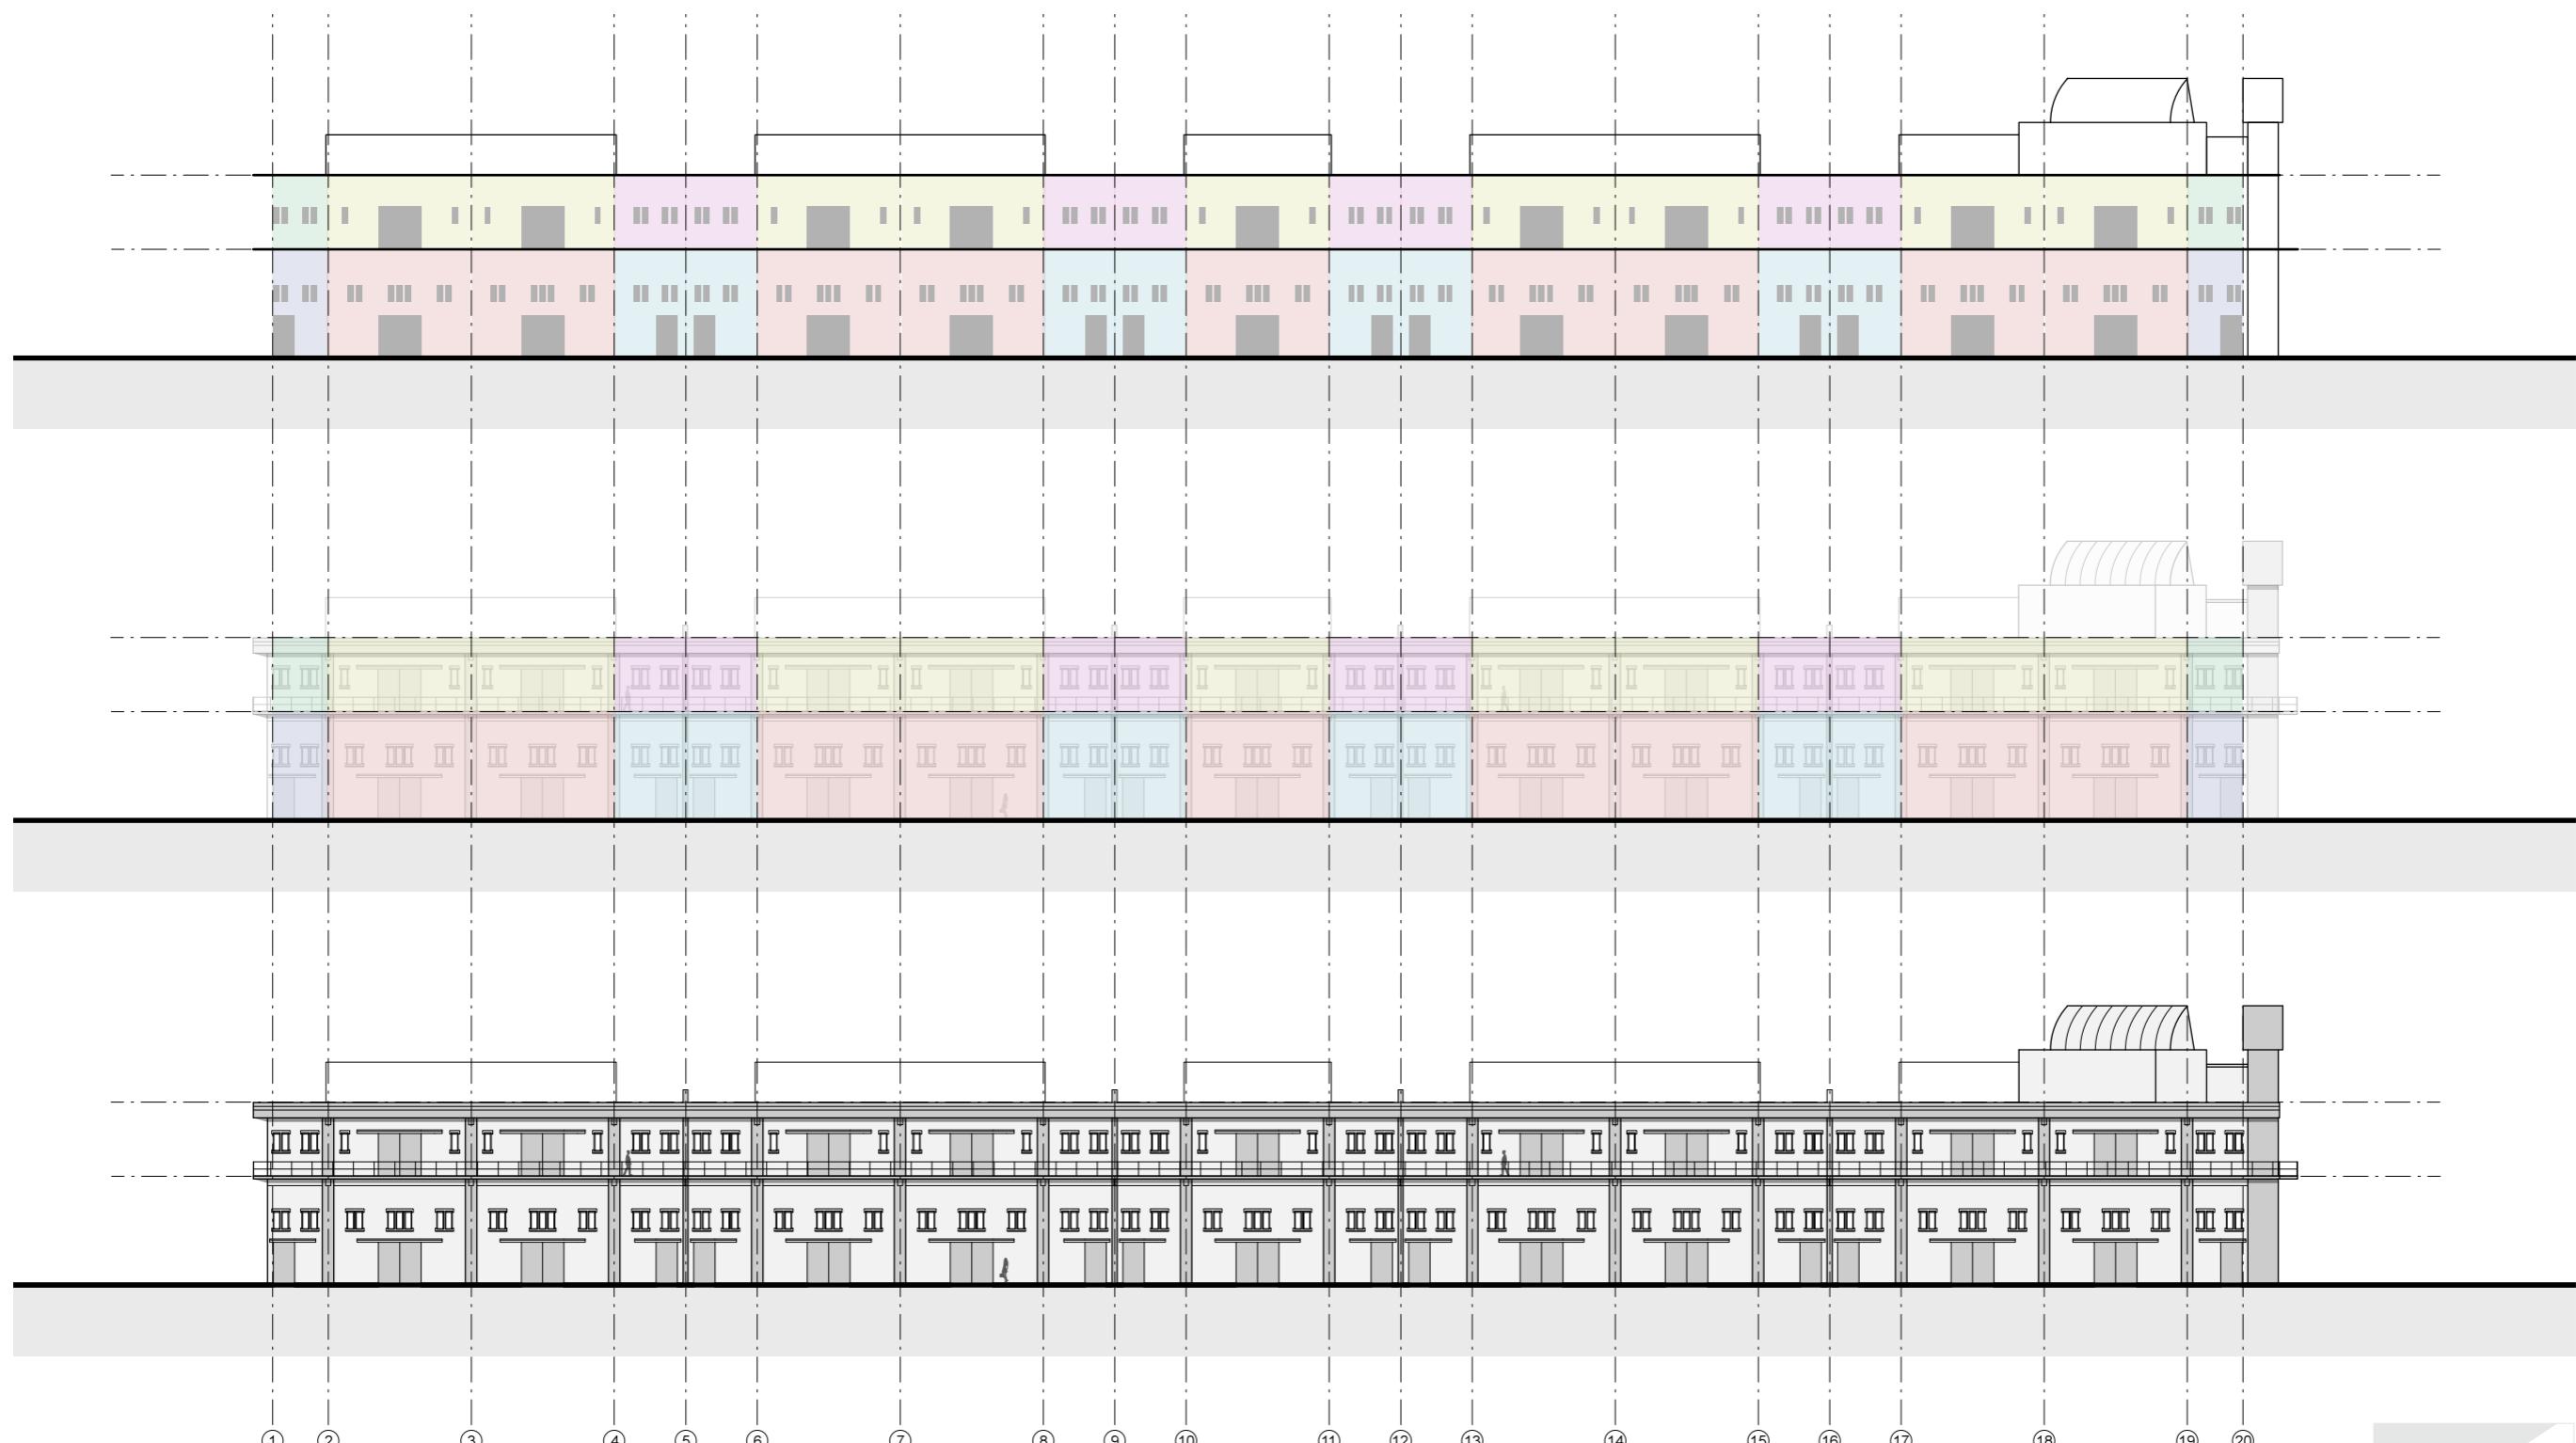
south facade elevation 1,2,3 by Jan Huis in 't Veld
(own illustration)

The 1:500 layers contain a 'regular' elevation, an elevation that displays the division of the facade and a schematic elevation. Each of these elevations can be traced back through the grid lines that run through all of them at once.

The placement of the doors corresponds directly to the conveyor system that transports the cotton through the building. The rhythm in the facade is organised with great consistency because of the same original function of the entire building. A few identical building blocks have been used to make the composition of the longitudinal façades (north and south). At the opposite heads of the building the same system has been used, however stairs, elevators and new entrances have broken through this pattern. The roof has a consistent rhythm and expression as well, only interrupted by the sample room angled on top. The 1:200 images provide

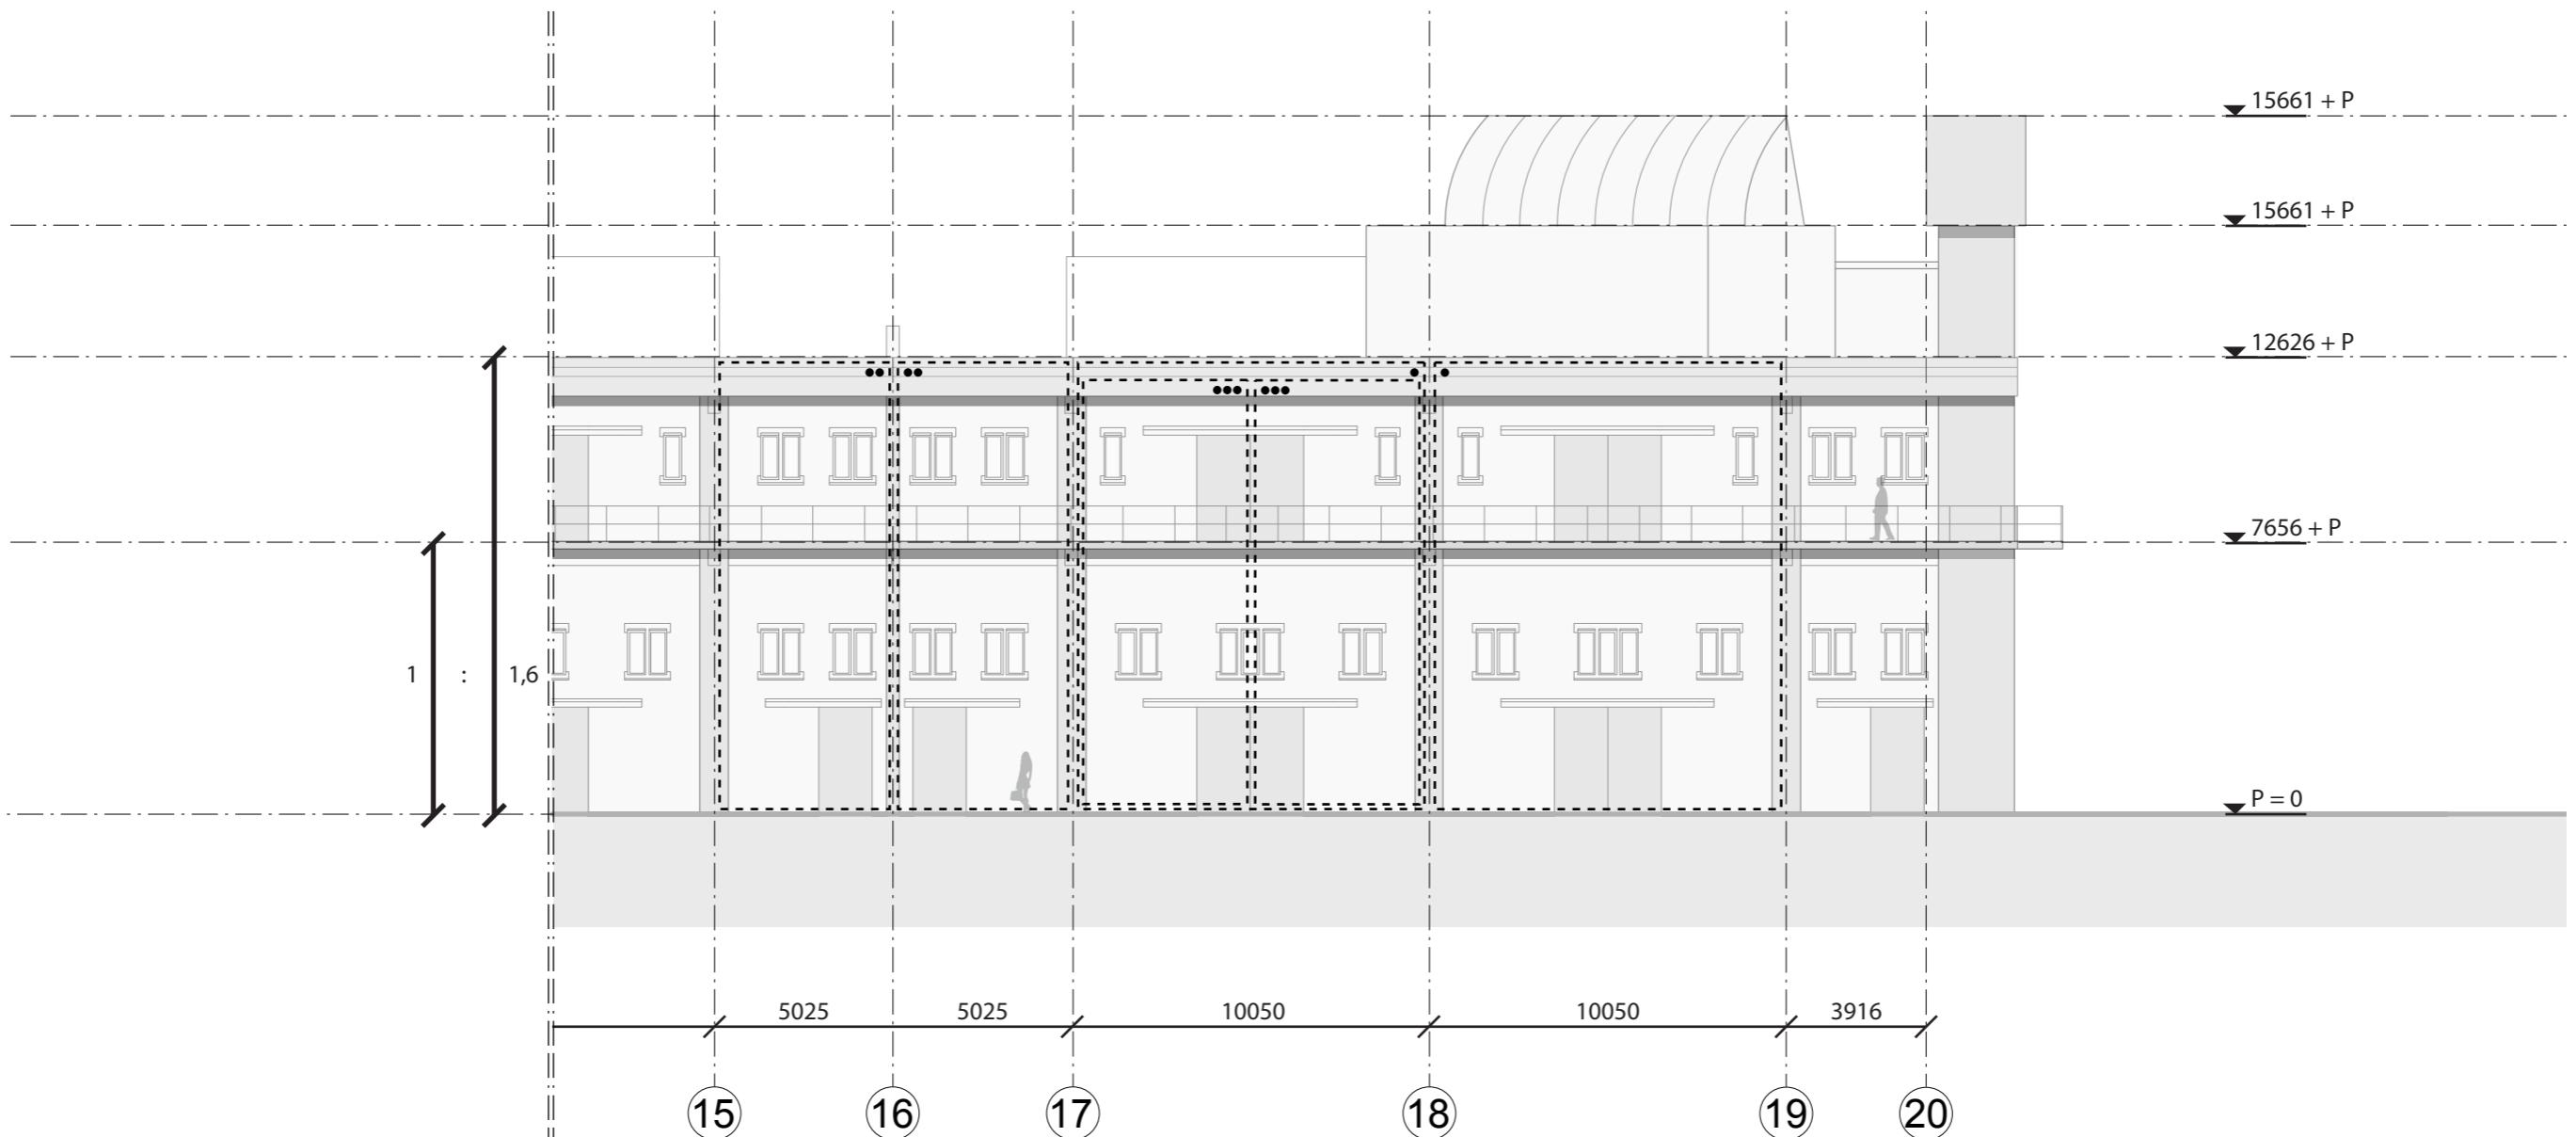
south facade elevation 4 by Jan Huis in 't Veld
(own illustration)

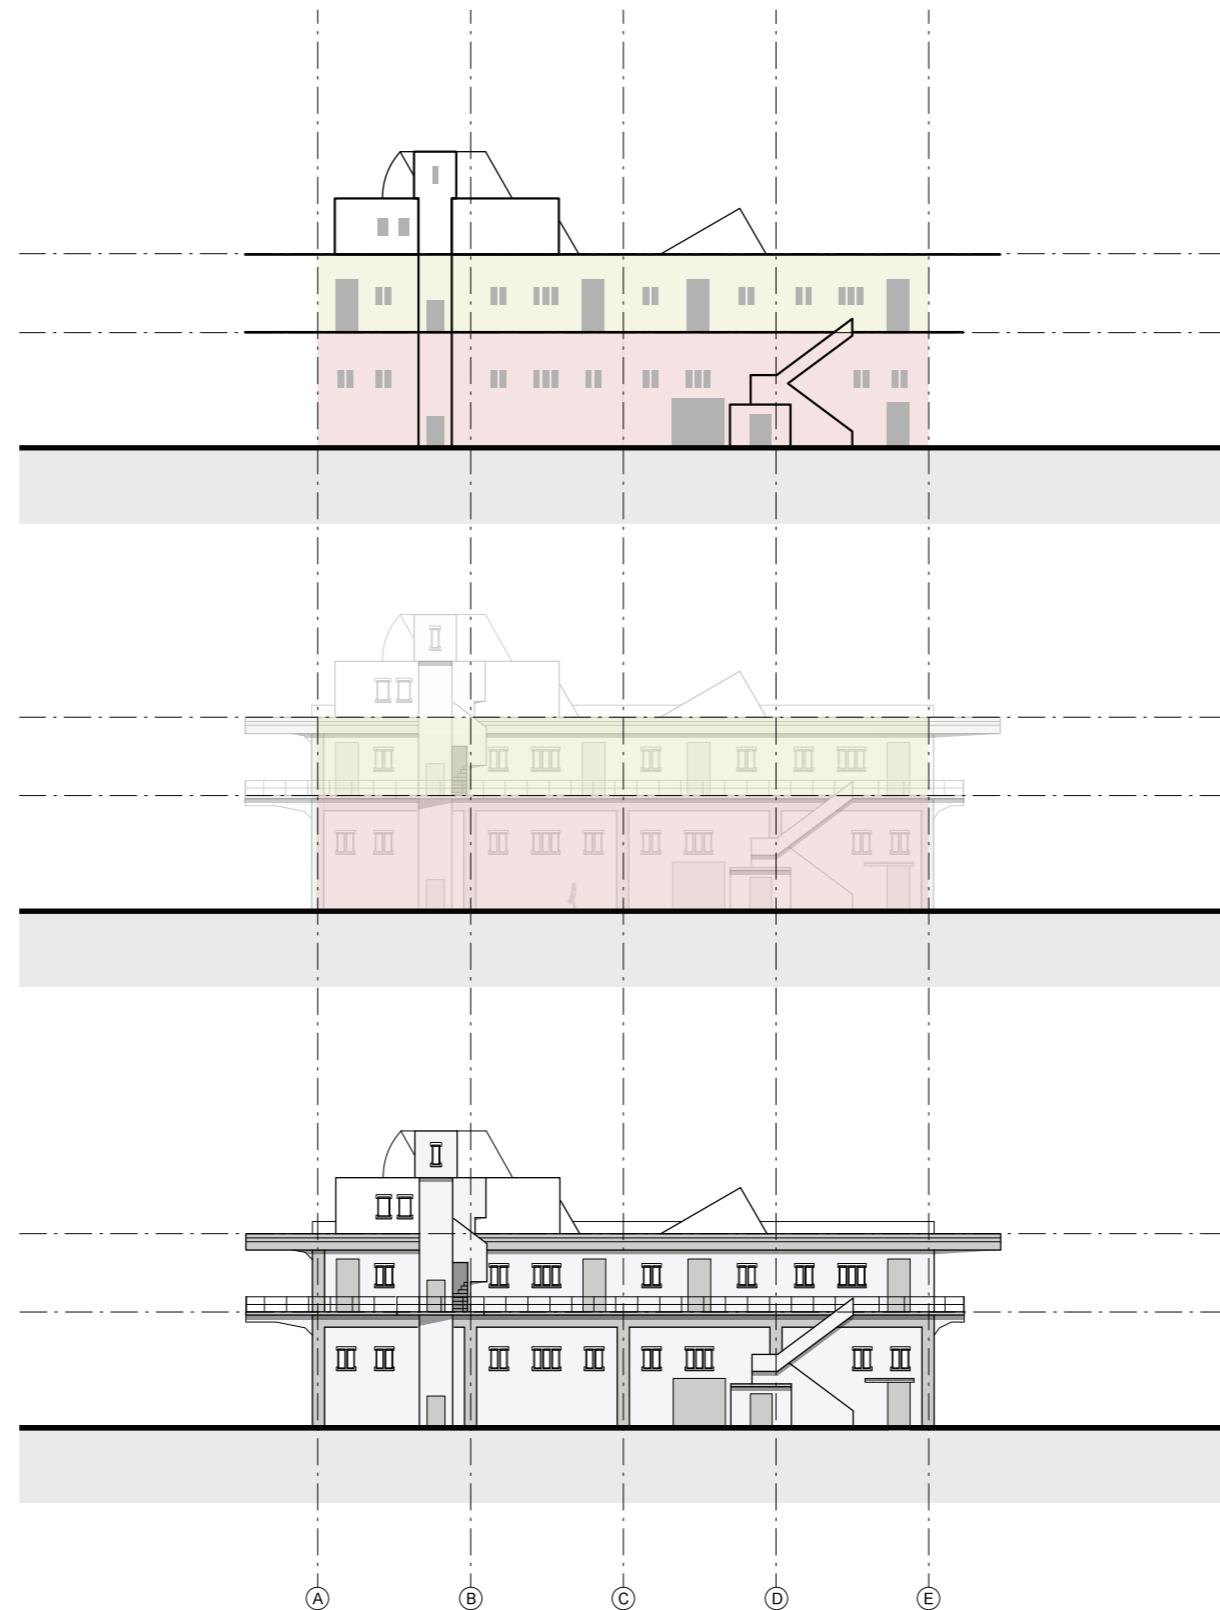
east facade elevation 1,2,3 by Jan Huis in 't Veld
(own illustration)

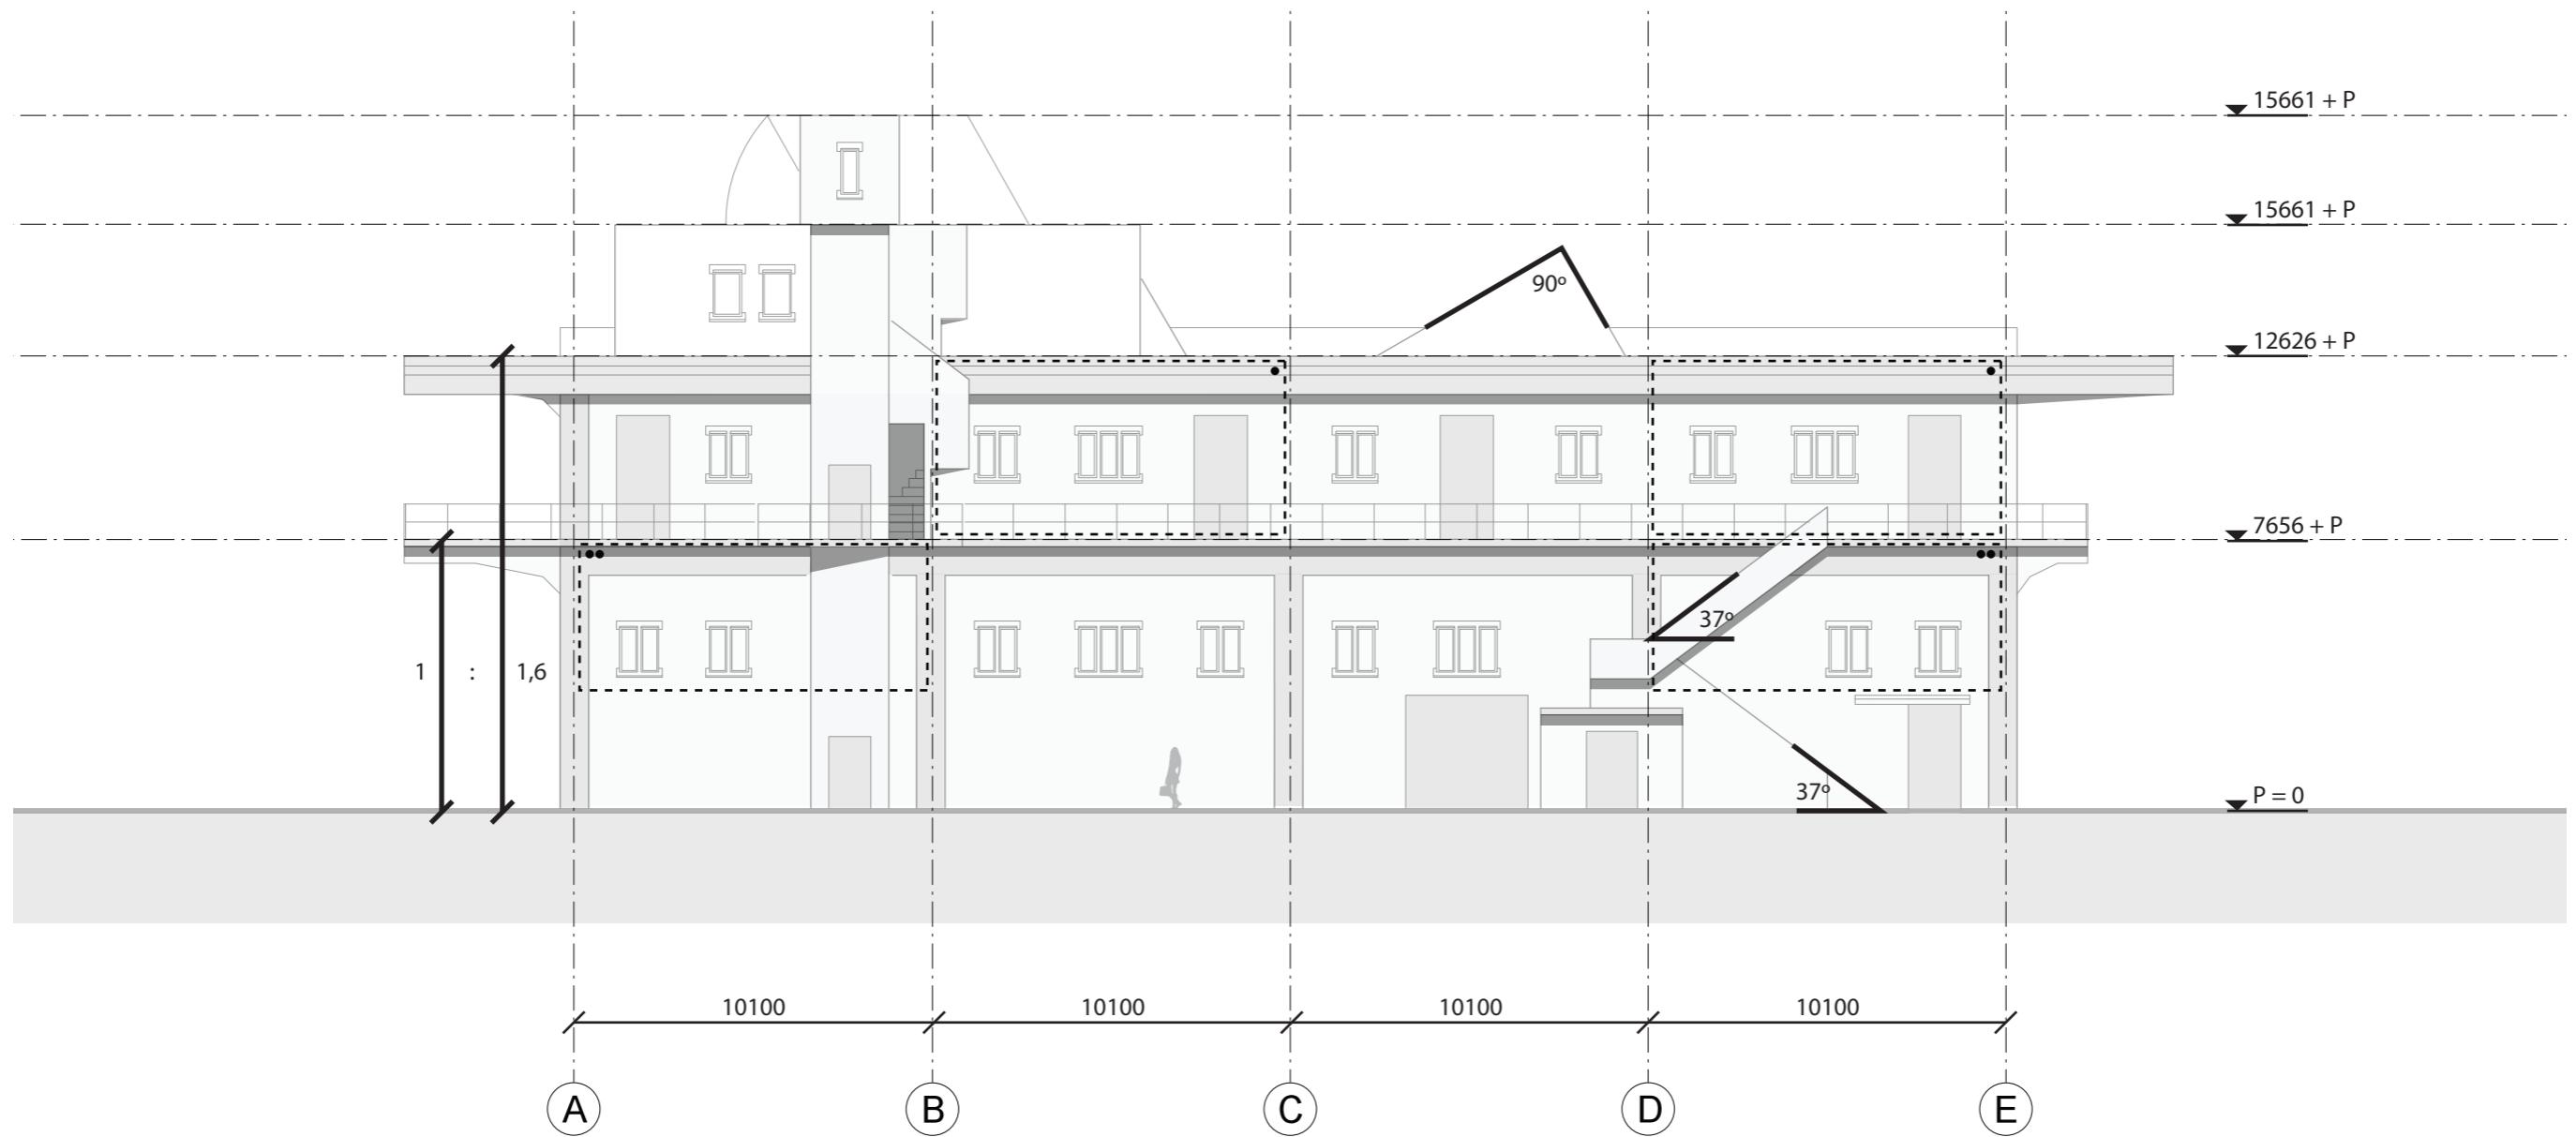
- building block 1
- building block 2
- facade opening
- mirroring part

east facade elevation 4 by Jan Huis in 't Veld
(own illustration)
