KATOENVEEM

MSc III Heritage & Architecture

Architectural & Building Technology Analysis

07/04/2017

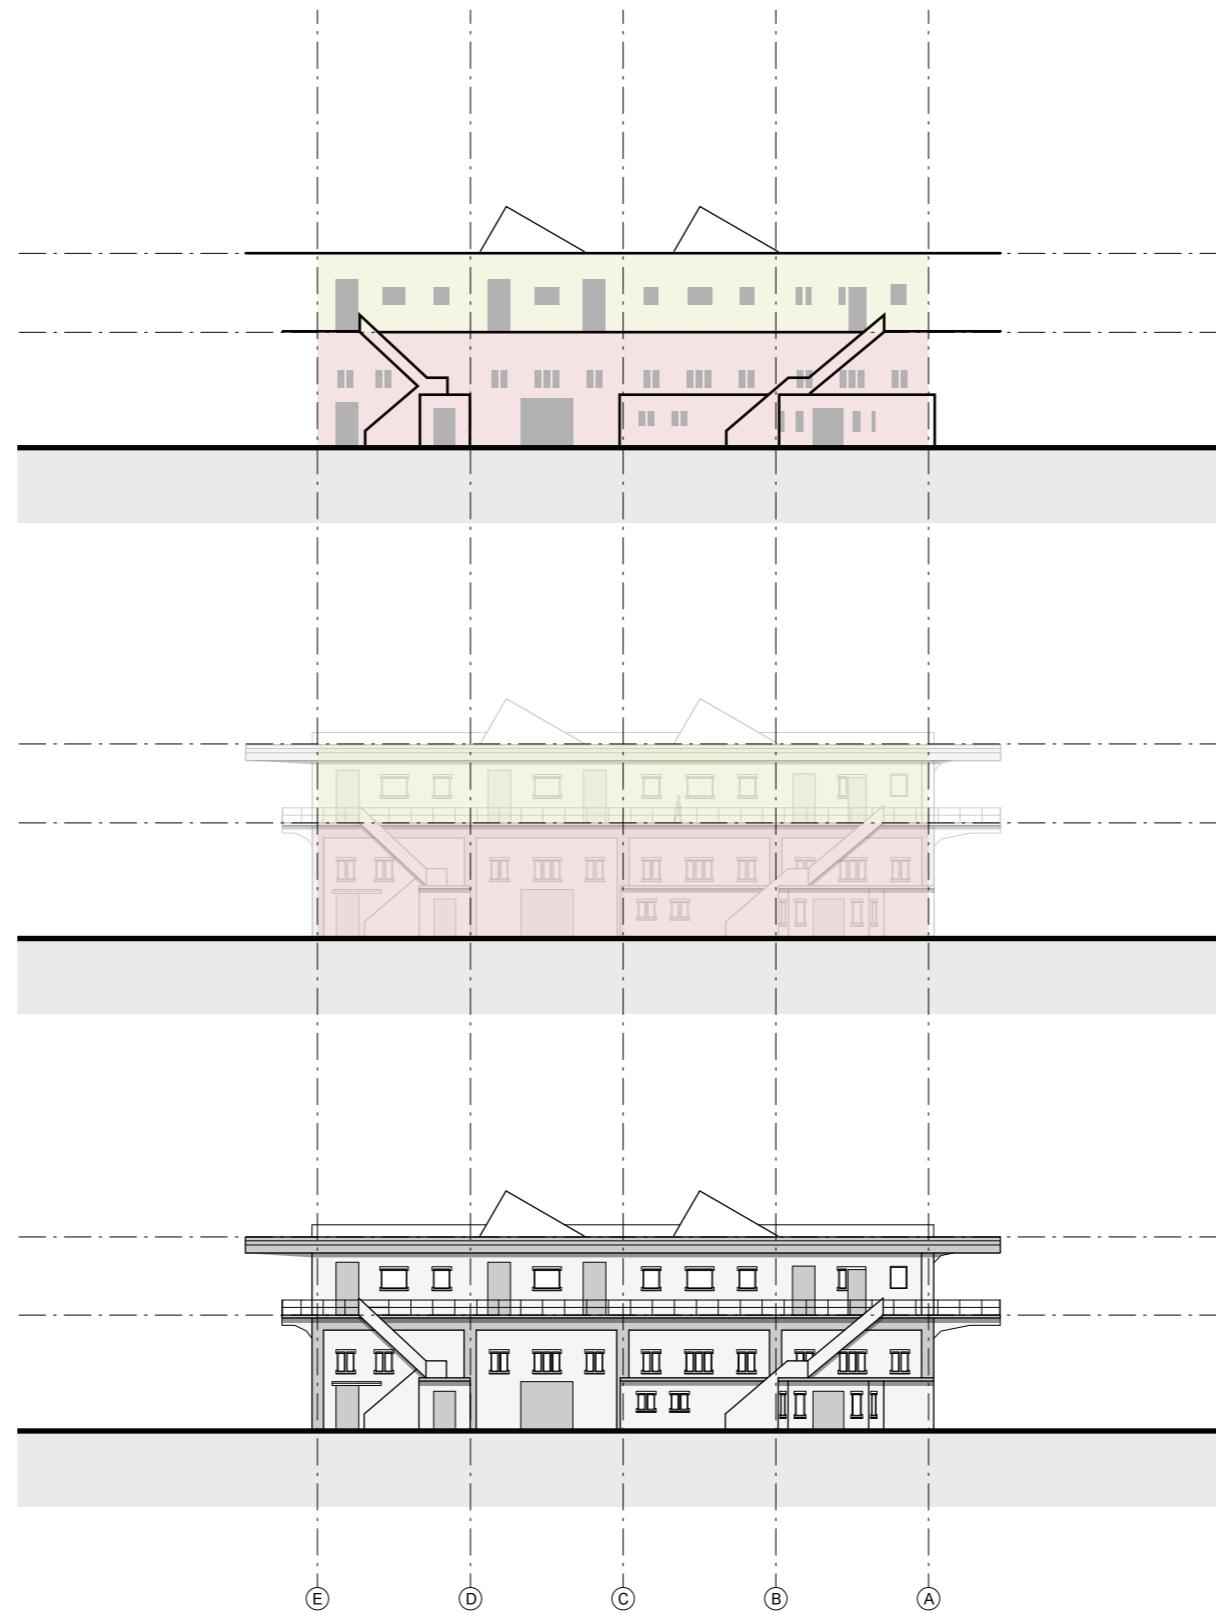
west facade elevation 1,2,3 by Jan Huis in 't Veld
(own illustration)

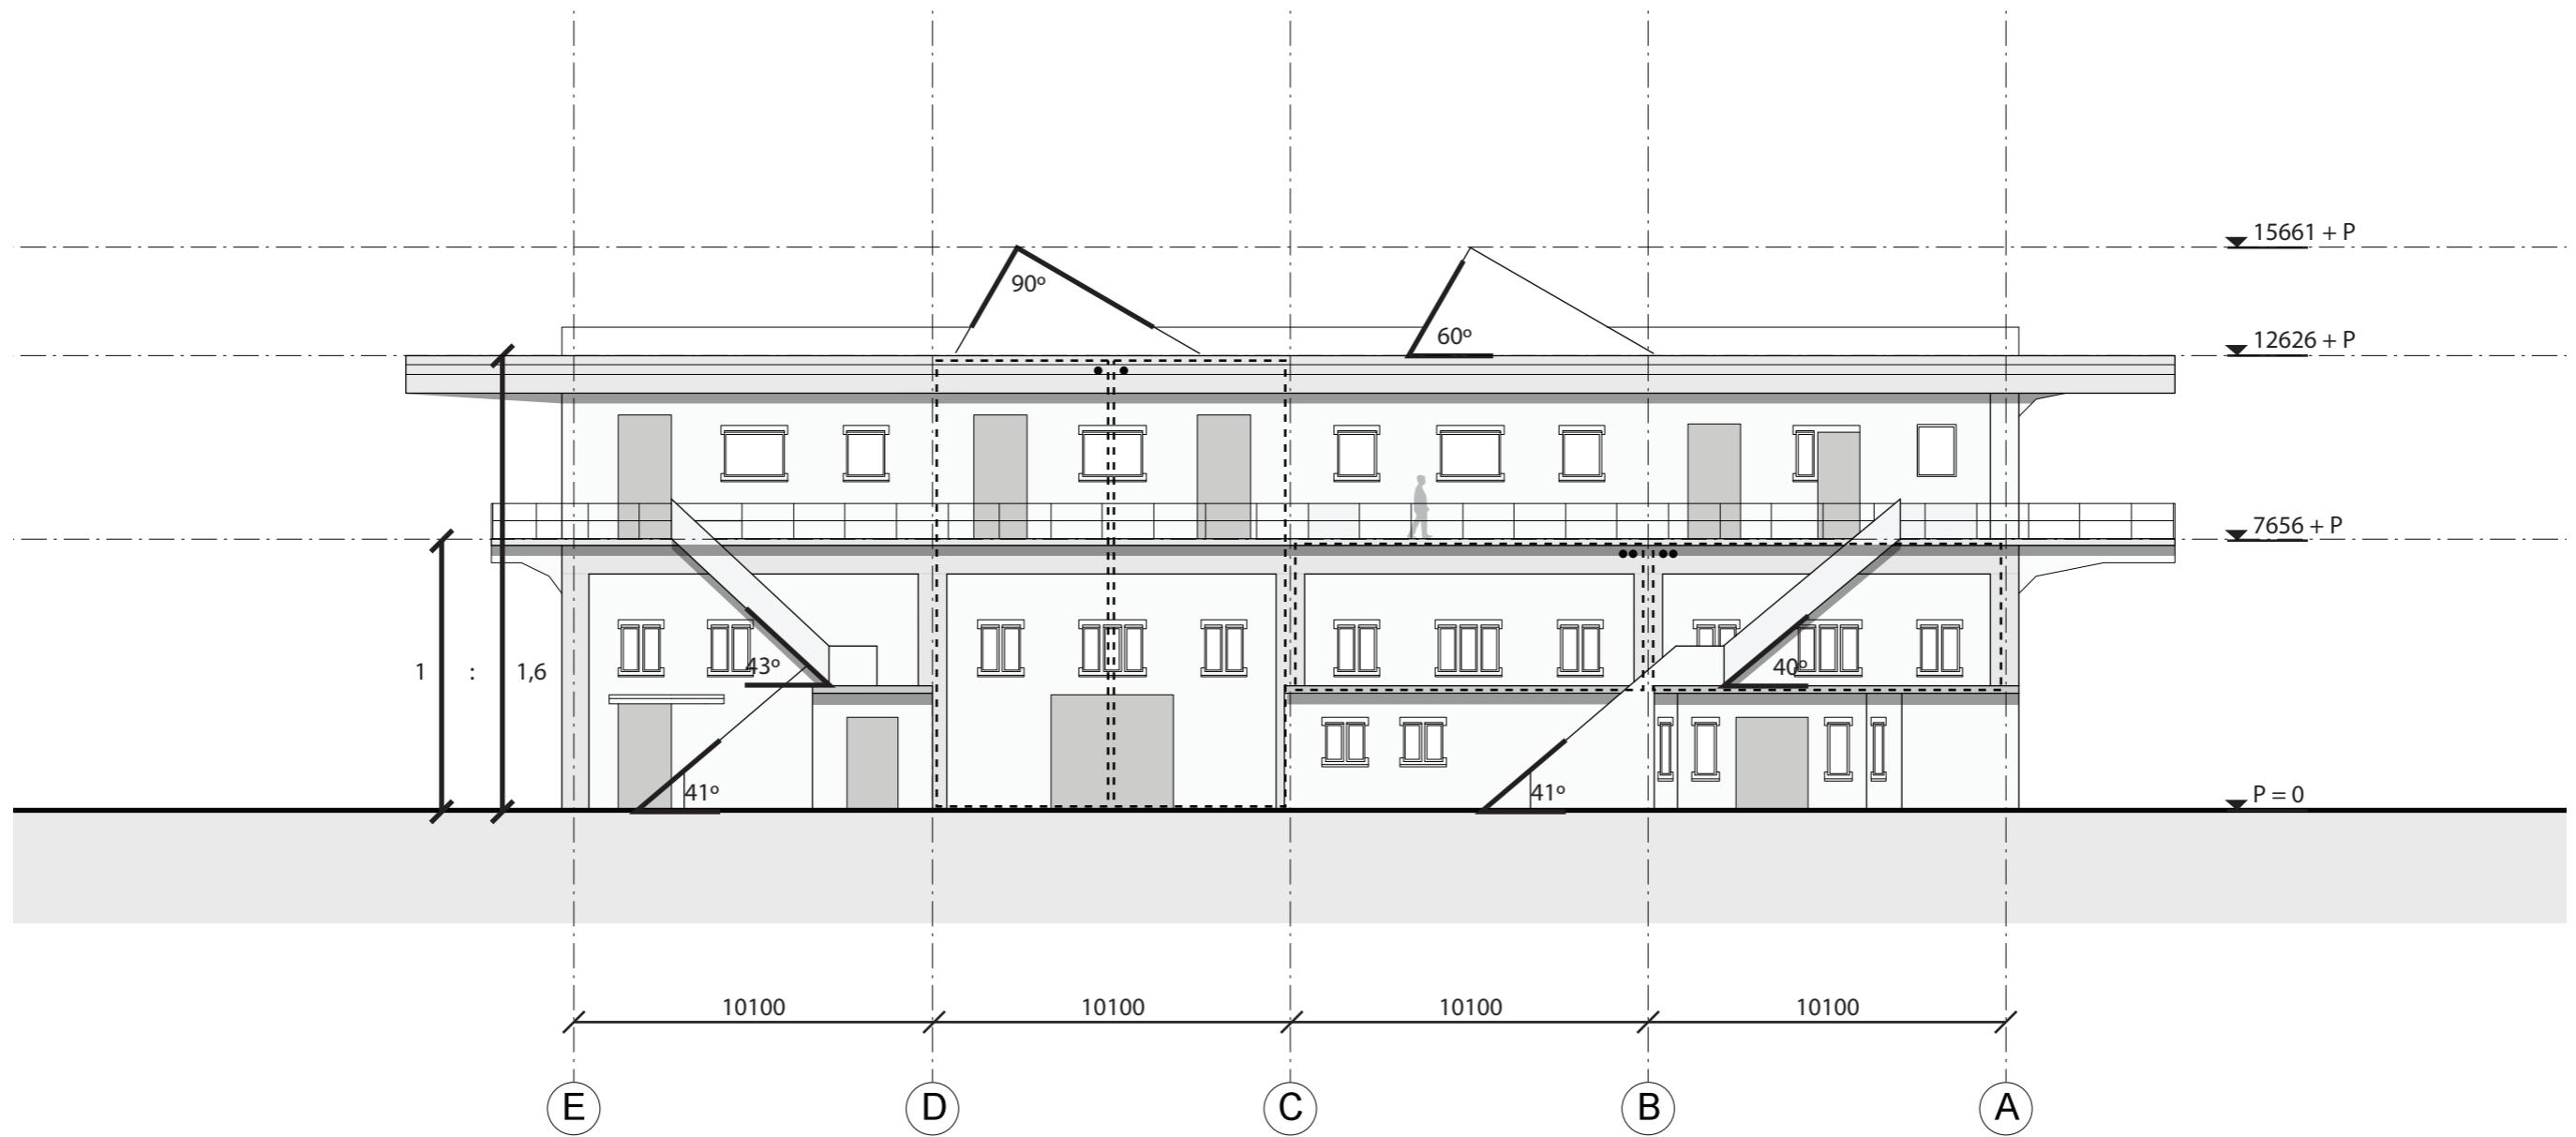
west facade elevation 4 by Jan Huis in 't Veld
(own illustration)

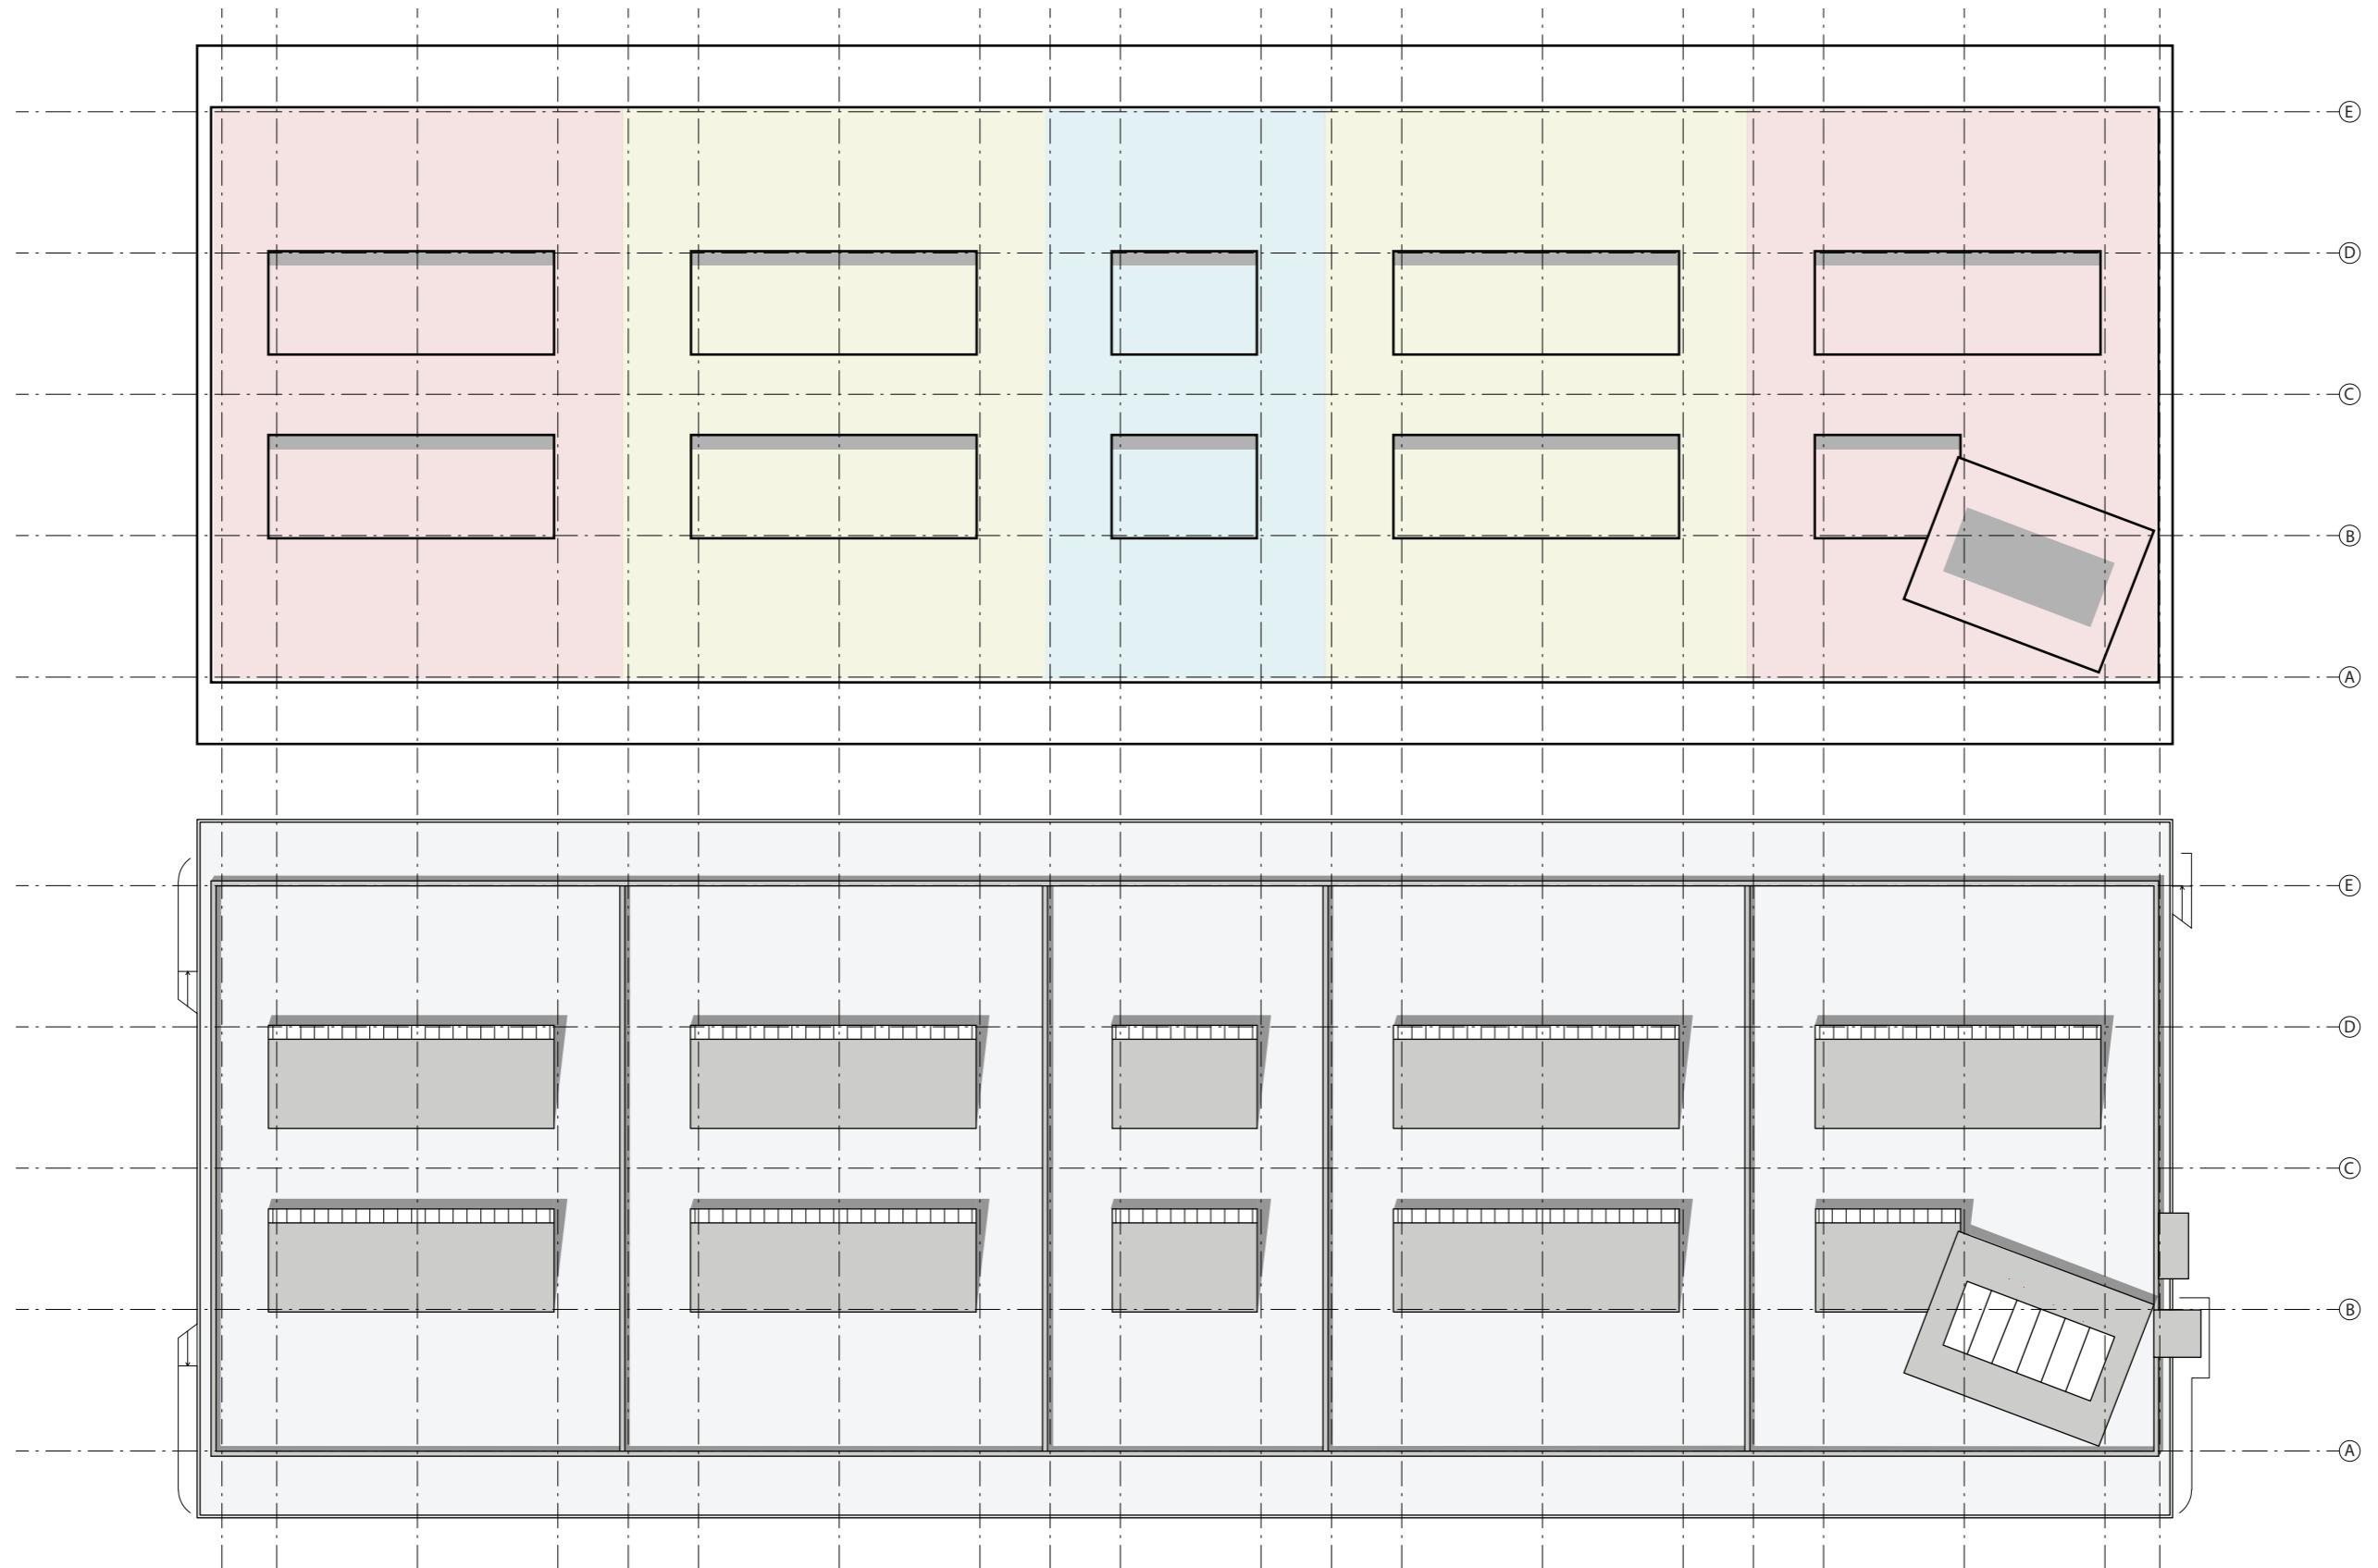
roof facade elevation 1,2 by Jan Huis in 't Veld
(own illustration)

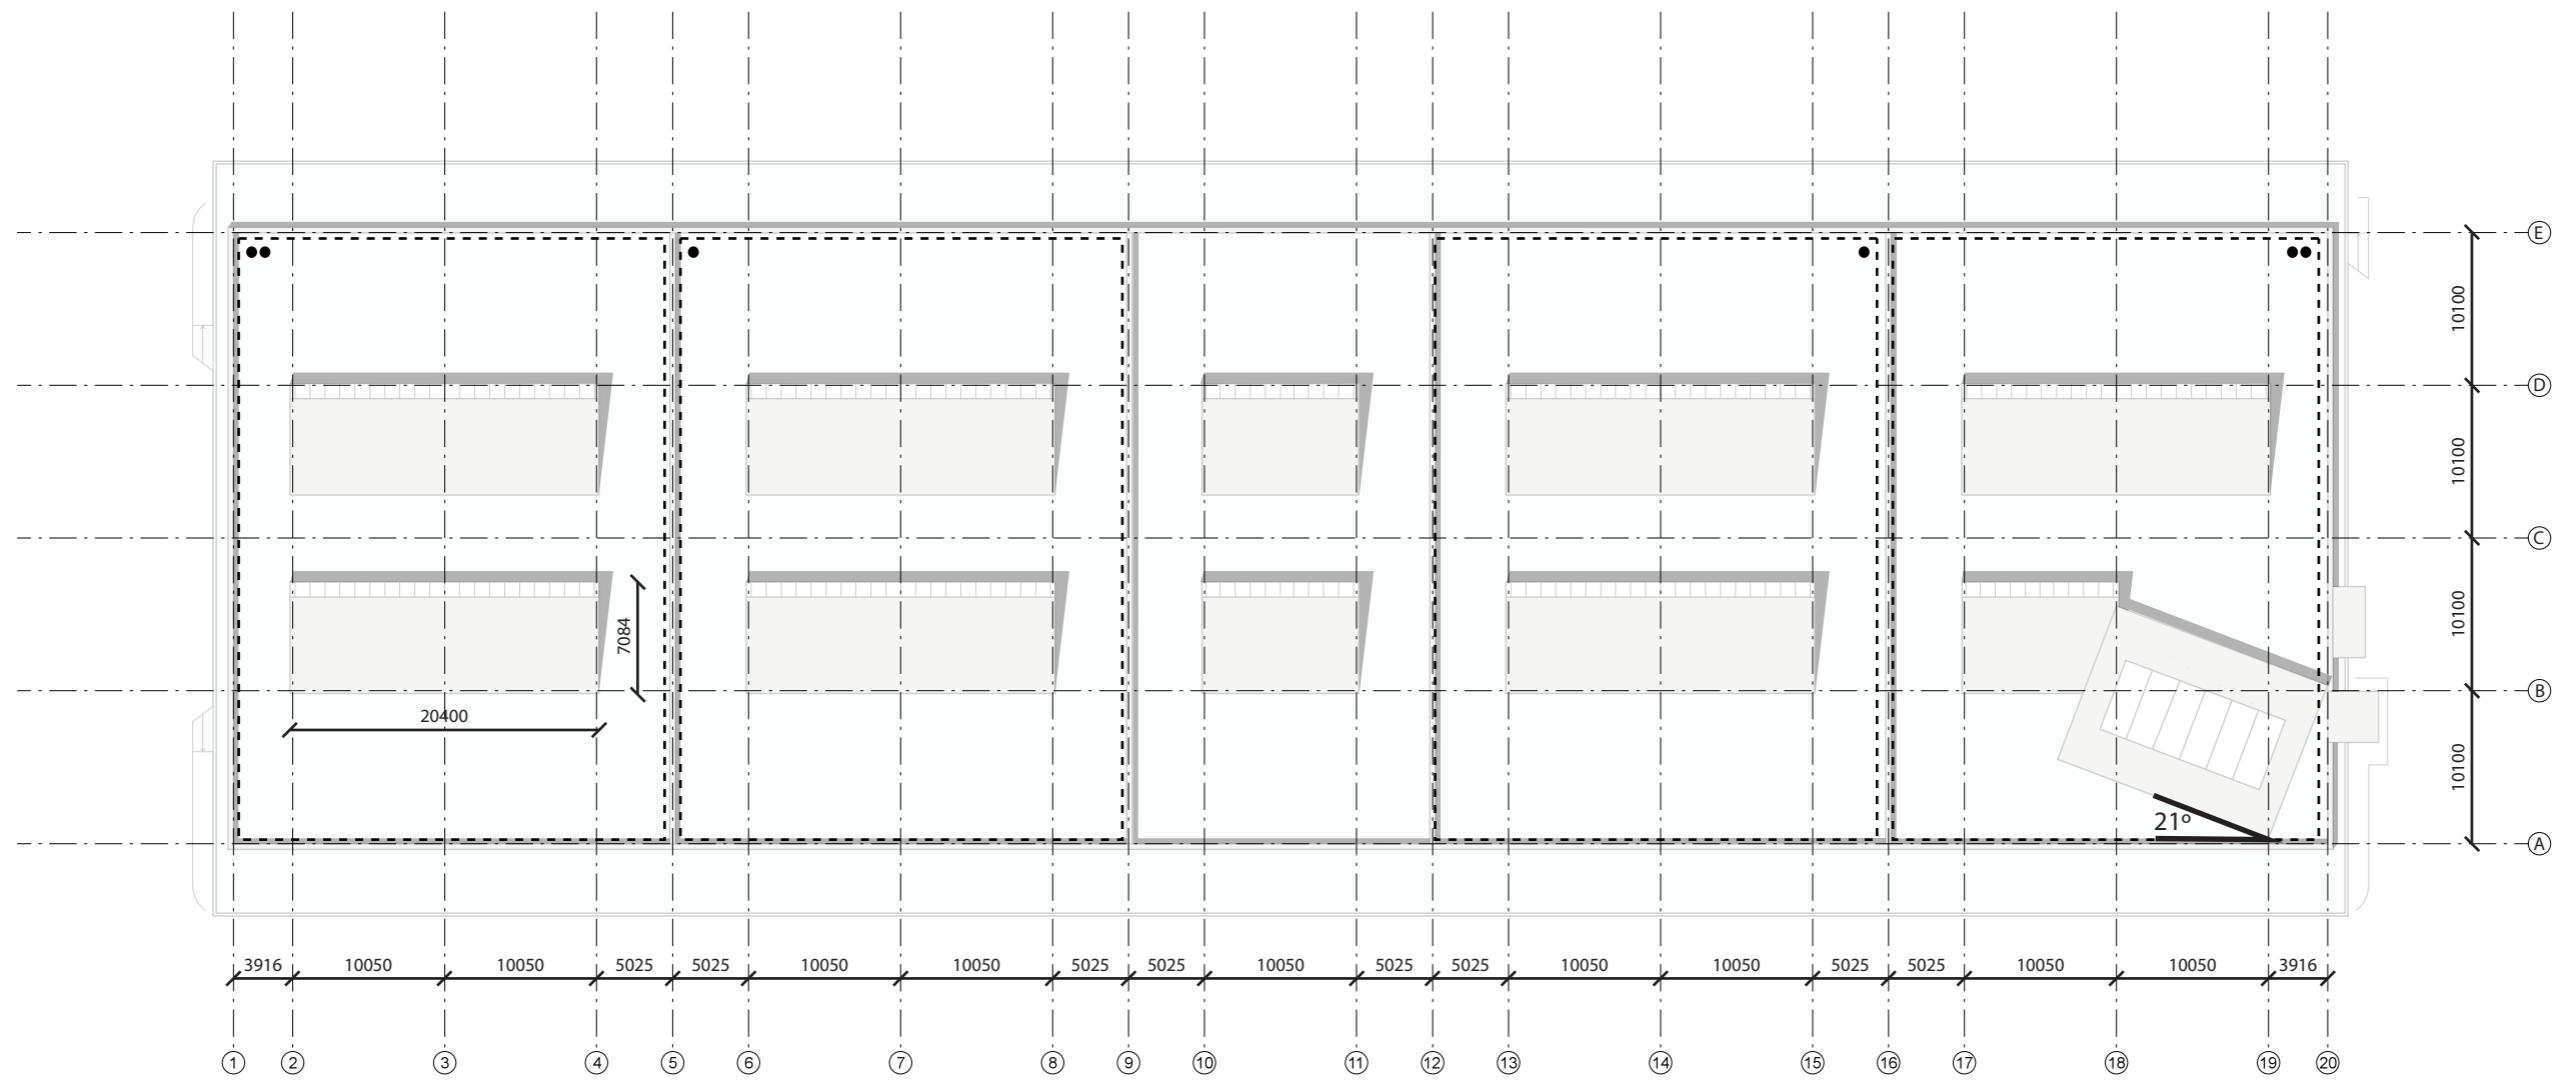
- building block 1
- building block 2
- building block 3
- facade opening
- mirroring part

roof facade elevation 3 by Jan Huis in 't Veld
(own illustration)

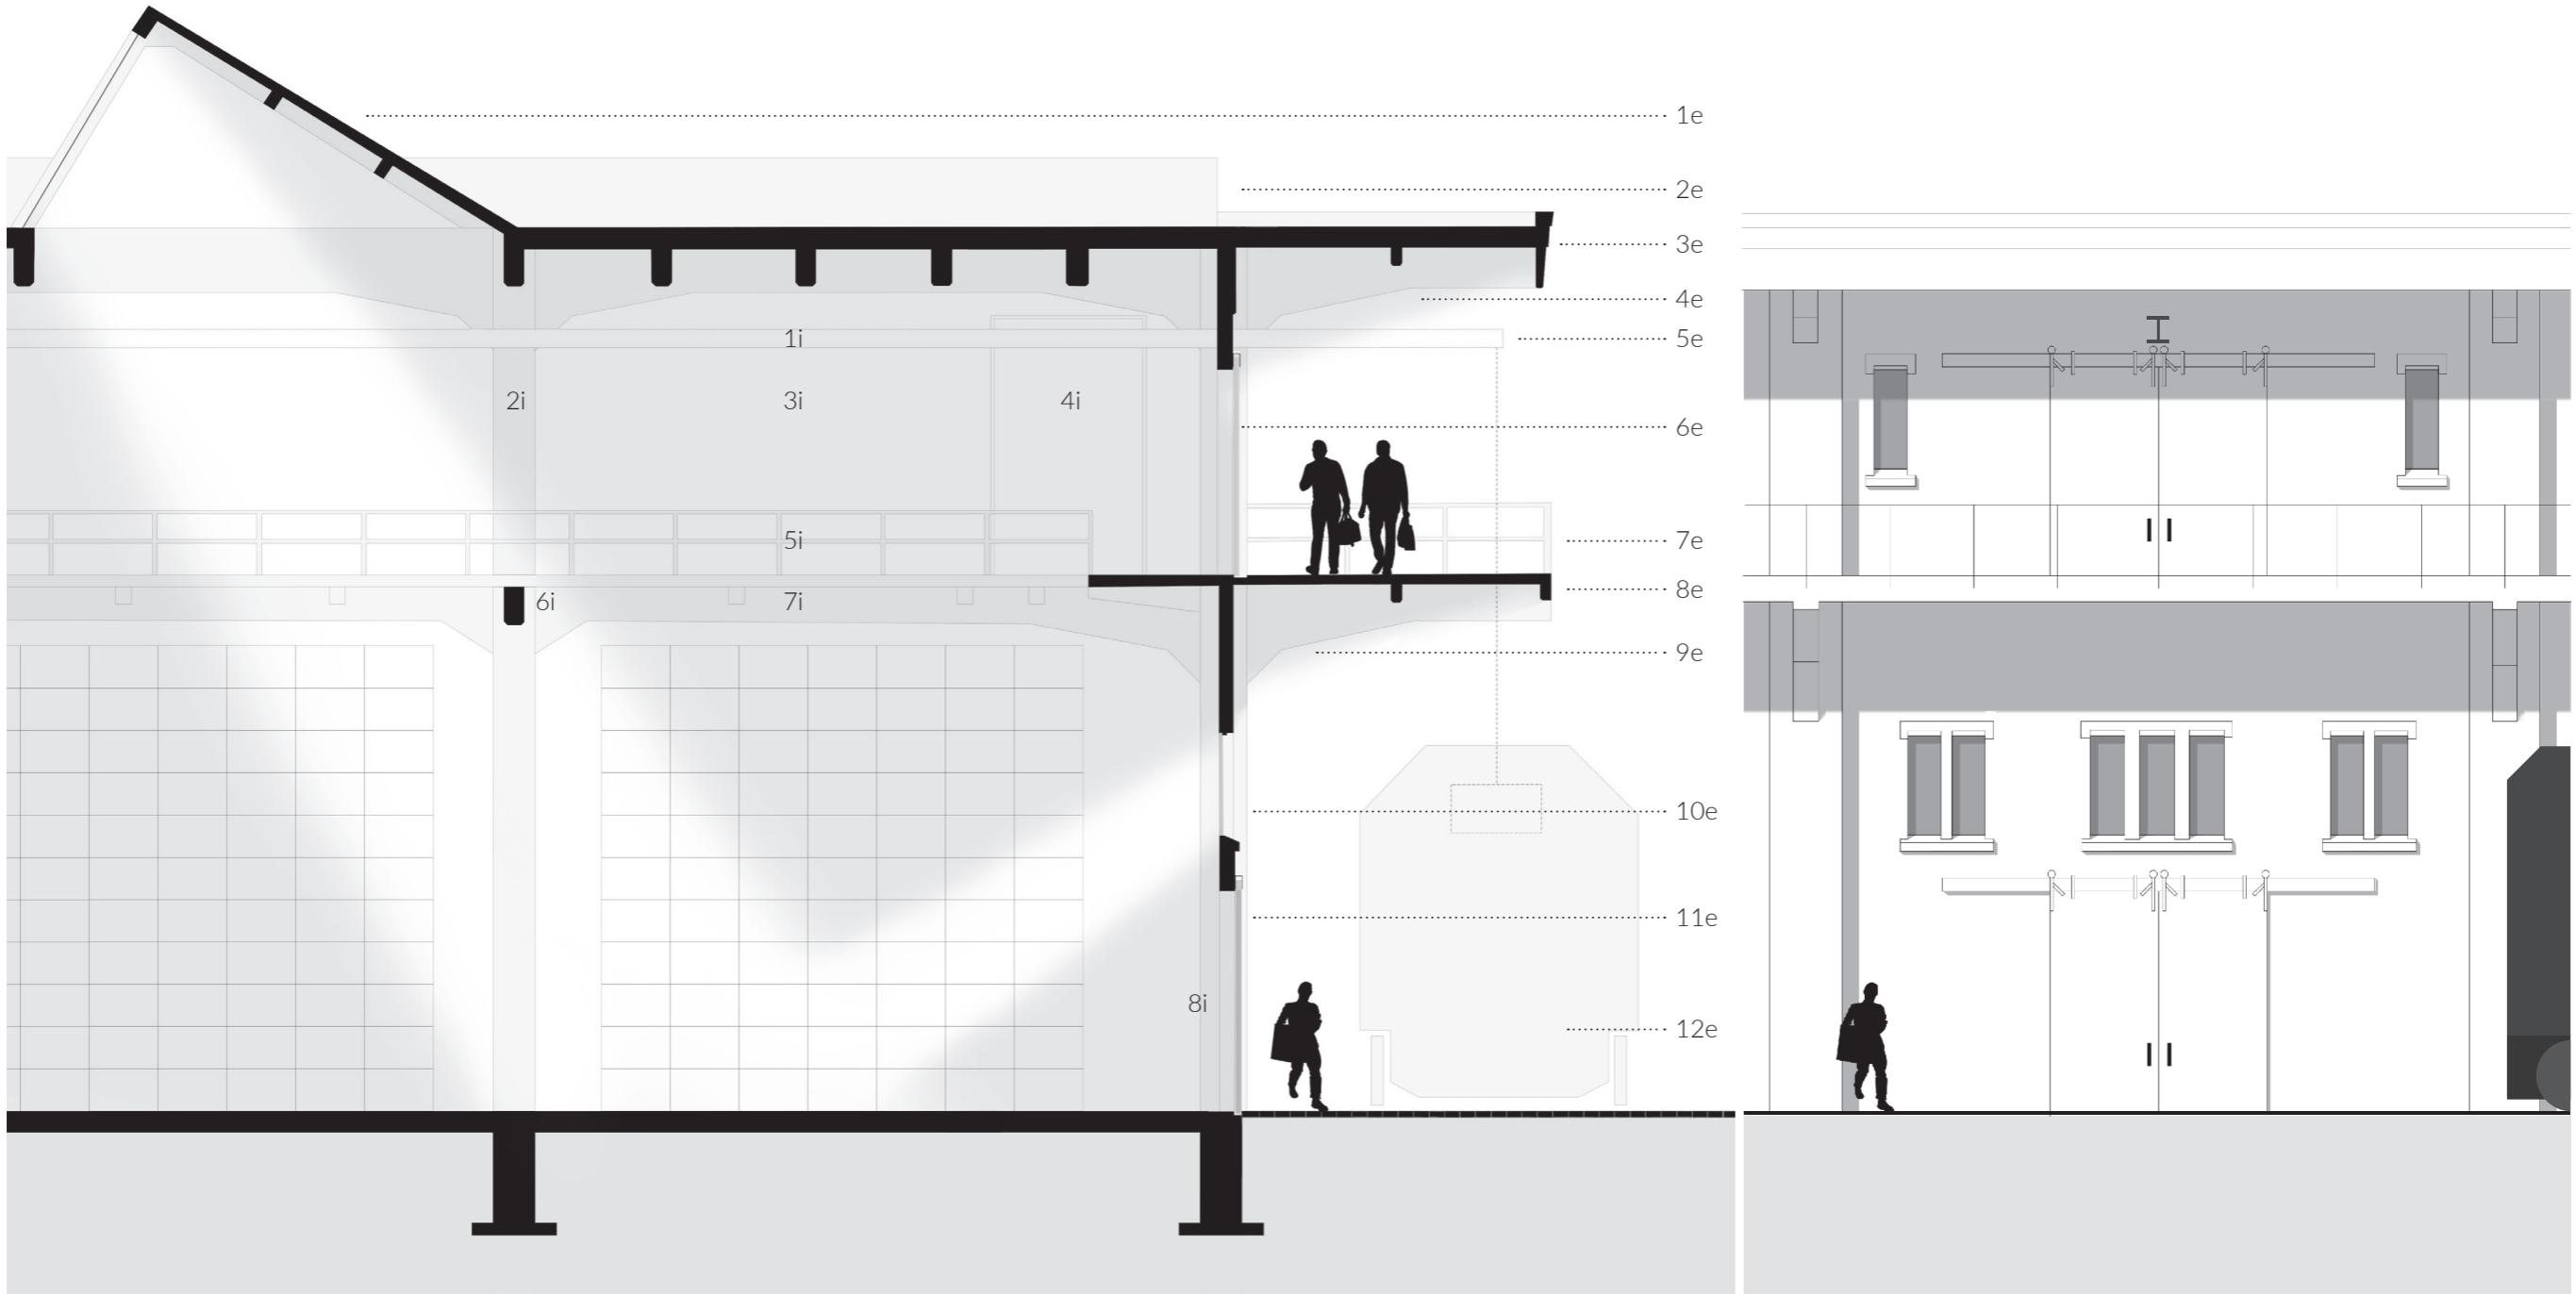
Katoenveem facade section & elevation 1:100 by joost van den Berge

exterior: 1. steel railtrack for easy transshipment of cotton bales - 2. large in situ concrete columns with paint finishing from ground floor till 2 meters above ground- 3. concrete in situ separation walls without finishing (traces timber casings still visible) - 4. Kinnear iron curtain doors/roller doors - 5. iron balustrade - 6. in situ concrete beams which connect columns and walls - 7. concrete in situ gallery's supported by small in situ concrete beams - 8. steel double sliding door suspended from a steel railing

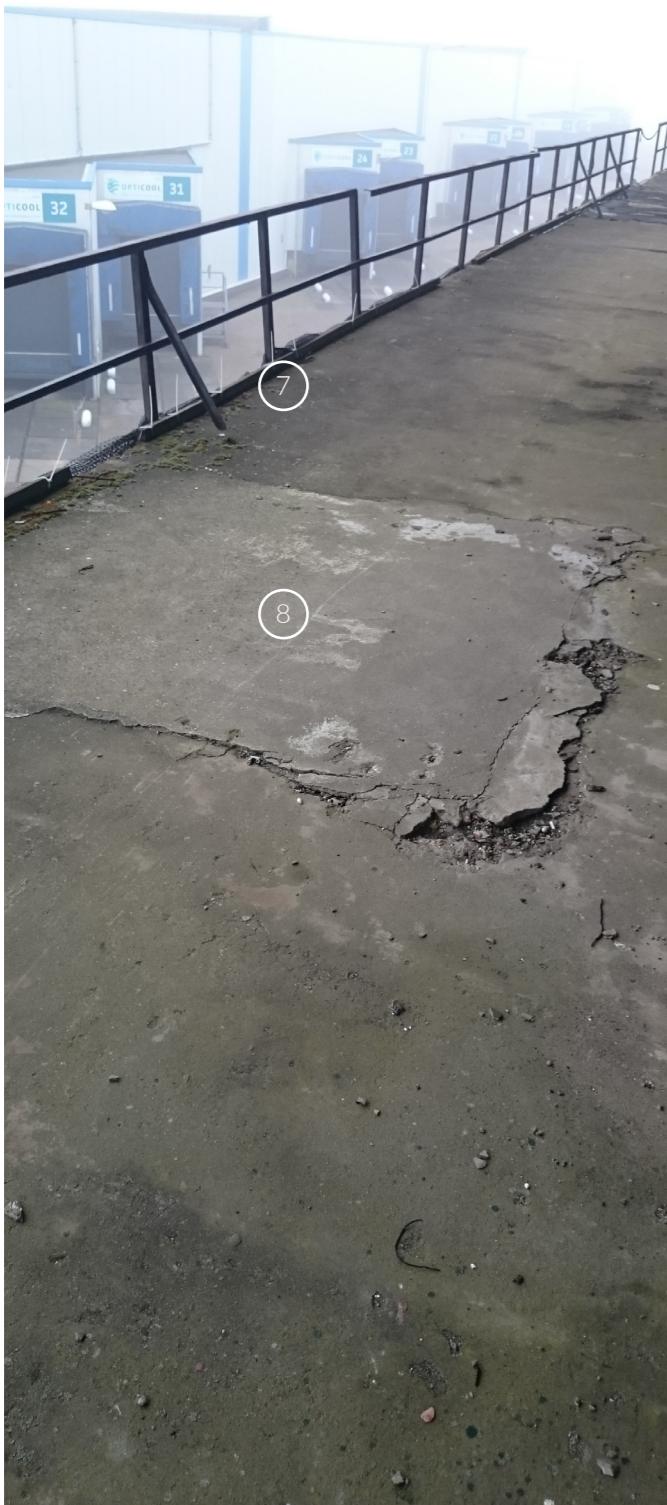
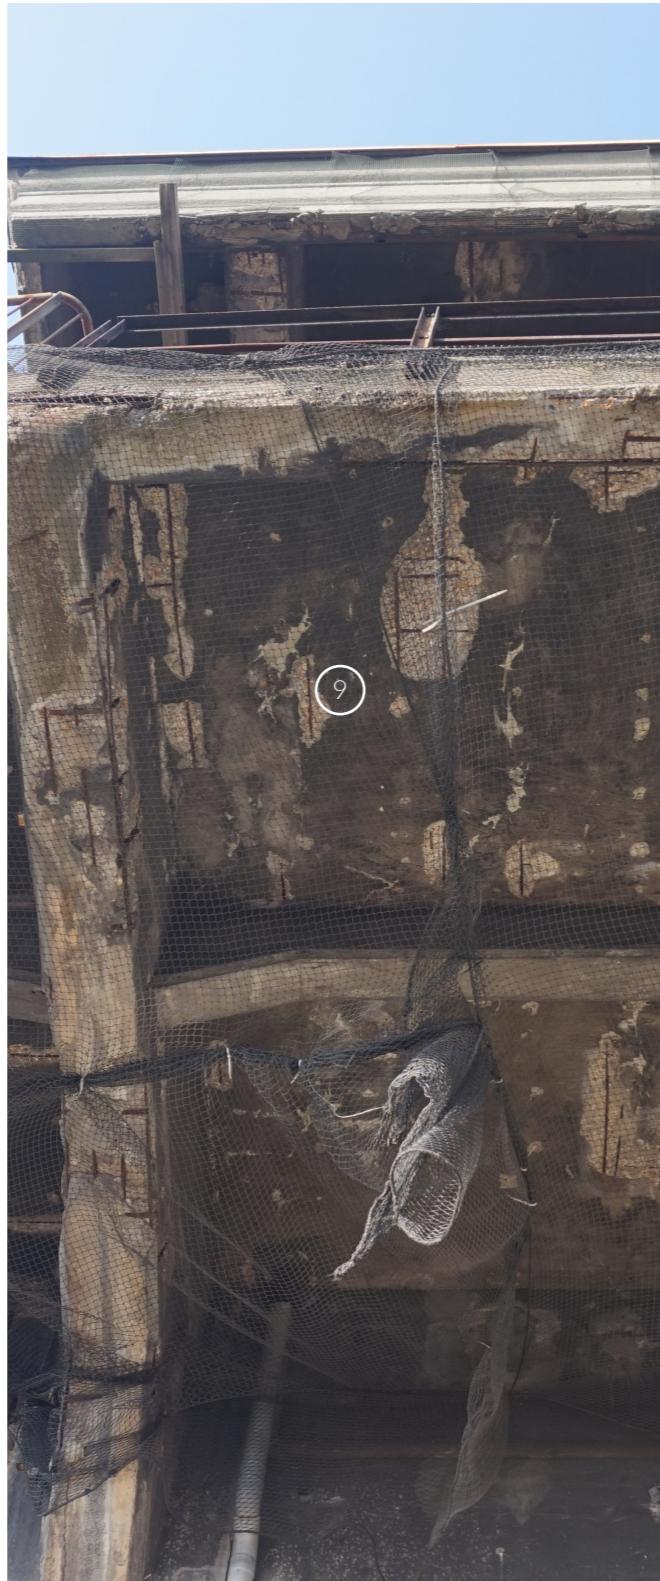
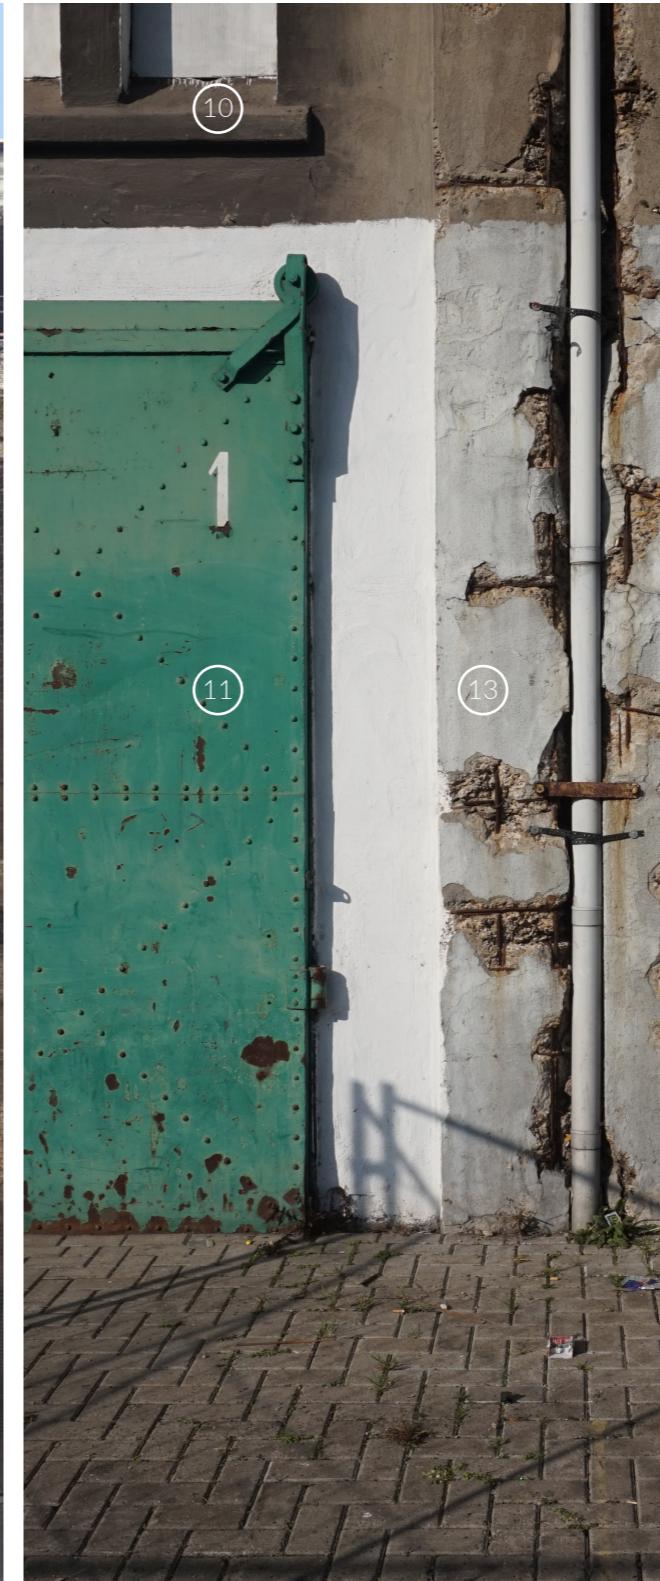
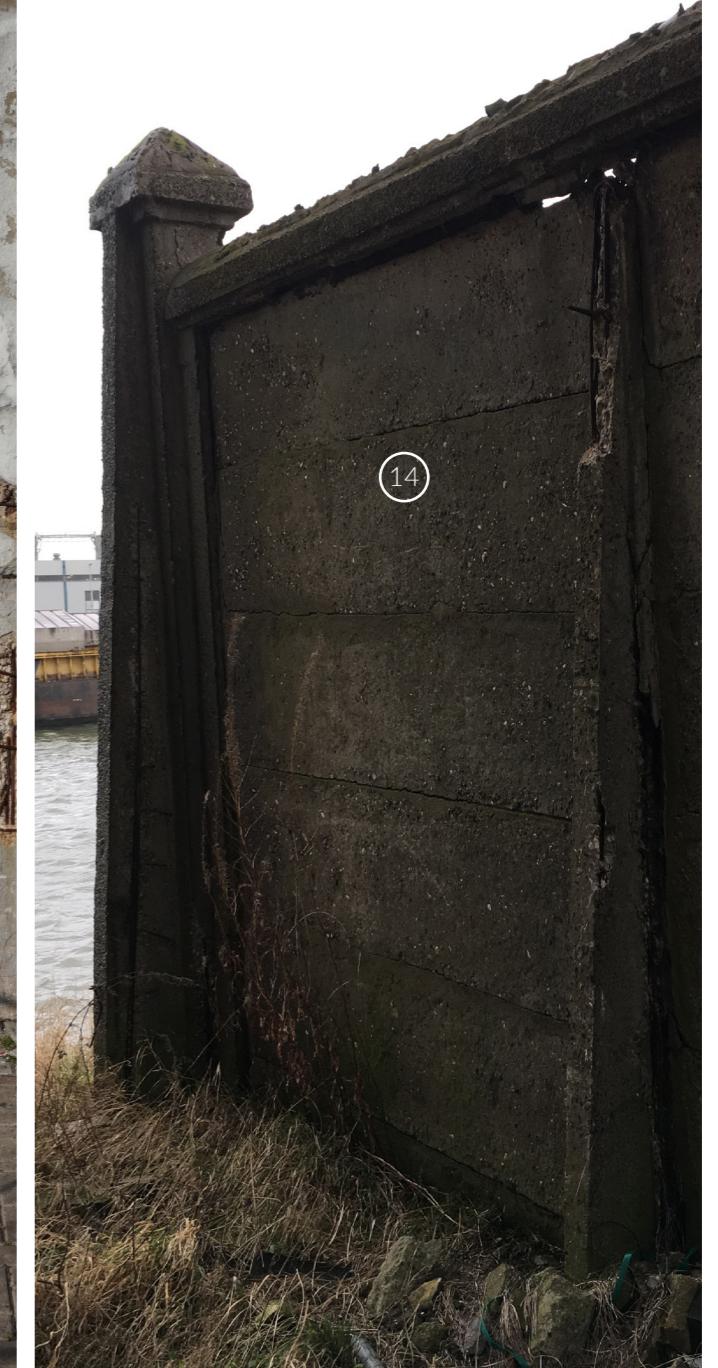
materialisation exterior and main elements by joost van den berge

7. here you can see the steel balustrade on the gallery and the bad state it is in. The balustrade is extremely weathered and damaged and some parts are even gone or destroyed - 8. at no. 8 you can see traces of the former holes in the gallery - 9. here you can see the bottom of the gallery with it's supporting beams and the reinforcement in the concrete. Clearly it has weathered in great measure and at several places the sand cement layer has come of. Next to that you can still see the black/greyish soot layer at many points derived from the industry, ships but mainly the trains that used to drive underneath the gallery's. - 10. the window sill and the window itself is visible at no. 10, also constructed in concrete (more about this on the next pages) - 11. here is one of the many green finished steel sliding doors of the American Kinnear system visible. They have many traces of damage and rust but are still in quite a good state - 13. here you can see the dilatation and a water drain between the different building volumes with extreme damages and rust - 14. in the last picture you can see the small part that is left of the former enclosing wall of the site with the same concrete structure as the Katoenveem building
