KATOENVEEM

MSc III Heritage & Architecture

Architectural & Building Technology Analysis

07/04/2017

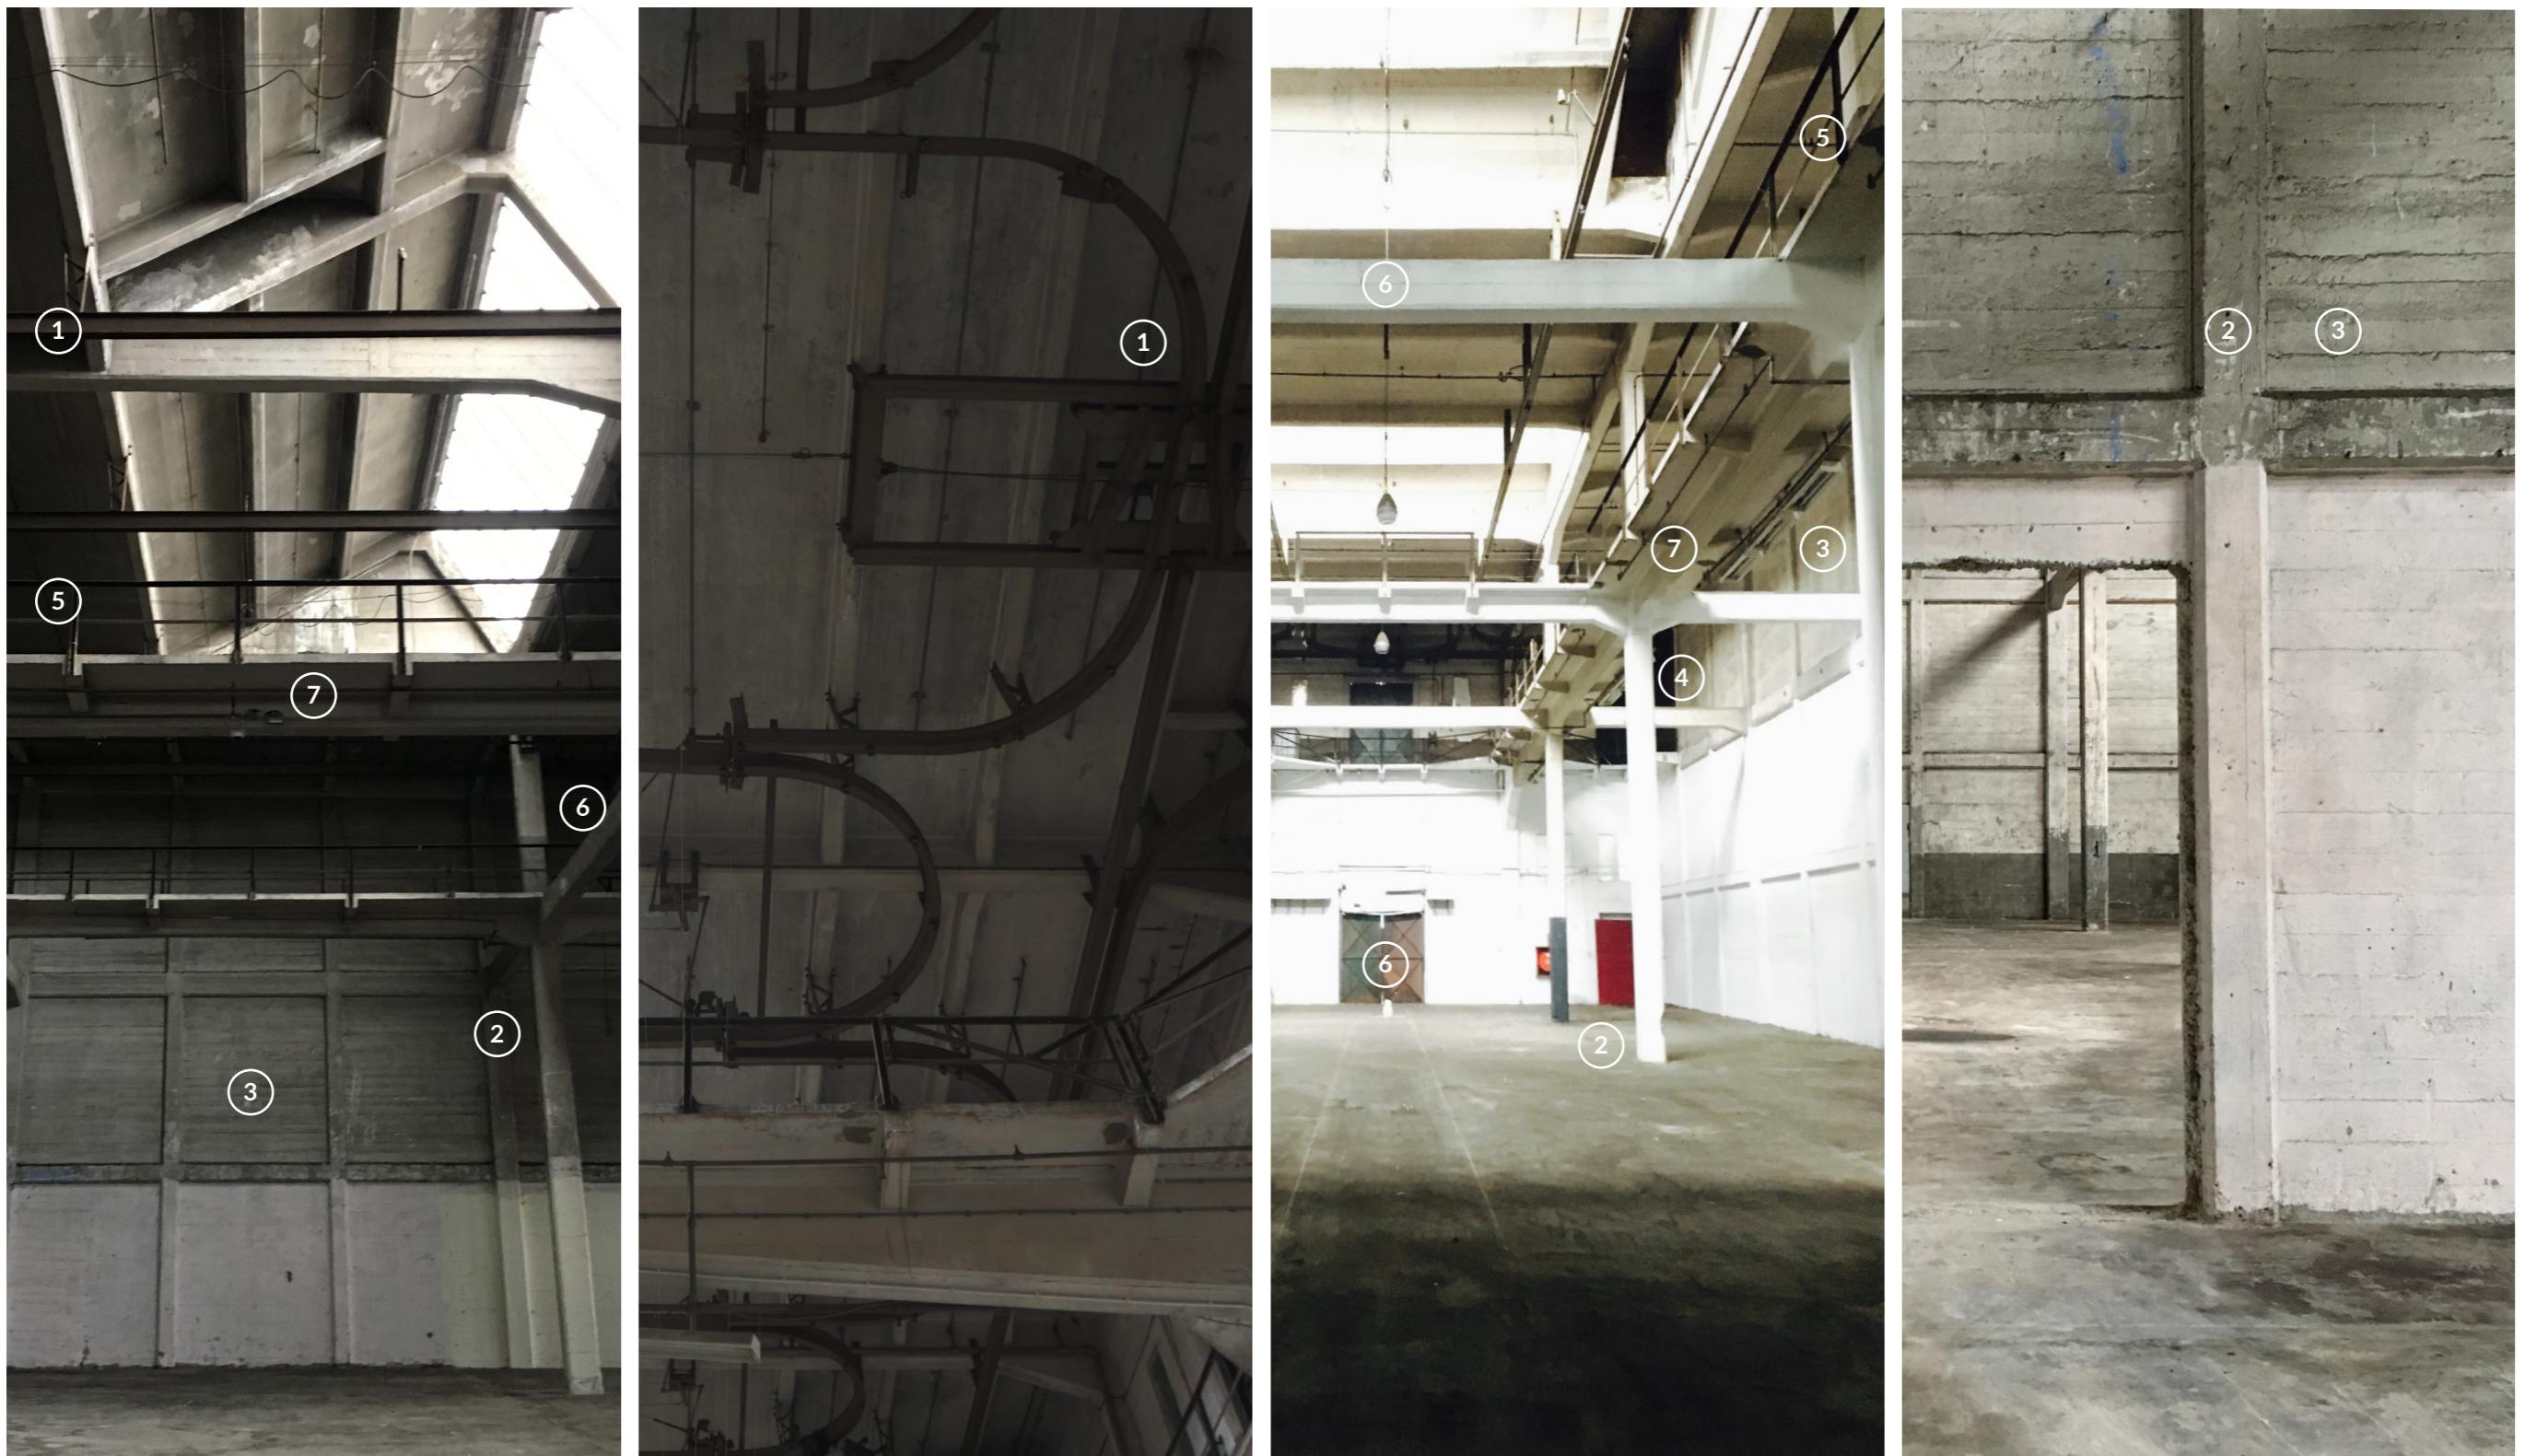
materialisation interior and main elements by joost van den berge

1. at the no.'s 1 you can see the loopkat or steel railtrack still in good shape - 2. at no. 2 you can see the large concrete columns, in sometimes unfinished state but mostly painted or with painted finishing until 2 meters from the floor - 3. here you can see the large concrete in situ separation walls where the way of constructing by wooden castings is still clearly visible, sometimes the walls are painted white - 4. at no. 4 the Kinnear iron curtain doors/roller doors are present - 5. no. 5 shows the iron balustrades present along the gallery's - 6. here the in situ concrete beams which connect columns and walls are visible, also painted white at some spots - 7. at no. 7 you can see the gallery's with the small concrete beams - 8. the last number shows the inside of the steel doors which have quite large amounts of rust but are still in quite good condition

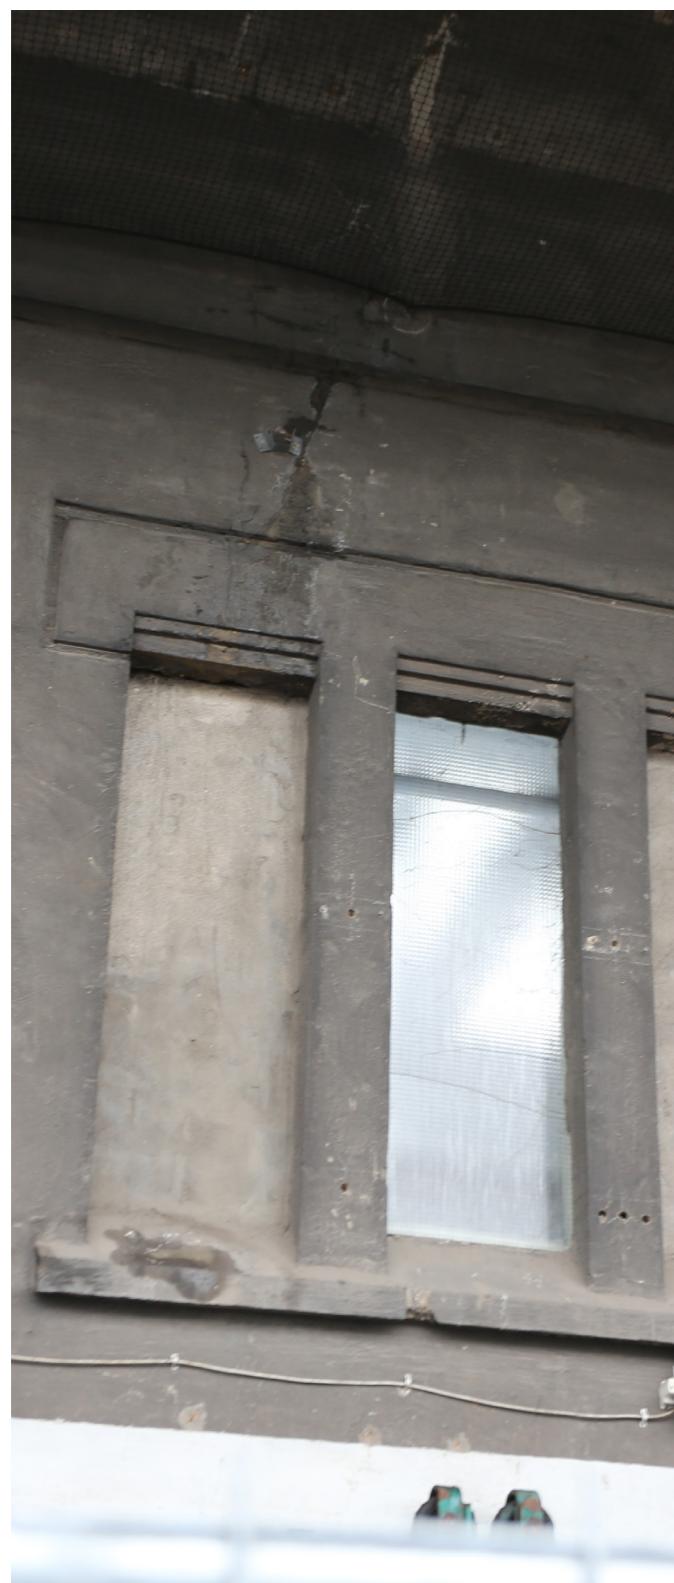
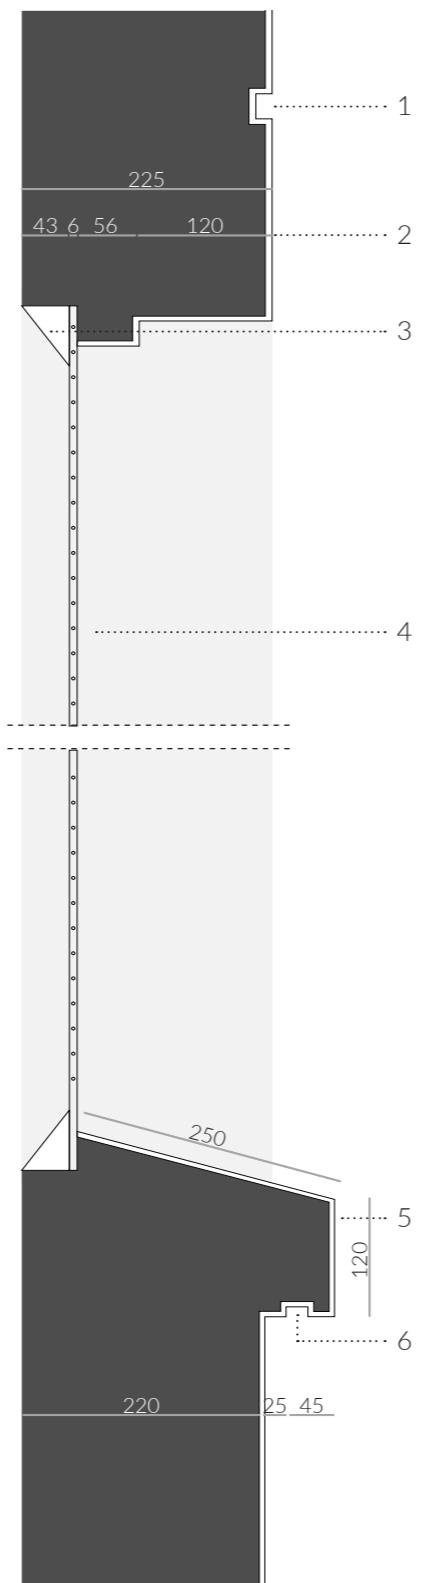
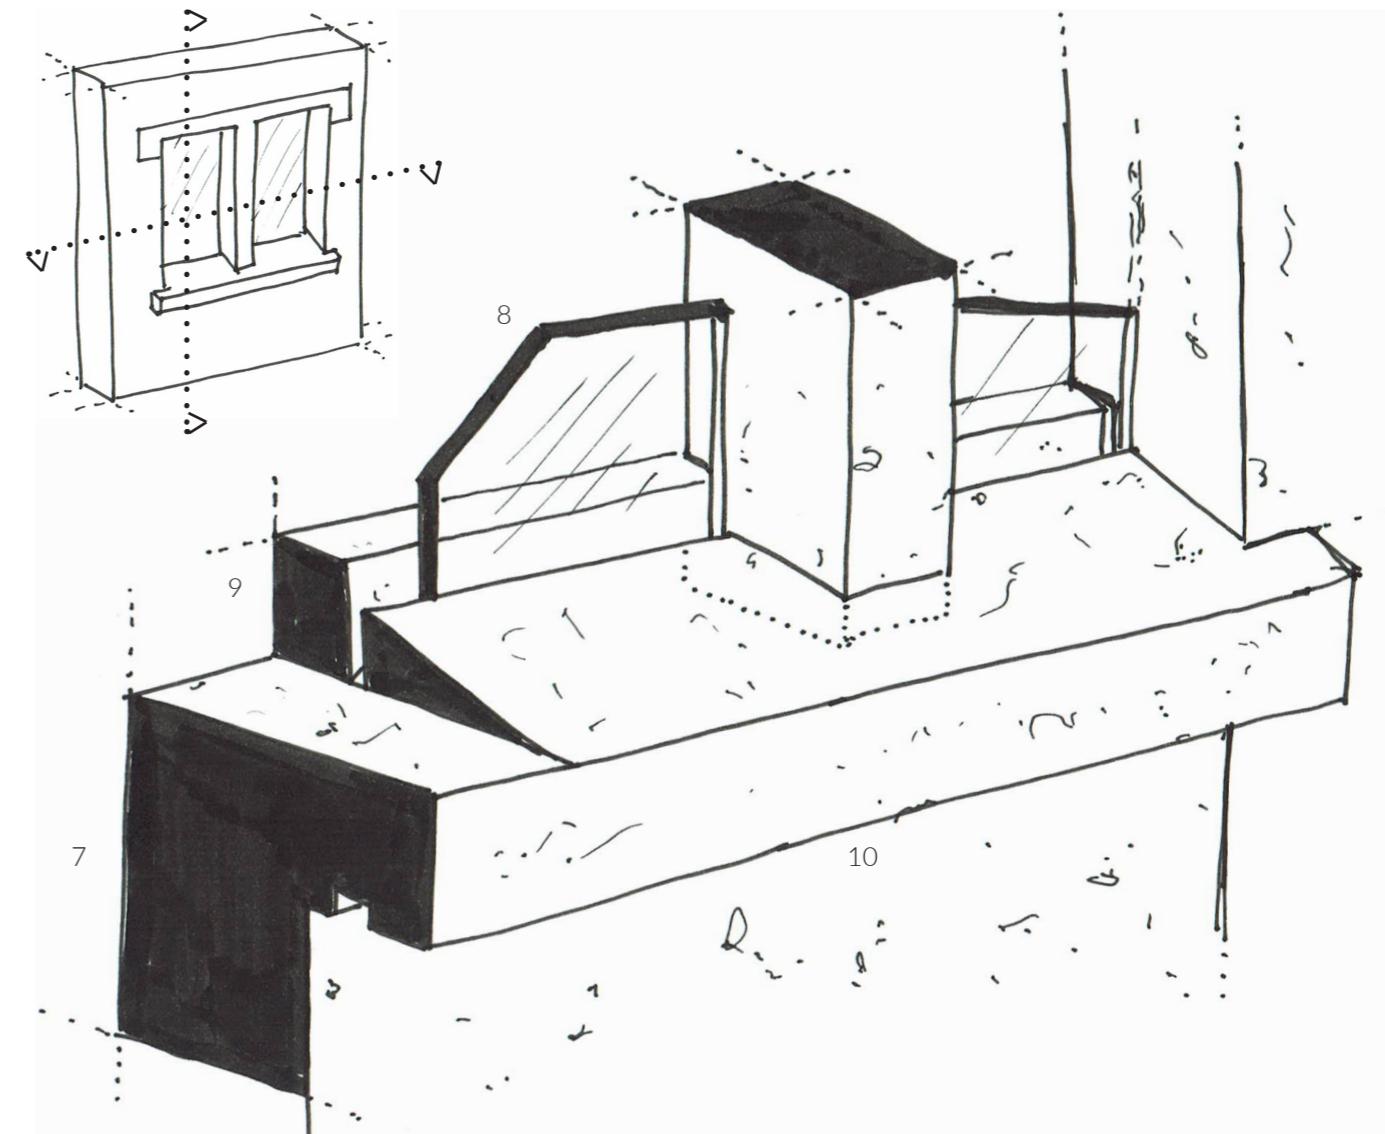
windows by joost van den berge

1. hole to suggest a lintel - 2. 10 mm sand cement layer - 3. sand cement sealing - 4. wired glass - 5. profiled concrete window sill - 6. water cutting hole

The window frames are built in one piece on the construction site, and poored into the concrete wall.

A remarkable detail is the suggestion of a lintel in het façade (see details and next page). The windows have wireframed glass, probably to prevent a fire transfer to another compartment.
construction principle: 7. first step: create window opening - 8. second step: placement wired glass - 9. third step: fixation glass sand cement sealing - 10. last step: addition sand cement layer

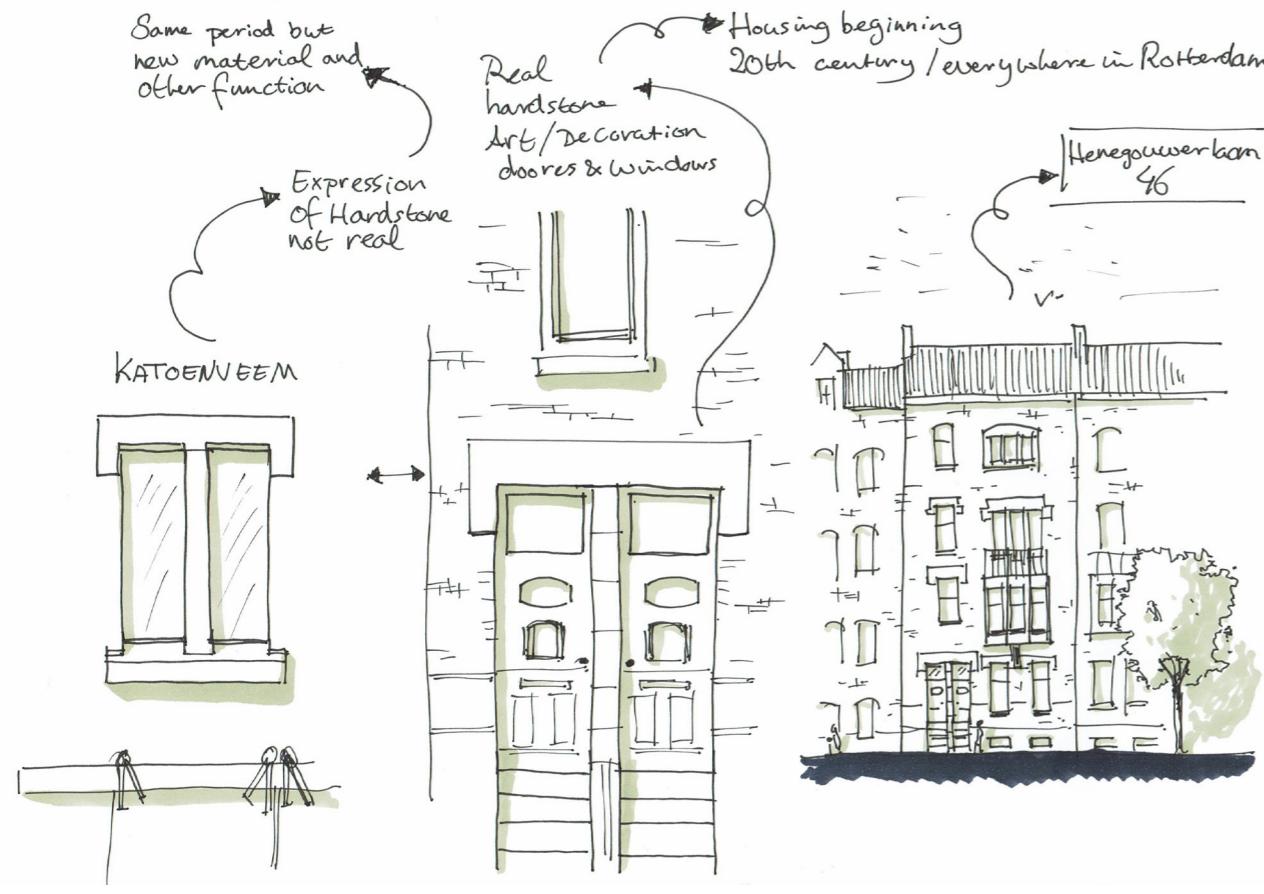
Katoenveem window decoration lintel study by joost van den berge

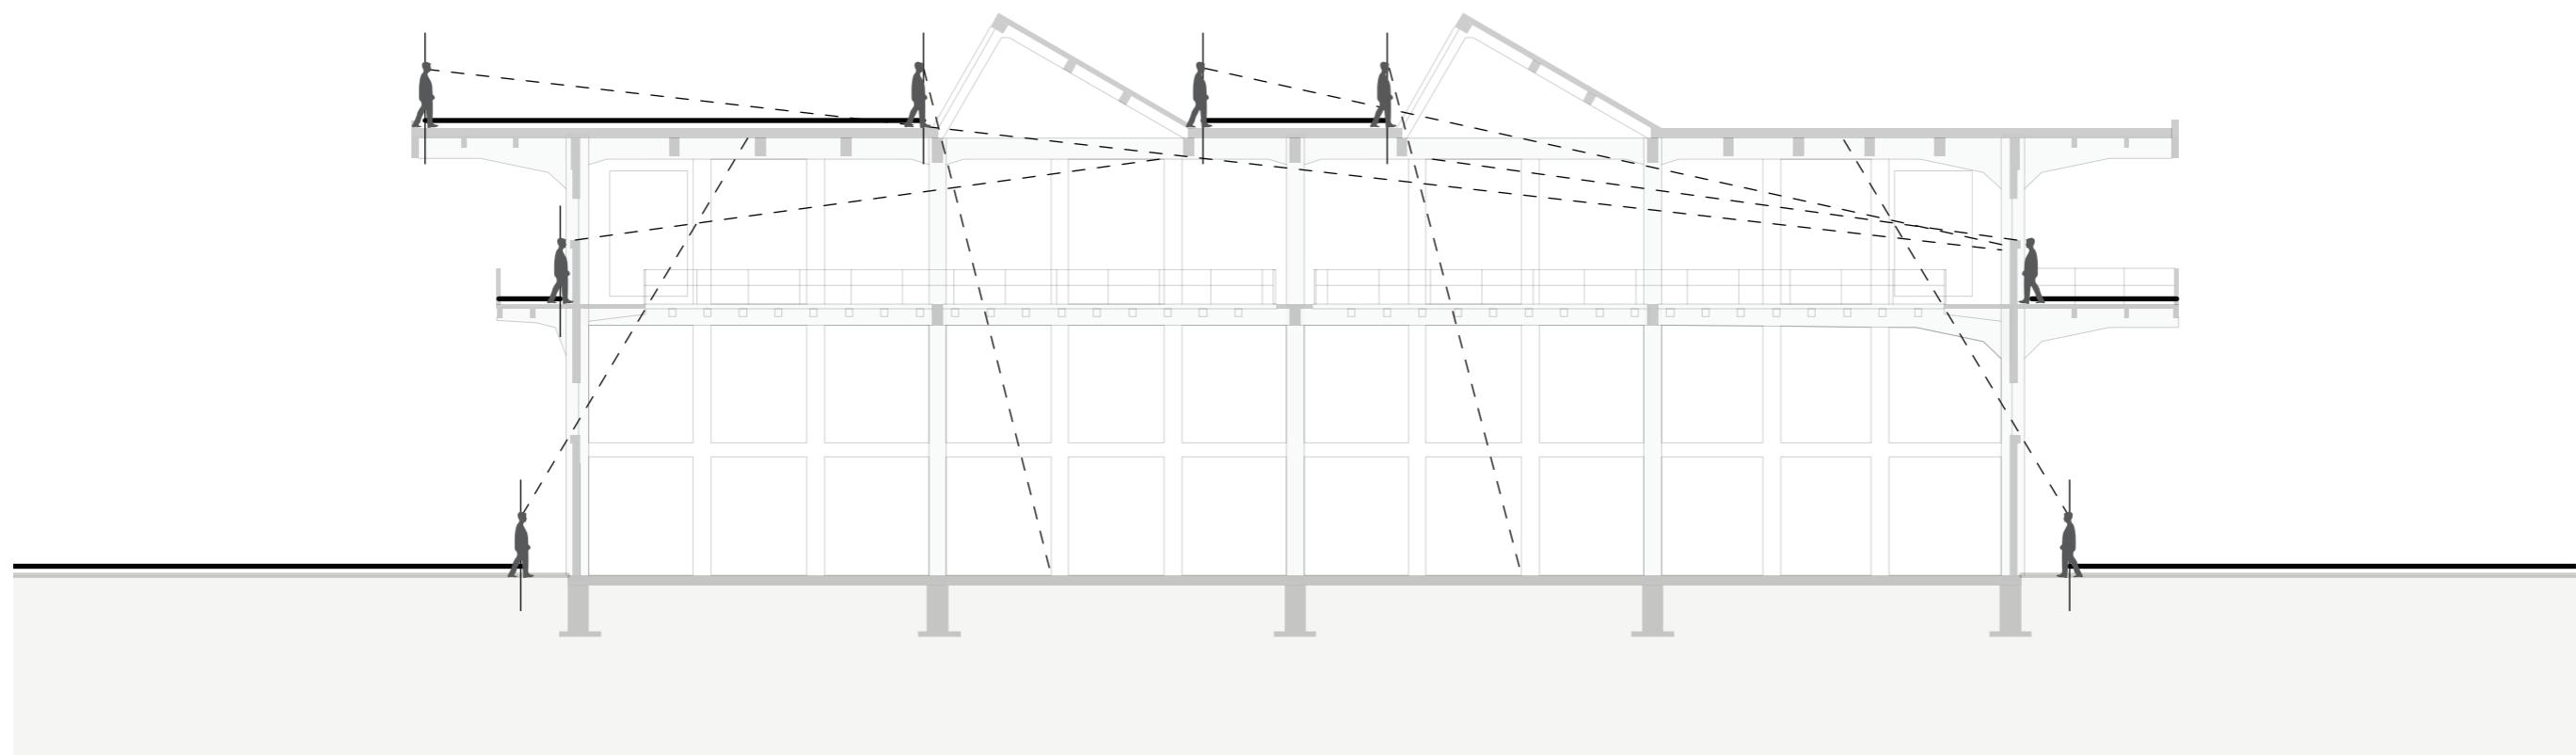
exterior - interior vision by Jan Huis in 't Veld
(own illustration)

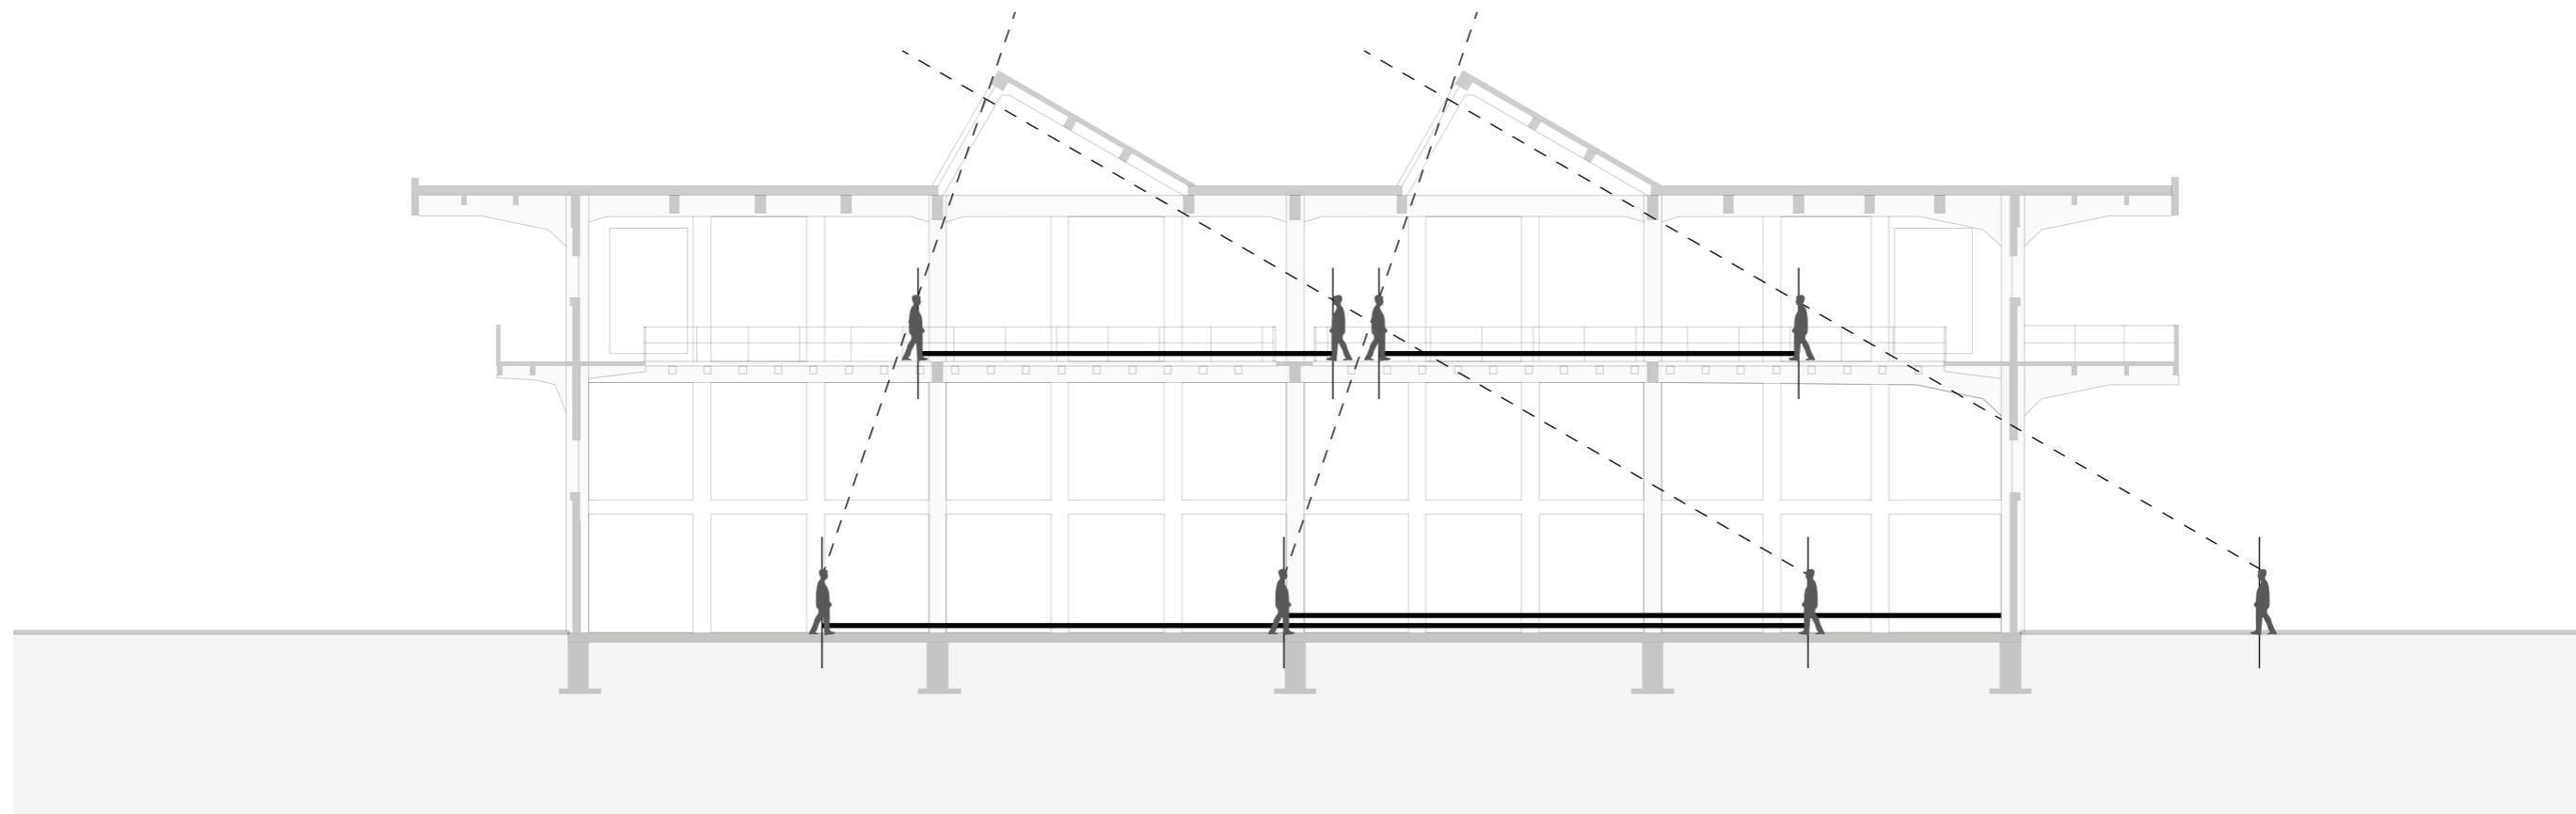
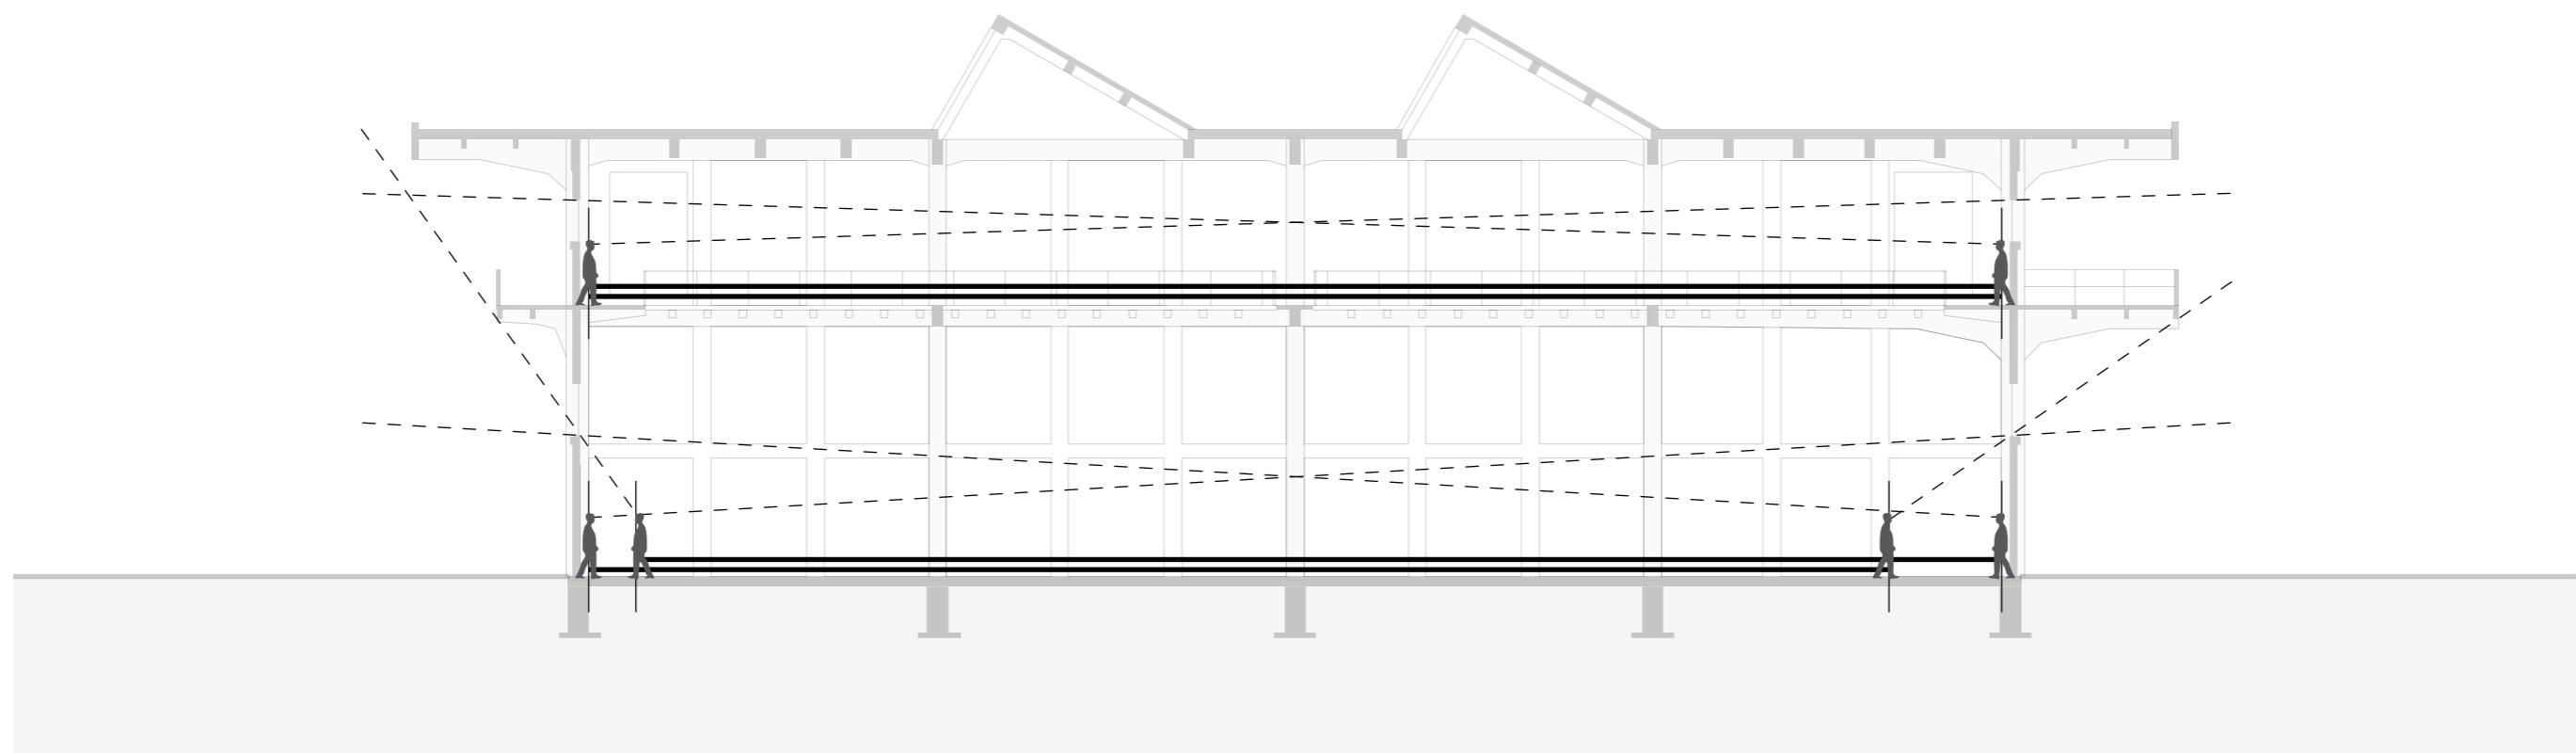
interior - exterior vision 1,2 by Jan Huis in 't Veld
(own illustration)

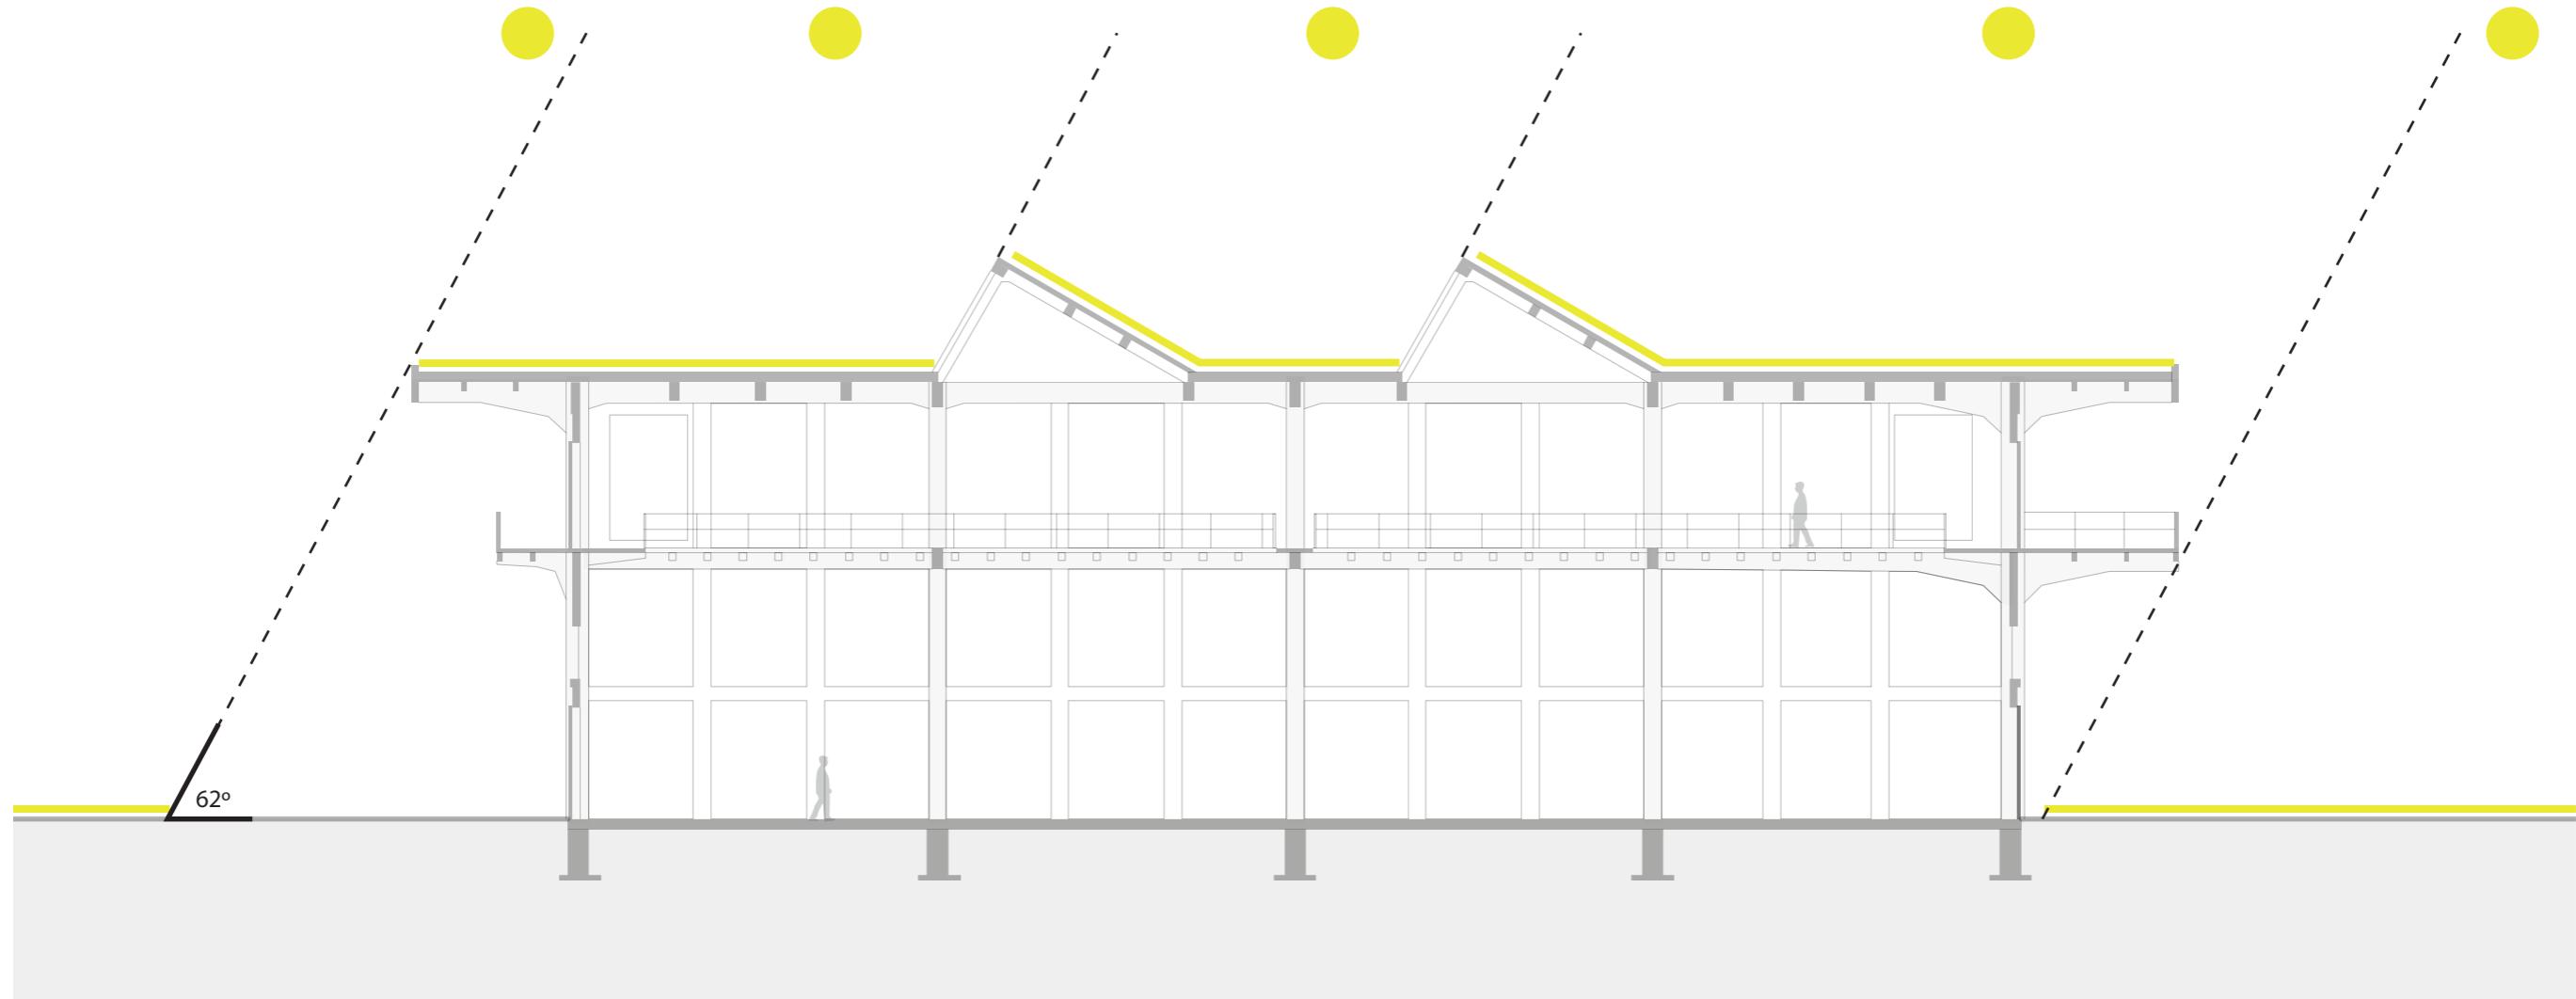
summer sun by Jan Huis in 't Veld
(own illustration)

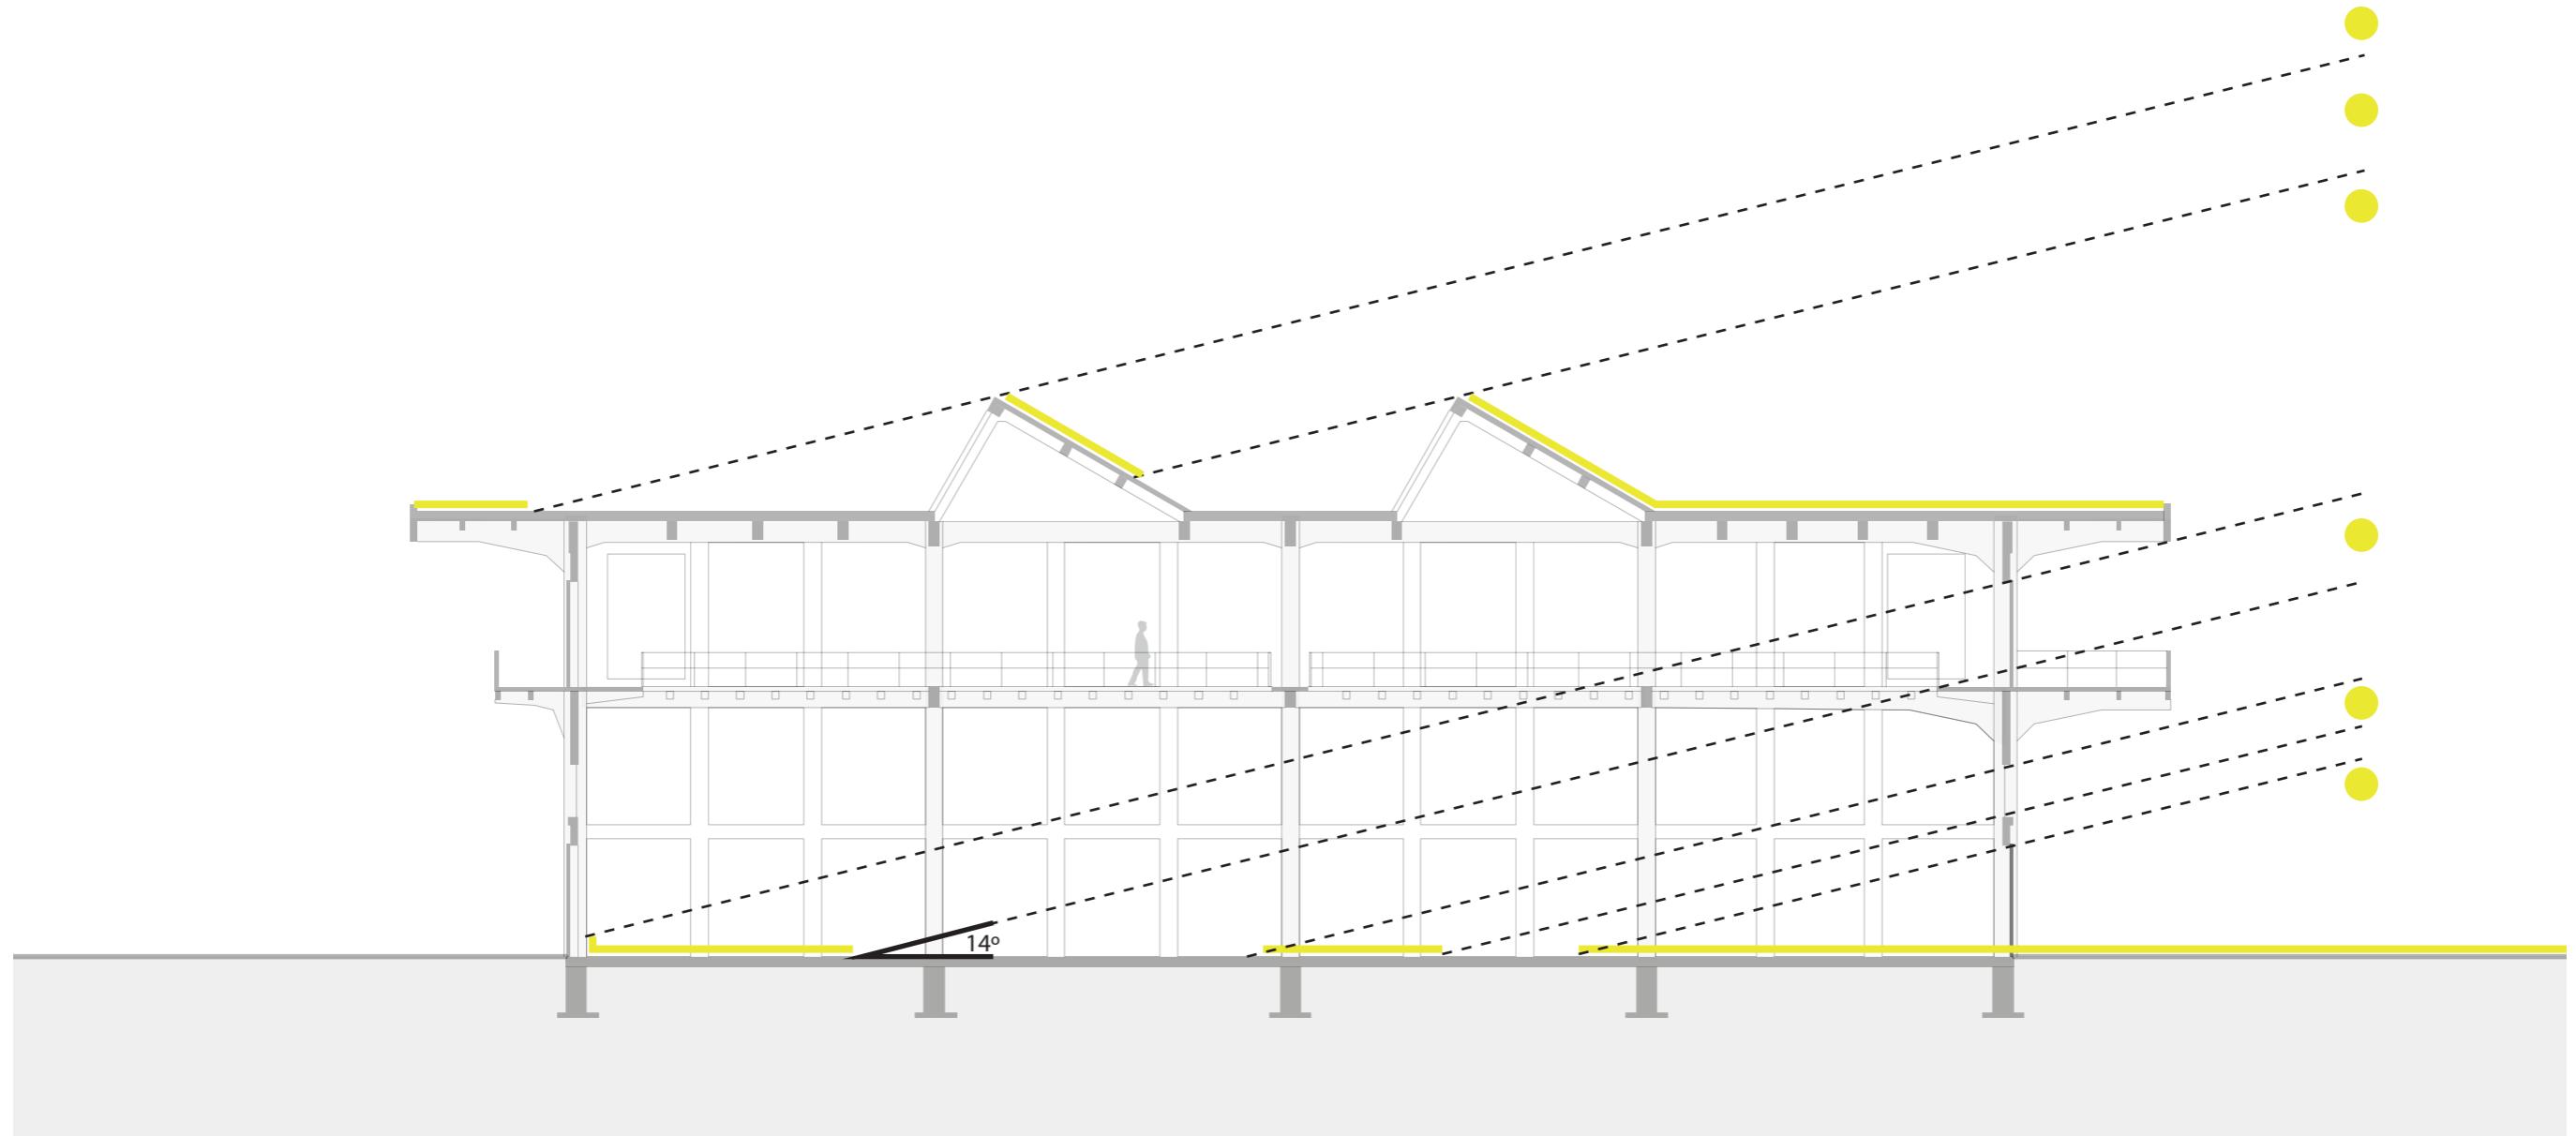
winter sun by Jan Huis in 't Veld
(own illustration)

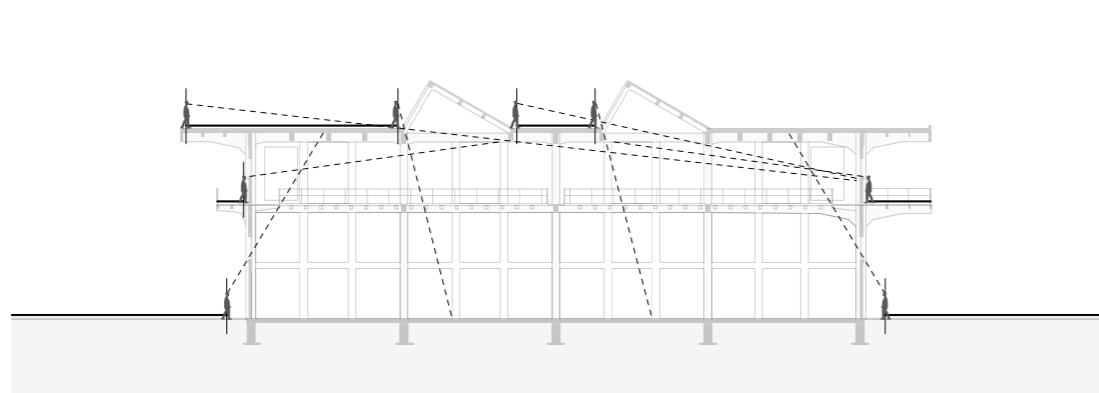
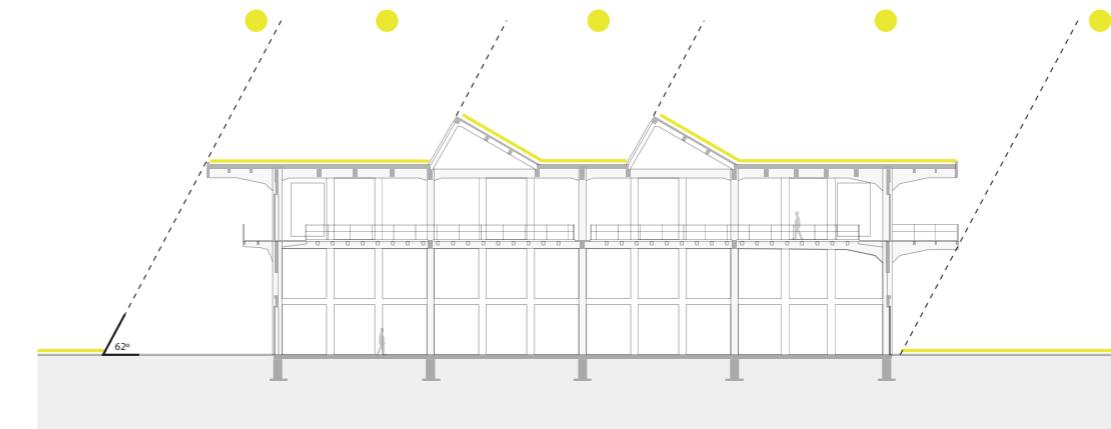
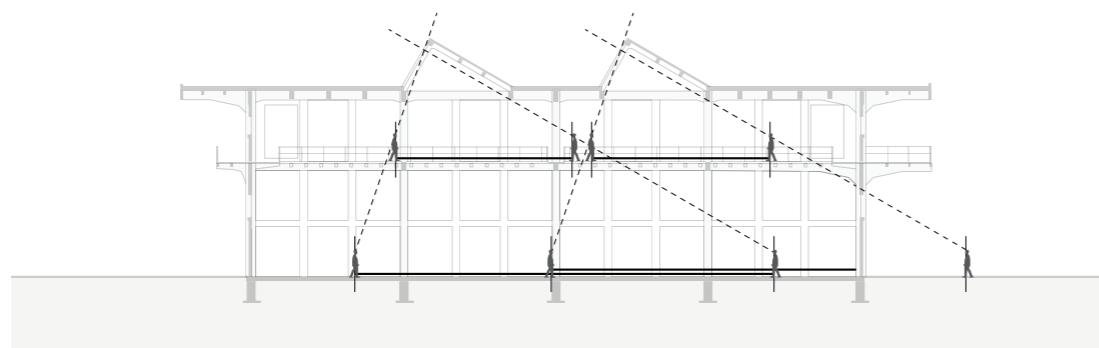
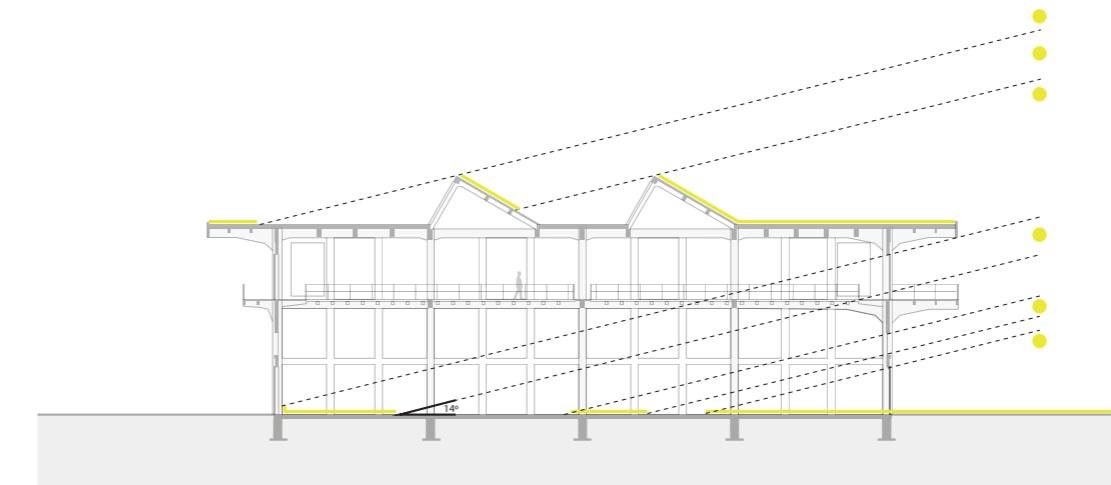
transparency schemes by Jan Huis in 't Veld
(own illustration)

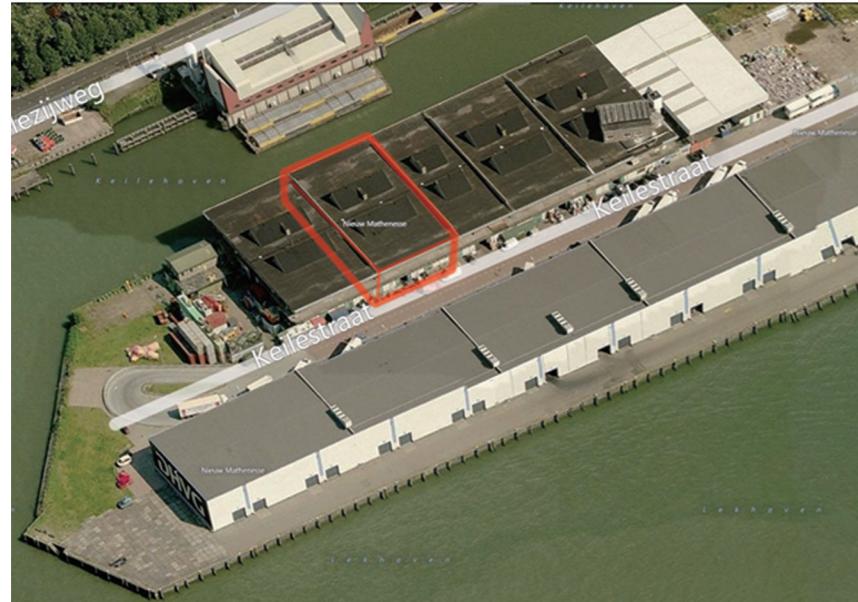
fig1.Bird's view of Katoenveem and the choice of compartment for structural analysis.

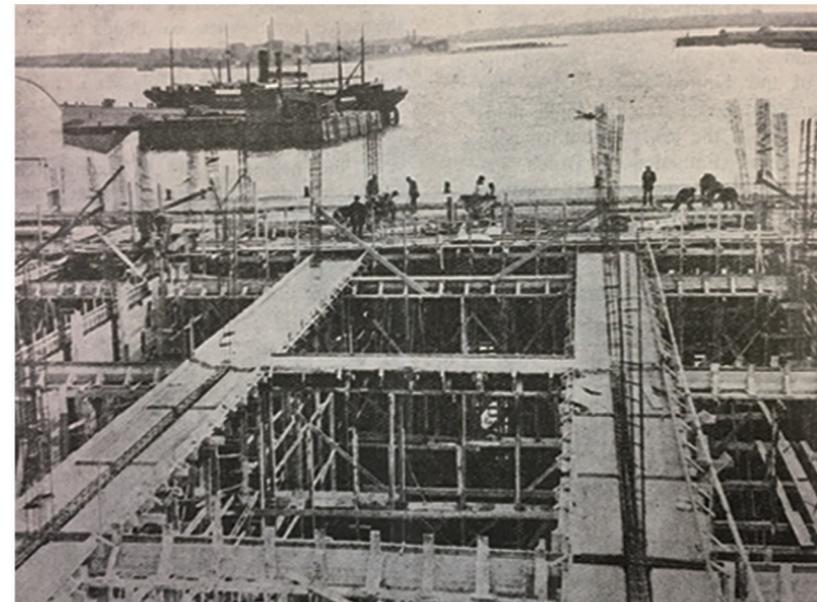
fig2. Building in construction. The use of reinforced concrete and wood moulds are visible in the photo.

foundation of the Katoenveem. The system of the columns in the Hennebique system and the Katoenveem appear to be similar. In certain damaged parts of the Katoenveem the structure was visible. Additionally the construction photograph of the Katoenveem shows a resemblance with the Hennebique system column (illustration 2).
