KATOENVEEM

MSc III Heritage & Architecture

Architectural & Building Technology Analysis

07/04/2017

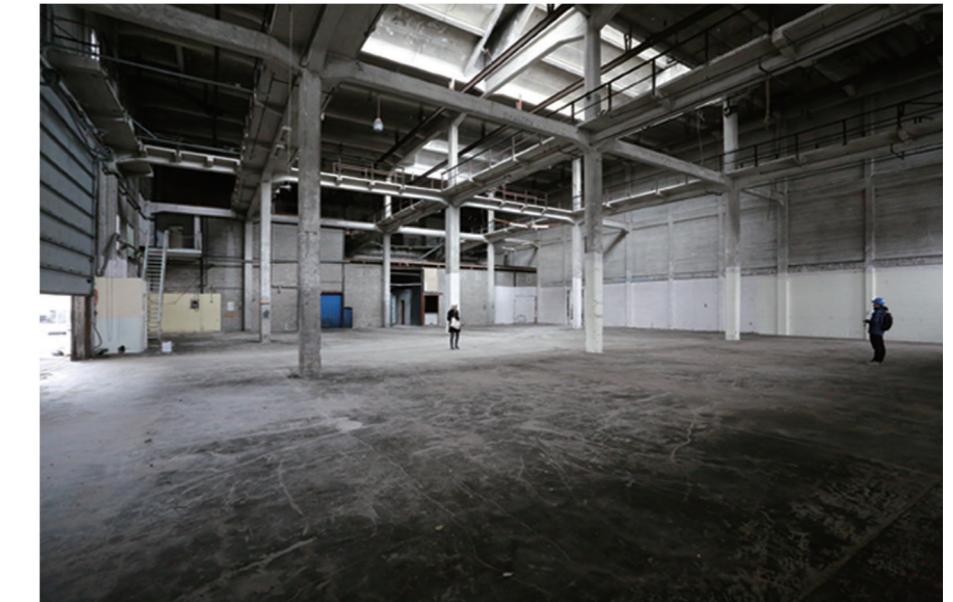
fig3. Interior appearance of the grid structure. The structure is over-human-scale.

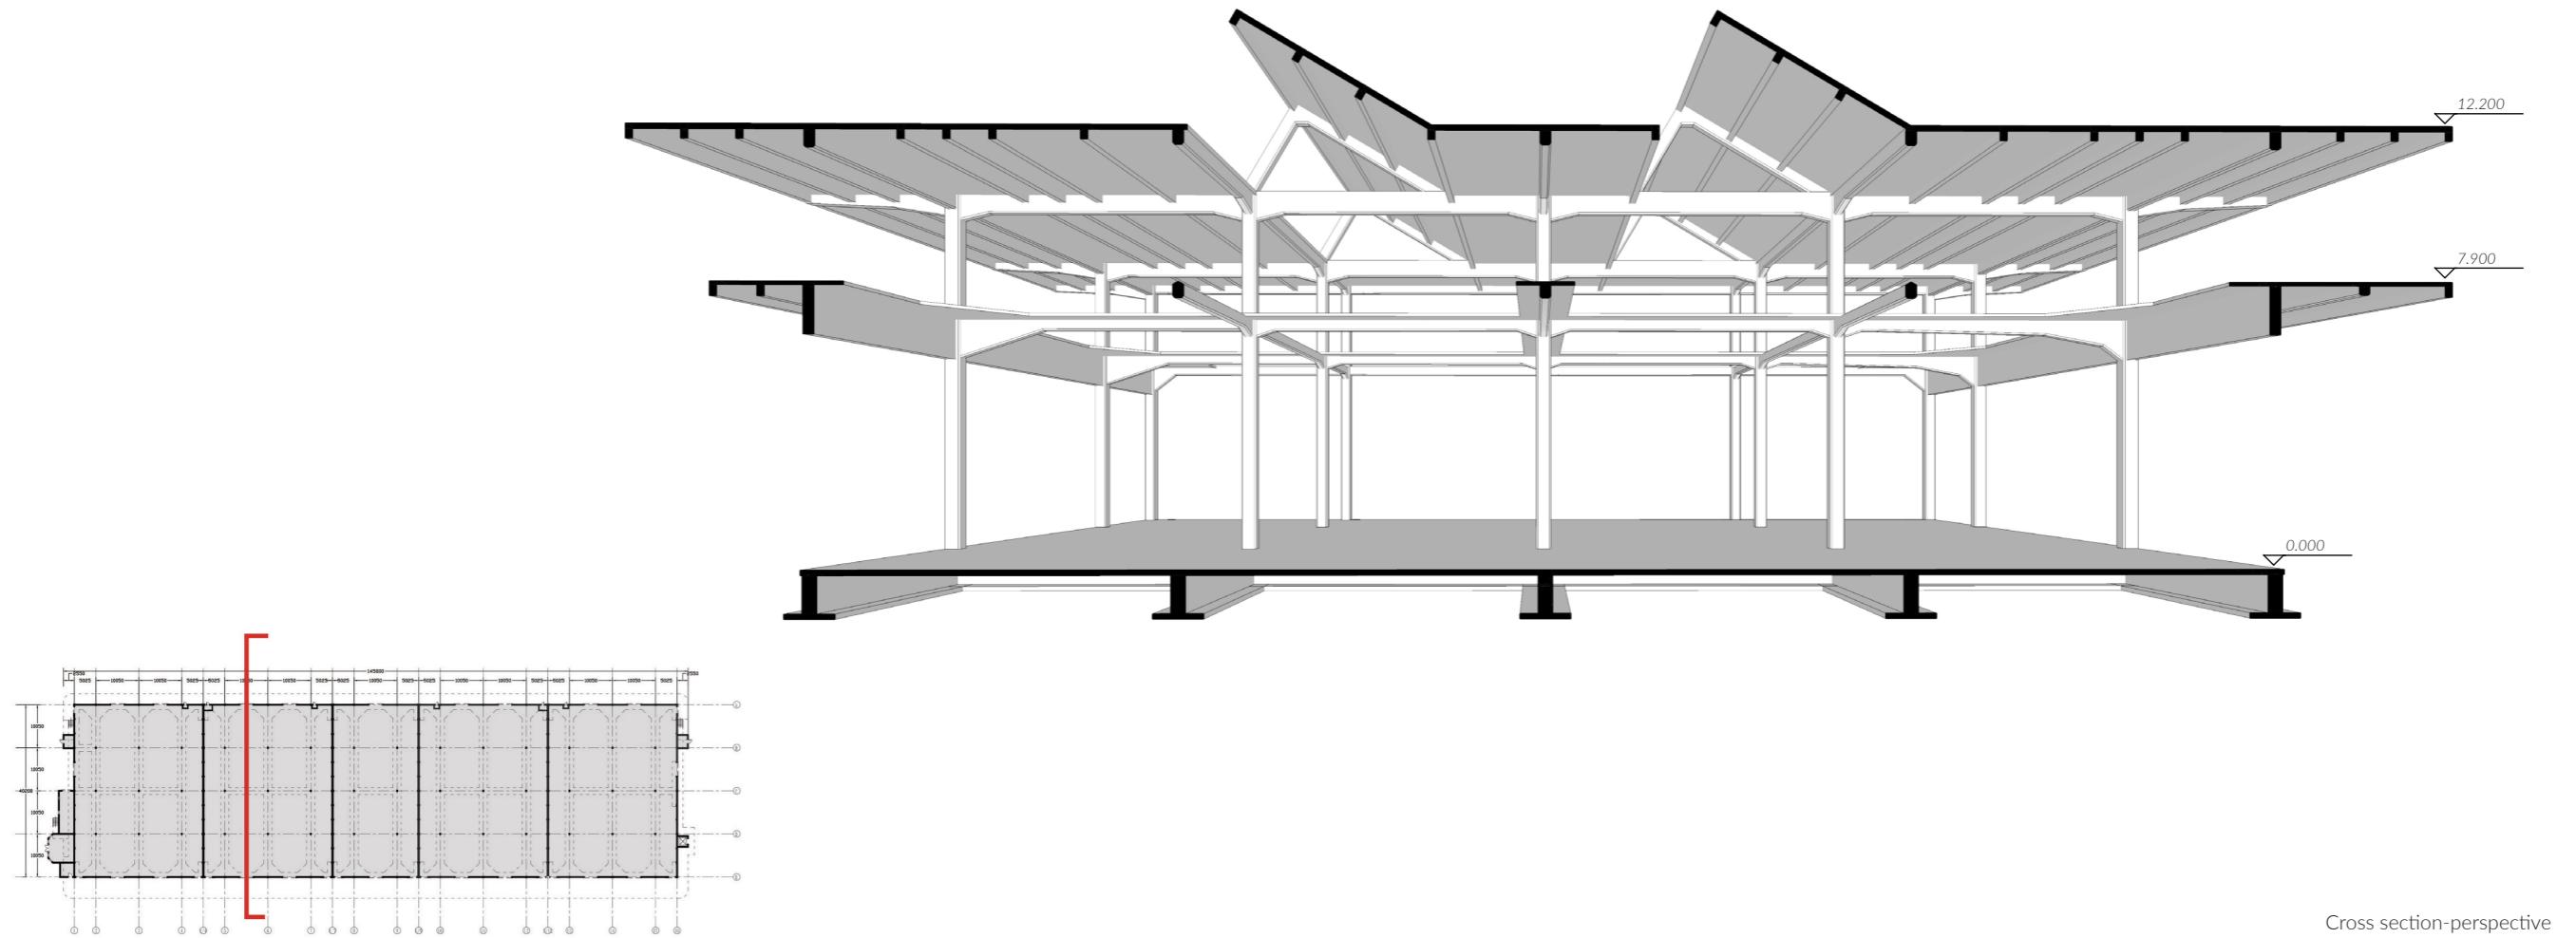
Cross section-perspective

The monolith structure consists of all parts of the building, including foundation, columns, beams, floors, roof, and cantilever balconies. Further analysis on each part will be carried out in the following pages.

The structure is economic and function-oriented, for very little decoration can be found in the building, and every aspect of the structure is related to the storage and transportation of the cotton.

The drawing above shows the tall space and walkways in the middle of the building which the structure enclosed.

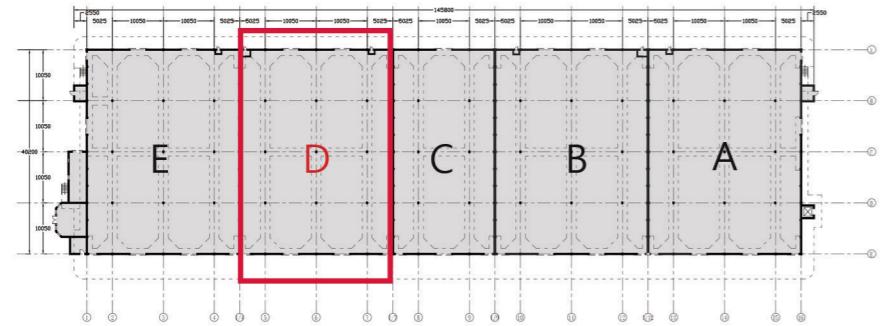
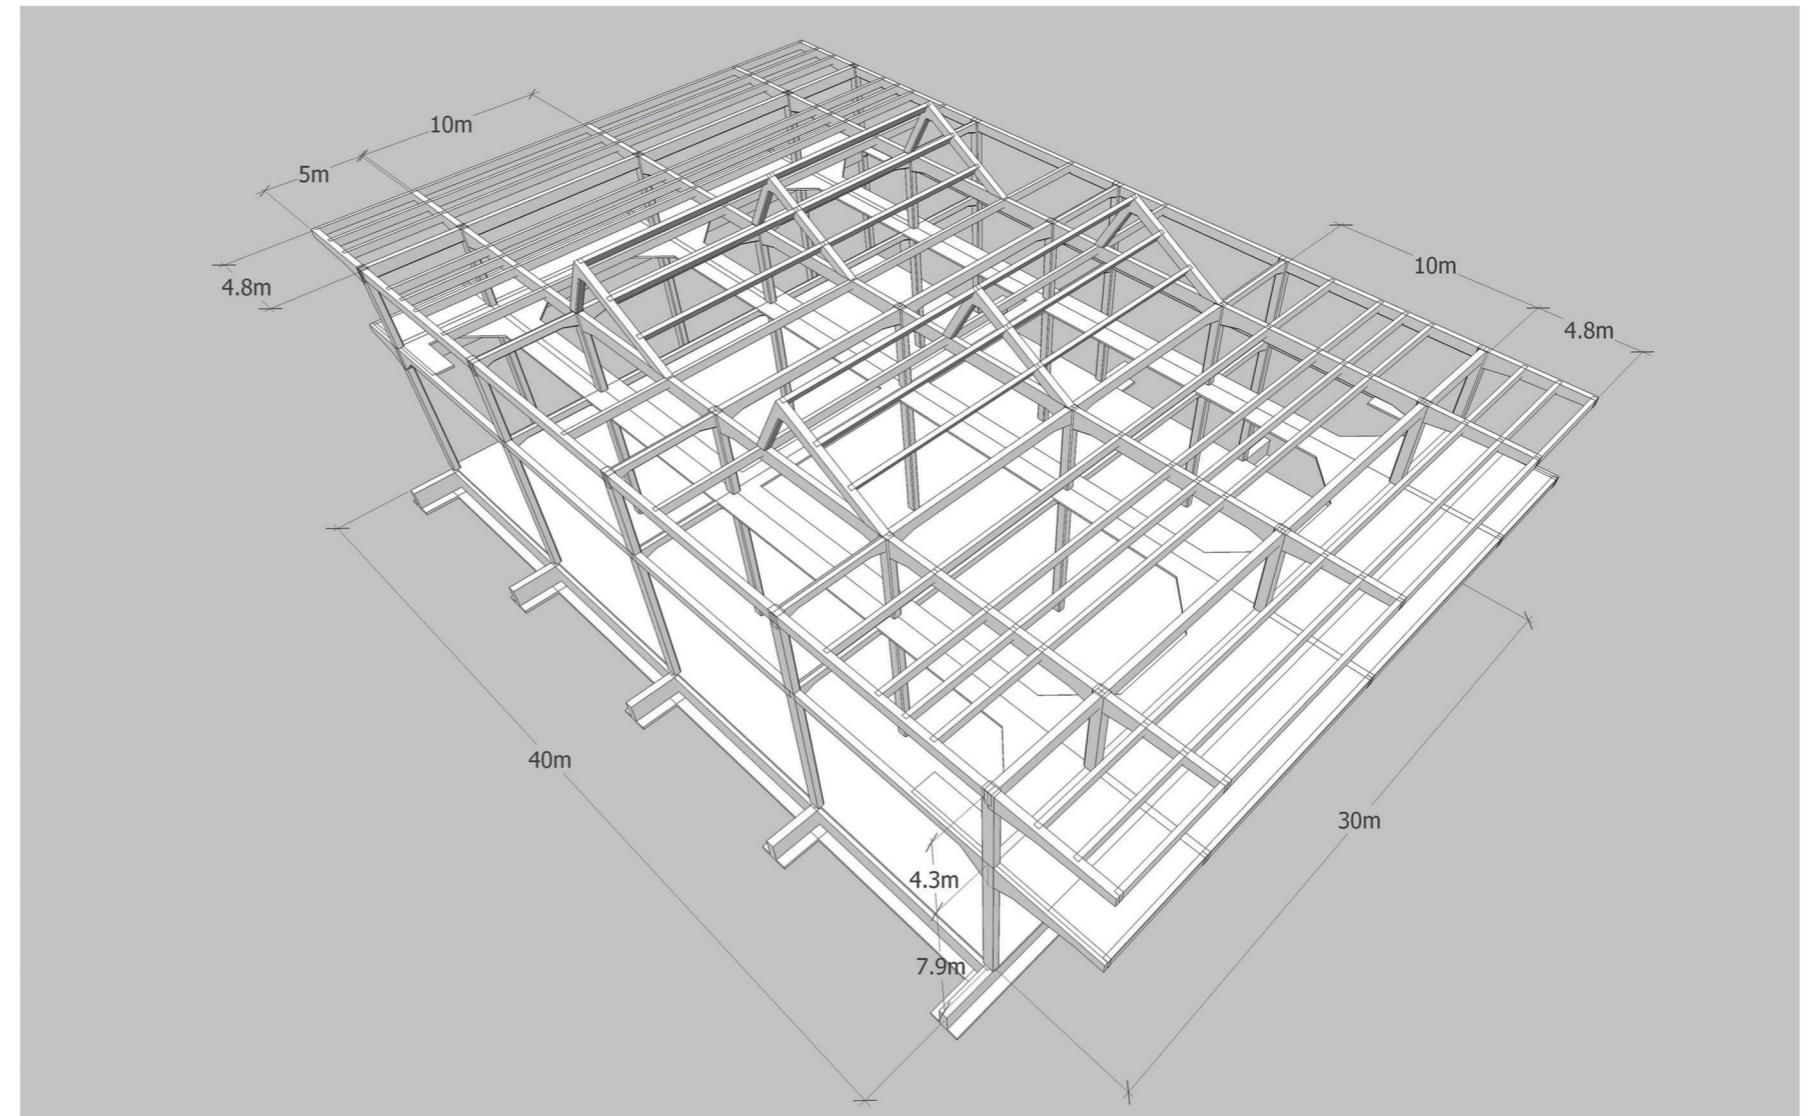
Perspective view of the structure of a compartment

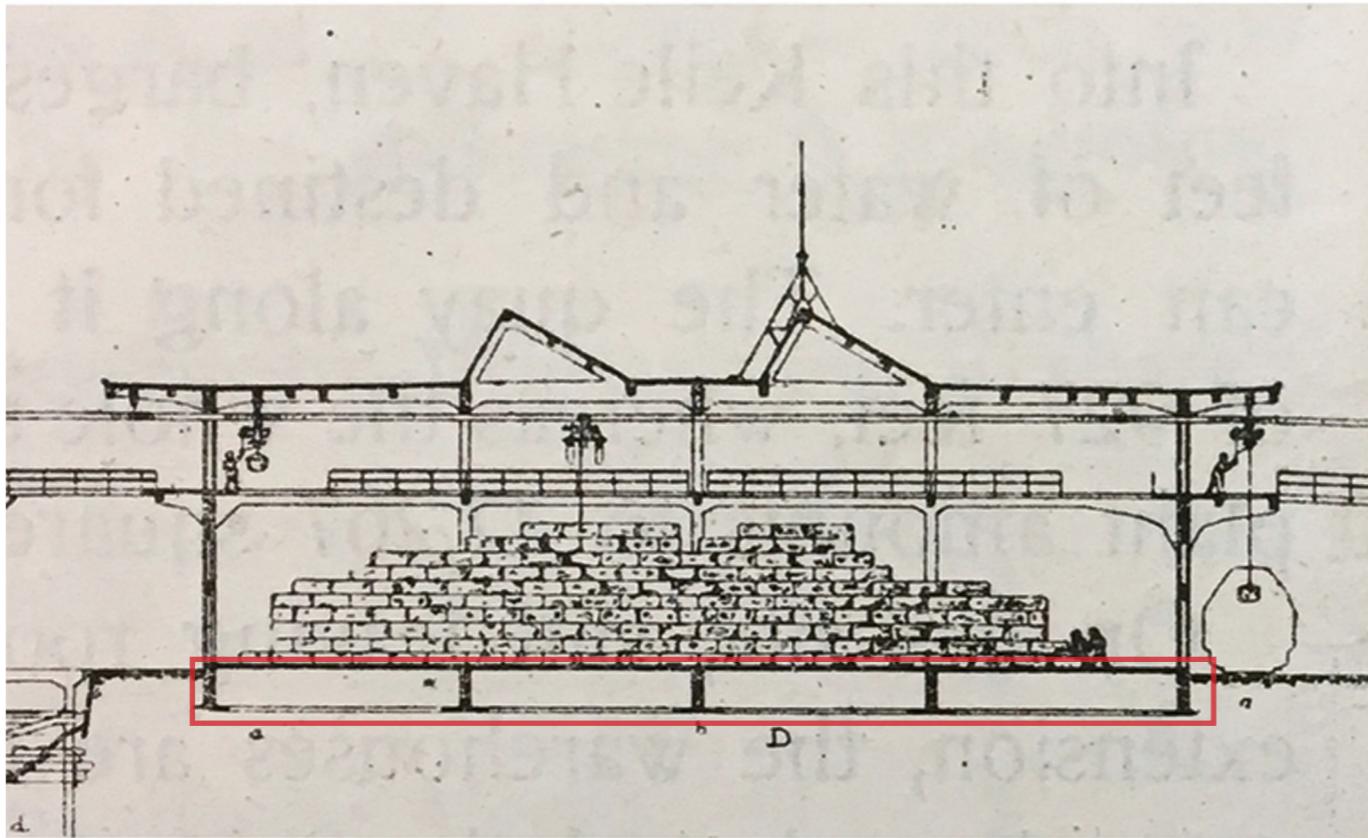
fig1. Foundation shown in section(historical drawing).

The foundation is a type without piles, with a cross section of up-side-down "T" shape. The 10m x 10m grid foudation is placed on the hard sand layer of the pier. The columns and the ground floor is directly sustained by this foundation

This foundation can be compared with the foundation of the Santos storage building in Rotterdam, which was also designed by architect JJ Kelters.

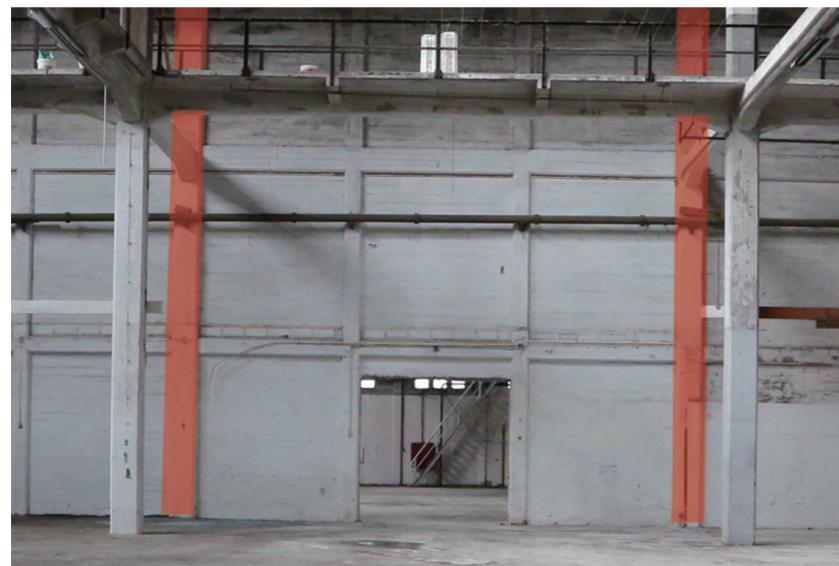
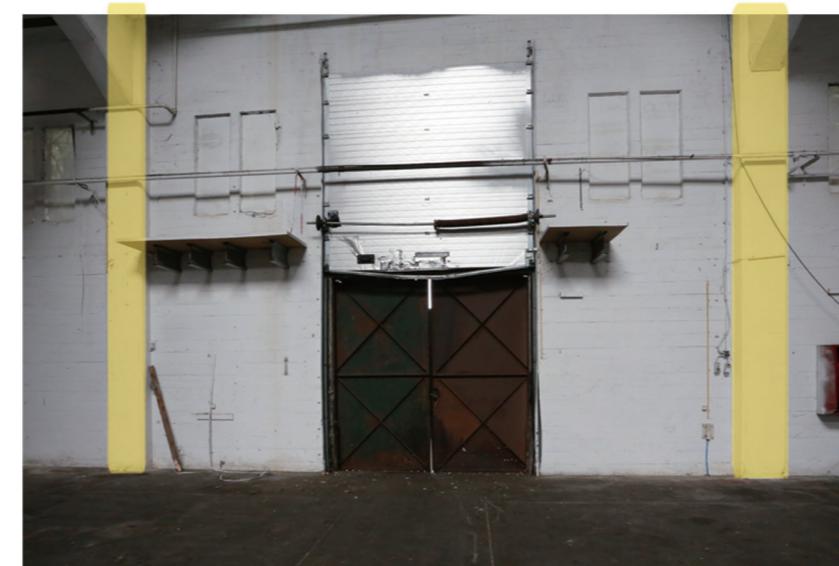
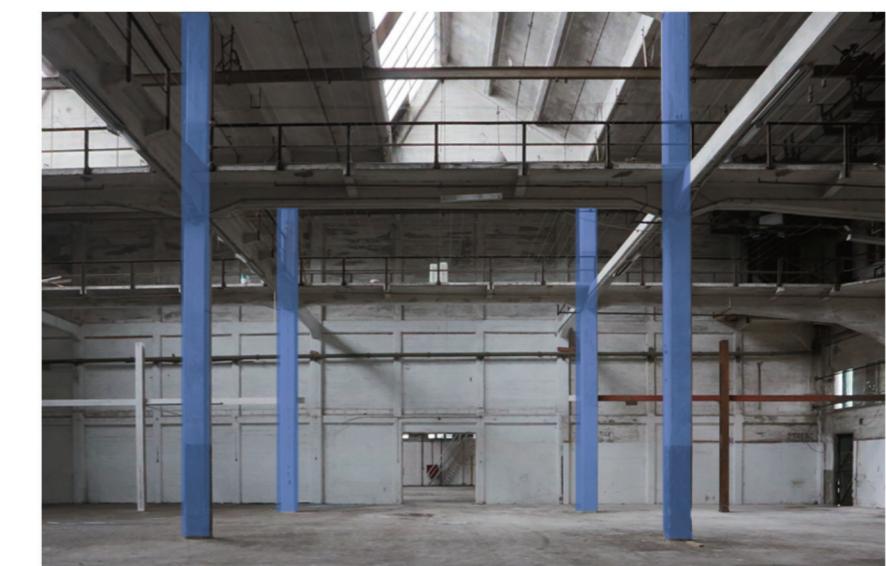
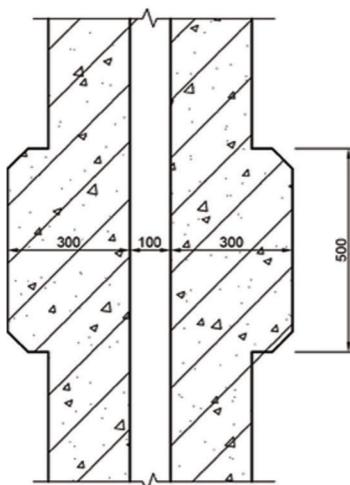
compartment wall columns
(colored in red)

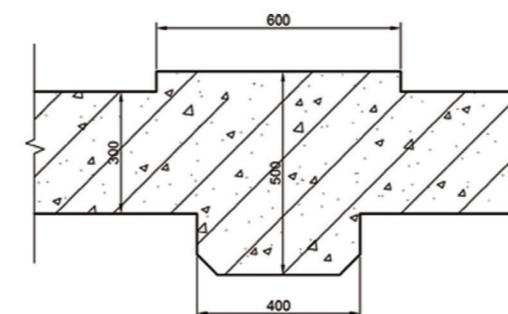
outer wall columns
(colored in yellow)

The outerwall columns has a wider surface on the outside, which results in a repetitive rhythm on the elevations. There are 6 outer wall columns in a standard compartment.

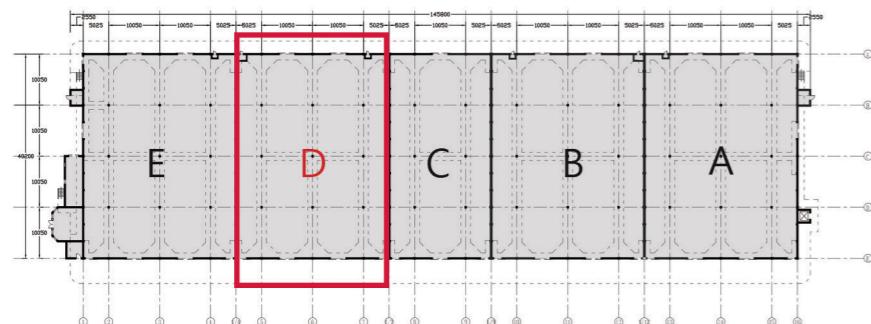
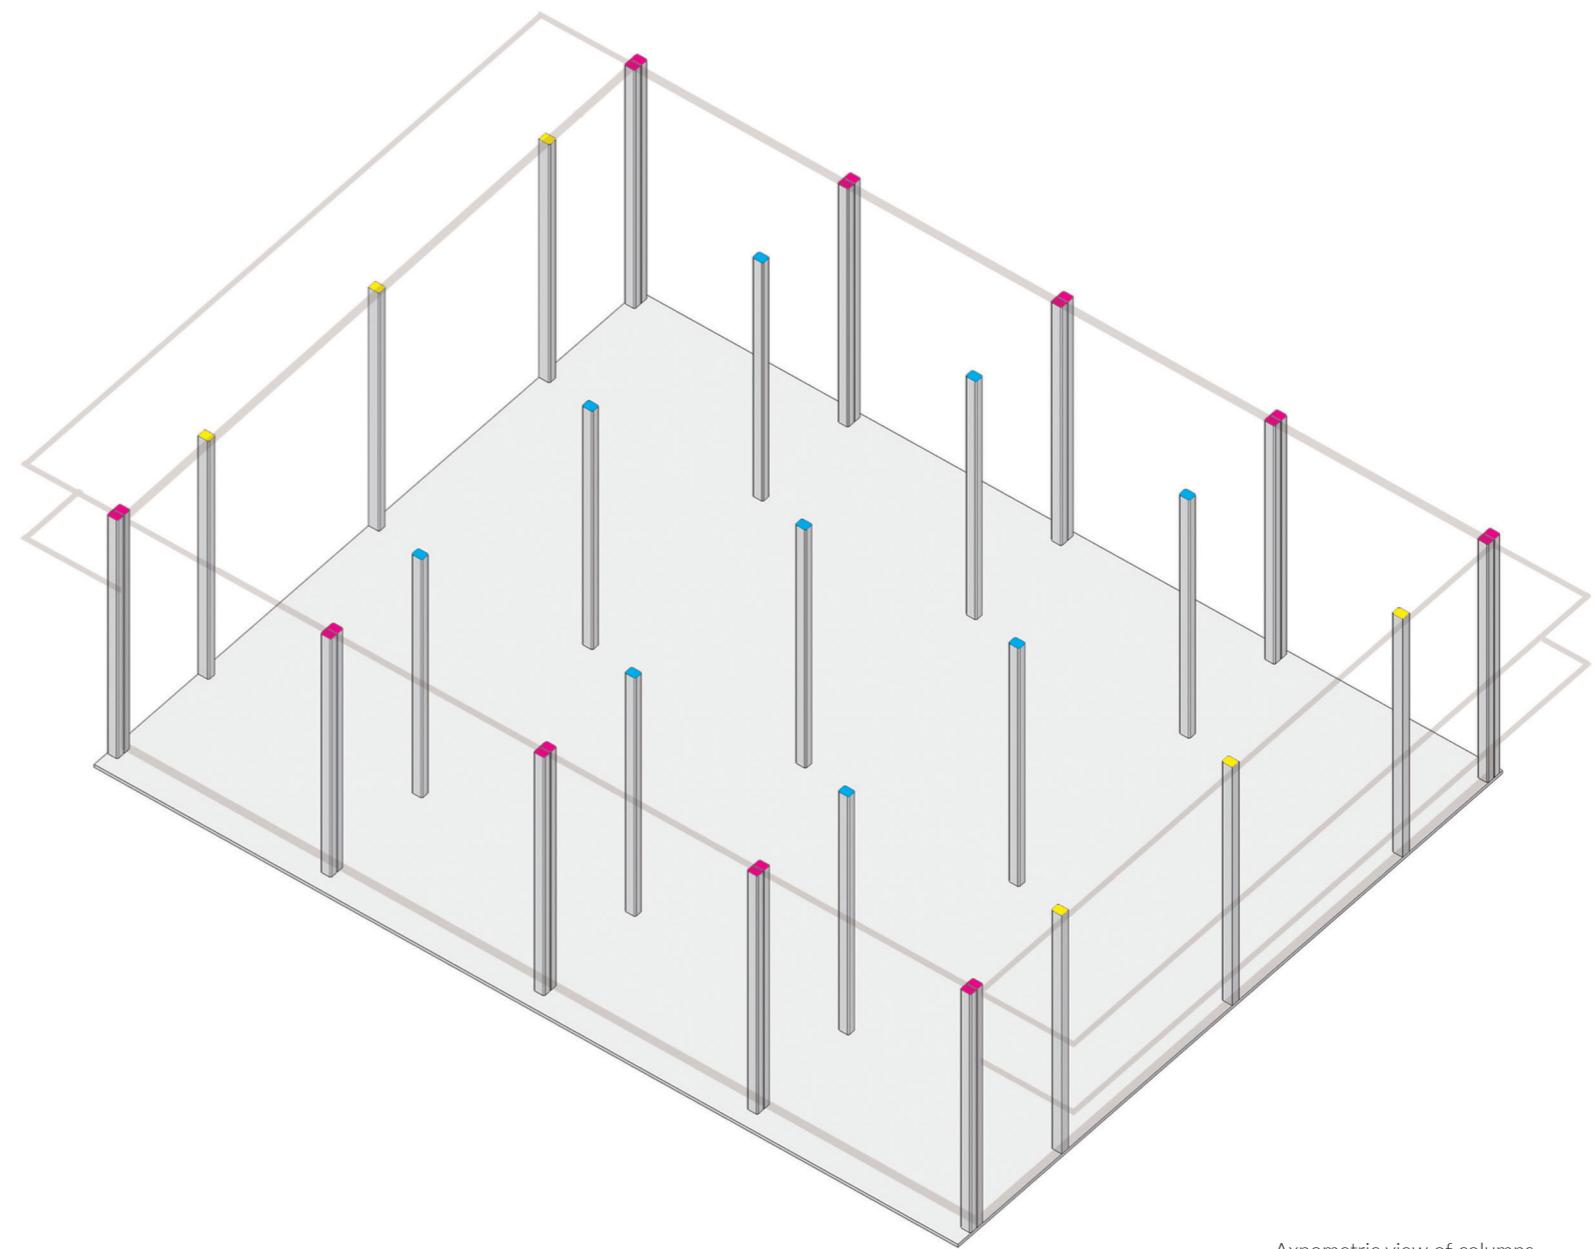
Axonometric view of columns

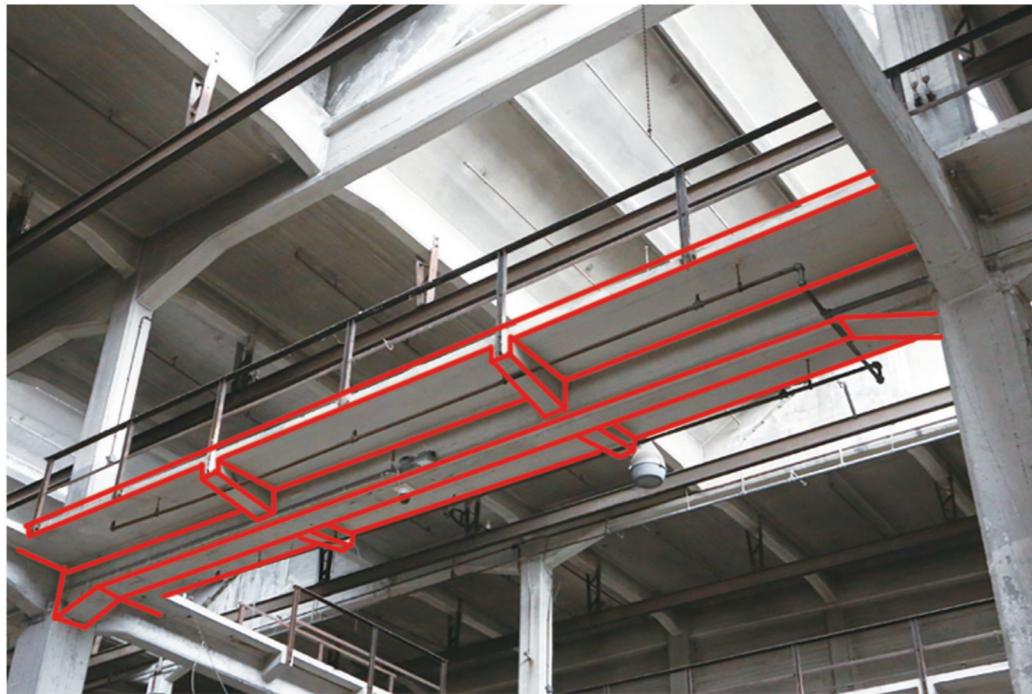
fig1. The walkway with secondary beams and steel hand rails.(marked in yellow)

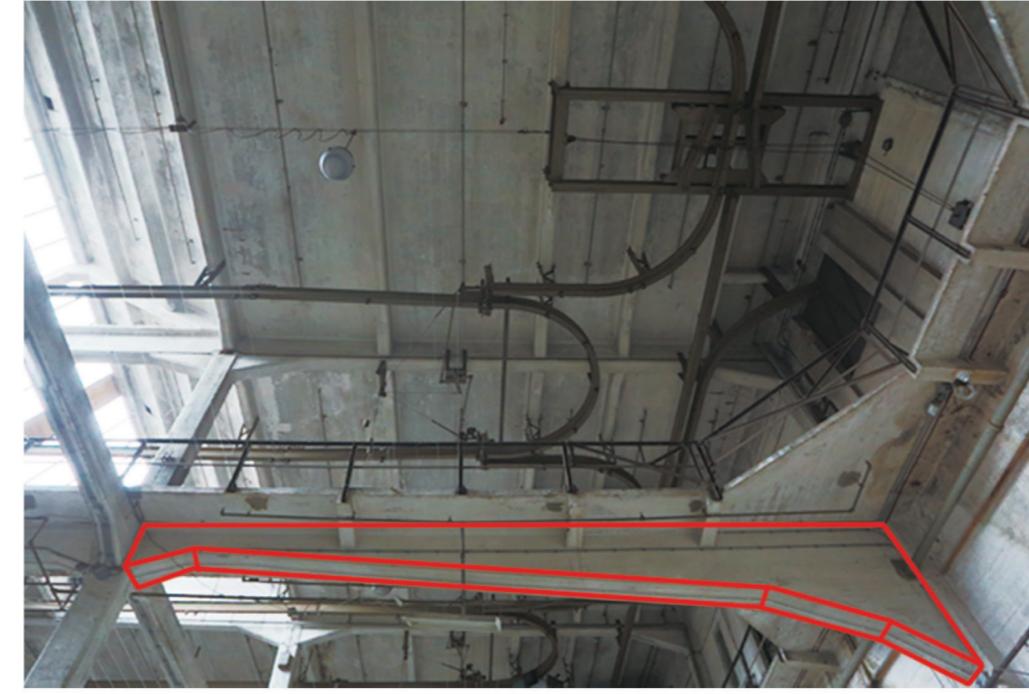
fig2. The big bracket on the 2nd beam from the south.(marked in blue)

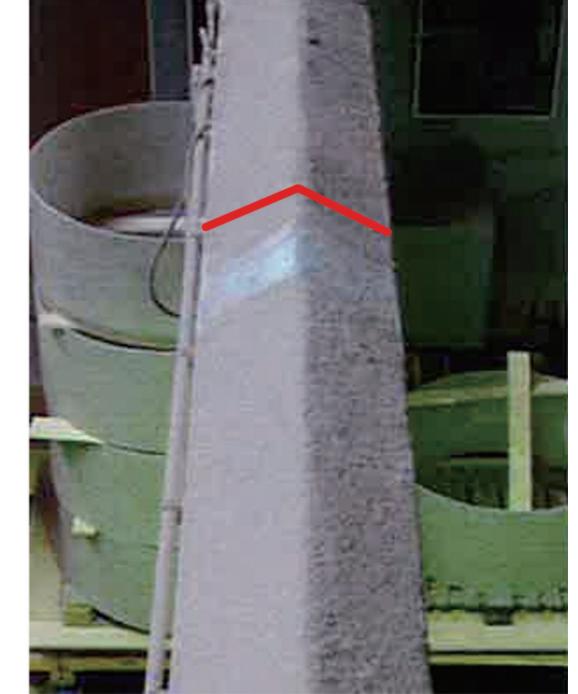
fig3. The sloped top surface of the beams without walkways on them.(marked in red)

The third one is the beams with a slope top surface. This is presumably done to prevent that it could be walked on the beam to the other side of the void for safety reasons.¹ We suggest that it it can also prevent dust to some extrend.

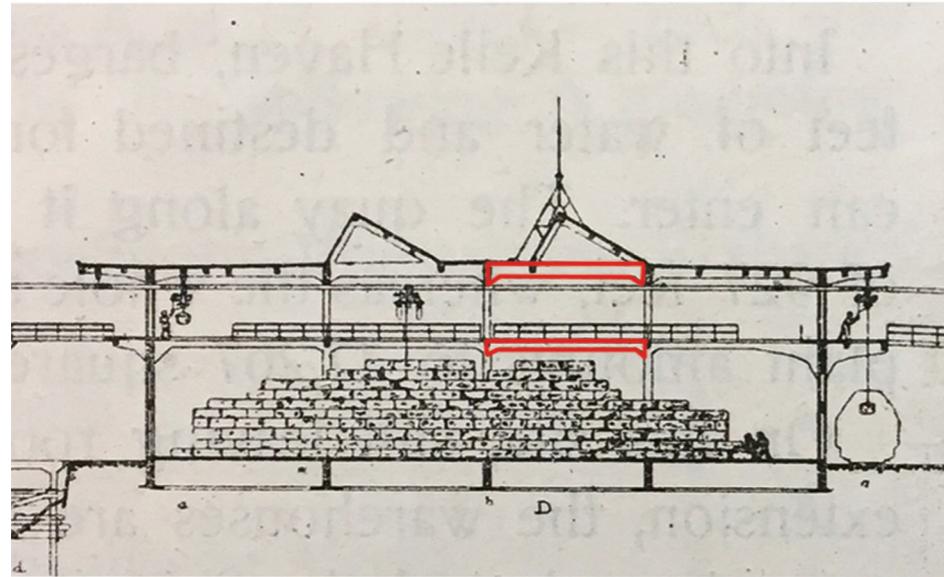
fig1. The height of roof beams is bigger than the 1f beams.

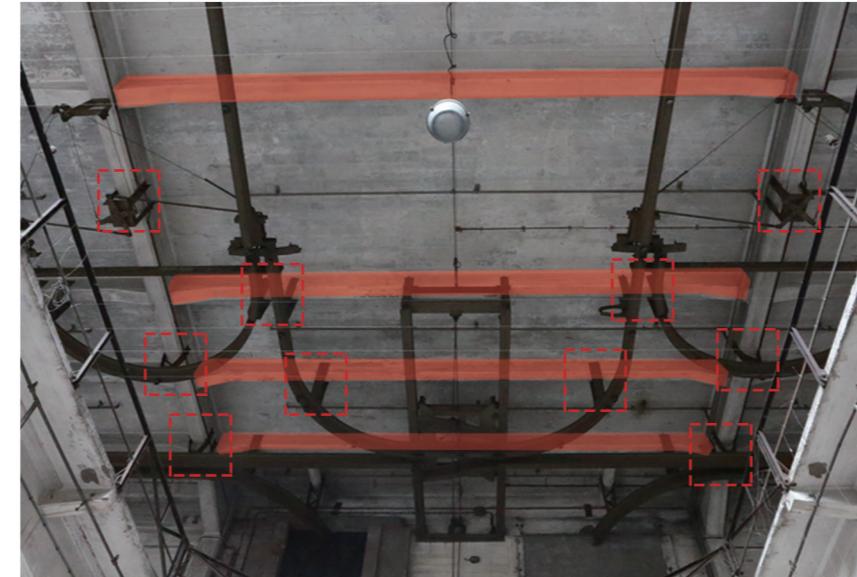
fig2. The additional smaller beams are designed for the loads of the conveyor system and cotton.(marked with "A")

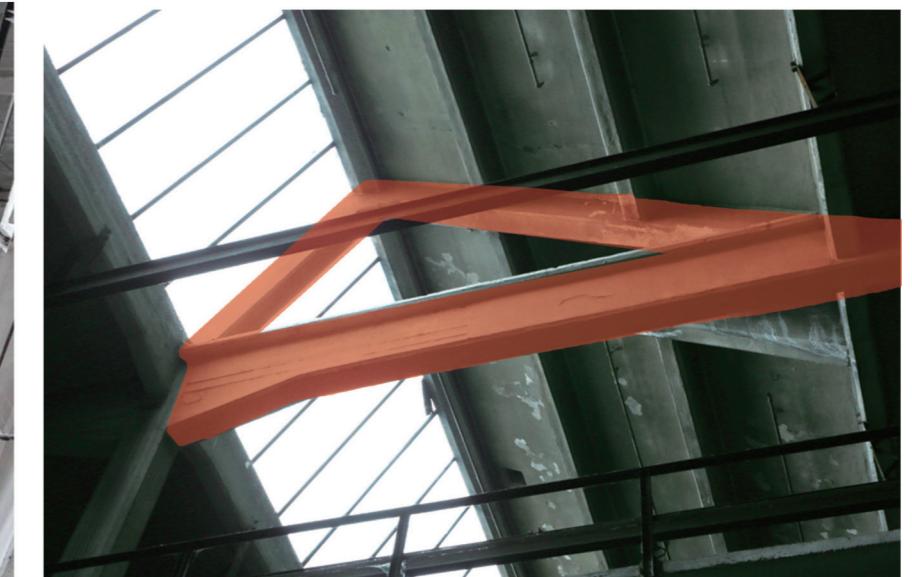
fig3. close-up look of the beams of the skylight.

for the big skylight windows has made it possible. There are secondary beams on the sloped surface as well, possibly because of the extra wind loads on them.

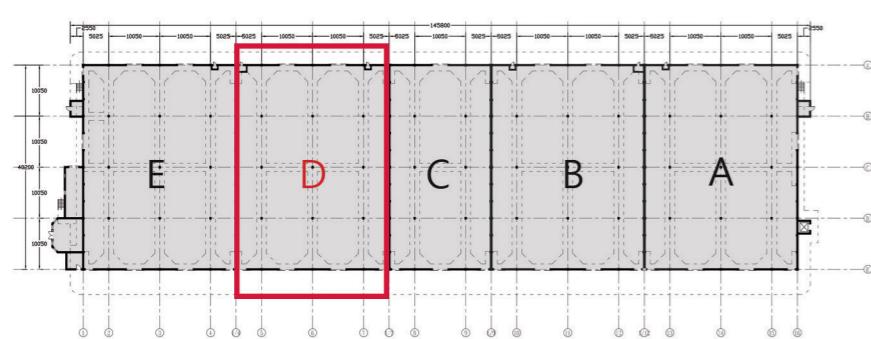
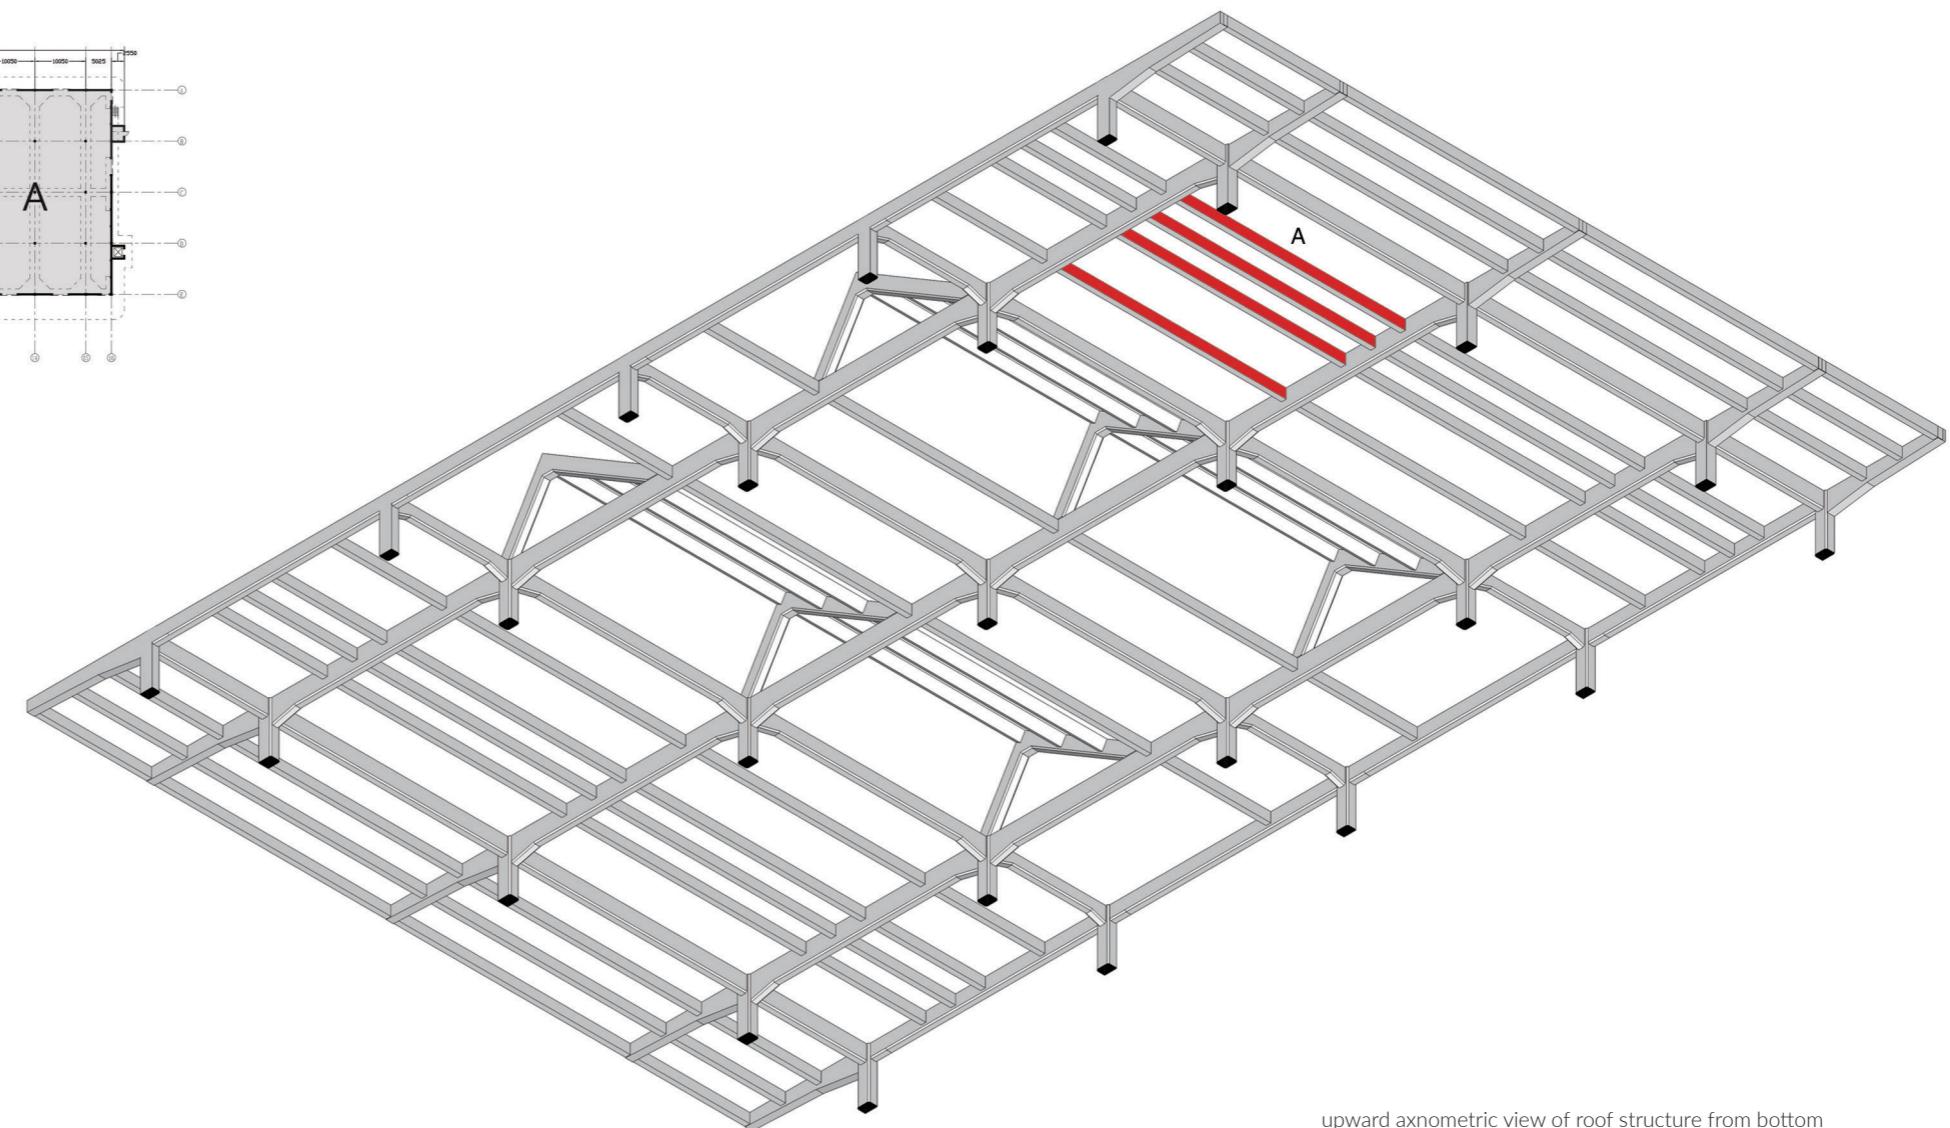
On the south and north side of the roof are the cantilever covers for the balconies. Both 4.8m-deep structure are sustained by the tapered beams .

upward axonometric view of roof structure from bottom

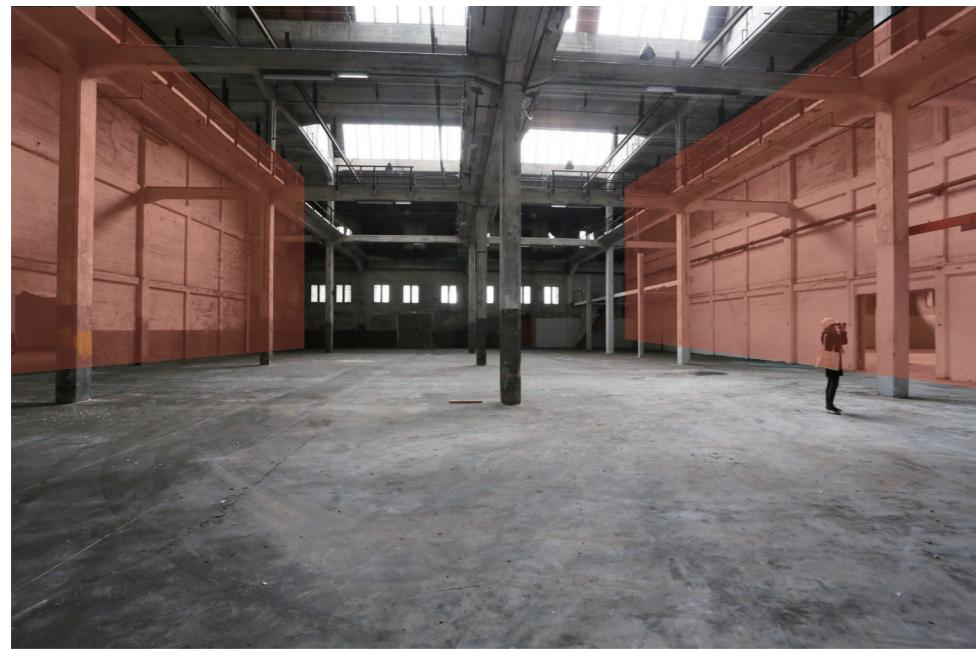
The compartment walls viewed from the interior

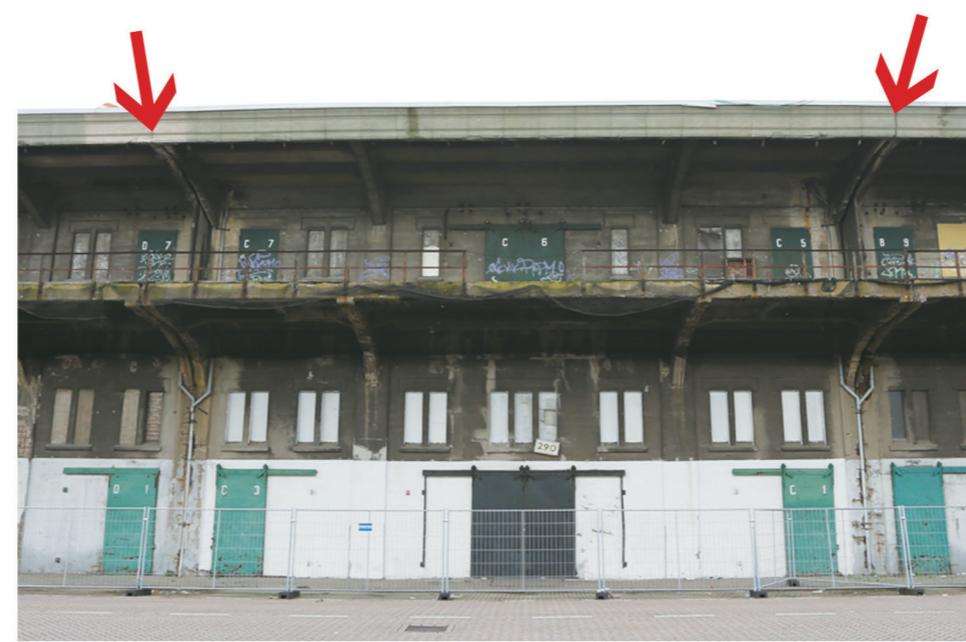
The dilatations of the compartments can be seen from the outside.

The other possible reason for the separation of the whole volume is to adapt to the thermal expansion and contraction.

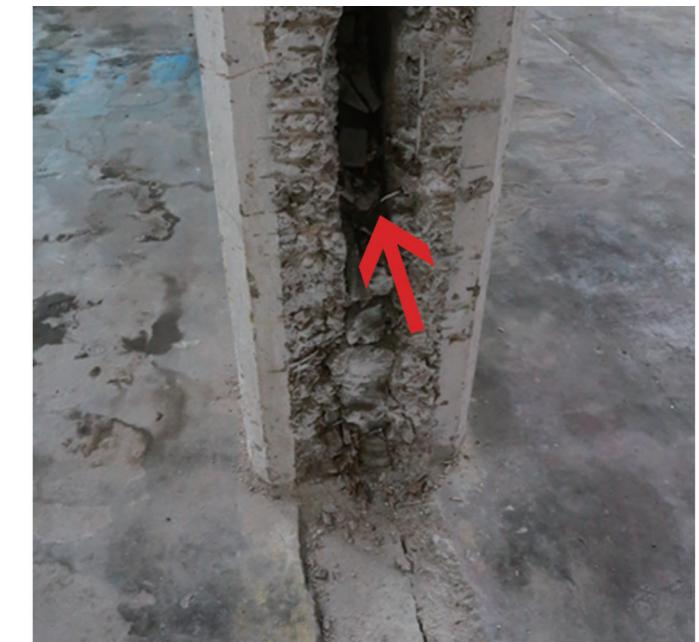
The cavity between compartment walls

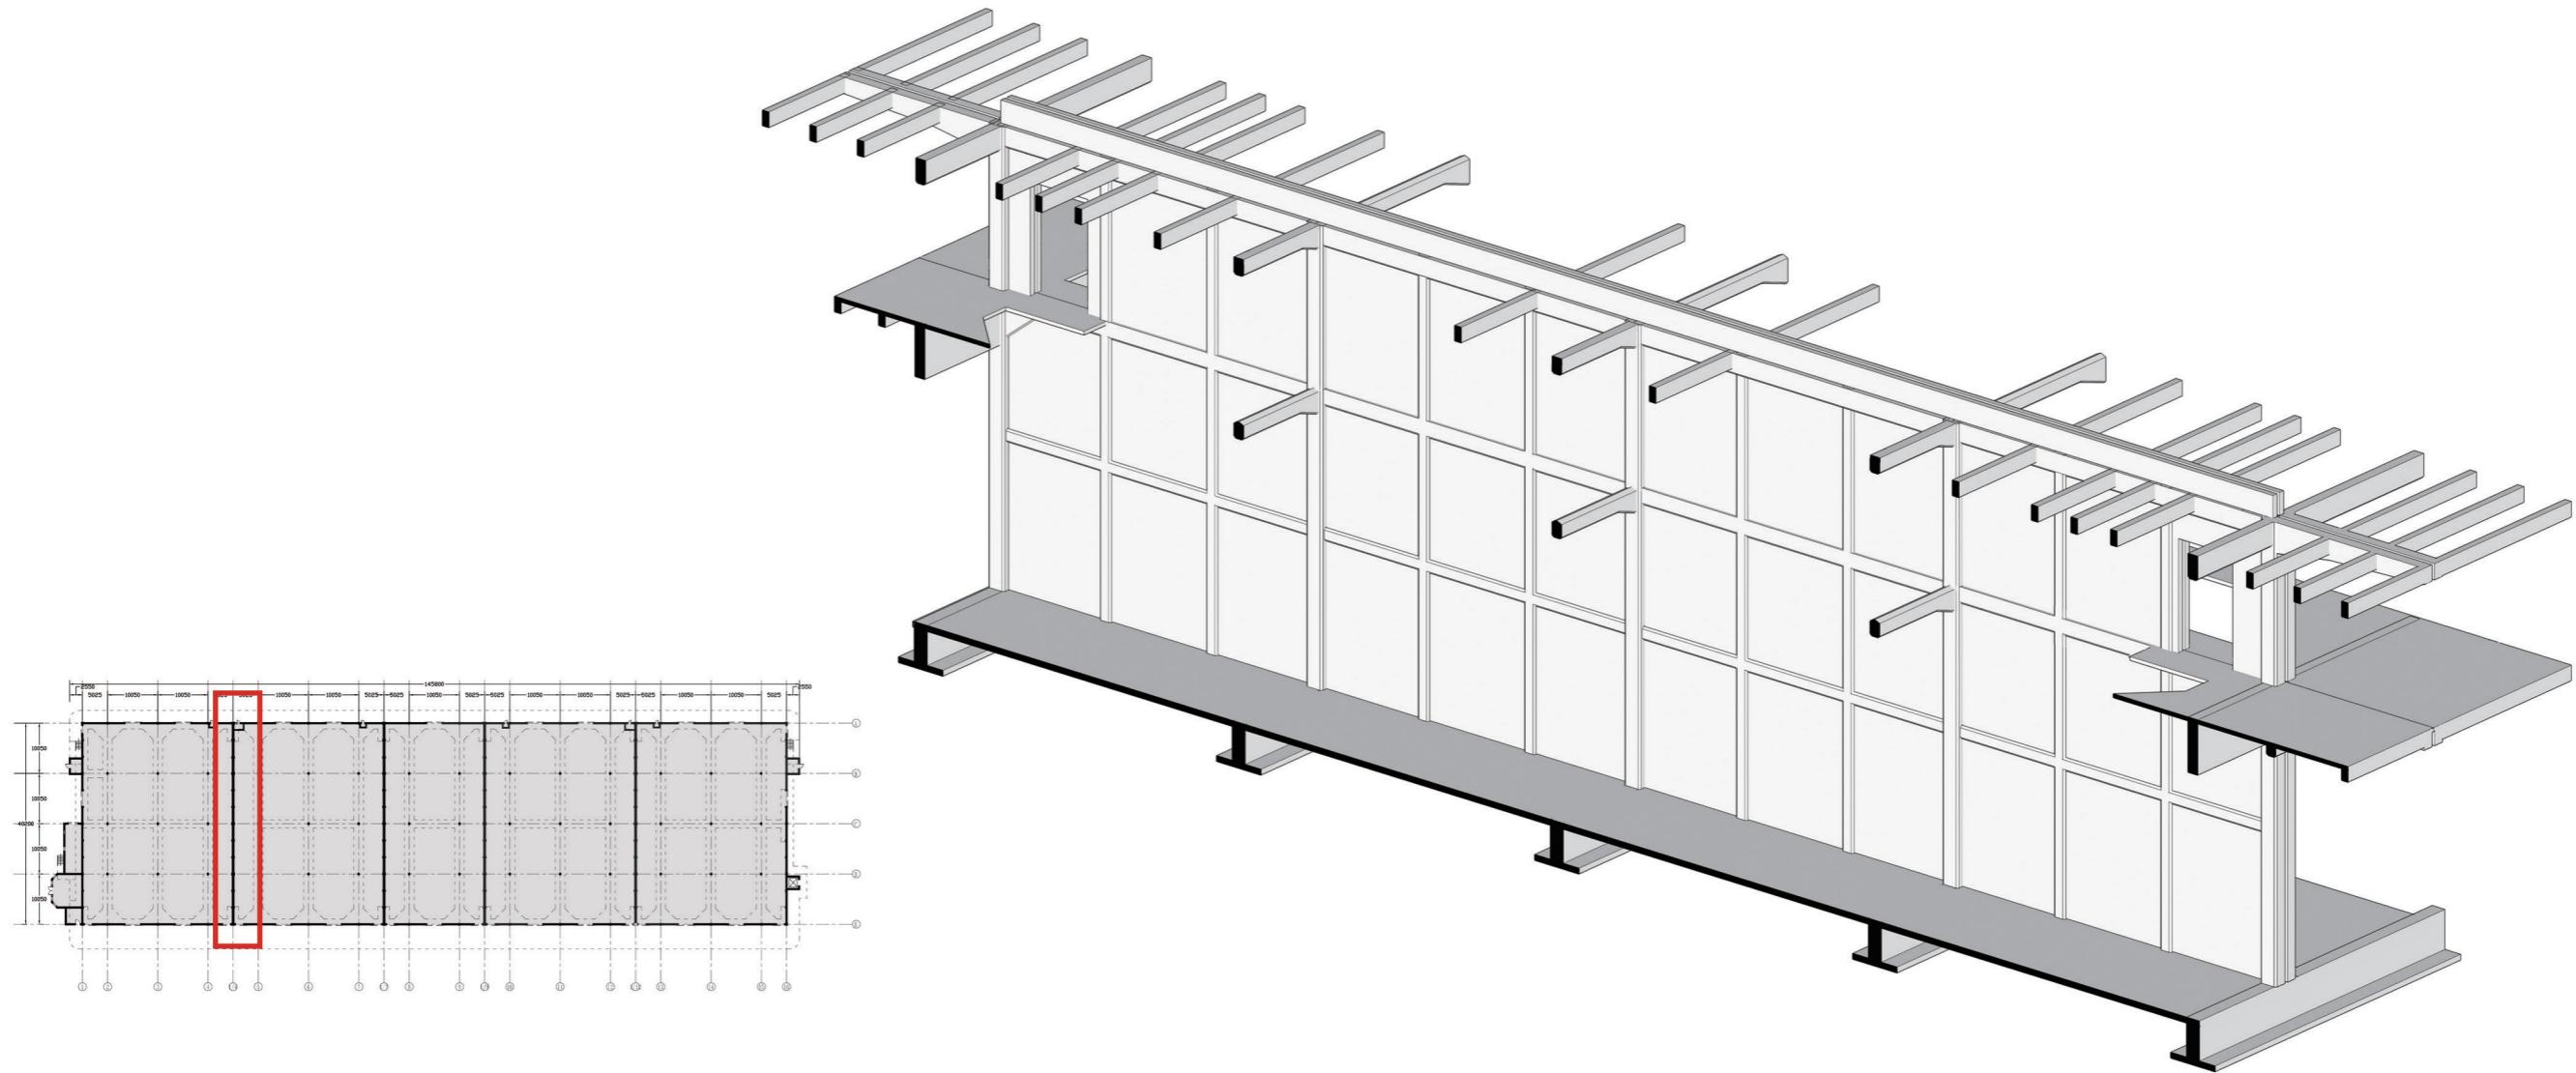
Axometric view of compartment wall

The five separate compartments are placed on the continuous foundation.

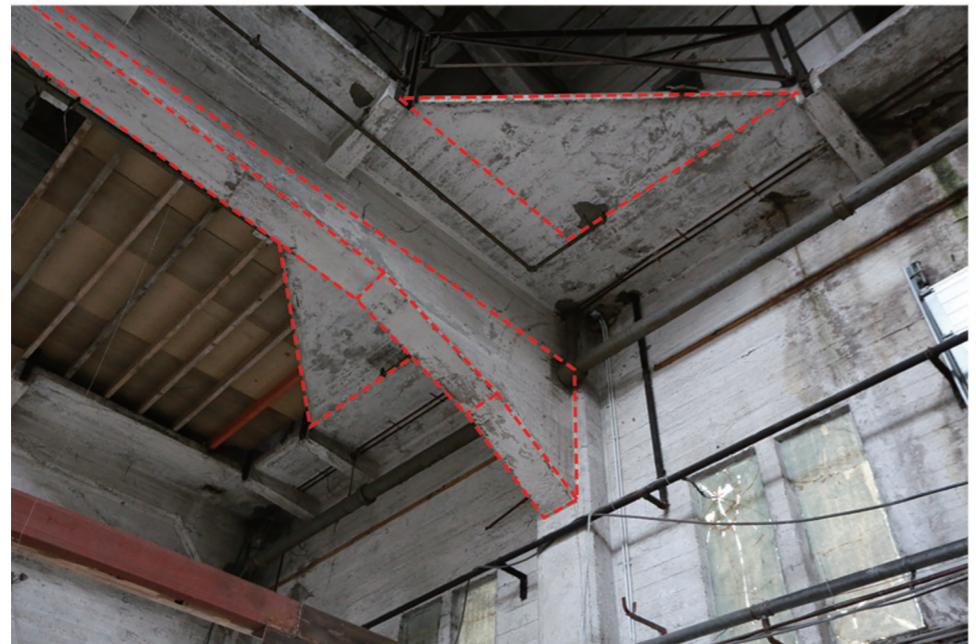
brackets of the beams and walkways

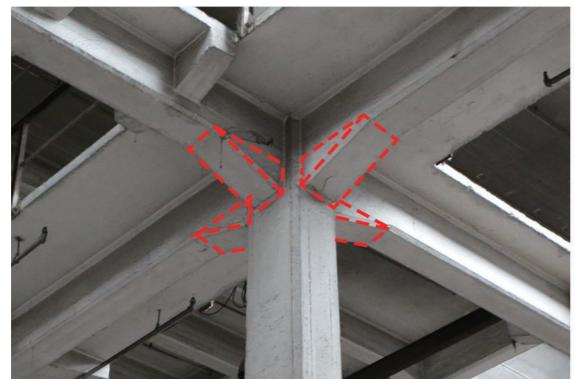
brackets of the beams
