KATOENVEEM

MSc III Heritage & Architecture

Architectural & Building Technology Analysis

07/04/2017

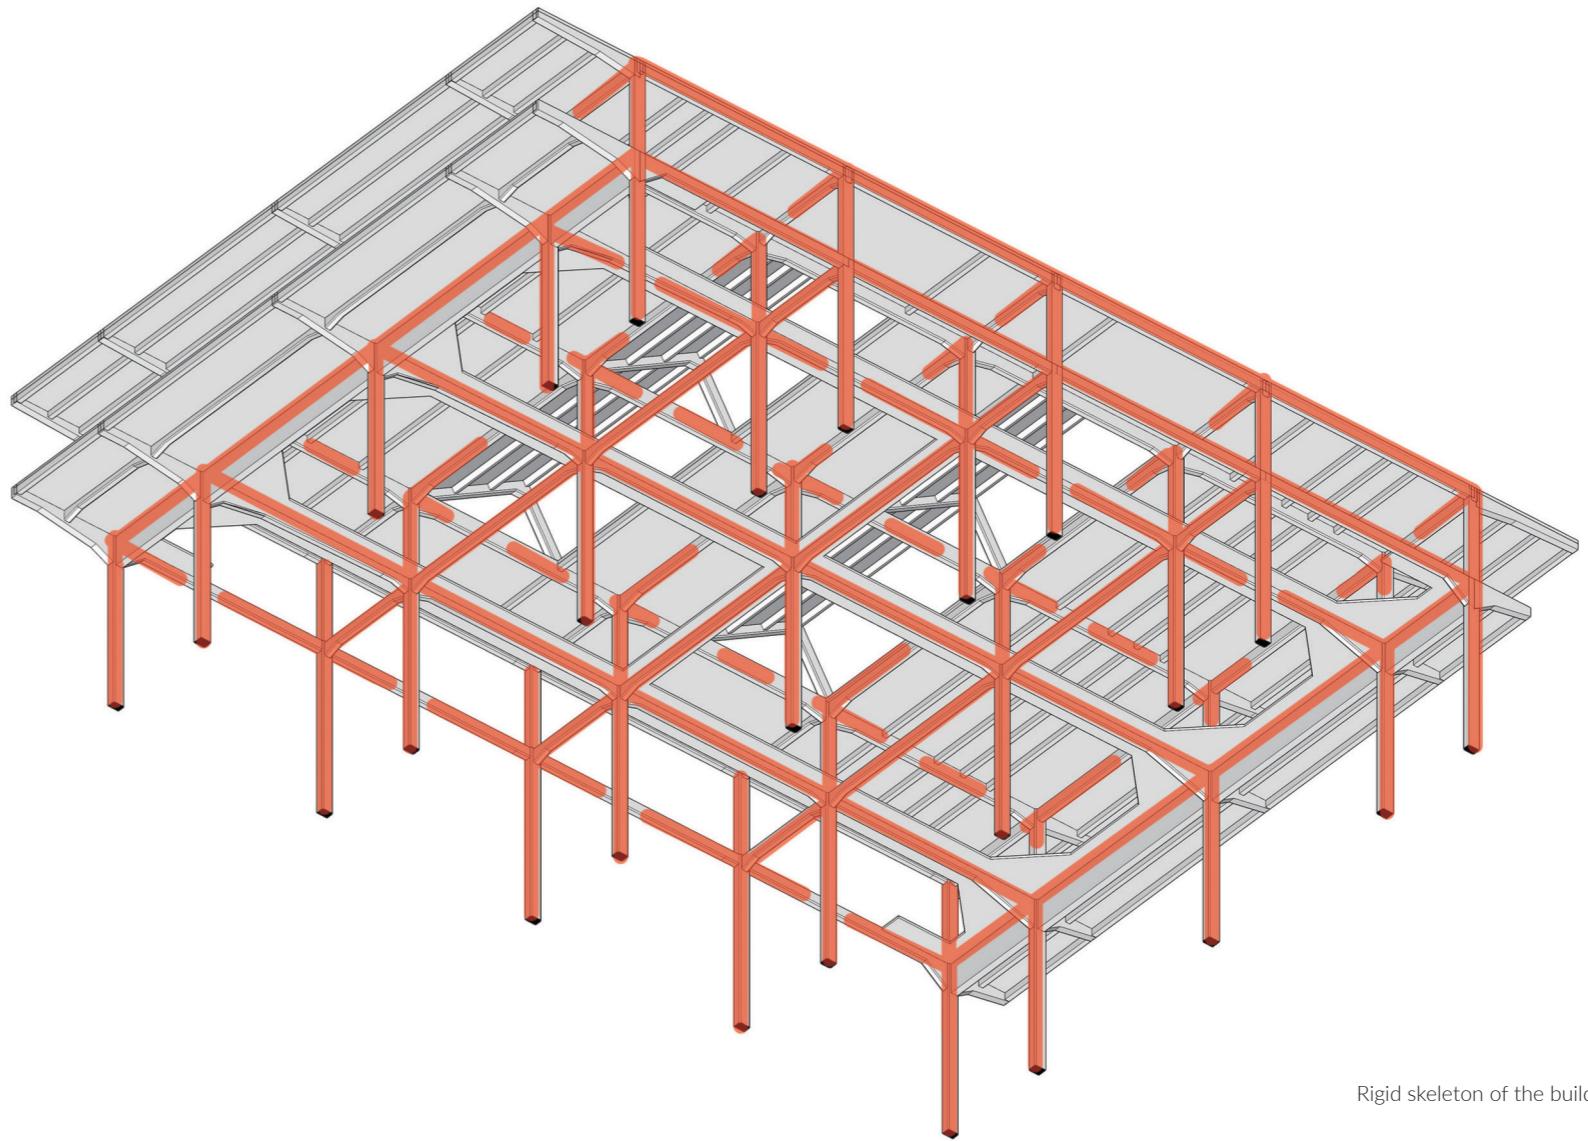
Rigid skeleton of the building

We can conclude that the Katoenveem has an Hennebique-like system that constitutes the entire construction. The complete construction; foundation, floors, beams, columns and the roof, is interconnected through the reinforcement of the steel. Certain elements of the Katoenveem bear a striking resemblance to the Hennebique system, where as other elements have been altered to fit the specific building.

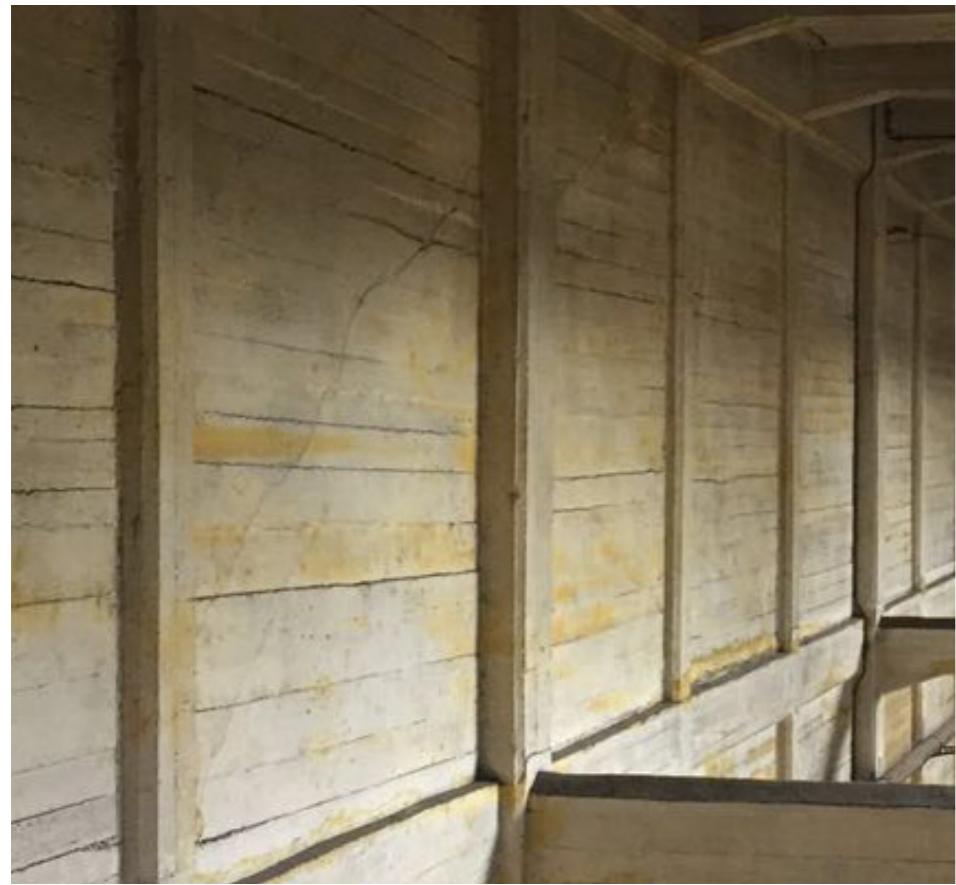
Yellow paint of the inner walls in section D

The majority of the inner surface of the walls were left as raw concrete, while in the section D, the original yellow paint can still be found. In other sections, the lower part of the wall (0-3m), were painted white.

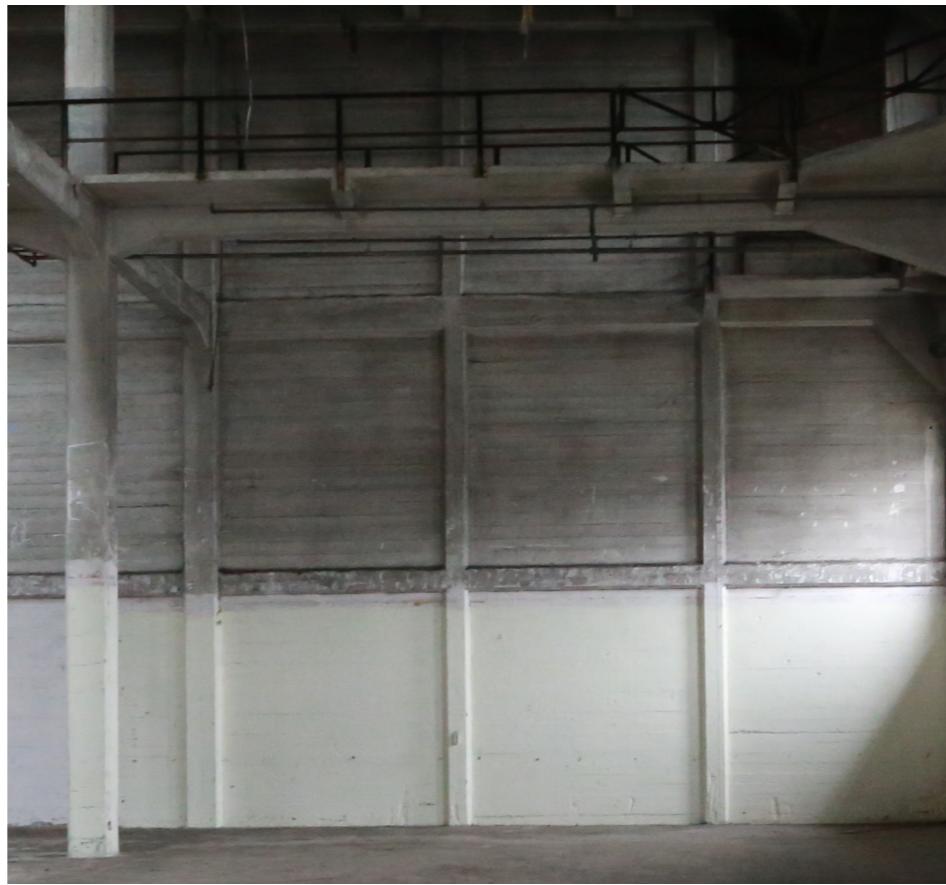
Raw concrete surface and white paints of the inner walls

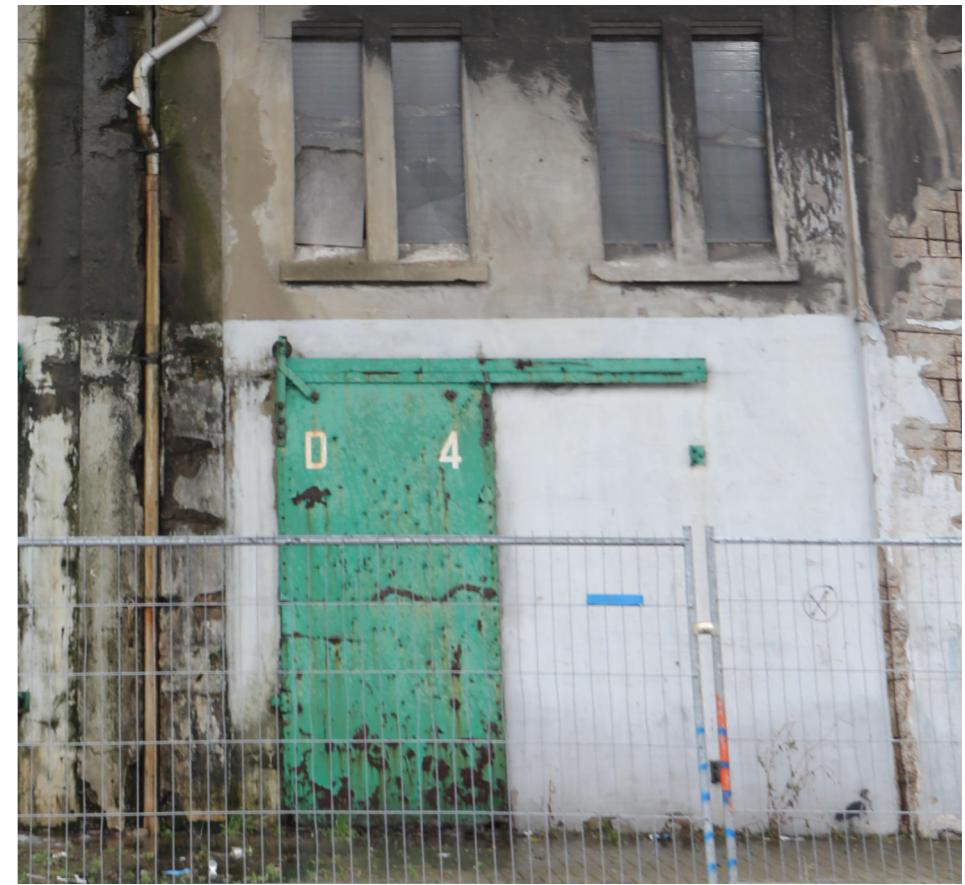
Plaster and white paints on the outer surface of the walls

On the outside of the walls, the trace of wood molds is covered by plaster and white paints on top. The damage and detail of the windows on the walls will be discussed as a separate topic in this report.

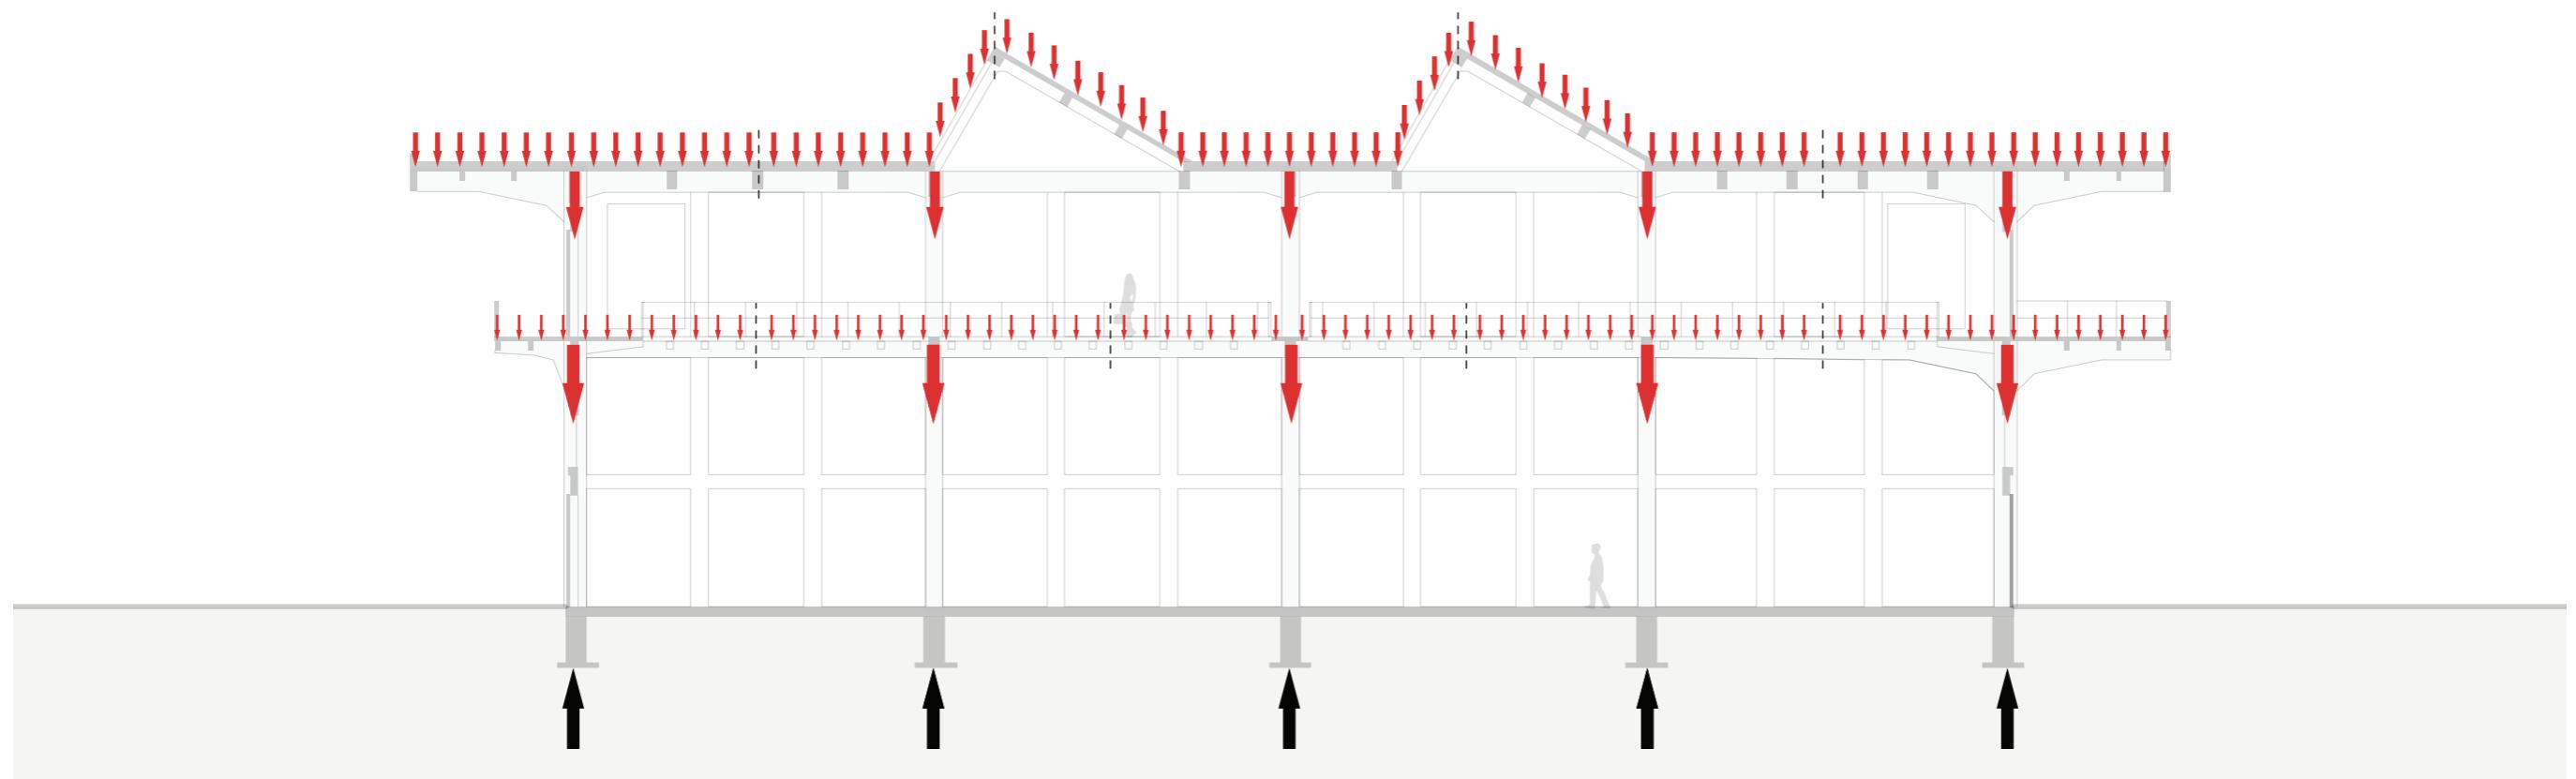
section AA vertical loads by Jan Huis in 't Veld
(own illustration)

In these sections the vertical load distribution through the building is displayed. The red arrows signify the forces on the building and the black arrows are a visualisation of the counter forces. The roof is much heavier than the first floor therefore the arrows have been thickened. The larger arrows are thicker at the first floor however, because the force of the floor is added to the weight of the roof structure. Throughout the building is the constructional rhythm very consistent; the forces are spread evenly through each columns, leading to the foundation. On the adjacent page only one portion of section BB is displayed, however the other 4 parts perform in exactly the same manner. The 5 parts each work separate from each other, because of the dilatations between them.

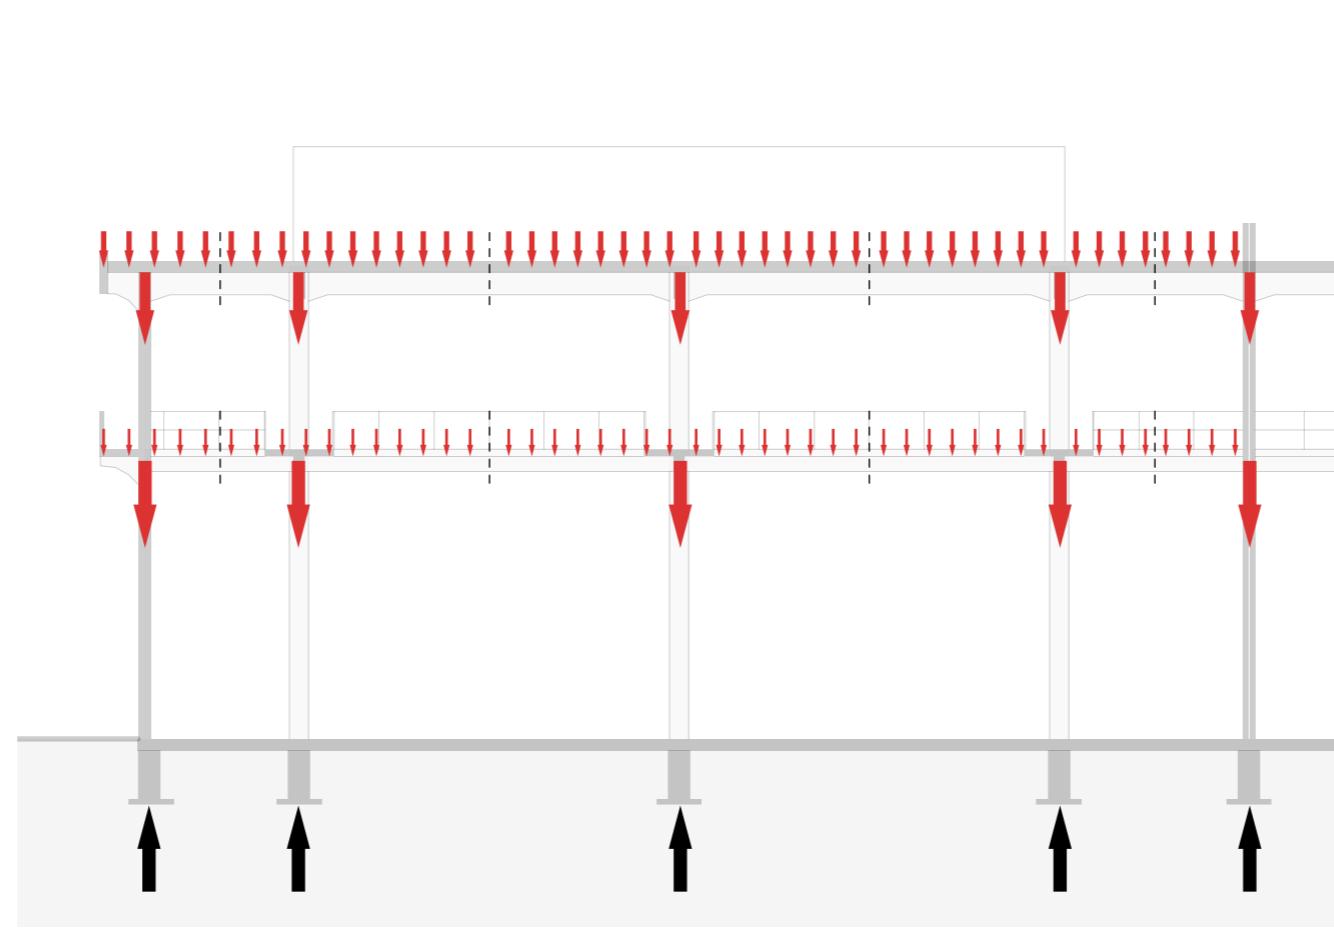
section BB vertical loads by Jan Huis in 't Veld
(own illustration)

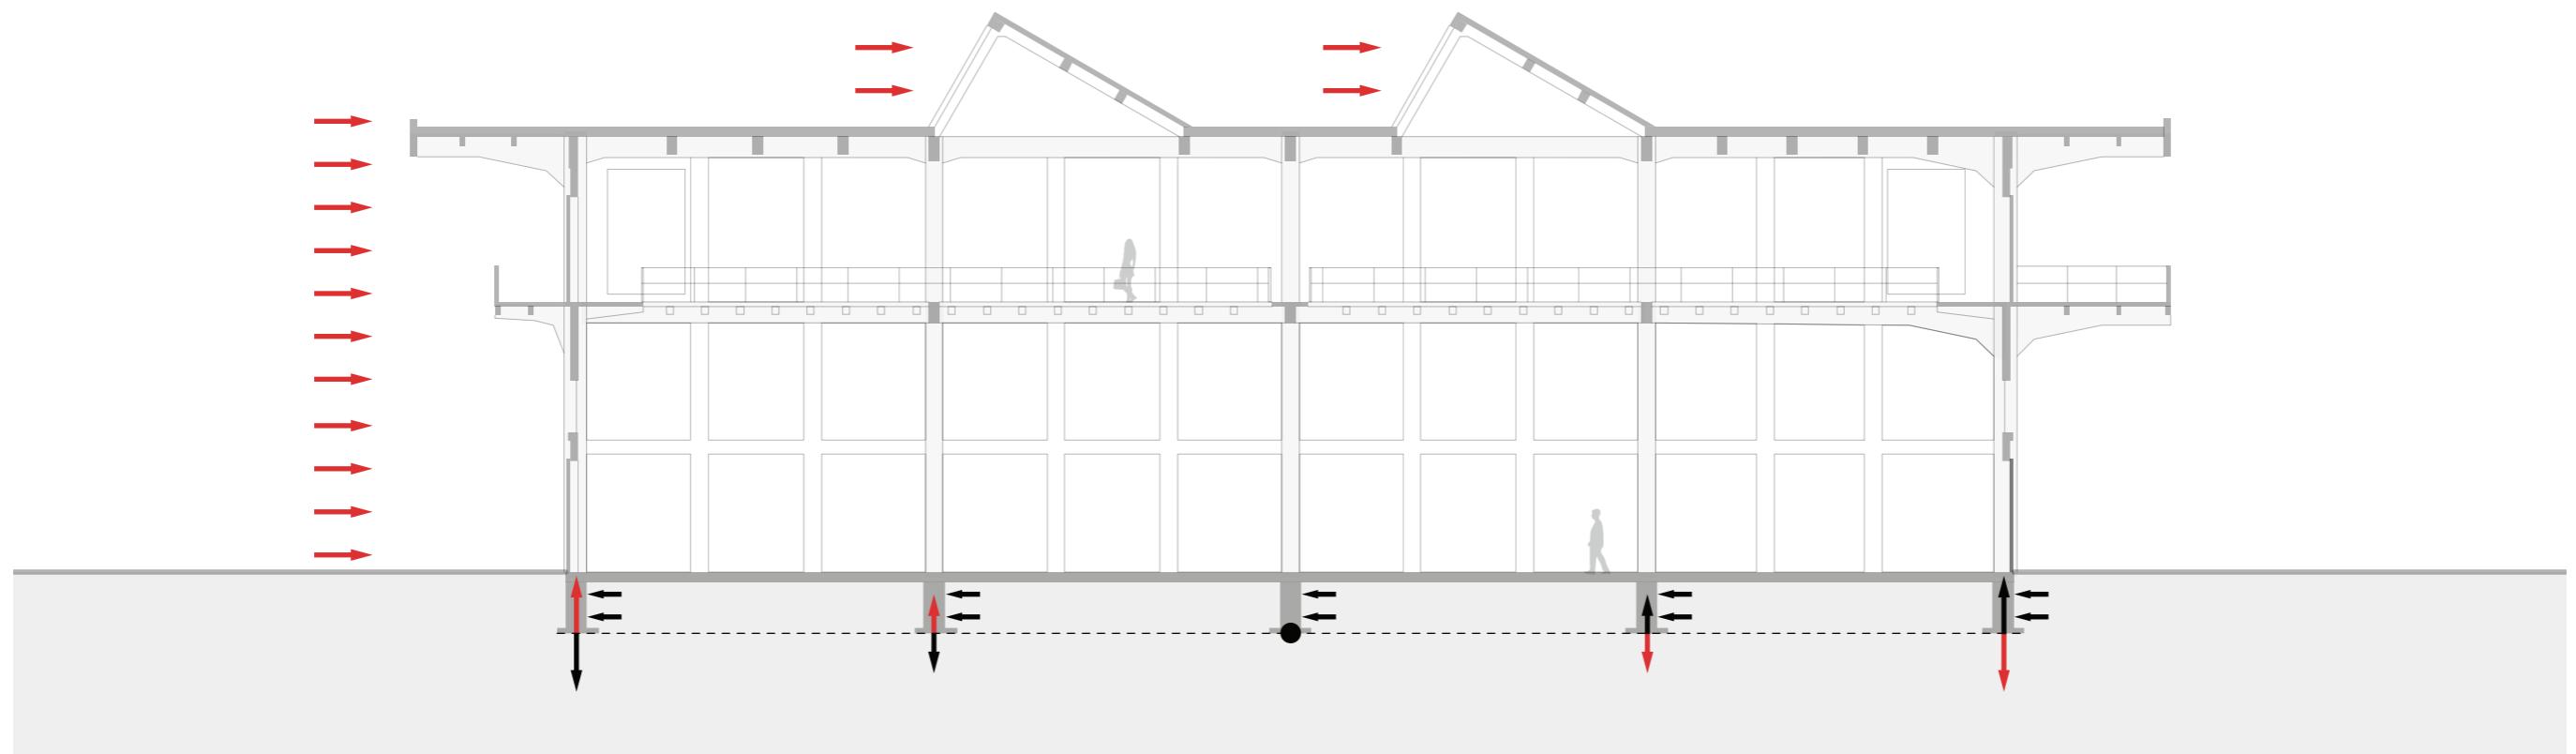
section AA horizontal loads by Jan Huis in 't Veld
(own illustration)

In these sections it becomes evident that the horizontal (wind) force causes 2 things. First of all the building wants to move horizontally. This is countered by

horizontal forces on the foundation. The friction of the ground because of the weight of the building is the main reason for this effect. Second of all the building wants to turn (clockwise in this illustration) around the centre. The vertical forces (and its counterparts) in the foundation make sure that the building stays in place. The circle in the centre of the foundation represents the pivot point of the phenomena through the forces. On the adjacent page only one portion of section BB is displayed, however the other 4 parts perform in exactly the same manner. The 5 parts each work separate from each other, because of the dilatations between them.

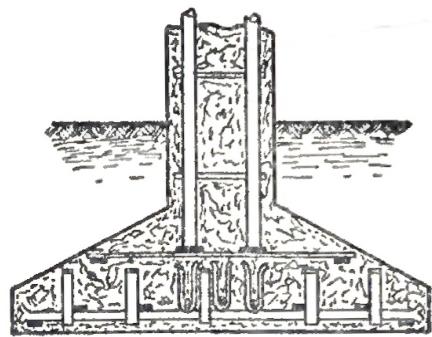
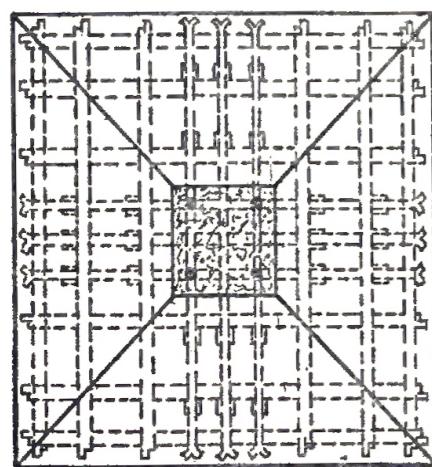
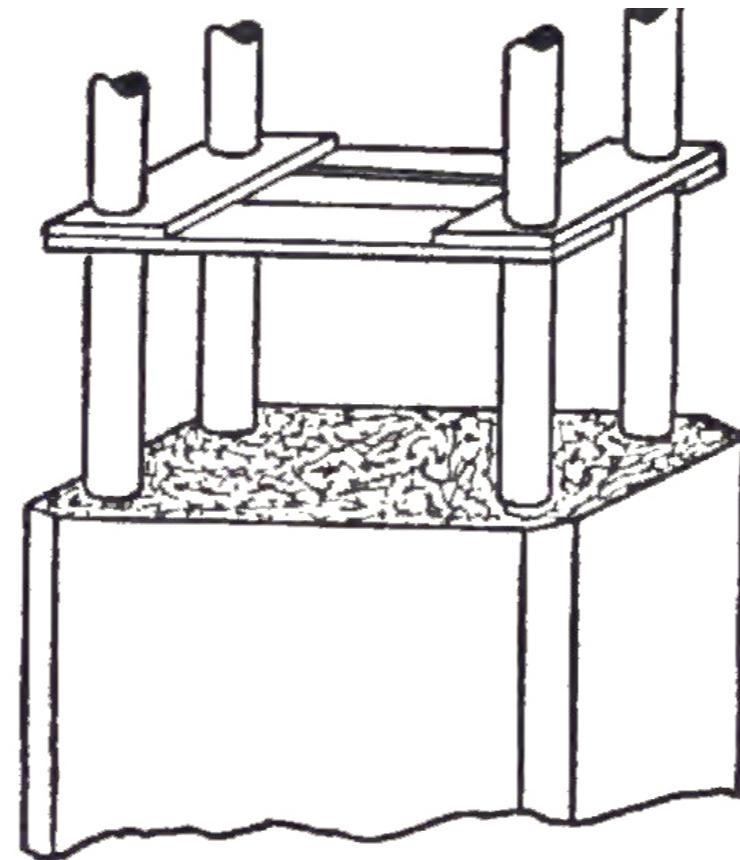
Hennebique System 1,2 by Jan Huis in 't Veld
(Radfords encyclopedia of construction - Volume 6: Concrete Construction)

foundation of the Katoenveem. The system of the columns in the Hennebique system and the Katoenveem appear to be similar. In certain damaged parts of the Katoenveem the structure was visible. Additionally the construction photograph of the Katoenveem shows a resemblance with the Hennebique system column (illustration 2).

When looking at the illustrations on this page a strong resemblance in the beam and floor systems between the Katoenveem and Hennebique. The column- and beam joints have a fixed angle in both systems and also

the edges constructional elements have been rounded off in both illustrations. What sets the construction apart from the Hennebique system, at least externally, is the double direction of the heaving load carrying beams in the Katoenveem. In the Hennebique system the heavy load carrying beams are supported by smaller, thinner beams in the other direction. Therefore we can assume that the entire joint has a different reinforcement system within the concrete.

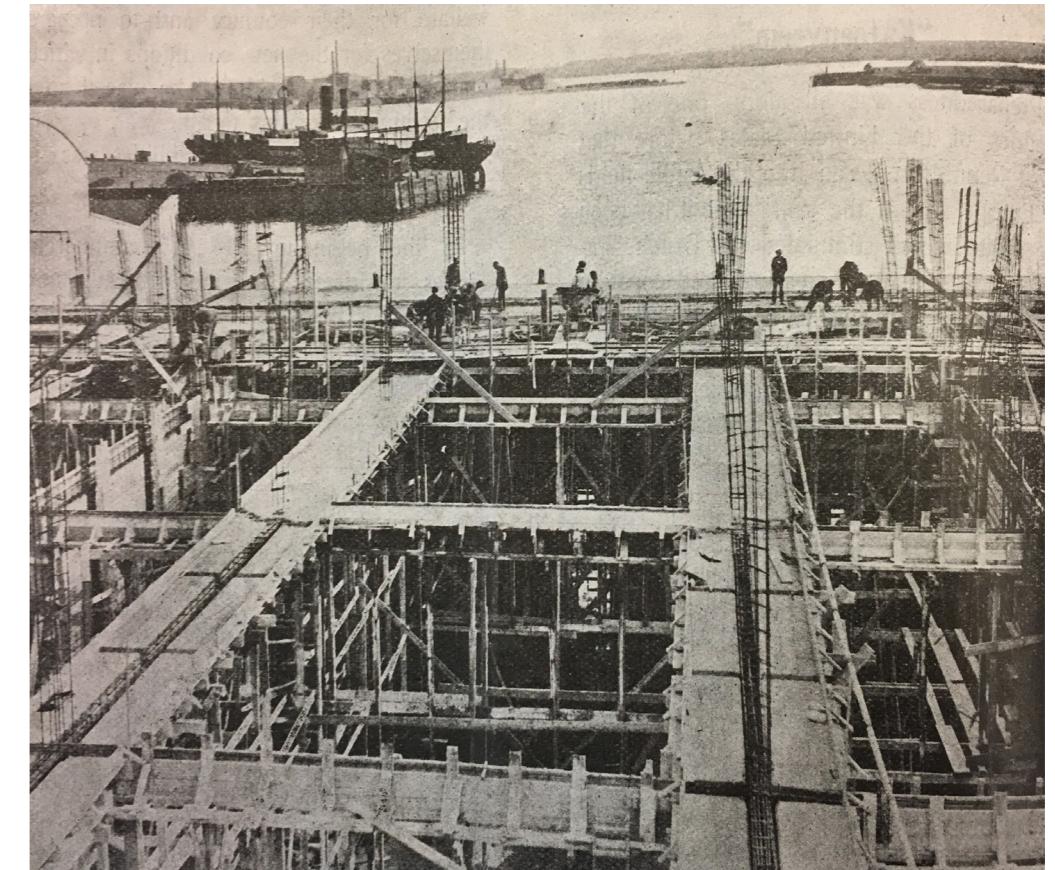
building site Katoenveem by Jan Huis in 't Veld
(The Pioneer #3, march 1919)

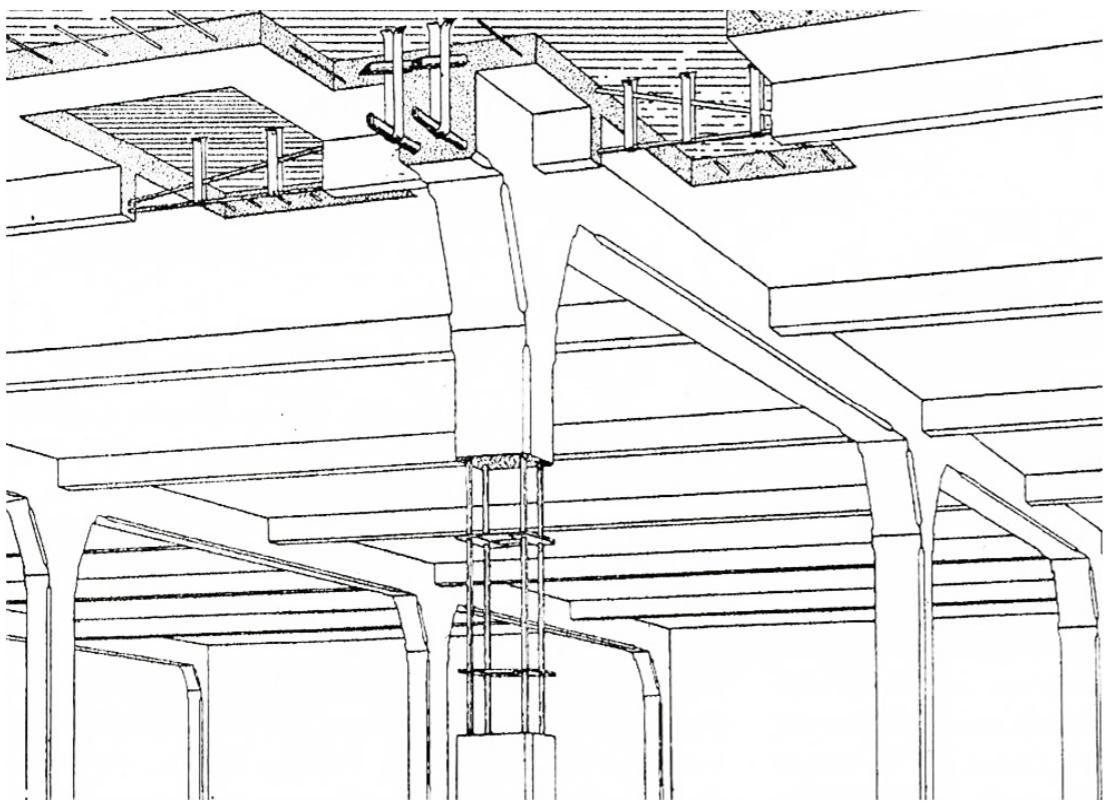
Hennebique System 3 by Jan Huis in 't Veld
(Radfords encyclopedia of construction - Volume 6: Concrete Construction)

which can also be used for upright columns, horizontal support beams and even floors. The patents lasted 25 years, therefore they started to expire from 1911 onwards. New 'Hennebique-like' systems started to emerge throughout Europe. The Katoenveem contains one of these systems. It is closely related to the Hennebique system, but it is not identical. The foundation of the Katoenveem is not displayed in any drawing or photograph in detail, only an outline is visible. The outline seems identical to the outline of the Hennebique foundation system (illustration 1). Therefore, without any further knowledge we will assume that the

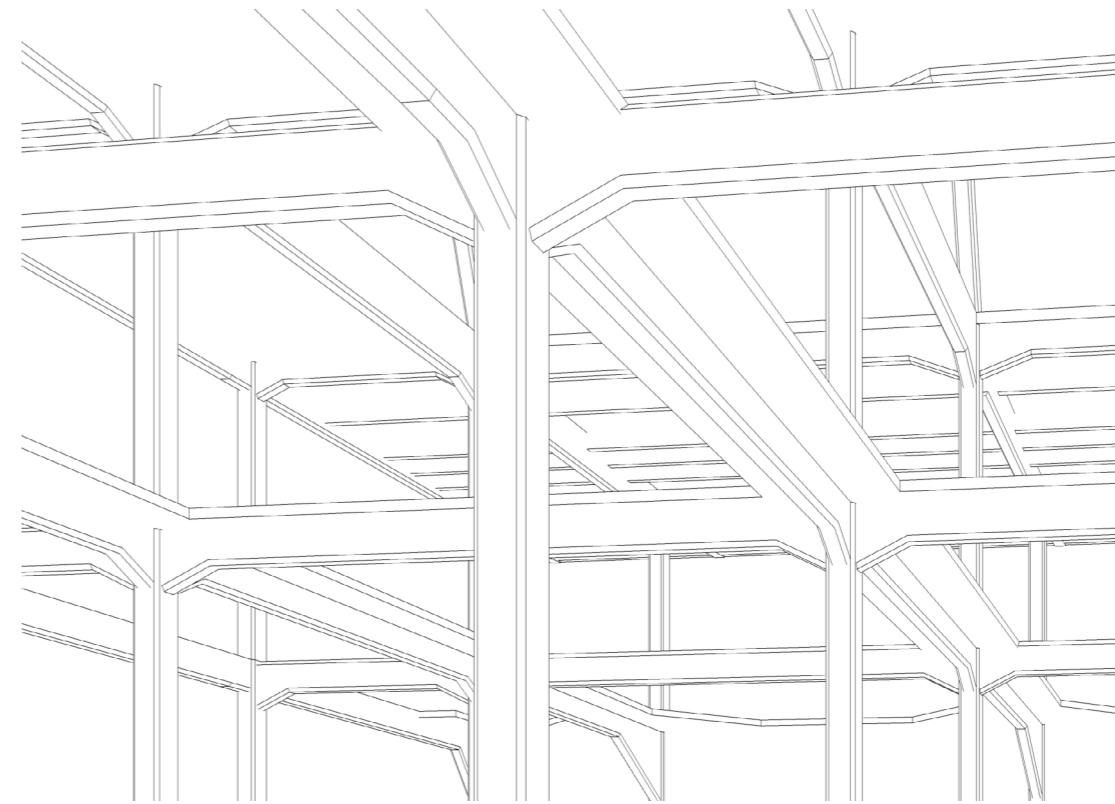
Katoenveem 3D construction by Xialo Yi
(Radfords encyclopedia of construction - Volume 6: Concrete Construction)

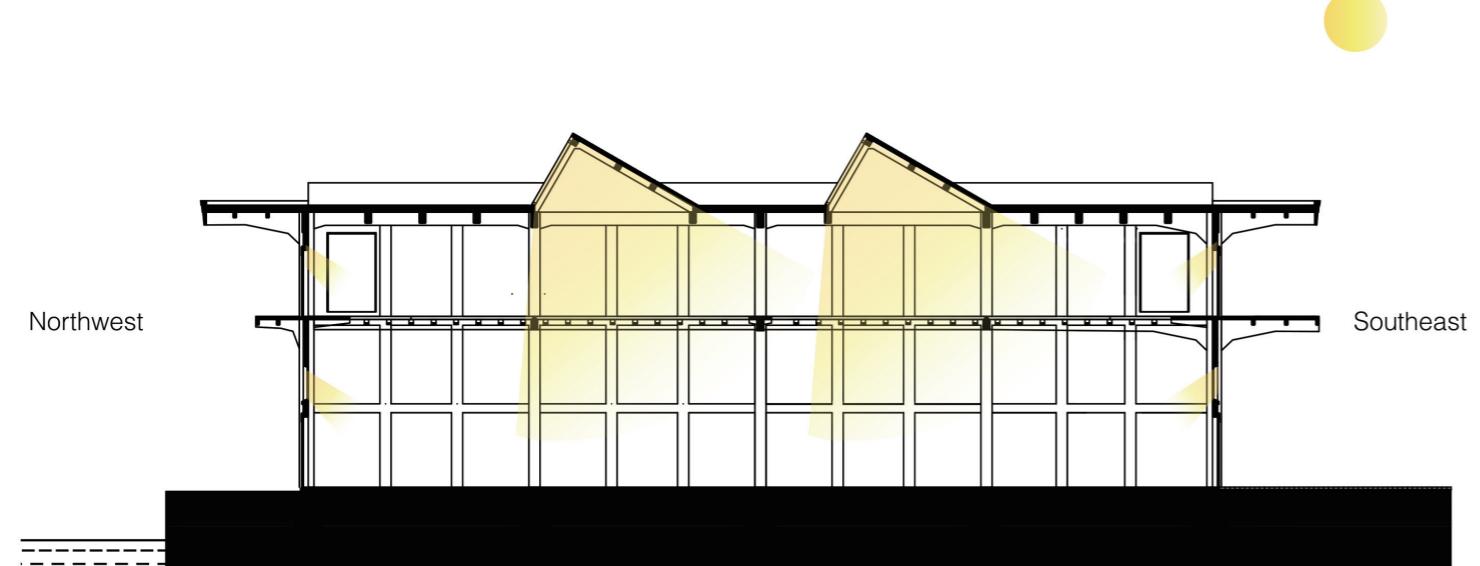
natural lighting shown in section

The high windows on the ground floor are placed above the 3-meter-high doors. All windows are under the shade of the cantilever balconies and roof. In this way, almost no direct sunlight would go into the building.

To conclude, the natural lighting of the Katoenveem is indirect and mild, sometimes insufficient (which is solved by artificial lighting)

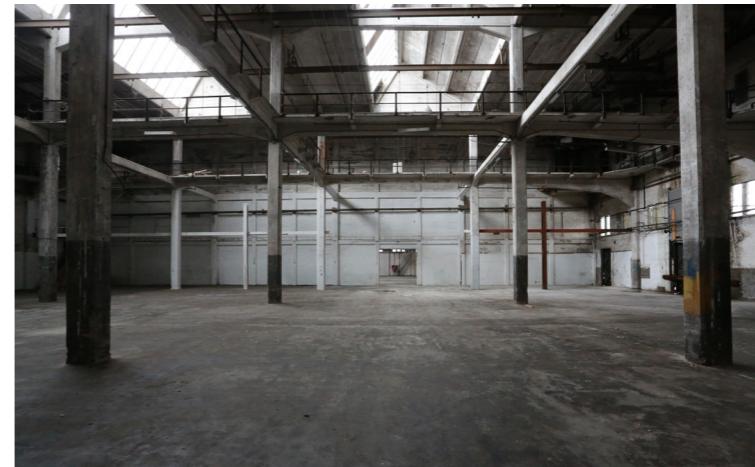
Skylights

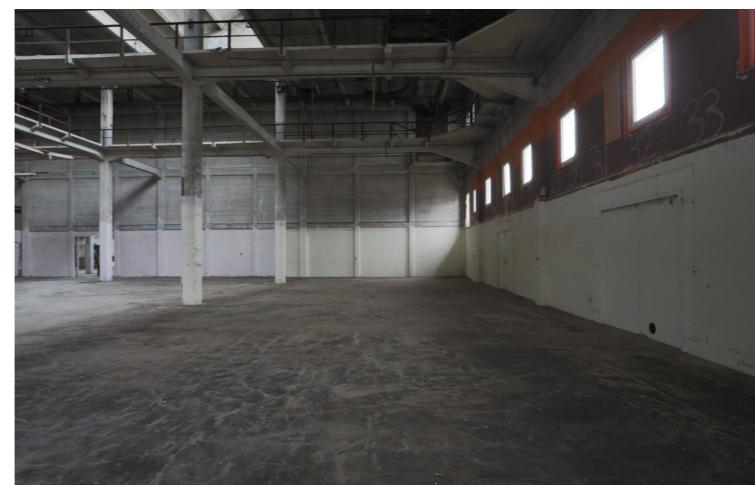
High windows

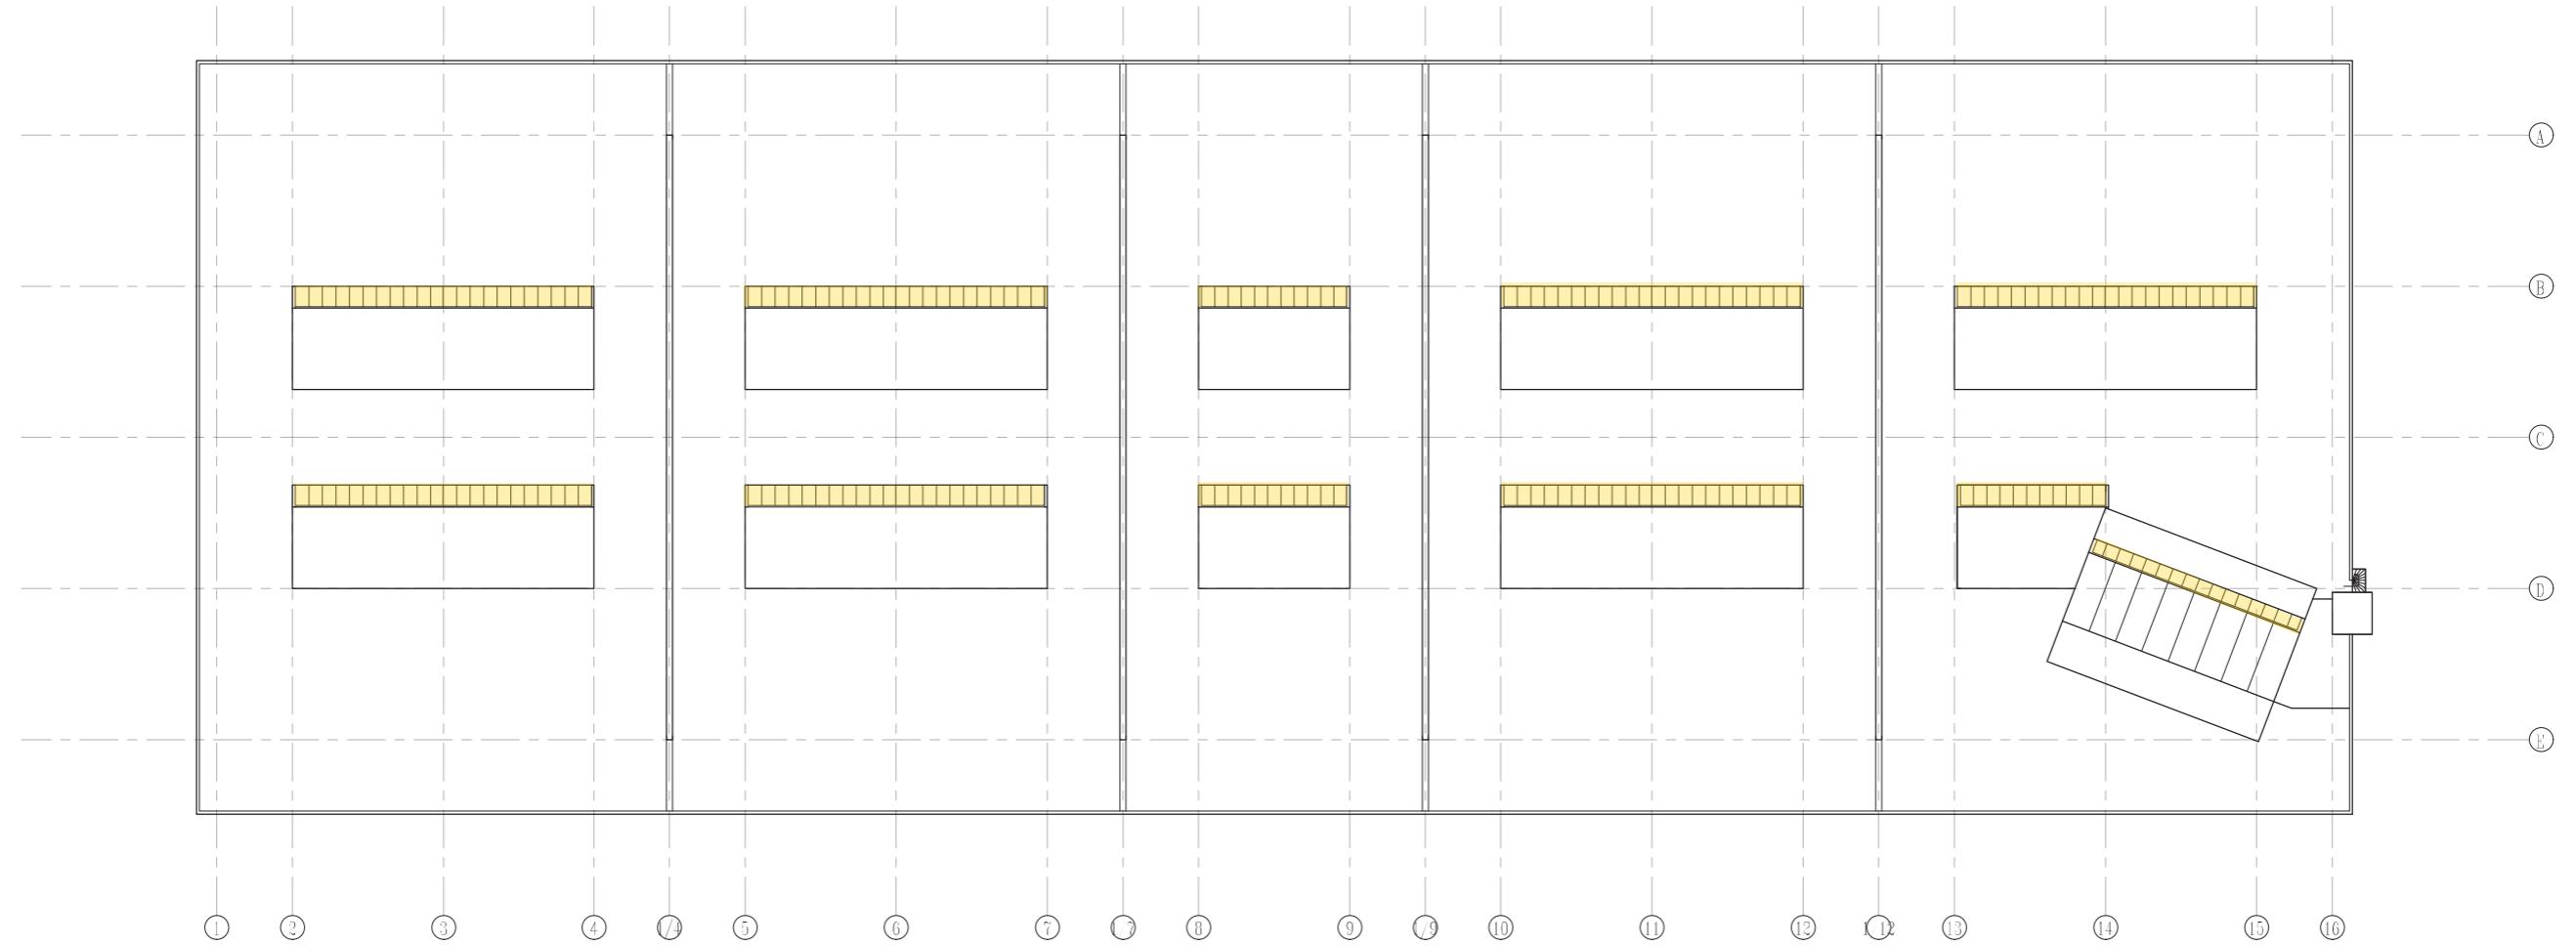
Roof Plan showing the location of skylights 1/500

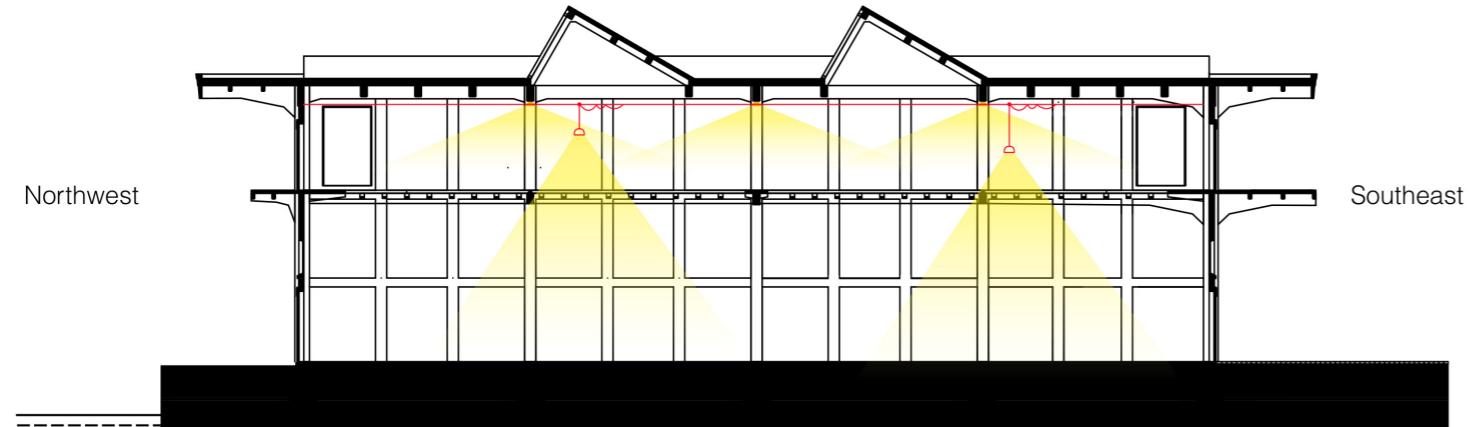
fig1.artificial lights shown in section

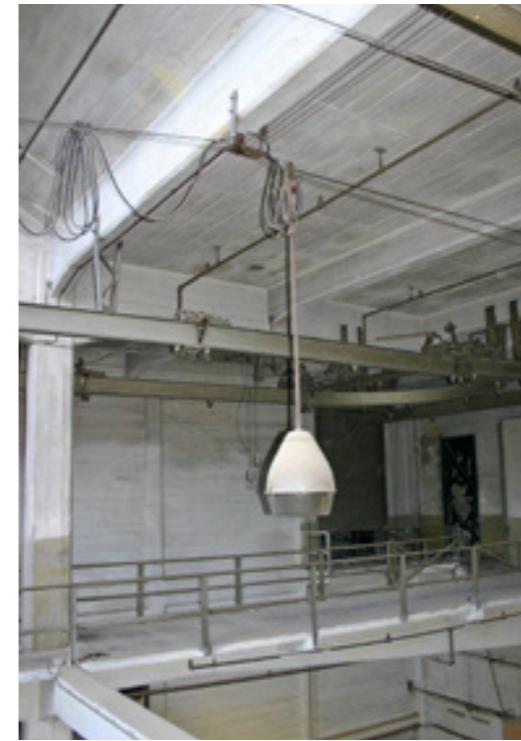
fig2. Moveable light

It is worth mentioning that the fixed lights shown in the Building Report does not exist in the building anymore, while the moveable lights can be found in every halls. With the two kinds of lights, the storage and transportation of cotton was operatable whtn the natural lighting was not enough.

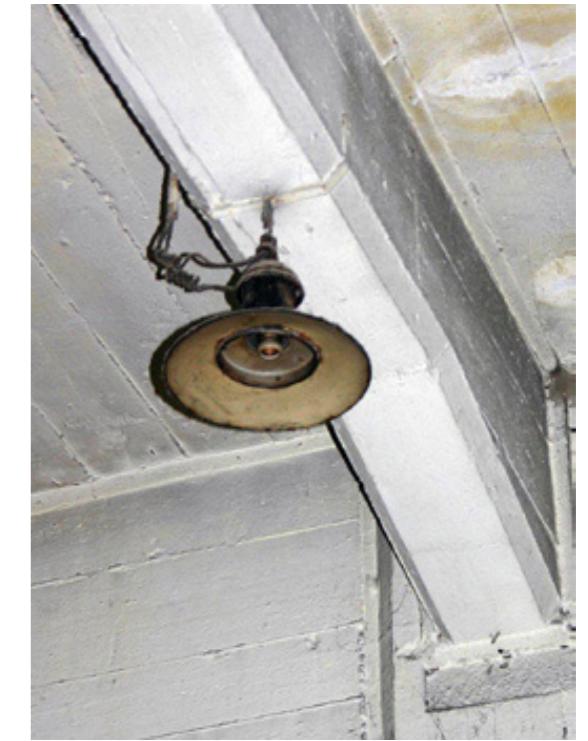
fig3. Fixed light

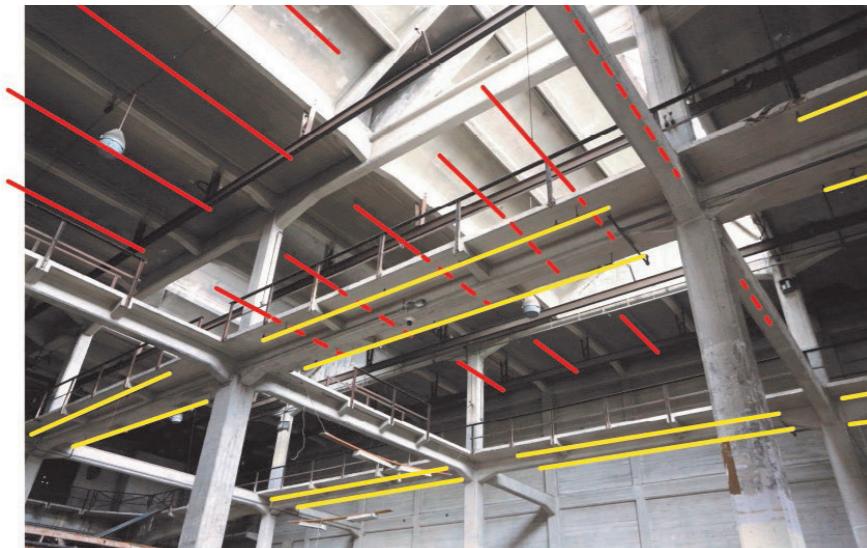
fig1.Sprinkler rails are placed on 2 different heights in the building.

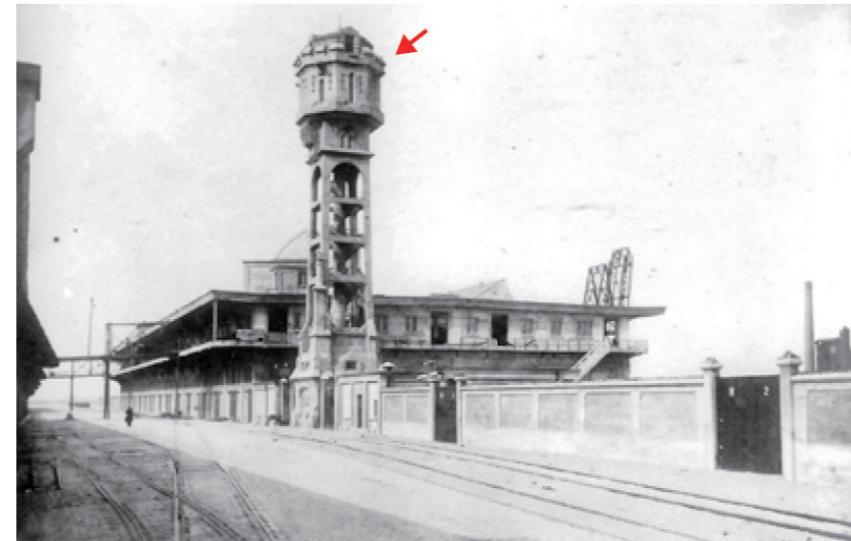
fig2. The water tower was an important part of the system

The sprinkler system was no longer in use since the demolition of the water tower in 1966.³

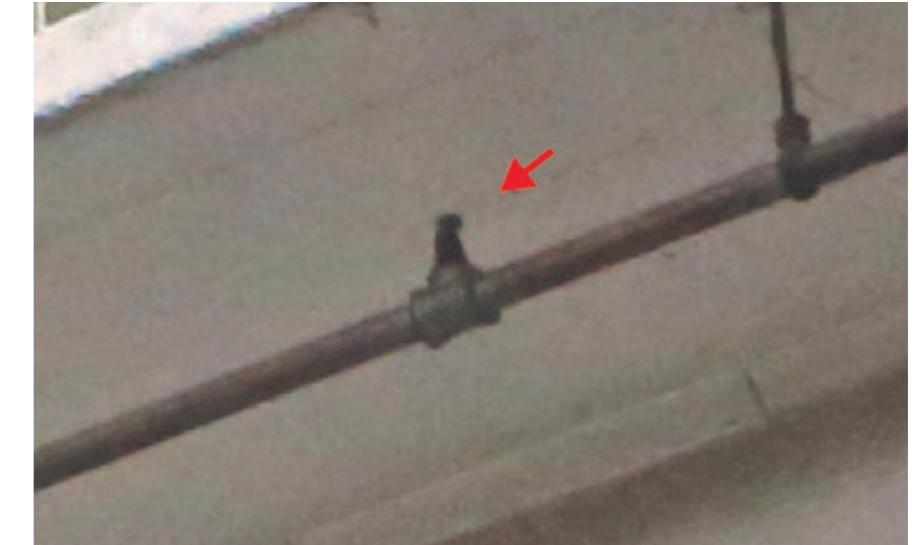
fig3. Close-up look of the sprayer of the system.
