KATOENVEEM

MSc III Heritage & Architecture

Architectural & Building Technology Analysis

07/04/2017

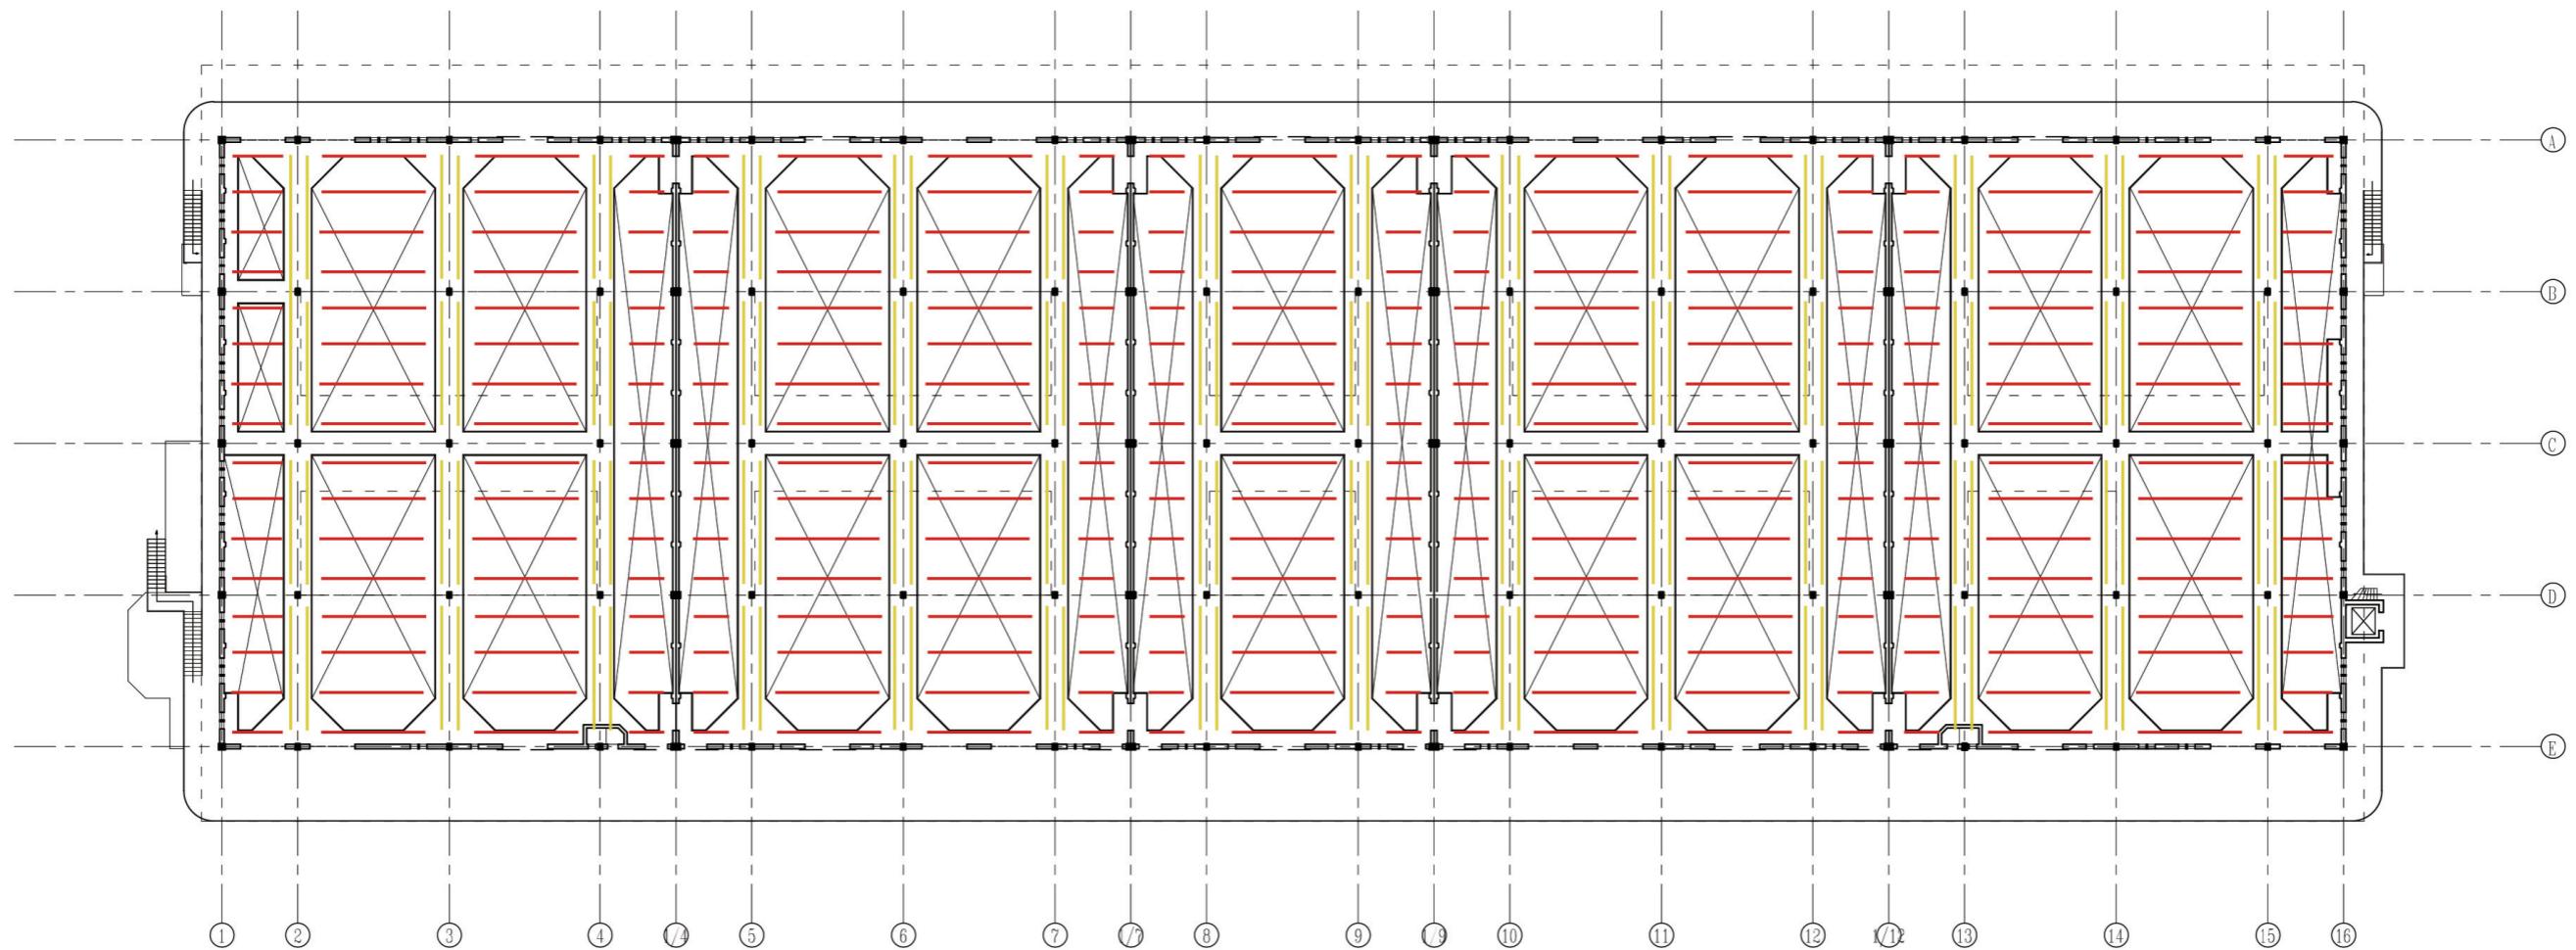
— sprinkler under the roof

— sprinkler under the walkways

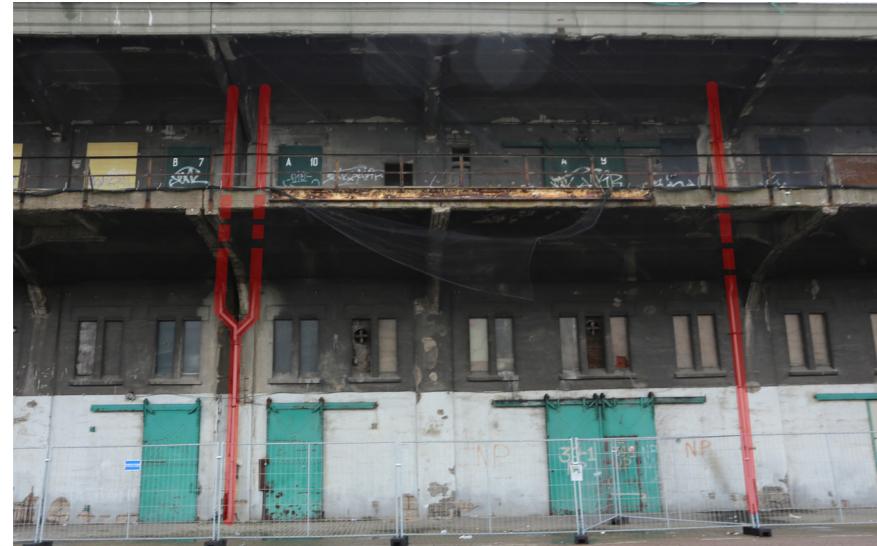
Drainage pipes shown on the facade.

There is much damp damage on the surfaces around the water pipes. This will be analysed on a separate

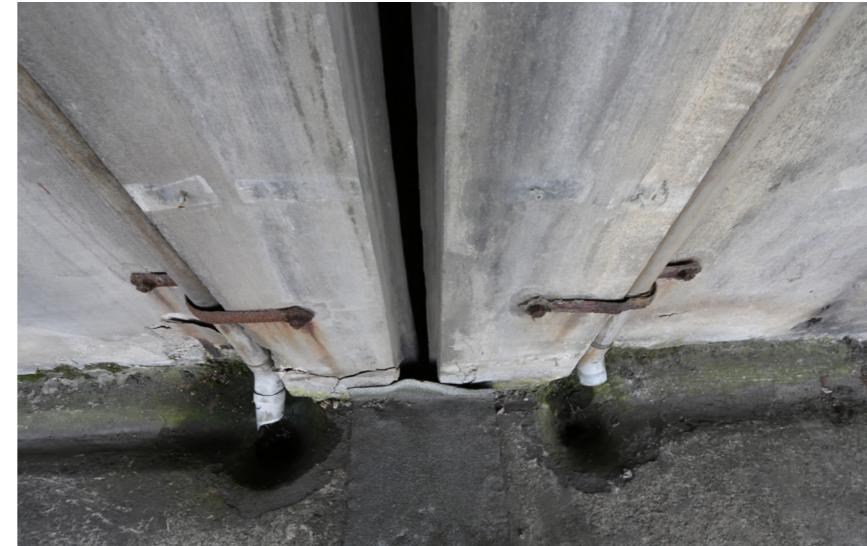
Two symmetrical drainage pipes and holes on the both sides of the compartment walls.

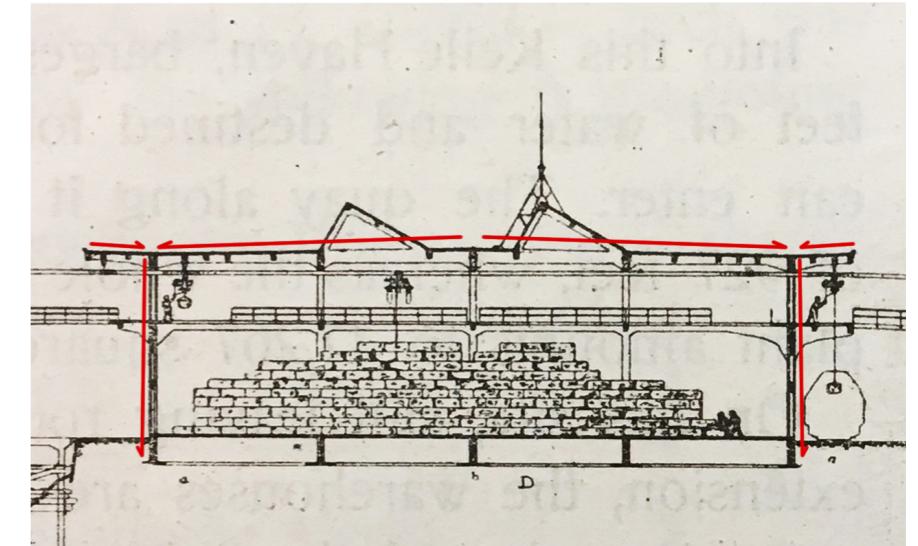
Rain water movement on the roof.

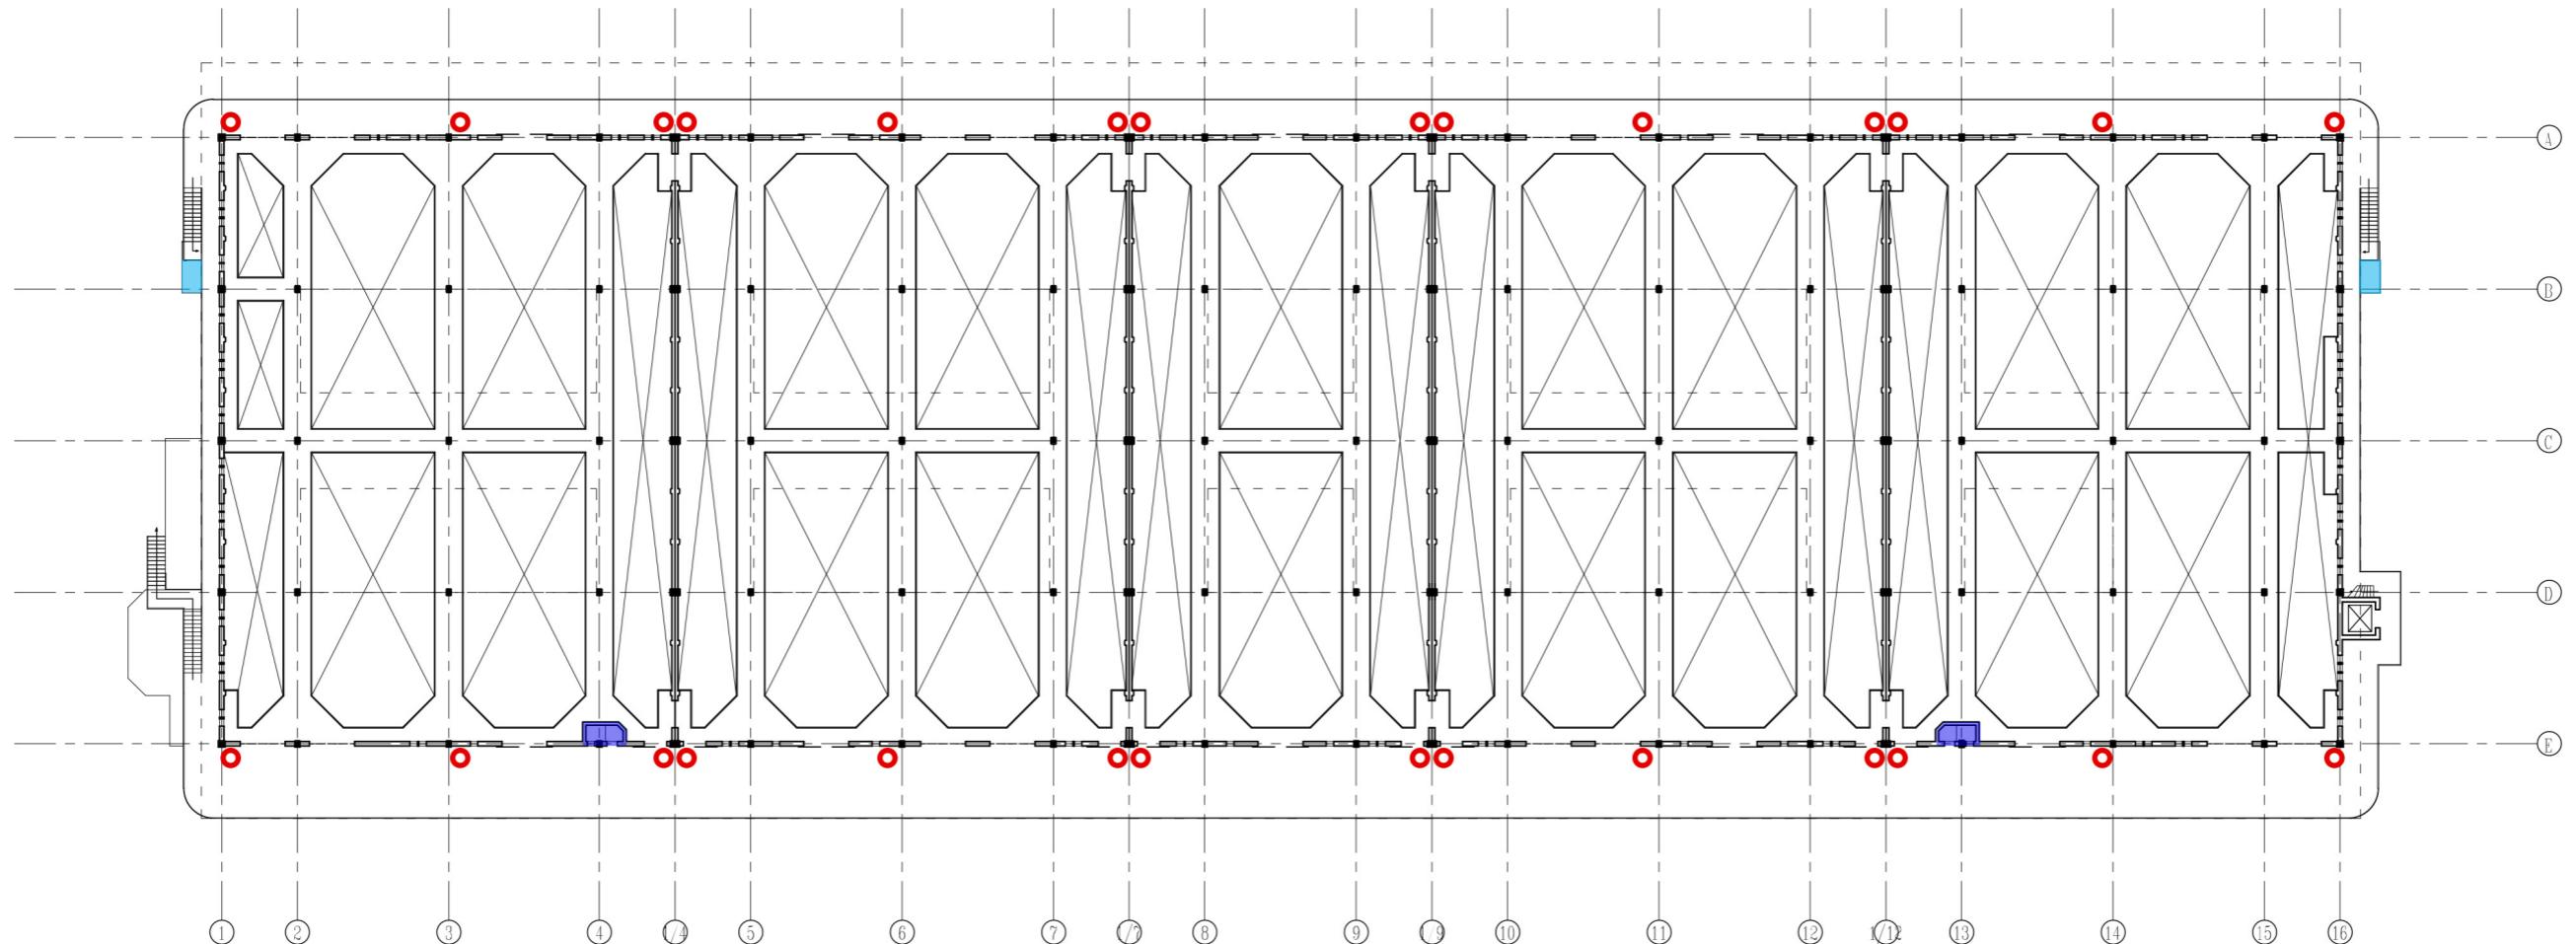
Location of drainage system and toilets shown on the 1F plan 1/500

There are four toilets in total, two on the ground floor, two others on the first floor. All of the toilets can only be accessed from the outside of the building. The morioring location of them provided efficiency of use.

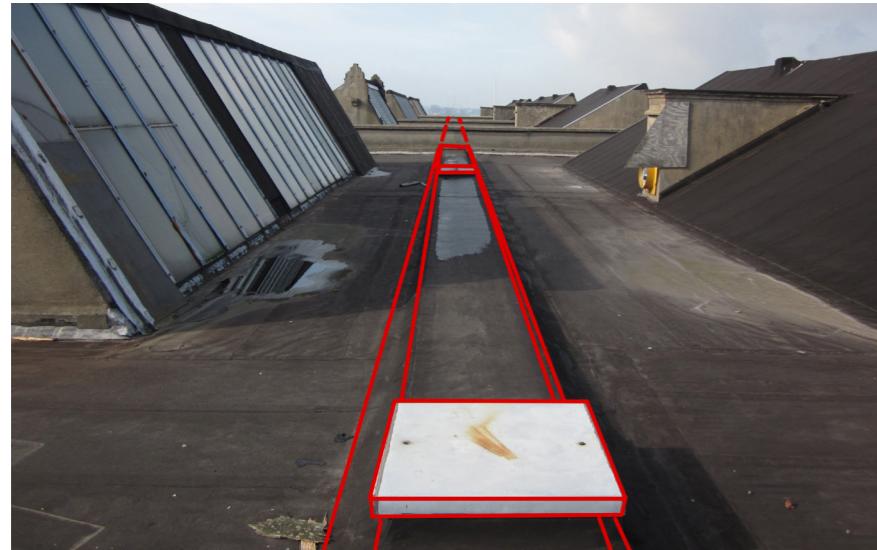
fig1.The tube in the middle of the roof that contains electrical wires for the building.

This arrangement of electricity distribution was able to minimize the chance of fire by separating the wires and cotton as much as possible. It is also safe to address that the original electricity system does not work anymore.

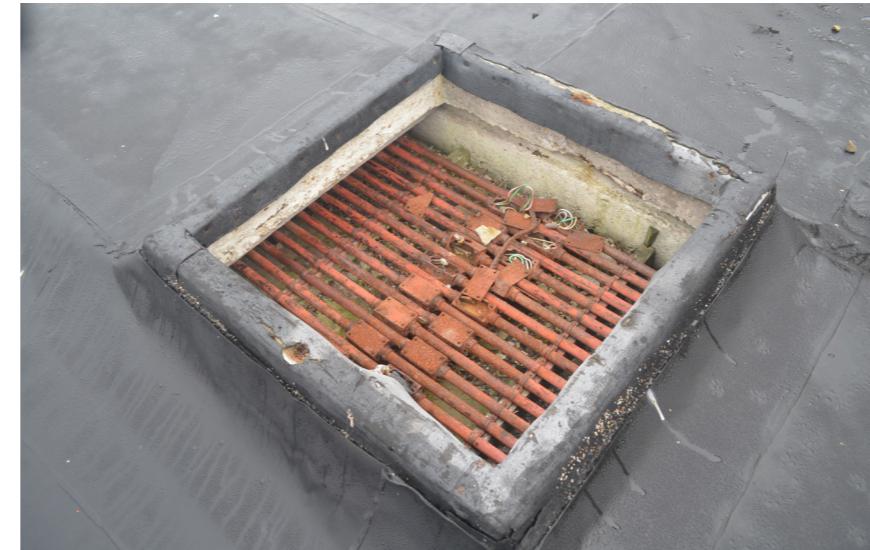
fig2. the covers can be opened for inspection and reparation

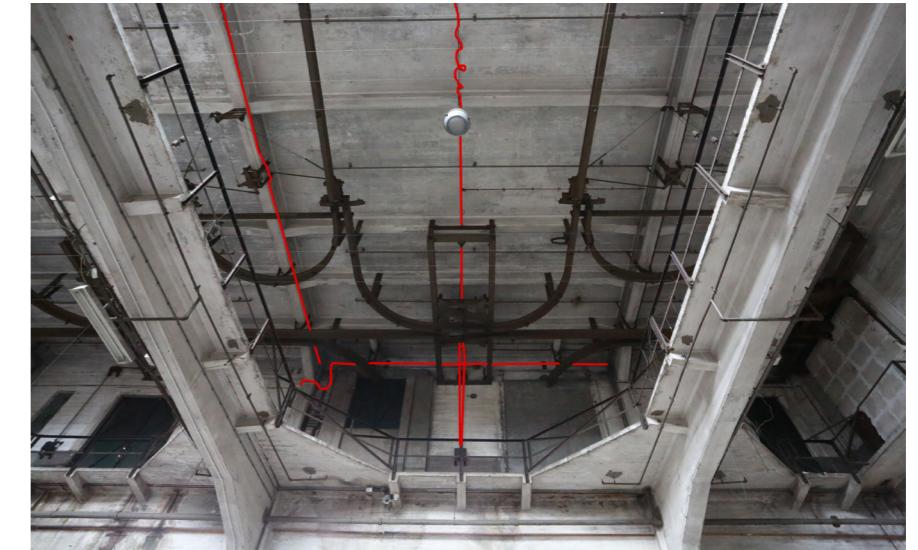
fig3. Wires from the roof that provide power for lighting and the conveyor system.

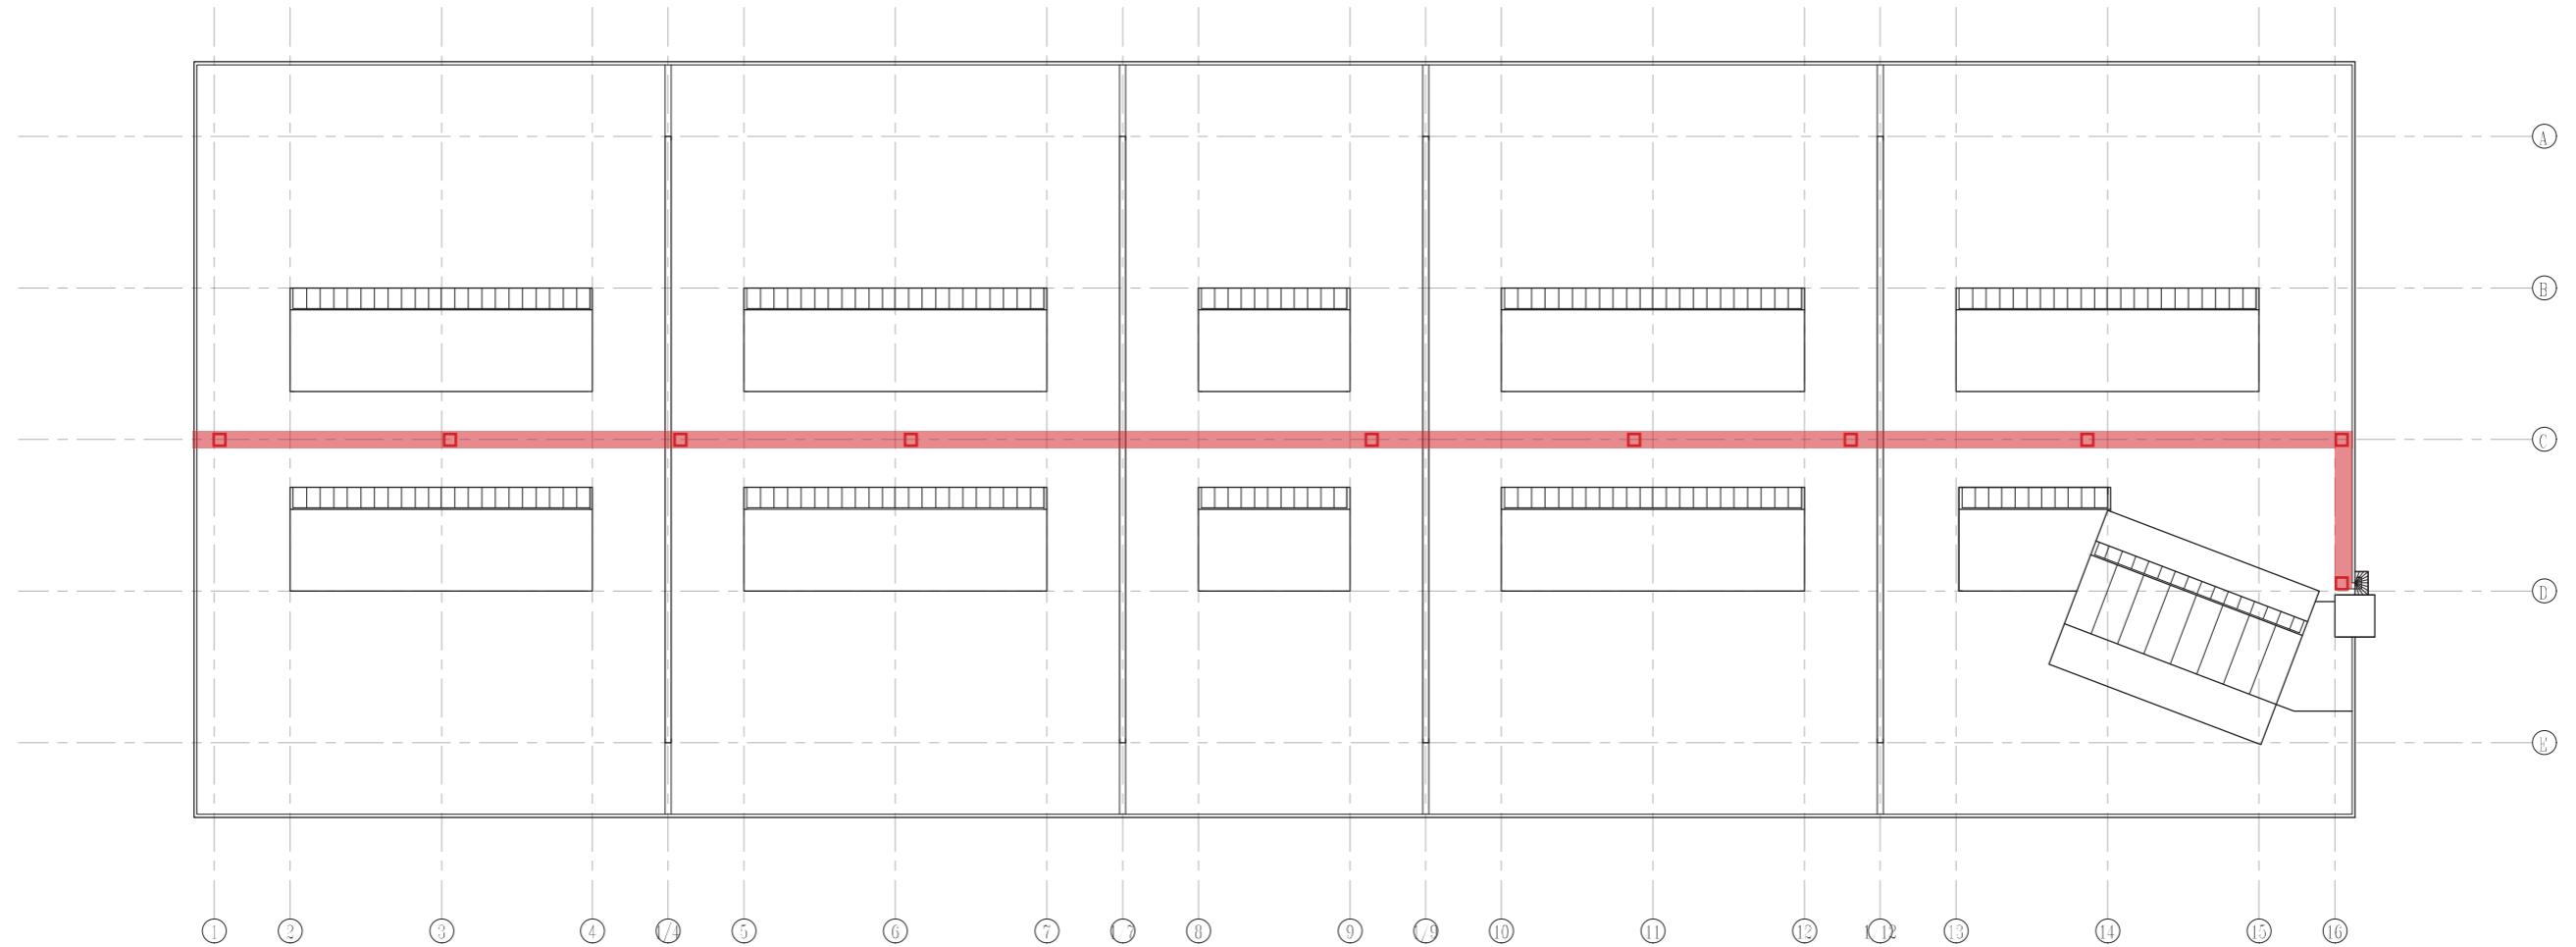
tunnel of electricity
 covering lids

location of electricity shown on roof plan 1/500

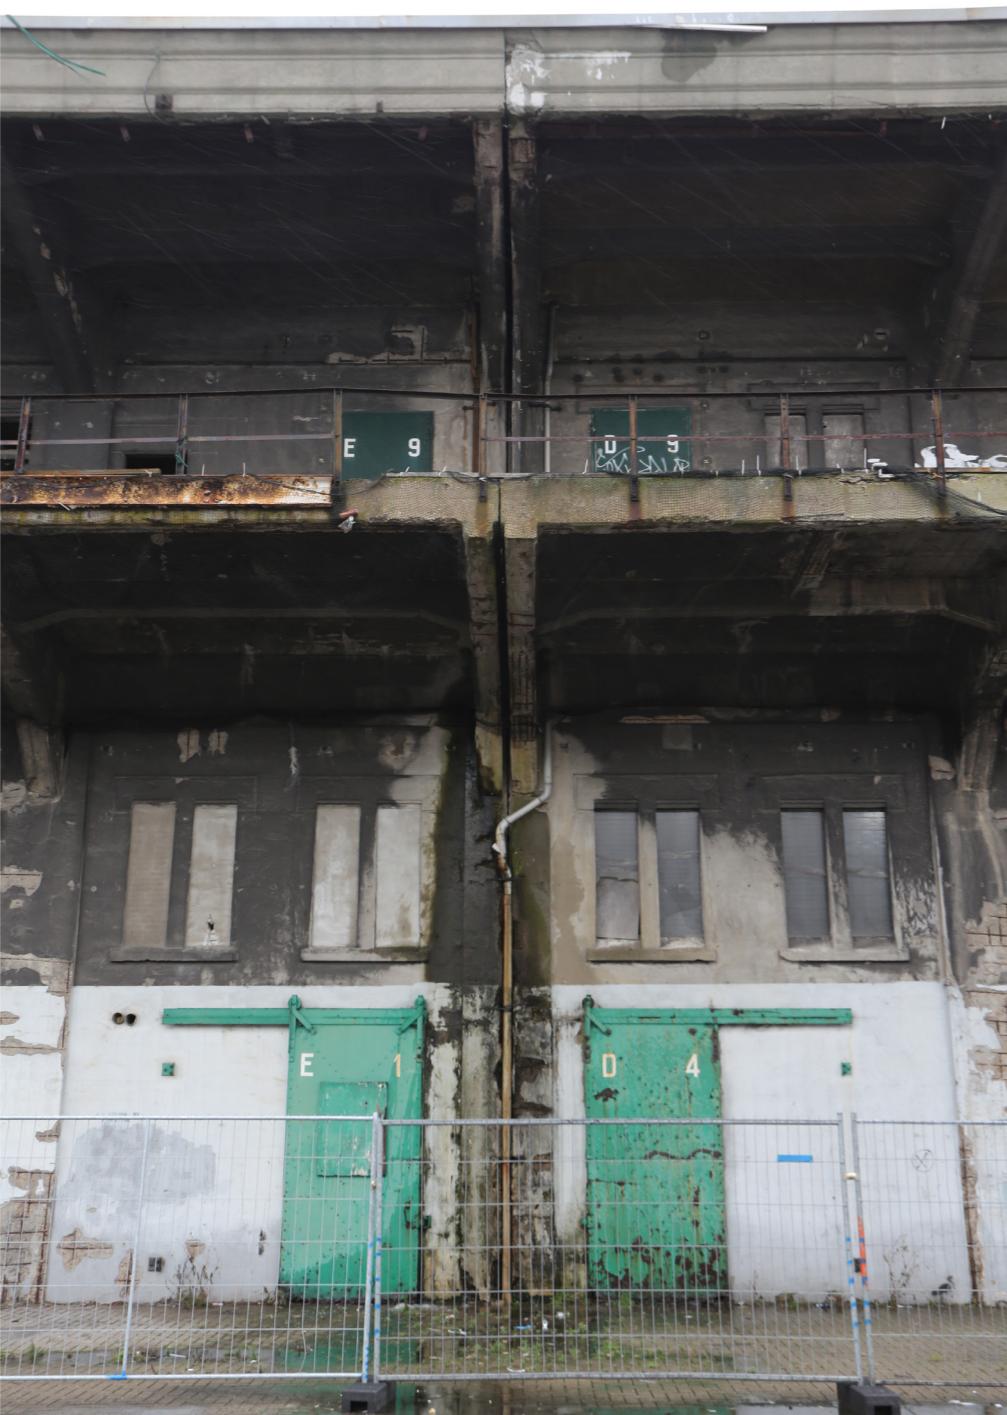
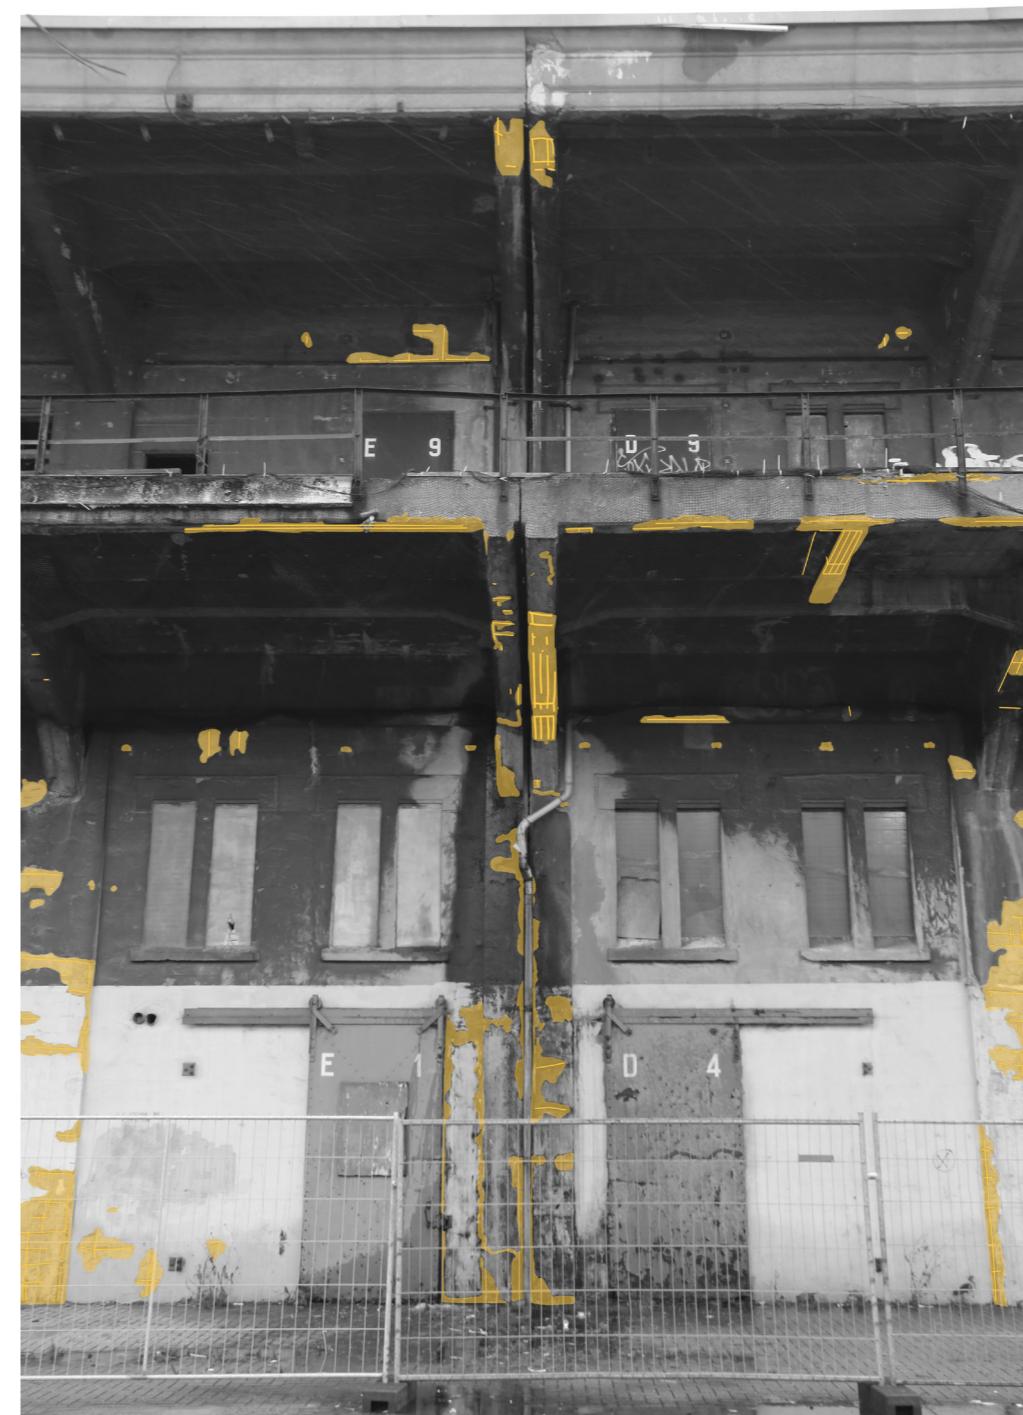
illustration 1&2 by Elmer
(source: personal sketch and photo)

First up is the visual damage, as can be seen when visiting the building. On the right image above, the yellow represents the damage to the concrete.

The source of this damage becomes clear at some point, the bright yellow shows this. This is where the metal reinforcement has been laid bare and is rusting away. The reason this happened is probably because the covering of the concrete that is supposed to protect the reinforcement has been too shallow; allowing the metal to

- Rusted reinforcement
- Spalling damage caused by rusted iron

To prevent this from happening in the future, we must first understand where this damage comes from.

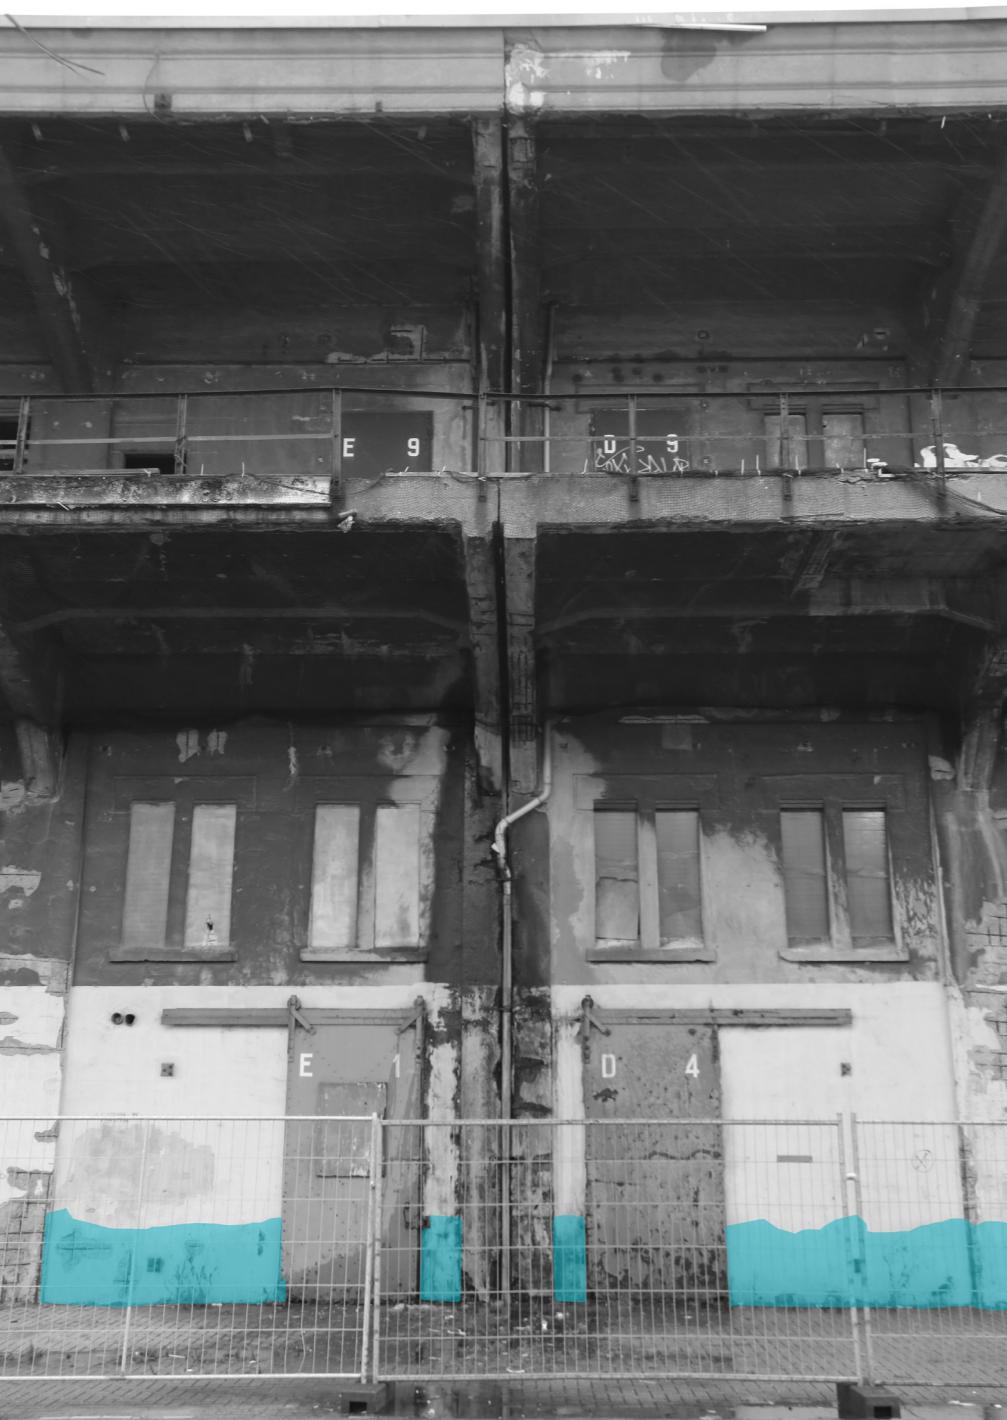
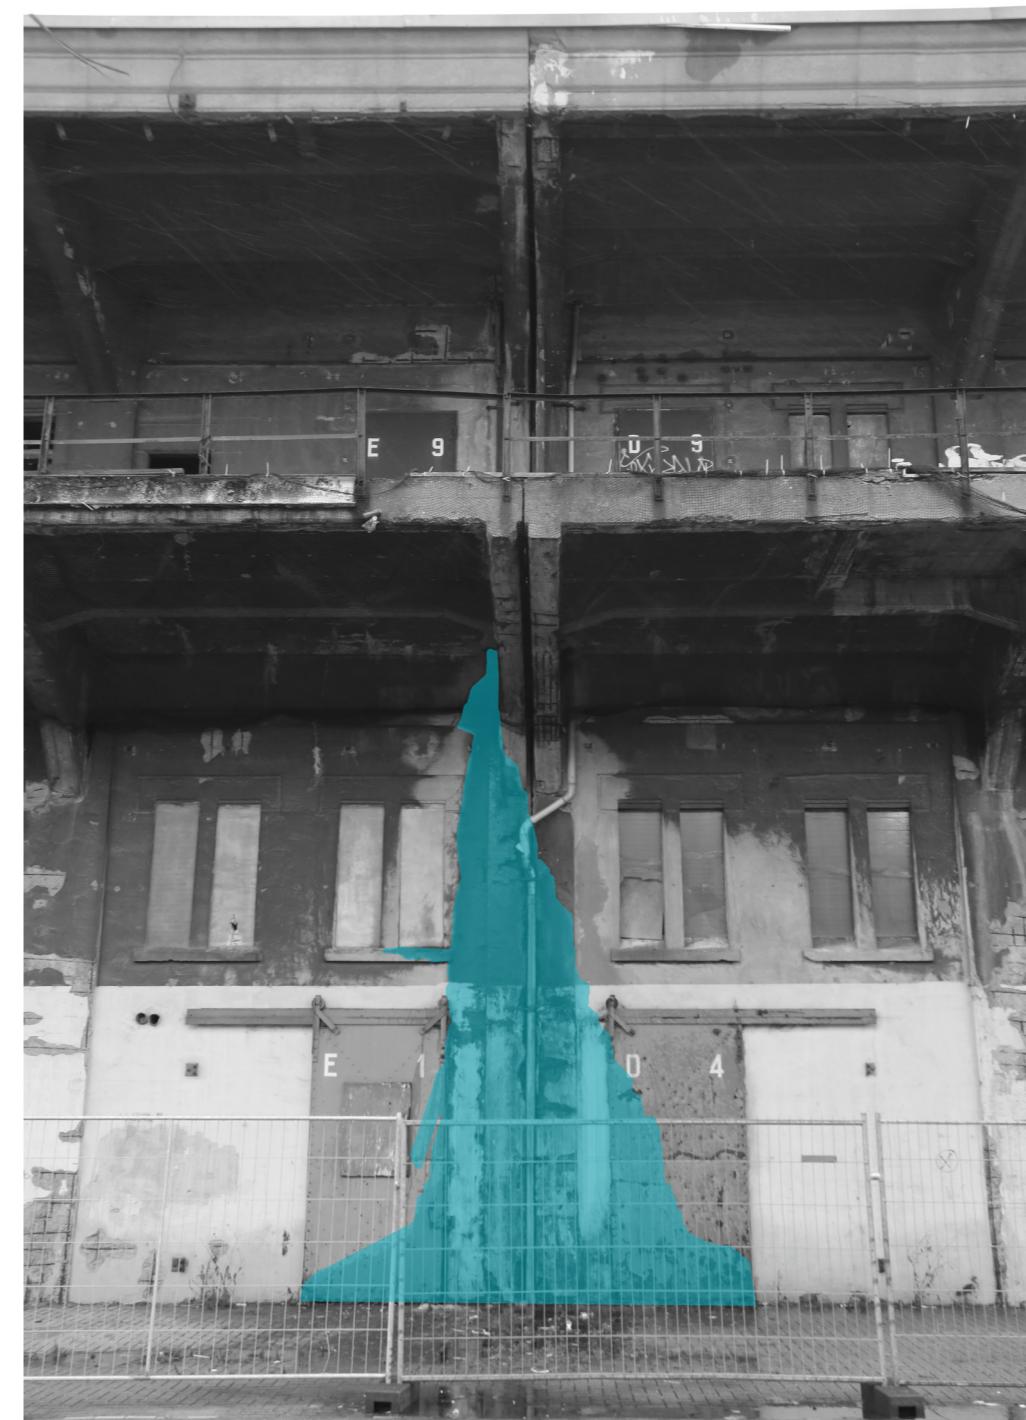
illustration 3&4 by Elmer
(source: personal sketch and photo)

The second major source is leakage, caused by broken

drainage pipes. This can be easily be fixed by replacing the broken pipes, but the effects can be devastating as seen in the image above here. The second image shows the traces of water as they were present there on the day of our visit. It was dry at the time of this picture, showing that a leakage such as this keeps a certain area wet for long periods than the rest of the building. The fact that the facade has been cleaned of the darkening soot (following page), shows that this leak has been there for some time.

■ Moisture visually present

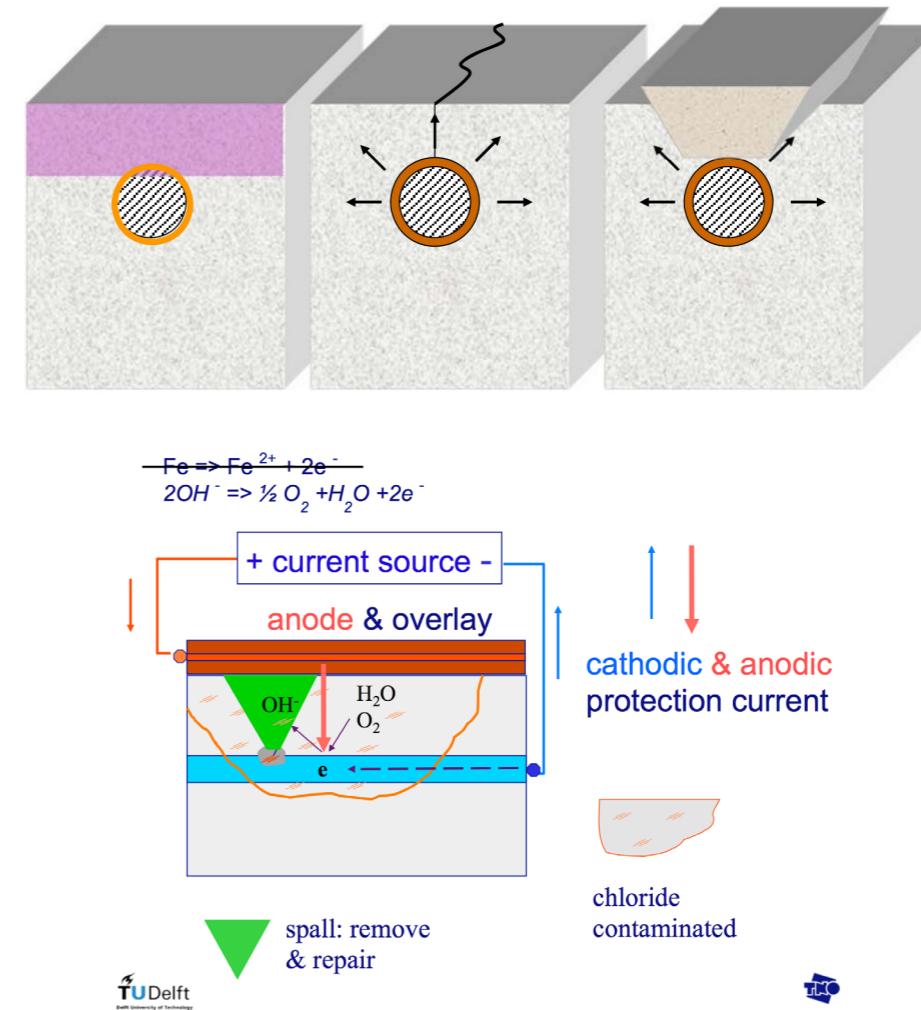
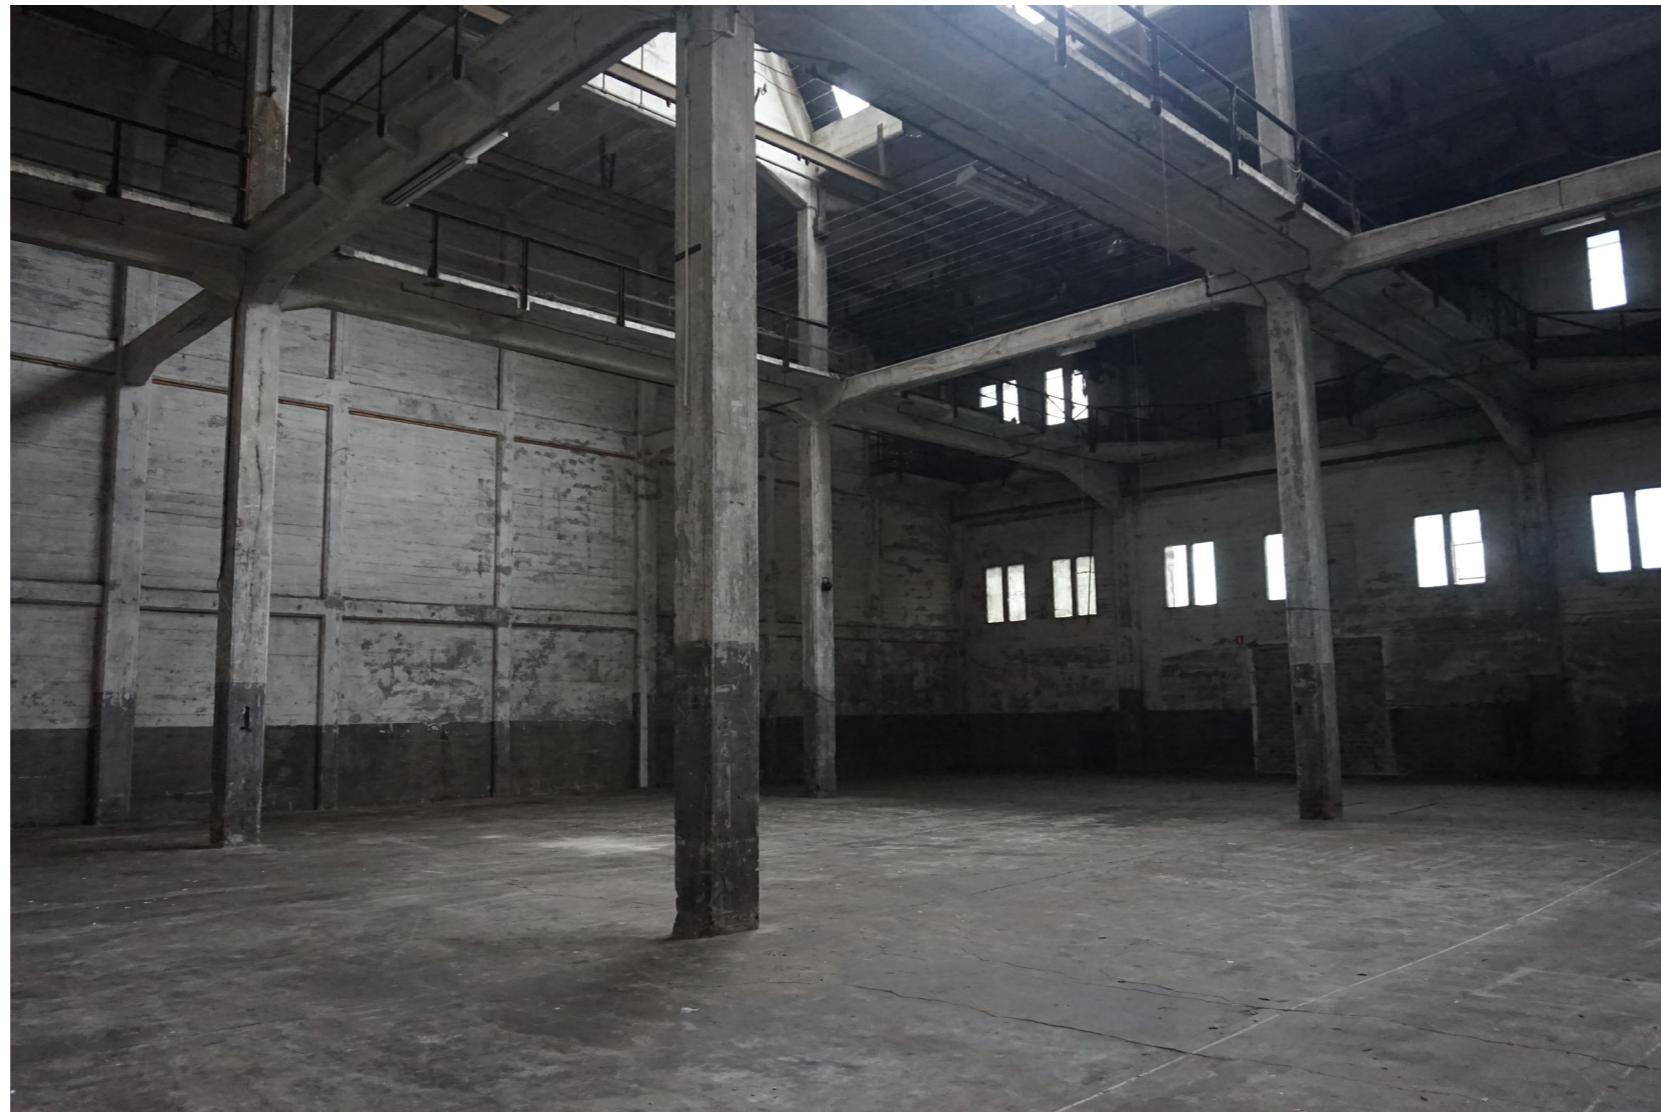
illustration 8 by Elmer Pietersma

The damaged reinforcement must also be treated. First it needs to be checked for structural integrity, needing replacing where it fails. Secondly further spread of rust needs to be stopped. This can be done by cathodic protection. In this reaction a metal of lesser nobility will degrade instead of the iron, making sure the rust is not eating away the reinforcement any further as is shown by the image 7.

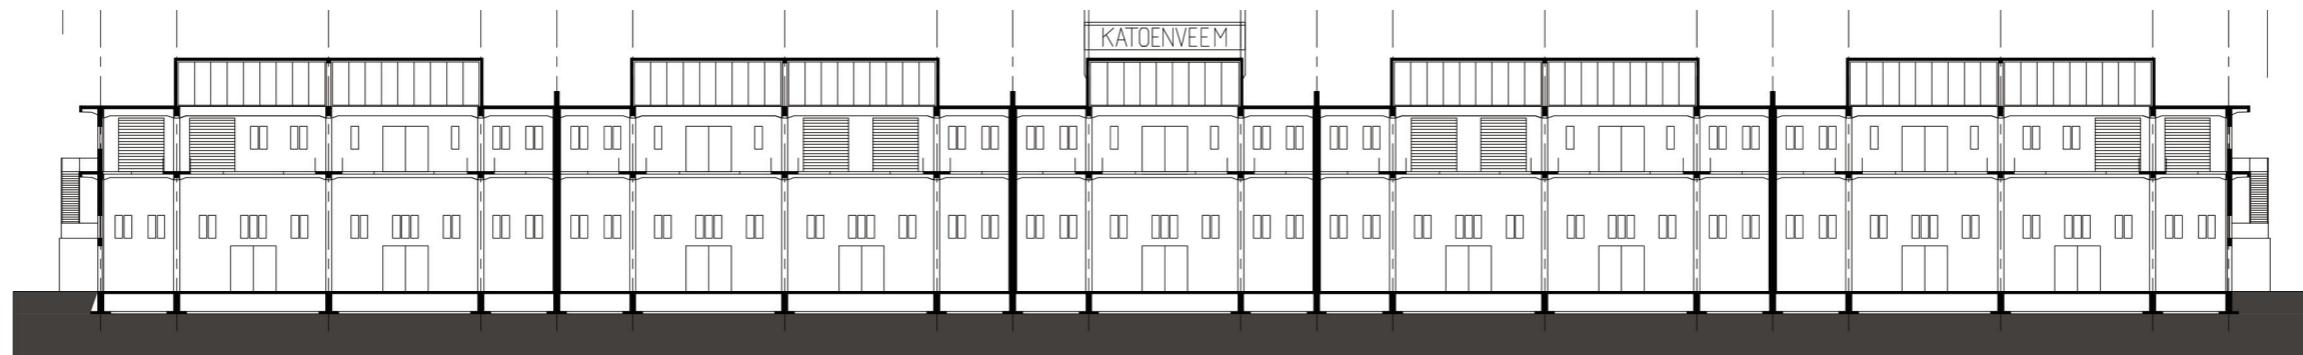
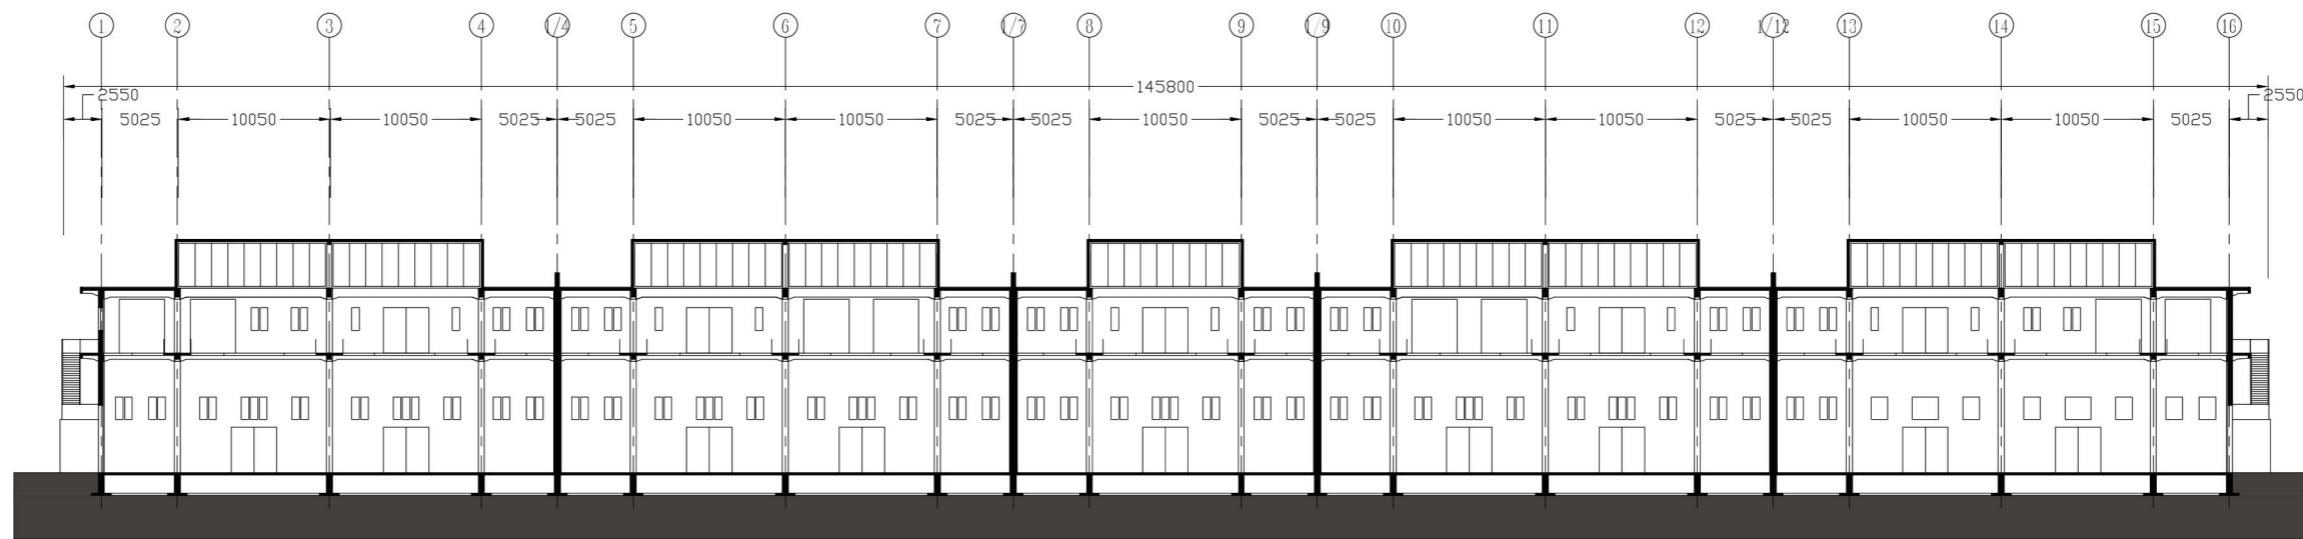
Upper drawing: Longitude Section 1/500_original status by Xihao Yi
Lower drawing: Longitude Section 1/500_current status by Xihao Yi

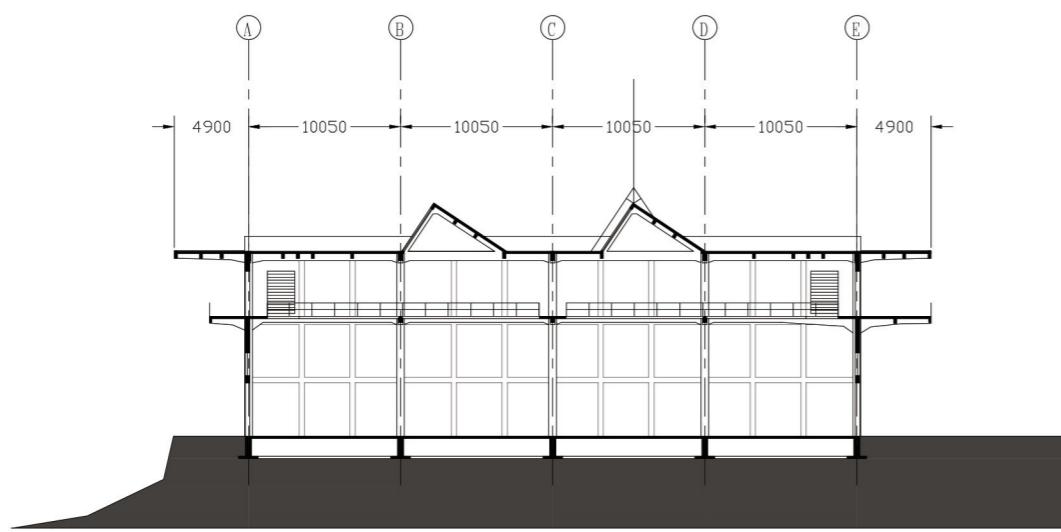
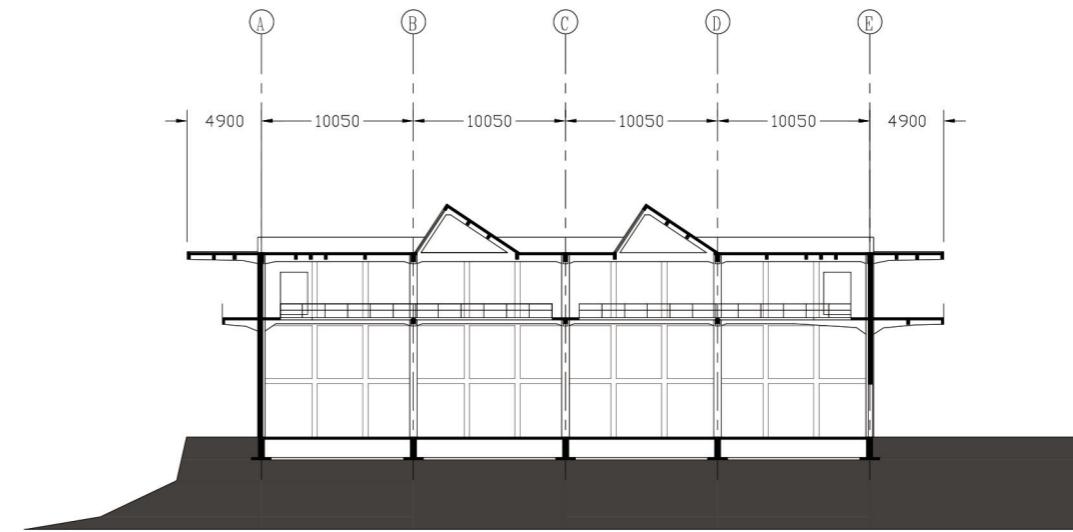
Left drawing: Cross Section 1/500_original status by Xihao Yi
Right drawing: Cross Section 1/500_current status by Xihao Yi
