KATOENVEEM

MSc III Heritage & Architecture

Architectural & Building Technology Analysis

07/04/2017

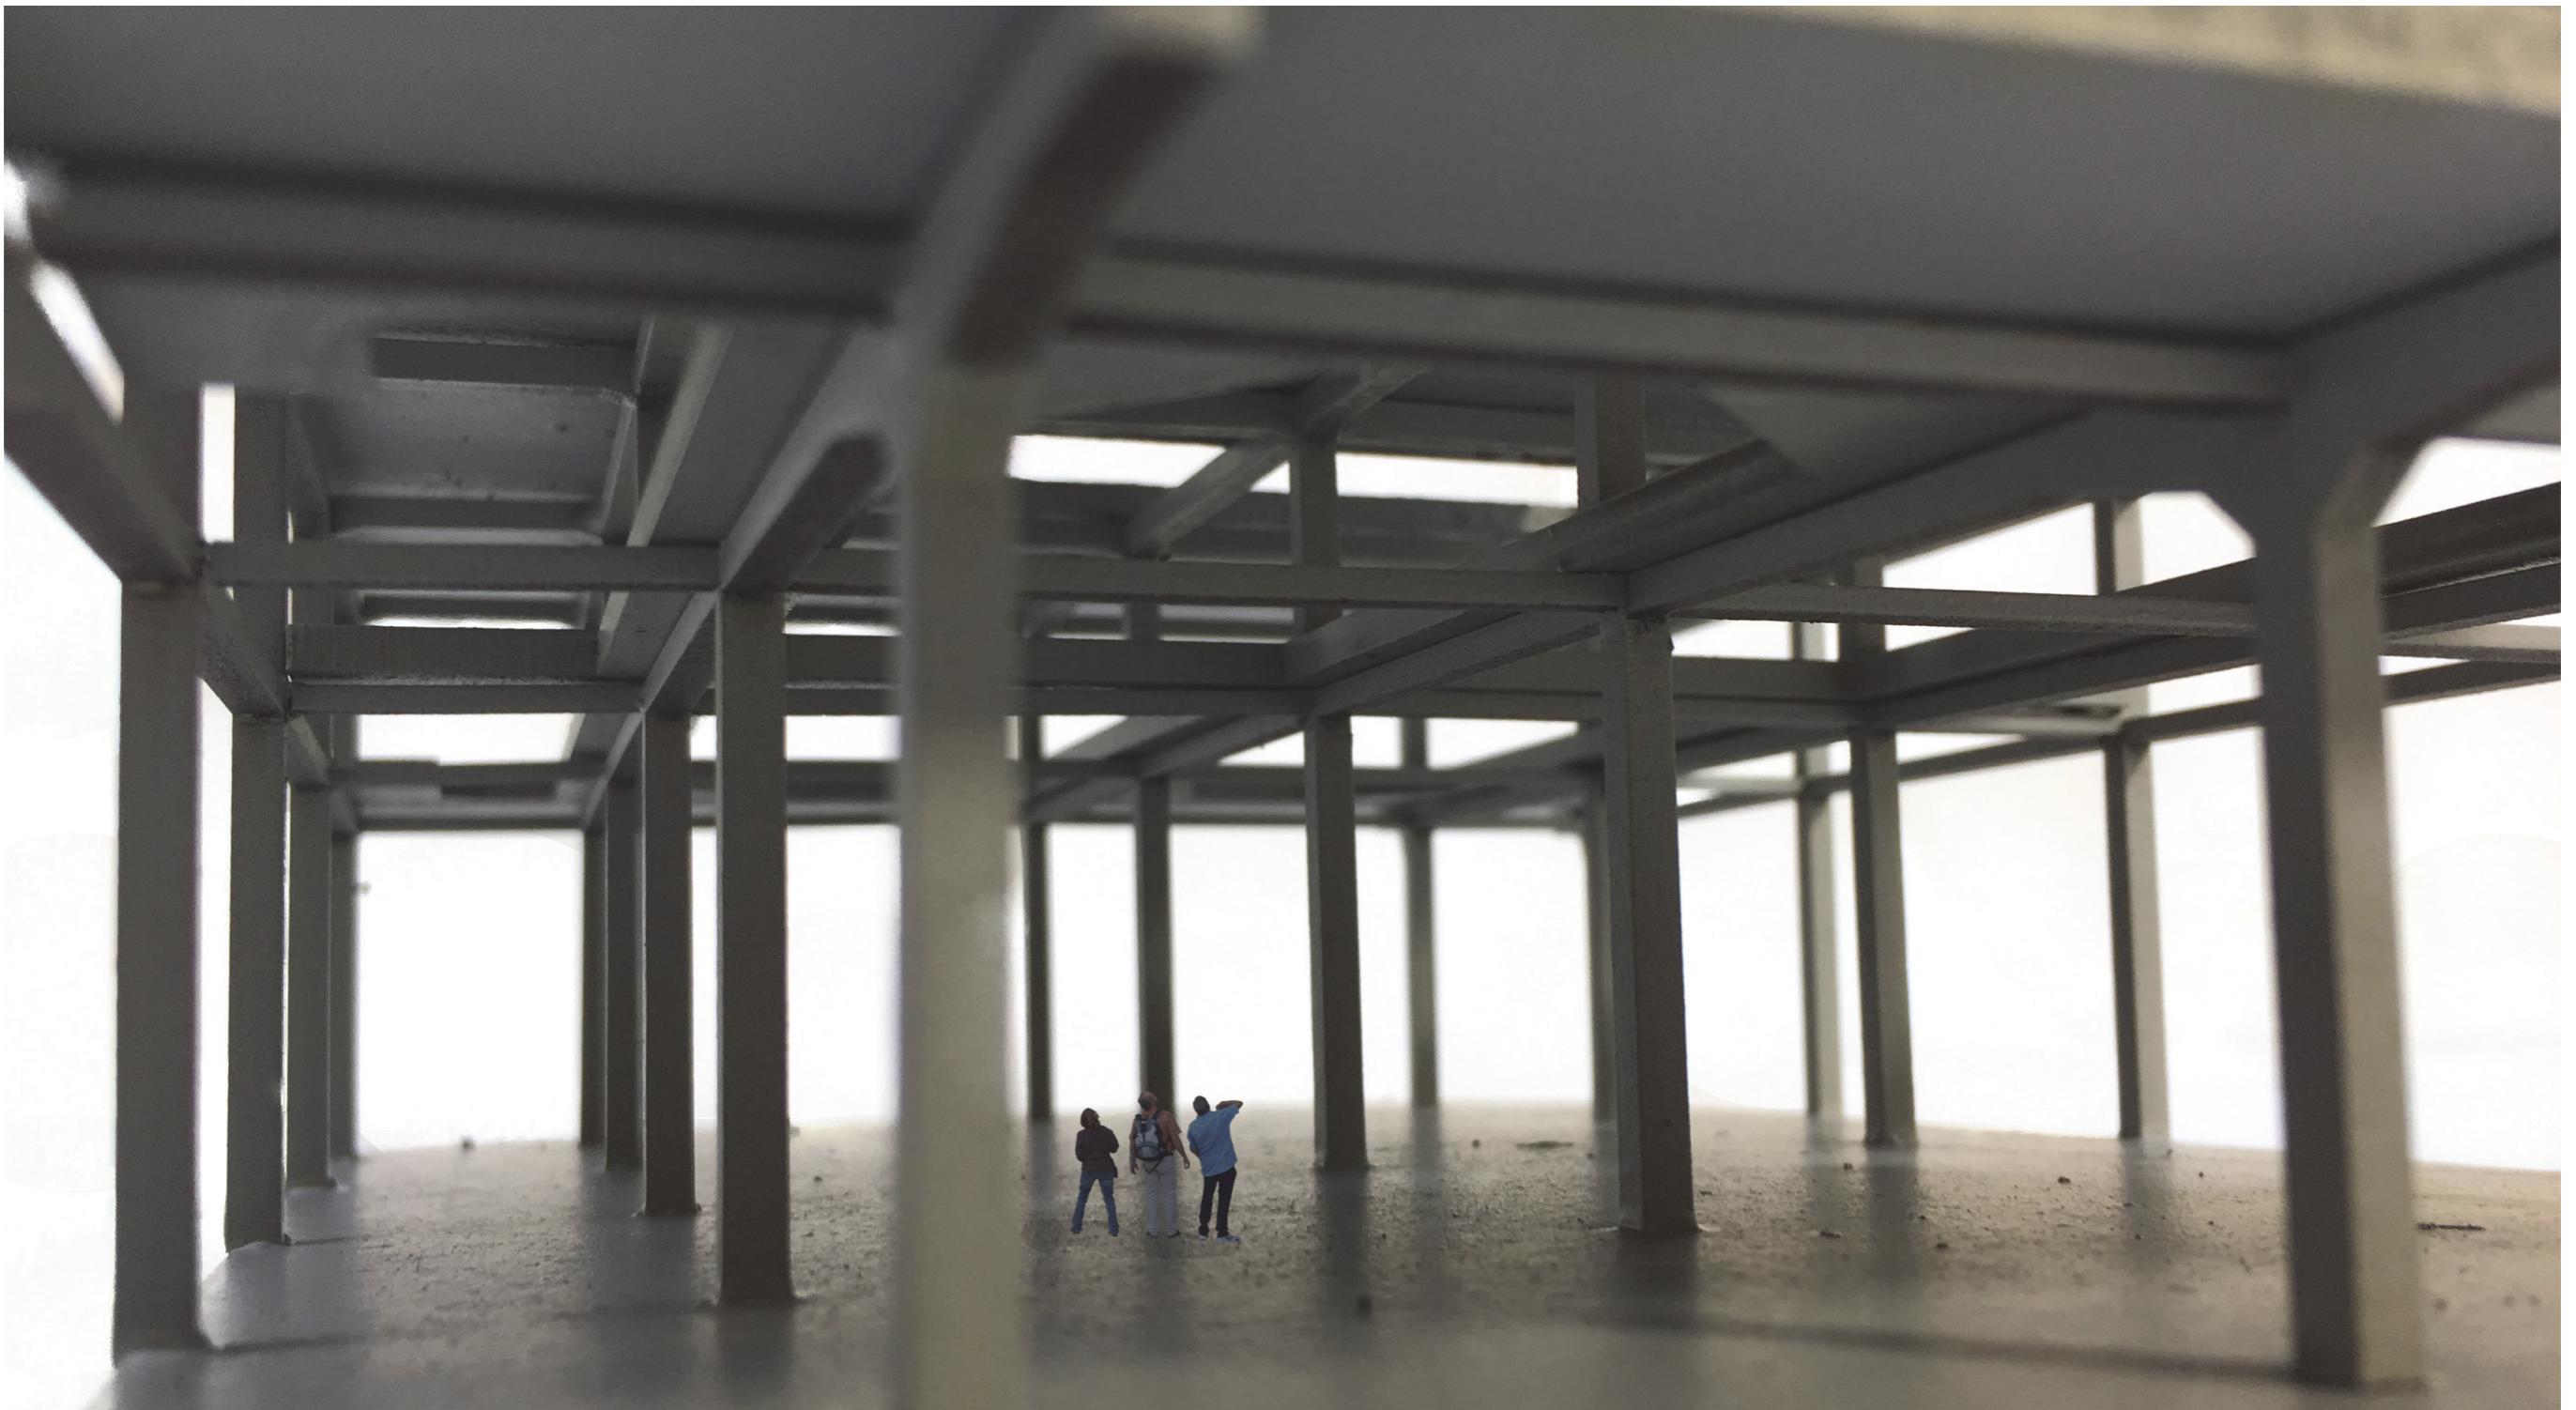
structure model adjusted photograph for the sence of scale by joost van den berge

the surroundings and a model of one of the building compartments to show especially the structure of the building. On the following pictures you can see some photographs we took of the two models.

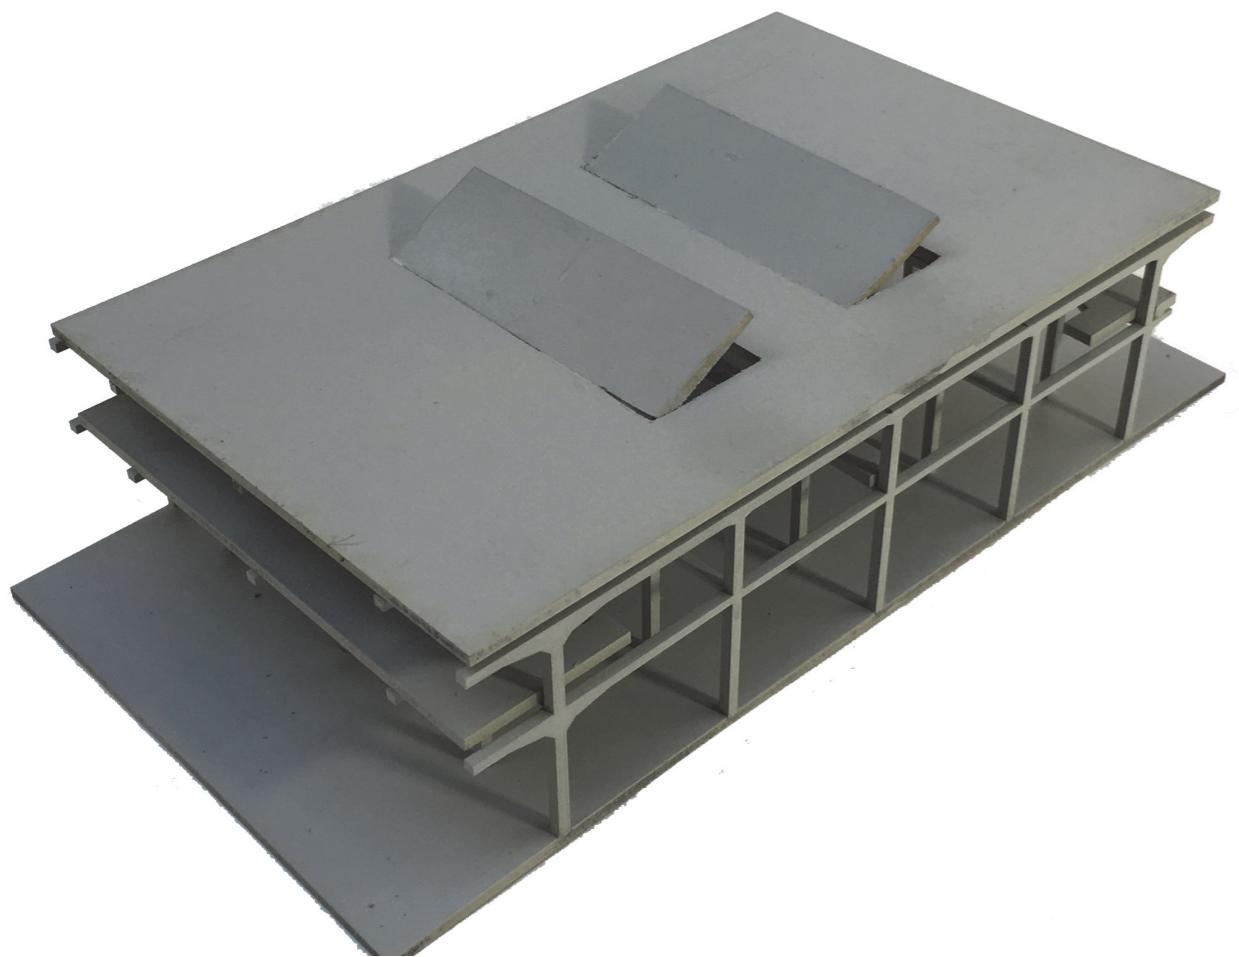
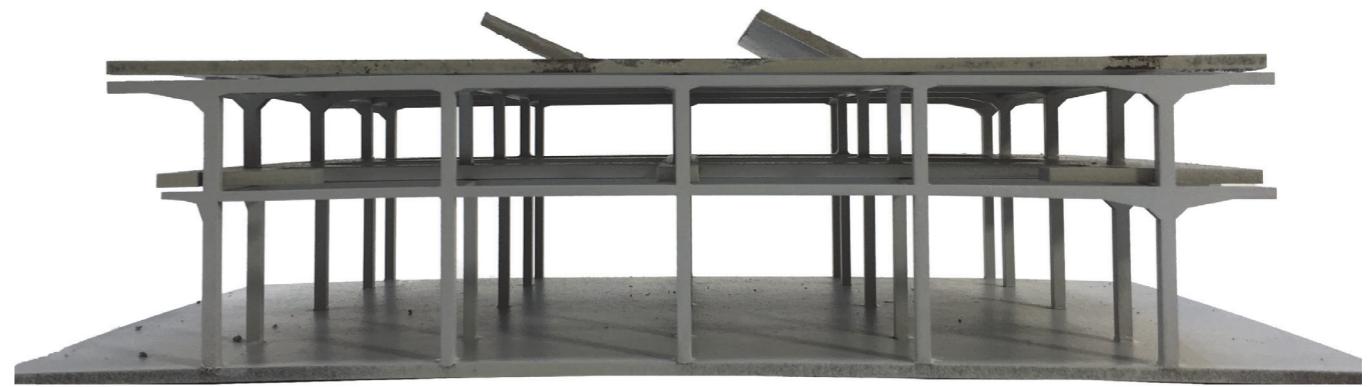
*two photographs of the structure model by joost van den berge
one from above and one sectional or sideways*

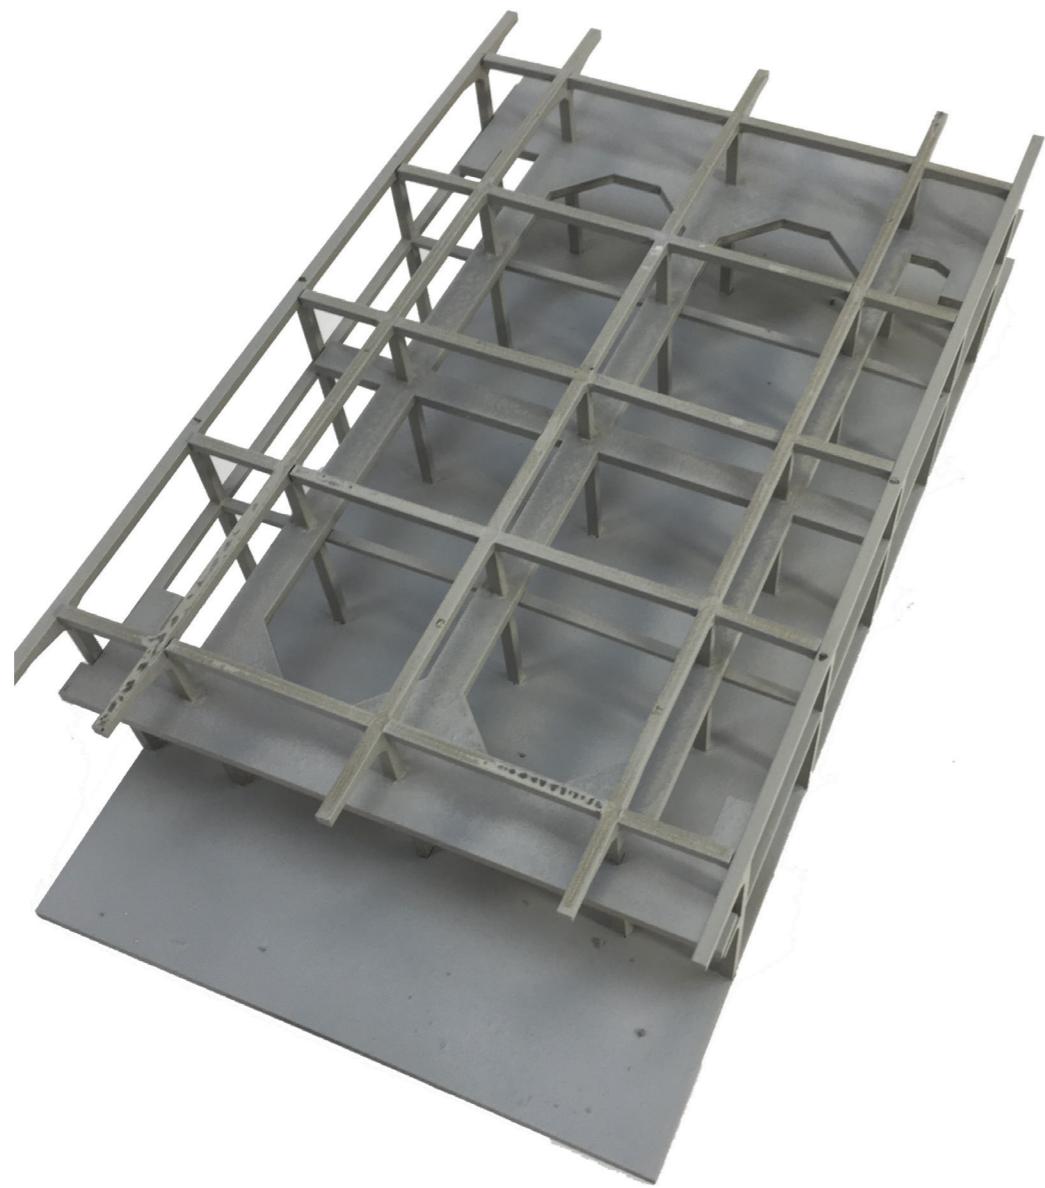
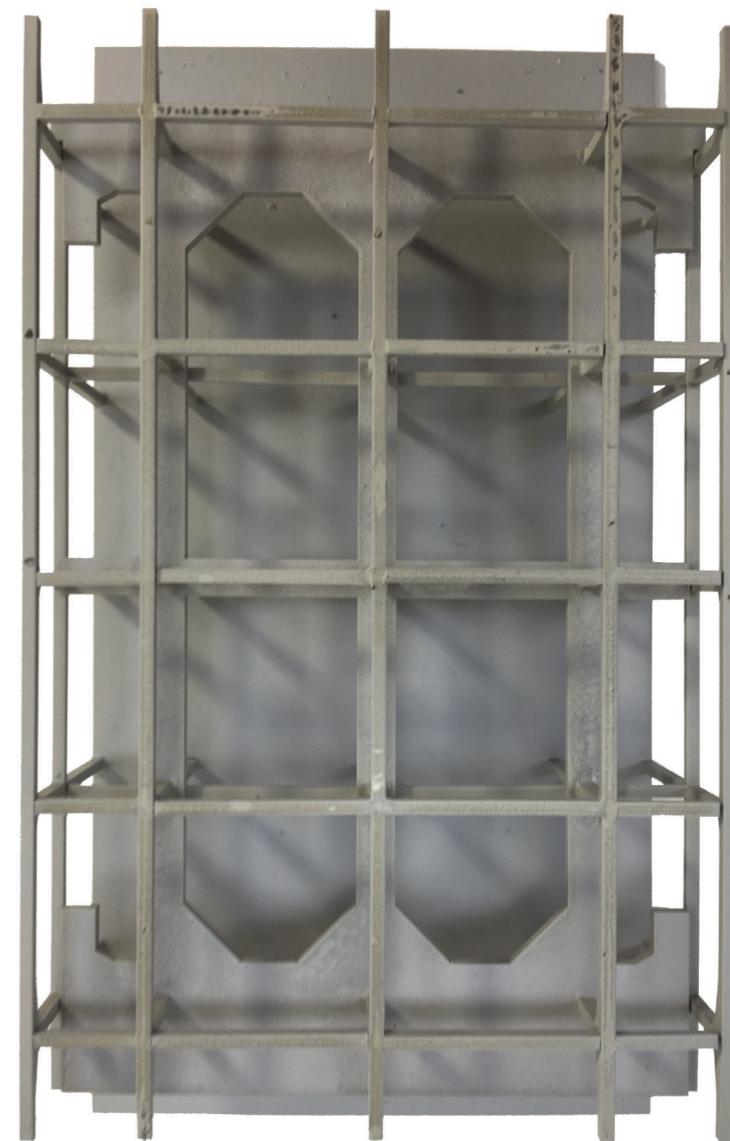
*two photographs of the structure model by joost van den berge
both from above but both without the roof*
