Title:	Consequences of floods - Visits to other countries		
Author:	Ir W. Roos	Institute:	TNO Bouw
	Ir S.N. Jonkman		RWS-DWW
	M.R.Tonneijck		RWS-Bouwdienst
	E.E. van der Hoek		GeoDelft
	Ir K. Heynert		WL Delft Hydraulics
	N. Asselman		WL Delft Hydraulics
	M. Bockarjova		Twente University
Number of pages	:	22	
Keywords (3-5)	:	Prague, Dresden, CURBE, floods	
DC-Publication-number	:	DC1-233-11	
Institute Publication-number (optional)	:		
Report Type	:	<input checked="" type="checkbox"/>	Intermediary report or study
	:	<input type="checkbox"/>	Final projectreport
DUP-publication Type	:	<input checked="" type="checkbox"/>	DUP Standard
	:	<input type="checkbox"/>	DUP-Science

As a part of the Delft Cluster project “*Consequences of floods*” several visits has been made to other countries to learn from their experiences during floods and their consequences. Visits were made to Prague in December 2002, Cambridge in March 2003 and Dresden in April 2003. The reason of these visits was the possibility to collect quantifying data of floods, which could be used for validation of the models made in the project. In general it can be concluded that it is difficult to collect data of recent floods

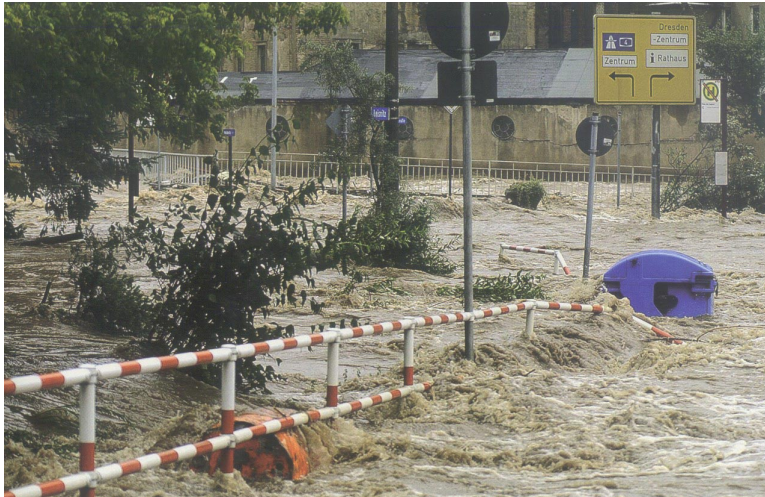
Figure 2 The Weißeritz during the flood

Because of heavy precipitation in whole Central-Europe, in Dresden the Weißeritz river and Elbe river overflowed its banks. The Weißeritz river is a tributary of the Elbe that flows into the Elbe river in Dresden (Figure 1). The flood in the Elbe river was estimated to have a return period of about 100 years, whereas the flood in the river Weißeritz had a return period of about 1000 years. Not only the return periods of the floods in both rivers were different, also the flooding characteristics differed. Water levels of the Elbe river rose gradually (about 5 cm per hour) and overbank flow velocities were low. Water levels in the Weißeritz river rose rapidly. The flood in this river reached its maximum within a few hours. Moreover, flow velocities, inbank as well as overbank, were high. This caused a lot of damage. This damage increased even further as the Weißeritz broke through its bank and shifted back into its old riverbed (Figure 1), in which many buildings as well as the main railway station of Dresden are now located. This was the third time that the Weißeritz shifted back into its old bed during flood.

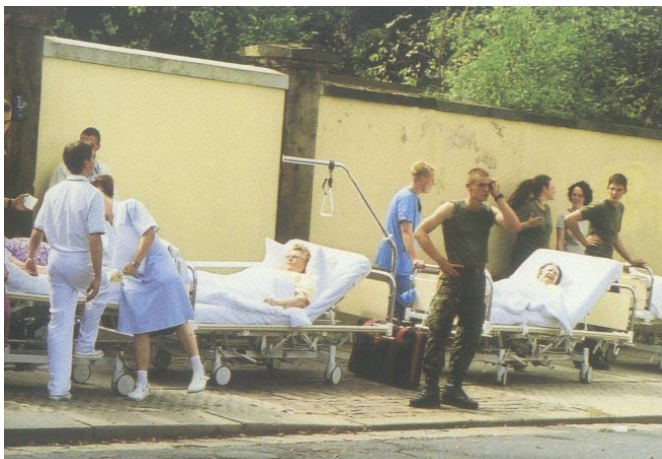
Figure 3 Evacuation of hospital

The administration of evacuated people from hospitals and elderly homes was chaotic, because computer data bases were not used, partly because of the lack of electricity.

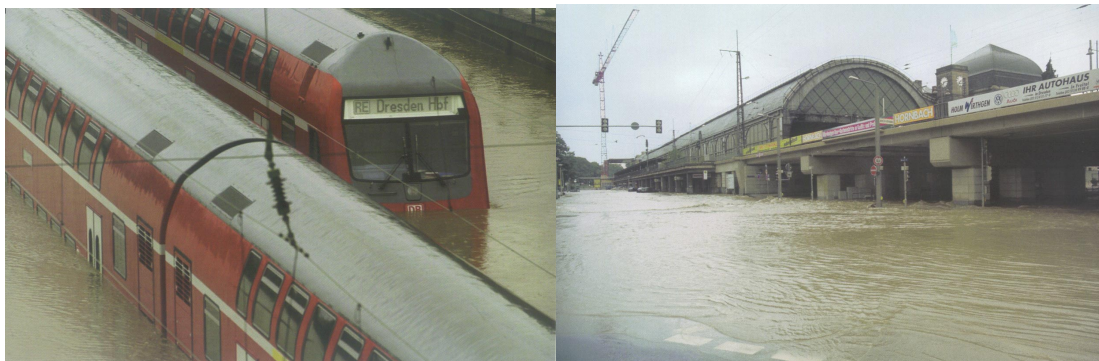
The main railway station is situated in the old riverbed of the Weißeritz. Because the Weißeritz river had broken through its old bed the main station was inundated completely. Consequently, public transport by train was disrupted for several months. The transportation of the people was taken over by buses during these months.

Figure 4 The railway station during the flood

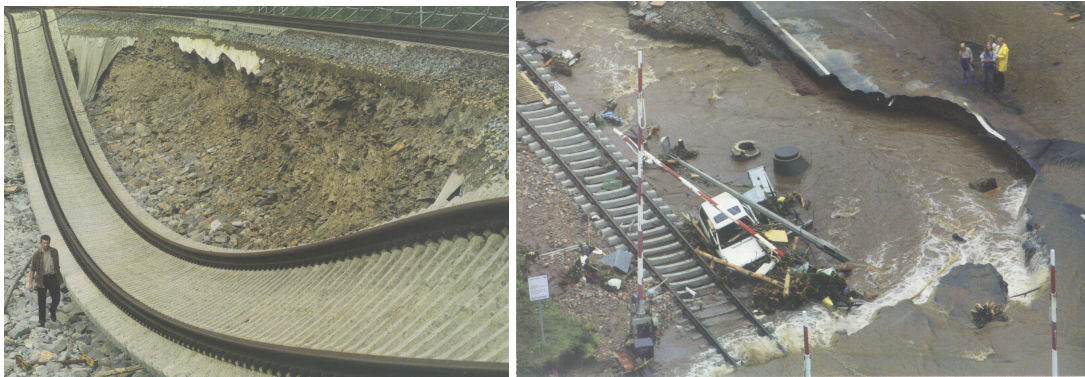
180 bridges and 20% of the railroad tracks were destroyed by the flood. The damage to the bridges was caused mostly by debris. The roads around Dresden were heavily affected as well by scour and until now some roads are still damaged. It is expected that not all undermined roads have been detected yet and that additional damage underground is to be expected.

Figure 5 Scour of railways and roads

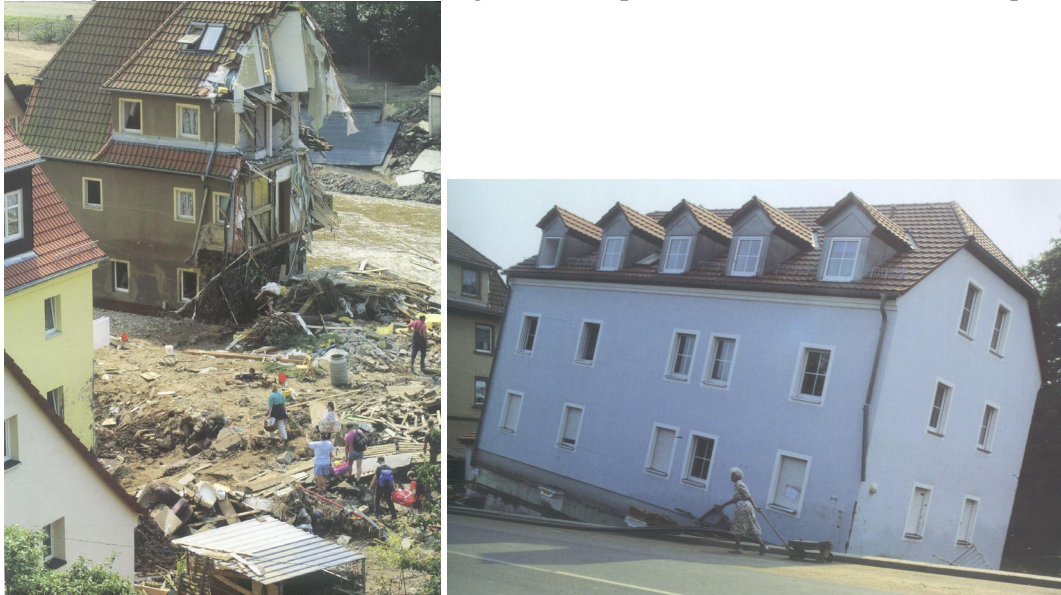
The buildings in the vicinity of the Weißeritz river were affected by the high flow velocities, in contrast to the buildings in the vicinity of the Elbe river, which were not exposed to high velocities. This caused different kind of damages in the city. The main or most serious damage to structures is caused by high flow velocities of the Weißeritz. However, the wiring in the houses was affected in both areas (Weißeritz and Elbe) due the fact they are mostly located in the cellar of the buildings. Therefore the electrical wiring and fibre optics cables must be rewired completely.

Figure 6 Damaged buildings

Another consequence of the flood was the raise of the ground water level in bigger parts of the city. This caused flooding and uplifting of the cellars and material damage. Additional studies into the state of the foundation of houses still have to be carried out.

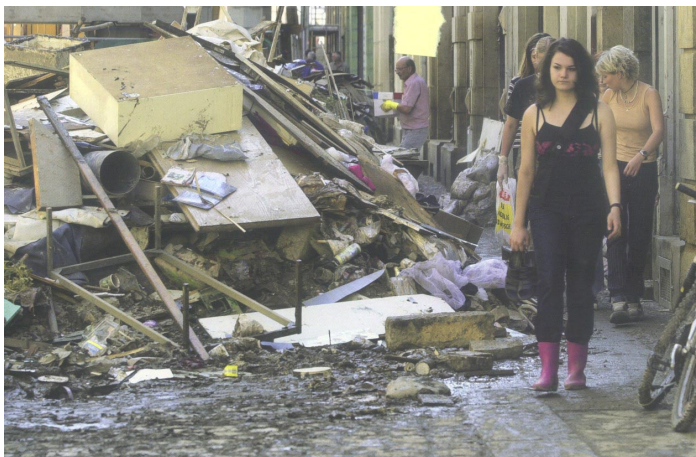
After the flood people put damaged furniture from the basement and ground floor, together with other debris, outside on the streets. This caused 100.000 tons of waste on the streets.

Figure 7 Debris on the streets

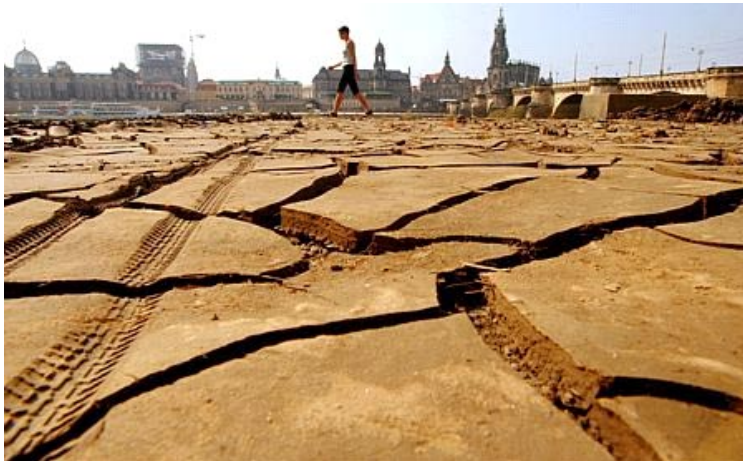
Sediments contaminated with heavy metals were picked up near mining sites in the upper part of the catchments in Germany and the Czech Republic because of the high flow velocities. This, together

with local pollution sources resulted in a high load. However, due to the large volume of water flowing through the river, concentrations remained relatively low.

Figure 8 Sediment on the streets
