Memorandum M-819

**Fractographic observations made in an
exploratory test program on steel specimens
loaded under constant-amplitude loading with
intermediate batches of overload cycles**

J. Schijve

11 November 1997

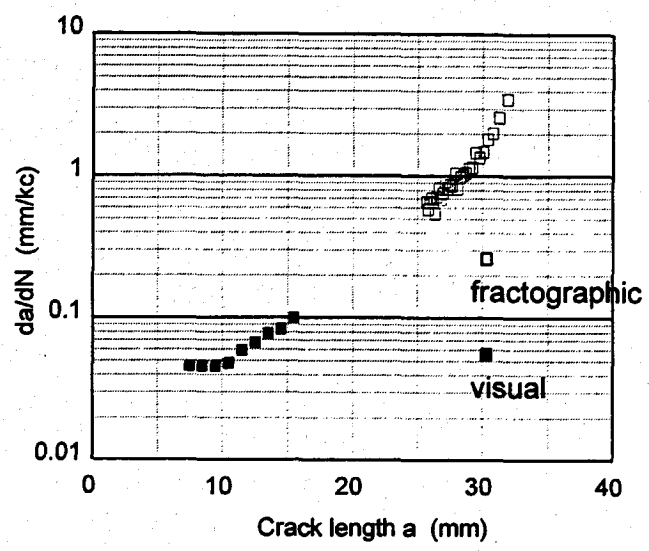
Fig.5: Results of specimen Steel-1.

Fig.5a: Record of visual observations.

Fig.5b: Record of streamlined data.

Fig.5c: Crack growth rates of the records.

Fig.5d: Crack growth rates of streamlined data.

Fig.5e: Crack growth rates of visual and fractographic observations.

This specimen was tested under spectrum 1. Fig.5a shows the crack growth curve. Some irregularities can be observed. Unfortunately no crack length measurements were made for a > 16 mm. The crack growth rates (da/dN) in Fig.5c calculated from the visual crack growth records clearly confirm the irregularities of Fig.5a. The first and the last data points in Fig.5c are considered to be unreliable. It should be mentioned that it was not easy to accurately determine the location of the crack tip because of the unprepared specimen surface (as rolled, somewhat rusty scaling).

In order to eliminate the irregularities the crack growth records were "streamlined" by drawing (by hand) a smooth curve through the data and subsequently reading crack growth data from this curve, see Table 1b. As illustrated by Fig.5b and 5d the irregularities are then eliminated. Of course streamlining could also be done by a regression analysis of the data, or by omitting irregular a/N results of the records. It always should be questioned whether all data are sufficiently reliable for further analysis, which quite often is a matter of personal judgement. Apparently the very first a/N data of this test were not reliable (see Figs 5a and 5c). This could be due to the fact that the test was started with a lower stress level (S_{\max} of OL=100 MPa). Crack nucleation did not occur, The stress level was then increased twice, first to $S_{\max}=125$ MPa and finally to $S_{\max}=150$ MPa.

The fractographic growth results, derived from Figures 12 and 13 (see Table 1c) are included in Fig.5e. Although there is a large gap between the visual results and the fractographic results they could be very well in the same scatter band.

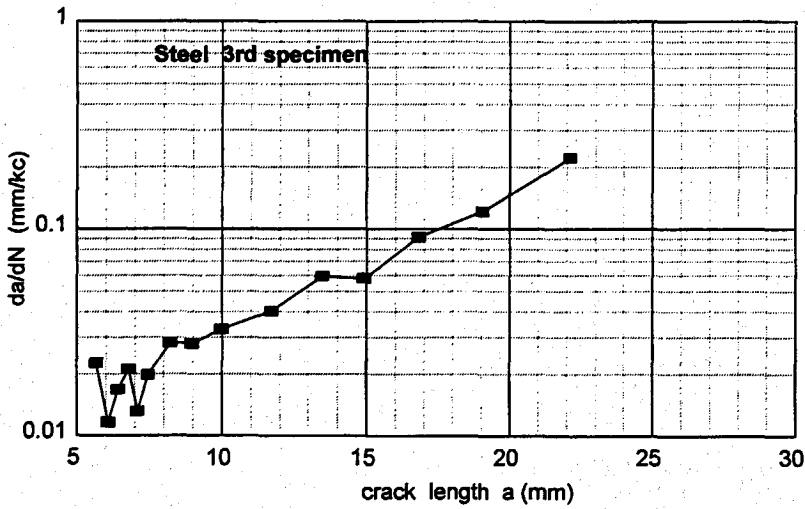
Fig.7a: Specimen Steel-3. Crack growth curve from records.

Fig.7b:
Specimen Steel-3.
Crack growth rates from records.

Fig.7c: Crack growth rates after omitting some data pairs (a,N). Fractographic results added.

Figure 7d: Specimen Steel-3. Crack growth rates in the three sub-blocks of spectrum 3. Results obtained from measurements on fractographs.

The specimen surface was hand polished with emery paper to improve the visibility of the crack tip. Crack growth records are presented in Table 3. The crack growth curve in Fig.7a shows a fairly smooth curve, but the crack rate in Fig.7b still shows some irregularities in the beginning of the test. By leaving out three data pairs (a,N), compare Table 3a with Table 3b, a more continuous da/dN -a relation is obtained, see Fig.7c. This is just another way of streamlining the crack growth records. The fractographic results derived from Fig.20 for the full spectrum blocks (four data points) are presented in Table 3c and plotted in Fig.7c. They appear to line up nicely with the growth rates of the crack growth records.

Bands of the batches of 50 OL cycles could again be used to derive the crack rate during the sub-blocks of base line cycles, in a similar way as described for specimen Steel-2. The results are presented in Table 3d and plotted in Fig.7d.
