# The effects of vegetation on riverbank stability in the Ayeyarwady River

**Delft University of Technology**

**The use of the Normalised Difference Vegetation Index as indicator for  
stabilising effects of vegetation by measuring bank retreat rates**

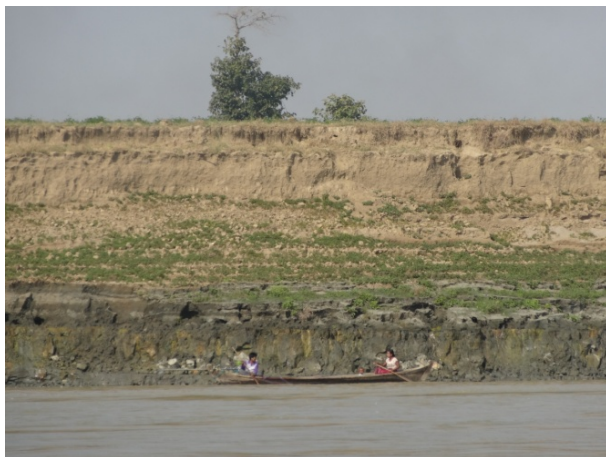
**Figure 9** Typical vertical riverbank in the Ayeyarwady. The riverbanks overflow during high water. This bank is classified as a steep riverbank.

In Figure 9 and Figure 10 some pictures of typical river features of the Ayeyarwady are shown, taken during the fieldwork. In Figure 9 a nearly vertical riverbank is shown, which in this thesis is defined as a ‘steep’ bank. When looking at the steep riverbank, it is possible to identify different types of soil, indicated by the difference in colour. In the top layer, mostly sand is present, whereas in the lower layers clay prevails. In the sandy layer, the erosion occurred more gradual what resulted in a more even layer, whereas in the clayey layer, humps of the bank are eroded as a whole which can be seen from the angular parts. In Figure 10 a flat bank is visible, which is further referred to as a ‘mild’ or ‘gentle’ sloped riverbank. It is necessary to keep the different types of banks in mind since there is a clear difference in erosion mechanisms.

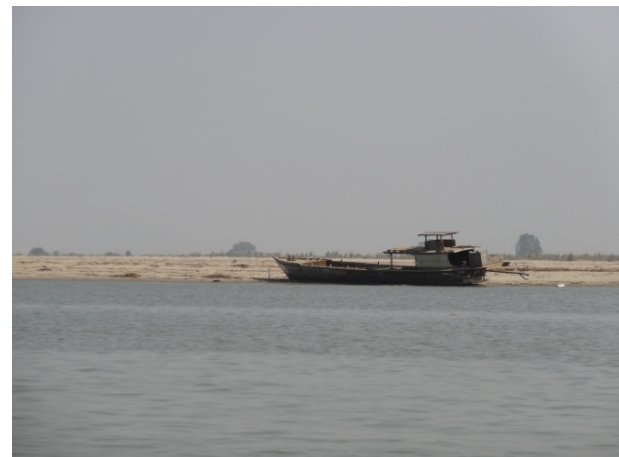
**Figure 10** A nearly horizontal sand bar/ island in the middle of the Ayeyarwady river. This bank is classified as a flat riverbank with a mild slope.

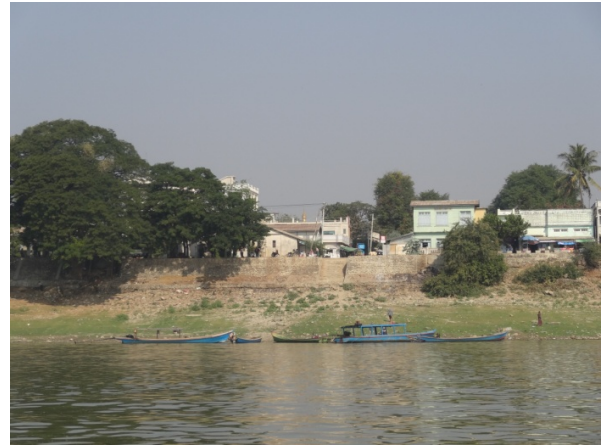
**Figure 13** The larger villages need some protections works, like this wall in front of a road. The buildings are in this way protected against the high water levels.

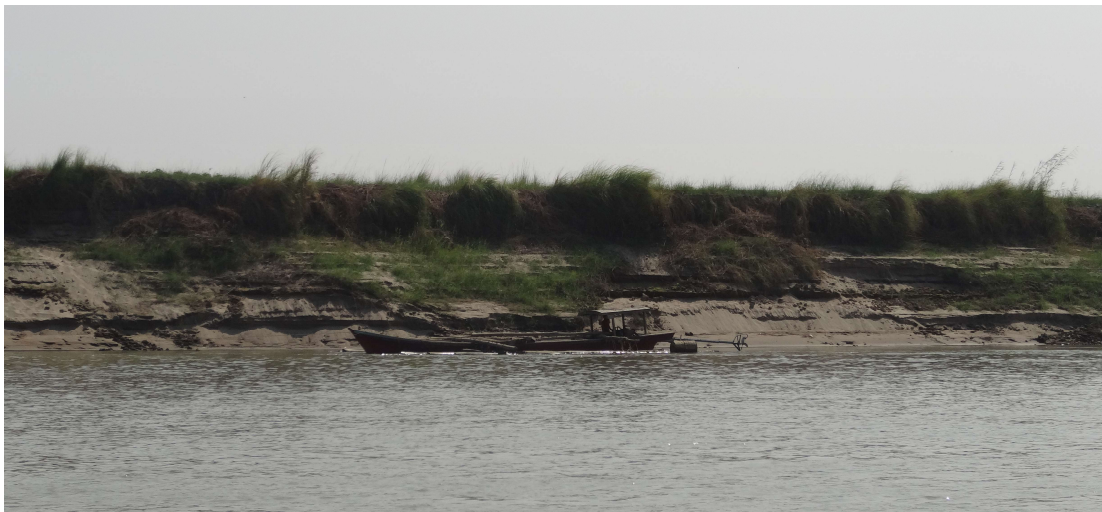
**Figure 16 Shear plane failure is also evident in the Ayeyarwady river. The ridges on the bank indicate locations where shear failure has taken place.**

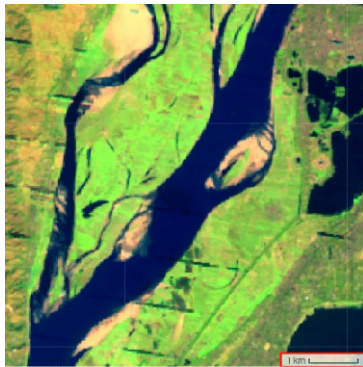
Figure 19 Low water, Composite picture of February 2016.

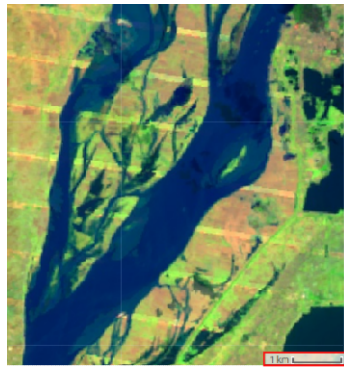
Figure 20 High water, Composite picture of August 2016.

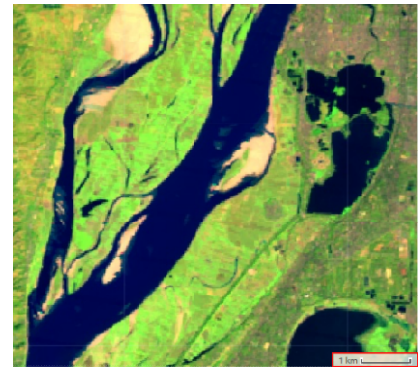
Figure 21 Low water, Composite picture of February 2017.

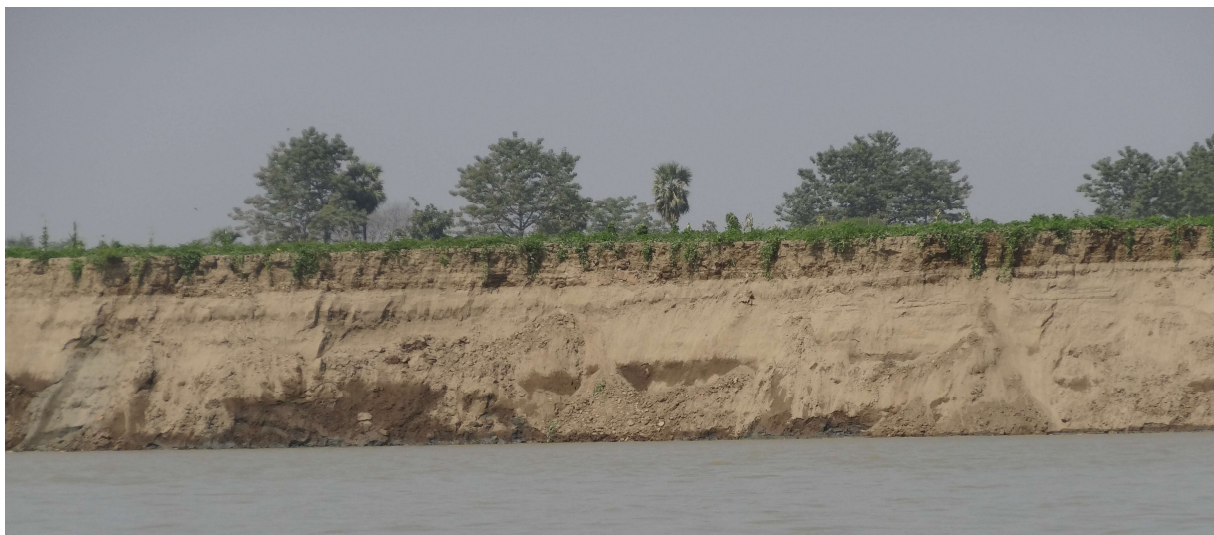
**Figure 26 Roots of vegetation are not able to strengthen the soil to prevent mass erosion.**

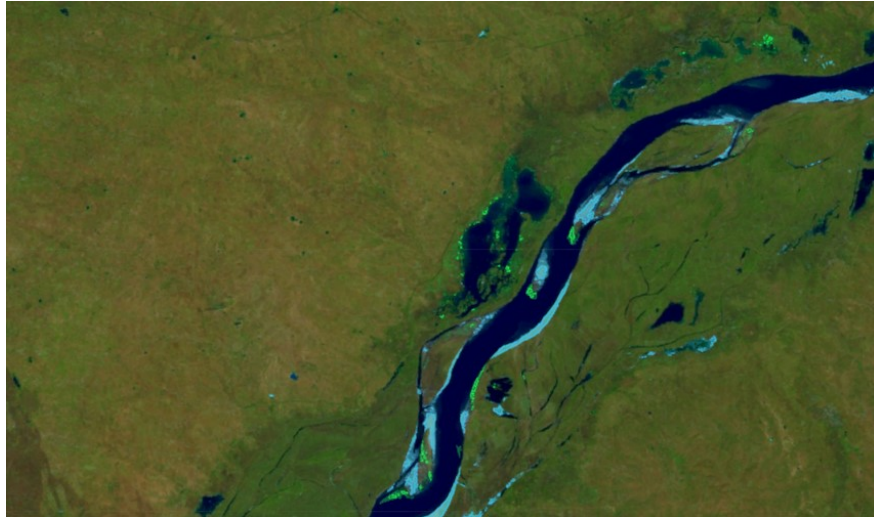
**Figure 30** Bank retreat (blue) and accretion (green) in the Ayeyarwady River made visible with the Aquamonitor. The image is the result of a comparison of a reach in the Ayeyarwady River between 2014 and 2016.

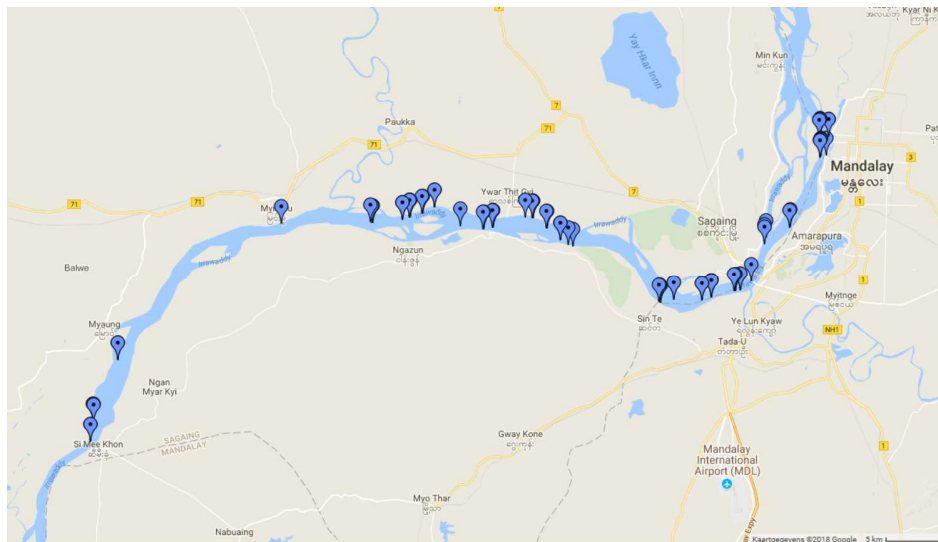
Figure 36 The locations of the collected photo material in the research area.

1. Localisation of the riverbank. Characteristics of different riverbanks were photographed during the fieldwork. The GPS information was stored together with the picture, so the coordinates of the picture could be extracted. The locations of the collected photo material are depicted in Figure 36. In total 295 photos were made, of which 72 photos were used for this research.
2. Determination of the NDVI values. For this the GEE script of Appendix C was used. The coordinates obtained in step 1 were used as input for the point of which the NDVI was to be determined. The geometry placed around this point would give the NDVI values over that area.
3. Comparison of various riverbanks. The final step involved the comparison of different riverbanks with different amount and types of vegetation with one another, to validate whether a riverbank with denser vegetation resulted in a higher NDVI.

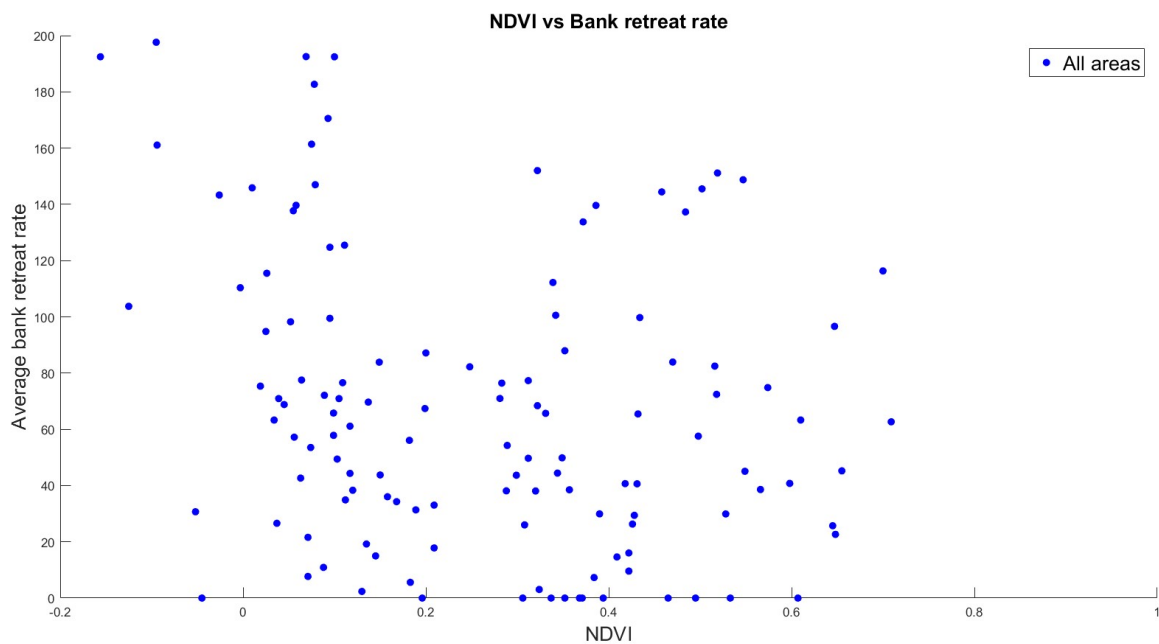
Figure 38 Result of the bank retreat of all areas together, plotted against NDVI.

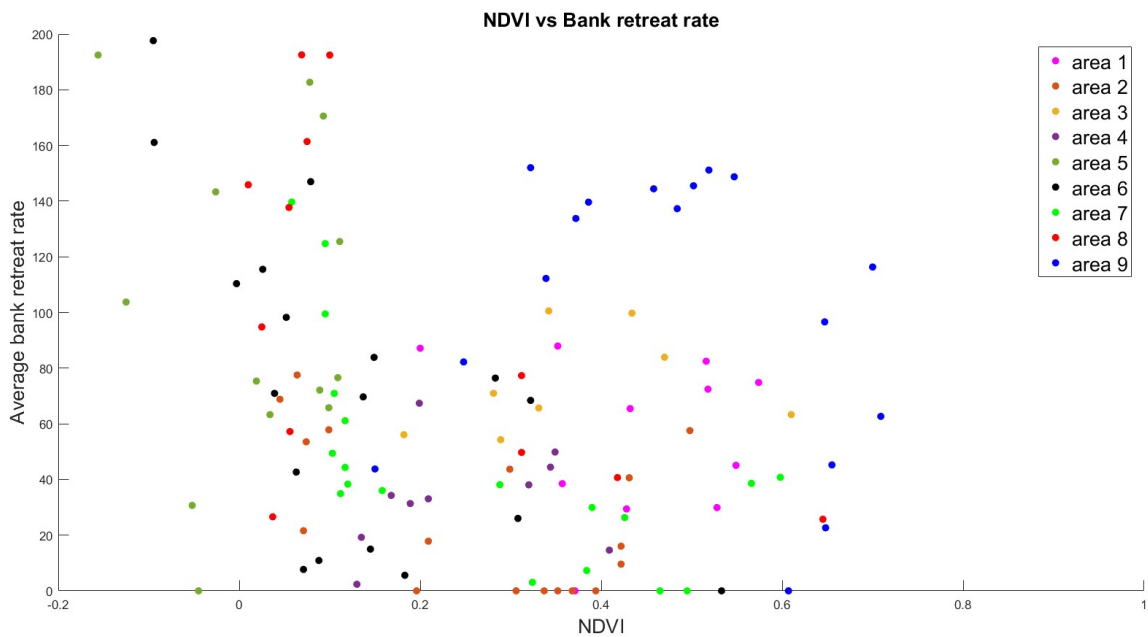
Figure 39 Total figure of erosion rates as a function of NDVI values. Each river section is represented by a different colour.

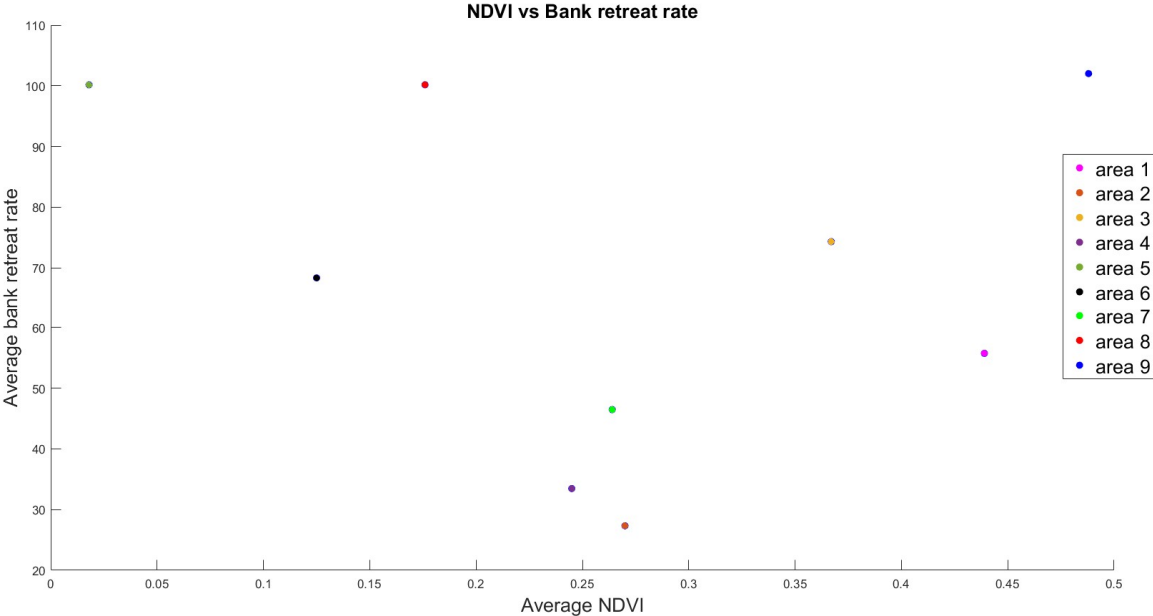
Figure 40 The average values of erosion rates per river section.

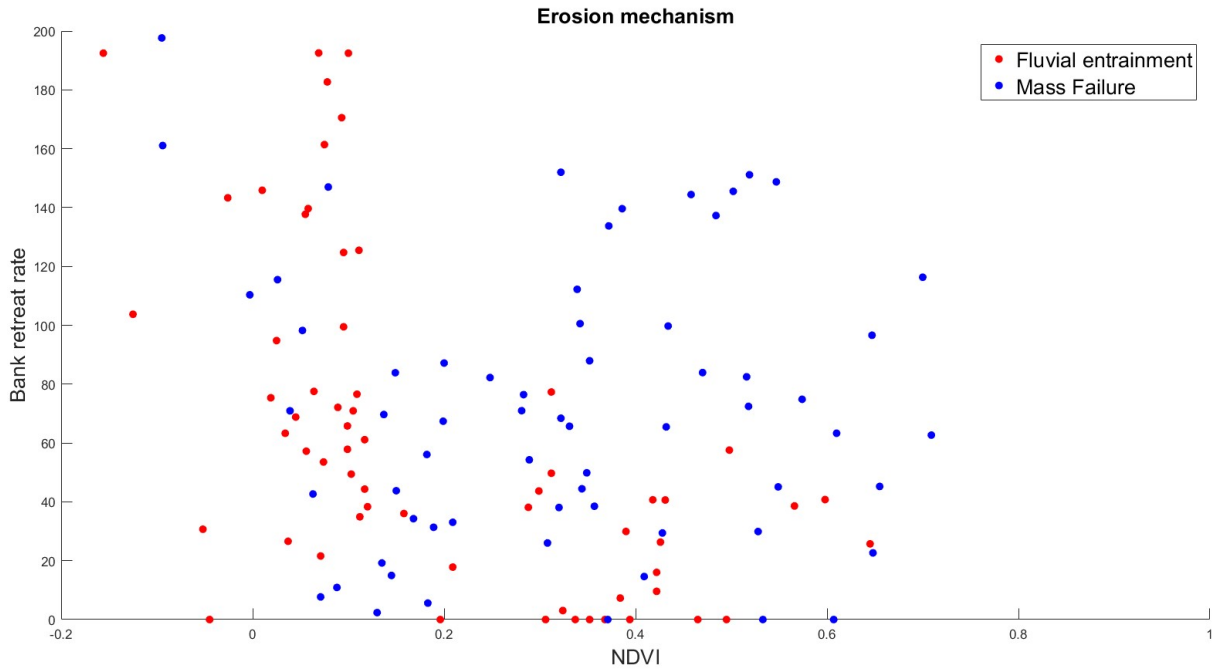
Figure 41 All bank retreat rates as function of NDVI, grouped per erosion mechanism.

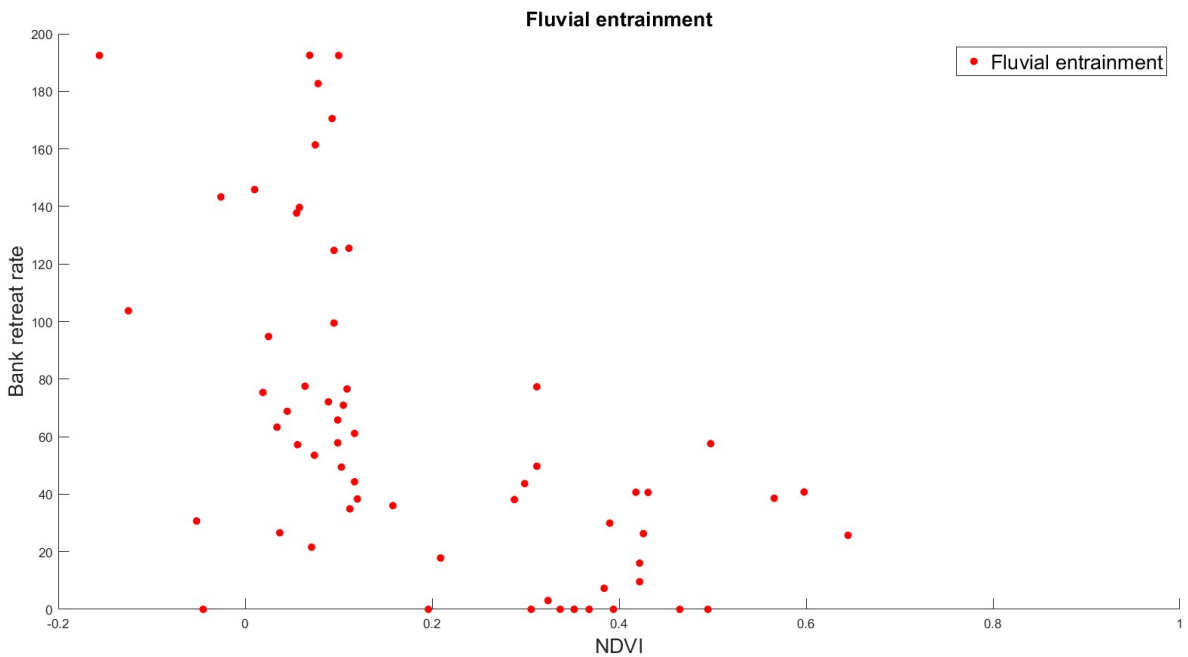
Figure 42 The bank retreat rates filtered results of the points subjected to fluvial erosion.

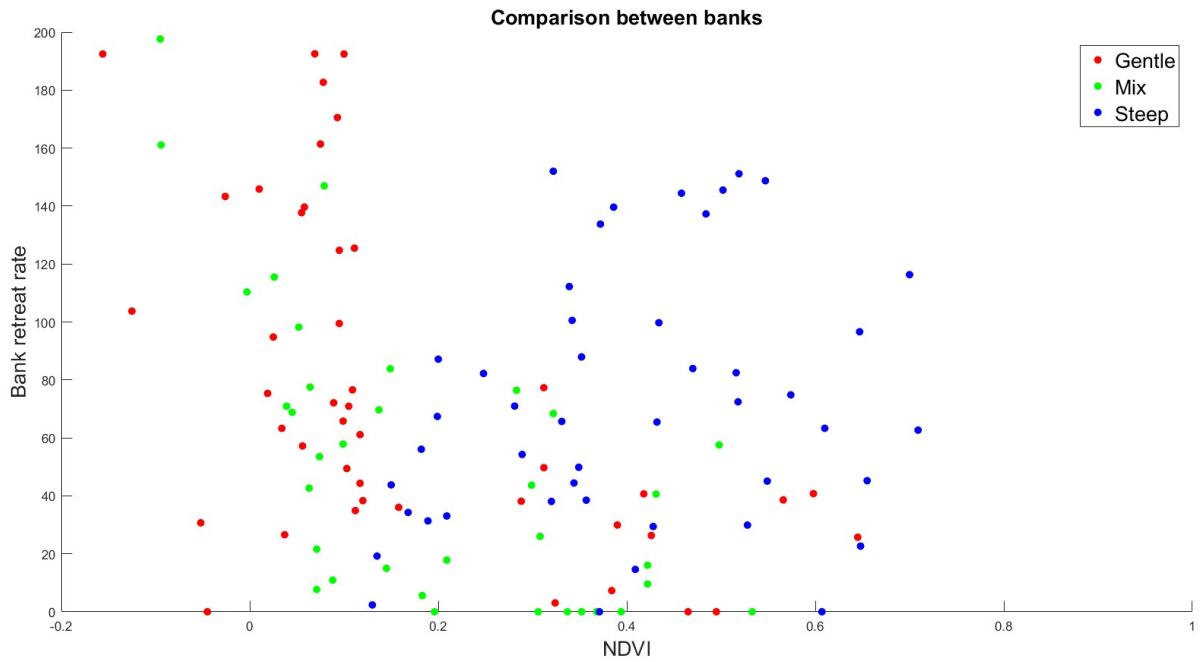
Figure 43 All bank retreat rates as function of NDVI, grouped per riverbank slope.

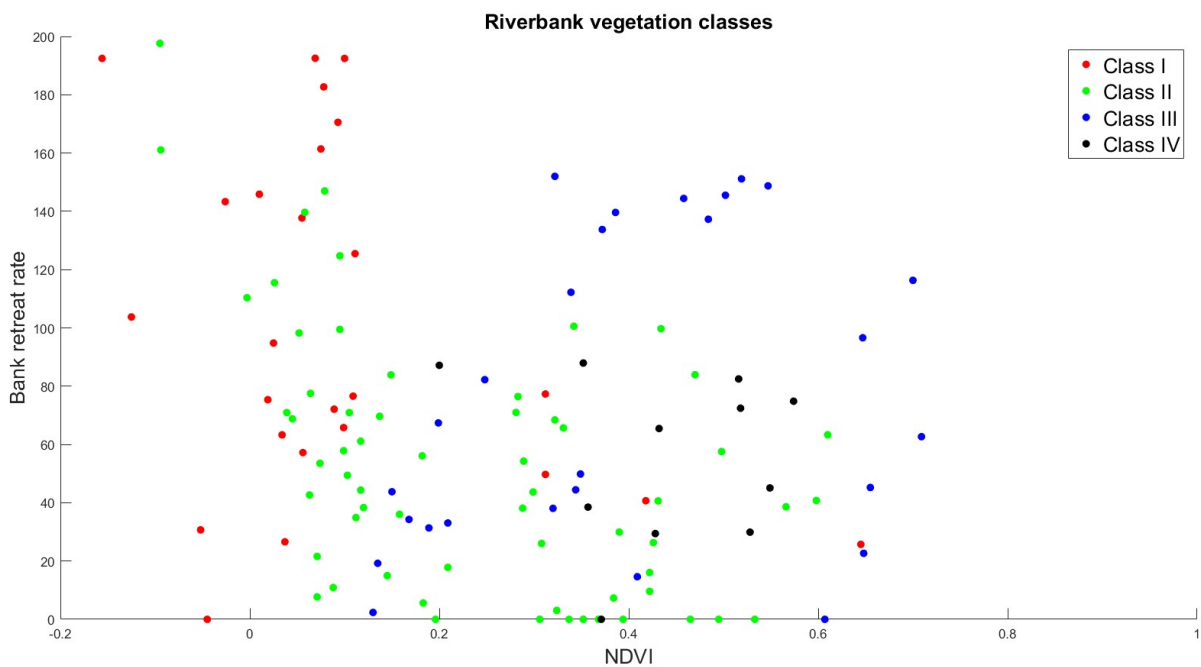
Figure 44 Results classified into riverbank vegetation classes.

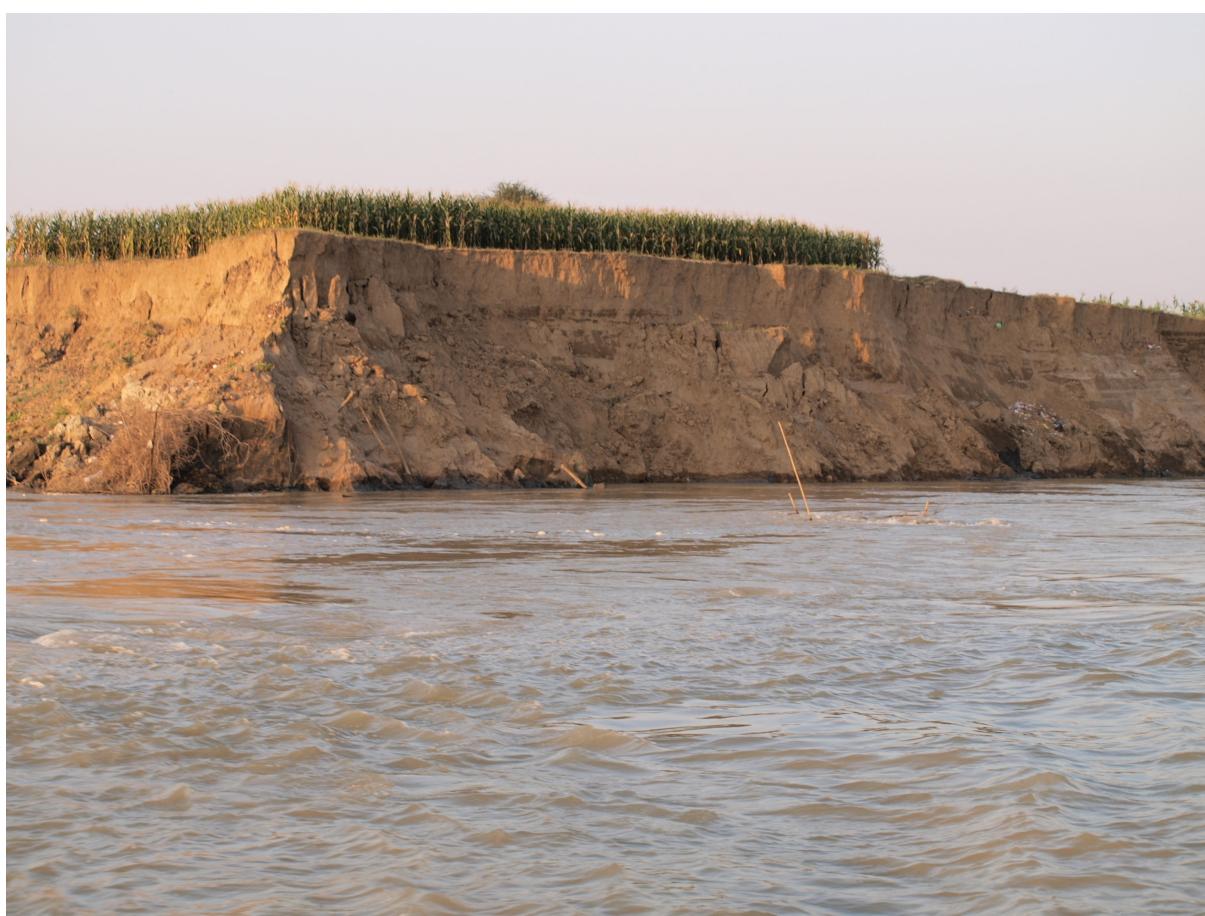
**Figure 45** A picture of a steep riverbank in the Ayeyarwady River. The vegetation on the edge of the riverbank indicates that the riverbank is retreating rapidly and the farmer should take its crops from the land before it is lost in the river.

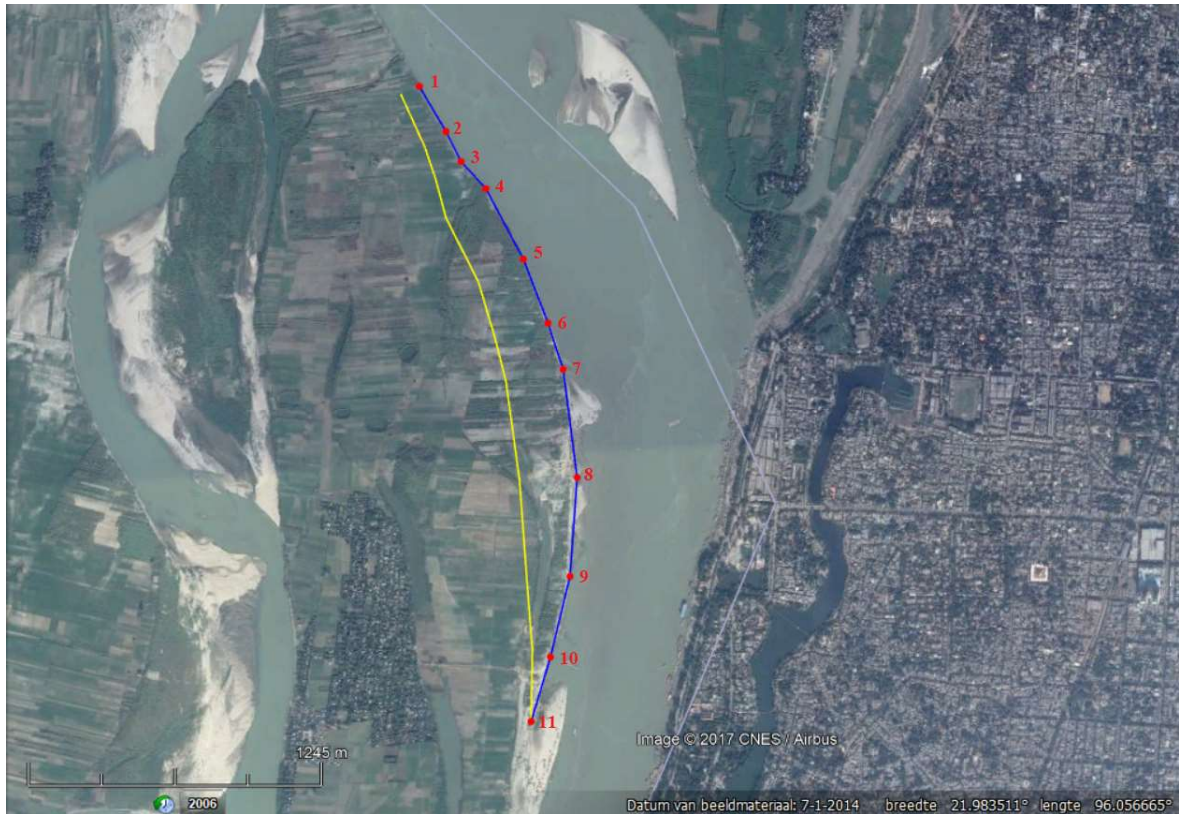
**Figure B3 Area 1 - Comparison riverbanks 7 January 2014 with 11 January 2017.**

Area 1 is located next to Mandalay, the start point of the fieldwork, on the opposite riverbank. Although this section is located in the inner bend, the last couple of years erosion has caused the bank to retreat, see Figure B3. The mid-channel bar (situated around points 1-4) pushes the flow towards the inner bend, causing inner bend erosion. From satellite images, it is noticed that the mid-channel bar originated in 2014 and propagated after each river flood downstream in the flow direction (towards points 9-11 in 2017). It is therefore expected, that when the bar propagates further downstream in coming years, bank retreat will also occur downstream of point 11.

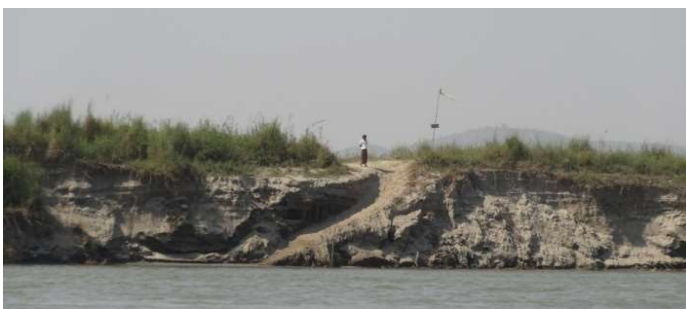
**Figure B4 Riverbank in area 3. Note the length of the vegetation with regard to the length of the human.**

The steep riverbanks indicate that the primary erosion mechanism is toe erosion, after which mass failure takes place. In this thesis, steep riverbanks are defined as vertical riverbanks, such as shown in Figure B4 and Figure B5. Gentle or mild sloped banks are defined as banks with a slope, e.g. the slopes on the background on Figure 1, although these slopes are still relatively steep. The grassy vegetation does not help to prevent toe erosion at this location, however, during high water, vegetation of that size has significant impact on the diversion of flow and the stability of the riverbank. The vegetation height proves that the vegetation is present for already multiple years, indicating that it can withstand high water levels and fluvial entrainment.

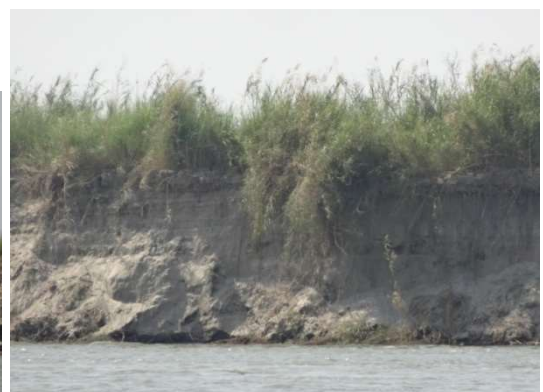
**Figure B5 Grassy vegetation on this riverbank is not able to prevent toe erosion and mass failure.**

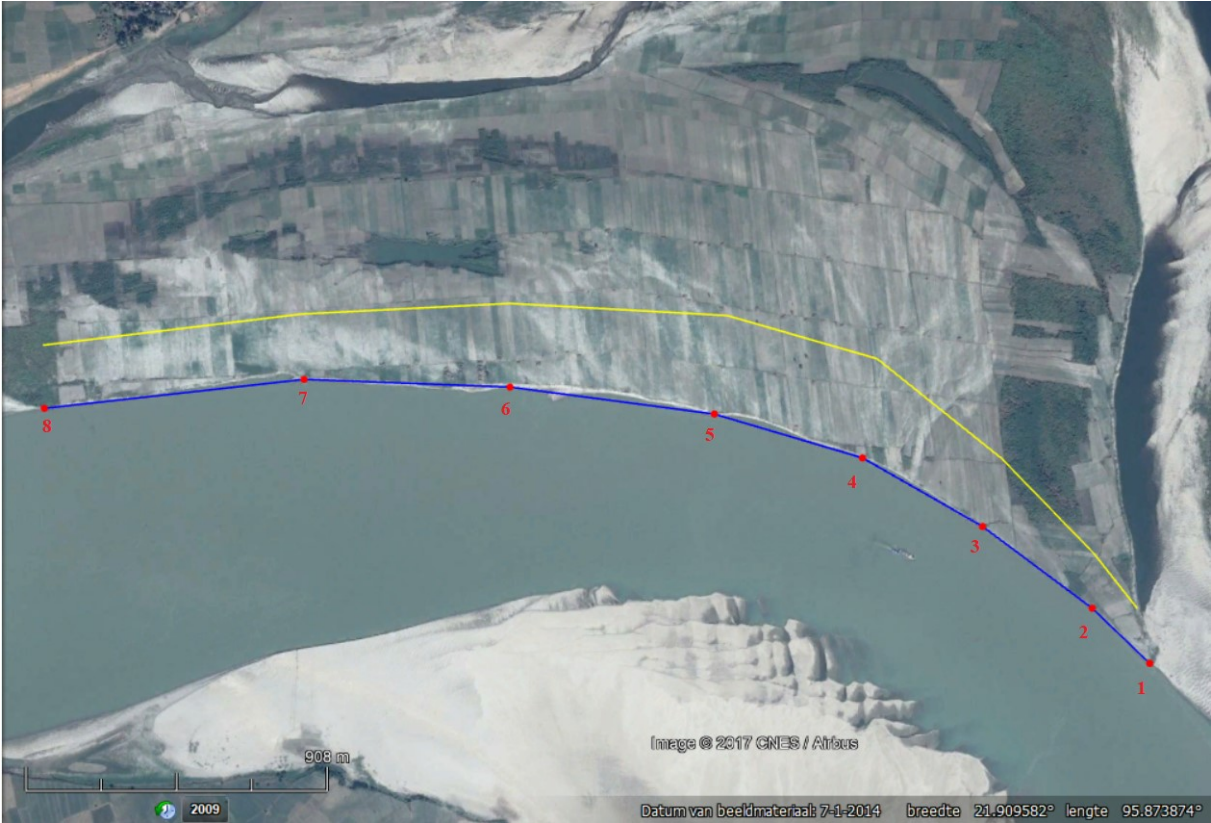
Figure B9 Area 3 - Comparison riverbanks 7 January 2014 with 11 January 2017.

This area is characterised by continuous bank retreat, which is visible in Figure B9. The formation of the inner bend point bar caused the flow to be directed outwards. The figure shows a gradual retreat of the riverbank and is a textbook example of bank retreat in an outer bend. Area 3, 4, 6, 7, 8 and 9 are all located in an outer bend. To compare the different bank retreat rates between the areas, the radii of curvature are investigated as well, together with the development of the point bars causing flow deflection. The radius of curvature of this bend is approximately 1000 meters. This radius has increased to 1300 meters in 2017.

From the satellite image (Figure B9), it can be seen that the subsoil shows similar features, however, the NDVI records vary within a wide range (0.812-0.610). This is visible in Figure B10. The points seem to be contradictory from the hypothesis. It seems that with increasing NDVI, bank retreat rates also increase, except for point 8 (NDVI = 0.610). The average NDVI is large when compared to all other areas, however, bank retreat rates are also relatively large. The large bend radius can be the reason for that.

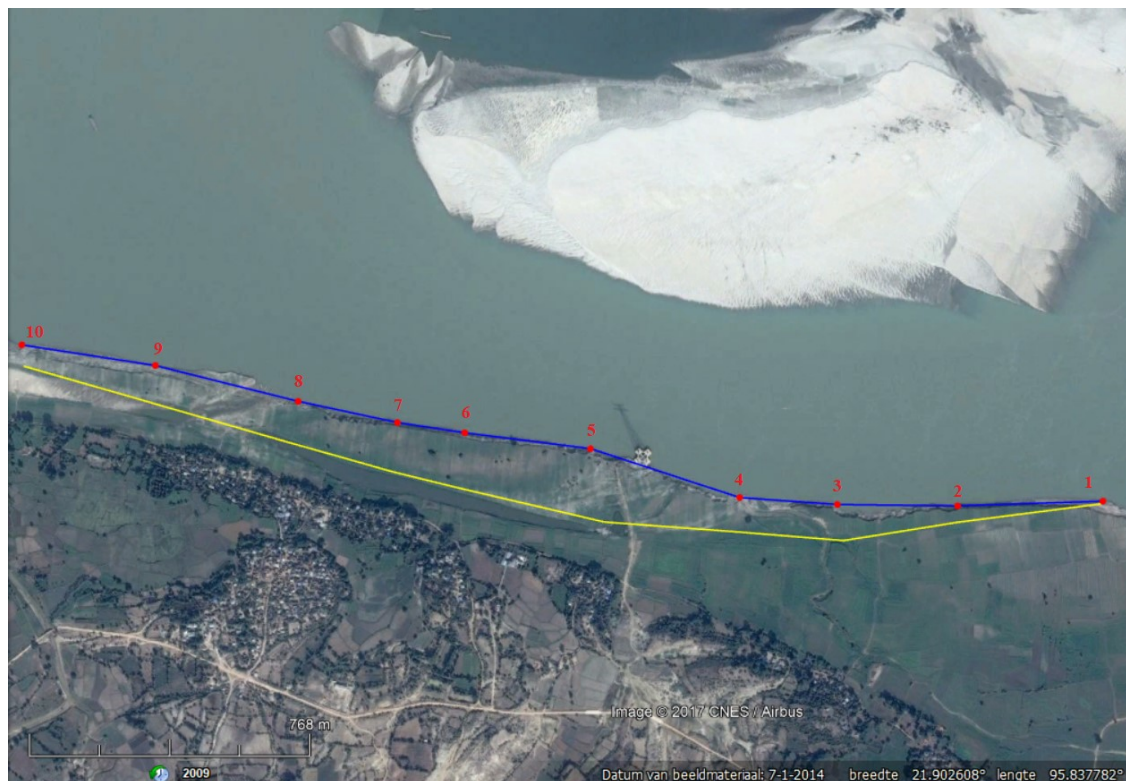
Figure B11 Area 4 - Comparison riverbanks 7 January 2014 with 11 January 2017.

Although not explicitly visible in Figure B11 this area is located in the opposing outer bend following area 3. The erosion mechanisms are similar, and both areas have steep riverbanks. However, the average NDVI values differ 10%, and bank retreat rates are twice as large in area 3 compared to area 4. The NDVI values, as well as the bank retreat rates, are lower in area 4, therefore not supporting the hypothesis. The reason could be that area 3 is located in a sharper bend, indicating higher hydraulic loads due to curvature effects. Especially when the radii of the two curves are compared, this seems to be the cause. This radius is only 550 meter, which is approximately half of the radius in area 3. Finally, when the maximum bank retreat rates between the two areas are compared, it is noticed that these are located in the narrowest part (both points 5 in Figure B9 and Figure B11). It is obvious that bank retreat rates are not only dependent on NDVI, but also on location and the surrounding conditions.

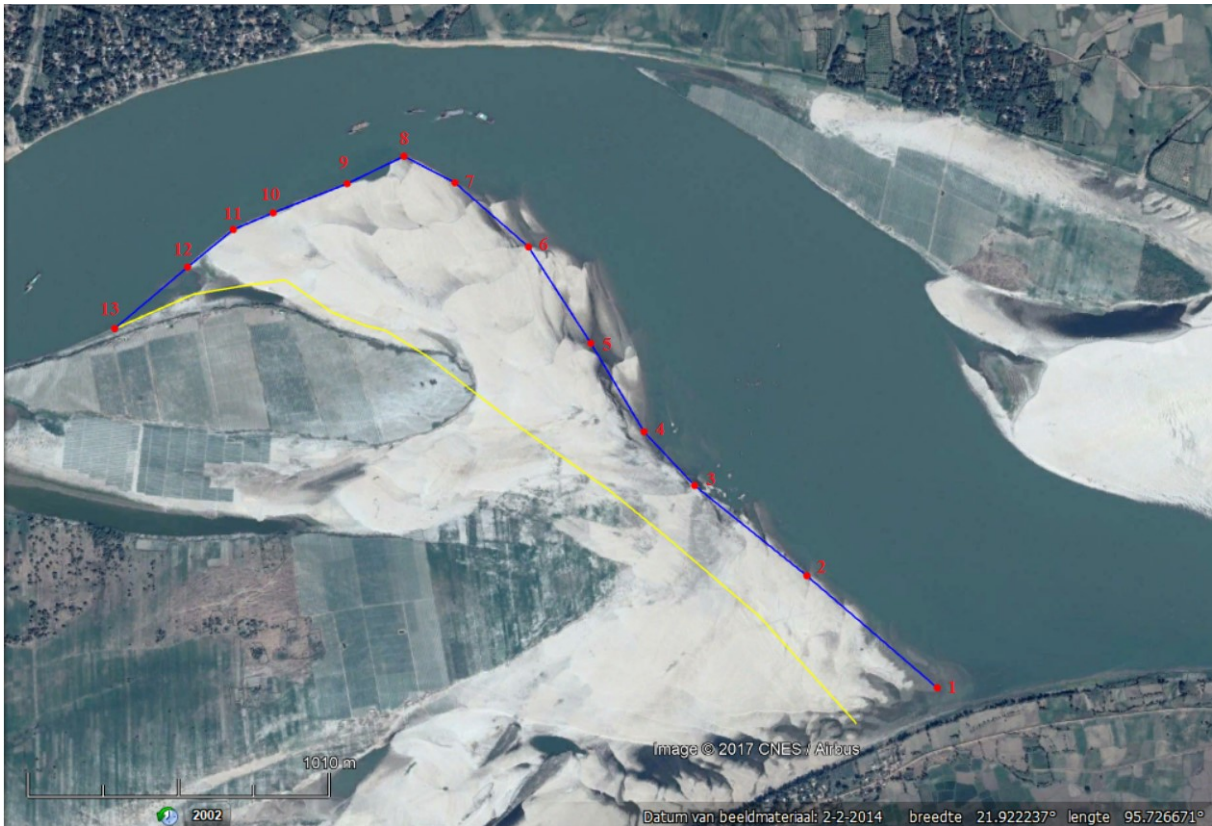
**Figure B13 Area 5 – Comparison riverbanks 2 February 2014 with 11 January 2017.**

Area 5 is subjected to a large amount of bank retreat. However, this bank retreat is mostly caused by sediment deposits against the head of a bar in 2014, which in the subsequent three years were transported further downstream. In Figure B13, it is shown that this head of the bar contains no vegetation at all, proving that it is recently deposited. From the low (negative) NDVI values can be observed that this part of the bar is often flooded, and the large bank retreat rates (order 100 meters per year) show that the material is easily being transported by fluvial entrainment.

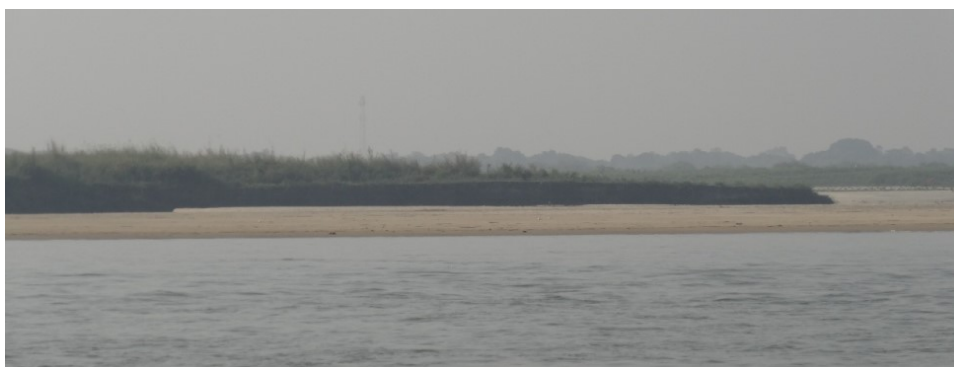
**Figure B14 Two different elevations in the Ayeyarwady river; a higher vegetated area and a lower unvegetated area.**

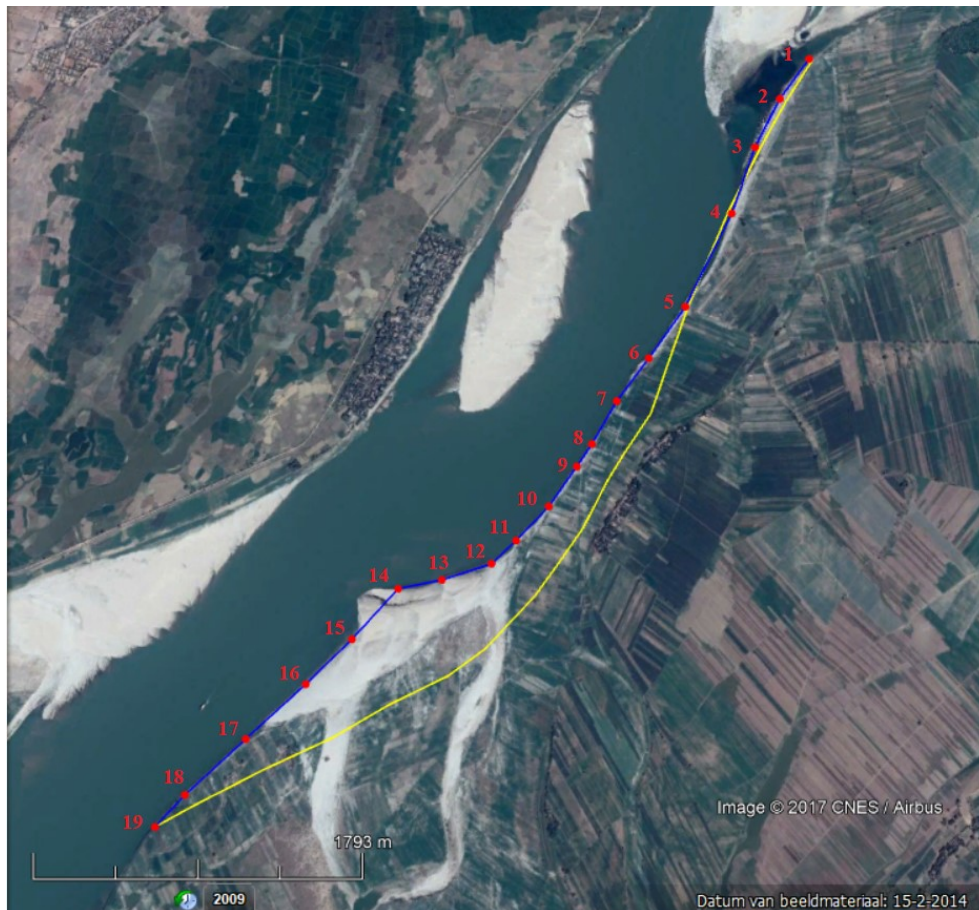
Area 6 is a small meandering section of the Ayeyarwady River, showing point bar growth and outer bend erosion, shown in Figure B16. The radius of curvature was approximately 550 meter in 2014. The points 1-5 are protected from bank retreat by the northern point bar. However, on the opposite (left) bank, another point bar is present. This example shows very well how the point bar is responsible for pushing the flow towards the right riverbank. From point 5 significant bank retreat is present. The amount of bank retreat increases with the influence from the point bar, and after the bank retreat reaches a maximum (point 14), the bar push effect gradually decreases and bank retreat rates decline. This shows how the surrounding circumstances are responsible for the amount of bank retreat. Also, in this example, a distinction can be made between vegetated areas (5-12) and (17-19) and a flat, bare, sandy area (13-16).

**Figure B16 Area 6 – Comparison riverbanks of 15 February 2014 with 2 January 2017.**

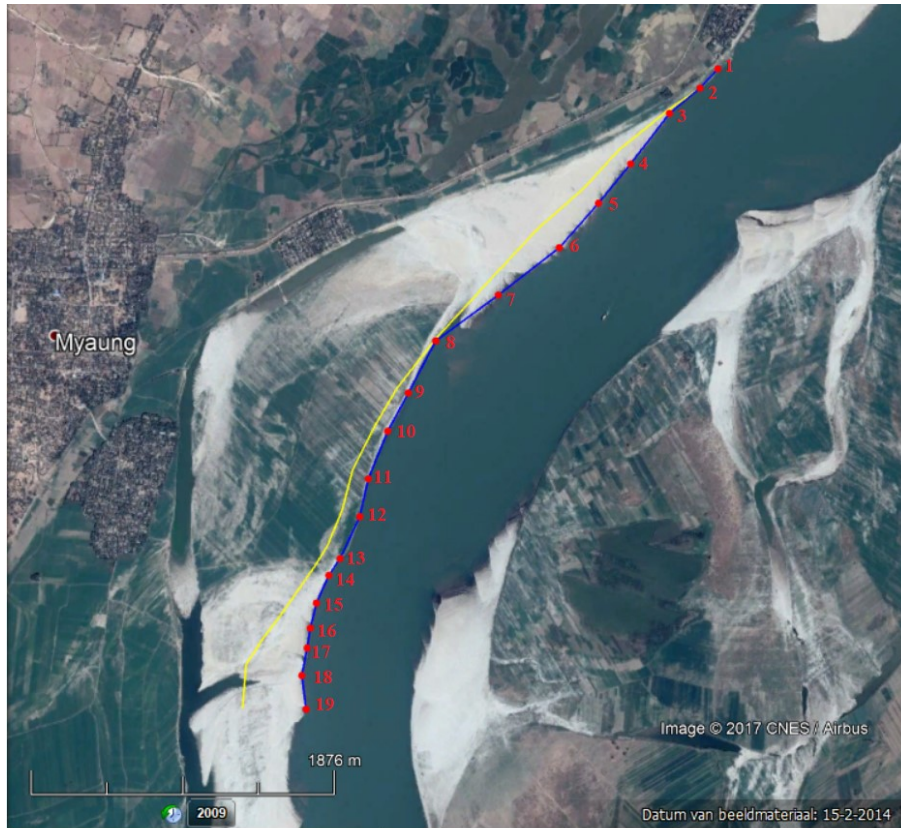
Area 7 is the subsequent bank on the opposing site of area 6 and shown in Figure B18. This area located in the outer bend is a floodplain, so a large part of this area is flooded with high water. This floodplain lends itself to the comparison of a vegetated and unvegetated bank section within one reach. The first (points 3-8) and the last part (points 14-19) are unvegetated sections. In the middle segment (9-13) vegetation is present. The radius of curvature is approximately 800 meters, so it is a sharper bend than in area 6.

Figure B18 Area 7 - Comparison riverbanks of 15 February 2014 with 2 January 2017.

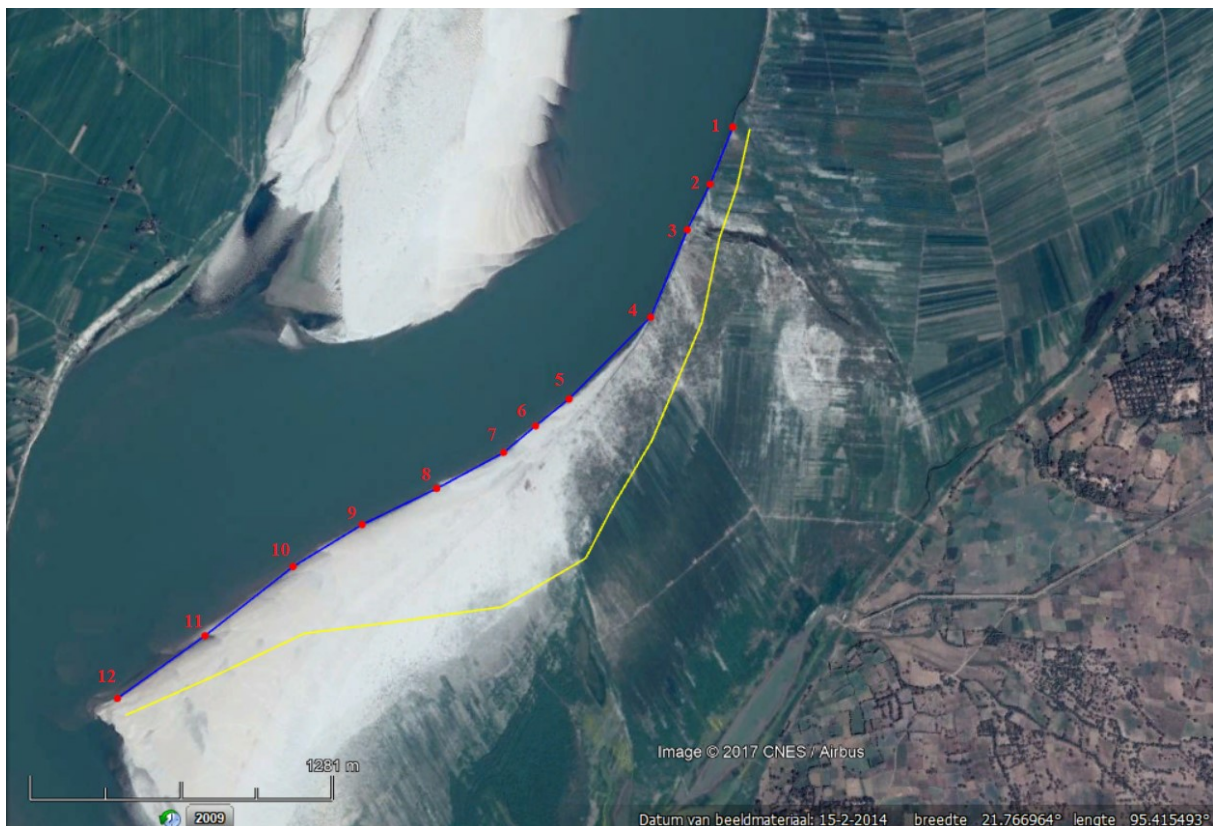
In Figure B20 it is visible that also in this area the bank retreat is mainly determined by the opposite point bar, which deflects the flow towards the outer riverbank. This river bend is quite sharp, which can be the reason for the large bank retreat rate. Similar to area 3 and area 6, the maximum bank retreat can be found in the centre of the river bend. It is no coincidence that the material is sandy. Similar as in locations 2, 5, 6 and 7 the sediment is settled at a wider reach after being transported through the river. During subsequent floods, the sediment is transported further. This is, as stated before, not considered as bank retreat, but as the pulsing mode of the river sediment transport.

Figure B20 Area 8 - Comparison riverbanks of 15 February 2014 with 2 January 2017.

Figure B21 shows a similar trend as Figure B17 and Figure B19. However, the reduction of NDVI cannot be ascribed to vegetation, since it is not present (Figure B20).

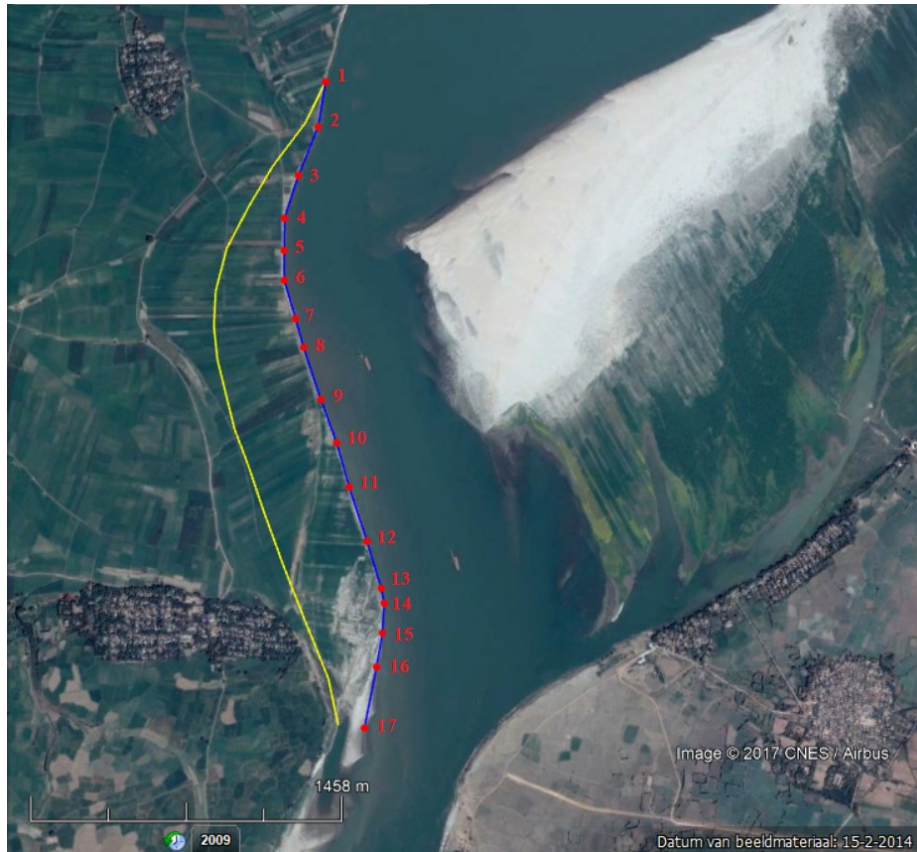
In area 9 there is some significant bank retreat in the outer bend, Figure B22. The bank retreat rates between points 5 and 15 are contributing to the largest average bank retreat rate in this analysis. A large portion of the riverbank is eroded away as a result of the expanding point bar on the other side of the river. This point bar deflects the flow towards the bank, pressuring the opposite riverbank. Note also the small village in the lower left corner of Figure B22, that starts to experience hindrance because of the riverbank bank retreat. In a couple of years, it is necessary to move their houses.

**Figure B22 Area 9 - Comparison riverbanks of 15 February 2014 with 2 January 2017.**

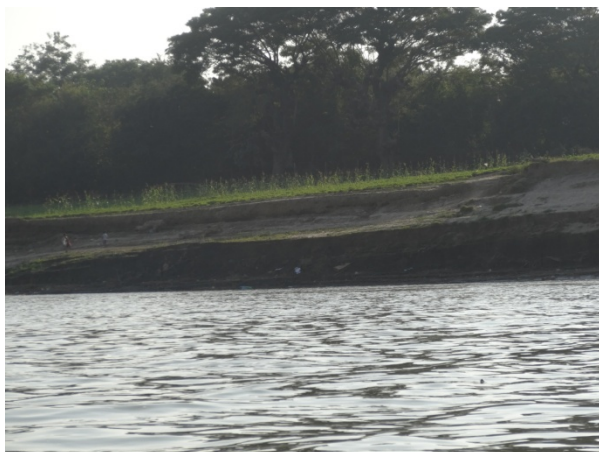
**Figure B23 Large amount of vegetation does not stop bank retreat of the riverbank.**

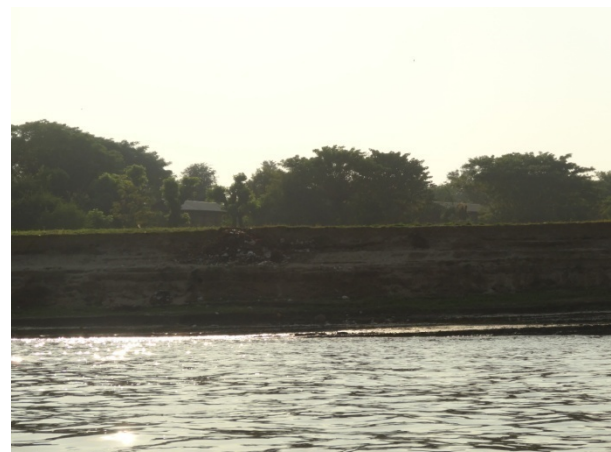
**Figure B24 The vegetation on top does not reach the toe of the bank, causing toe erosion to erode the riverbank.**

Figure B23 and Figure B24 show the conditions of the riverbank in area 9. It is quite unusual that with so much vegetation present, the riverbank is susceptible to bank retreat. Next to the numerous trees, also smaller vegetation is present and it was expected that this combination would provide sufficient strength to prevent erosion. Apparently the force of the flow of water is too strong for the riverbank to remain stable. A contributing factor is the sharp bend.
