Proceedings of the XVII ECSMGE-2019

# Impact of the Eemdijk full-scale test programme

## Impact du programme d'essais à grande échelle Eemdijk

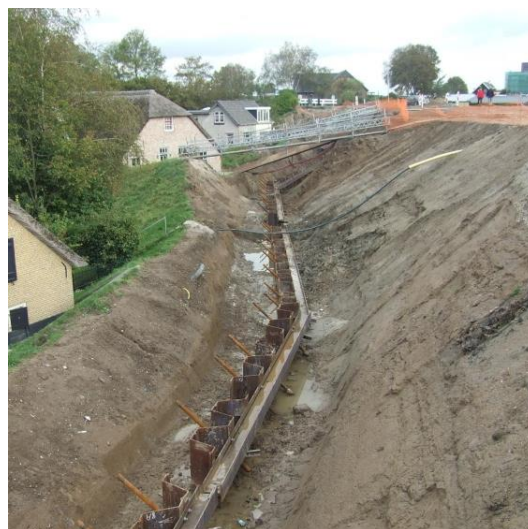
Figure 1: Installation of discontinuous sheet pile wall as reinforcement of Lekdijk Krimpenerwaard

Unlike a soil structure levee, the structurally reinforced levee is required to apply to strict deformation requirements. In the serviceability limit state both crest settlement and horizontal wall displacement need to be smaller than 0.10 m; in the ultimate limit state the wall deflection is not allowed to exceed 2% of the wall length (with a maximum of 0.5 m). Also, in contrast to what in (EN 1993-5, 2007) is allowed, if class 1 and class 2 profiles are applied, only the elastic (thus not the plastic) capacity of the steel wall may be taken into account according to the design guideline. Finally, the structure is not allowed to obstruct groundwater flow within the levee. This generally leads to a discontinuous wall from panels of several sheet piles, connected with a waling (see Figure 1).

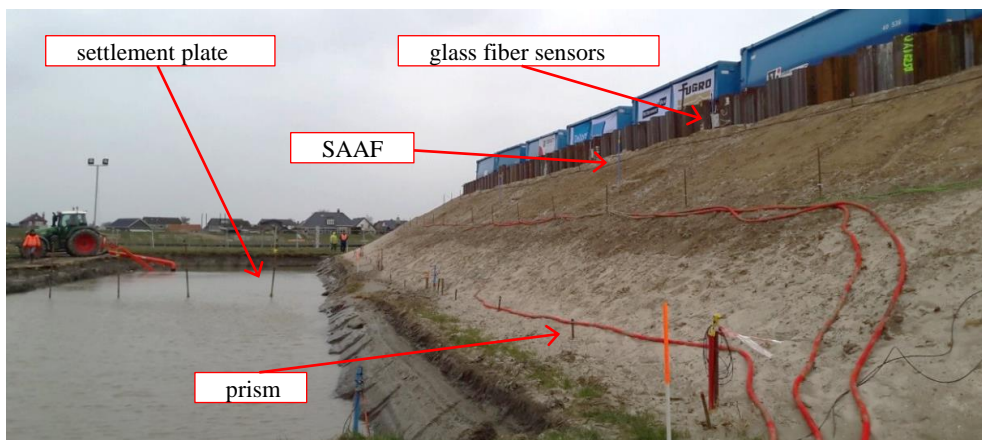
Figure 7: Monitoring campaign FST on (non-)reinforced test levee

Figure 7 gives an impression of the monitoring during both FSTs. The development of deformation over time of the inner slope (including sheet pile head) has been followed with a total station that measured dozens of prisms at three levels in the outer contour over the entire length of 60 m.
