DOCOMOMO Journal

# FROM DETERIORATION TO REVIVAL

## Approaches to the Conservation of Plastic Buildings

Ashal Tyurkay, Uta Pottgiesser

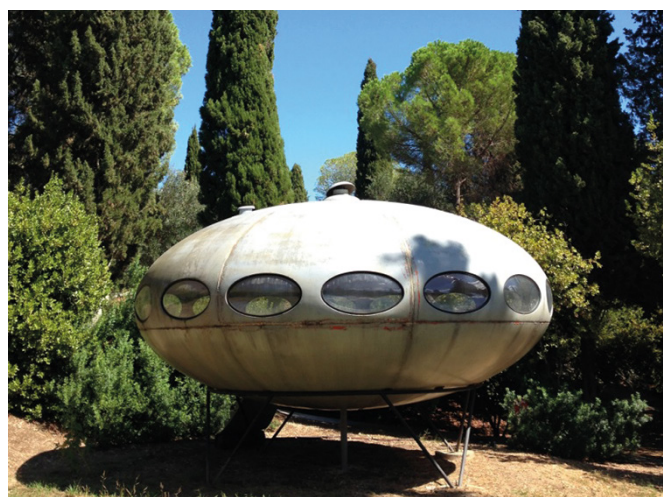
02 The *Corfu-Futuro* house installed in Limni, Corfu island. © D. Joannou, 2014

Unlike the *Futuro No. 000*, the *Corfu-Futuro* is kept outside, so the elimination of the adverse effects of atmospheric factors was of great importance. The restoration in 2008 aimed to repair the exterior surfaces of the Futuro without altering its appearance. Consequently, the old-worn window seals were replaced and a transparent varnish was applied to its exterior shell surface to protect the shell structure and the indoor environment against atmospheric factors. However, only one year later, the interior surfaces developed new moisture-related damage due to condensation. Because both restorations in 2008 and 2009 have caused further damage after 10 years, a conservation management plan for the *Corfu-Futuro* should be developed.
