# Development of an Open-Air Laboratory to Test Nitrate Removal in Bioswales

to obtain the degree of Master of Science

at the Delft University of Technology,

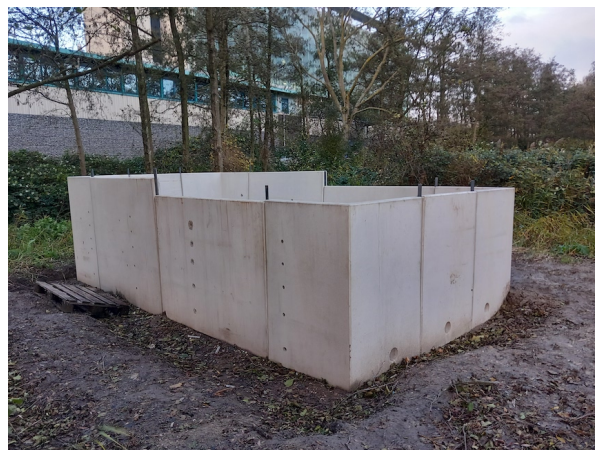
**Figure 2.1:** MeSUDa facility at start of current project

Cahill worked on the development of the two setups at Flood Proof Holland (FPH), a site run by TU Delft's Green Village and VP Delta for outdoor experiments and demonstrations. FPH is located on the southern end of the TU Delft campus. The OALs were intended to "inform research, practice, and educational activities for eco-based sustainable water management" [27] and Cahill placed specific emphasis on the enablement of long-term performance monitoring while still supporting short-term experiments. This remains the overarching philosophy for the continued development of the site. At the end of Cahill's research, and thus at the beginning of the current project, the foundation and walls of the bioswale OAL facility had been constructed (Figure 2.1). Cahill also included a number of design recommendations in their work, which are discussed in the following section. In the course of the current project, the bioswale setup was named the **Managed experimental Sustainable Urban Drainage area**, or MeSUDa.

MeSUDa was designed as a gradual slope split into "three sections to monitor long-term vegetated swale hydrological and bio-chemical behaviour" [27]. Cahill's original draft design for MeSUDa can be seen in Appendix 7.1. The outer walls of the facility consisted of precast L-shaped concrete elements, forming a sort of container. As to the continued construction, Cahill recommended partitioning the container into three isolated sections using wooden dividers, lined with plastic to form an impermeable barrier for each section. The partitioning would allow for the conduction of parallel experiments with simultaneous long-term and short-term monitoring in the setup. The isolation of the setup was also recommended in order to prevent external interactions with the natural subsurface, specifically the local groundwater table. It would also allow for the measurement of infiltration fluxes. Thus, Cahill recommended the installation of controlled drainage locations where the outflow could be monitored as necessary.

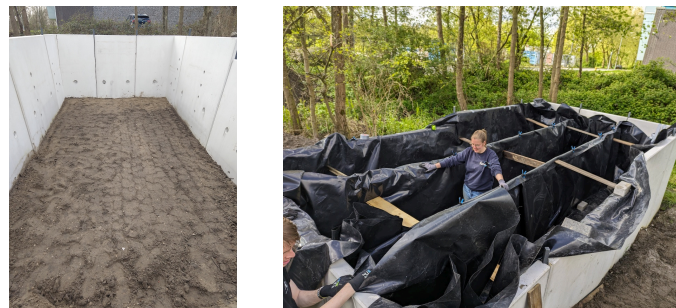
**(a)** Base layer with 2% slope. **(b)** Securing plastic lining over wood planks.

**Figure 2.5:** Construction of base layer and impermeable swale linings.

Physical construction of the setup began in late-March 2024 and was completed in mid-July 2024. The construction process began with the establishment of the 2% slope using the mixed base material (Figure 2.5a). Wooden barriers were installed in the structure, dividing it into three sections of equal size, each approximately 1 m wide. LDPE plastic lining was draped over the barriers and the outer walls of the structure, isolating each section (Figure 2.5). The lining was affixed to the barriers and walls and smoothed as much as possible, to prevent any folding that might result in preferential flow paths along the swale sides.

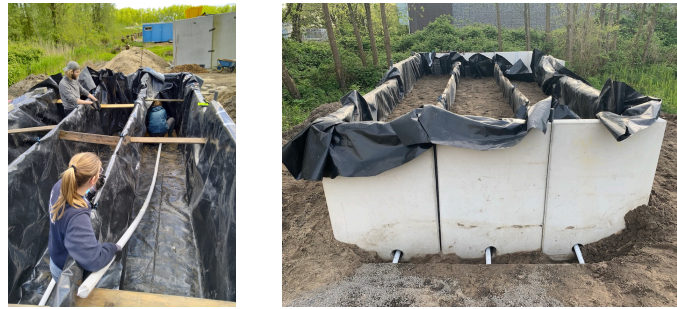
(a) Installation of underdrains. (b) Gravel, coarse sand, and fine sand filled.

**Figure 2.6:** Underdrain installation and filled media.

Underdrains were installed at the bottom of each swale, each inside of a filter stocking to prevent clogging (Figure 2.6a). The pipes were slid through the lining and the drilled outlets at the front of each section. A special plastic adhesive was used to seal the lining around each pipe to prevent leakage. Gravel was smoothed around the drainage pipes, with the coarse sand on top of it forming a slight angle inward towards the pipe to promote drainage. Following the drains and gravel/coarse sand, the fine sand was filled into the swales (Figure 2.6b). Between each material addition, the filled media was smoothed to make the individual layers as homogenous as possible.

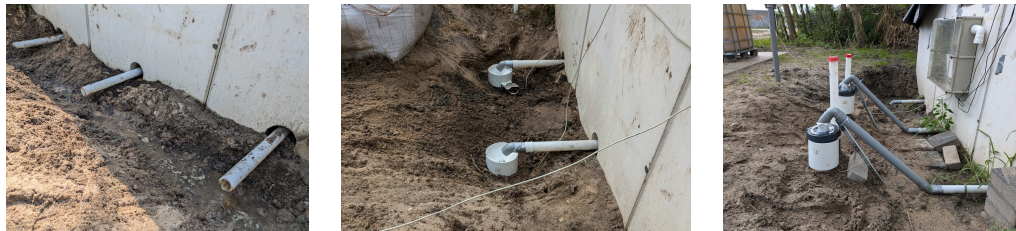
(a) Outlets of underdrains.

(b) Free-flowing configuration.

The outlet of each swale was constructed in such a way that it would allow multiple outflow configurations and, therefore, some control over hydraulic behaviour inside of the setup. Initially, enforced water table configurations were applied to swales #2 and #3 to create anaerobic zones of 50 cm, while swale #1 was fitted with the free-flowing configuration. However, after leakage was observed in swale #3 (as further discussed in section 3.1.2), its outlet was changed to the free-flowing configuration.

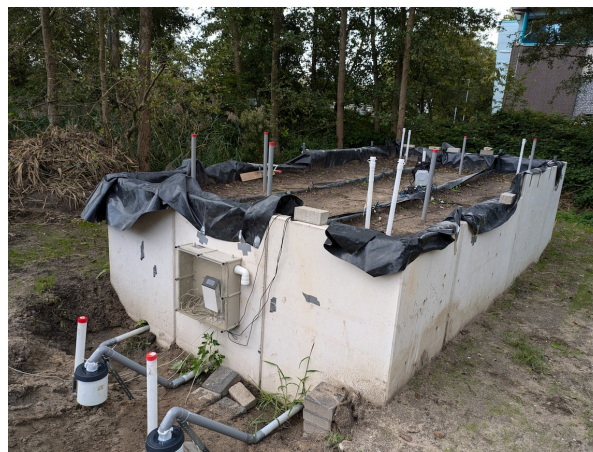
**Figure 2.8:** Final construction.

The completed construction of MeSUDa is shown in Figure 2.8. Note: the installation of piezometers and other sensing hardware seen in the figure will be discussed in the next section.

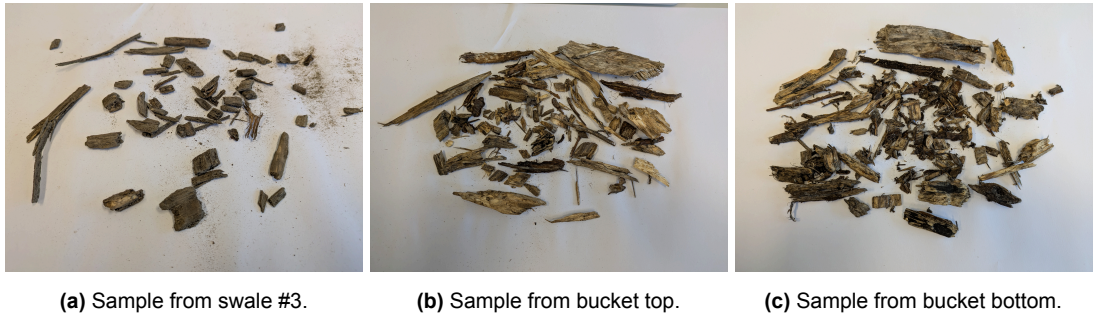
Figure 2.17: Woodchip samples.

Woodchip decomposition in MeSUDa served as a proxy for denitrification potential. The qualitative decomposition analysis assessed whether the woodchips could successfully break down in the swale, thereby releasing additional DOC and initiating the denitrification process. A sample of woodchips was extracted from swale #3 approximately 230 days after installation (Figure 2.17a). Two additional samples were collected from a bucket of woodchips that had been stored indoors in a dry environment for the same amount of time: one sample from the top (Figure 2.17b) and one from the bottom (Figure 2.17c). These served as a reference to assess decomposition of the swale woodchips.

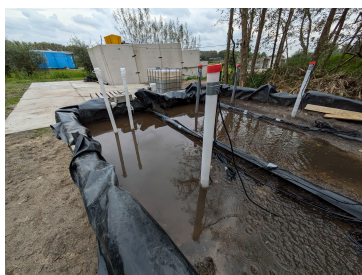
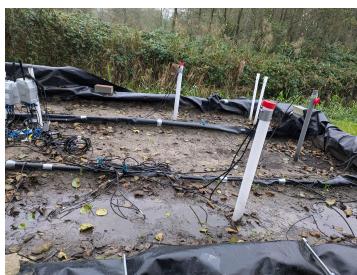
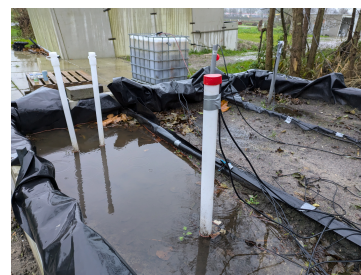
(a) Swale #3, filling attempt.

(b) Swale #1, tracer testing.

(c) Swale #3, tracer testing.

**Figure 3.4:** Pooling in MeSUDa.

Limited infiltration was evident throughout testing, as any significant water influx resulted in ponding on top of MeSUDa. In swale #3, substantial pooling was observed at the front of the swale during attempted water table establishment (Figure 3.4a) and again during tracer testing (Figure 3.4c). Swale #1 experienced more localised pooling, also during tracer testing (Figure 3.4b). While MeSUDa was designed to promote slight ponding and gradual infiltration, the depicted extent of water accumulation was not desirable.

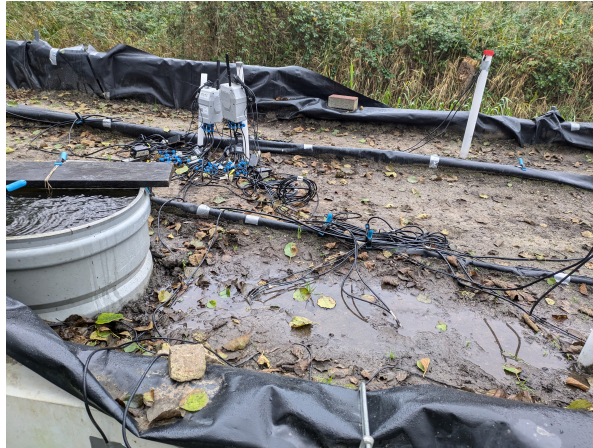
**Figure 3.6:** Pooling above sensor profiles during tracer testing in swale #1.

Although the water inflow was set to the lowest possible pumping rate to avoid overflow, enough spillage occurred to influence the tracer results. Further analysis concluded that some water from the injection ring had overflowed and travelled overland towards the front of the swale. Depressions in the topsoil, such as those above sensor installation points, led to localised pooling (Figure 3.6) and subsequent infiltration directly into the vertical sensor profiles. It was suspected that this vertical infiltration occurred more quickly at location #2 compared to location #1 because these sensors were freshly installed at the time of the tracer and the soil had not yet settled enough to eliminate any preferential flow paths. The salt pulse therefore appeared to arrive at location #2 prior to location #1.

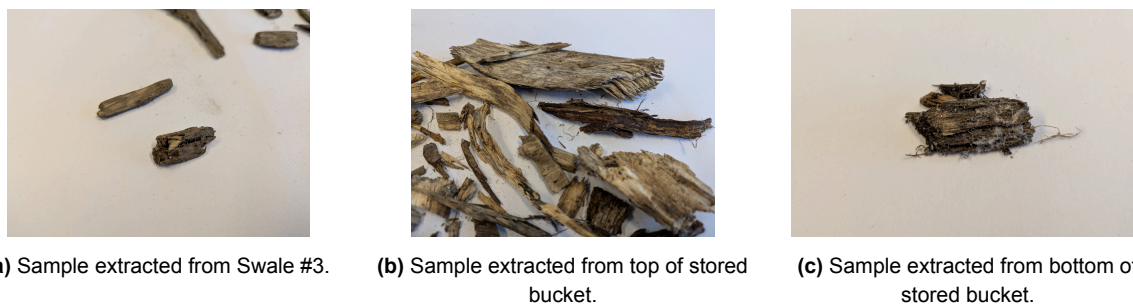
**Figure 3.16:** Woodchip samples assessed for decomposition.

The final sample was extracted from swale #3 and was assigned a decay status of “minimal” based on the results of the DC3 classification and pick test. The chips did not exhibit any visual indicators of rot fungi. These findings were unexpected, as it was assumed that the woodchips in the swale had decomposed at least partially in the 230 days since their installation. However, unlike the other two samples, the general observations made at the time of extraction and analysis were not consistent with the assigned decay status. The extracted woodchips were compact and smooth, lacking the fibrous edges present in the reference samples (Figure 3.16a). The chips were also quite strong and hard. These observations indicate that the woodchips in swale #3 had indeed decayed, to the extent that the softer, more fibrous outer layers of the woodchips had completely broken down, leaving only the harder, more decay-resistant inner wood behind. Observations made during the extraction, namely that the soil had “a dark grey colour and distinct sulphuric smell”, are consistent with decomposition activity in swale #3. These observations are all considered indicators of anaerobic soil [38], suggesting that the microorganisms responsible for decomposing the woodchips had consumed the surrounding oxygen. Finally, only a handful of woodchips were retrieved from the swale, despite drilling in several locations. It is possible that many of the original woodchips had decomposed, and those that had not were too small to easily extract. Combined with the initial expectation of decomposition in swale #3, these observations indicate significant decay in the setup.
