<i>Project number</i>	C31B67
<i>File reference</i>	C31B67WP4-12
<i>Date</i>	30 th December 2017
<i>Corresponding author</i>	Geert J.P. Ravenshorst (g.j.p.ravenshorst@tudelft.nl)

TU Delft Large-scale testing campaign 2016 – WP4

TEST REPORT ON CYCLIC BEHAVIOUR OF PLANK-JOIST CONNECTIONS OF SAMPLES EXTRACTED FROM EXISTING BUILDINGS

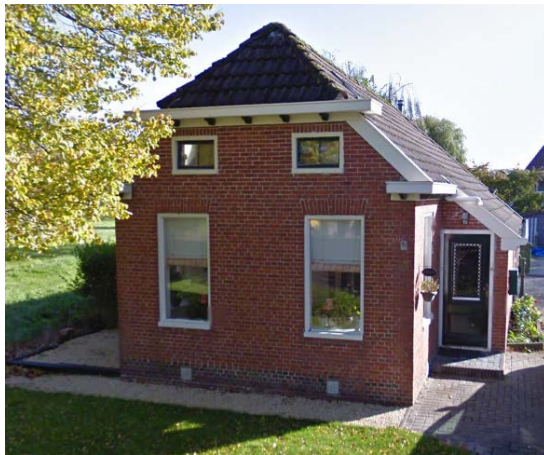
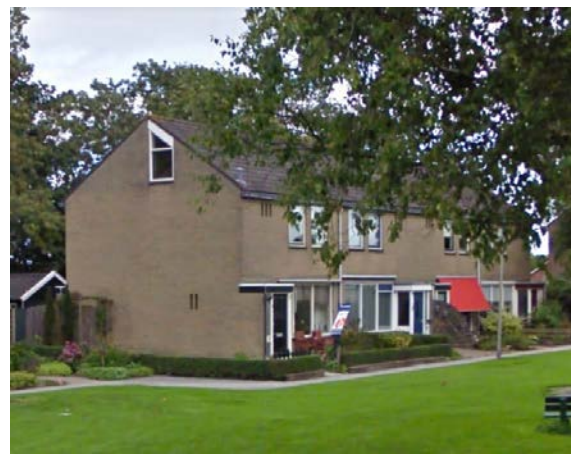
Figure 2: NAM houses from which the samples were extracted

Rengersweg 15, Godlinze

Zijlvest 25, Loppersum

NAM is in possession of a number of houses in the Groningen area, some of which had to be demolished: thus, they served as a source for the extraction of samples, which were cut into elements to be tested in the laboratory of the TU Delft to compare the material properties and test conditions of future experiments to the actual conditions.

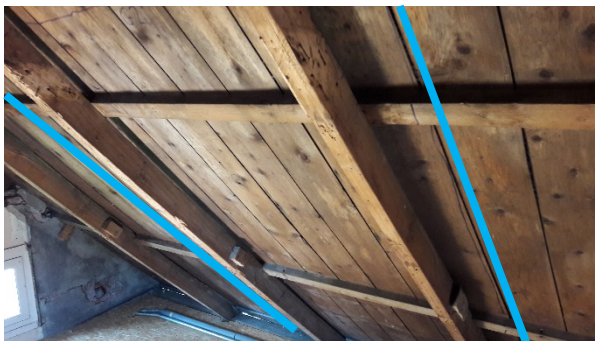
Figure 4: Roof sample G2 and its location in the house.

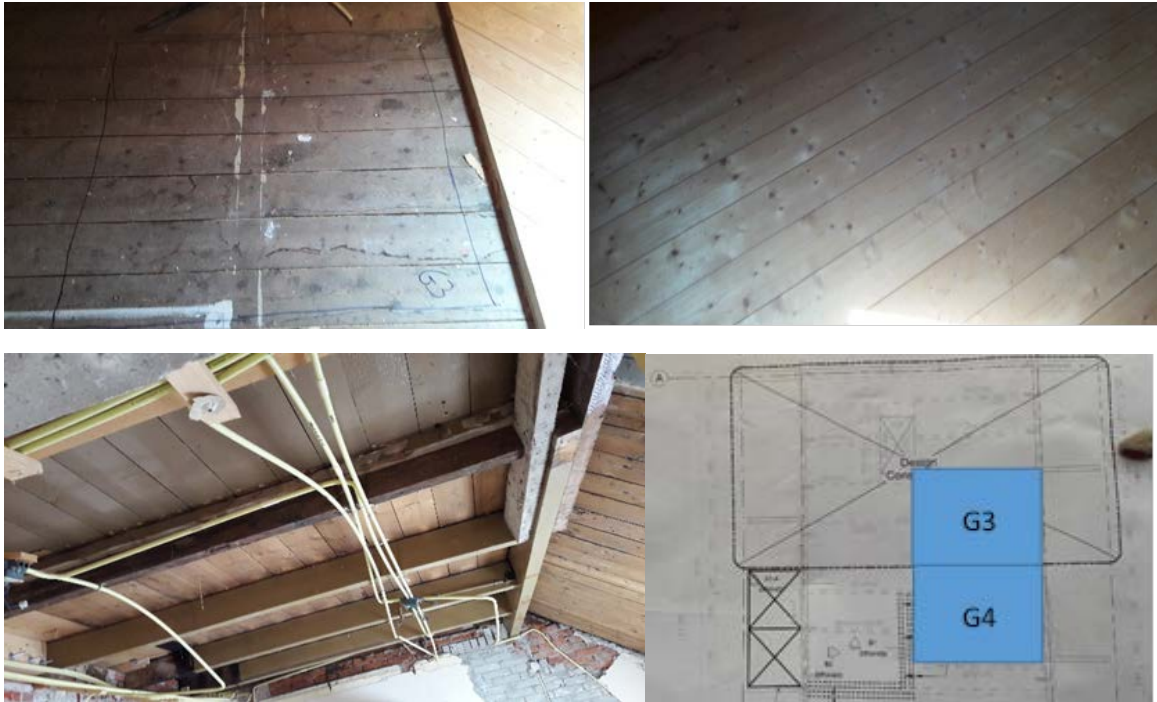
Figure 5: Floor samples G3 and G4; upward and downward facings and location in the house.

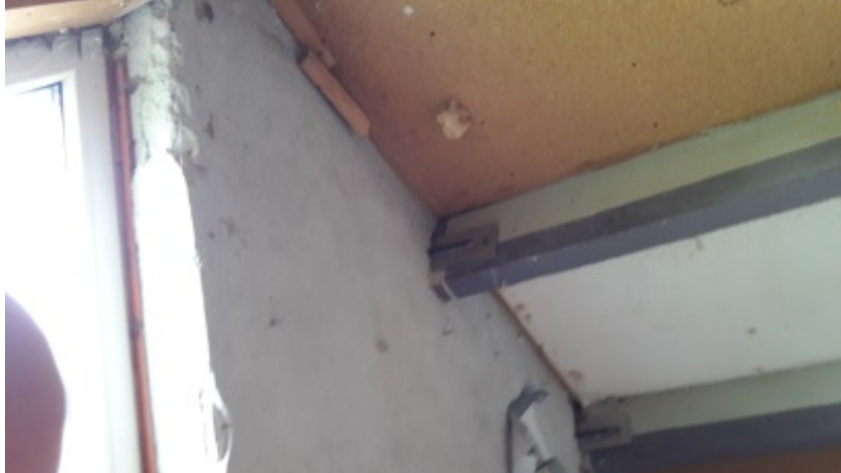
Figure 7: View of Z2 roof panels and purlins (the white-coloured part is only a piece of wall paper).

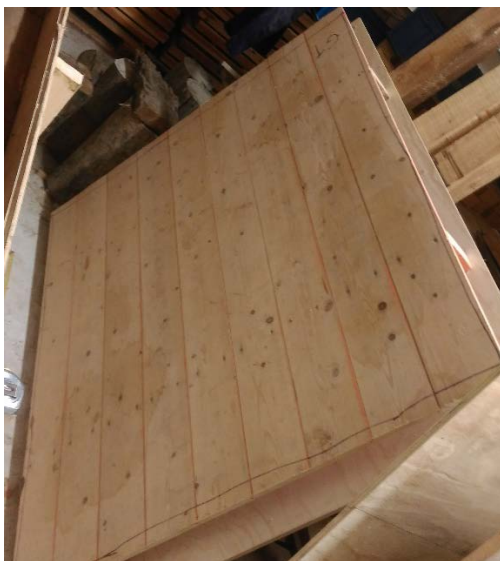
Figure 9: (a) Ground floor sample G1 with planks from Rengersweg 15, Godlinze [2], (b) overview of the test specimens that were extracted for the plank-joist connection test.

In Figure 9, sample G1 and its disassembly plan are presented. The heart-to-heart distance between the joists measures 788 mm.

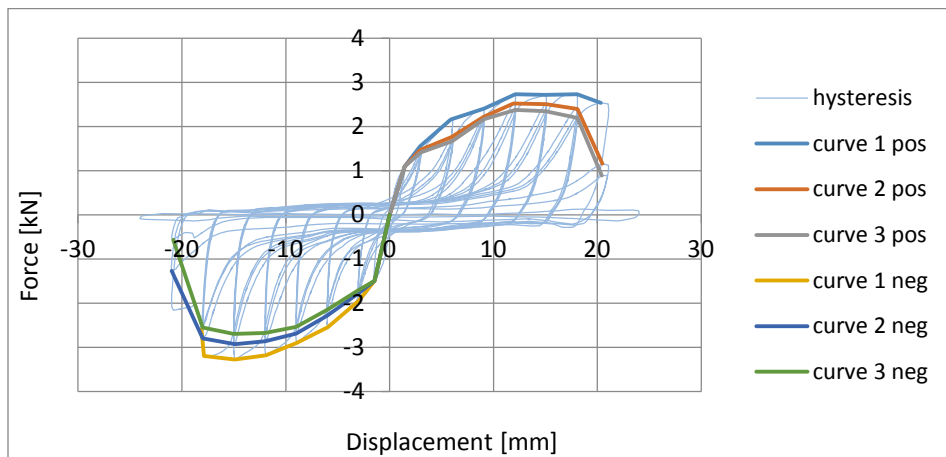
6.2.3 Test results G1-b2-2-A

Figure 22: Hysteresis diagram and backbone curves
