# State of Conservation of Concrete Heritage Buildings: A European Screening

**Abstract:** Historic concrete buildings are at risk. Limited knowledge of concrete technology until the 1960s led to more sensitive buildings than modern concrete buildings. In addition, the lack of sensibility regarding their heritage value and insufficient protection is leading to remorseless demolition. Still, concrete has proved to be a resilient material that can last over a century with proper care. There is not yet an estimation of the status of historic concrete buildings in Europe. Until now, a few attempts have been done to secondarily, and subjectively, gauge their conservation status. This paper is the result of a joint investigation studying forty-eight historic concrete buildings distributed in four countries. They were surveyed by expert teams according to a predefined methodology. The study aims to identify recurrent damages and parameters affecting the conservation state. It also aims to serve as the first trial for an objective and measurable methodology, to apply it with a statistically significant number of cases. Damages related to the corrosion of reinforcement and moisture-related

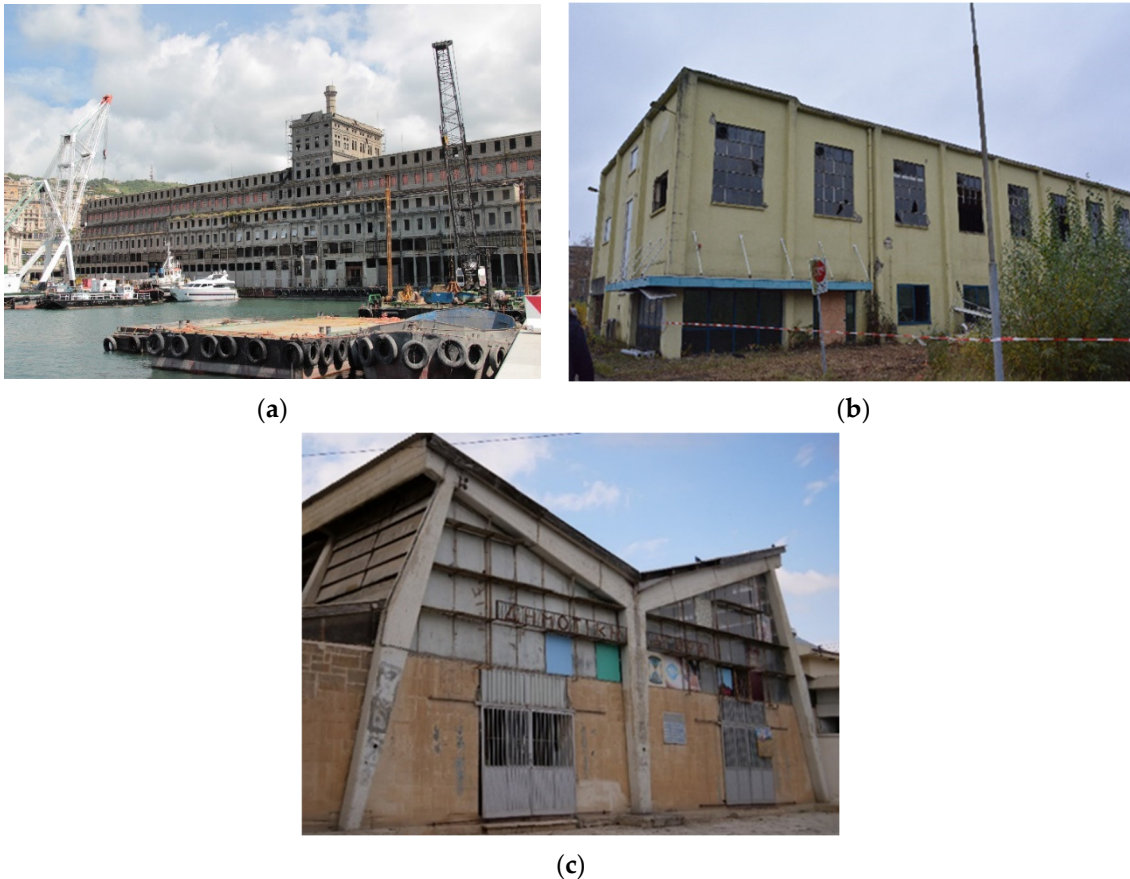
**Figure 1.** Historic concrete buildings. (a) Hennebique Silos in Genova (1901–1906). Source: Authors 6; (b) Calve Building (1908) in Delft, the Netherlands. Demolished in 2019. Source: Author 1; (c) Athienou Municipal Market (1951–1955) in Cyprus. Source: Authors 3 and 4.

Reinforced concrete (RC) started to be used in Europe in the late 19th and early 20th centuries. The new material was eagerly adopted in some countries to construct new buildings; whereas in others, concrete boomed in a later period. In Genova, Italy, for instance, the Hennebique silos (1901–1906) (Figure 1a) exhibited an early mastery in the use of concrete systems in a large-scale building with a system patented nine years before [1]. Whereas, in the same period, in the Netherlands, RC buildings tended to be of less entity and complexity like the Calve building in Delft (1908) (Figure 1b) as concrete had not yet found its niche in the country.

Cyprus, for instance, started late in the tenacious use of concrete. When the island was a British colony (1922–1960), RC was introduced to modernize the Cypriot landscape (Pyla and Phokaides, 2009). However, it was not until the decade of the 1960s, with the island's independency from the British Empire, when the concrete 'boom' started with the construction of many private and public buildings (Figure 1c).

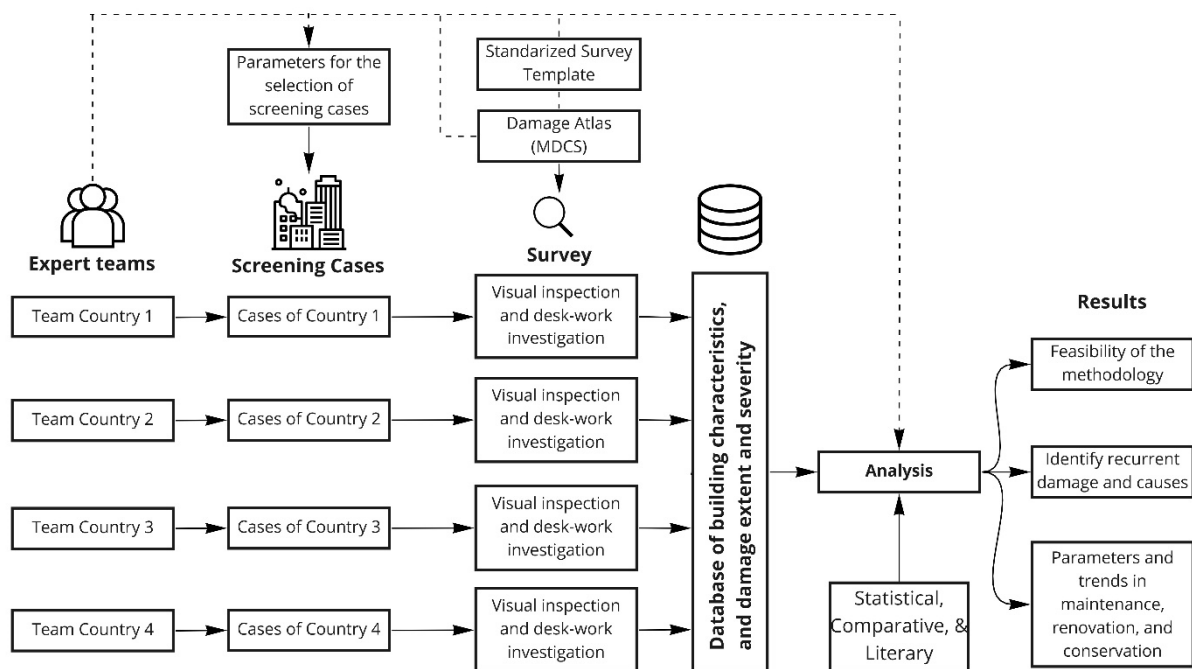
Figure 2. Flow chart of the proposed methodology.

A scheme of the methodology can be found in Figure 2. The survey for each building was carried out by a designated team in each country. Each team was specialized in damage assessment, conservation, and concrete degradation. Starting from the visible damage, each team recorded the most common damage types and evaluated the possible cause(s) of each damage. For this task, the Damage Atlas of the online tool MDCS was used [9], which defines illustrative examples and explains the characteristics and plausible causes of the different damage types.

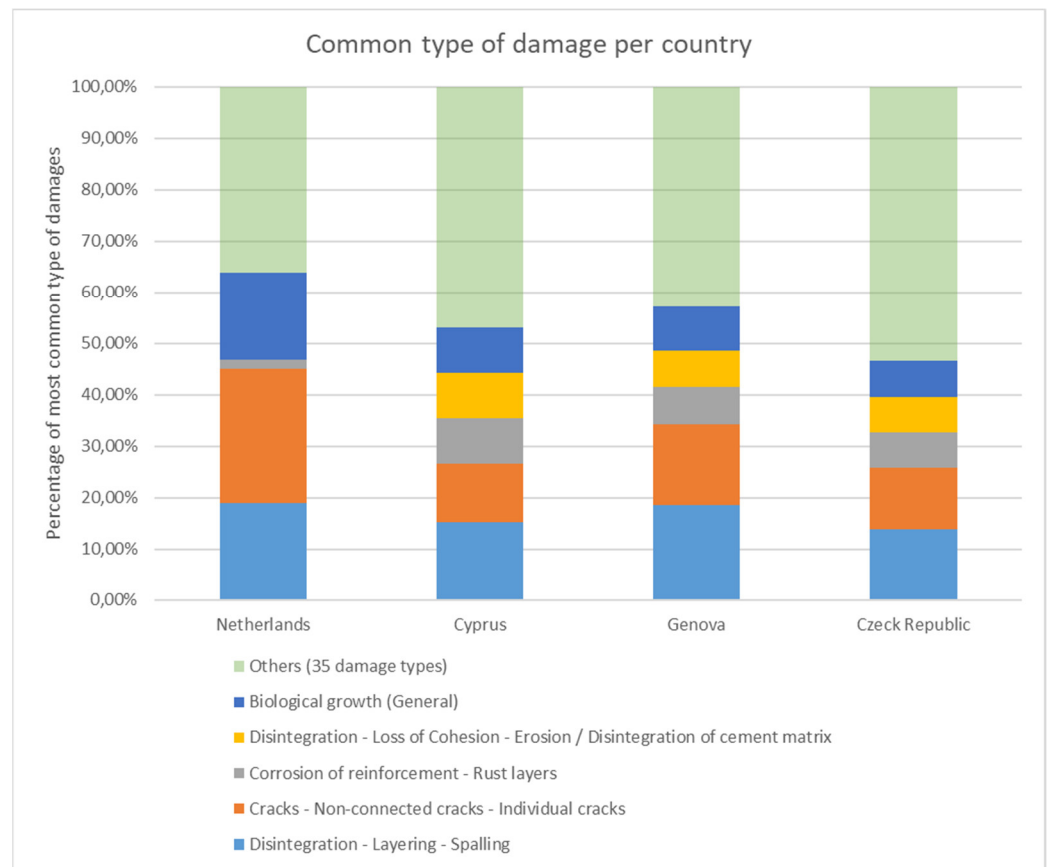
Figure 4. Damage types per country.

Among the types of damage defined for concrete in MDCS (Figure 3), the most recurrent ones were: spalling and delamination (16.42%), individual cracks (11%), corrosion of reinforcement-rust layers (8%), disintegration of cement matrix (6%), and biological-growth-related damages (discoloration and moist spots, 3.85% each). These five types of damages formed around 50% of the damages found across the countries, although the orders of magnitude have slight variations as shown in Figure 4.

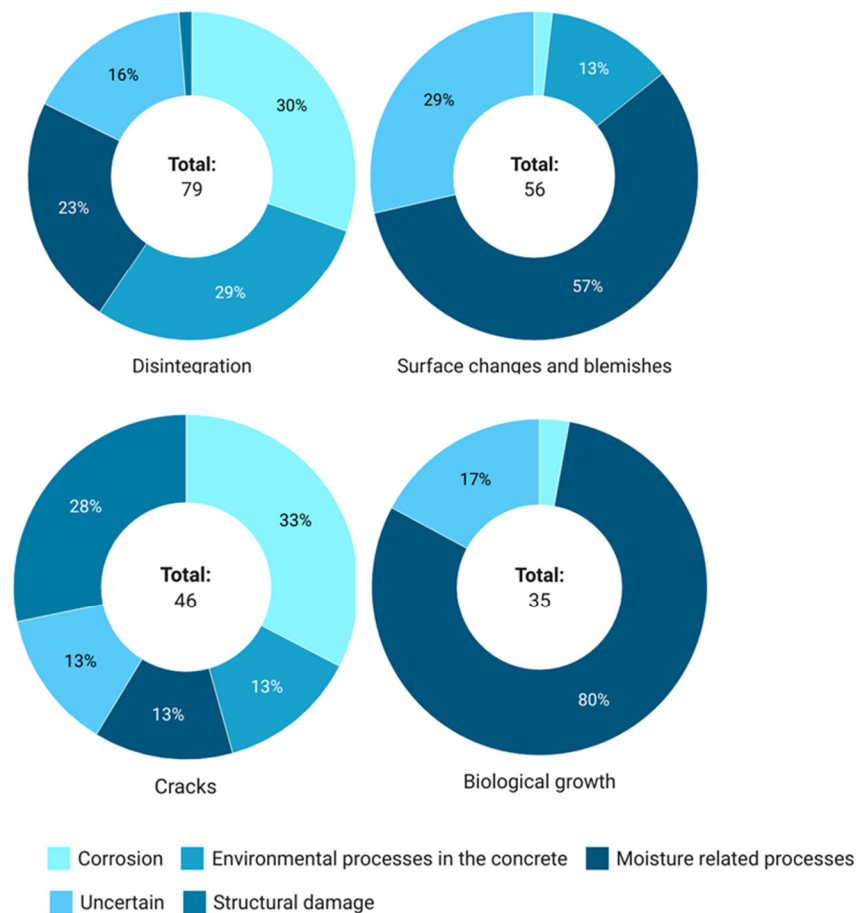
Figure 5. Hypothetical causes of damage per type of damage group.

The correlation between the damage and the potential cause/s is summarized in Figure 5. The most relevant results were that Cracks were predominantly related to corrosion and structural damage, and Disintegration was primarily linked to corrosion, moisture, and environmental processes. The rest of the correlations did not provide significant findings.

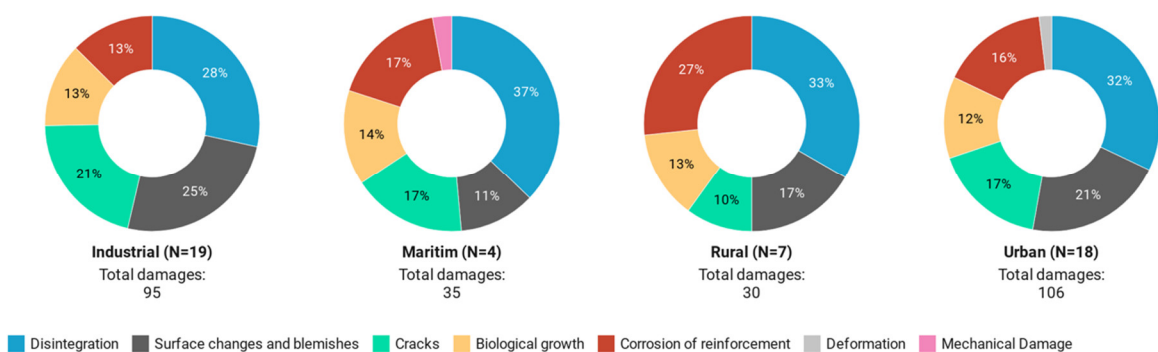
Figure 6. Types of damage per environment.

The environment is believed to be one of the leading causes of concrete degradation [15]. This non-physical characteristic was also studied by comparing different environments. Buildings in urban areas showed more extent and severity of damage than buildings in industrial areas (refer to Table 3). The highest severity of damage was found in buildings in maritime areas, although the number of buildings was limited to only three. A relation was also expected between specific types of damage, depending on the environment. However, the relative distribution of the types of damage was similar across all environments studied (refer to Figure 6). Disintegration was the most common damage, followed by surface changes and blemishes in most environments. Corrosion, cracks, and biological growth appeared in lesser numbers.

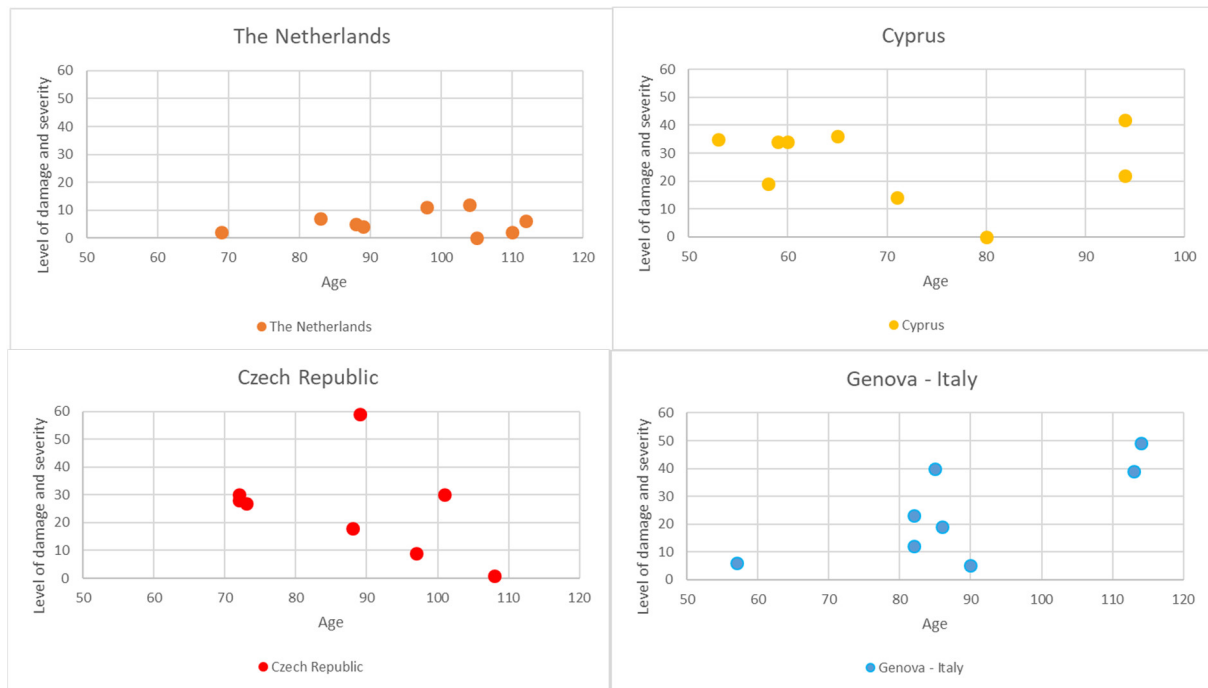
**Figure 8.** Age (X axis) and Level of damage (Y axis) of the non-restored buildings in each country.

By comparing the state of conservation of non-restored buildings, a trend in building maintenance could be observed among countries. In Figure 8, the non-restored buildings of each country are displayed in terms of Age (X axis) and Level of damage extent and severity (Y axis). The large scatter of the results does not allow for precise conclusions, but some trends can be extracted. Buildings in the Netherlands showed a better state of conservation, having the lowest level of damage across all ages. Cyprus had, on average, higher damage—even in younger buildings. The Czech Republic had scattered results but there seems to be a tendency for a better state of conservation of older buildings. On the contrary, Genova had an opposite trend, where the younger buildings were in a better state than older buildings.

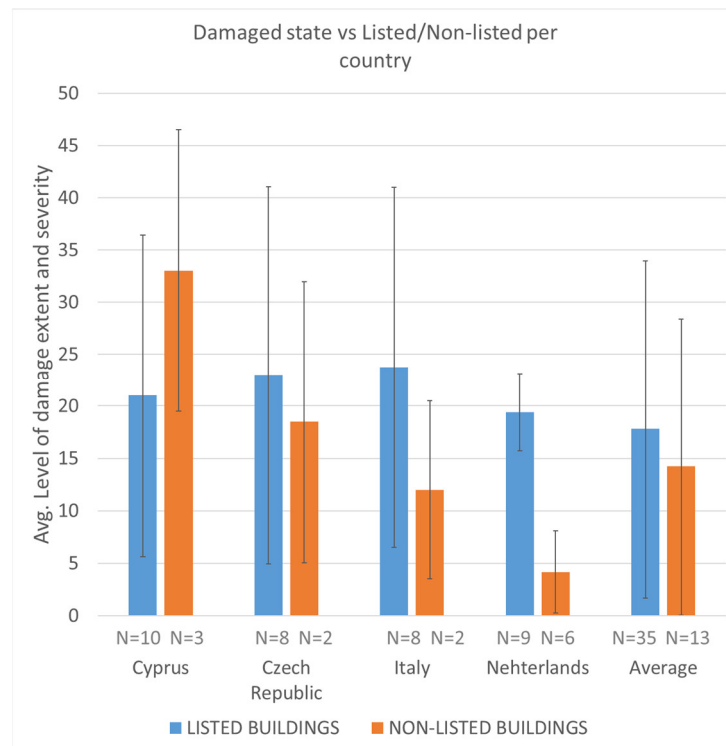
Figure 10. Level of damage severity vs. Building protection per country.

On average, 73% of all buildings had some type of monumental protection. The protection could be local, provincial, or national. Interestingly, the level of damage severity was higher in listed buildings, compared to non-listed, in all countries except Cyprus (Figure 10).

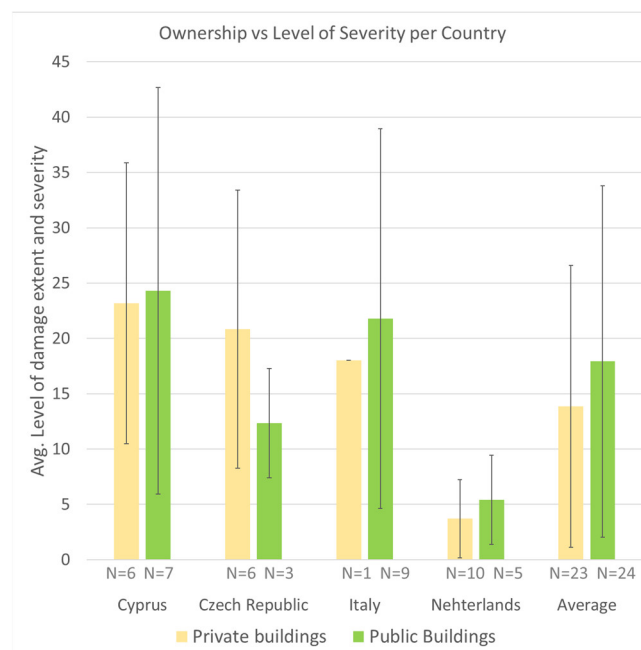
Figure 11. Level of damage severity vs. type of ownership per country.

Generally, there is an even number of private and public buildings in the sample, although there are significant differences in their state of conservation among countries. Considering all the buildings, restored and non-restored, the Netherlands and Czech Republic have similar ratios, 67–33% and 60–40% ratios of private–public buildings, respectively. On the contrary, the buildings in Genova were predominantly public ones (90%). Cyprus had an even ratio, 46–54% of private to public buildings. There is not a clear indication between the level of damage and the ownership; although, private buildings tend to be in a better condition than public ones (Figure 11).
