Degradation Analysis by Accelerated Ageing of Epoxy based Mortar

Durability Research on the Lantern of the Liverpool Metropolitan Cathedral

Technische Universiteit Delft

Master of Science
in Aerospace Engineering

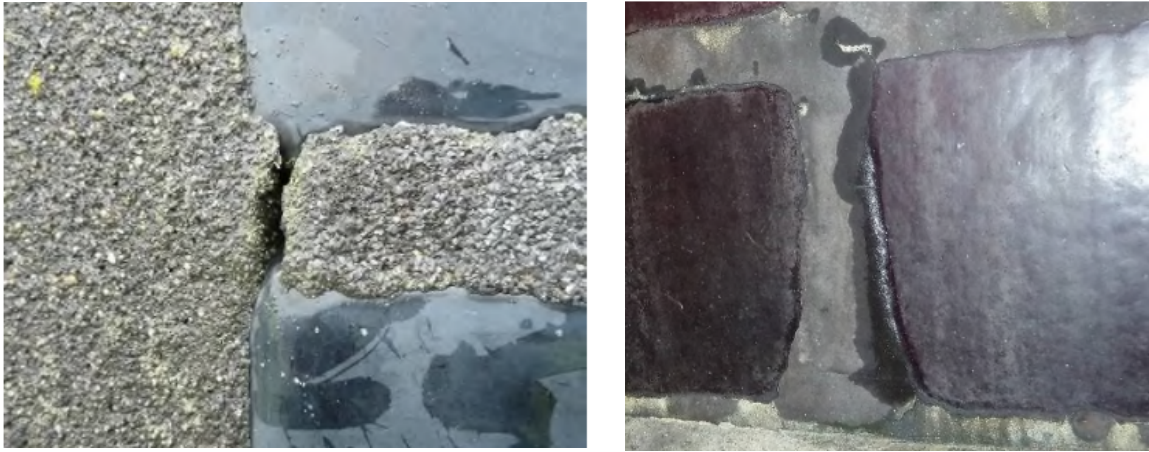
Figure 2.3: Visible cracks in the epoxy mortar and de-bonding of the glass-resin interface simultaneously with moisture ingress [4].

There are distinct patterns of deterioration on the different aspects of the lantern. By far the worst deterioration is apparent on the SE (or blue) section and significantly less on the NW (red and yellow) sections. This deterioration manifests itself with more severe cracking and degradation of the external resin and the resulting water penetration and damage to the internal faces. There is also more extensive pooling and staining on the walkway below. External surveys of the glazing have shown that the glass itself is generally in good condition. However, the resin has deteriorated more significantly. In particular, there are areas of cracking both on the thin sections between the glass dalles, where cracks can be full depth, and at the junction between thick resin over the concrete members. the separation of the resin around the glass dalles, figure 2.3 (left). It was found in numerous locations that the adhesion at the interface between the glass and the resin has failed, so water has the chance to penetrate, figure 2.3 (right).

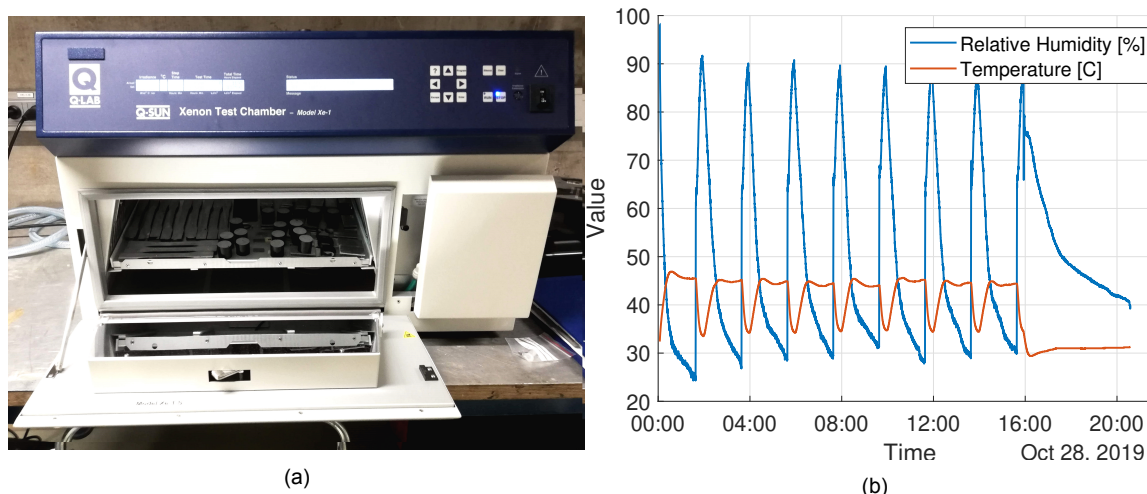
Figure 5.2: (a) Weiss climate chamber with samples. (b) Measured temperature and relative humidity during WS cycle in the Q-sun climate chamber.

To test the effects of outdoor light exposure (UV) this standard test is adjusted to by removing the water spray: alternating 18 hours of light (42 W/m², insulated black panel temperature of 63 °C) with 6 hours of dark (insulated black panel temperature of 42 °C). From the UV chamber it was given that 1050 hours of light cycles is equal to approximately 121000 kJ/m² of solar irradiance.

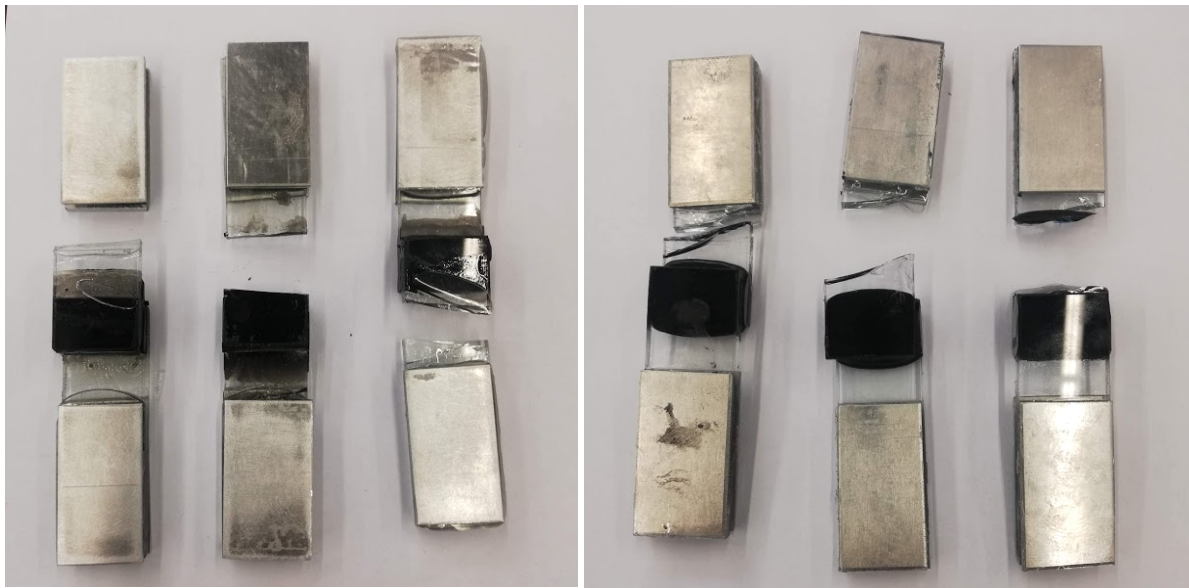
Figure 7.4: Glass failure in UV cycle after 350 hours (a) and TC cycle after 700 hours (b)

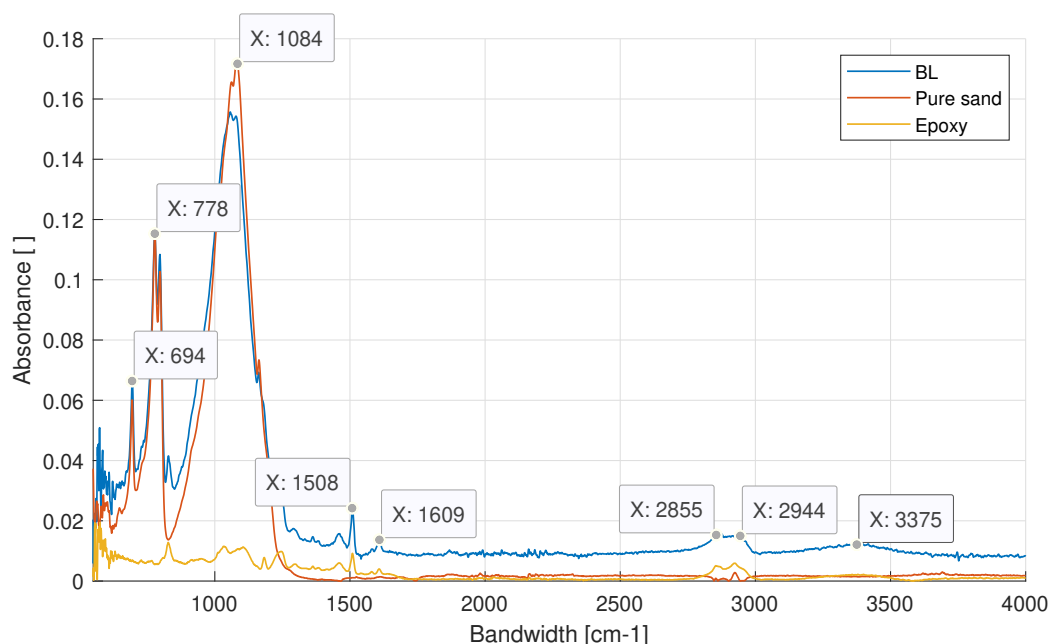
Figure 8.1: FTIR Reproduced sample, Sand only and Epoxy only

A number of clear peaks can be observed in the FTIR analysis. The interpretation of the peaks of different functional groups present in the material is done by looking at characteristic IR absorption frequencies of organic functional groups [48]. Figure 8.1 shows the FTIR spectra of un-aged reproduced samples, pure epoxy and pure sand. The two most prominent peaks in the reproduced material, between $700\text{--}800\text{ cm}^{-1}$ and $850\text{--}1200\text{ cm}^{-1}$, are related to the sand present in the mortar.

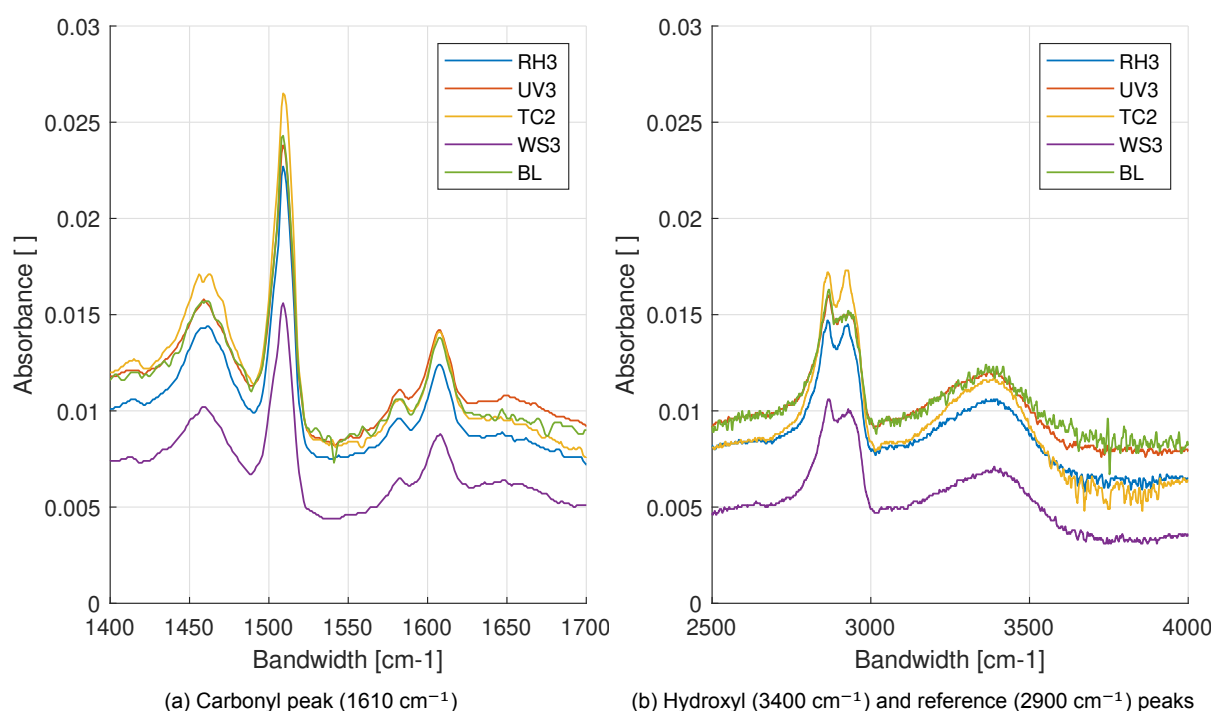
Figure 8.3: FTIR graphs of reproduced samples after 1050 hours of ageing and baseline (BL)
