Sensors

# Evaluating Degradation at Railway Crossings Using Axle Box Acceleration Measurements

**Keywords:** railway infrastructure monitoring; axle box acceleration measurement; crossing degradation; 3D profile measurement

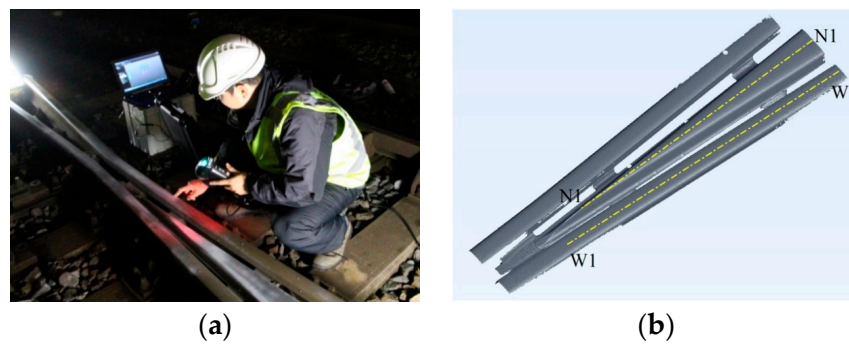
**Figure 6.** 3D profile measurement. (a) Measurement using HandyScan and (b) a measured 3D crossing profile. Cross sections W1 and N1 are along the centerlines of the wing rail and crossing nose, respectively.

The crossing profile was measured in 3D using the laser-based non-contact apparatus HandyScan; see Figure 6a. In this measurement, the laser stripes project a reference on the rail surface, which is captured by two cameras. The accuracy of HandyScan is 0.03 mm in arbitrary directions. Figure 6b shows an example of the measured 3D profile.

To gain insight into the measured profile, two longitudinal-vertical cross sections are selected from the wing rail and crossing nose; see Figure 6b. The cross sections W1 and N1 are along the centerlines of the wing rail and crossing nose, respectively. Figure 7 compares the crossing profile of the nominal and degraded states, where the origin of the abscissa aligns with the tip of the crossing nose. Along W1, the height difference between the nominal and the degraded profiles reaches the maximum of 0.8 mm at 102 mm. Because of the misalignment of the rolling direction of the wheelset and the centerline of the wing rail, the running band on the wing rail shrinks laterally towards the gauge side, ultimately reaching zero at 305 mm.

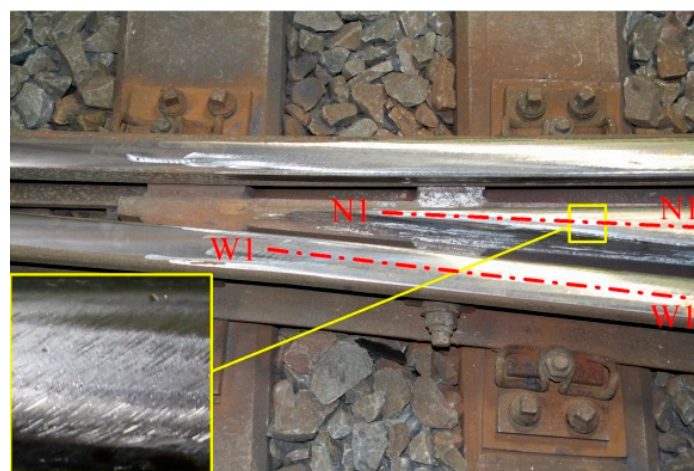
**Figure 11.** Repaired crossing profile with a magnified image of grinding marks. The degraded crossing was repaired through a grinding-welding-grinding process: first, rail surface damages were removed via grinding; second, hollow regions were filled by welding material; last, the rails were ground again to shape the profile.

Because the concerned crossing had degraded significantly, repair maintenance in terms of grinding and welding was performed to extend its service life and avoid sudden failure. The repair procedure was as follows: first, the crossing rails were ground to remove surface damage (e.g., cracks, uneven wear and plastic deformation); second, the hollow regions caused by grinding were filled by welding; finally, the crossing rails were ground again to the desired profiles. Figure 11 shows the repaired crossing profile. Because of the current incapability of operating a train-borne grinding machine at a crossing, the repair was performed manually. The repaired profile depends on the experience of the technicians and may differ significantly from the nominal profile; this is the unknown degradation status for the trial detection.
