## Repair mortars for historic masonry Effects of the binder choice on durability

Groot, Caspar

**Published in**  
Heron

Groot, C. (2016). Repair mortars for historic masonry: Effects of the binder choice on durability. *Heron*, 61(1), 33-56.

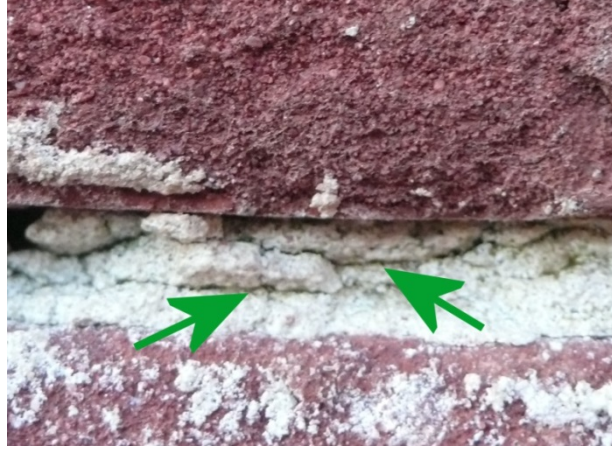
*Figure 4. Frost damage in an uncarbonated air lime mortar due to an application of the mortar too late in the season (Brussels, Belgium)*

From the parameters mentioned above it can be concluded that a certain materials strength is needed to avoid frost damage; this is especially the case in situations of outdoor exposure where rain is directly followed by frost. A certain strength means for historic masonry: a relatively low strength; After all, in historic masonry brick and mortar strength usually are relatively low; consequently, the application of a repair material with a too high strength may cause compatibility problems (mechanically and hygrically) (figure 4). A way to avoid high strength levels in the repair materials is the application of traditional binders, such as air lime, lime-pozzolan, natural hydraulic lime. Apart from low strength these binders show as well a slow strength development: this is in particular the case for air lime. The reason is that sufficient strength is obtained as a result of the carbonatation reaction (formation of  $\text{CaCO}_3$  from the reaction of  $\text{Ca(OH)}_2$  with  $\text{CO}_2$  from the air); the carbonatation penetrates slowly with time from the surface into the repair material. Measurements in a render (exterior plaster exposed to the weather) have shown penetration depths of 8 mm in 2 months (Waldum 2002) and 5 mm in 4 weeks (Ratcliffe and Orton 1998); obviously, the penetration rate will decrease with depth. From this it can be understood that application of air-lime mortars should be done well before the onset of winter. In early ("air lime") times the application season for lime mortars was between March and October.
