# Fatigue life and damage tolerance of postbuckled composite stiffened structures with indentation damage

Carlos G Dávila<sup>1</sup> and Chiara Bisagni<sup>2</sup>

Journal of Composite Materials

## Abstract

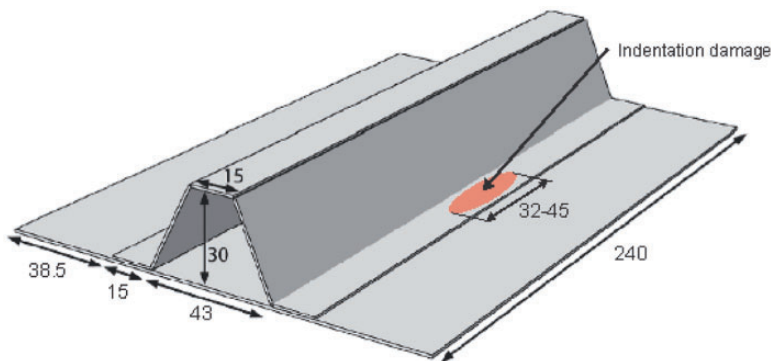
**Figure 1.** Single-stringer compression specimen (all dimensions in millimeter).

The SSC specimen is composed of a skin and a hat-shaped stringer. The dimensions of the test section of the specimen are shown in Figure 1. The skin consists of an eight-ply quasi-isotropic laminate with a stacking sequence of  $[45^\circ/90^\circ/-45^\circ/0^\circ]_S$  and a total thickness of 1 mm. The stringer consists of a seven-ply laminate with a symmetric stacking sequence of  $[-45^\circ/0^\circ/45^\circ/0^\circ/45^\circ/0^\circ/-45^\circ]$ , which results in a nominal thickness of 0.875 mm. The skin and stringer are cocured in an autoclave and the material is IM7/8552 prepreg tape. Tabs for load introduction are potted and machined at the ends of the specimen after the curing cycle. A more detailed description of the SSC specimen can be found in the literature.<sup>12–16</sup>

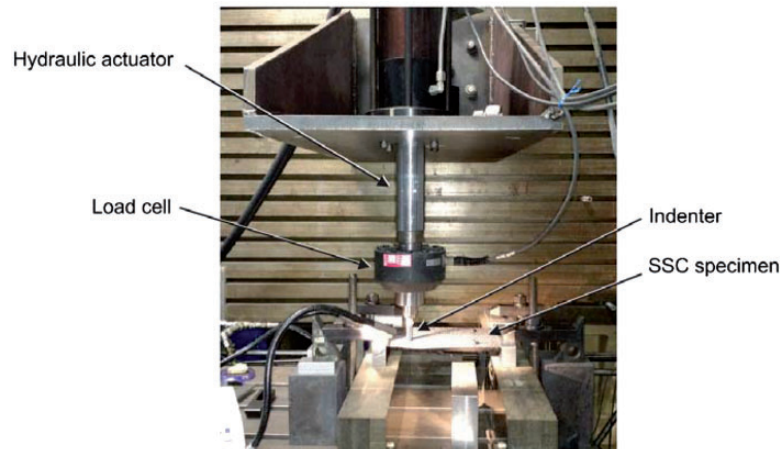
**Figure 2.** Hydraulic indenter used to induce initial damage onto flange of SSC specimens.

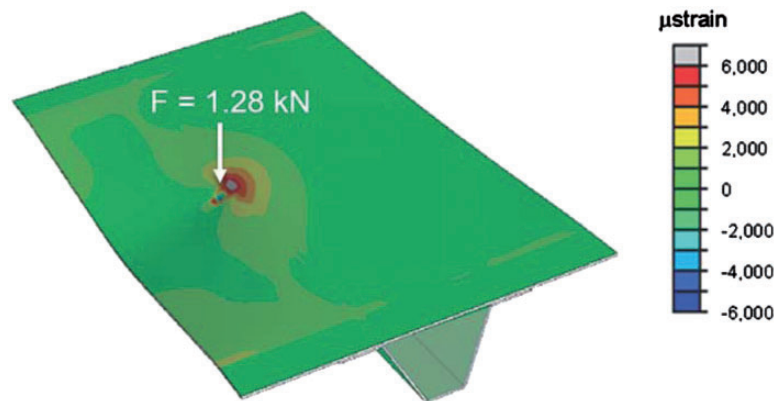
**Figure 3.** Strain plot for finite element damage model of indentation with an applied load of 1.28 kN.

To ensure that the indentation force would not cause damage in locations outside of the indentation zone, a finite element model of the indentation process was constructed using Abaqus/Std v6.14 finite element code.<sup>17</sup> The model of the SSC specimen developed in the previous studies<sup>12,13,16</sup> was used for this investigation. This model consists of two layers of S4R shell elements representing the skin and the stiffener. Wall offsets were applied so that the nodes for both shell layers were coincident in the flange sections of the stringer. The two layers are connected with COH3D8 cohesive elements. The material properties used are listed in Table 1. The analysis results, shown in Figure 3, indicate that at 1.28 kN, the predicted load for initiation of indentation damage, the strains do not exceed 4000  $\mu$ strain anywhere outside of the immediate indentation zone. Since the fiber and matrix strains to

failure for IM7/8553 are greater than 10,000  $\mu$ strain, these results indicate that no damage other than local indentation damage will occur in the panel for loads below 2.8 kN. The analysis was not carried past the damage initiation load because the shell model is inadequate for larger amounts of damage.

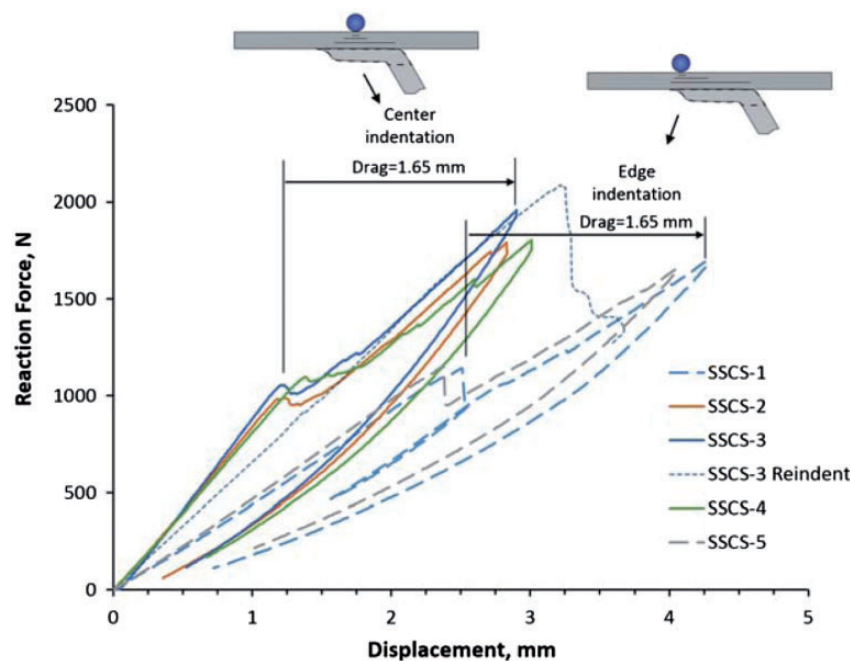
**Figure 4.** Force-displacement curves of indentations performed on specimens SSCS-1–5.

one of two locations: at the center of the flange and at the edge of the flange. The load-displacement responses of the indentation process for all five specimens are shown in Figure 4. Although the center and edge indentation points are only 7 mm apart, the stiffness of the response for center indentations is considerably higher than that for edge indentations, as can be observed in Figure 4.

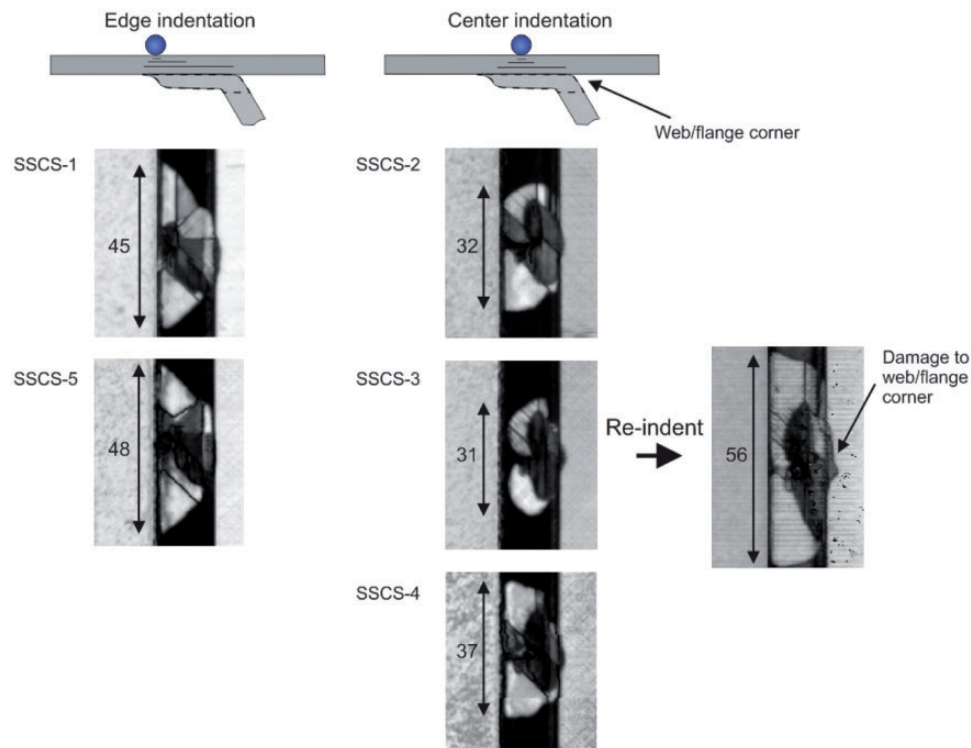
**Figure 5.** UT images of damage induced in specimens SSCS-1–5 by indenting at either the edge or the center of stringer flange. UT: ultrasonic testing.

UT images of the induced indentation damage for the five specimens are shown in Figure 5 with arrows illustrating the damage length in millimeter. An indenter drag of 1.65 mm induced a damage length of approximately 45 mm along the skin-stringer interface for the edge indentations, and approximately

35 mm for the center indentations. The longer damage length for the edge indentations, compared to the center indentations can be observed in Figure 5.

The damage length obtained by indenting SSCS-3 was considered too small for fatigue testing, so it was reindented using the same procedure as for the initial indentation. However, the initial 31 mm damage length grew unstably to 56 mm during reindentation. Additional damage was also observed at the web/flange corner, as called out in Figure 5.

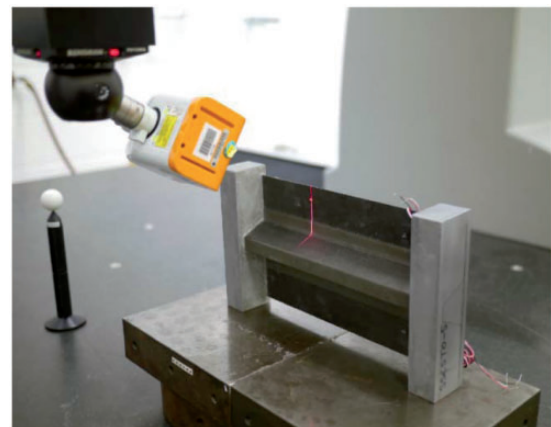
**Figure 6.** Laser scanning of indentation damage with CMM. CMM: coordinate measuring machine.

different postbuckling deformations,<sup>13,14</sup> the flatness of the skin of the specimens after the damage indentation was measured using the VIC-3D digital image correlation system.<sup>18</sup> In order to capture more detail, the depth of the indentation was also measured in a coordinate measuring machine (CMM), as shown in Figure 6. The resolution of the measurements taken with the laser scanning head shown in the figure is approximately 10  $\mu\text{m}$ .

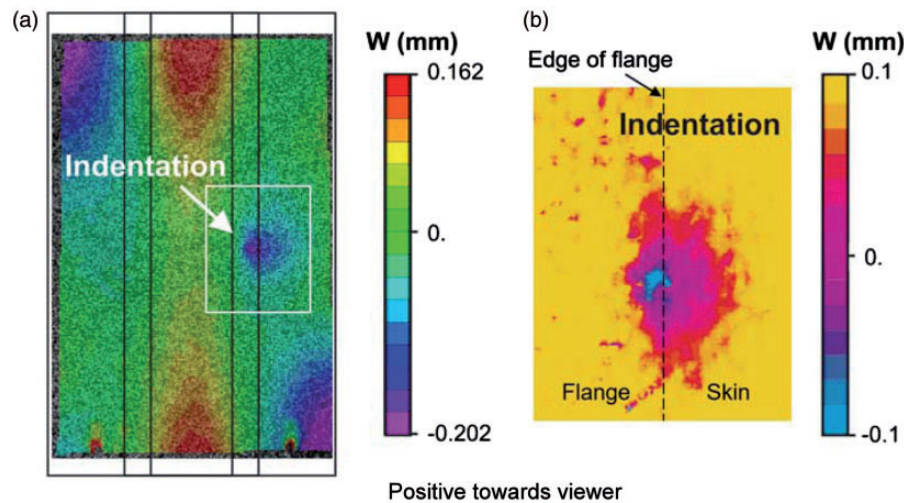
**Figure 7.** Global and local out-of-plane deformation after indentation for specimen SSCS-3. (a) Panel initial imperfection from VIC-3D and (b) local indentation depth measured from CMM. CMM: coordinate measuring machine.

A typical out-of-plane initial deformation of the skin measured with VIC-3D is shown in Figure 7(a). The nonflatness of the skin is mostly due to the residual thermal strains that develop from the curing process. It can also be observed that the panel has a slight twist. The amplitude of the deformations is approximately 0.4 mm, which is 40% of the skin thickness. A typical result from the CMM that provides details for the residual dent depth is shown in Figure 7(b). The residual indentation depth is approximately 0.1 mm.

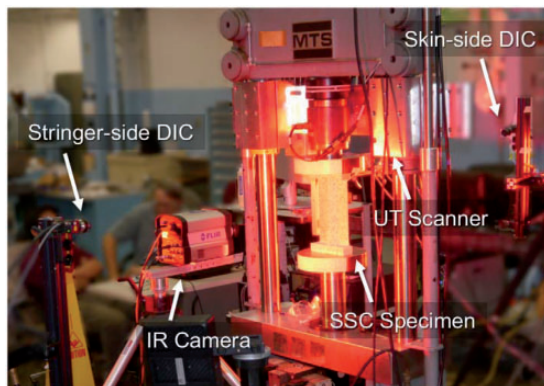
**Figure 8.** SSC specimen, load frame, and test instrumentation.

The tests were conducted using a uniaxial test frame and with instrumentation that allows a precise evaluation of the postbuckling response and damage. The test frame and the instrumentation shown in Figure 8 is the same as used in the previous test campaign conducted on SSC specimens with Teflon films and described in Dávila and Bisagni.<sup>16</sup> The primary instrumentation consists of (i) two three-dimensional digital image correlation (VIC-3D) systems<sup>18</sup> that are used to measure the postbuckling full-field deformations and strains on the skin and stringer sides of the specimen, (ii) an infrared camera for the passive thermal monitoring<sup>19</sup> with a frame rate of 60 Hz that can track the position of a delamination front during fatigue cycling, and (iii) an in situ UT scanner<sup>20</sup> mounted on the load frame which is used to obtain detailed measurements of the damage. The digital image correlation system acquired images at a rate of 0.2 Hz, the infrared camera at 60 Hz,

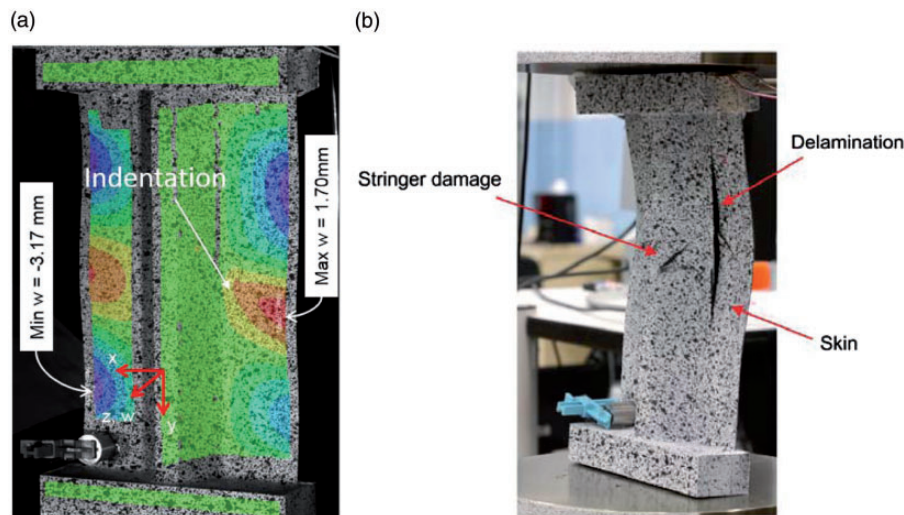
**Figure 10.** Fatigue and posttest assessment of specimen SSCS-1: (a) deformation at 96,000 cycles and (b) after collapse.

An image captured by the digital image correlation system on the skin side of a typical panel (SSCS-1) after 96,000 load cycles is shown in Figure 10(a). When subjected to a load of 31.1 kN, the maximum out-of-plane displacement is equal to 3.42 mm in the direction opposite to the stringer and 1.79 mm in the direction of the stringer. It can be observed that the deformation is similar to that for panel SSCS-2 but of opposite amplitude. Differences in the postbuckling response of two nominally identical specimens are common and attributable to small differences in the initial imperfections of the panels and, possibly, to minute differences in the alignment of the specimen in the test platens. Therefore, it is extremely difficult to predict the mode that will develop in a particular panel.

Specimen SSCS-1 failed suddenly at 117,506 cycles as a consequence of an unstable delamination between the skin and both stringer flanges. The posttest deformation is shown in Figure 10(b), where it can be observed that there is separation at the skin-stringer interface and crippling damage in the stringer.

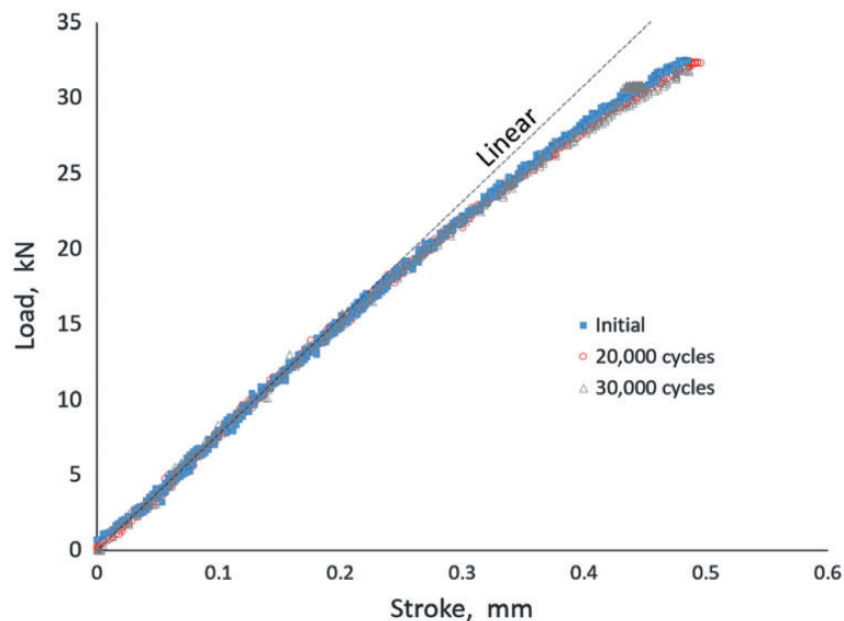
**Figure 11.** Quasi-static load-stroke curves at three stages of the fatigue life of specimen SSCS-5.

Quasi-static load-shortening curves for specimen SSCS-5 are shown in Figure 11, which is representative of what was observed for all specimens. It can be seen that the initial response is nearly identical to that at

20,000 and 30,000 cycles. Clearly, the global response of the SSC specimens retains a constant nonlinearity and is only mildly affected by the progression of fatigue damage. The specimen collapsed at 33,623 cycles.

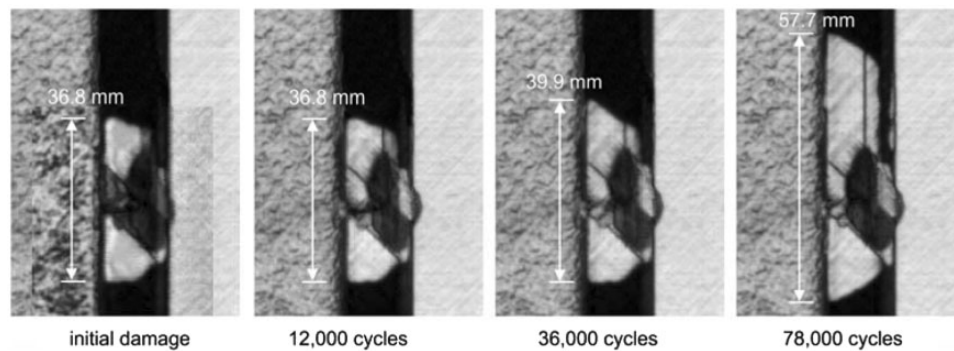
**Figure 12.** UT images showing damage propagation for specimen SSCS-4 at different cycle counts.  
UT: ultrasonic testing.

As was described earlier, the fatigue tests were conducted in stages so that UT scanning of the indented area of the panel could be performed at regular intervals. To illustrate the typical propagation of damage, a sequence of images for SSCS-4 obtained by the UT scans immediately after indentation and at 12,000, 36,000, and 78,000 cycles are shown in Figure 12. The

images show an extension of the initial skin-stringer separation along the length of the specimen. Collapse of the specimen occurred at cycle 78,135, shortly after the last image was taken.

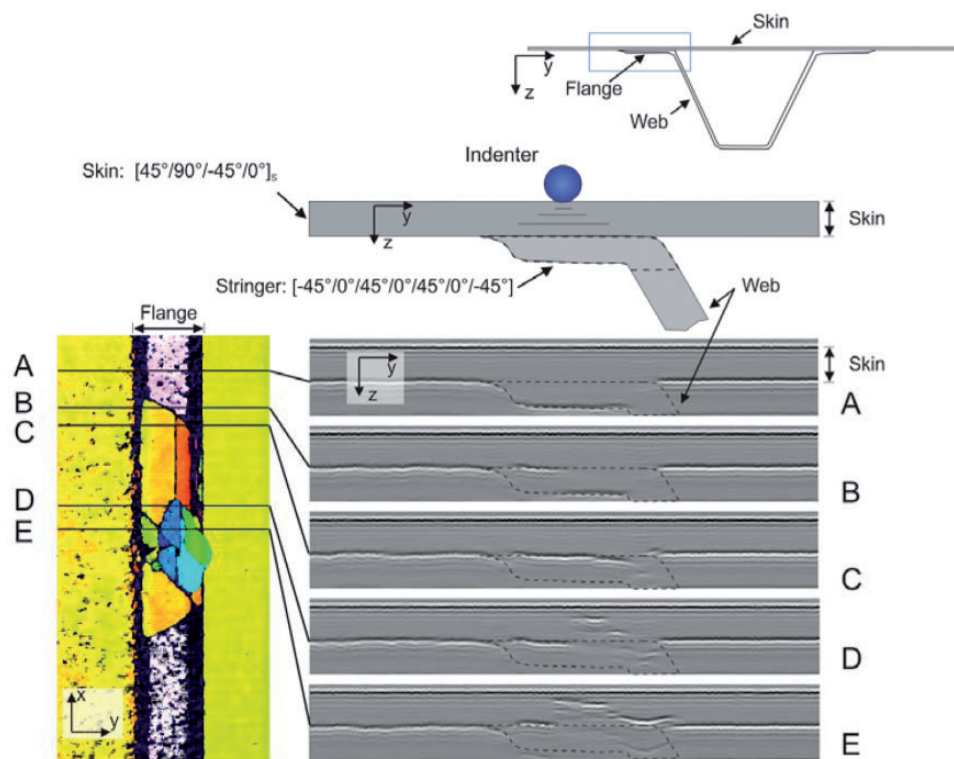
**Figure 13.** UT images using "time-of-flight" processing for depth location of delaminations (SSCS-4).  
UT: ultrasonic testing.

To examine the morphology of the damage, the UT scan of specimen SSCS-4 at 78,000 cycles was processed and colorized according to “time of flight” (TOF). TOF is the delay between the emitted ultrasonic sound wave and the reflected echo, which is a relative measure of the depth of the surface closest to the probe. The resulting image, shown in Figure 13, identifies the

depth of the various delaminations. Five cross-sections of the skin and stringer flange are examined. The results indicate that only two delaminations propagate during cyclic loading and that both delaminations propagate together: one interface is at the skin-stringer interface, and the other one is one-ply deep into the stringer flange, at the  $-45/0$  interface. The smaller delaminations in the skin do not appear to grow under fatigue.

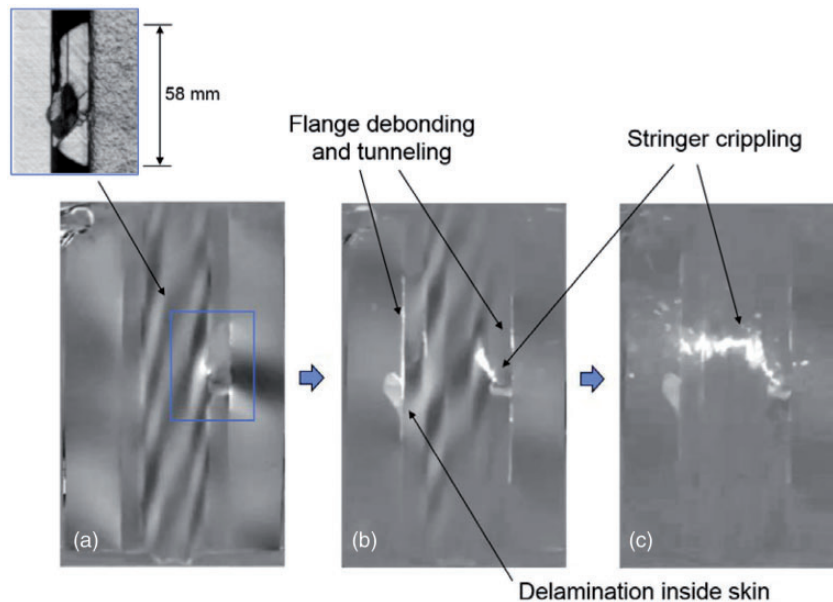
**Figure 14.** Infrared images illustrating sequence of collapse (SSCS-4). (a) Delamination reaches critical size, (b) unstable tunneling, and (c) stringer crippling.

loading, it was found to be particularly capable for capturing the sequence of damage events that occur during collapse. The sequence of three infrared images shown in Figure 14 illustrates the collapse of specimen SSCS-4 after 78,135 cycles. The heating, represented by lighter regions of the image, can be seen at the strain gauges and along the delamination front at the skin-stringer interface. The postbuckling deformation of the stringer appears as oblique lines in Figure 14(a). A faint outline of the damage at the skin-stringer interface can also be observed. A UT

image of the damage zone recorded after 78,000 cycles is shown for comparison, and the area of the UT scan is highlighted with the blue rectangle in Figure 14(a). Note that the thermal image was captured from the stringer side of the specimen, while the UT scans were performed from the skin side of the specimen. Therefore, the UT image was flipped horizontally to match the orientation of the infrared image.

The images in Figure 14(b) and (c) indicate that the collapse of the specimen, which occurs in about 1/60th of a second, consists of debonding of both flanges of the stringer, followed by the crippling failure of the stringer. In addition, a delamination internal to the skin grew in the region of the flange opposite to the initial indentation damage during the final instances of the collapse.

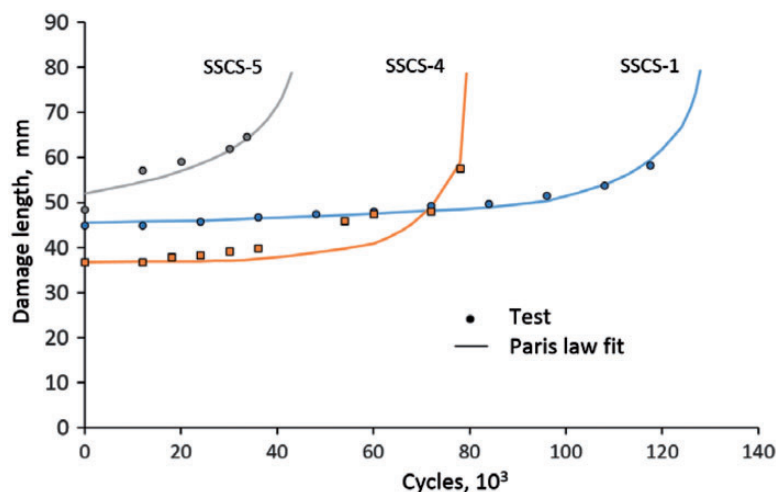
**Figure 15.** Damage length as a function of loading cycles for specimens SSCS-1, SSCS-4, and SSCS-5.

The results of the fatigue damage propagation are illustrated in Figure 15, where the experimental results are represented by symbols, and the lines correspond to the damage lengths calculated with the Paris law. Two values of  $C$  were determined by curve fitting: one for edge indentation and a different one for center indentation:  $C_{\text{Edge}} = 1 \times 10^{-36}$  and  $C_{\text{Center}} = 50 \times 10^{-36}$ . For simplicity, the exponent  $m = 14.9$  was kept the same for both types of indentations.

As can be observed in Figure 15, a single set of Paris law parameters provides a good fit to both specimens

with edge indentation (SSCS-1 and SSCS-5). This indicates that similar propagation laws characterize the damage growth in both specimens in spite of the differences in initial damage size and cyclic load. It is also apparent that the rate of propagation for center indentation (SSCS-4) is about 50 times higher than for edge indentation, perhaps because center indentation causes more damage toward the highly loaded web/flange corner than edge indentation.

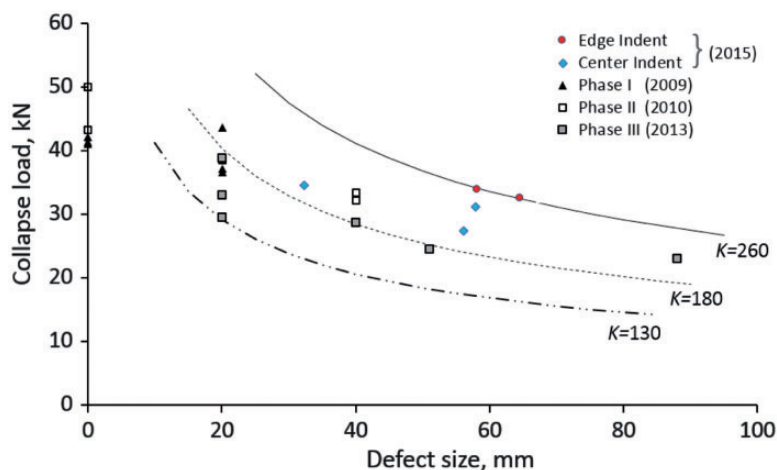
**Figure 16.** Effect of defect size on collapse load of SSC specimens.

a critical load that causes a collapse of a SSC specimen. The collapse load as a function of defect size is shown in Figure 16. In addition to the results from the phase IV test campaign, results from the three previous experimental phases<sup>12,14,16</sup> are included. For quasi-static tests, the defect size is the initial defect size, and for fatigue tests, the defect size is the damage length at the moment of collapse. The damage length at the moment of collapse is estimated by adding an incremental extension of the damage length calculated from the Paris Law equations determined above to the last measured damage length.

Following the concept used in the previous section, it may be useful to compare the results of different tests according to the stress intensity measure. Using Figure 16, it can be observed that the edge indentation specimens collapsed at approximately  $K = 260 \text{ kN} \times \text{mm}^{0.5}$ . The center indentation specimens failed within the range  $196 \leq K \leq 237 \text{ kN} \times \text{mm}^{0.5}$ . It appears that specimens from previous test campaigns failed at lower values of  $K$ , which indicates that indentation damage may be less severe than a Teflon insert of the same size. A number of additional contributing factors that deserve the attention of future work, such as the shape of the postbuckling deformation, also contribute to the damage tolerance of a postbuckled panel. Therefore, the proposed classification of the collapse strength of similar specimens according to their stress intensity measure provides a useful means to assess different aspects of the response on the damage tolerance of stiffened structures with defects.
