# Methodology for the prediction of the strength of naturally aged glass based on surface flaw characterization

to obtain the degree of Master of Science in Civil Engineering  
at the Delft University of Technology,  
to be defended publicly on Friday September 30, 2022 at 14:00.

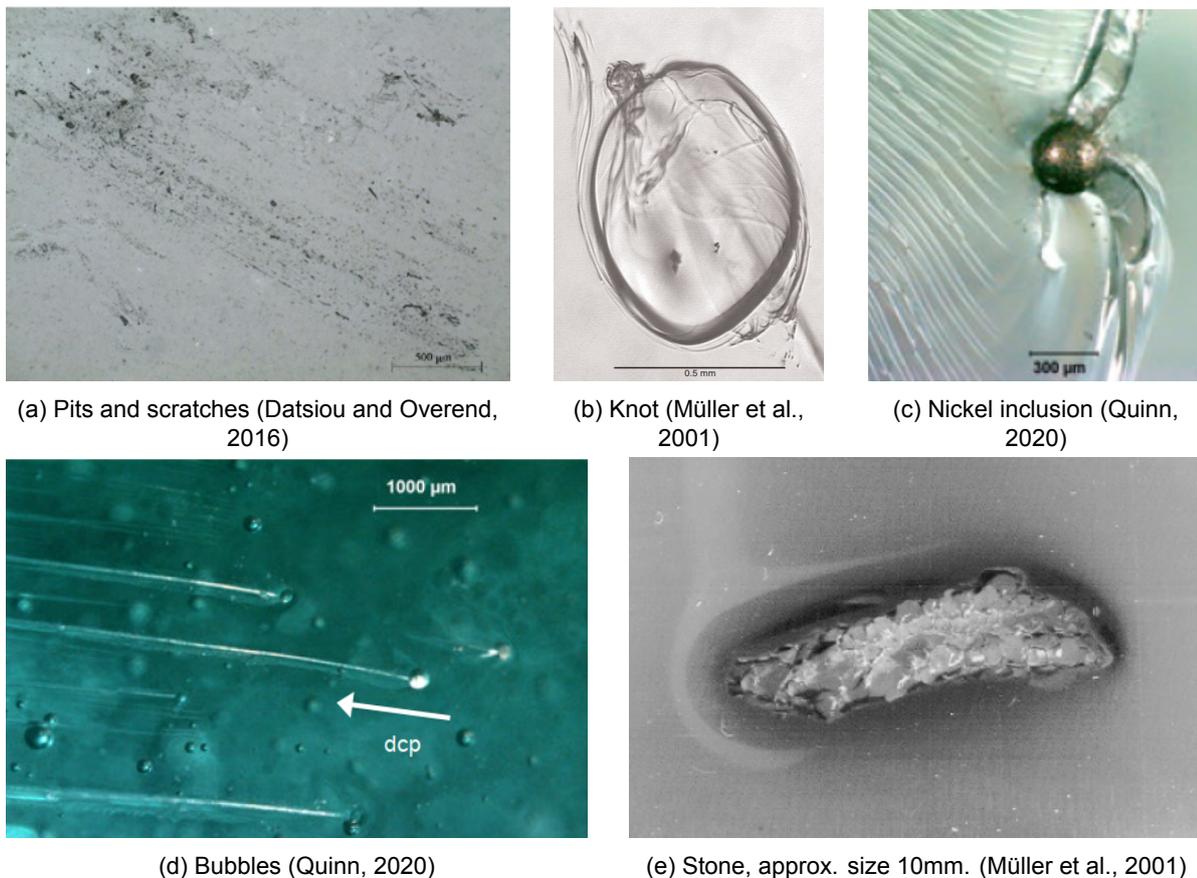
Figure 3.1: Images of several types of defects in glass.

Figure 3.1 illustrates several volume and surface defects of glass, as they were identified under observations with microscopes by several researchers.

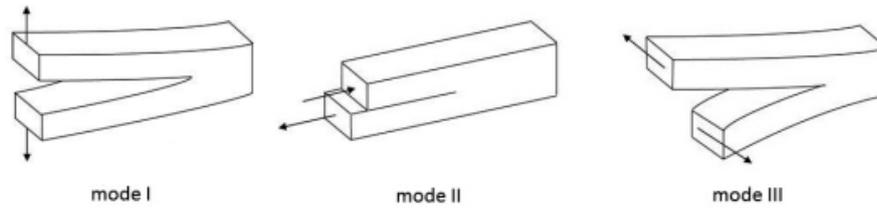
Figure 3.2: Three failure modes, mode I (opening mode), mode II (sliding mode) and mode III (tearing mode) (LINDQVIST, 2013).

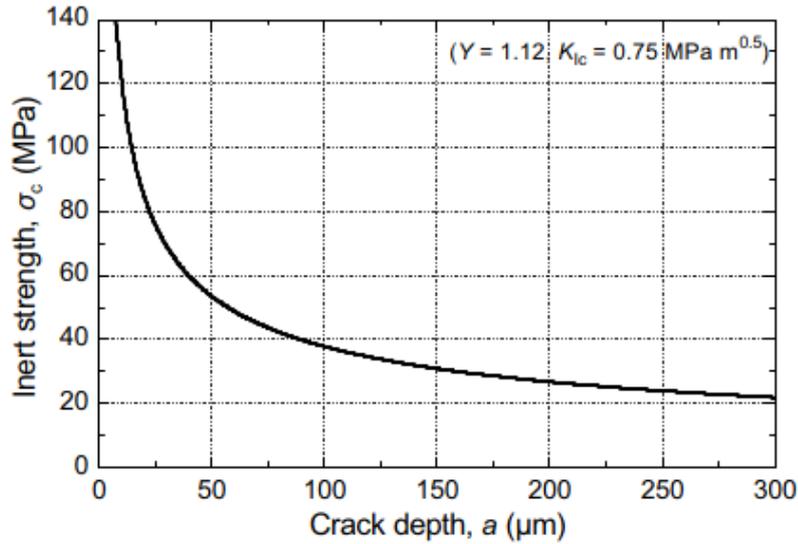
Figure 3.3: Inert strength of a single crack as a function of its depth by Haldimann, 2006.

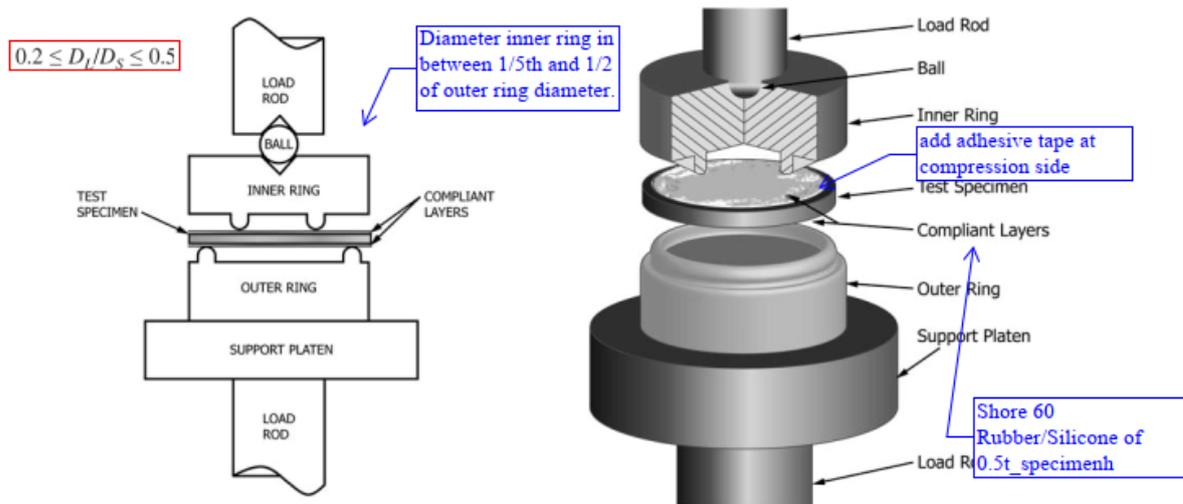
Figure 3.4: Section View and Perspective View of Basic Fixturing and Test Specimen for Equibiaxial Testing (ASTMC1499-09, 2013).

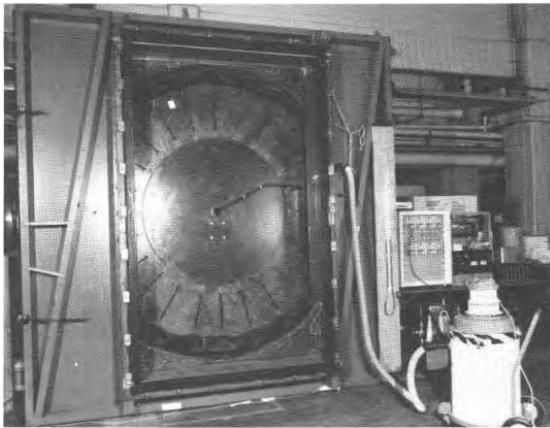
Figure 3.5: Front view of dynamic glass testing rig showing the 2.35m diameter piston behind the opening where the glass will be installed (Dalgliesh and Taylor, 1990).

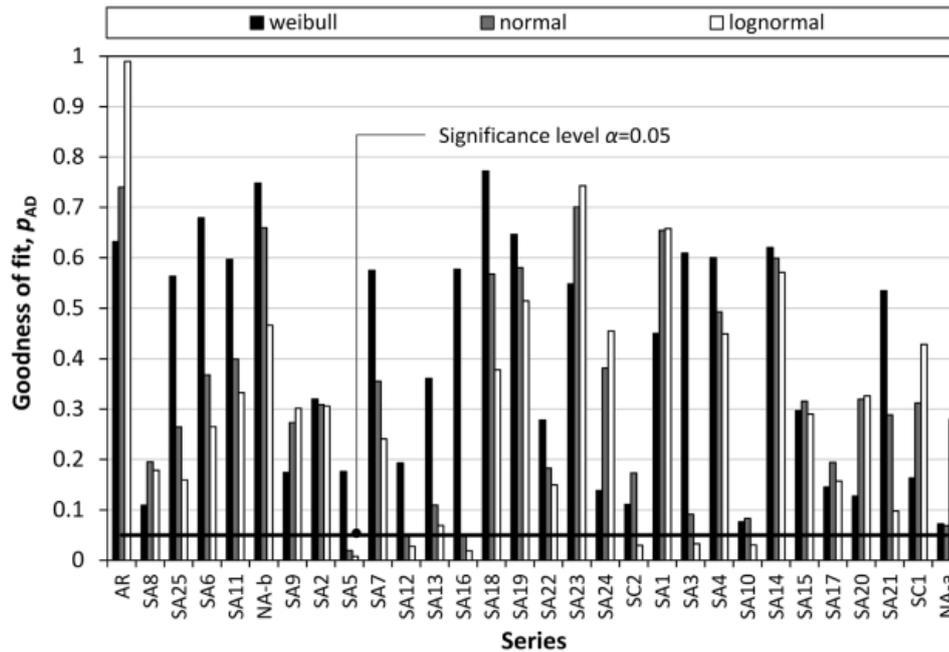
Figure 3.7: Goodness of fit for all data series fitted to a Weibull, a Normal and a Lognormal distribution (Datsiou and Overend, 2018).

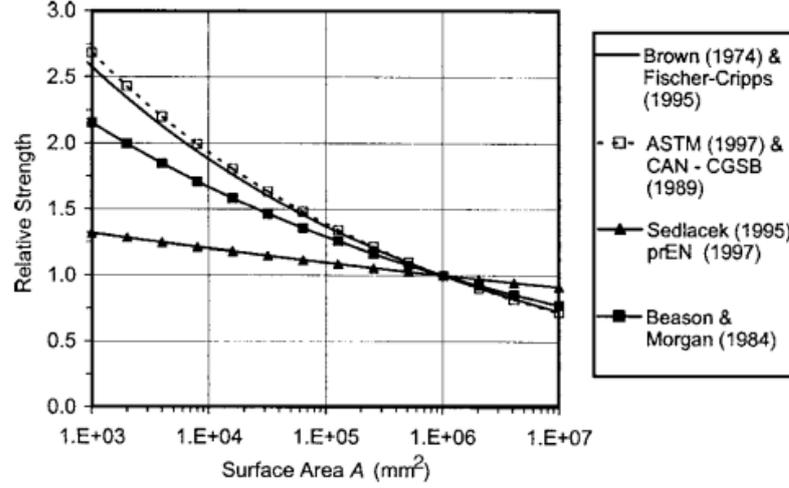
Figure 3.8: Relative strength of annealed glass with variation in surface area (dotted lines represent weathered glass) from Overend et al. (2007).

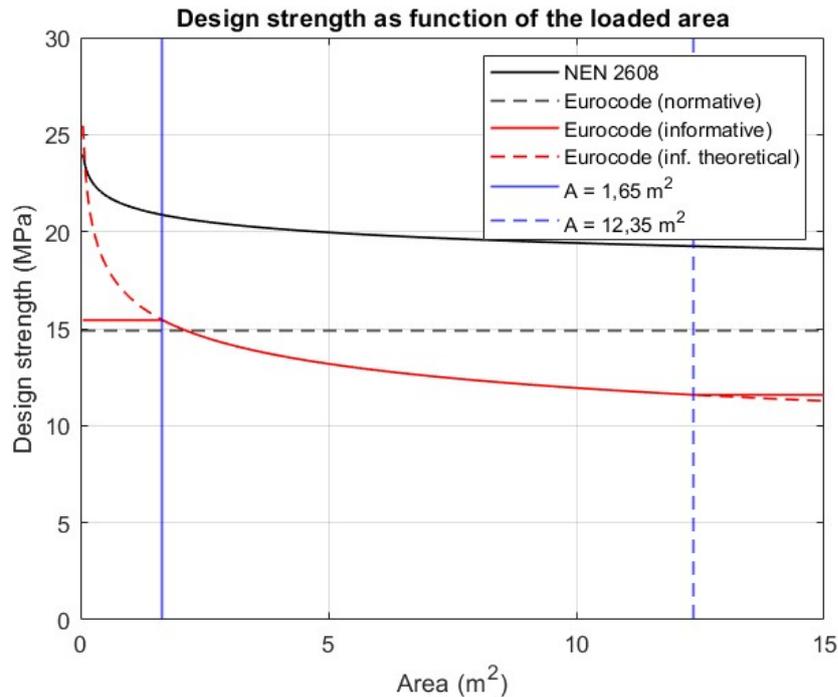
Figure 3.9: Design strength as a function of the loaded area, according to the European and Dutch standards, for a four-sided supported plate under wind load with duration 5 seconds (For annealed float glass with as cut edges).

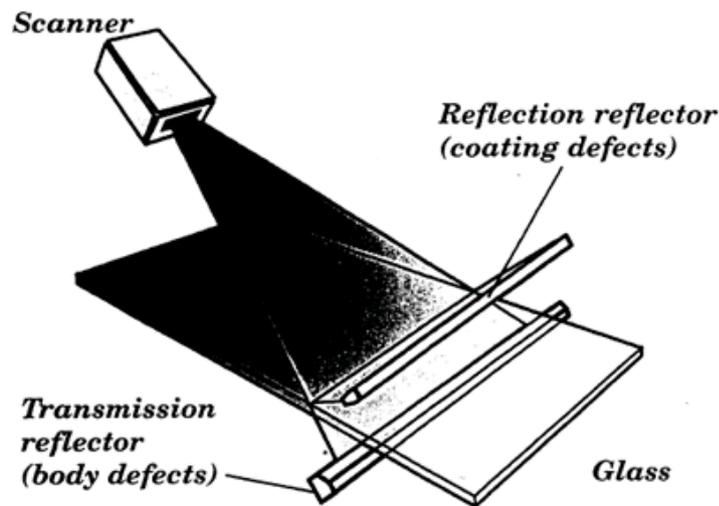
Figure 3.10: Configuration of retroreflective scanner for simultaneous detection of body glass defects and coating defects (Holmes, 1997).

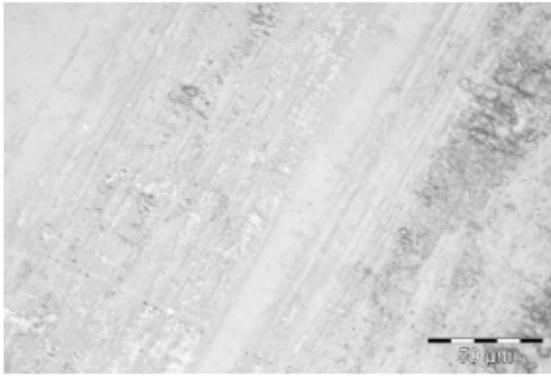
Figure 3.11: Optical microscope image of the external surface of weathered glass (Zammit and Overend, 2010).

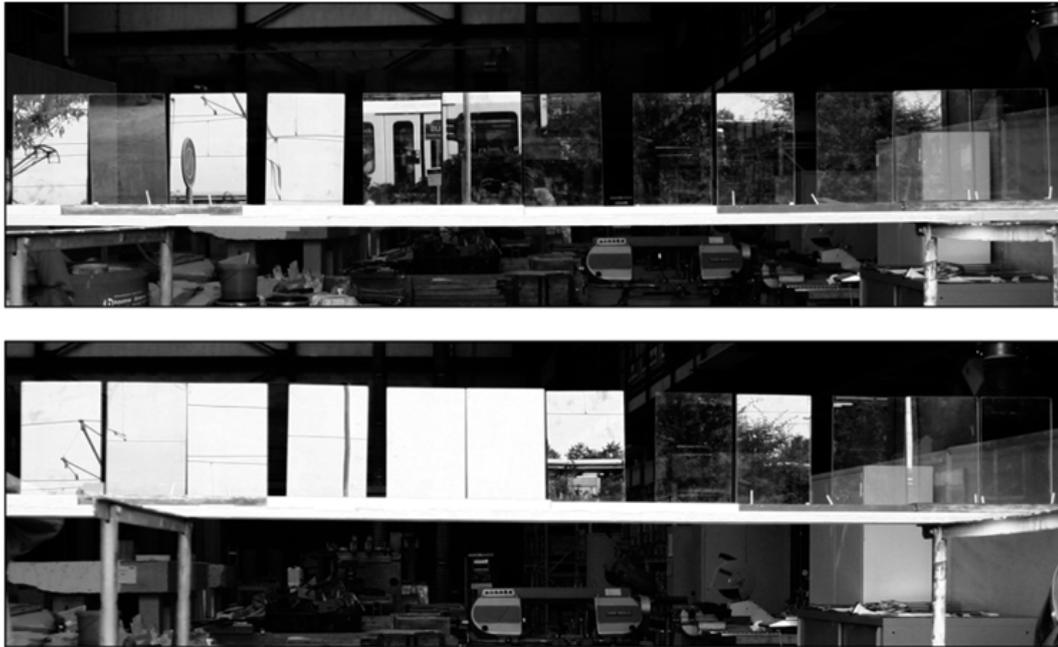
Figure 3.13: The influence of the viewpoint on visual detectability: inwards view, high viewpoint (top); inwards view, low viewpoint (bottom) (Haldimann, 2006).

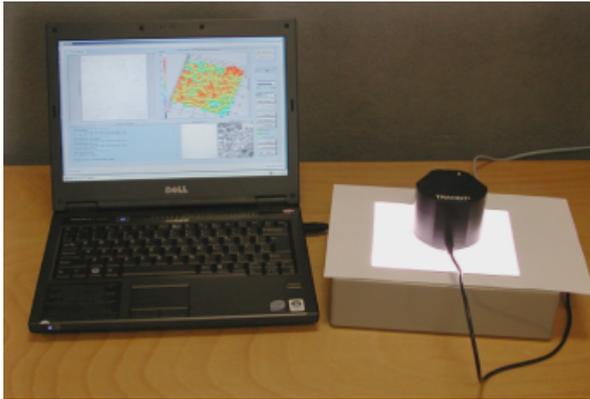
Figure 3.16: Traceit<sup>®</sup> mobile 3D profilometer (Innowep GmbH, n.d.).

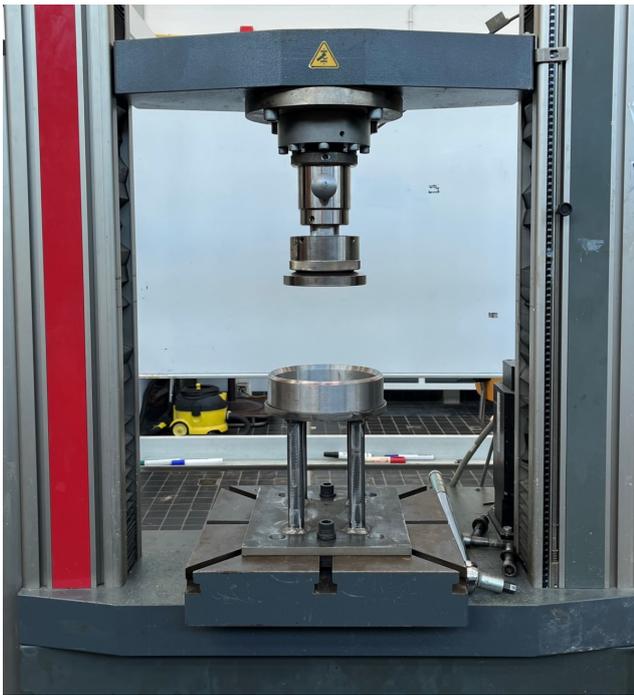
Figure 4.10: Materials testing machine Zwick Z100 at the Faculty of 3ME, TU Delft.

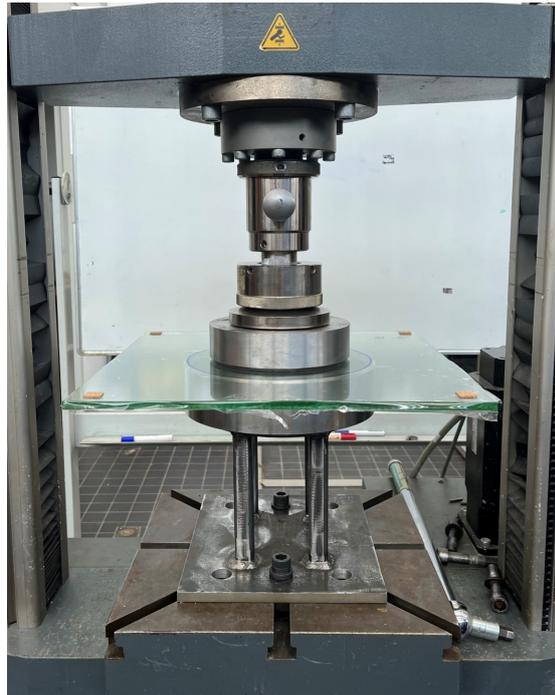
Figure 4.11: Experimental setup for the CDR tests on the large specimens.

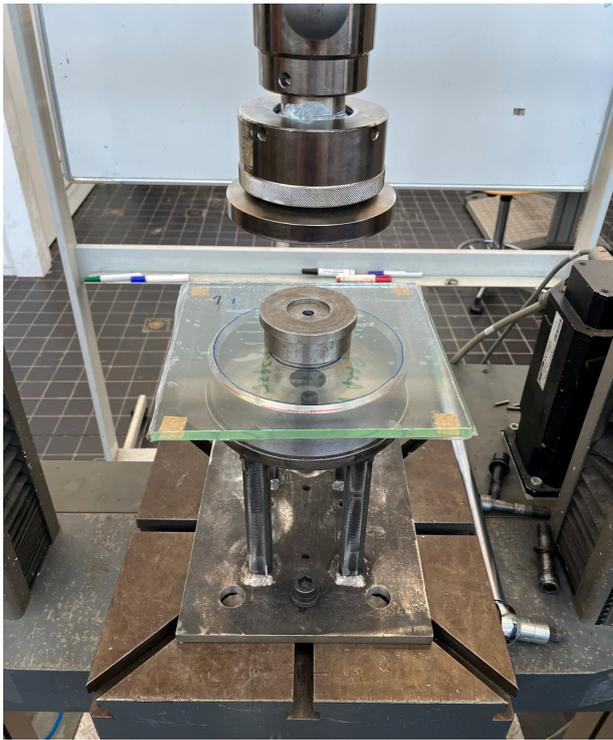
Figure 4.12: Experimental setup for the CDR tests on the small specimens.

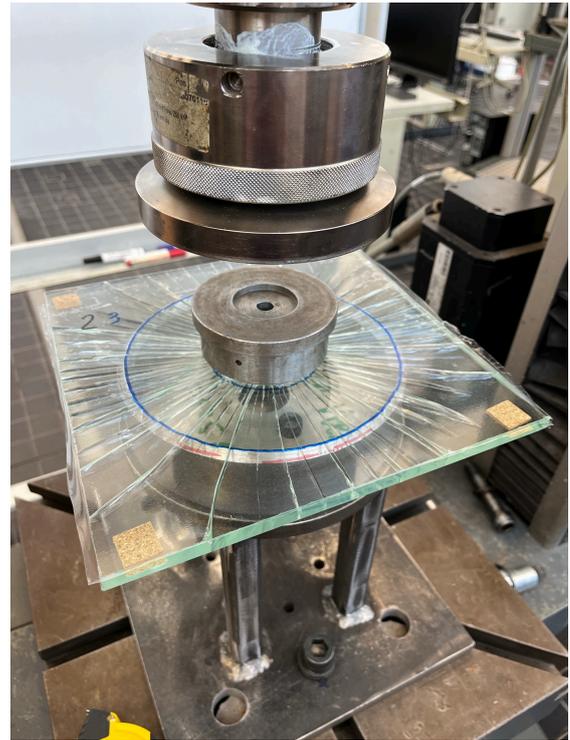
Figure 4.13: Small specimen after fracture in a CDR setup.

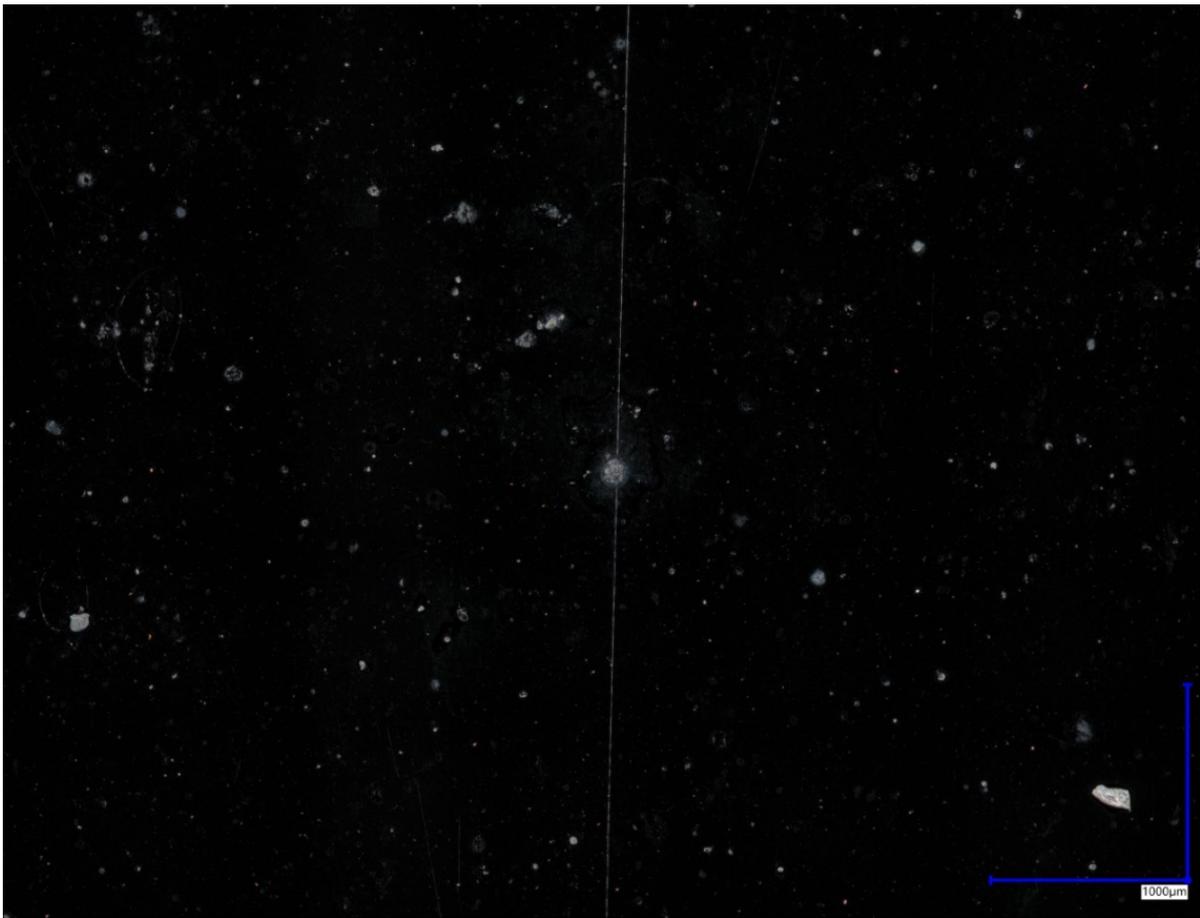
Figure 4.14: Micrograph of the 50-year-old tested glass, taken with the Keyence VHX7000.

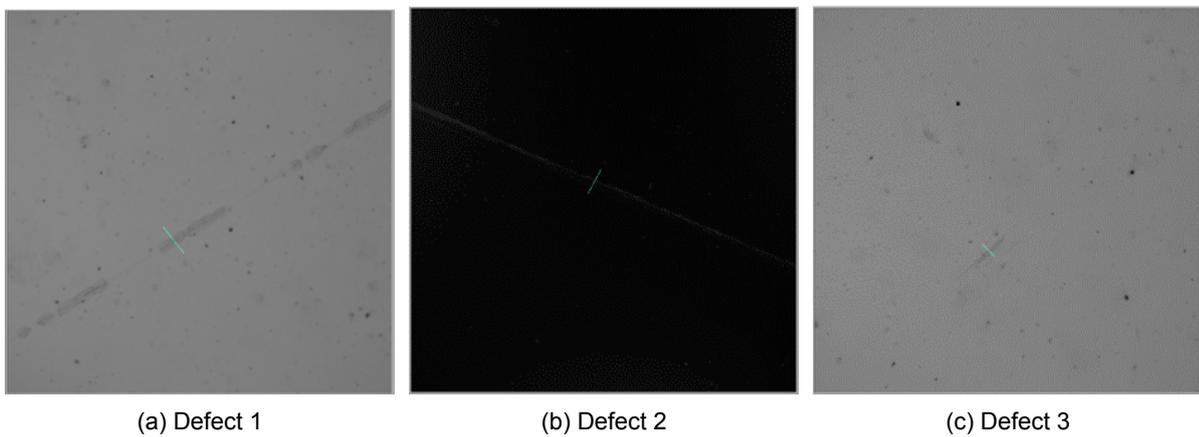
Figure 4.21: The three examined defects on the same specimen, as captured by Traceit®. The green line indicates the location of the measurement along the defects.

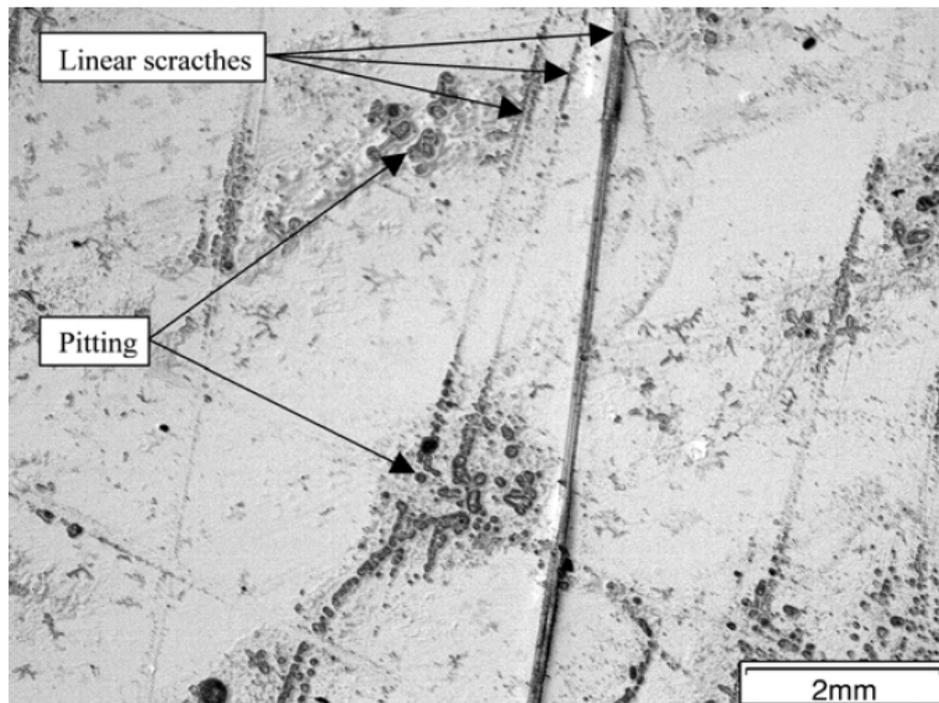
Figure 4.22: Micrograph of 20-year-old weathered float glass. (Overend and Zammit, 2012).

Images of the naturally aged surface of glass are rarely found in the existing literature. An example of such image, namely a micrograph of a 20-year-old weathered float glass, is presented in Figure 4.22.

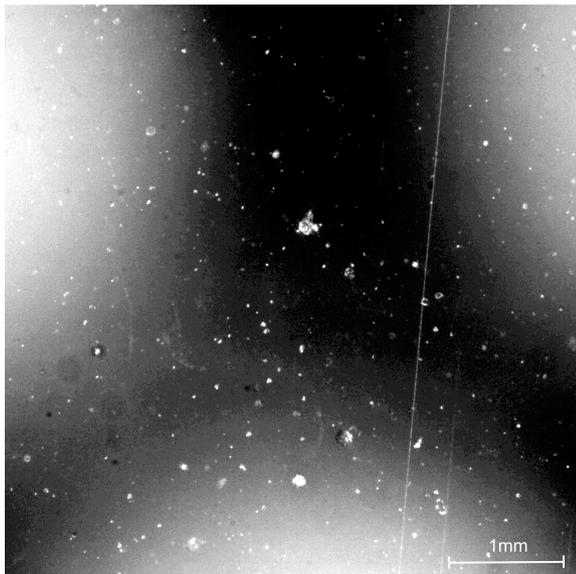
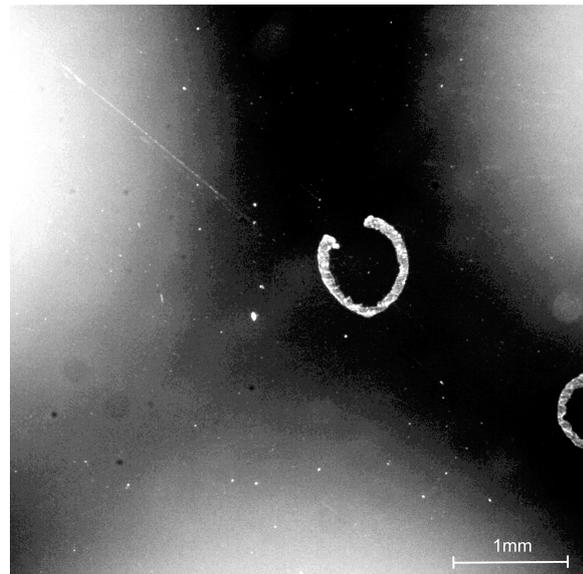
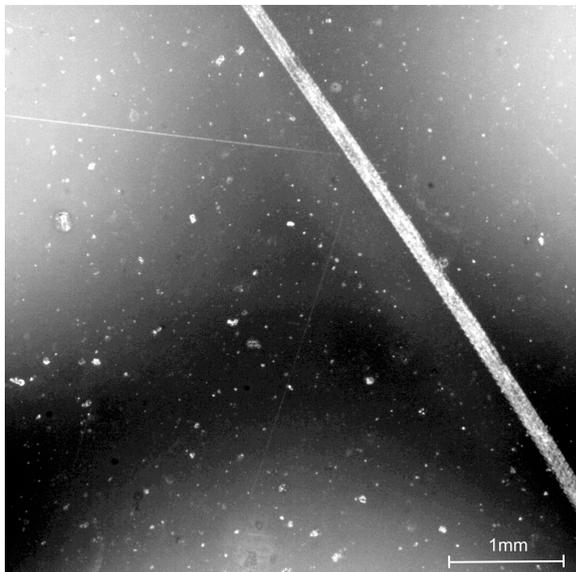
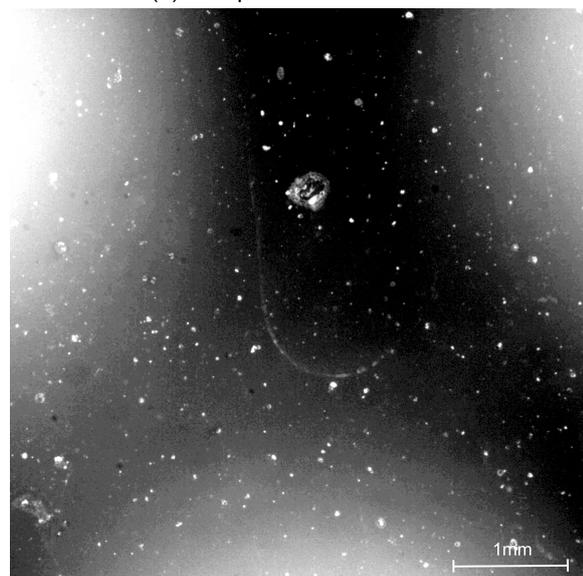
(a) Type of damage on most of the specimens.

(b) Damage on the internal surface of glass.

(c) Thick scratch on the external side.

(f) "Dig" type defect.

Figure 4.23: Images of several types of defects as captured with Traceit<sup>®</sup>, after processing. The images show an area of 5mm by 5mm of the glass specimens.

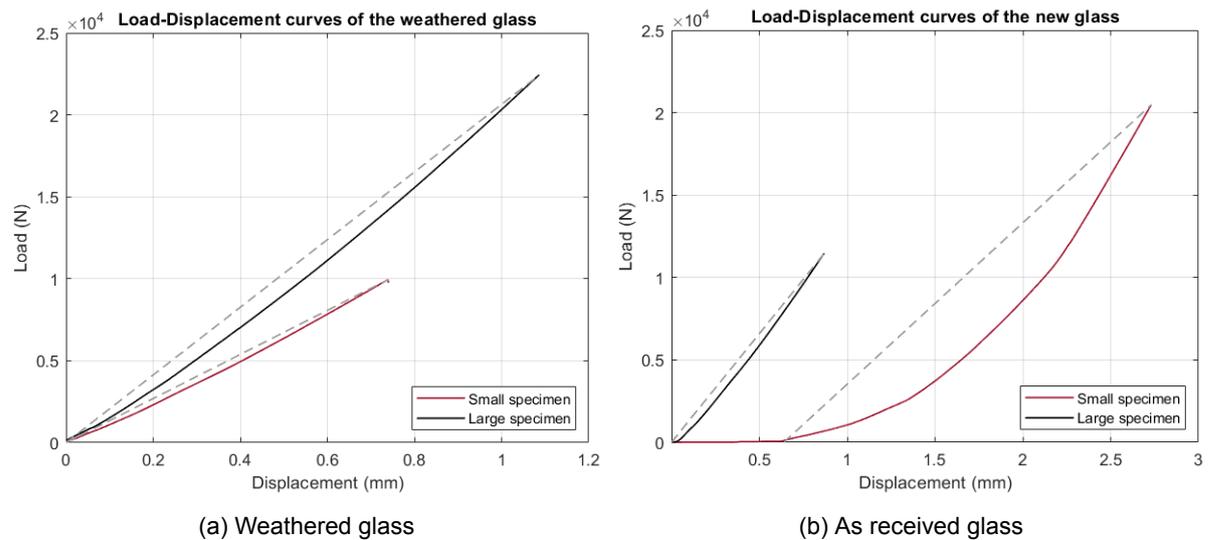
Figure 4.24: Force-Displacement curves of the tested specimens

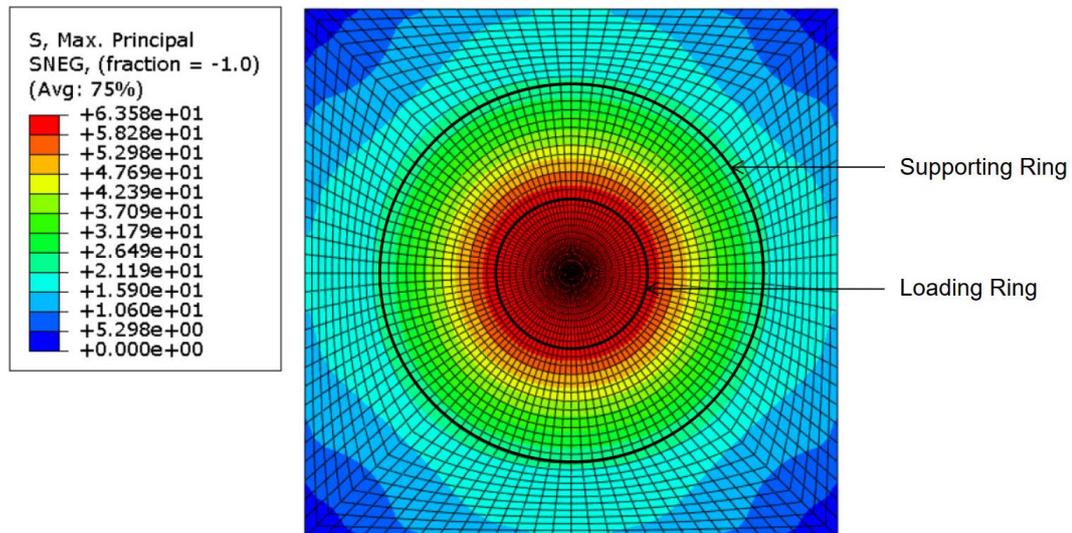
Figure 4.25: Finite element model of the small specimens in Abaqus SIMULIA (2022).

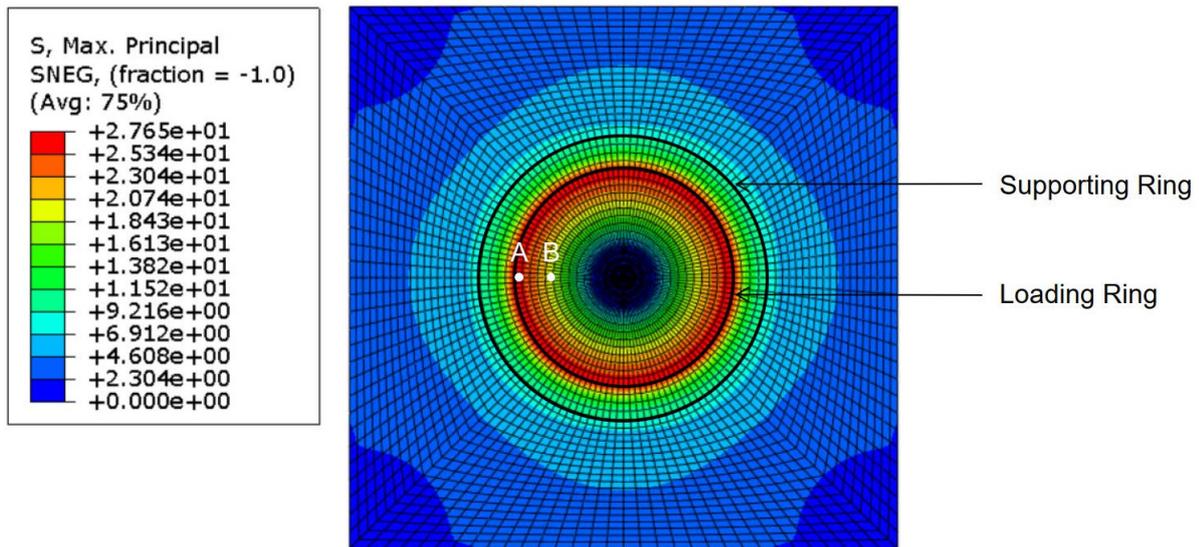
Figure 4.26: Finite element model of the large specimens in Abaqus SIMULIA (2022).

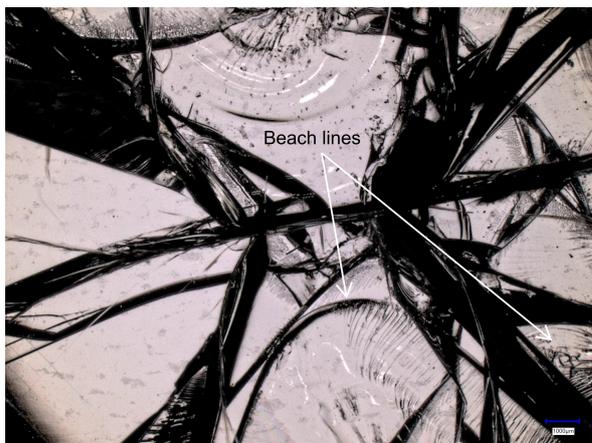
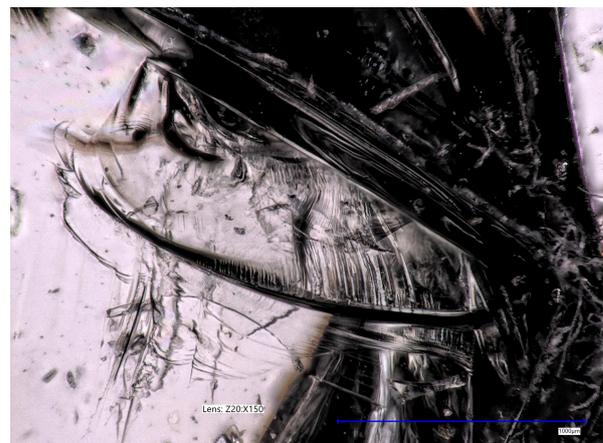
(a) "Beach marks" at magnification x20.

(b) "Beach marks" at magnification x150.

Figure 4.31: Microscopic images of "beach marks", below the surface of glass

Finally, signs like "beach marks" were found in all the fracture patterns, as illustrated in Figure 4.31. These lines indicate the 3D nature of the crack propagation since this phenomenon was observed at levels below the surface of glass. Therefore, such a crack below the surface could also be the reason for the fracture of the specimen 1.1 at that location or for the fracture of the specimens with no visible defects.

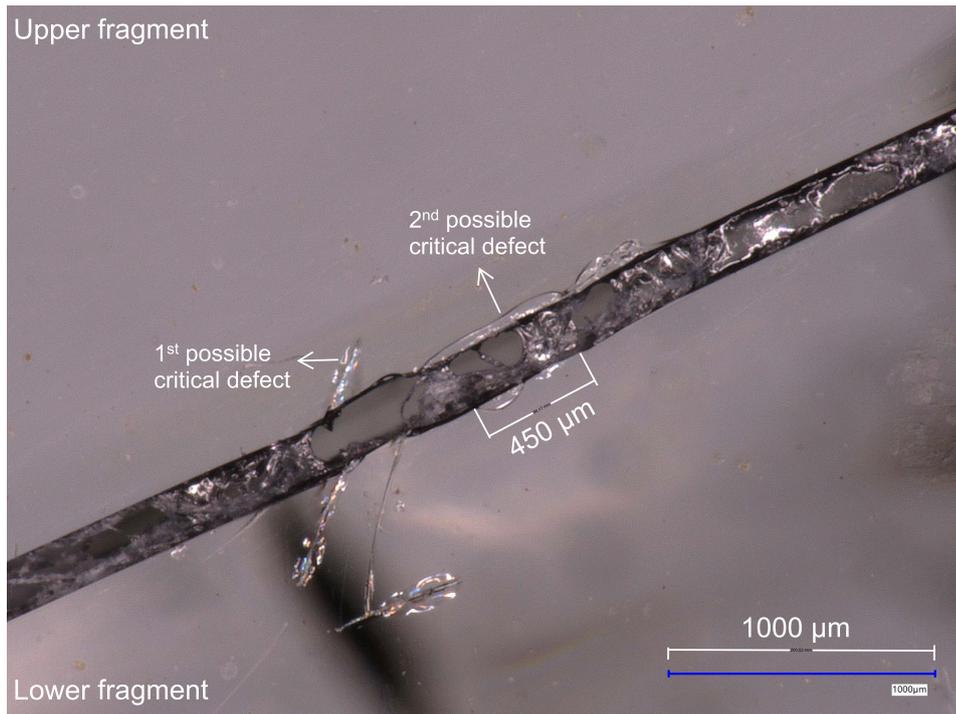
Figure 4.33: Critical defect of the specimen of series NA-1a which failed at the lower stress ( $\sigma_f=37,1$  MPa).

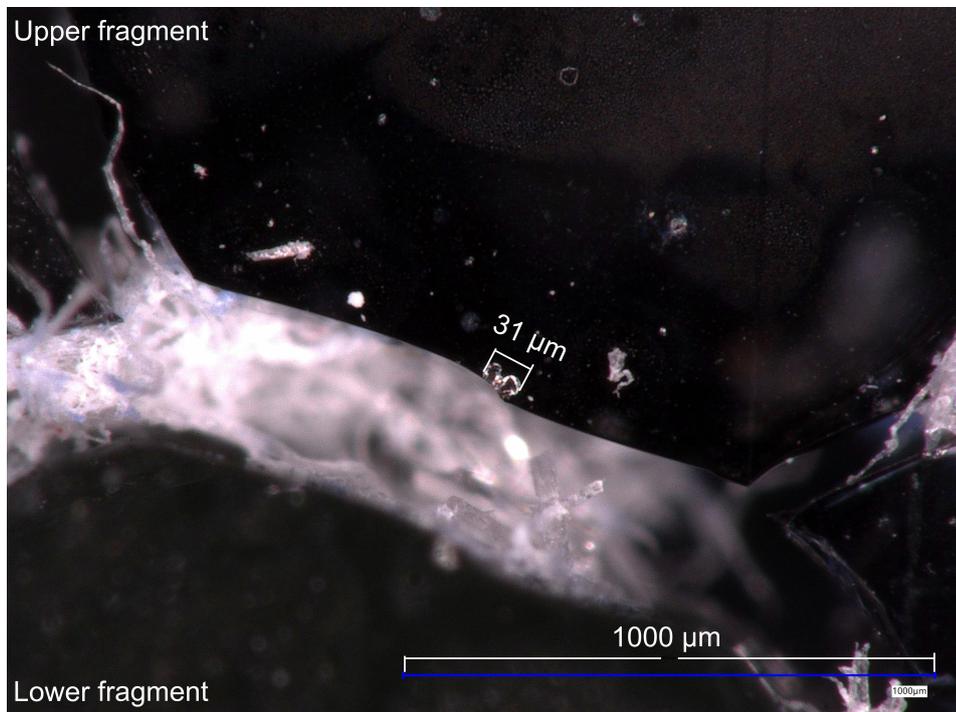
Figure 4.34: Critical defect of the specimen of series NA-1a which failed at the highest stress ( $\sigma_f=88,9$  MPa).

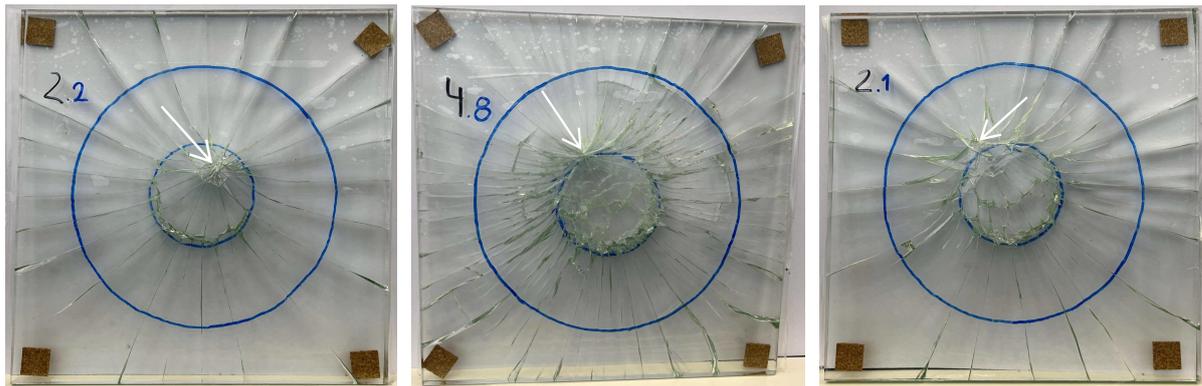
Figure 5.1: Examples of specimens which broke inside, just below and outside the loading ring.

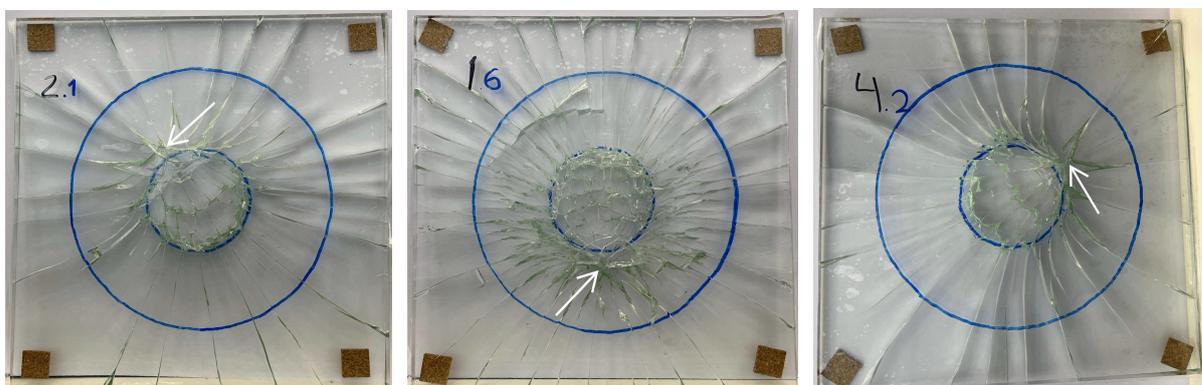
Figure 5.2: Examples of specimens which broke outside the loading ring - invalid tests.

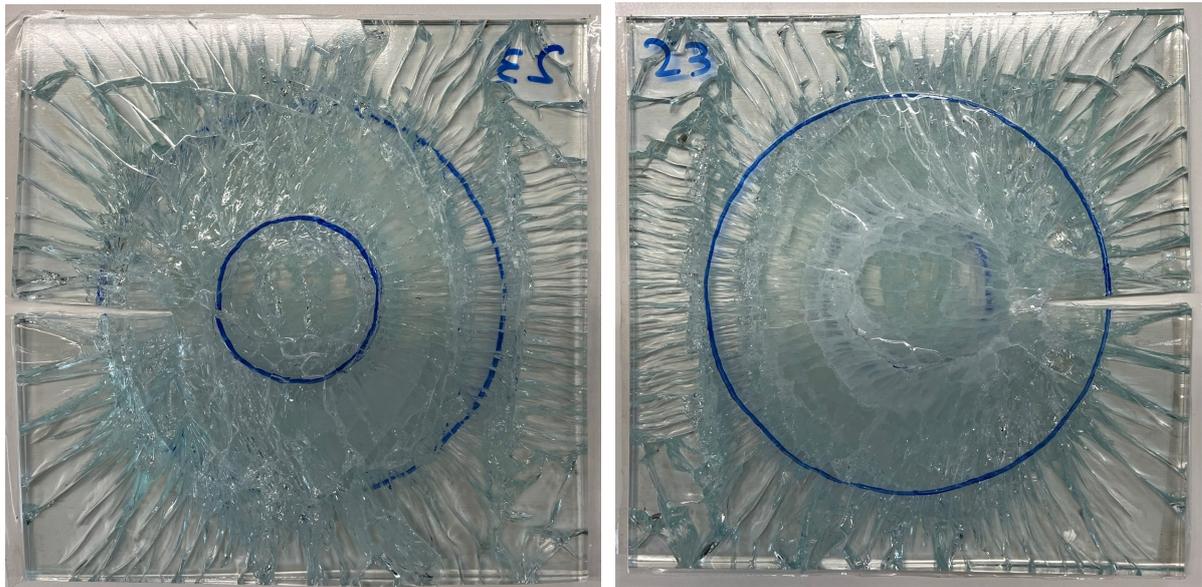
Figure 5.4: Specimen with not detectable fracture origin ( $F_{break}=36960\text{N}$ ).

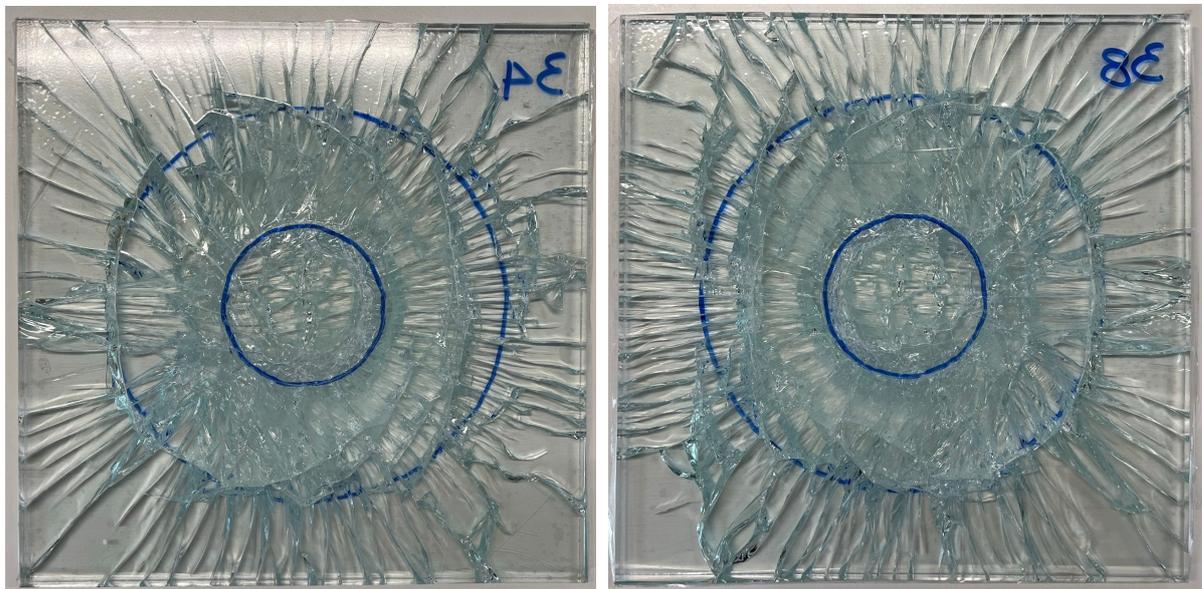
Figure 5.5: Specimens with probably more than one fracture origins ( $F_{break}=27080\text{N}$  and  $30047\text{N}$ , respectively).

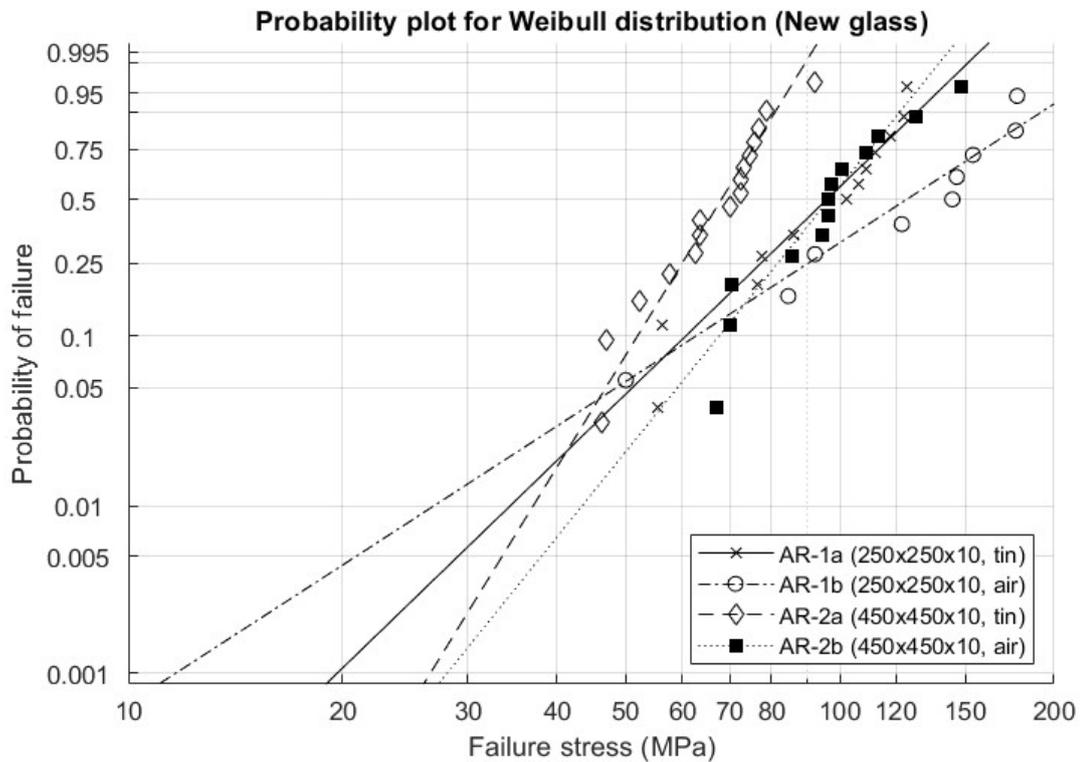
Figure 5.7: Normalised strength data of as received glass fitted to the Weibull probability distribution function.

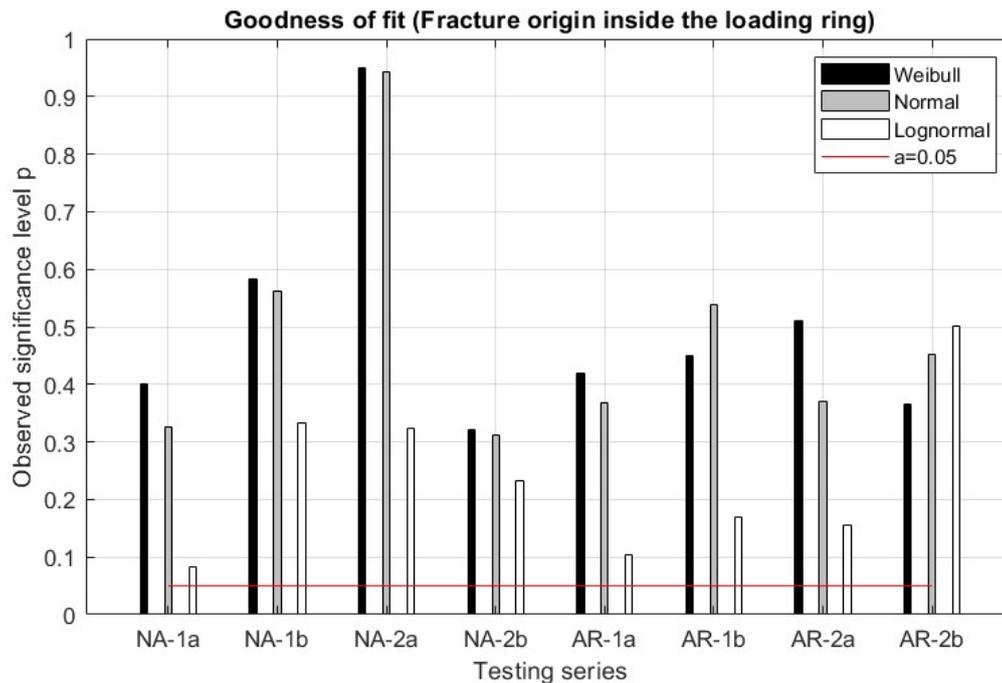
Figure 5.8: Goodness of fit of the test data to the three probability distributions, compared to the chosen level of significance  $\alpha=0,05$ .

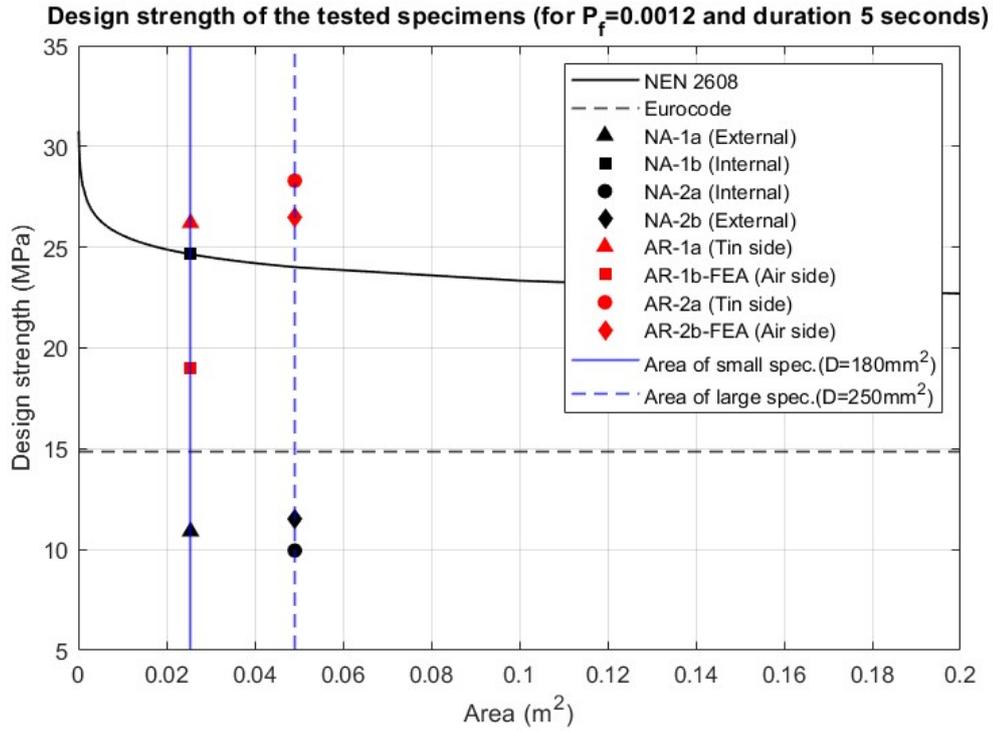
Figure 5.17: Theoretical design strength and design strength according to EN1990:2002 (2005) of the tested specimens (for  $P_f=0,0012$  and load duration 5 seconds).

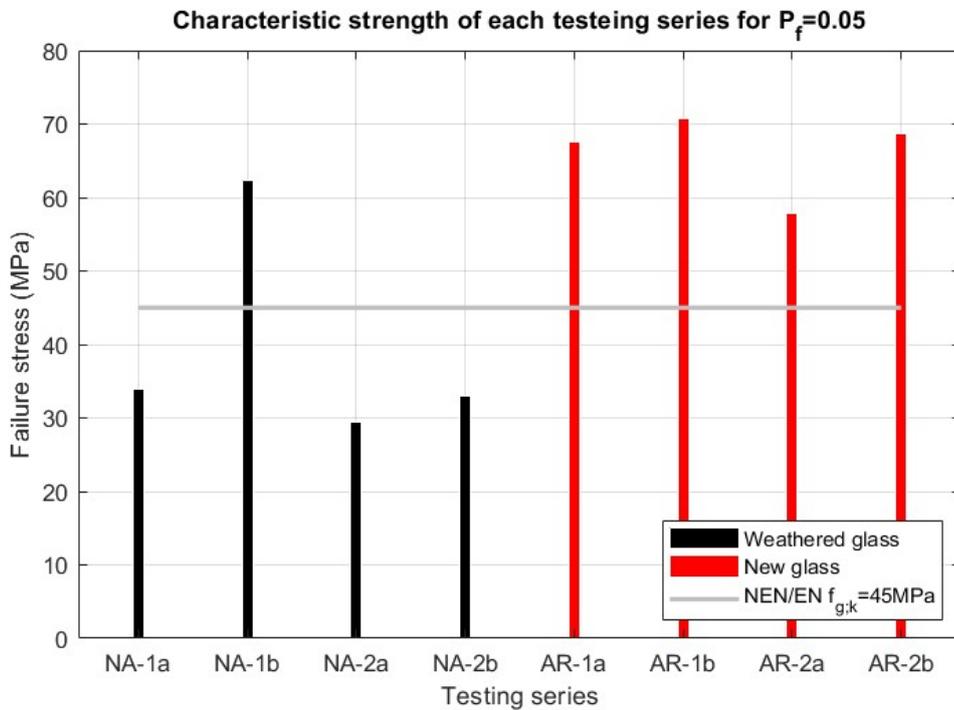
Figure 5.18: Theoretical and experimental characteristic strength of the tested specimens (for  $P_f=0,05$ ).

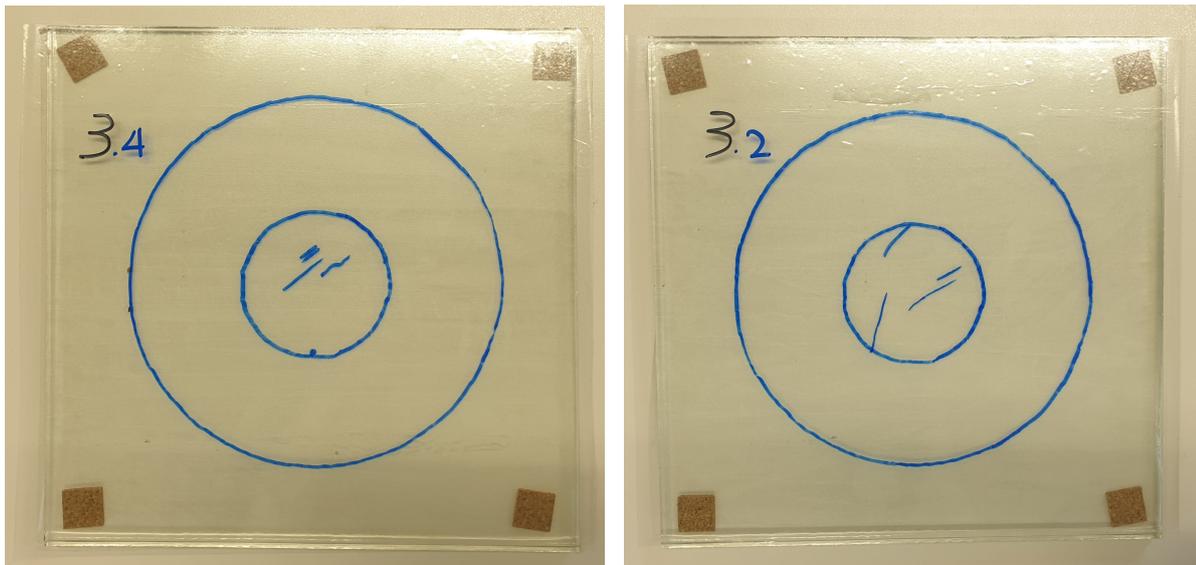
Figure 6.1: Specimens with the deepest defects marked on their surface.

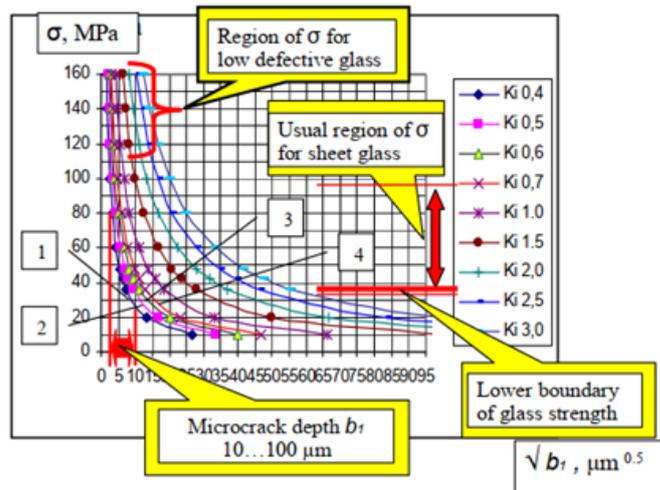
Figure 6.2: The calculated dependencies of the bending strength of glass plates subject to the depth of semi-elliptical surface micro-crack in a fracture focus (Rodichev and Veer, 2010).
