# Methodology for the prediction of the strength of naturally aged glass based on surface flaw characterization

to obtain the degree of Master of Science in Civil Engineering  
at the Delft University of Technology,  
to be defended publicly on Friday September 30, 2022 at 14:00.

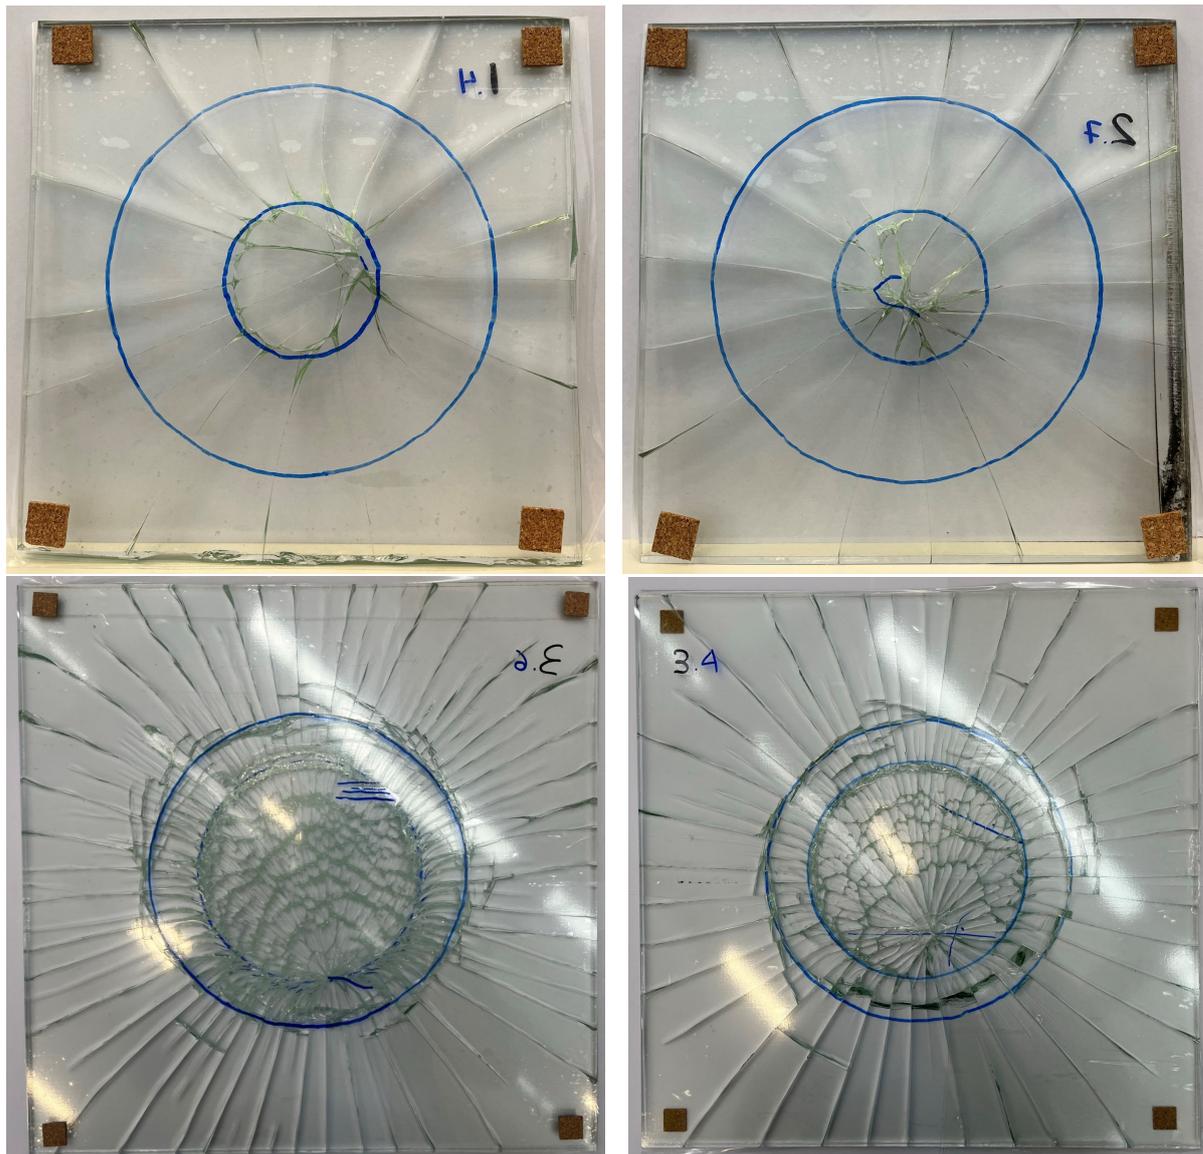
Figure 6.4: Specimens which broke at the detected "critical flaw".

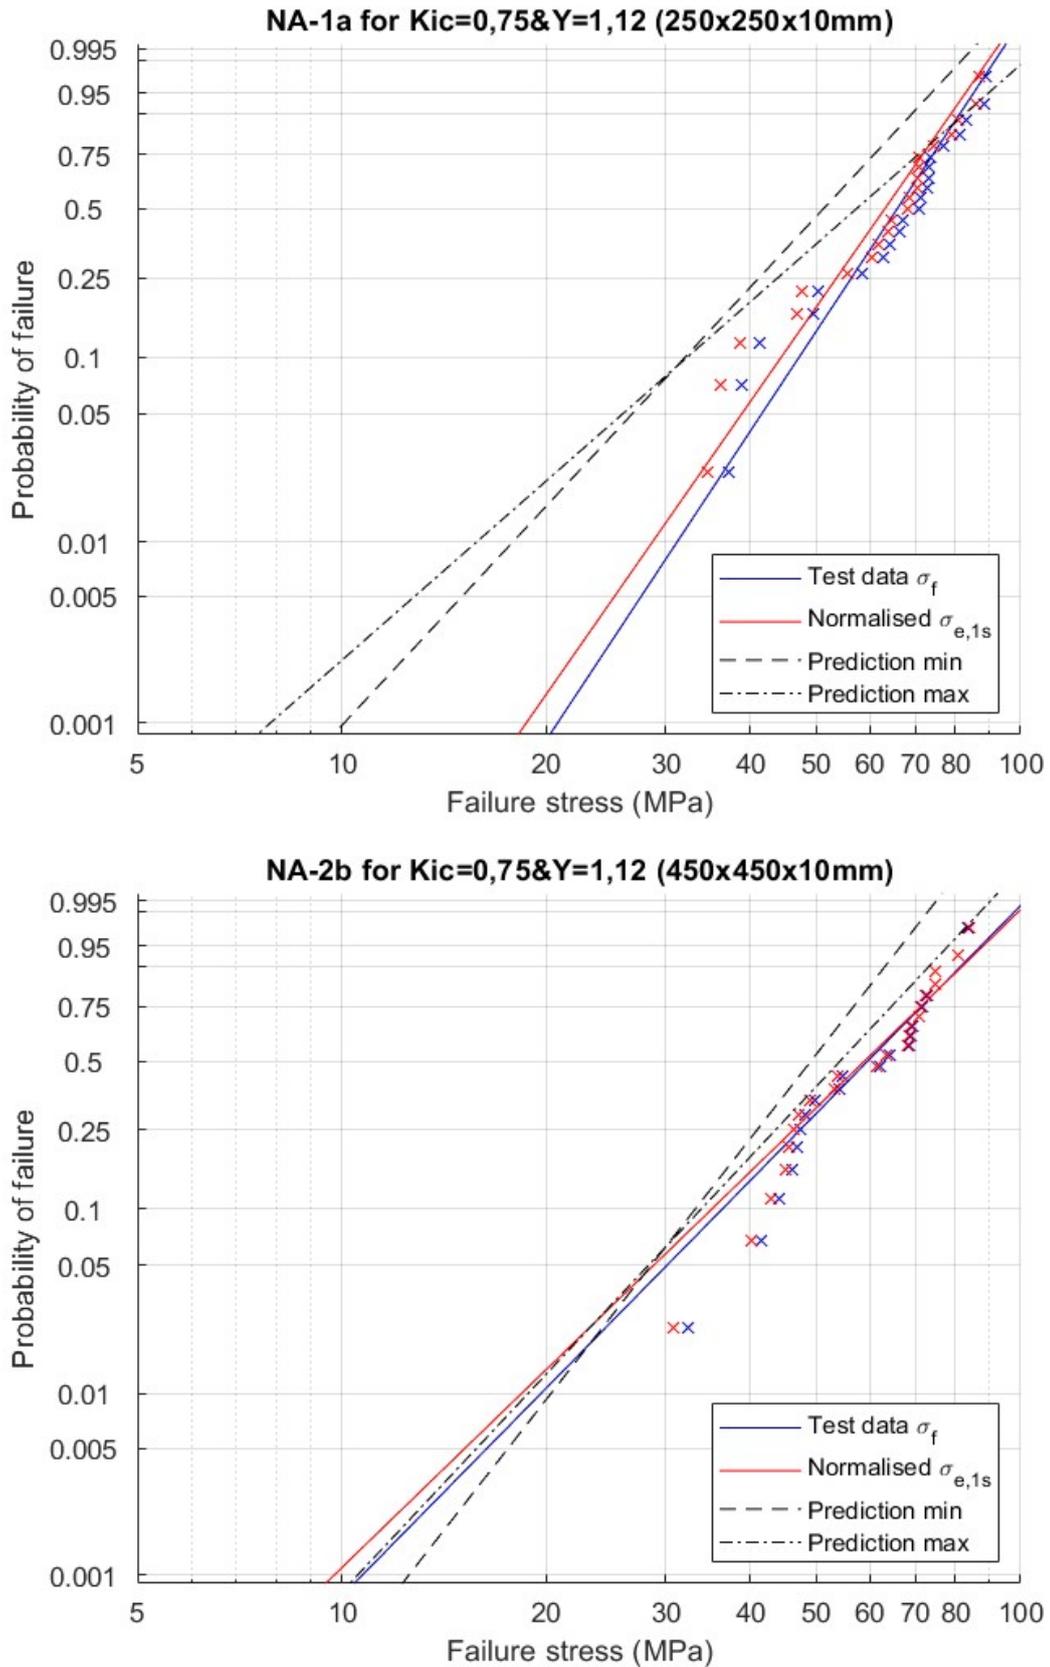
Figure 6.6: Weibull plots of the actual and predicted failure stresses for the specimens tested with the external surface in tension, for  $K_{Ic} = 0,75 \text{ MPa } m^{0,5}$  and  $Y=1,12$ .

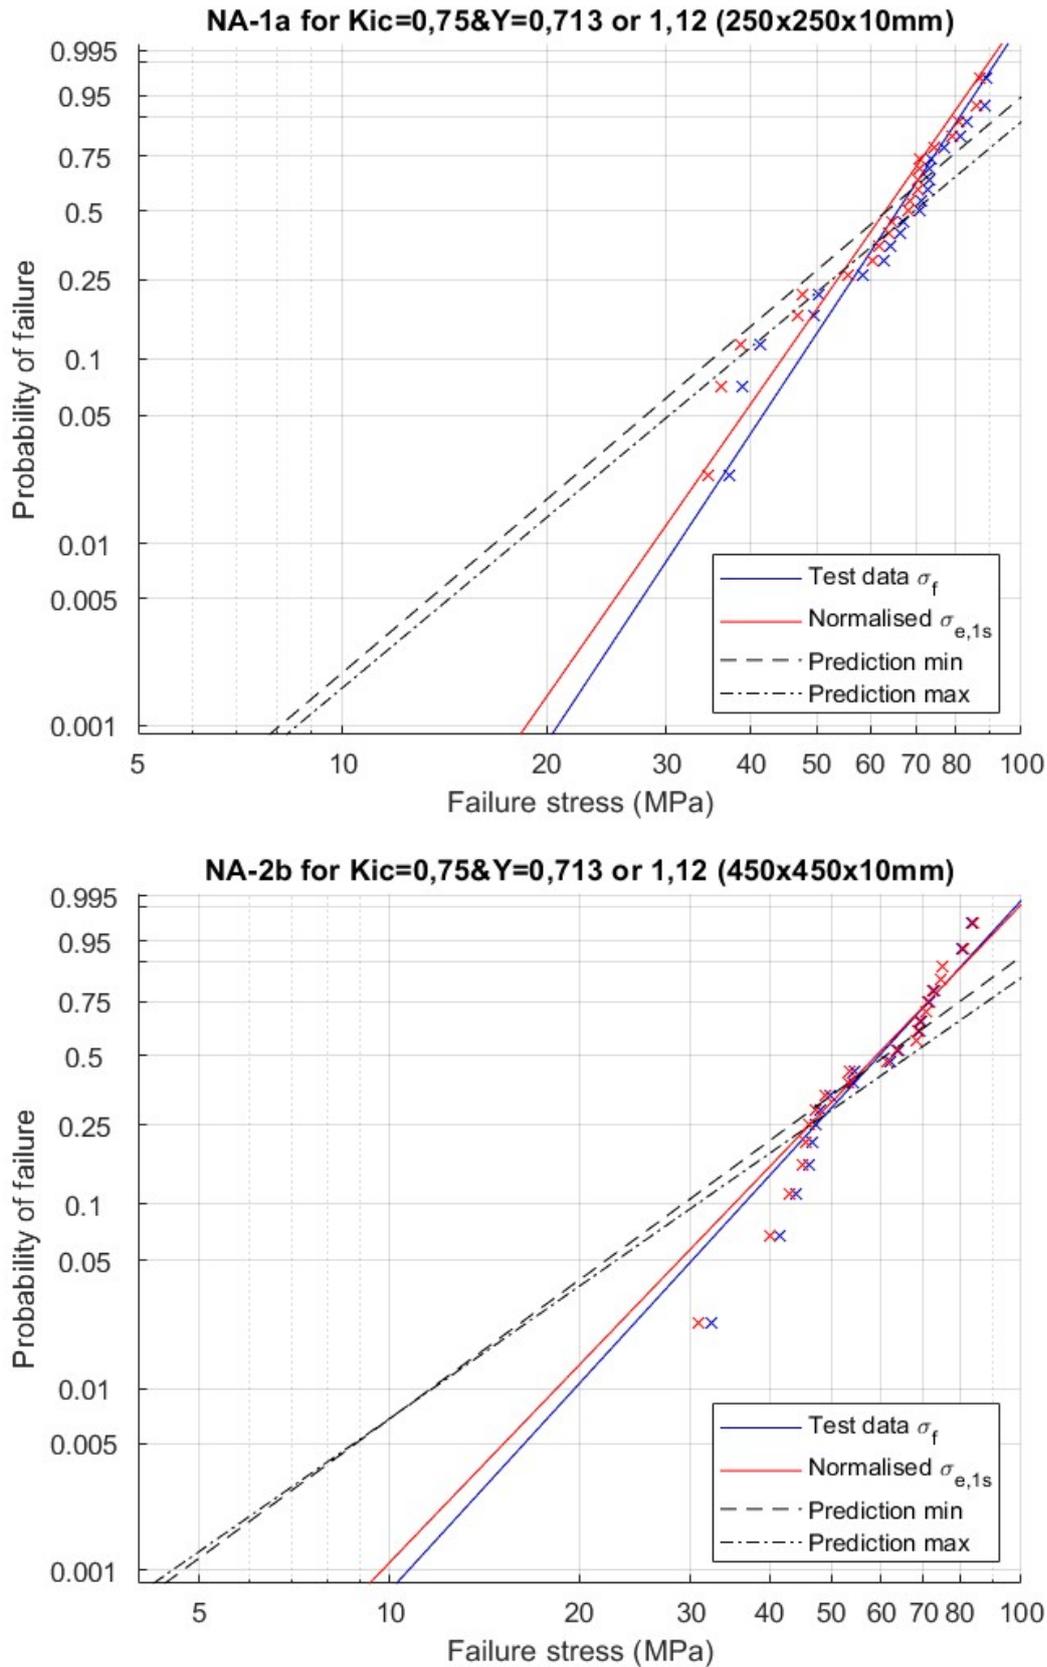
Figure 6.7: Weibull plots of the actual and predicted failure stresses for the specimens tested with the external surface, in tension for  $K_{Ic}$  0,75 MPa  $m^{0,5}$  and  $Y=1,12$  or  $Y=0,713$ .

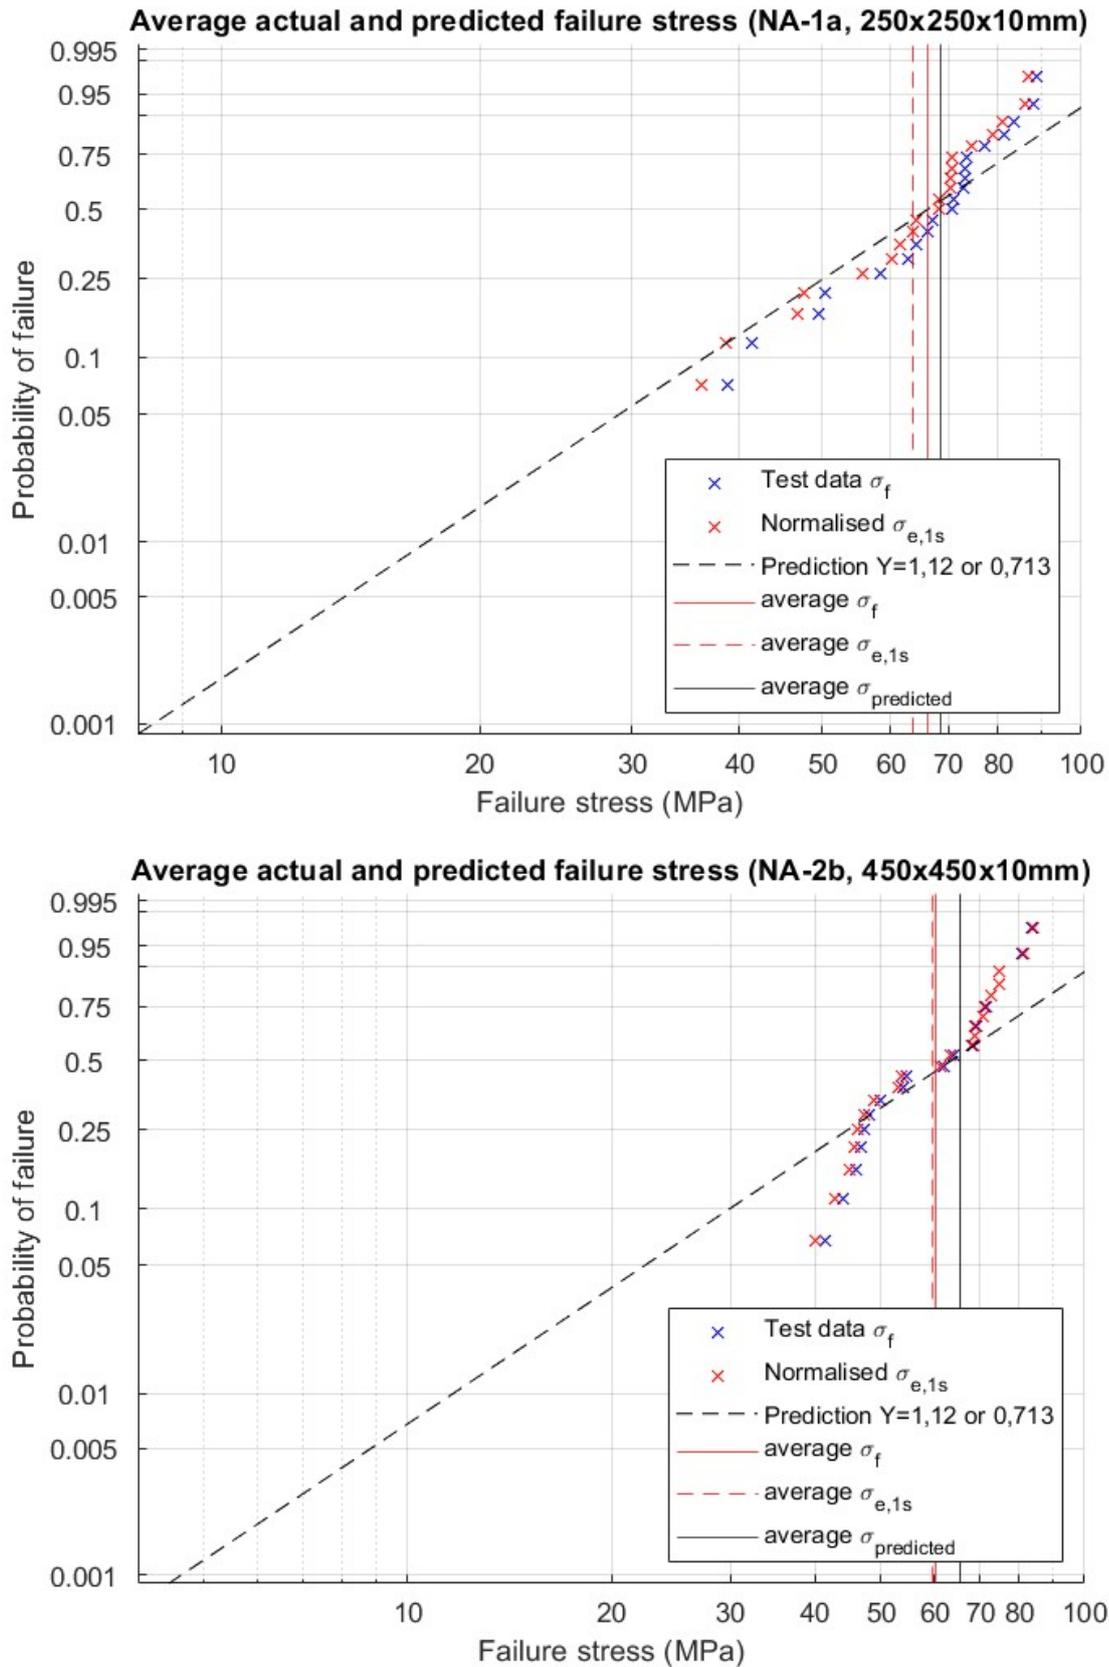
Figure 6.8: Weibull plots of the average actual and predicted failure stresses tested with the external surface in tension.

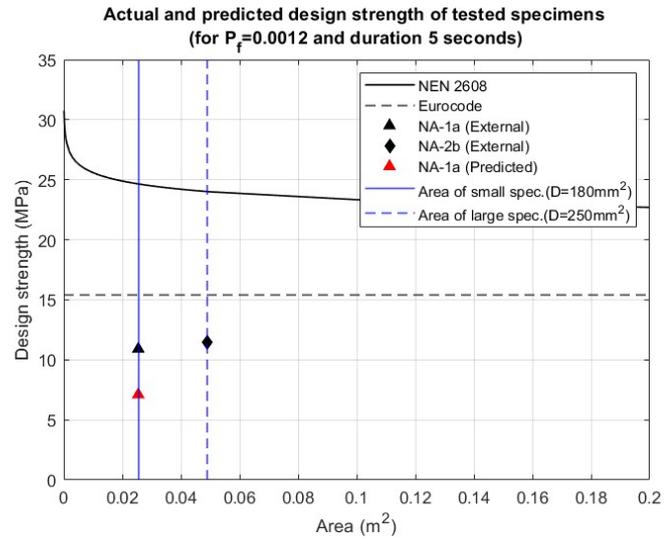
Figure 6.10: Actual and predicted design strength (for  $P_f=0,0012$  and load duration 5 seconds) of the series NA-1a, along with the design strength according to the Dutch and the European standards.

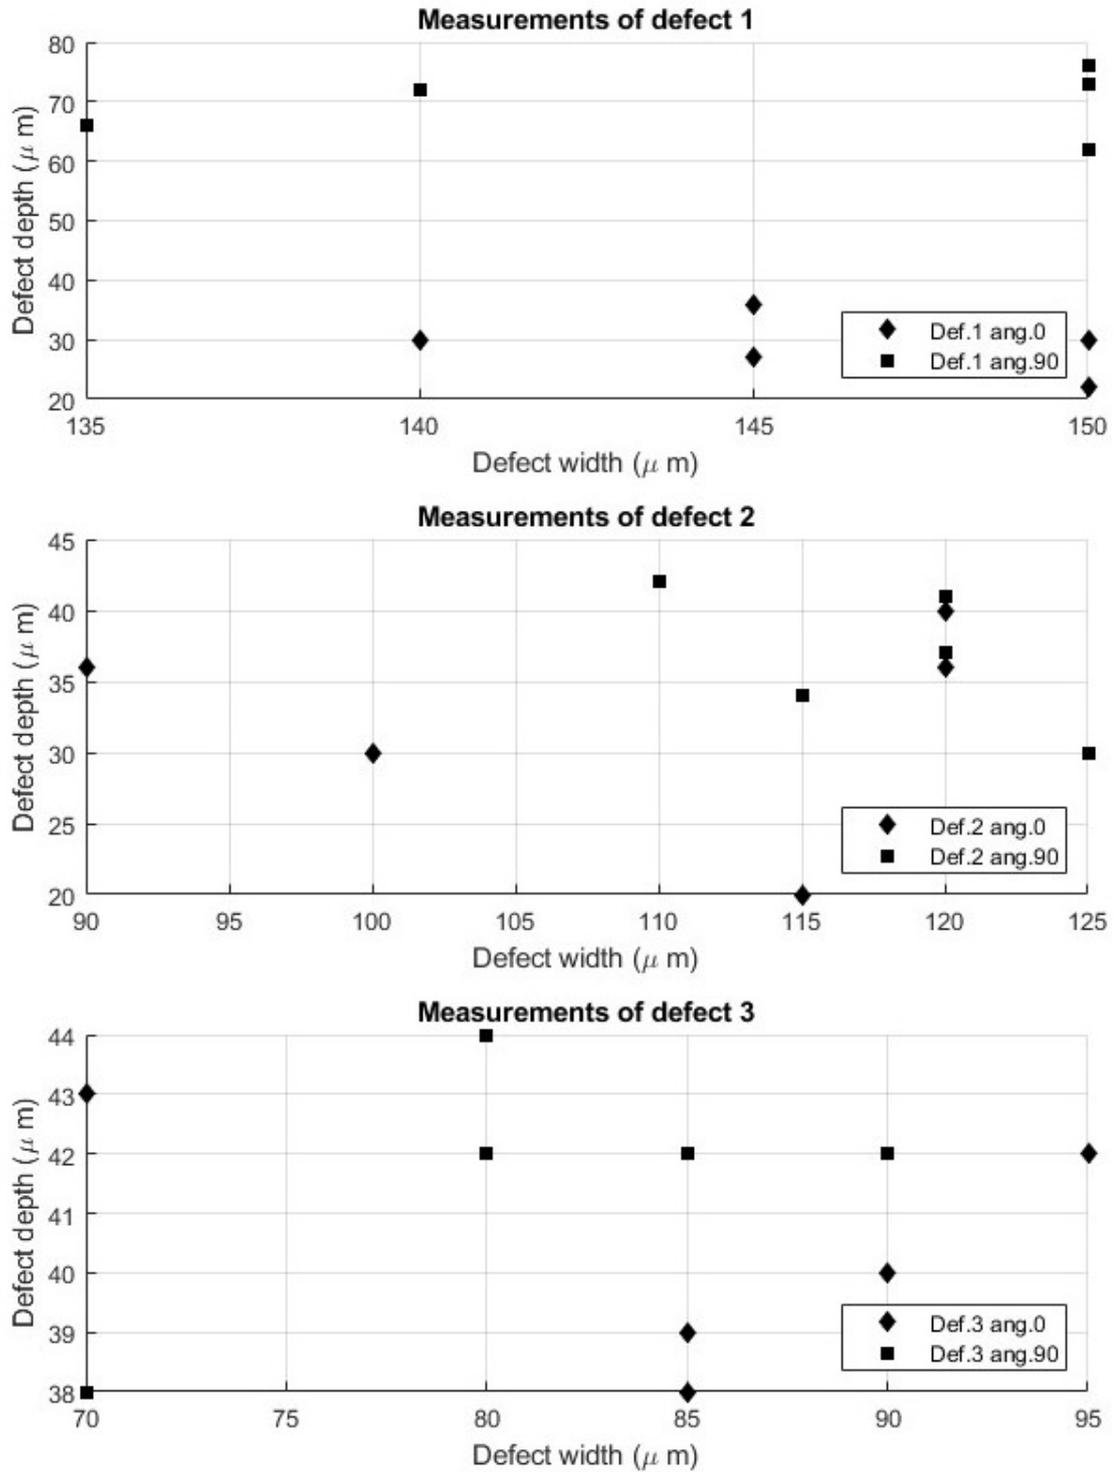
Figure C.1: Plots of the ten measurements for the three examined defects.

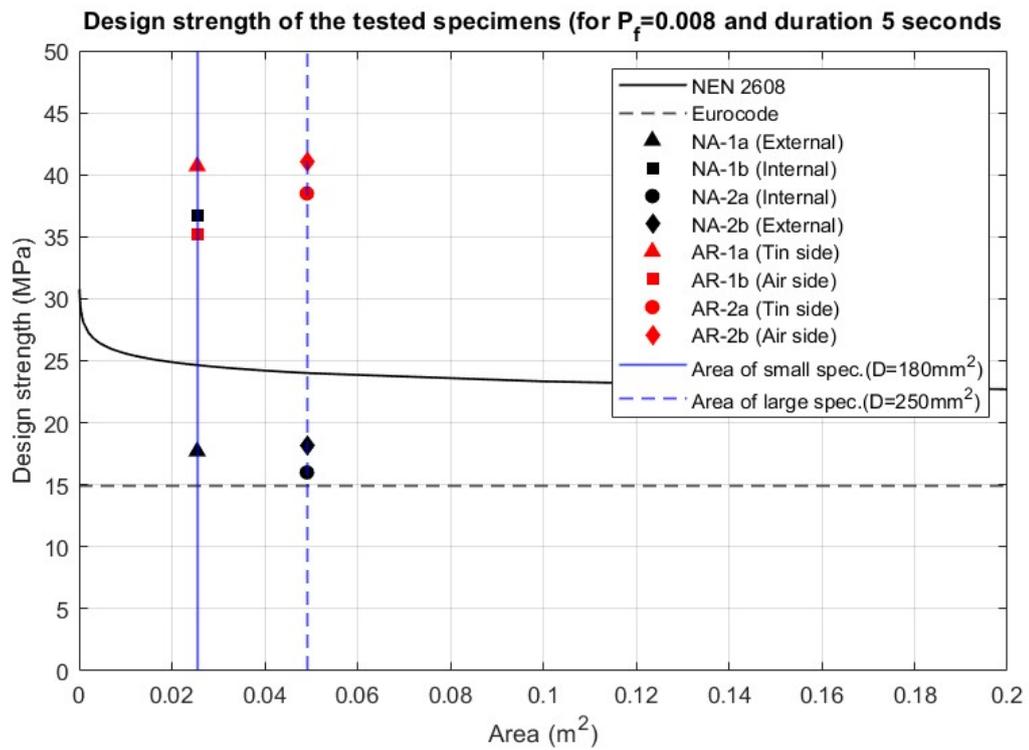
Figure G.1: Theoretical design strength and design strength according to ASTM-E1300 (1997) of the tested specimens (for  $P_f=0,008$  and load duration 5 seconds).
