# **What future for the past?**

Adaptive Reuse of the Sliedrecht Water Tower

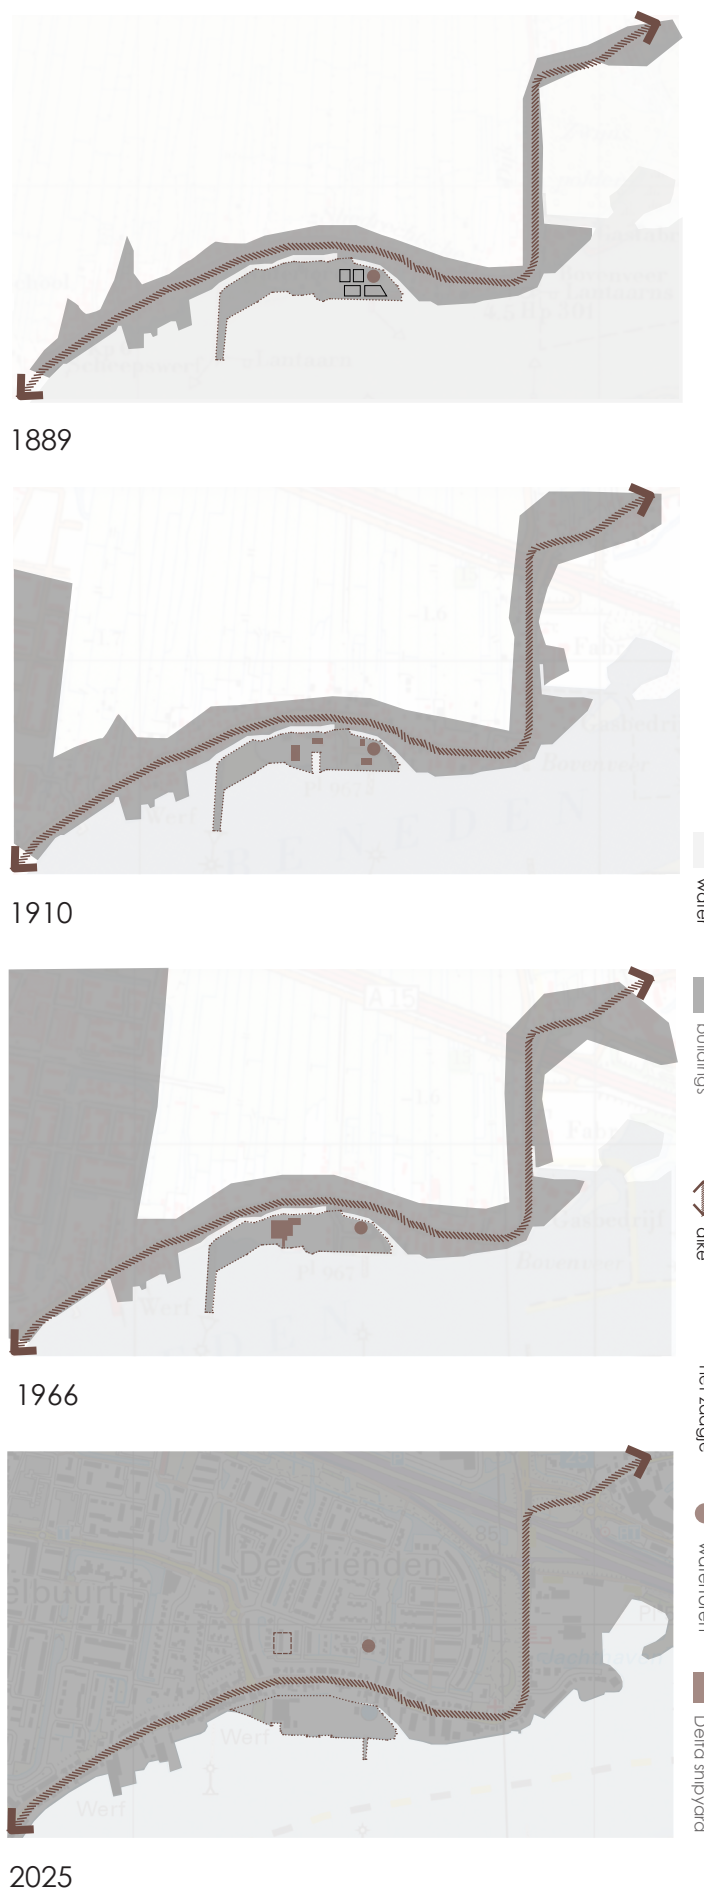
Figure 02: urban analysis

and the rise of the hydraulic engineering and dredging industry. Until well into the 19th century, the town primarily consisted of a linear settlement along the dike, with homes and businesses situated directly on the waterfront. The water tower and the 't Zaagje site played a crucial role in the further expansion and modernization of the town (Historische Vereniging Sliedrecht, 2011). The historical analysis of Sliedrecht's urban growth is illustrated in figure 02.

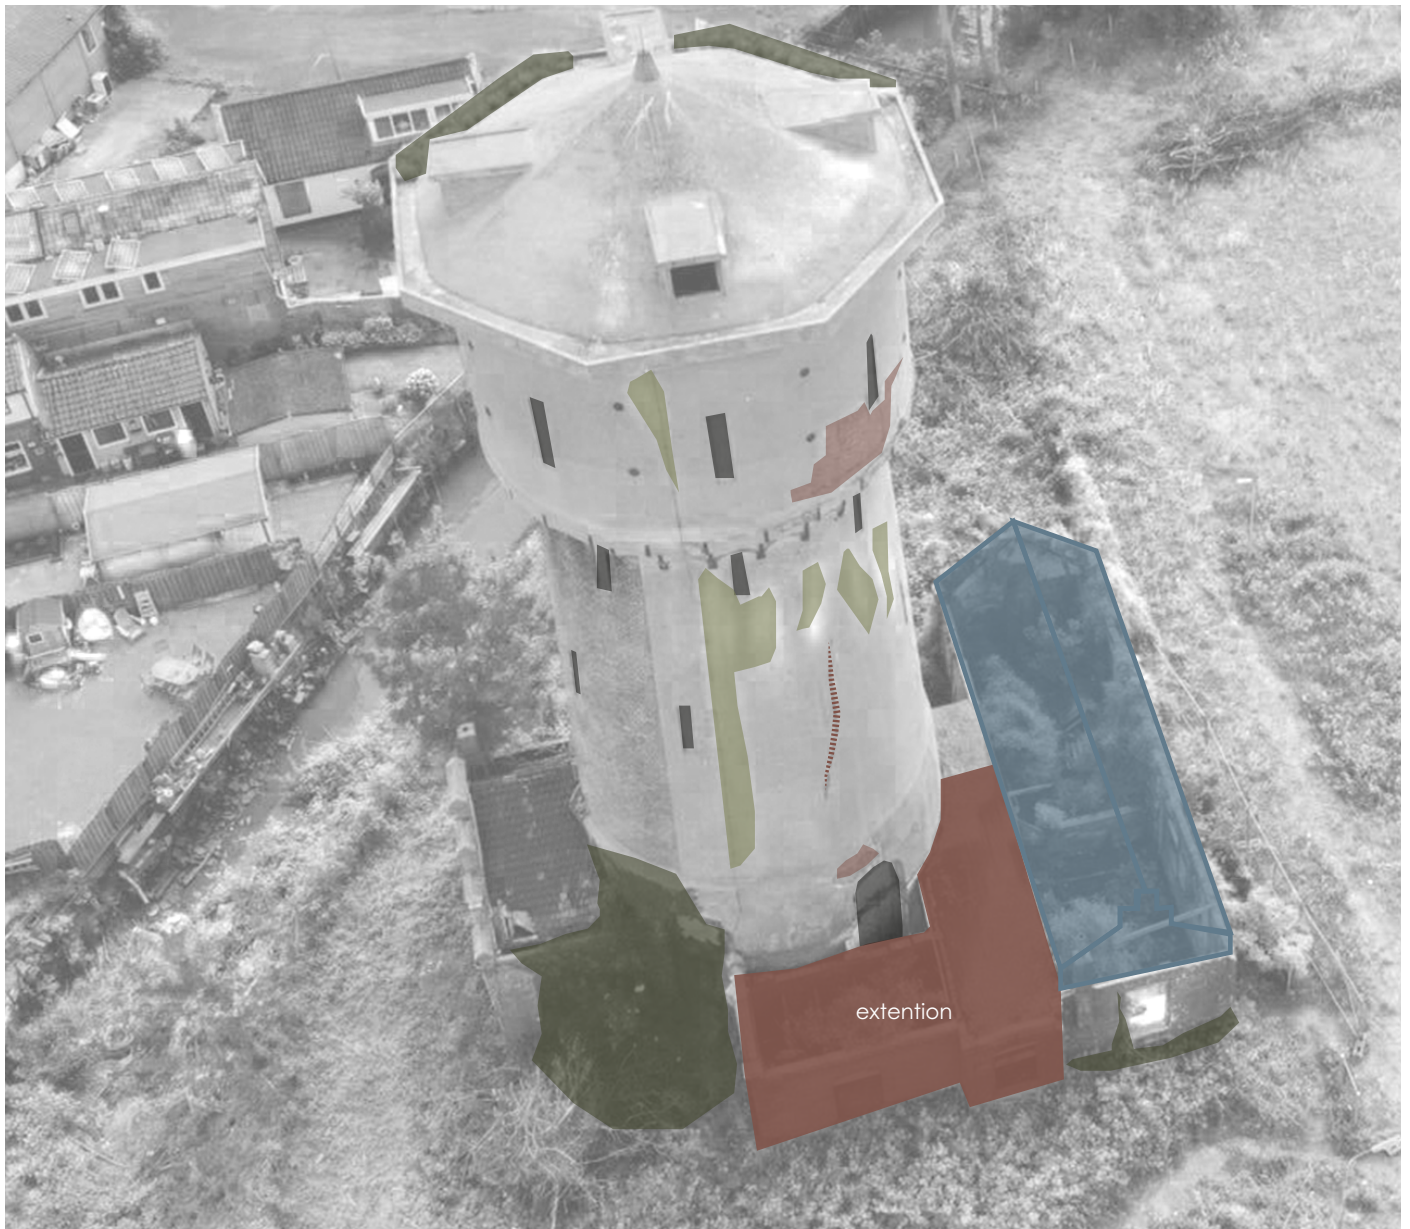
Figure 04: water tower aerial view (Sliedrecht24. (2023))

Dense vegetation and standing water around the base (Figure 04) indicate drainage deficiencies. Lubelli (2021) notes that excessive moisture retention near foundations accelerates settle-

The ground floor, including the former boiler house, exhibits notable instability. These single-story structures, featuring simple segment-arched windows, were built with a slightly different execution than the original plans. During the 1930s, an extension was added to the ground floor (see figure 04), adding extra weight to the foundation and further affecting its stability.

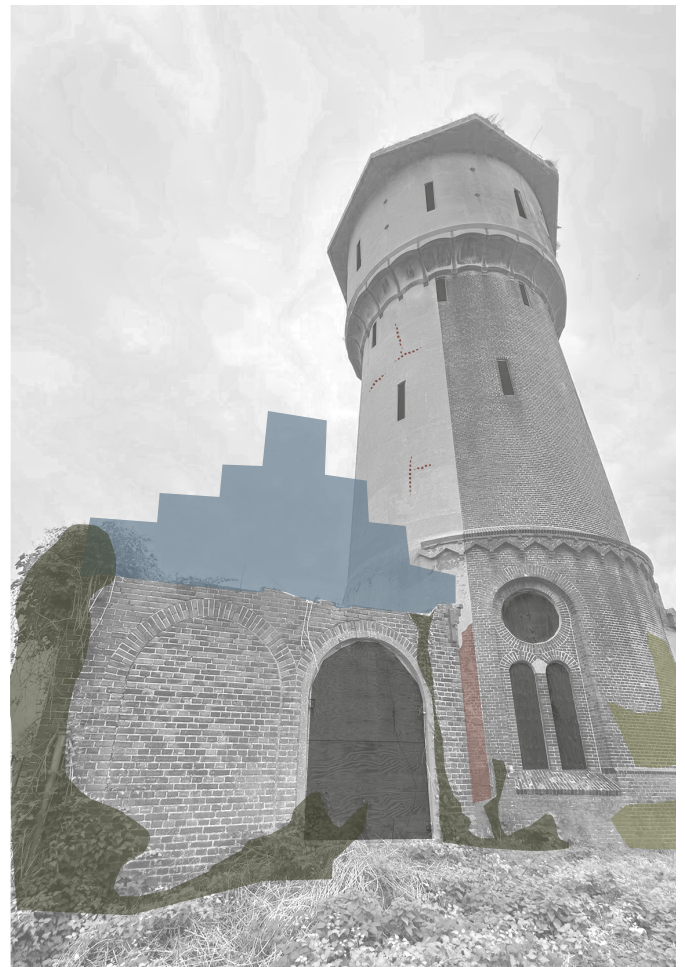
Figure 05: water tower

Documenting visible damages such as cracks, plaster deterioration, and vegetation growth. Figure 05 highlights that grass growth in the roof gutter occurs only on one side, likely due to water retention. This may be related to structural tilt, or it could be influenced by the building's orientation. Further analysis, such as digital leveling measurements and hydrological assessments, is needed to confirm these hypotheses.

These buildings once featured decorative brickwork along the roofline and a prominent chimney on the west facade (highlighted with blue in figure 05). However, years of neglect have left them severely damaged. The boiler house, once a key component of the water supply system, had its roof removed due to safety concerns. Its walls are heavily deteriorated, suffering from extensive moisture damage, with wooden doors missing, and window frames either decayed or completely absent.

The plaster has detached in some areas, with the most significant loss concentrated on one section of the masonry (visible in figure 05 and 06). This could indicate underlying moisture retention or material incompatibility. Lubelli (2021) describes how cement-based plasters, when applied to historic masonry, can restrict moisture evaporation, leading to internal stress and detachment.

The vegetation around the tower base should be carefully removed to avoid further moisture retention and mechanical damage to the foundation and walls. Regular maintenance to prevent root growth near the structure is essential (Feilden, 2003). This can prevent root penetration, which could exacerbate cracking and further destabilize the structure (Doehne & Price, 2010).

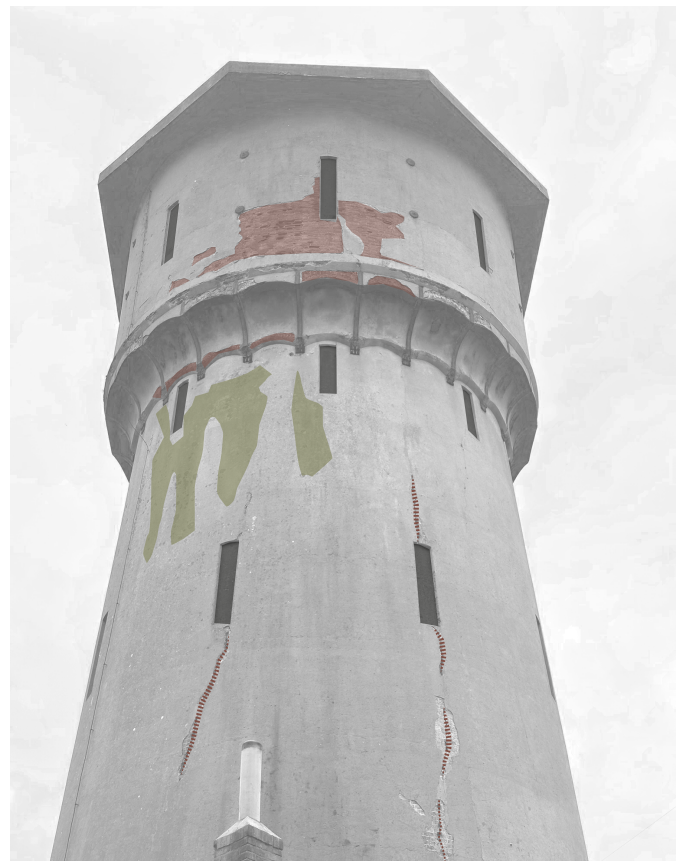
Figure 06: water tower upper part

The presence of long vertical cracks in the plastered sections (Figure 06) suggests settlement issues. These could be linked to differential foundation subsidence, potentially due to groundwater fluctuations or inadequate foundation depth. According to Monumentenkennis (n.d.-a), such cracks typically occur due to variations in soil-bearing capacity, exacerbated by inadequate drainage or structural loads. Additionally, Lubelli (2021) explains that rising damp and capillary moisture transport can weaken masonry, accelerating crack propagation. The cracks' concentration on the cemented façade raises questions: does cement plaster contribute to differential moisture retention, influencing crack formation? Further structural monitoring, including leveling measurements and soil composition analysis, would help confirm this hypothesis.

The tower's upper sections experience significant wind pressures, leading to shear stress cracks. These are most pronounced at transitions in geometry, particularly at the junction between the cylindrical shaft and the wider top section (Figure 06). Monumentenkennis (n.d.-b) describes how shear stress accumulates in historical masonry due to material fatigue and fluctuating environmental loads. According to Quist (2021), wind pressure-induced shear stress is particularly problematic in tall, slender structures, necessitating careful reinforcement. Advanced digital strain analysis and wind load simulations should be conducted to assess the long-term impact of these stresses.

Use crack width gauges and digital leveling measurements to monitor crack progression over time. Inject a flexible, compatible mortar (e.g., lime-based mortar) into the cracks to prevent further moisture infiltration (Monumentenkennis, n.d.-b). If cracks are structurally significant, stainless steel anchors or tension rods may be installed to reinforce affected areas (Stichting ERM, n.d.). Improve foundation stability by addressing drainage issues to prevent further settlement (Monumentenkennis, n.d.-a).

Conduct digital strain measurements and wind simulations to assess wind pressure impact (Monumentenkennis, n.d.-b). Inject an elastic joint mortar to better absorb future stress distribution. If necessary, apply carbon fiber reinforcements or steel strengthening profiles to improve stability (Quist, 2021).

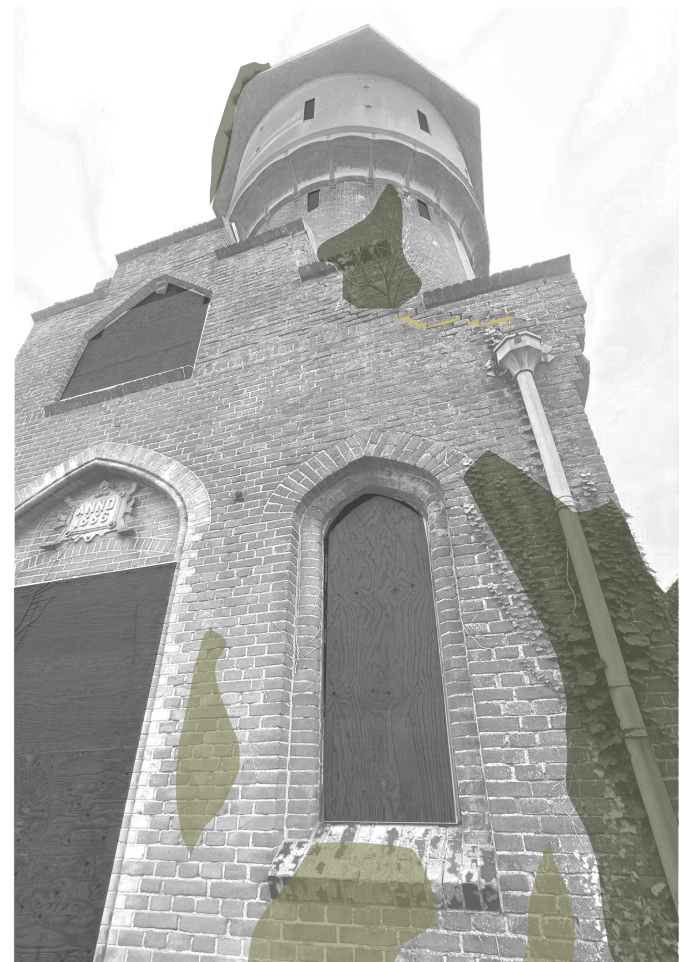
Figure 08: entrance

The exposed brick surfaces, particularly on the lower portion of the tower (figure 08), show signs of erosion. This could be due to prolonged exposure to freeze-thaw cycles, where absorbed moisture expands and contracts within the bricks, leading to spalling and surface loss (Rijksdienst voor het Cultureel Erfgoed, 2012).

Restore damaged bricks using historically compatible masonry to minimize material stress. Apply a breathable hydrophobic coating to reduce water absorption without compromising masonry permeability (Monumentenkennis, n.d.-b). Improve drainage around the tower to prevent prolonged moisture accumulation.
