Yao, Mingchen; Zhang, Yue; Dai, Zihan; Ren, Anran; Fang, Jiaxing; Li, Xiaoming; van der Meer, Walter; Medema, Gertjan; Rose, Joan B.; Liu, Gang

# Building water quality deterioration during water supply restoration after interruption: Influences of premise plumbing configuration

Premise plumbing  
Water supply restoration  
Water quality deterioration  
Discoloration  
System configuration

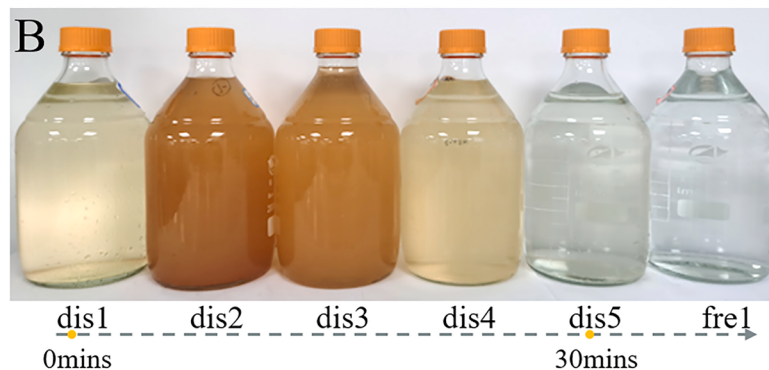
**Fig. 1.** A) Detailed configuration of the laboratory and toilet plumbing. Sampling points marked in Yellow. The pipe length, velocity, Reynolds number, and shear stress are given in Table 1; B) picture of disturbed samples from laboratory plumbing during restoration of the water supply condition (Lab-dis, heavy discoloration).

The study was conducted in an office building on the campus of the Research Center for Eco-Environmental Sciences, Chinese Academy of Sciences. It is an 8-floor building of 10,000 m<sup>2</sup> with office and laboratory rooms. The premise plumbing components that distribute water to laboratories and toilets are connected to the water main separately with parallel vertical pipes (Fig. 1A). The configurations of laboratory and toilet plumbing are different, both of which have a vertical plastic-lined galvanized steel pipe and horizontal branch polypropylene-random (PPR) pipes. There are two regular taps for the laboratory plumbing and seven flushing toilets and two taps for the toilet plumbing. The water usage in the laboratory and toilets are also different, which leads to significant differences in hydraulic conditions in the two piping systems (e.g., velocity, Reynolds number, and shear stress, Table 1).

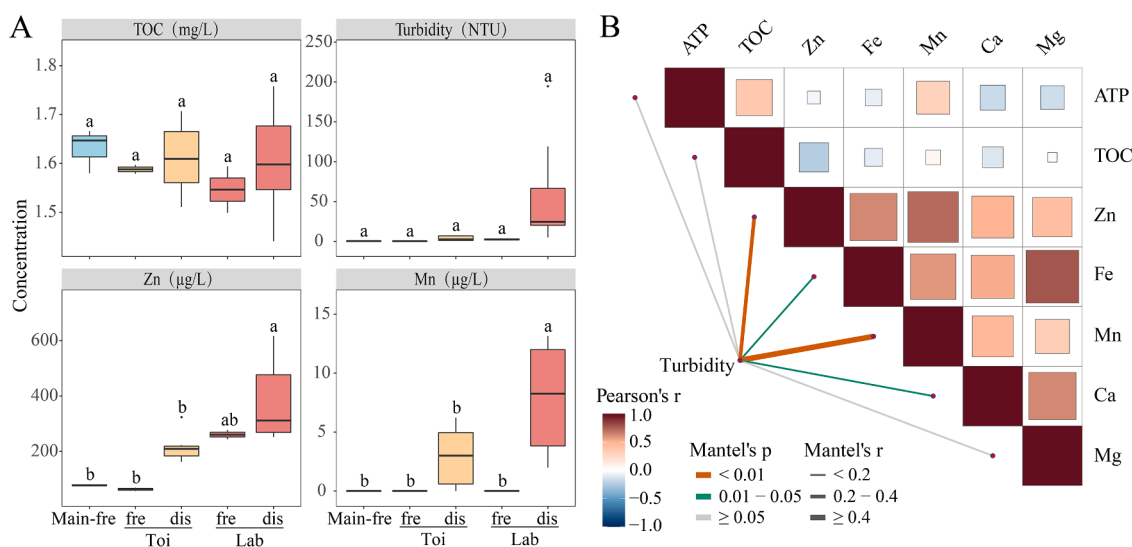
**Fig. 2.** Comparison and correlation analysis of water quality parameters: A) Boxplots showing the results of total organic carbon (TOC), turbidity, Zn and Mn in different sampling groups. Different lowercase letters on the boxes represent significant differences assessed using ANOVA; B) pairwise comparison among water quality parameters, the color gradient denotes Pearson's correlation coefficients. The correlations of turbidity with other parameters were assessed by Mantel tests. Edge color represents the statistical significance, and edge width corresponds to Mantel's  $r$  statistic.

supply (Fig. 2A). The concentrations of both Zn and Mn were significantly higher in the water samples from the laboratory than in those from the toilet. This may be due to the smaller diameter and flow in the laboratory, which offered a higher surface-to-volume ratio and longer retention time. Zn might have been released from vertical galvanized pipes, while Mn would have accumulated in the pipes during regular water supply and been released during restoration of the water supply. Interestingly, it was observed that the Zn in the fresh samples from the laboratory was clearly higher than that from the toilet and main, indicating the considerable contributions from laboratory plumbing but not toilet plumbing to the sharp increase in Zn (78.2 to 260.7  $\mu\text{g/L}$ ) during regular water supply.

It is important to note that laboratory plumbing significantly increased the Zn concentration and Simpson diversity of the planktonic bacterial community during regular water supply (Lab-fre vs. Main-fre, Figs. 2A and 3B), while toilet plumbing did not. Although the number of observed ASVs increased in both Lab-fre and Main-fre to a similar level (Fig. 3C), the bacterial communities of Lab-fre were significantly different from those of Main-fre, but the bacterial communities of Toi-fre were clustered closely together with those of Main-fre (Fig. 4A). In other words, significant changes were observed in laboratory plumbing but not toilet plumbing during regular water supply, which may be because the small water demand and flow velocity in laboratory plumbing resulted in a longer stagnation time than that in toilet plumbing (Montagnino et al., 2022; Proctor et al., 2020; Zlatanović et al., 2017). During the restoration of water supply, the laboratory plumbing lead to significant changes in elemental composition, while the toilet plumbing lead to significant changes in ATP and clearly differences in dominant ASVs (Figs. 5 and 6). This highlights the importance of premise plumbing configurations. It poses significant influences during both regular and interruption of the water supply.

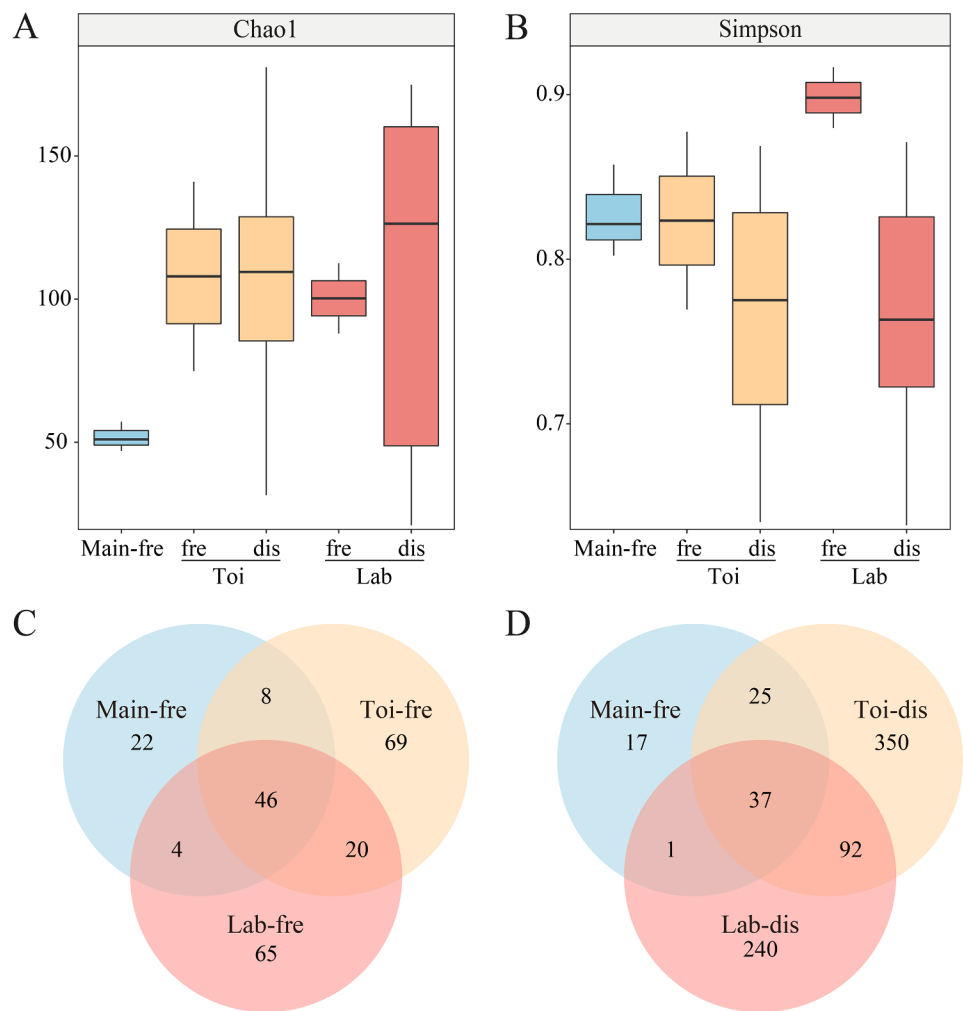
**Fig. 3.** A) Chao 1 indices of different sampling groups; B) Simpson diversity of different sampling groups; C) Venn diagram among fresh samples; D) Venn diagram among disturbed samples.

showed higher values and larger variations than the toilet samples. The higher species richness in disturbed samples during water supply restoration was better revealed by the Venn diagram in Fig. 3C and 3D.

Interestingly, although the species richness was higher in Lab-dis and Toi-dis, their Simpson diversities were much lower than those in Lab-fre and Toi-fre (Fig. 3B), indicating that the relative abundances of community members in fresh samples were more evenly distributed, while the community of planktonic bacteria during water supply restoration was possibly predominated by a few species. This is directly confirmed by the bacterial community composition results in the following section. Moreover, during regular water supply, toilet plumbing did not influence Simpson diversity, whereas laboratory plumbing clearly increased the Simpson diversity of the bacterial community (Fig. 3B).

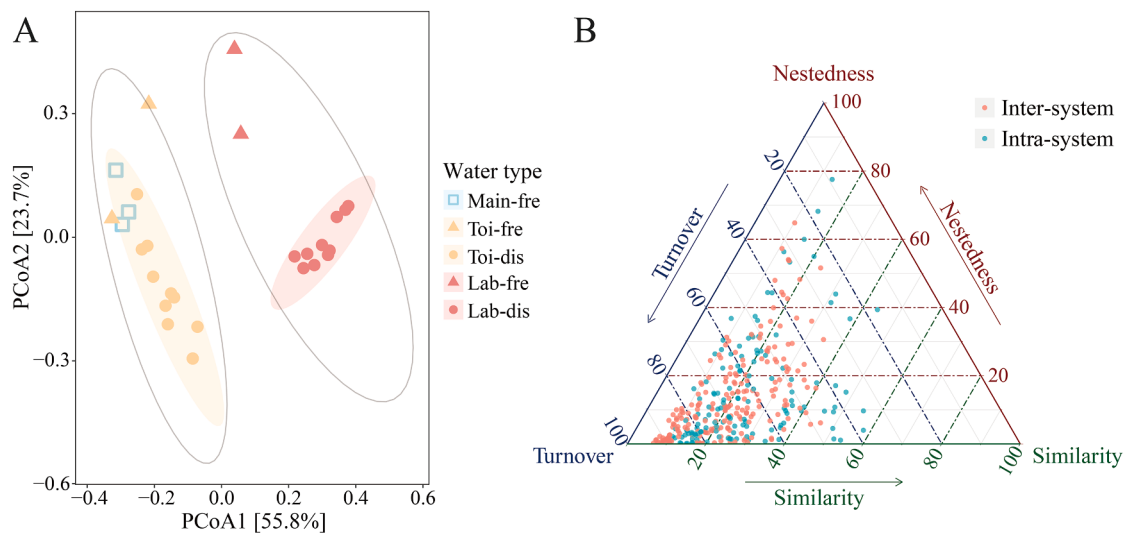
**Fig. 4.** A) PCoA plot based on Bray-Curtis dissimilarity; B) triangular plots of beta-diversity partitioning (using Jaccard dissimilarity index) comparisons for bacterial communities. Each point represents a pair of samples.

The PCoA plot showed clear clusters of sample groups, indicating the dissimilarity among their bacterial communities (Fig. 4A). According to statistical tests, both plumbing configurations and water supply interruption/restoration significantly influenced the planktonic bacterial community (PERMANOVA,  $P < 0.05$ , Table S1), while the variances were mostly explained by the former ( $R^2 = 0.537$ , Table S1). Comparing the fresh samples, the bacterial community of Main-fre is similar to that of Toi-fre (overlapping) but different from that of Lab-fre (different clusters), confirming the significant influences of the plumbing configuration. During the restoration of the water supply, Lab-dis clustered closely together and completely separated from Lab-fre, while Toi-dis is more dispersed and separated from Toi-fre samples. The differences between Lab-dis and Lab-fre are sharper than that of Toi system. This means sharper changes may occur in laboratory plumbing during water supply restoration, which complied with the visually observed discoloration in Lab-dis samples, as mentioned above.

To reveal the underlying mechanisms of variation in microbial assembly, the beta diversity was further partitioned into species turnover and nestedness (Fig. 4B). The average Jaccard pairwise dissimilarity

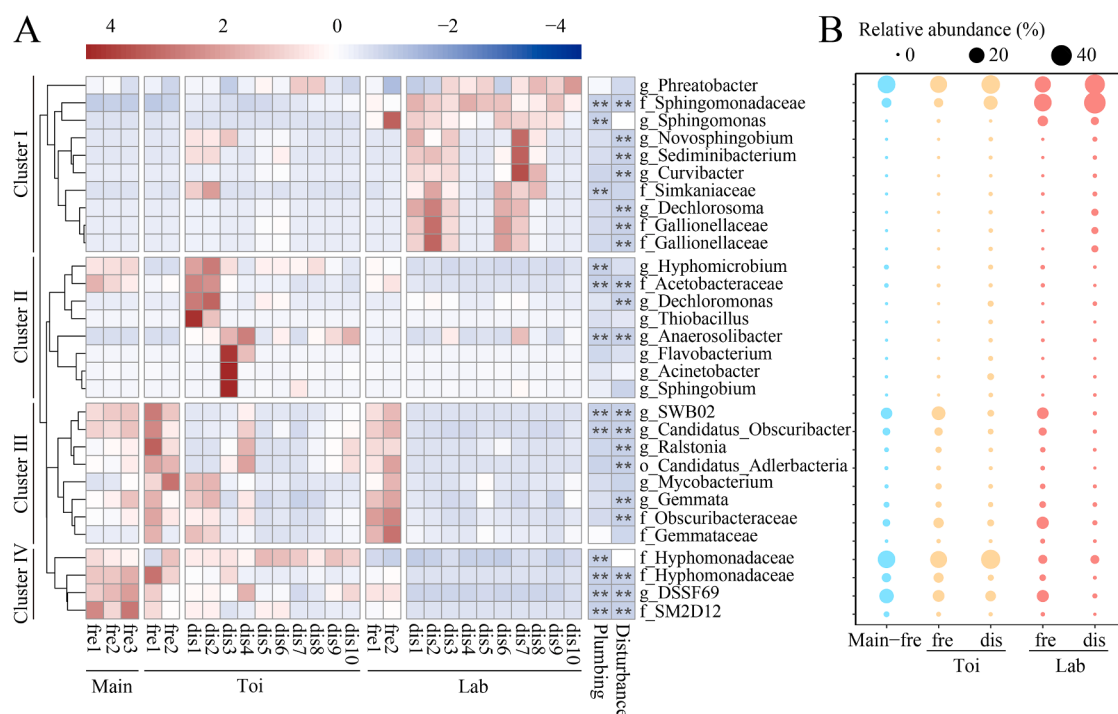
**Fig. 5.** Relative abundances of the top 30 genera: A) Distribution of the normalized relative abundance of the genera in different samples. Colors from blue to red denote an increase in normalized relative abundance. The significant difference between groups was calculated by Kruskal–Wallis tests ( $P$  values:  $** < 0.05$ ); B) Relative abundances of the genera in different sampling groups. The genera were classified into two types and four clusters: affected by disturbance (Clusters I and III) or by both disturbance and plumbing system configuration (Clusters II and IV). The genera of Cluster IV were only less abundant in the Lab-dis group. The genera of Cluster II were mainly found in the Toi-dis group.

At the genus level, the top 30 abundant bacterial genera across all samples are shown as a heatmap in Fig. 5A (normalized relative abundance) and a bubble plot in Fig. 5B (relative abundance). During regular water supply, both laboratory and toilet plumbing promoted community members, such as *Mycobacterium* spp. (0.1% to 1.0%) and *Gemmata* spp. (0.9% to 1.3%), and prohibited community members, such as *DSSSF69* spp. (16.7% to 9.9%) and *Hyphomicrobium* spp. (0.4% to 0.1%). In contrast, laboratory plumbing promoted *Sphingomonas* spp. (0.1% to 6.8%), while prohibited *Phreatobacter* spp. (28.1% to 21.9%), but toilet plumbing did not. During the restoration of the water supply, it is remarkable to observe that a few genera were not present in fresh

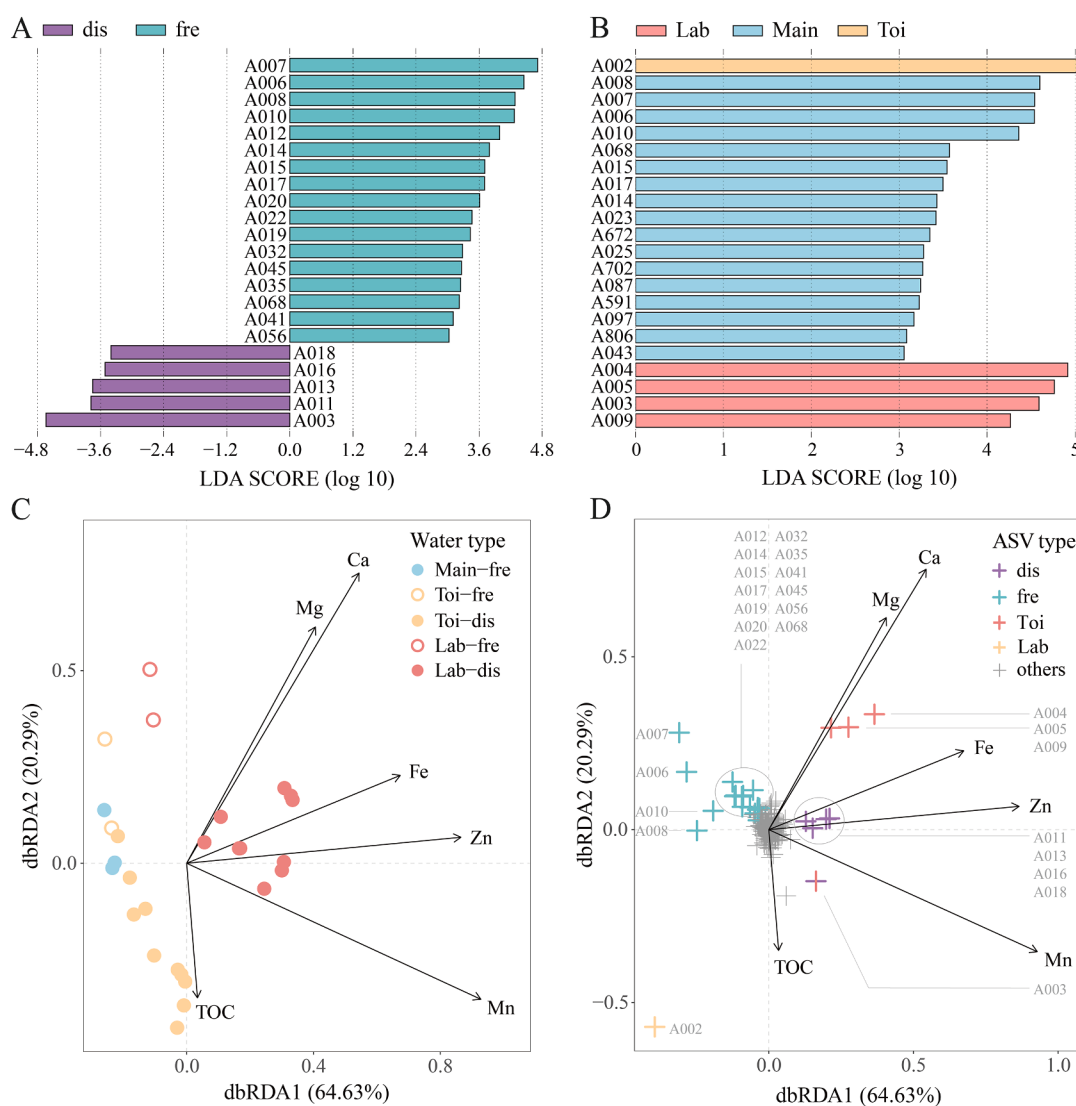
**Fig. 6.** A) LEfSe analysis selected significantly enriched ASVs during regular water supply (fre) and restoration of water supply (dis); B) LEfSe analysis selected significantly enriched ASVs in water main (Main), toilet (Toi) and laboratory plumbing (Lab); C) distance-based redundancy analysis (db-RDA) of the relationship between the bacterial community and environmental variables; D) db-RDA of the relationship between ASVs and environmental variables.

The LEfSe analysis identified ASVs significantly enriched by regular and interrupted water supply (Fig. 6A) and by premise plumbing with different configurations (Fig. 6B). The taxonomy information of these ASVs is given in Table S3. Remarkably, 3/5 of the ASVs enriched during water supply restoration were assigned as *f\_Gallionellaceae*, the group of which is commonly called iron bacteria. This complies with, presented below, that iron drove bacterial community changes during the restoration of water supply (Fig. 6C, 6D). In addition, all ASVs enriched in laboratory plumbing belonged to *f\_Sphingomonadaceae*, and the key sensitive ASVs in toilet and laboratory plumbing were strongly correlated with Ca and Mg.

The db-RDA plot showed that the first two axes cumulatively explained 84.6% of the total variance (Fig. 6C, 6D). The bacterial community of Lab-dis was mainly driven by metal elements (e.g., Mn), while the bacterial community of Toi-dis was mostly driven by TOC. This was directly confirmed by Mantel tests (Table S4). More specifically, the variations in species between the laboratory and toilet were more related to Ca, Mg, Fe and Zn, whereas the bacterial community changes induced by the disturbance during water supply restoration
