# **Graduation project Vacant Heritage Analysis booklet - Sustainable estate of the future**

*Research and design into a sustainable reuse of Dutch  
buitenplaats Huis 't Velde*

Mathyn Carsten Klein MA. ing.

Final version P5  
June 16, 2022.

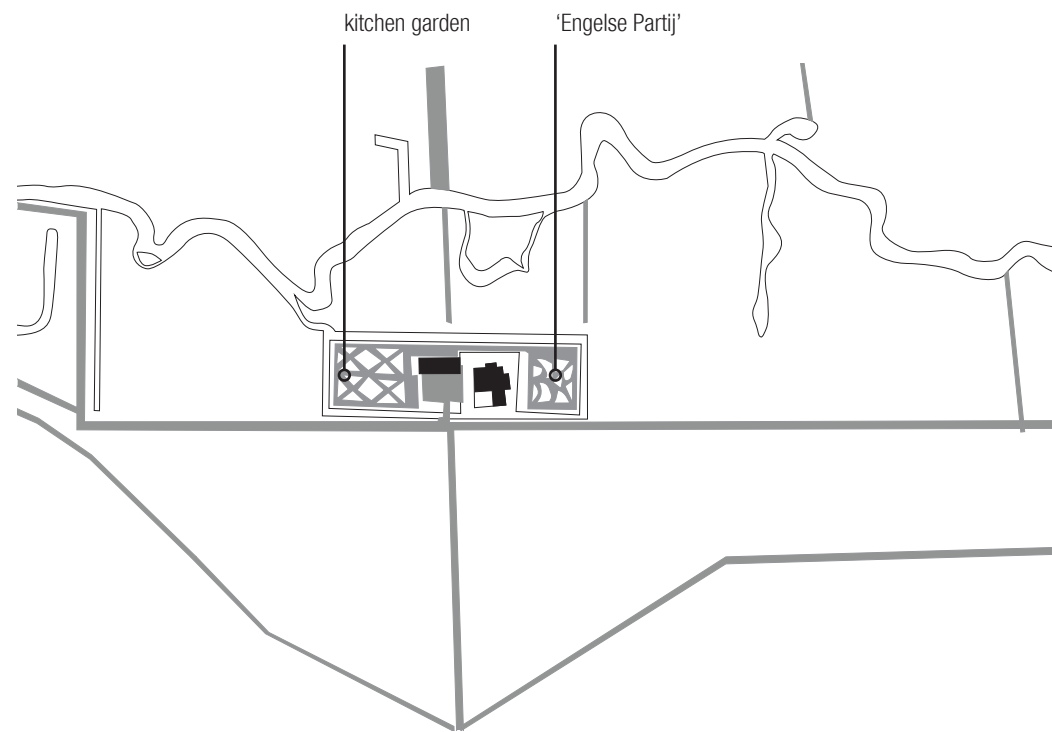
1778- Formal garden: the medieval structure of the garden is still visible and the gardens are surrounded with a moat. The left island contain a kitchen garden and a farm house. Later will this house be replaced for the carriage building. In the middle is the main building and on the right a 'Engelse Partij' -style garden, a typology for a specific garden design style with a formal layout. This was the precursor for the English Landscape style. There is no hunting lodge yet.

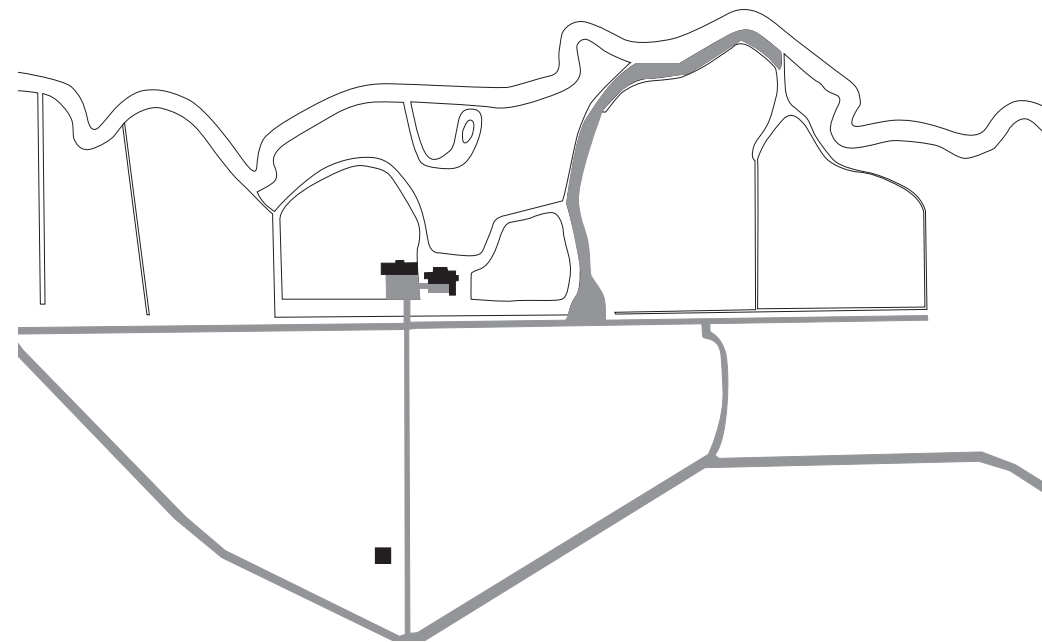
1810 - First phase landscape garden: a new garden design and place for farmlands in a English Landscape style garden. Left and right from the middle islands are places for meadows. Under the main entrance (triangular shaped) fields for farmers. There was no high vegetation to ensure a free view to and from the house. The hunting lodge is built together with a special forest for hunting (sterrenbos), this is not shown on this map.

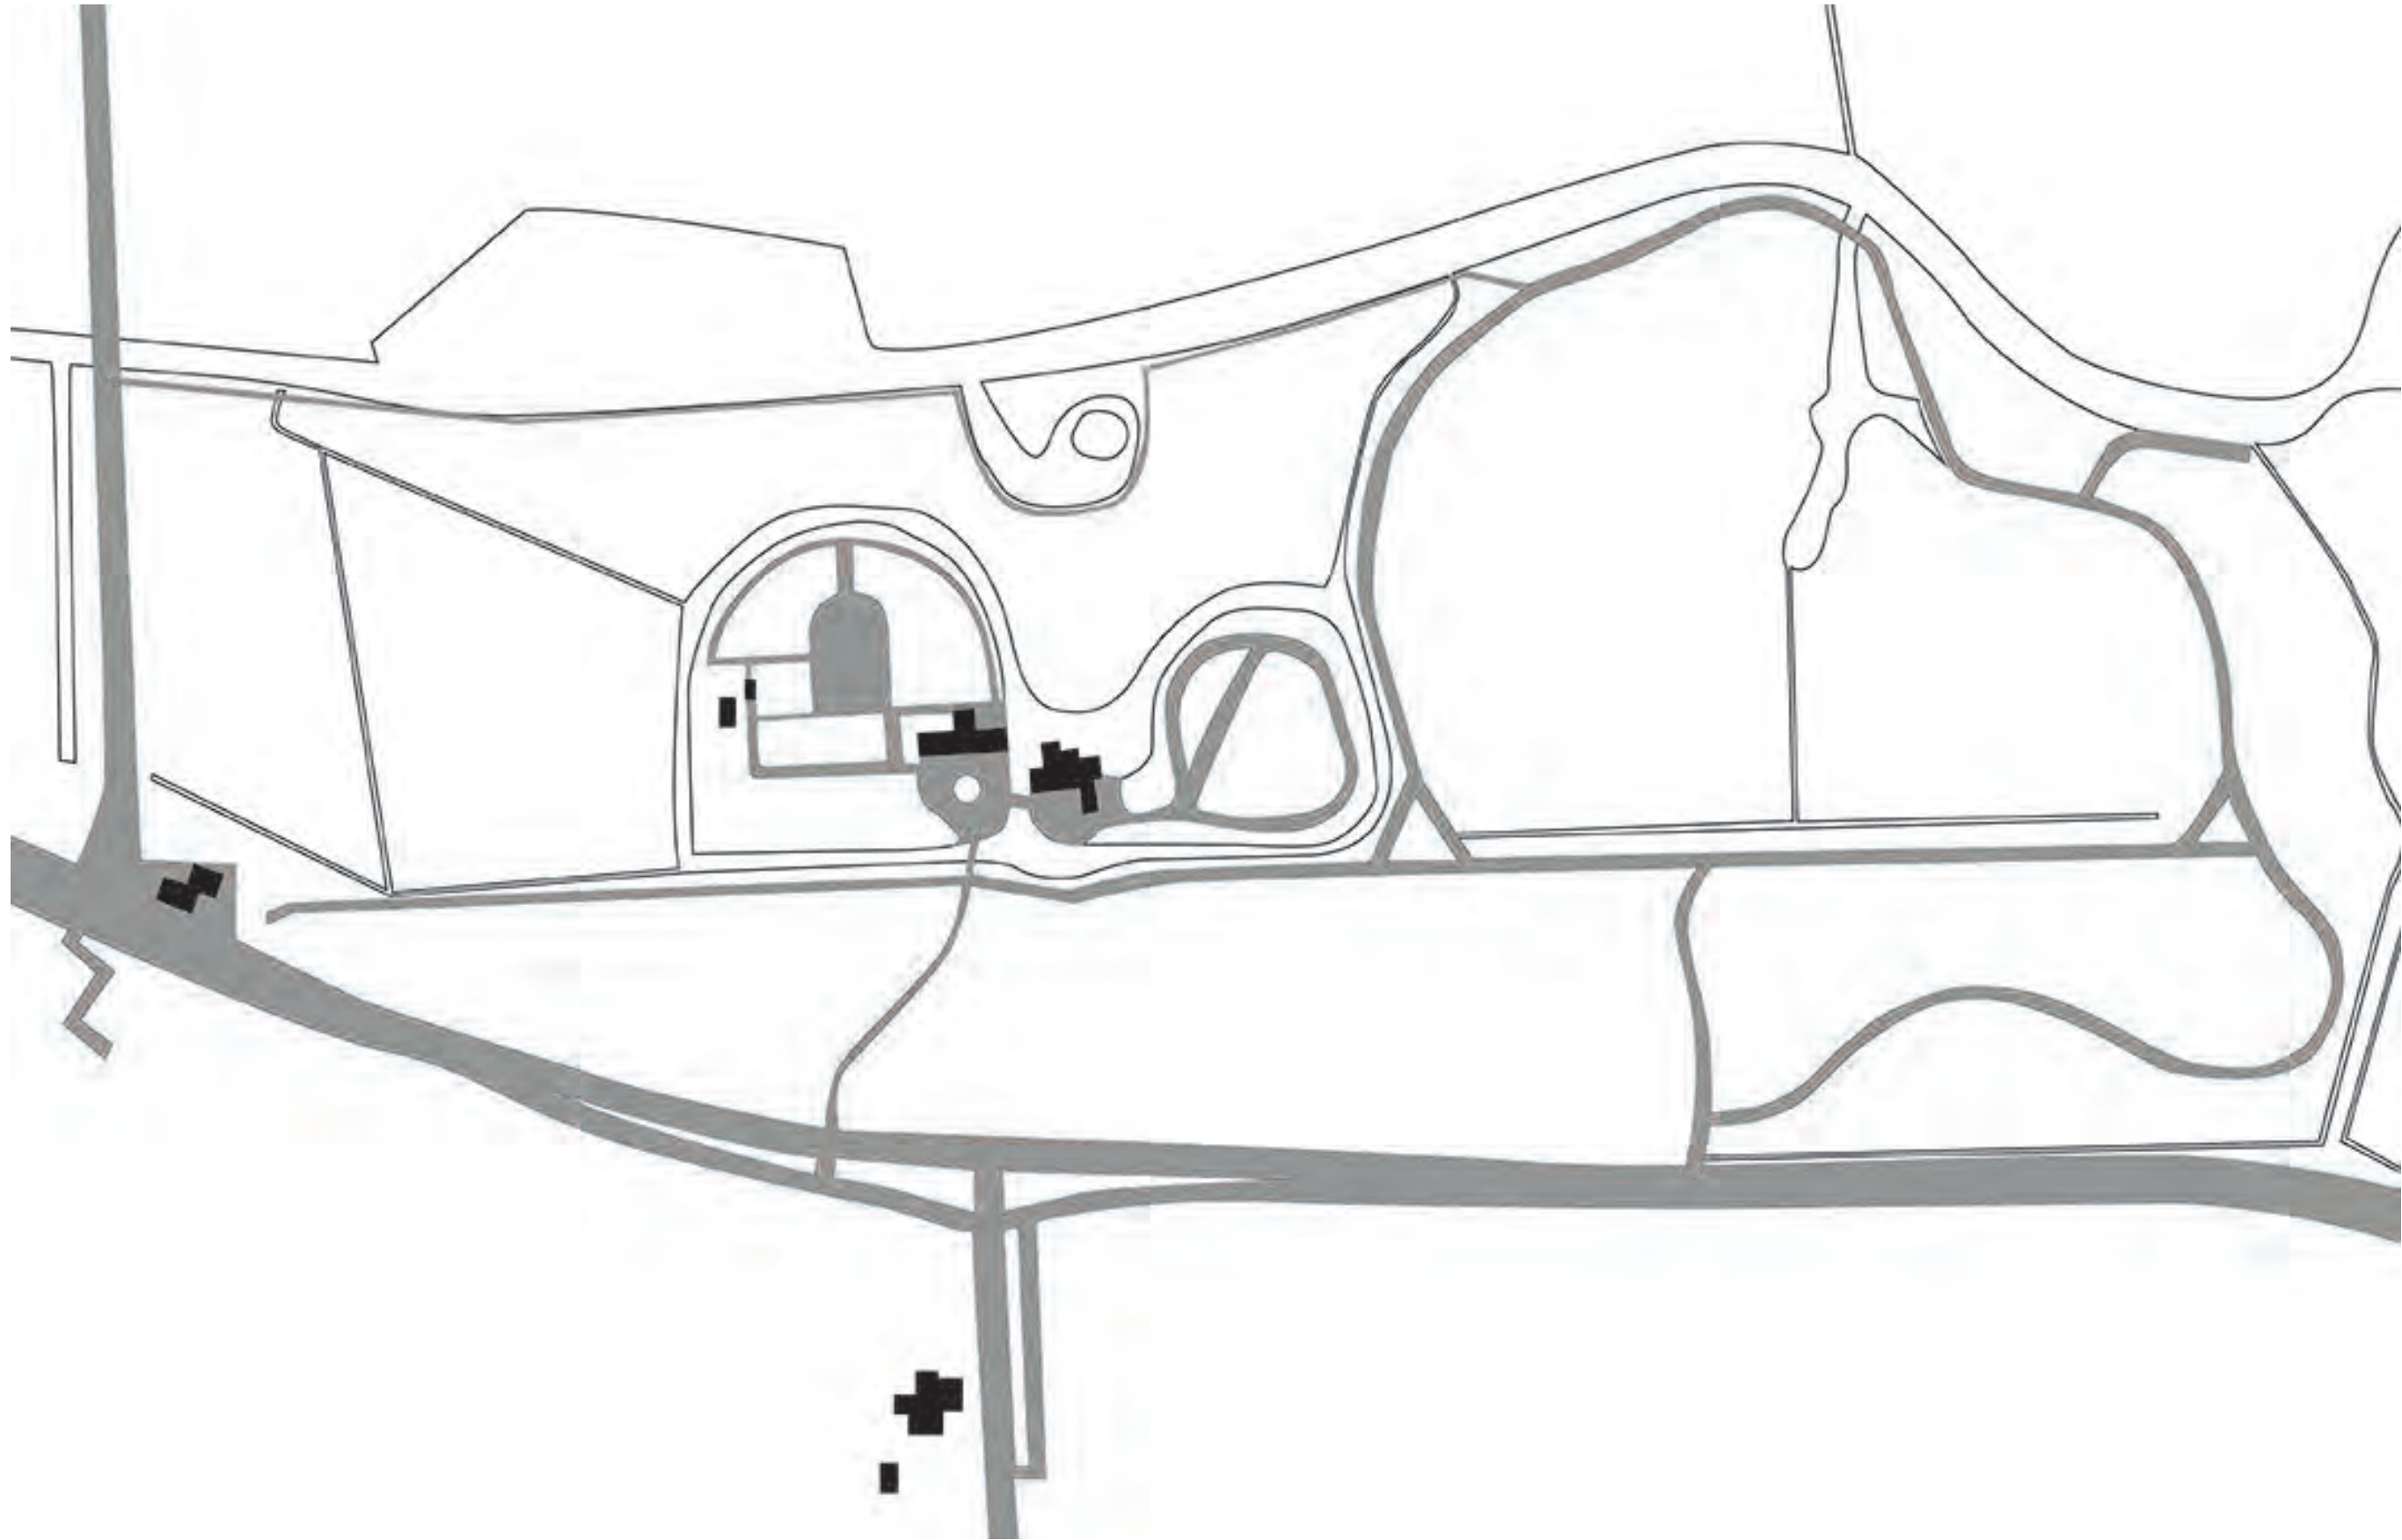
2021 - current situation: in 2005 is the small kitchen garden replaced for a memorial garden: 'Tuin van Bezinning'. There is no longer agricultural activities on the estate, besides the farms in the southern parts. Nevertheless, are these parts of the former estate in private ownership and therefore not part of the estate anymore. But, because of the familiar architecture and materials it is still visible that they once belonged to a group of buildings of 't Velde.

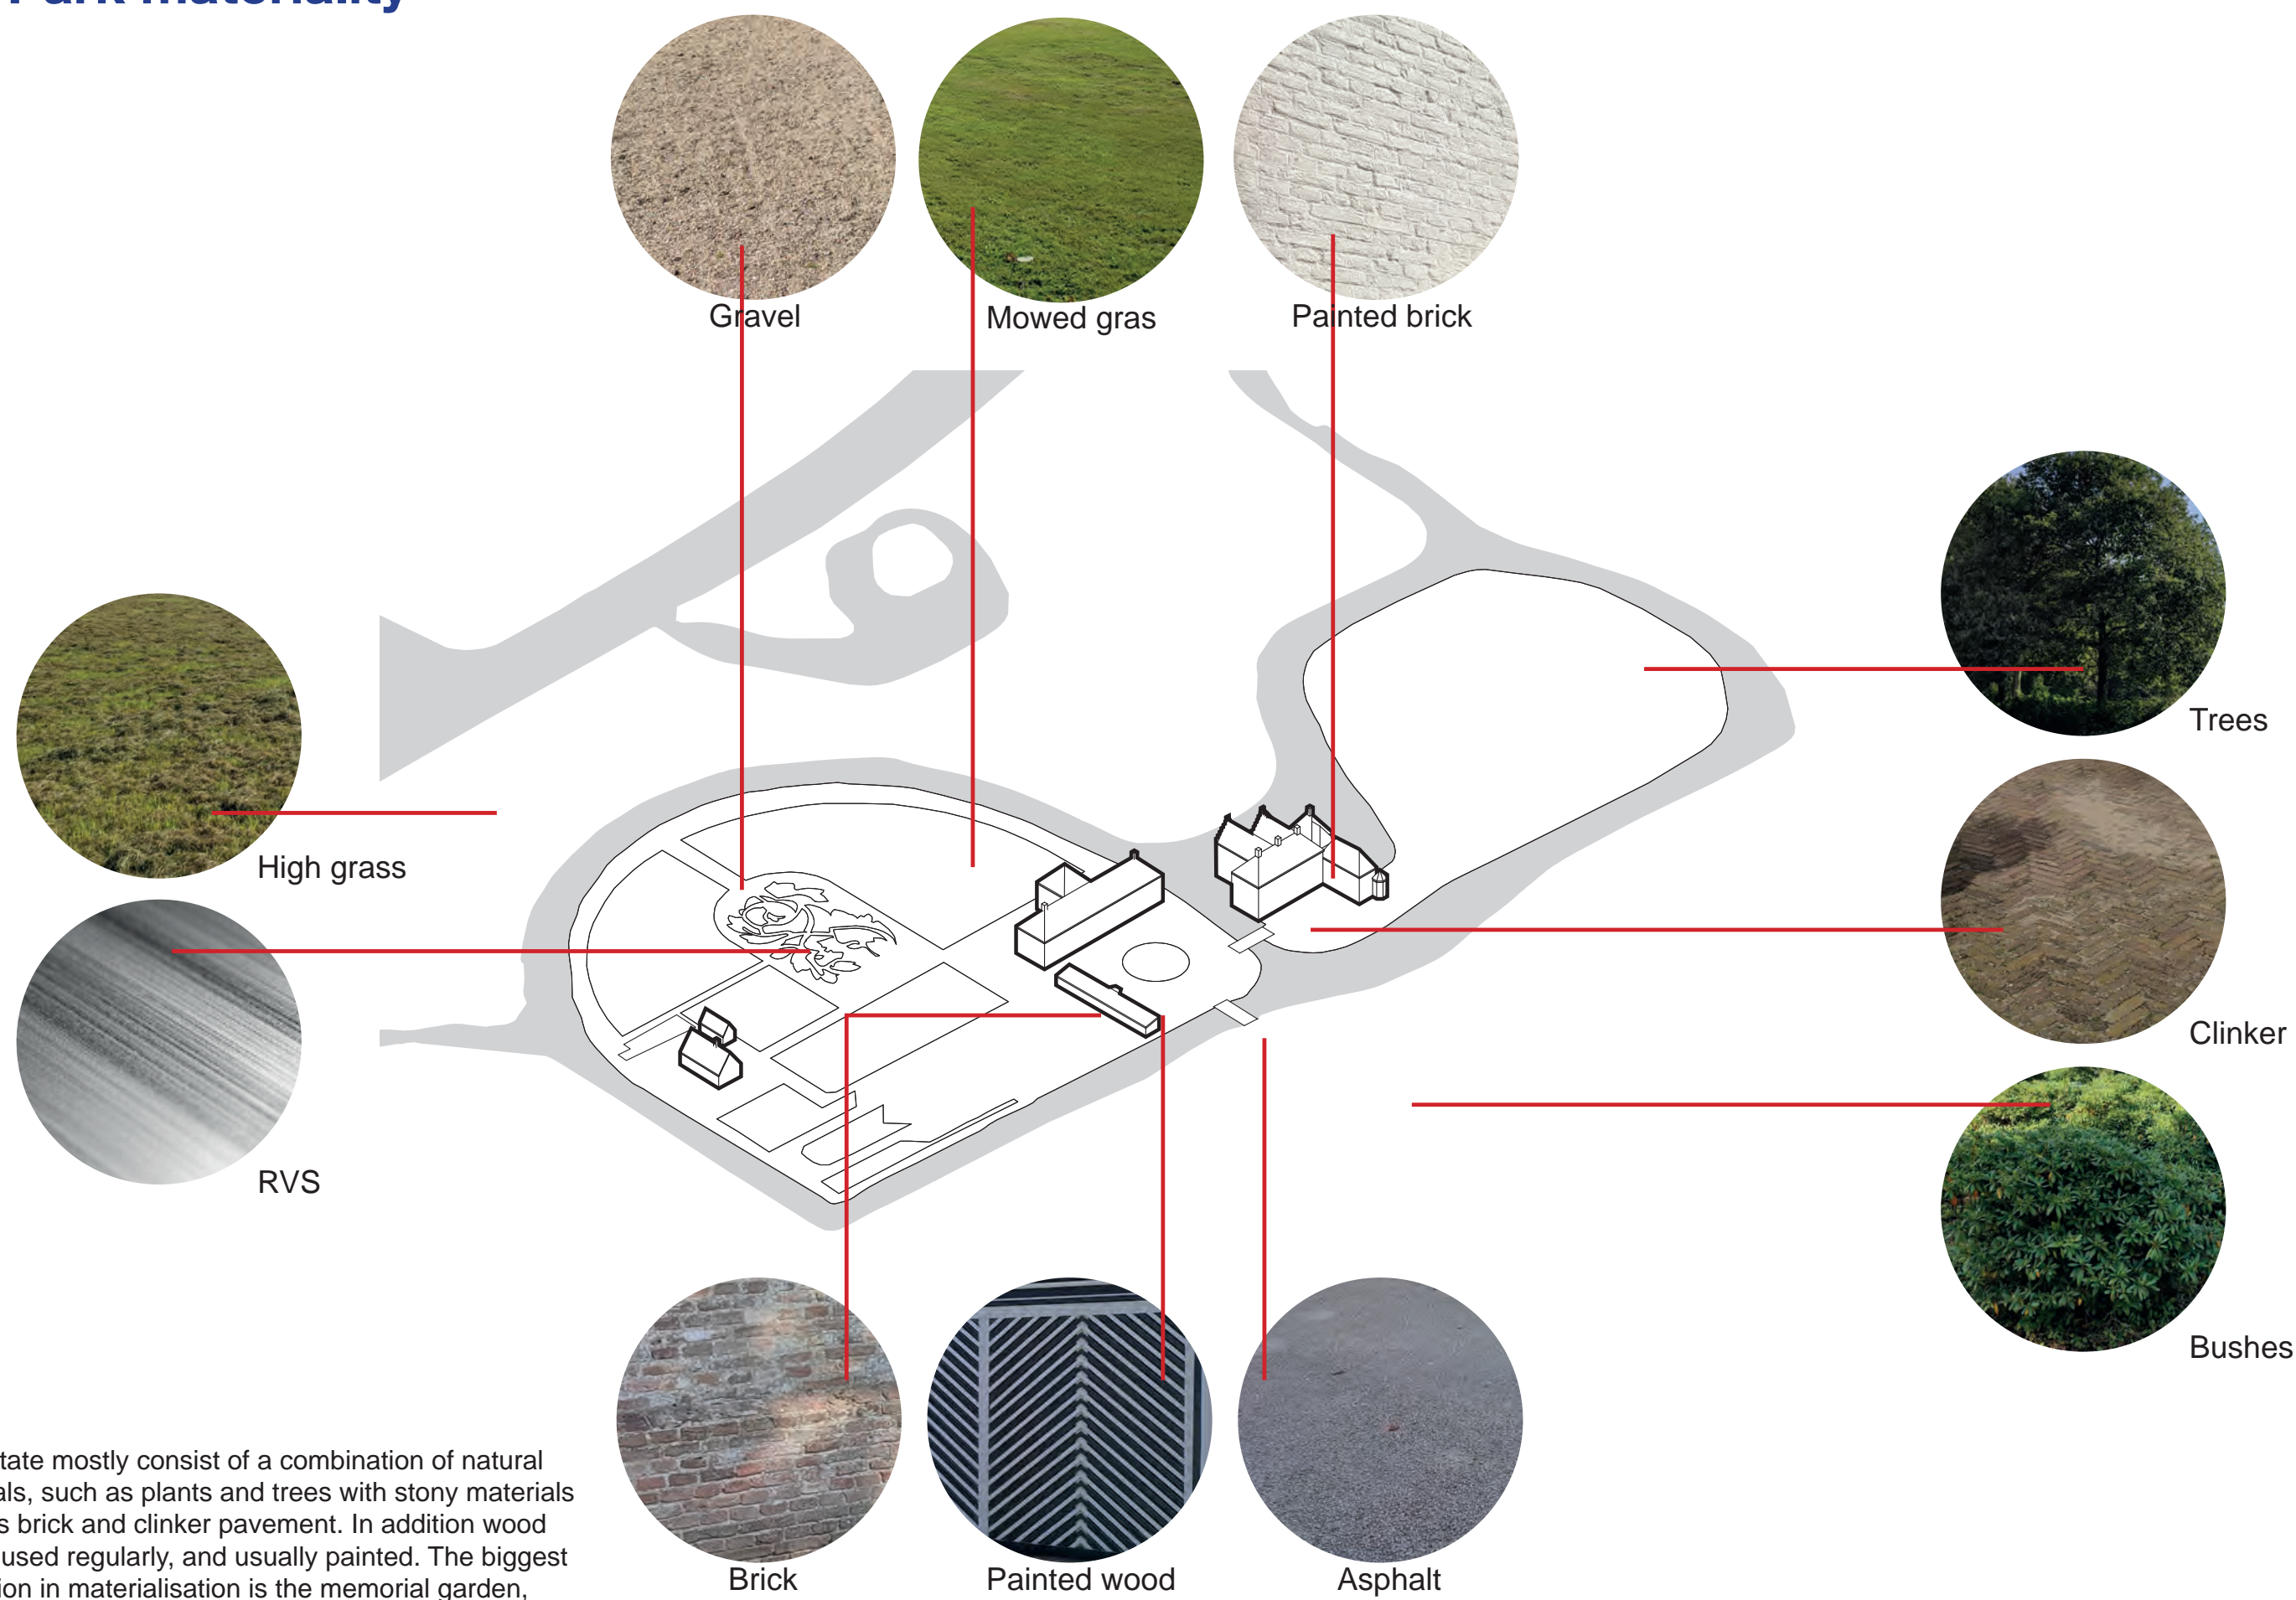
### 3.3 Park materiality

The estate mostly consist of a combination of natural materials, such as plants and trees with stony materials such as brick and clinker pavement. In addition wood is also used regularly, and usually painted. The biggest exception in materialisation is the memorial garden, where RVS plays a major role.

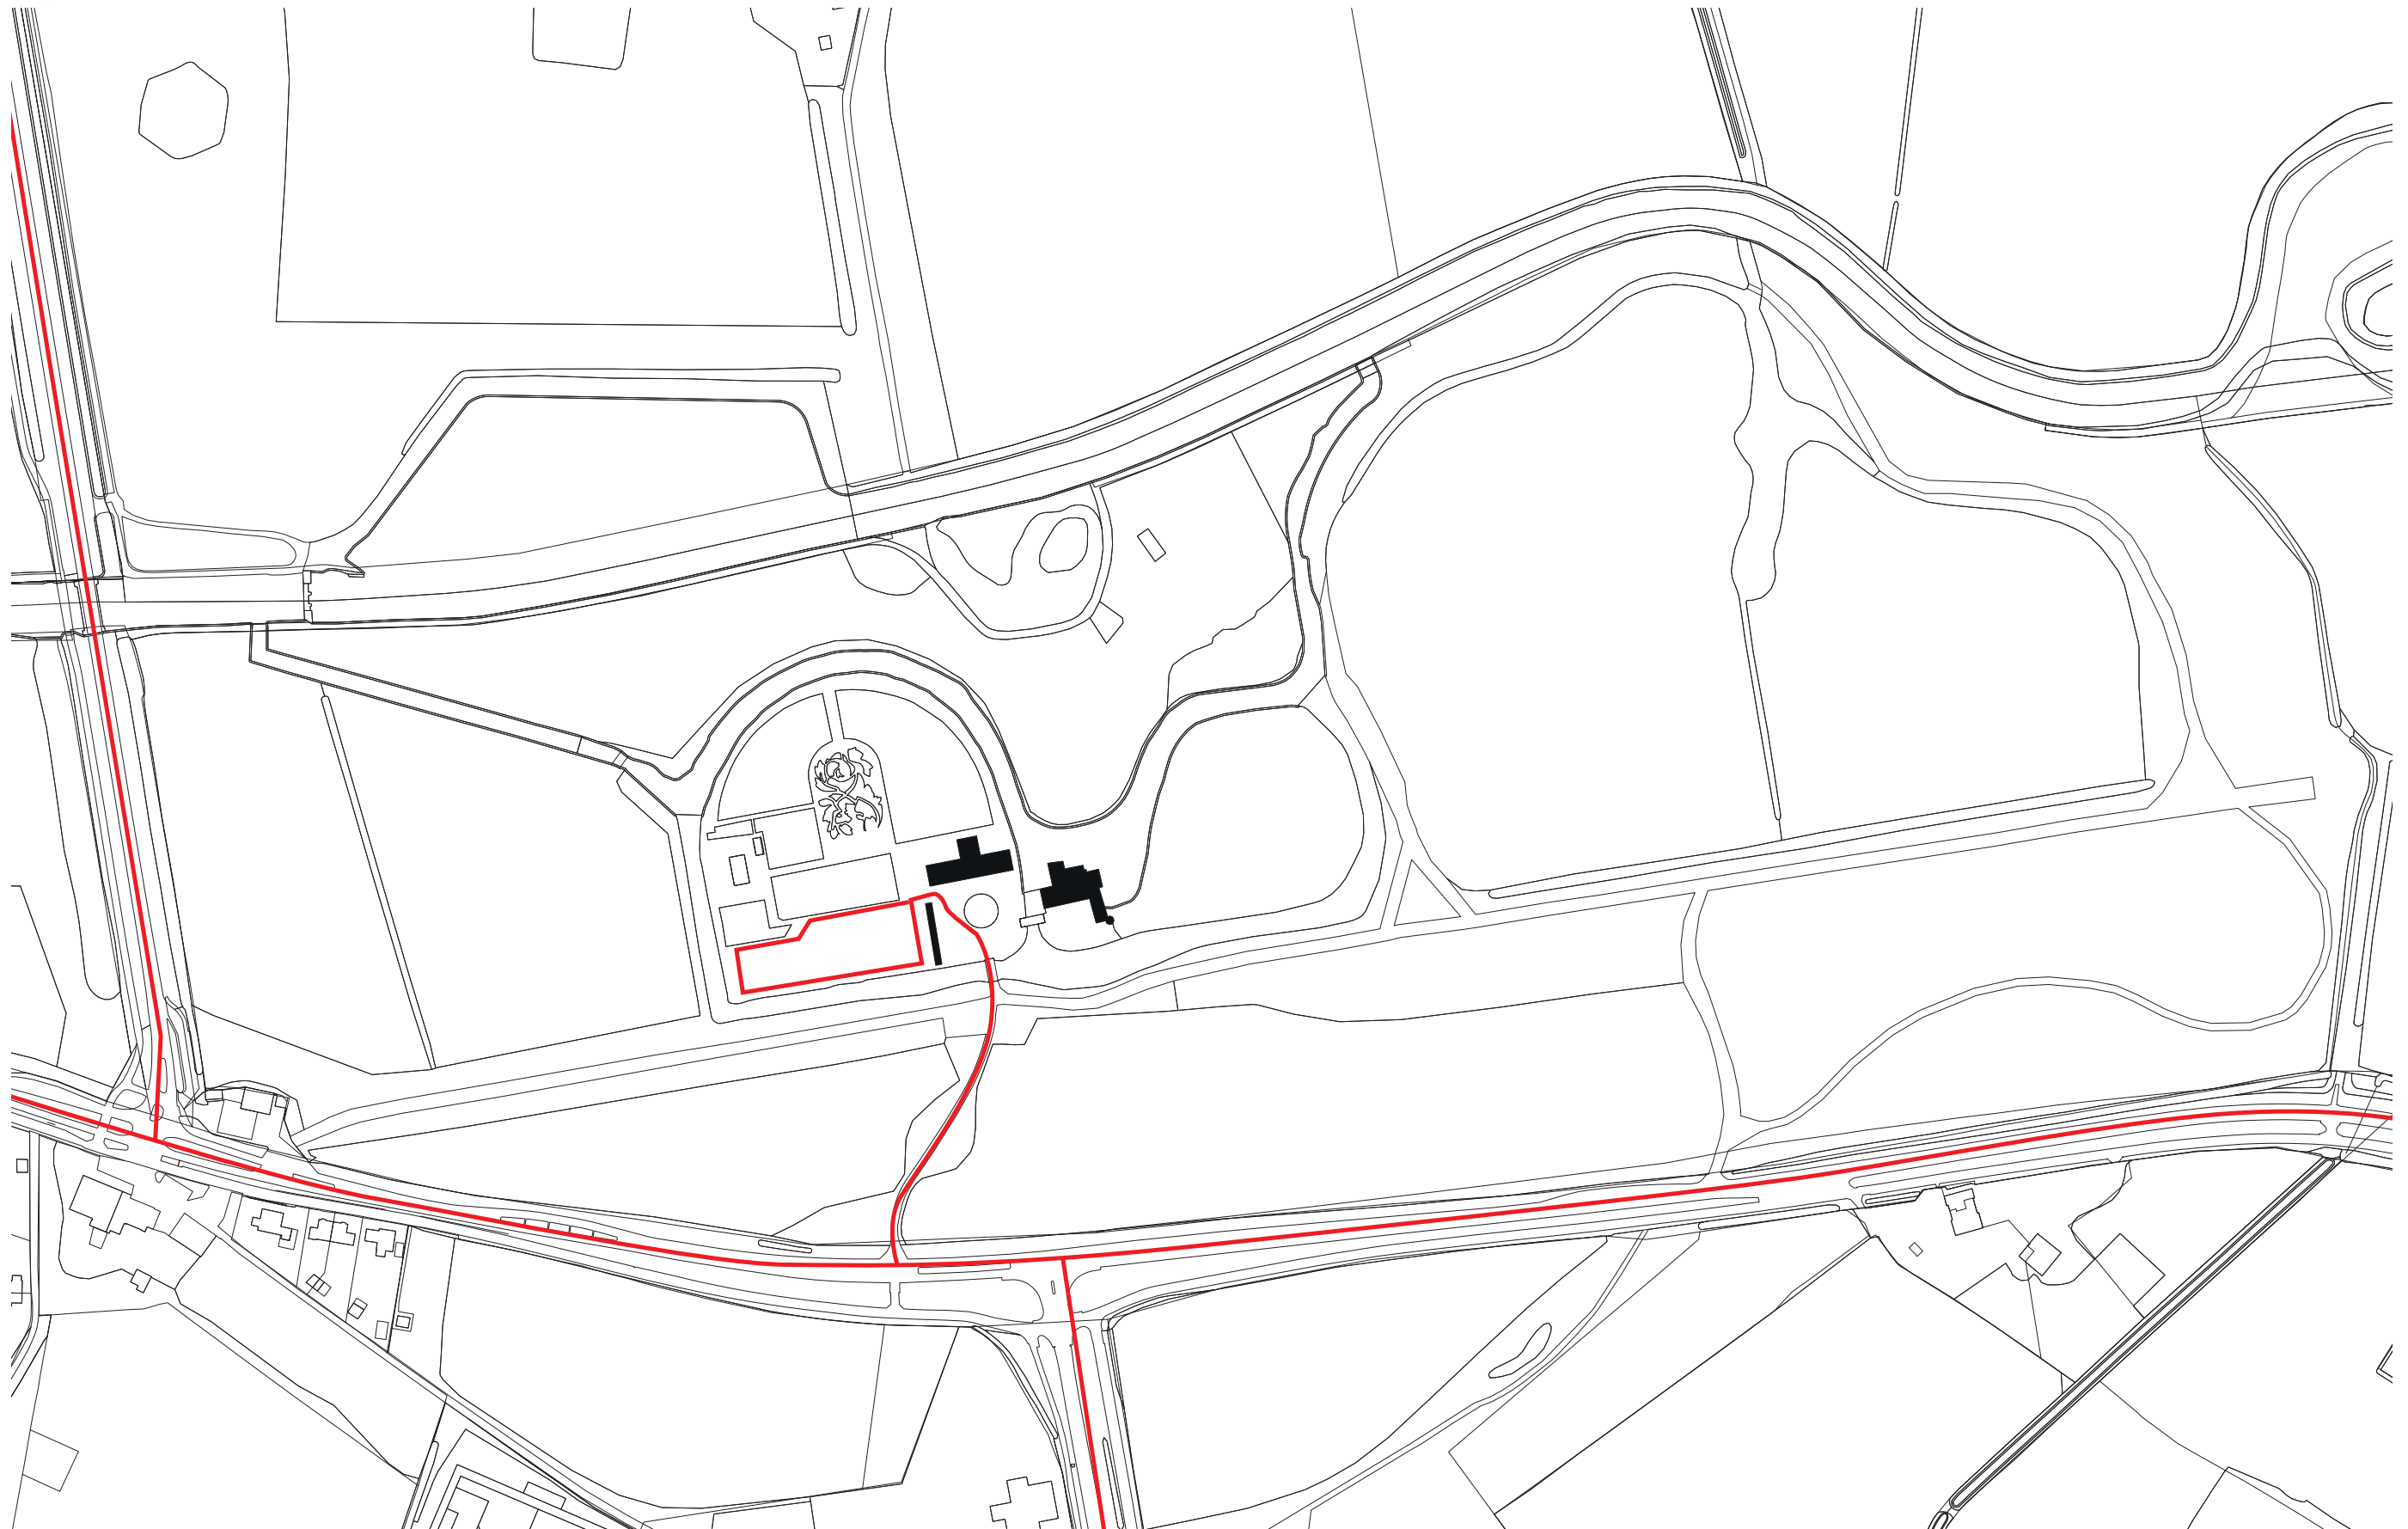
### 3.6 Car roads

South of the estate is the main road Rijksweg. The parking of the estate can be reached from this road via an access avenue. West of the estate is the Kapperallee, which leads in the direction of De Voorst. In front of the estate, on the historic sight line is the Vordenseweg.

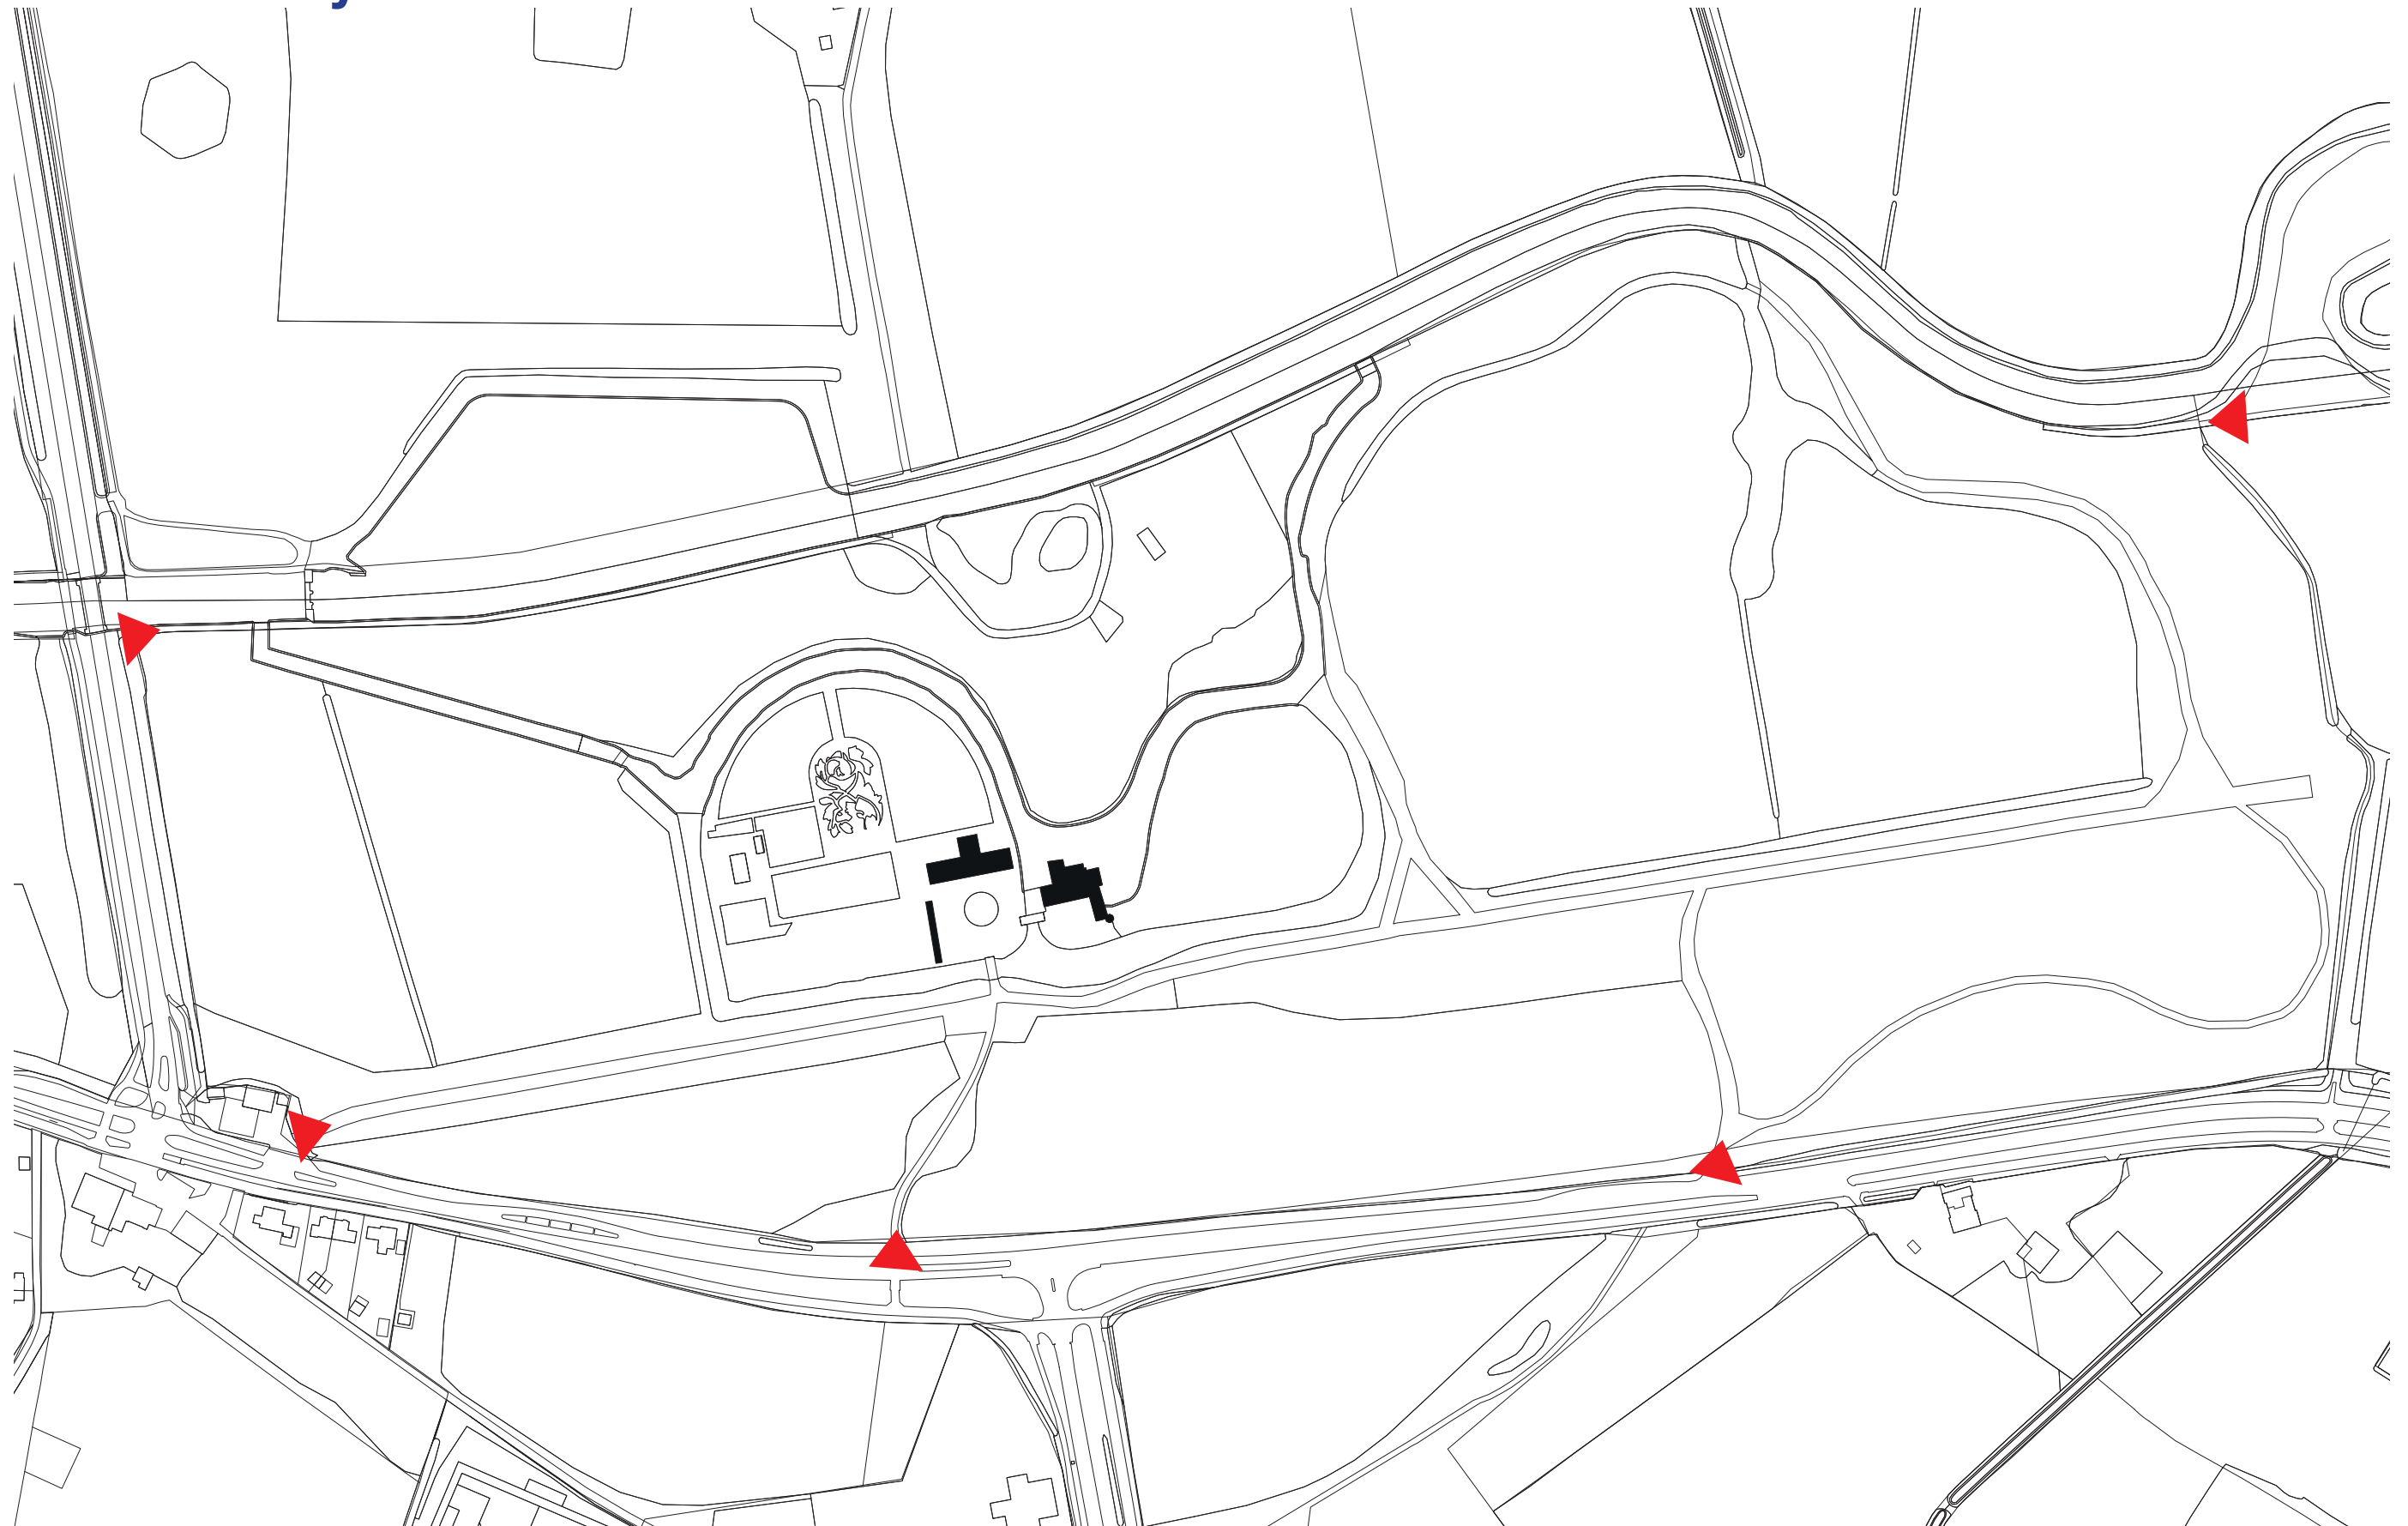
### 3.7 Accessibility estate

The plot has 5 different entrances. Two are located along the river Berkel. The main entrance is located in front of the buildings, and can be accessed from the Rijksstraatweg. The two other entrances are also accessible from the Rijksstraatweg, and connected to the walking routes over the estate.

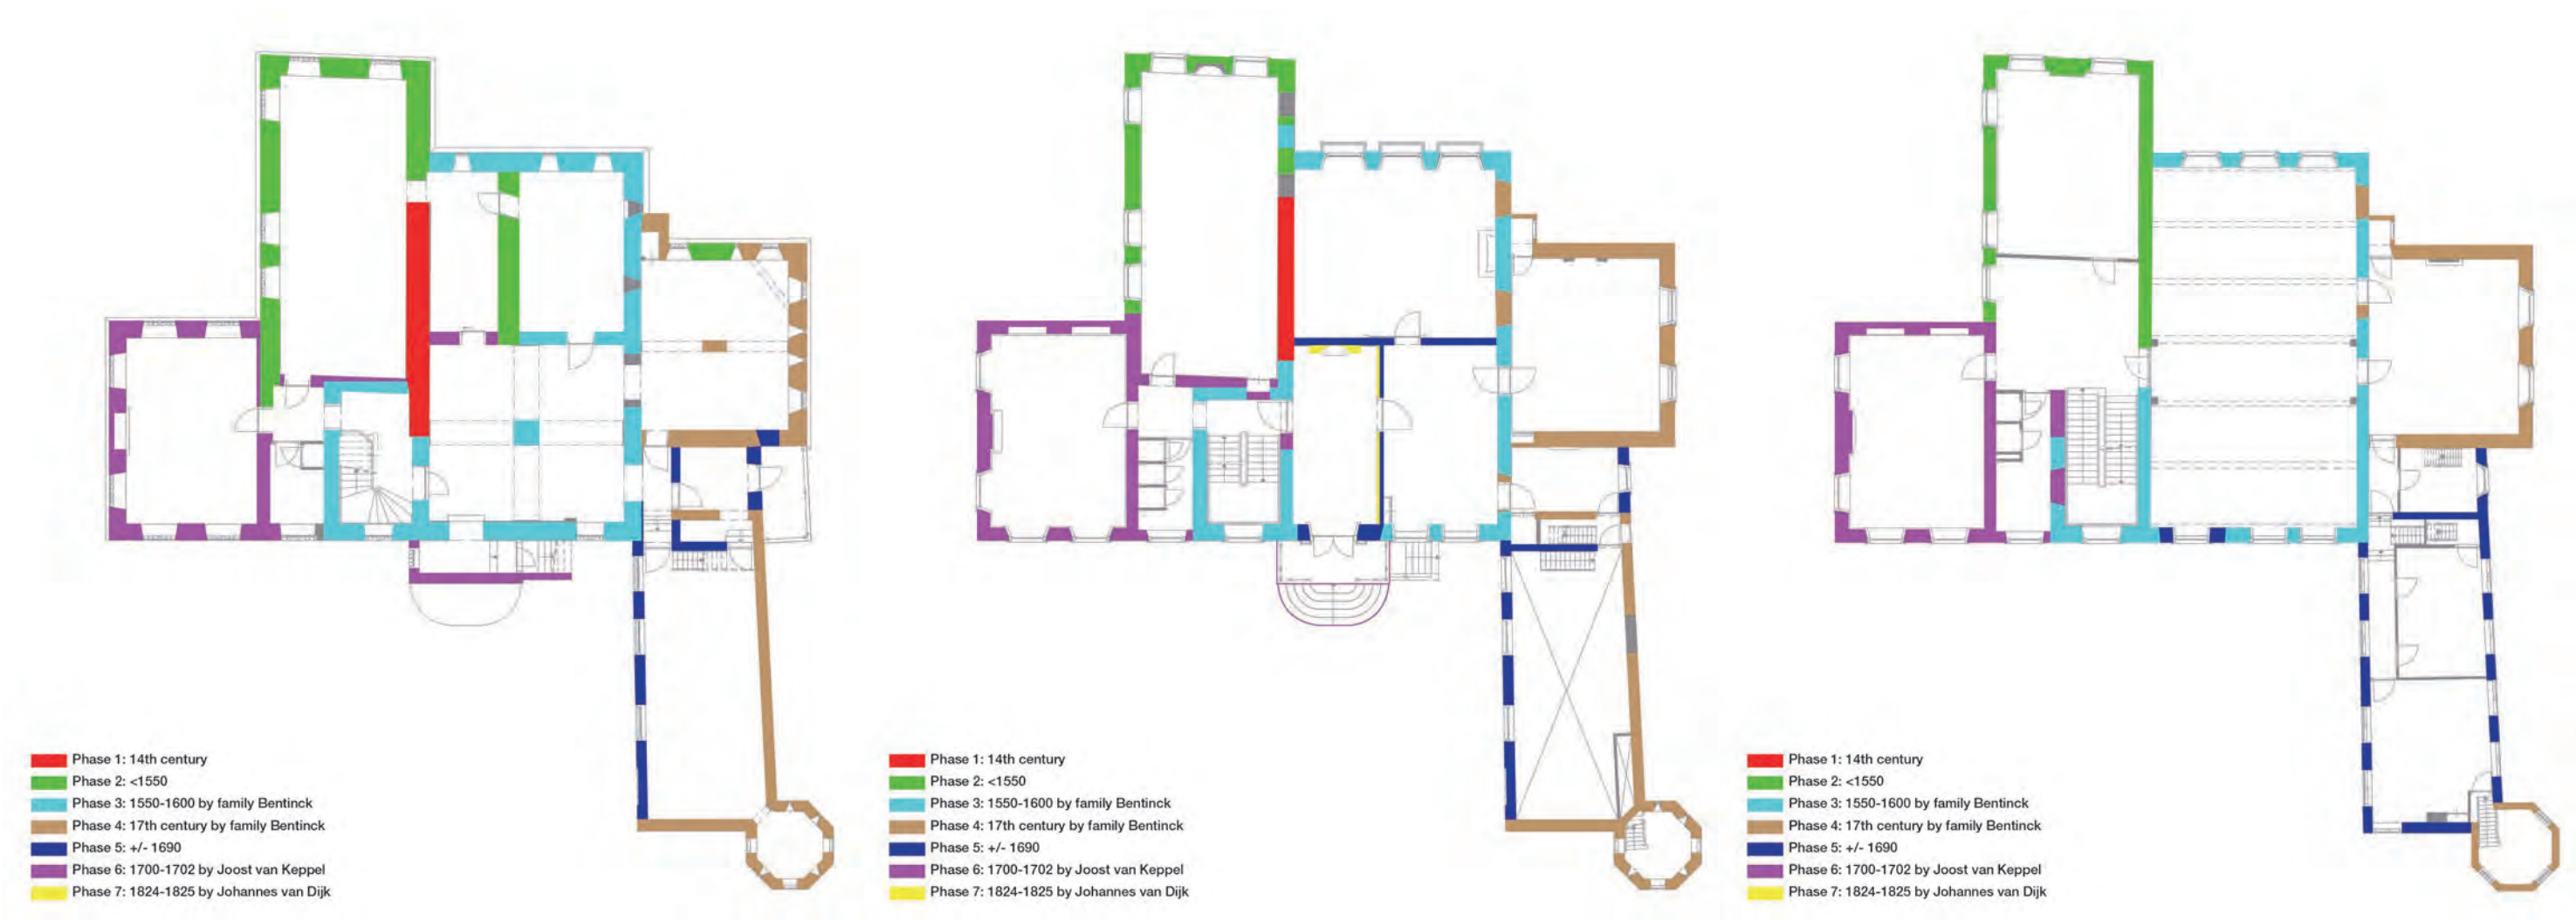
# 4.2 Construction age

The development of the mansion on the estate Huis 't Velde consist of many different extension. From the oldest building phase are probably only some parts of the brick construction left. Most of the other added building volumes are still clearly visible. The last major changes, around 1824 where mostly architecturally; no large volume was added.

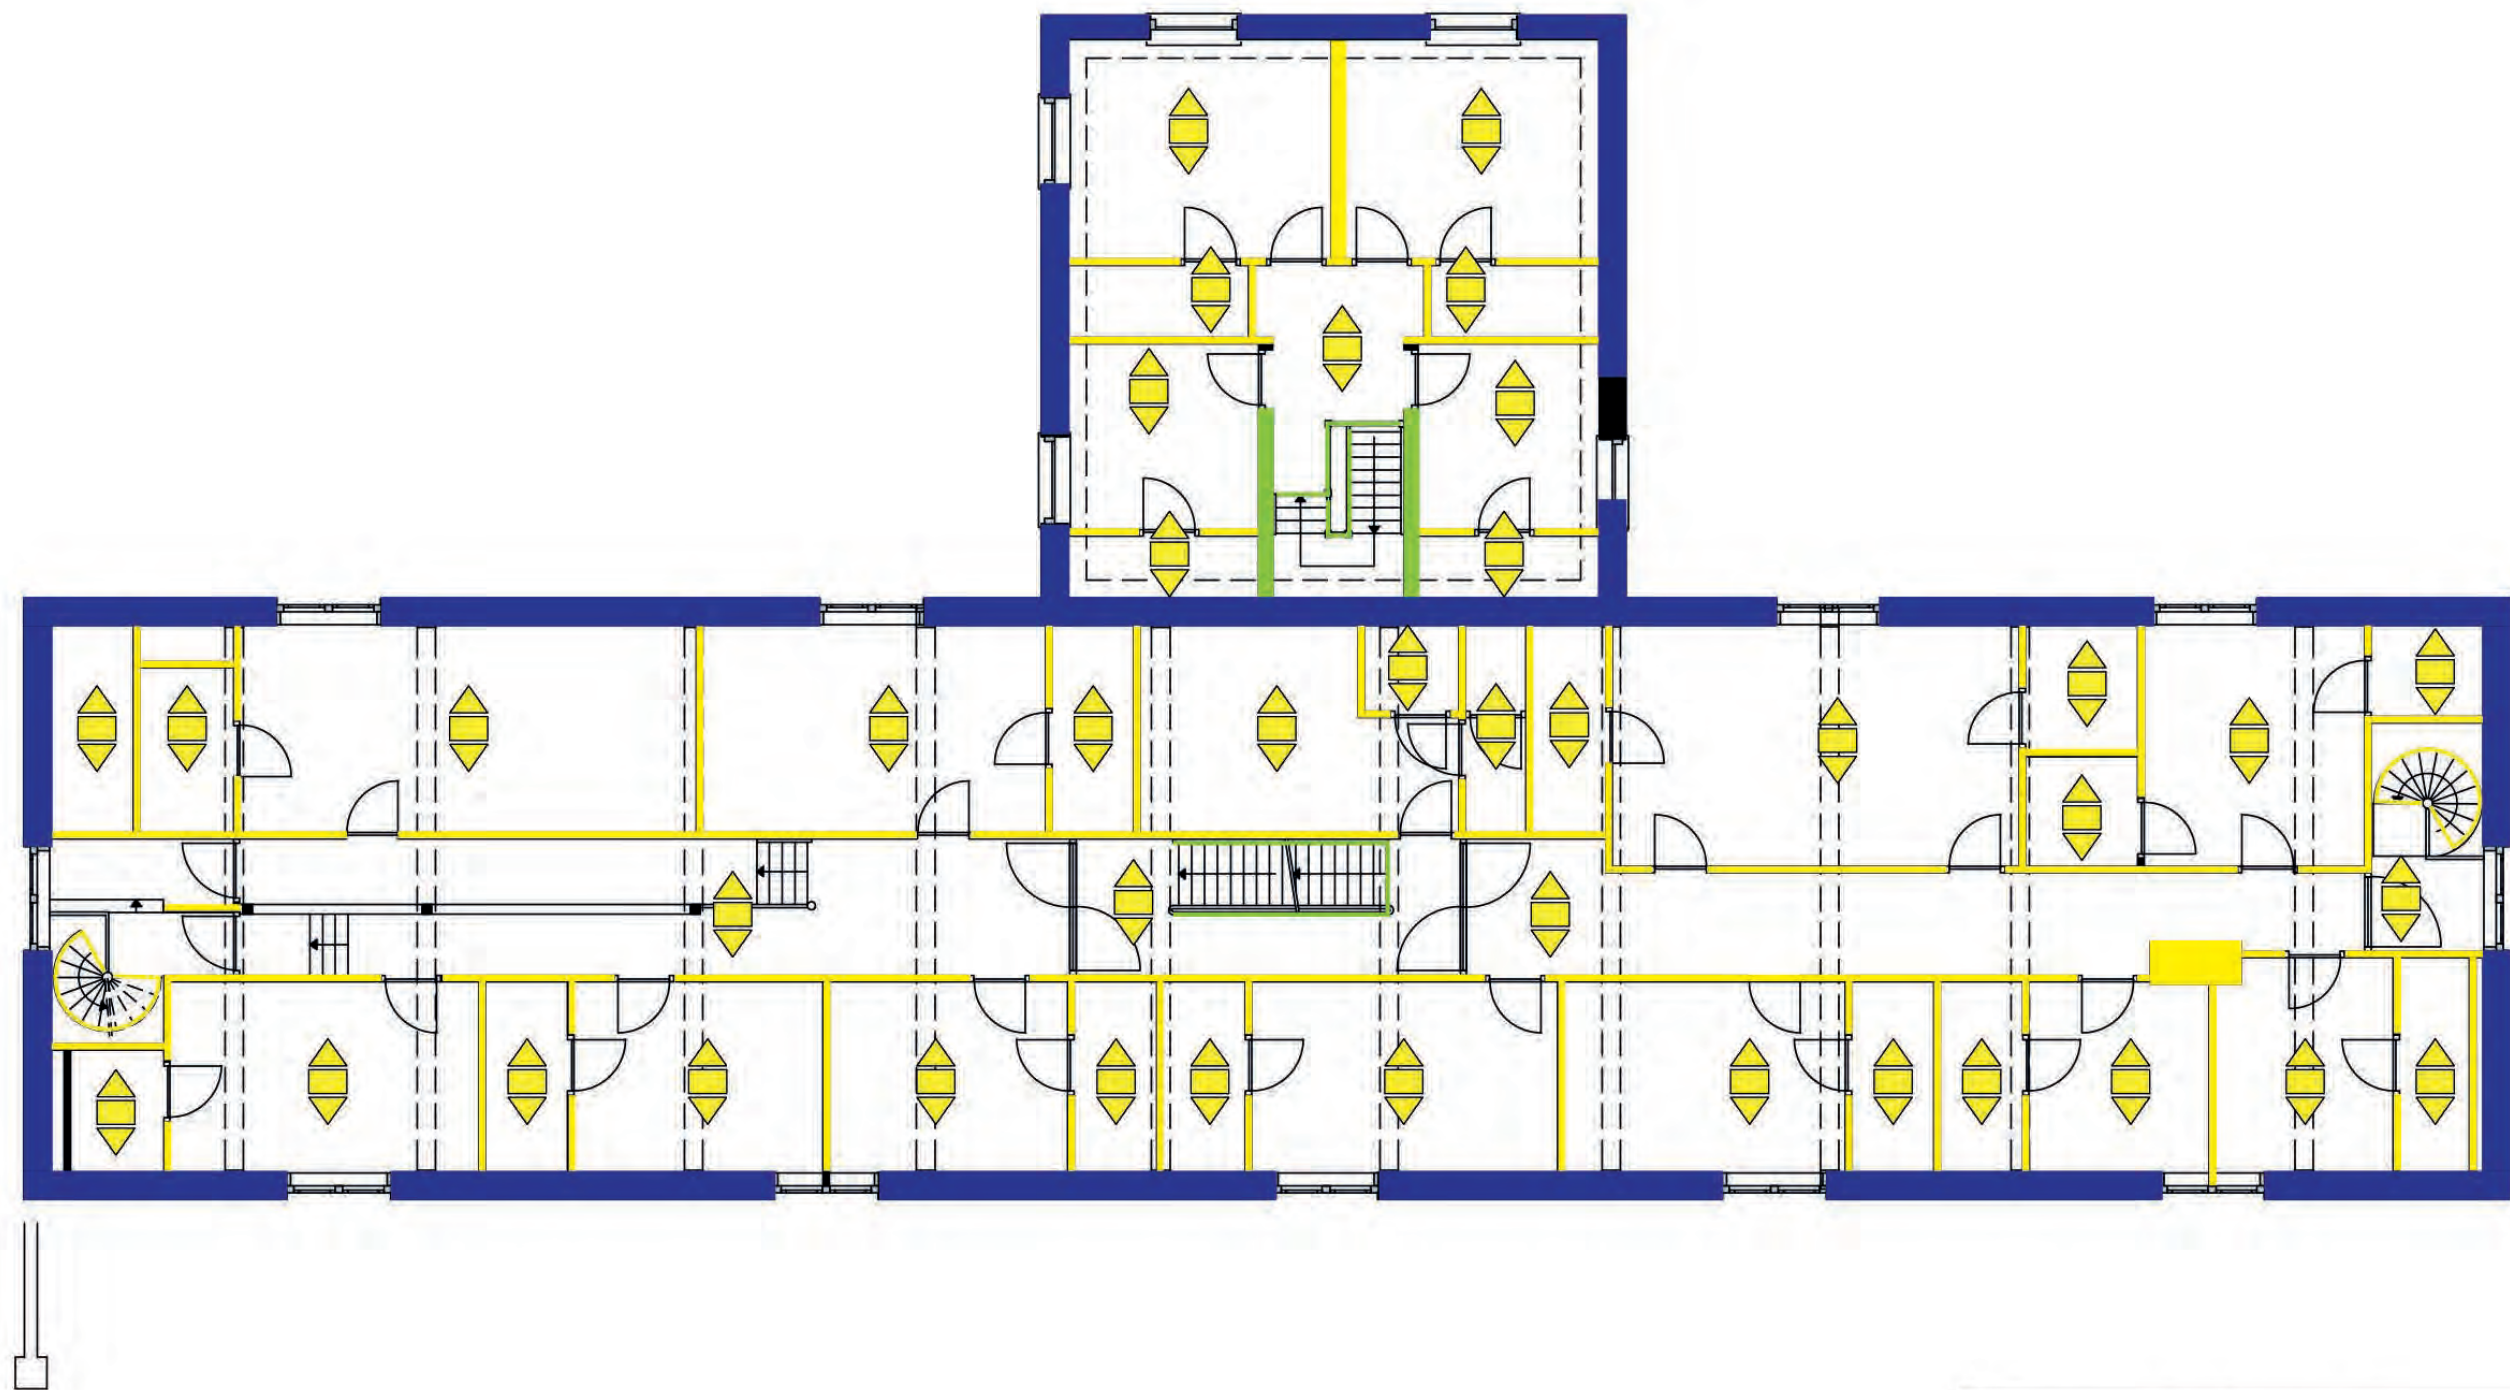
**Monumental value assesment**  
 Valued are: interior finish and structure

Carriage building first floor (existing situation)

- Window frames have a 'high' value unless otherwise stated
- Windows in the above frames are from the 1965 restoration period. These are valued 'positive'.
- The interior is completely renovated during the redesign for a hotel user function. There are no monumental parts left.
- Wooden column and truss construction presumably part of old structure.
