# **Graduation project Vacant Heritage Analysis booklet - Sustainable estate of the future**

*Research and design into a sustainable reuse of Dutch  
buitenplaats Huis 't Velde*

Mathyn Carsten Klein MA. ing.

Final version P5  
June 16, 2022.

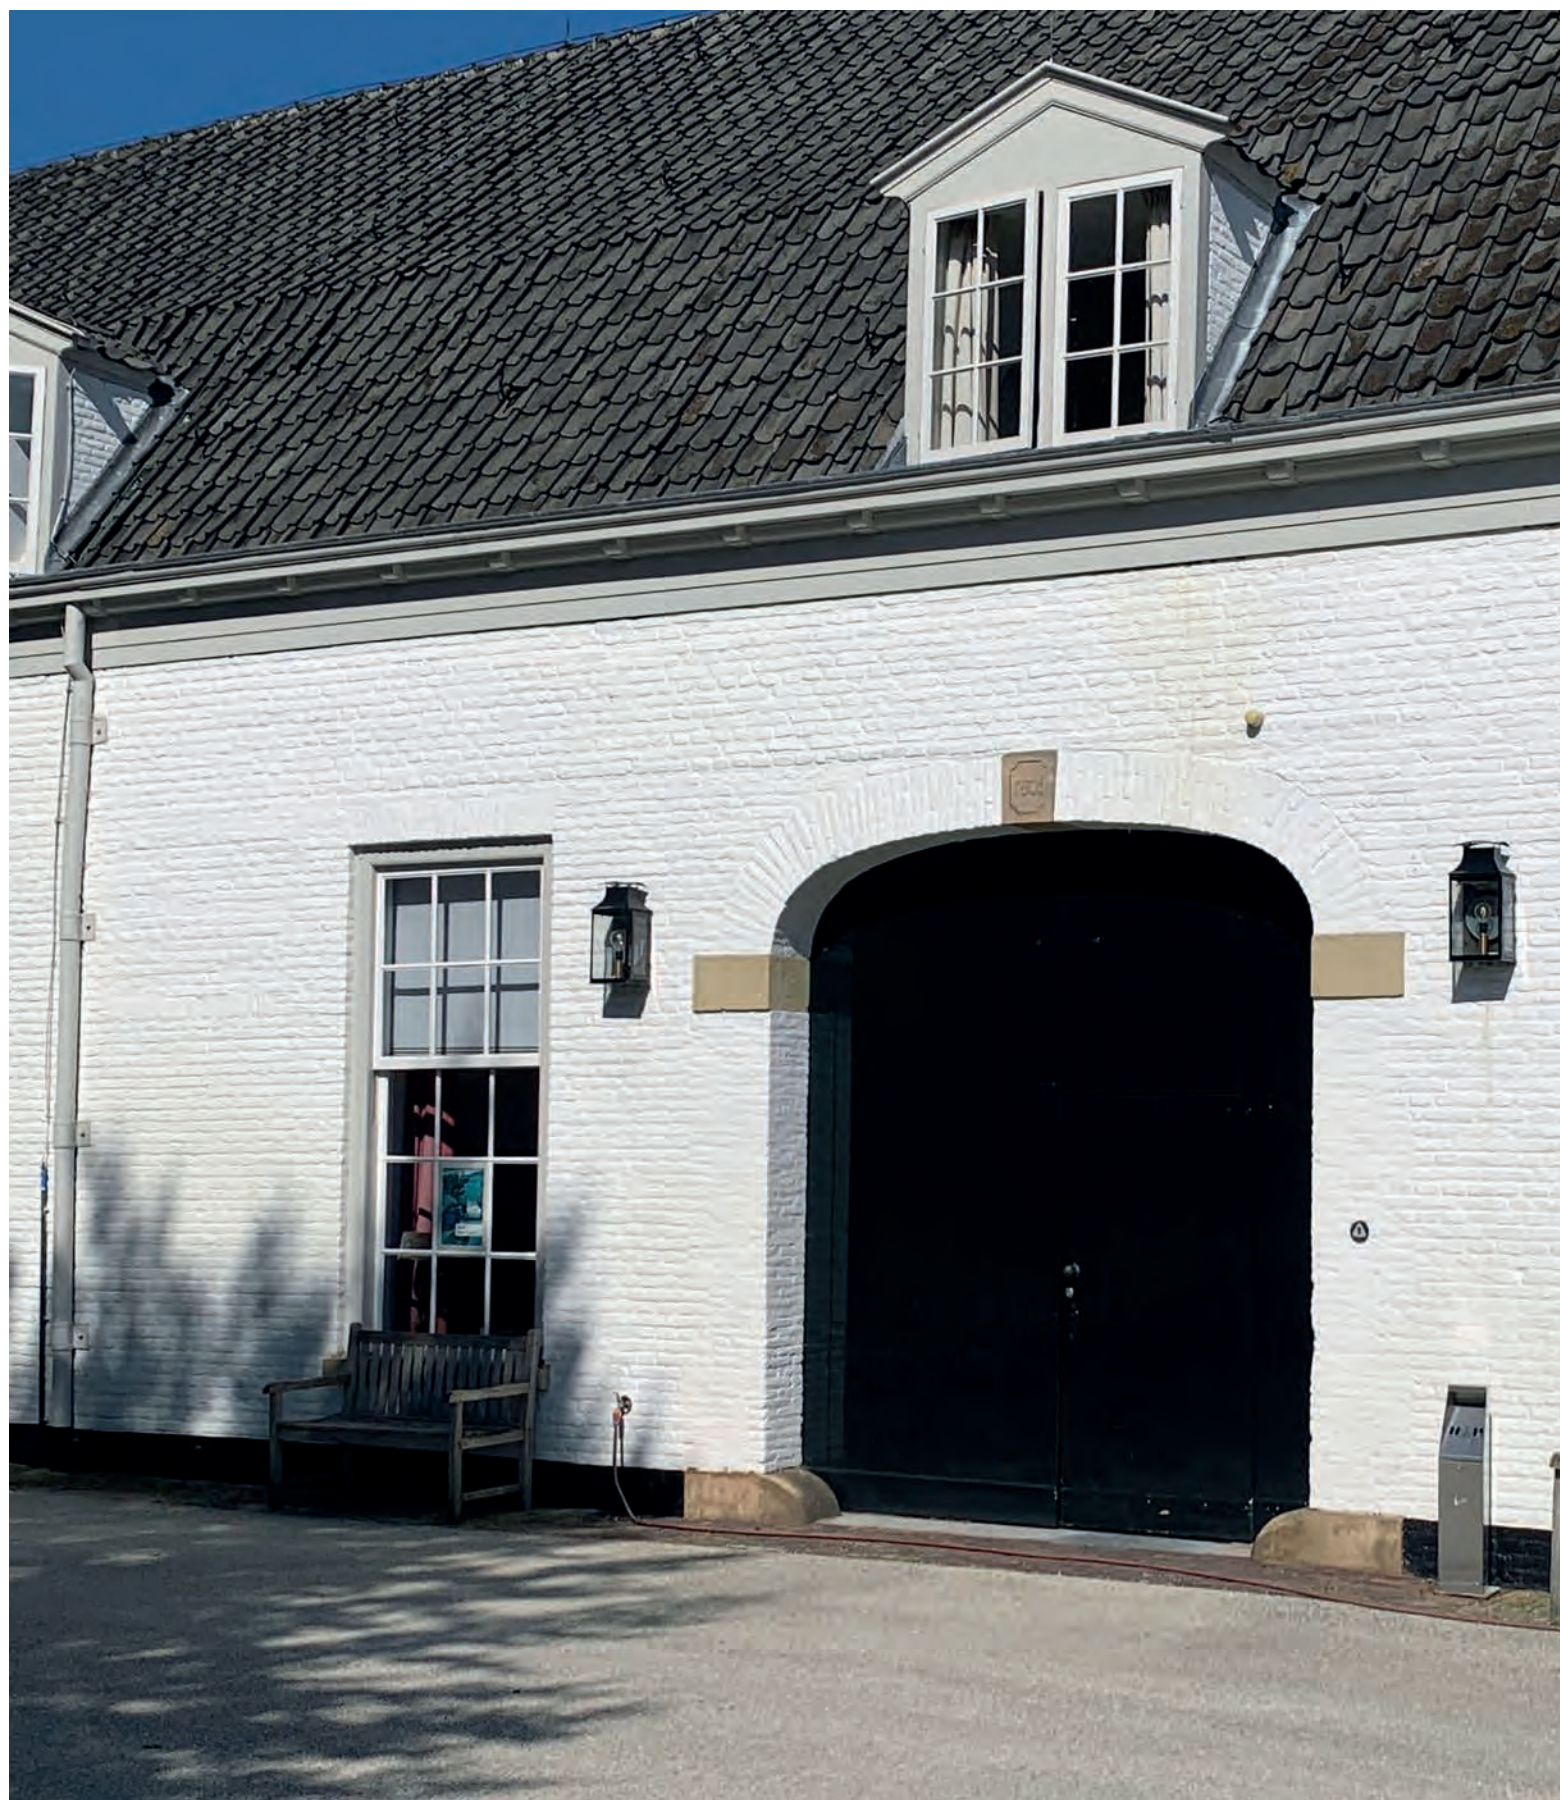
The building volume may only consist of one storey and a roof. The basic shape is rectangular or a T-shape. The shape of the roof may be varied, as shown in the diagrams on the right. A 3D study elaborates on this.

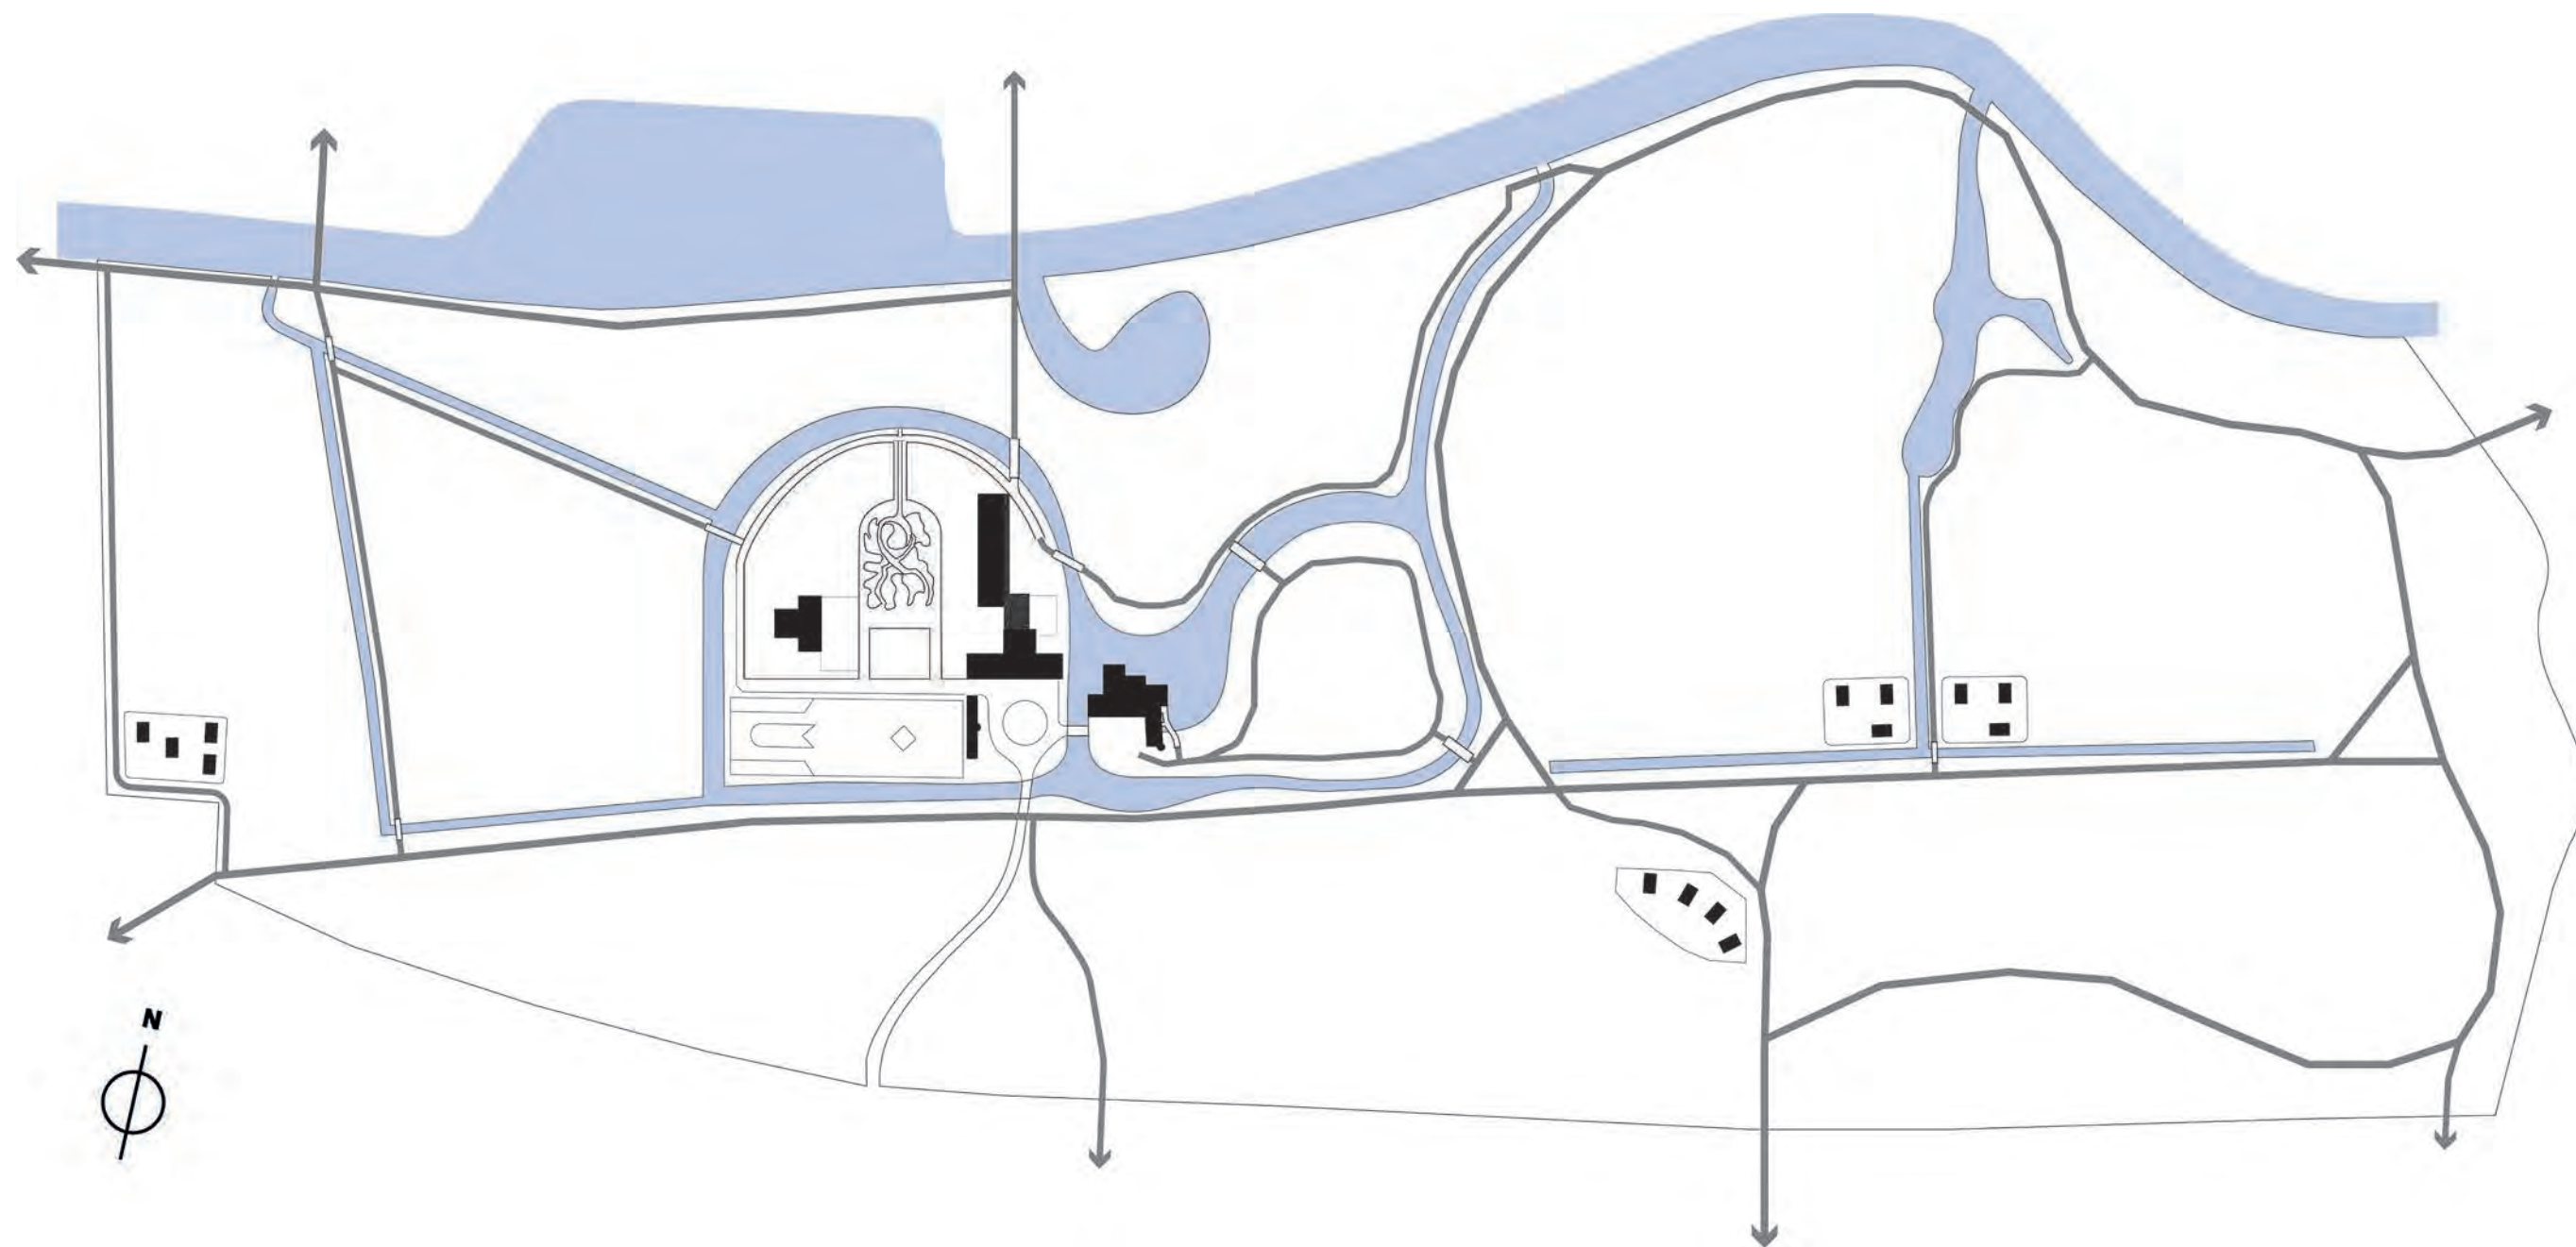
### Drawing of the new design of the estate

Four locations are selected to built residential areas. The locations have been selected for their situation. It is close to a forest edge, path and not directly in sight of the mansion.

The layout of the areas is free to design, but is subject to a number of boundary conditions that have been drawn up for this. In this way, an architectural style is guaranteed that fits the estate. Regardless of which architect designs it. On the next page, these criteria are elaborated in an example plan of one area.
