Measurements Hedwige - Prosperdijk

This appendix treats the results of the grass pull tests that were executed on the Hedwige - Prosperdijk. The coordinates of the location where the measurements took place are 51°20'52.4"N 4°13'46.2"E. The subsoil is characterised as clay with a low sand content. Two different types of tests have been conducted:

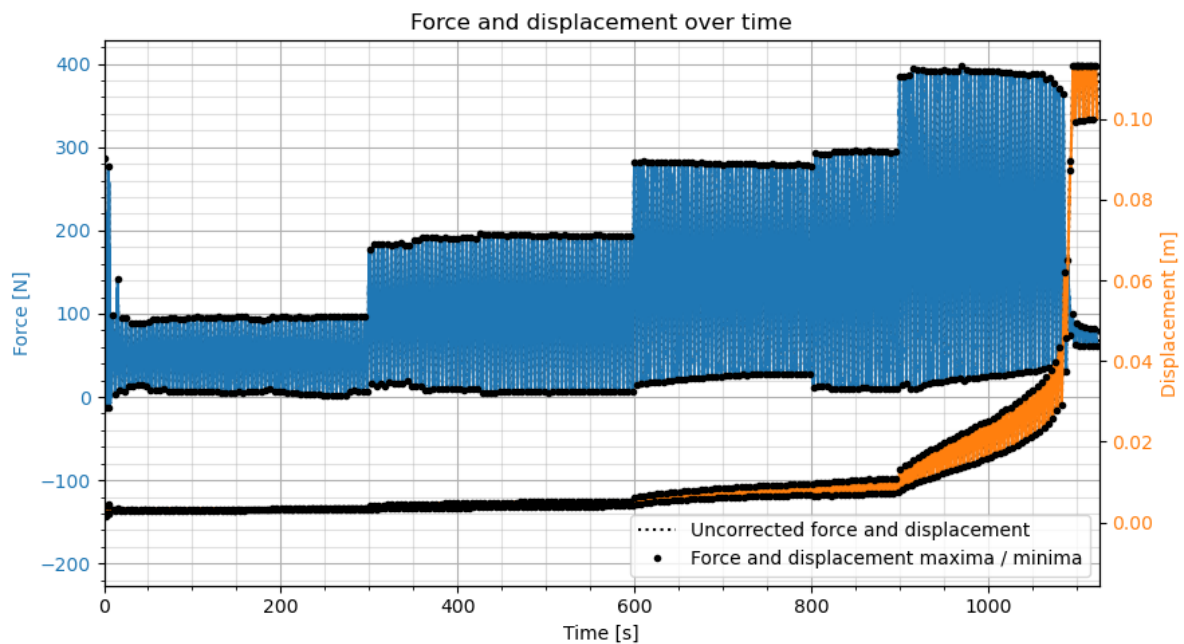
Force and displacement over time

Value 1	Value 2	Value 3	Mean
Date		03-03-2021			
Time		13:21:00			
Cyclic Load regime	[N]	Stepwise			
Weight	[kg]	8.0			
Width	[cm]	18.0			
Length	[cm]	21.0			
Dike orientation		South-west			
Percentage of occurrence	[%]	50.0	20.0	30.0	
Sod thickness	[cm]	8.0	7.0	5.0	7
Root length	[cm]	3.0	10.0	5.0	5.0
Mean peak stress	[kN/m ²]	5.84			
Maximum number of cycles	[-]	224			
Comments		-
