UNIDIRECTIONAL SULFATE INGRESS IN LIMESTONE CALCINED CLAY CEMENT (LC³) PASTES UNDER CYCLIC EXPOSURE

Qiao Wang* (1), William Wilson (1) and Karen Scrivener (1)

(1) École Polytechnique Fédérale de Lausanne, Switzerland

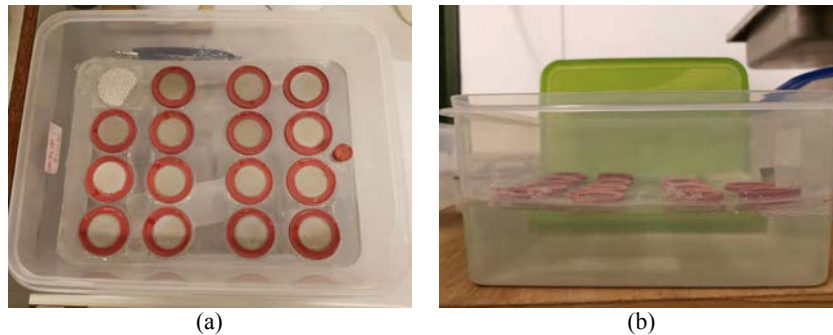
Figure 1: The setup for unidirectional sulfate penetration test

slices were then ready for installation in the semi-immersion setup, as illustrated in Fig. 1. The setup was placed in a 40 °C room with relative humidity 33 % and, after one week, the setup was transferred into a 20 °C room with relative humidity 78 %. This 2-week cycle was repeated until the age of testing.

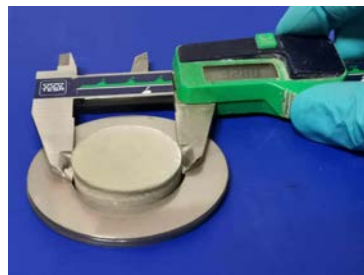
Figure 2: Lateral expansion measurement

The lateral expansion was measured parallel to the degradation front (parallel to the exposed surface). The measurement was carried out as shown in Fig. 2, using 1-mm thick steel rings and a digital slide calliper.

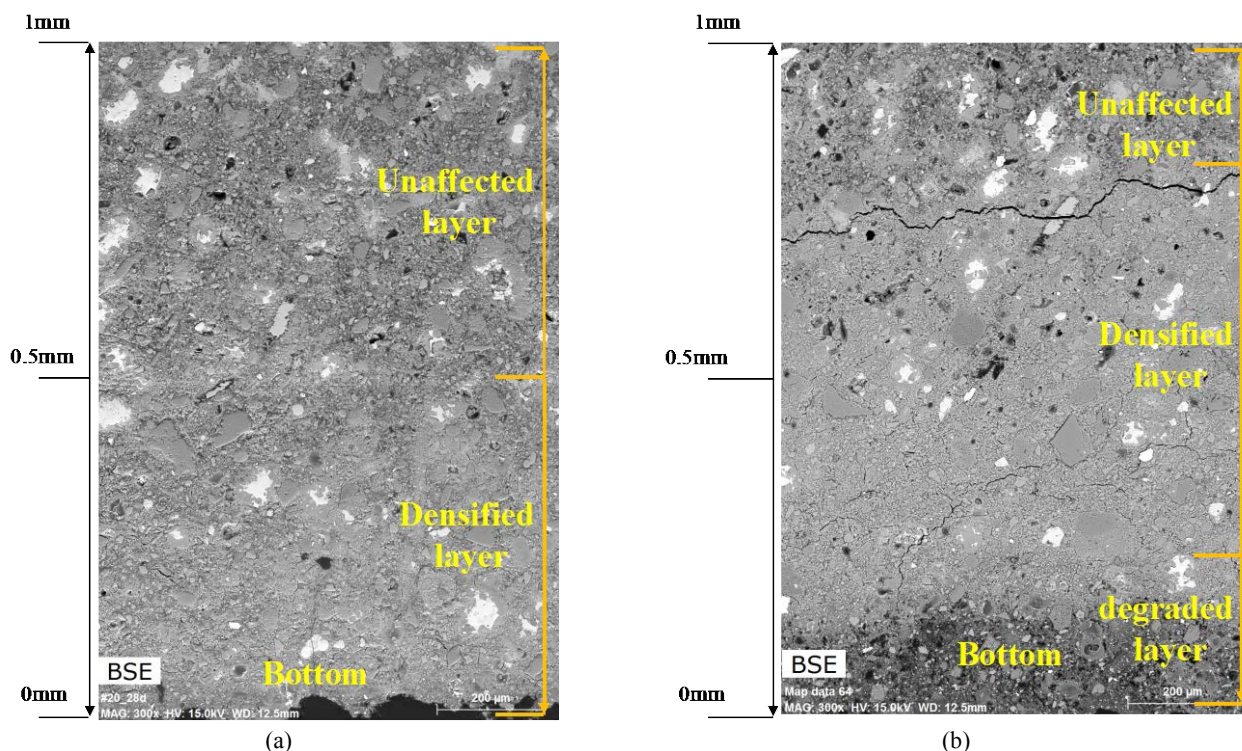
Figure 5: Comparison of BSE imaging of the bottom of LC³ samples after exposures of (a) 28d and (b) 56d

When the significant changes according with the expansion are seen, it must be something happening in the microstructure. From a qualitative analysis of BSE images, the porosity variation over depth can be clearly seen in Fig. 5. At 28d of exposure, a bottom layer of approximately 0.5 mm was densified due to the new hydrates precipitating in the cement paste voids. With time, the densified front shifted deeper towards the top of the sample and a porous degraded layer remained below, as seen from the visual evidence at 56d. It is exactly the reason that the sulfate ions can still move inside easily in such a porous material. In later age sample, cracks were observed in most cases parallel to external surface, but it is not clear if cracking occurred from the degradation or during sample preparation, as the cracks were empty at 56d.

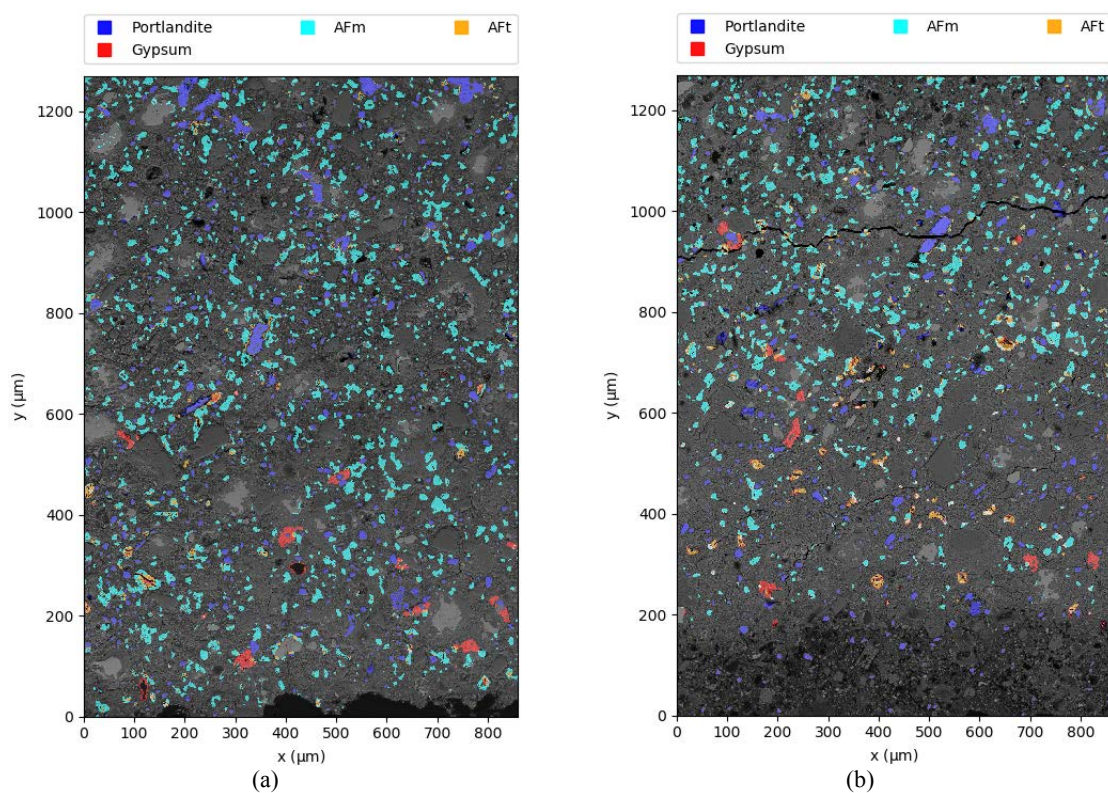
Figure 7: Phase composition maps of LC³ cement at 28d & 56d. (a) 28d; (b) 56d

The phase maps were obtained from the SEM-EDS mappings analysed using the EDXIA framework[9]. Fig. 7 presents phase maps overlaid on BSE micrographs, showing that the gypsum and ettringite hydrates were mainly precipitated in the densified areas. This result further supports that these two phases could cause expansion especially when they coexist[6]. AFm and portlandite phases are the main phases consumed for the formation of ettringite and gypsum, which can be observed from the 56d map. Furthermore, the first 200 micrometres were totally degraded with high porosity at 56d. Above the densified layer, more portlandite and AFm phases were present. However, it was quite difficult to detect the ettringite phase since they were precipitated in very small pores mixed with C-S-H phase, at a scale smaller than the interaction volumes investigated by SEM-EDS.
