# RILEM TC 277-LHS report: lime-based mortars for restoration—a review on long-term durability aspects and experience from practice

**Abstract** For conservation interventions of historic masonry generally lime-based mortars such as pure air lime mortars, lime-pozzolan mortars, natural hydraulic lime mortars and ternary mortars (lime-pozzolan-cement) are used. The main reason is that their hygric and mechanical (strength and ductility) performance are easy to adapt to most existing historic masonry (compatibility requirements). Although the basic appropriateness of lime-based mortars for restoration is undisputed, there are also some limitations in the

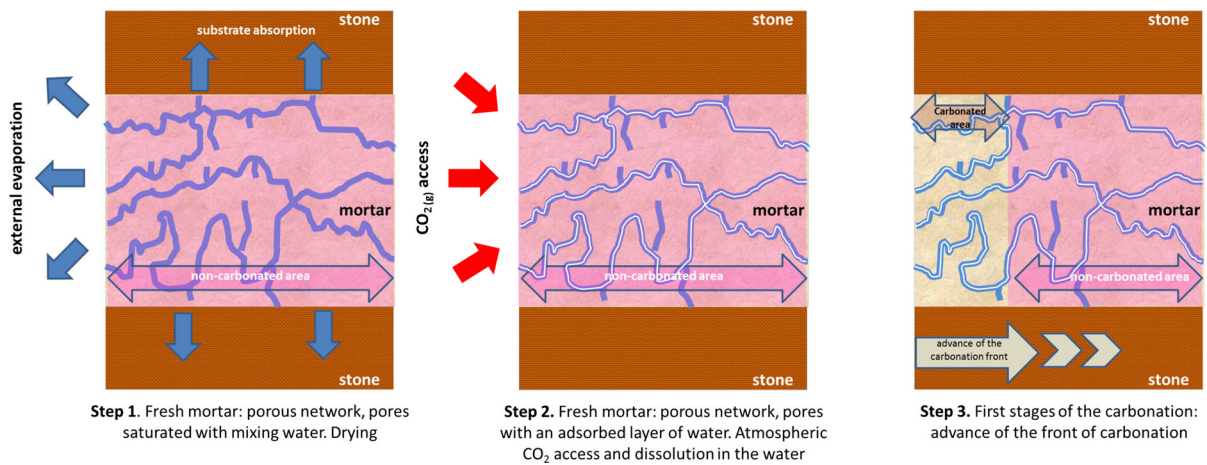
**Fig. 1** Scheme of the carbonation process of an air lime bedding mortar of stone masonry. Step 1: drying; Step 2: CO<sub>2</sub> access and dissolution in the adsorbed layer of water; Step 3: carbonation front advance

The thickness of the applied mortar strongly influences the rate of carbonation. For new repair air lime mortars, final carbonation values ranging from 80 to 92% were found [10]. This issue should be considered especially for new bedding mortars and grouts, in which a relevant part of the mortars is confined within the masonry structure. The limited carbonation can negatively affect the durability and performance of these mortars; therefore, the access of  $\text{CO}_2$  should be guaranteed by an appropriate pore size distribution of the hardened specimens [35].

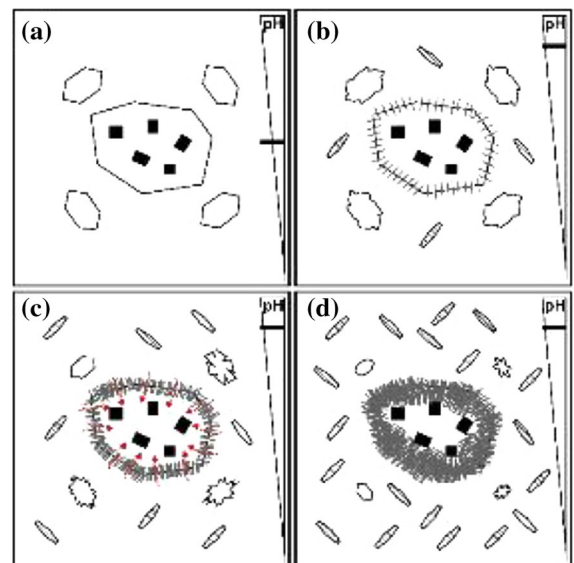
**Fig. 2** Scheme of the pozzolanic reaction process: **a** Initial state (portlandite crystals depicted as hexagonal polygons, pozzolanic particle depicted as a large polygonal shape with non-reactive mineral constituents in black); **b** Initial dissolution period (C-S-H crystals depicted as grey lines, C-A-H crystals depicted as elongated textured polygons); **c** Induction period (red dashed arrows indicating water diffusion through osmosis); **d** Main reaction period

form hydrated reaction products (calcium silicate and calcium aluminate hydrates) with marked binding properties related to their crystalline structure [44]. Pozzolanic reaction processes can be subdivided into three reaction stages (Fig. 2) [45], namely initial

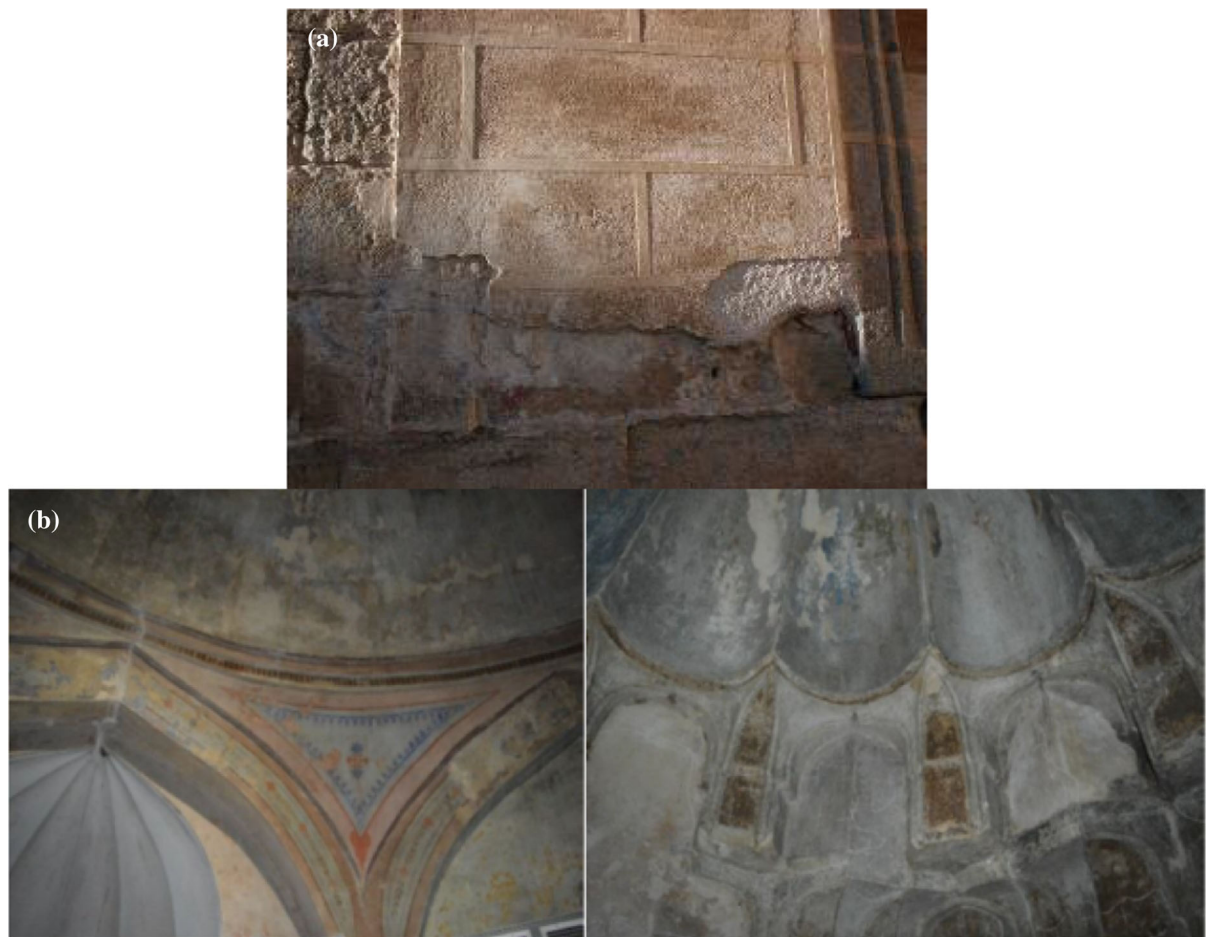
**Fig. 3** **a** Durability of air lime render imitating stone over stone masonry in Évora Cathedral, in Portugal (seventeenth century); **b** Interior of Pasa Hamam, Thessaloniki (1530 AD), with well-

preserved air lime renders ( $\text{CaO} \geq 55\%$ ) although soluble salt content was high  $\geq 1\%$

Many ancient constructions, all over the world, are composed of masonry with air lime mortars, thus proving the high durability and fitness for use of this material [74–79]. Due to their low modulus of elasticity, air lime mortars can follow the movements of the structures with minor cracking, also ensuring optimal adhesion. Furthermore, the high porosity and water vapour permeability of the mortars allow quick drying of walls, with evaporation of internal moisture to the exterior, thus contributing to a healthy internal environment and to the good condition of the walls. The slow hardening mechanism by carbonation ensures an improvement of performance along time and contributes, together with the self-healing properties, related with dissolution–recrystallization cycles of calcium carbonate, to a high durability, if destructive actions (by nature or by human activity) do not occur (Fig. 3).

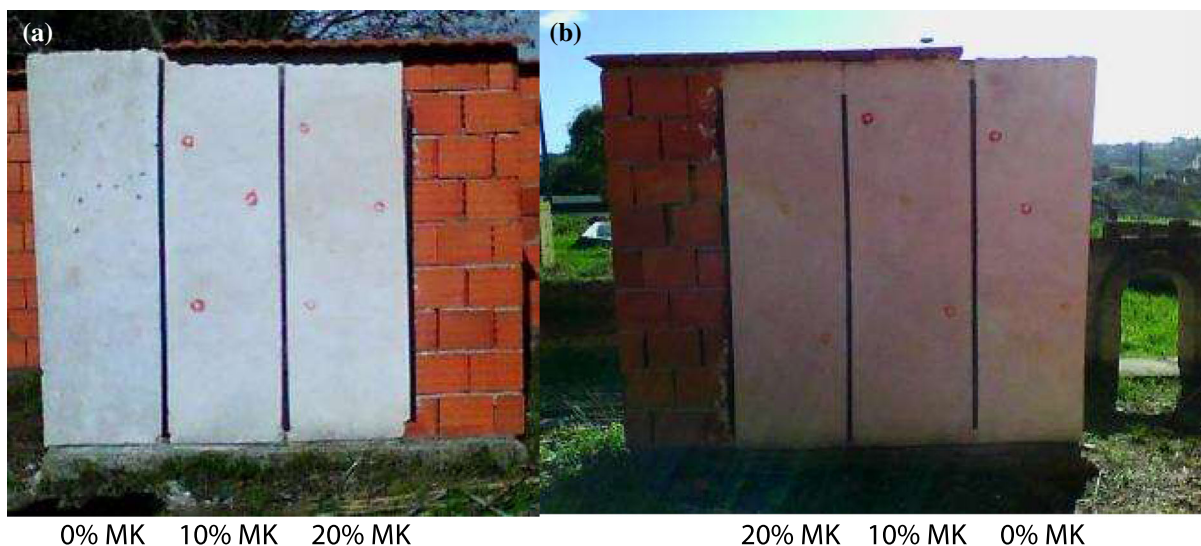
**Fig. 4** Experimental pure air lime renders and air lime-metakaolin (MK) renders (marked with the percentage of MK replacing lime) after 7 years of natural exposure **a** South and **b** North, in a semi-urban environment 3 km from the Atlantic Ocean

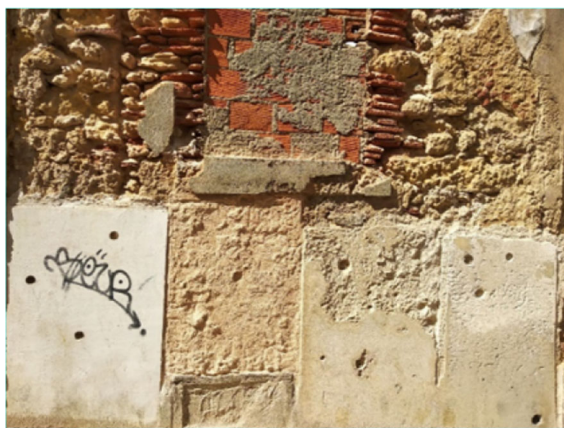
**Fig. 5** Experimental panels applied on an ancient wall in the Historic Centre of Palmela (Portugal), 12 years after application: second from the left is air lime + MK and third from the left is air lime as the only binder

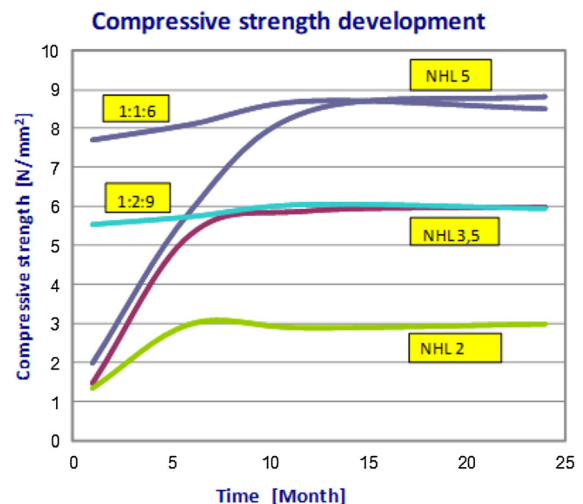
**Fig. 6** Slow strength development for the NHL mortars and quick hardening of the cement-lime mortars: NHL mortars, 1:2.5 (NHL: sand) in vol.; cement-lime mortars e.g. 1:1:6 (cement: lime: sand), in vol.; curing conditions 20 °C and RH 90% [99]

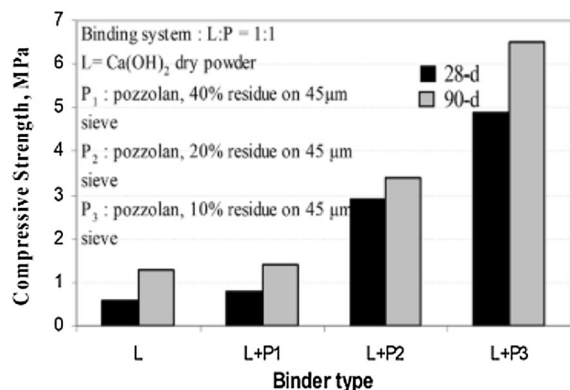
**Fig. 7** Influence of fineness of pozzolan (after grinding) on mortar's strength development

tested by preparing mortar mixtures with lime and siliceous sand 0–4 mm (L:P 1:1, B/A 1:3 by mass). The water added responded to a flow of 15 cm (according to EN 1015-3). Curing conditions were the following: moist curing > 90% RH for P1, P2, P3 mortars and dry curing 60–65% RH for L mortar [100].

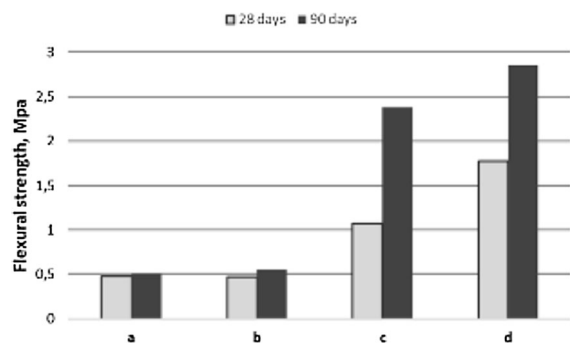
**Fig. 8** Effect of curing regime on flexural strength development of lime:pozzolan (1:1) mortars. a: natural curing; b: based on EN 459–2, 2015 “Building lime”, concerning standard mortar; c: concerning hydraulic lime; d: based on ASTM C 311, strength activity index with lime

Furthermore, as previously mentioned, moist curing conditions are essential for pozzolanic reaction, as showed in Fig. 8. Volcanic natural pozzolan (after grinding to 10% residue on 45 μm sieve) was used with lime powder (CL90) for the manufacture of the mortar, together with a standard CEN sand (B/A ratio 1:3 by mass). The water content was adjusted to have 14.5 cm flow (measured according to EN 1015-3).

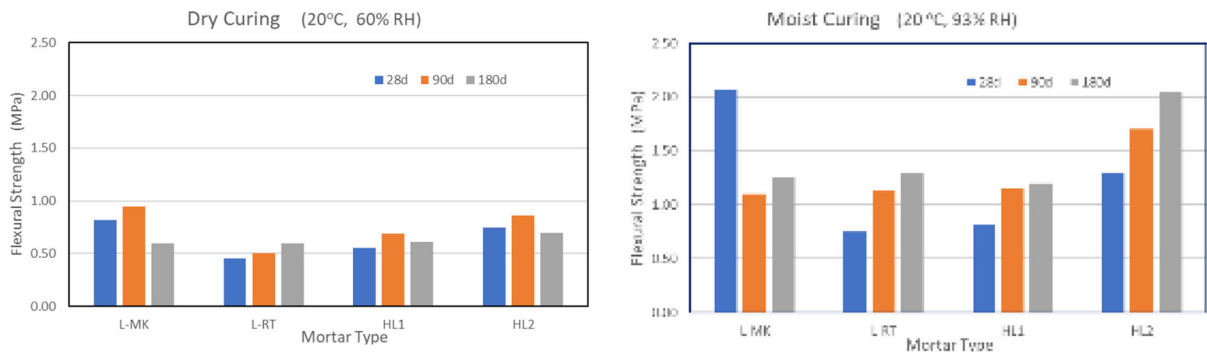
**Fig. 9** Flexural strengths values for Lime-Metakaolin (L-MK), Lime-Rhenish trass (L-RT), and two types of Natural Hydraulic Lime (HL1 and HL2) mortars, for 2 curing conditions: dry curing and moist curing (adapted from [58])

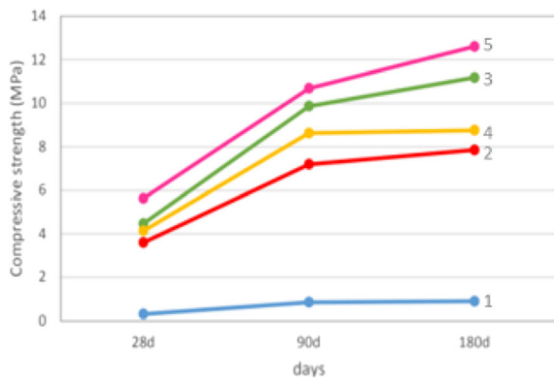
**Fig. 11** Long term strength of lime-based mortars with: 1 lime powder CL90, 2 lime:natural ground pozzolan (1:1), 3 lime:natural ground pozzolan (1:1) (with coarse aggregates), 4 NHL 3.5, 5 lime:pozzolan:cement (1:0.7:0.3)

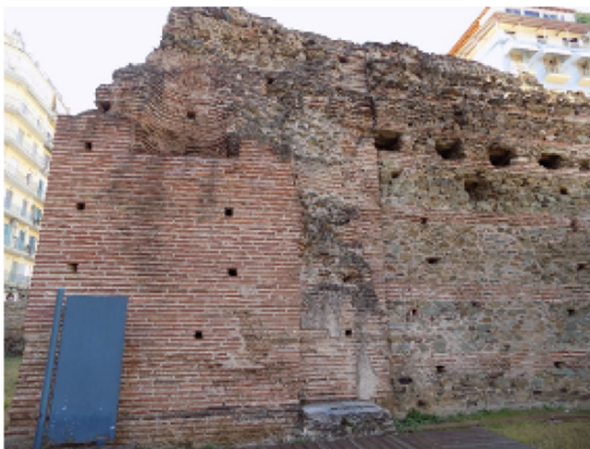
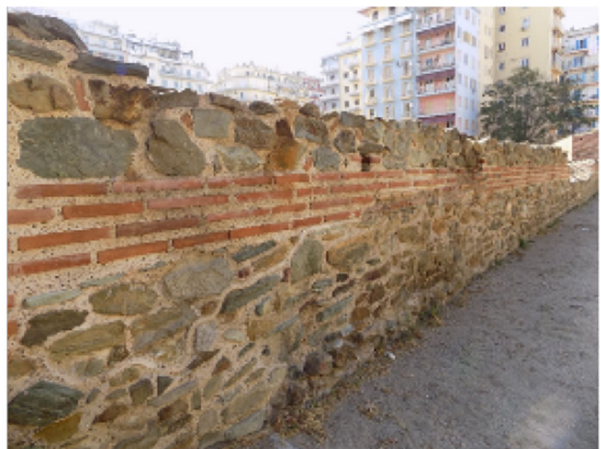
**Fig. 13** Repaired masonries of Galerius Palace, as they are now

In the case of repair works of the Galerius Palace in Thessaloniki, most of the interventions with lime-natural pozzolan mortars took place in 1997 and 2000.

In 2018, ten samples of repair mortars (bedding and plasters) were taken and thoroughly analysed by determining porosity, specific gravity, compressive strength, soluble salt content, mineralogical composition and microscopical characteristics. The intention was to evaluate the behaviour of repair mortars which have been designed and proposed by Lab. of Building Materials 15–20 years before (see Fig. 13) after the analysis of a great number of old mortar samples (about 60) to understand compatibility requirements.

The mineralogical analysis of repair mortars showed the existence of hydrates (calcium silicate and calcium aluminates) and carbonates. The micro-cracking was limited and mortars remained sound. Compressive strength ranged from 2.00 to 5.40 MPa. The 28d strength of trial laboratory mixes (15–20 years before) ranged from 2.5 to 4.5 MPa (moist curing conditions) and porosity from 26 to 30%, while specific gravity ranged from 1.57 to 1.80 [108].

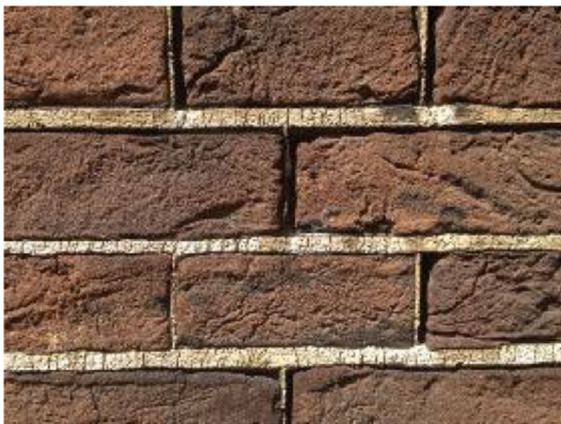
**Fig. 14** Cut to shape pointing, with typically very high binder content, showing shrinkage cracks

However, a great advantage of lime mortars consists in the fact that early shrinkage cracks can still be taken care of by simply re-elaborating the

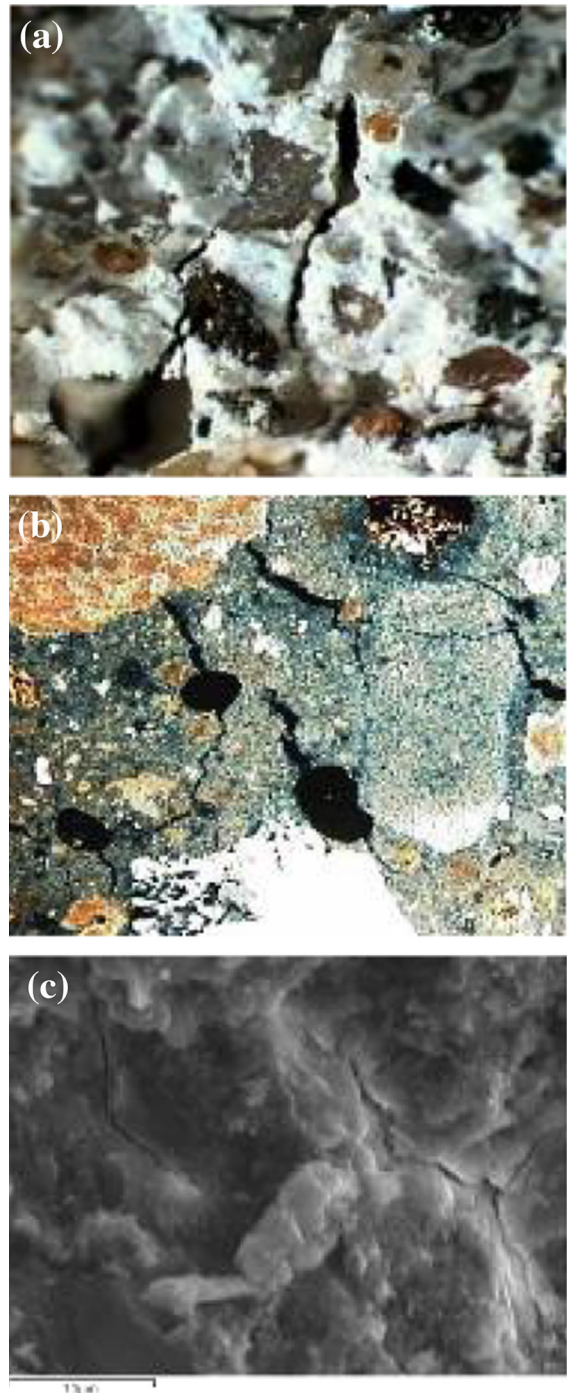
**Fig. 15** **a** Shrinkage in a lime mortar (stereoscope  $\times 8$ ); **b** Mortar cracking under polarized microscope ( $\times 150$ ); **c** Mortar cracking under SEM ( $\times 1000$ )

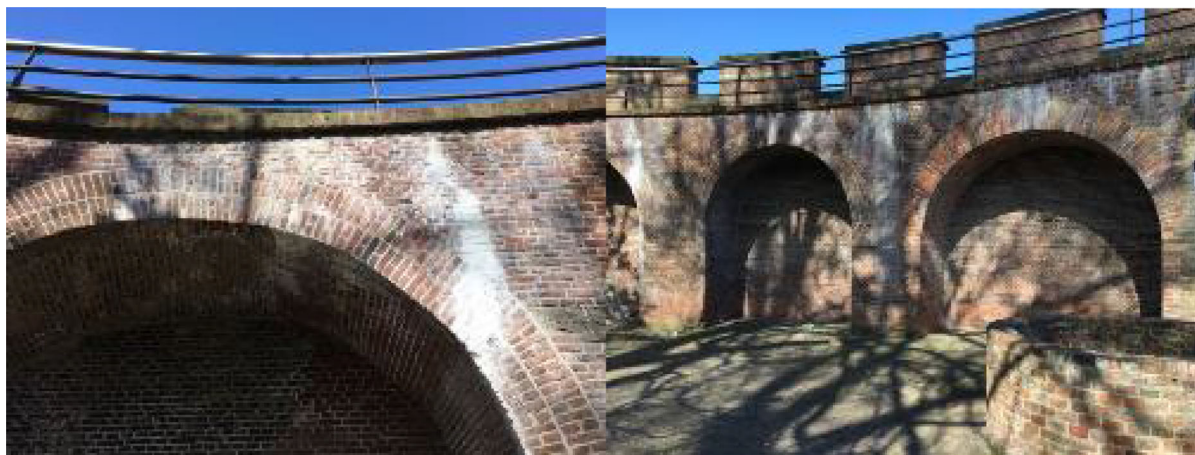
**Fig. 16** Lime leaching after repair of historic masonry; see also 4.7

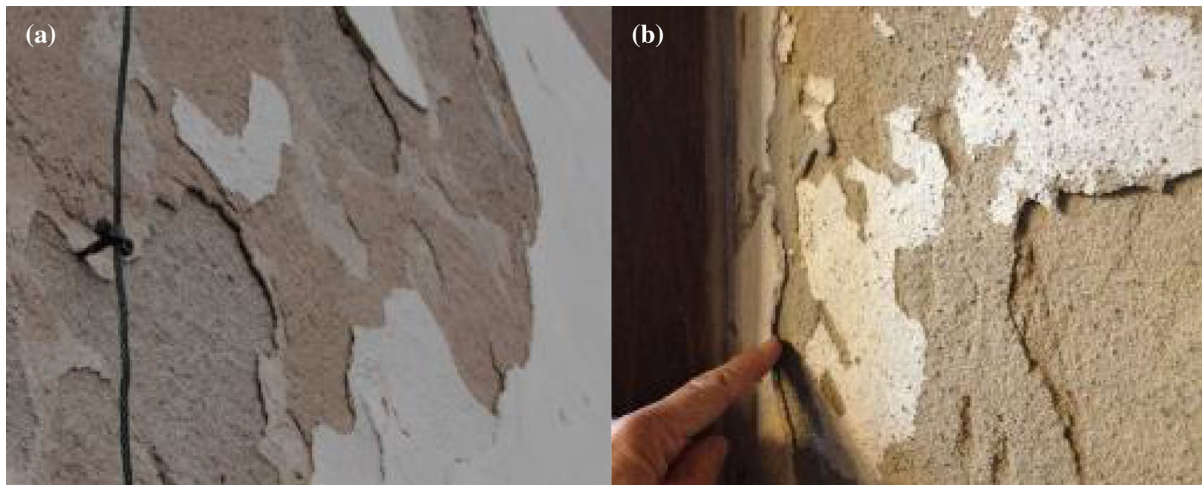
**Fig. 17** Typical forms of layering in renders and plasters. Separate render layers coming off due to freezing temperatures in a saturated and porous render (a), [110]; similar damage, due to salt crystallization in a plaster, applied on a wall with capillary rising damp (b)

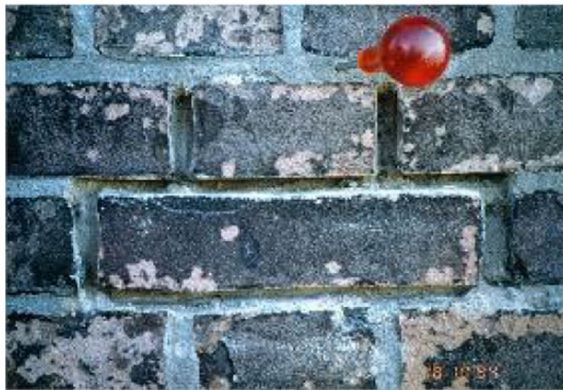
**Fig. 18** Weak, decayed trass lime re-pointing

In this case indeed the lime reacted only with carbon dioxide from the air. Lime converted into calcium carbonate is no longer available for the trass-lime reaction. As the trass did not react, it acts just as a filler and a very weak mortar results.

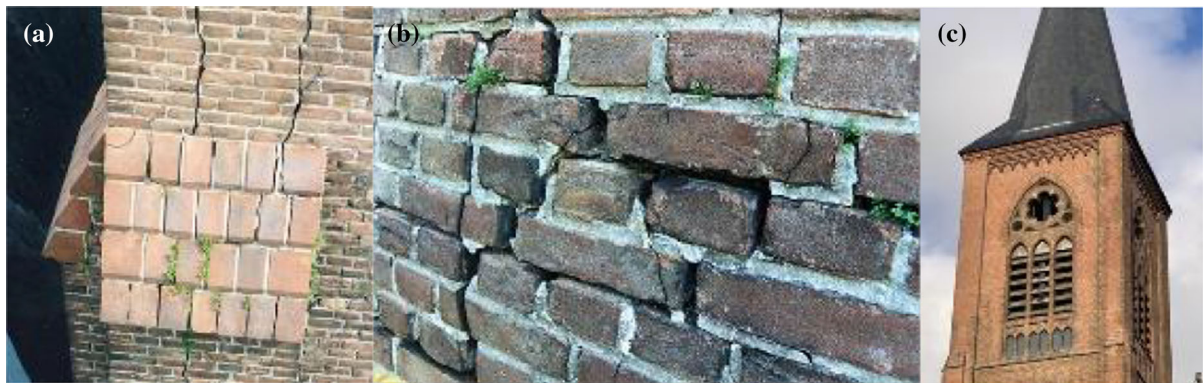
**Fig. 19** Cracks in masonry, caused by expansion of bedding mortar, deeper in the wall section, due to formation of thaumasite (a); push out of the pointing is a secondary effect (b); situation several years after repair: no recurrence (c)

In practice situations, it is therefore advisable to first try to take away at least one of the essential

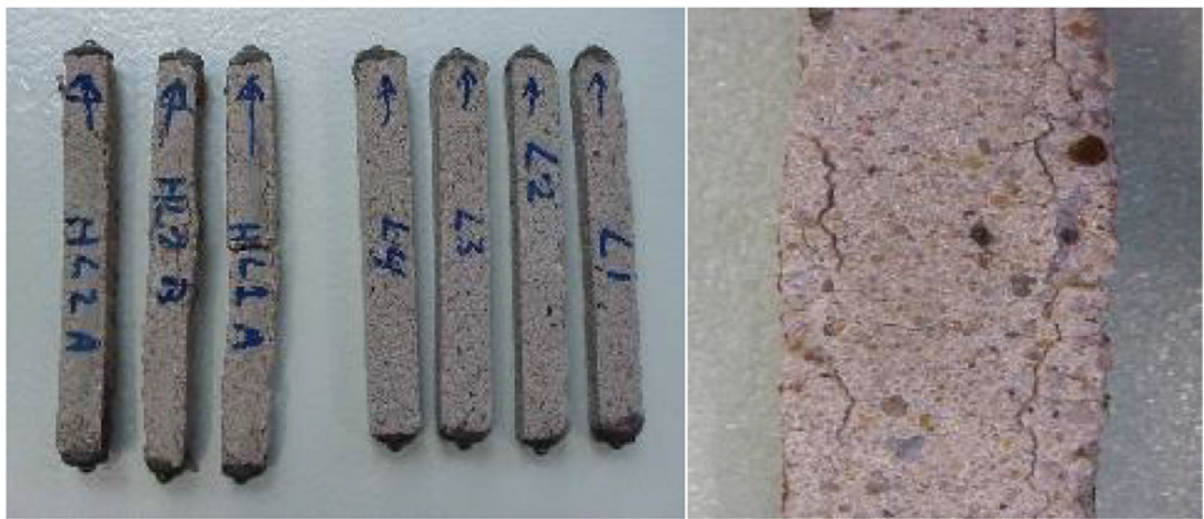
**Fig. 20** Mortar prisms after 15 weeks in sulfate solution. Natural Hydraulic Lime based (NHL) specimens with clear expansion and deformation and Hydrated lime based (CL)

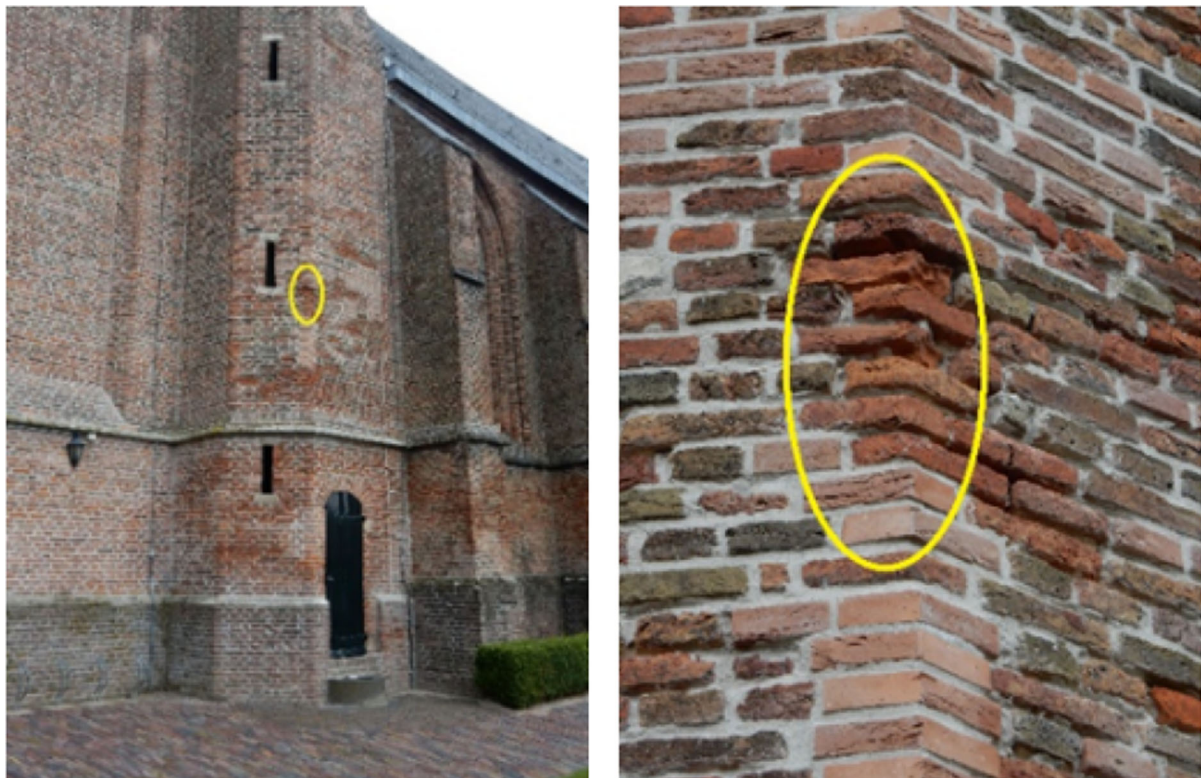
**Fig. 21** Situation of the damage in 2016. Left, the reddish parts of the masonry indicate where the repointing is damaged. Right, detail of one of the spots with damaged repointing

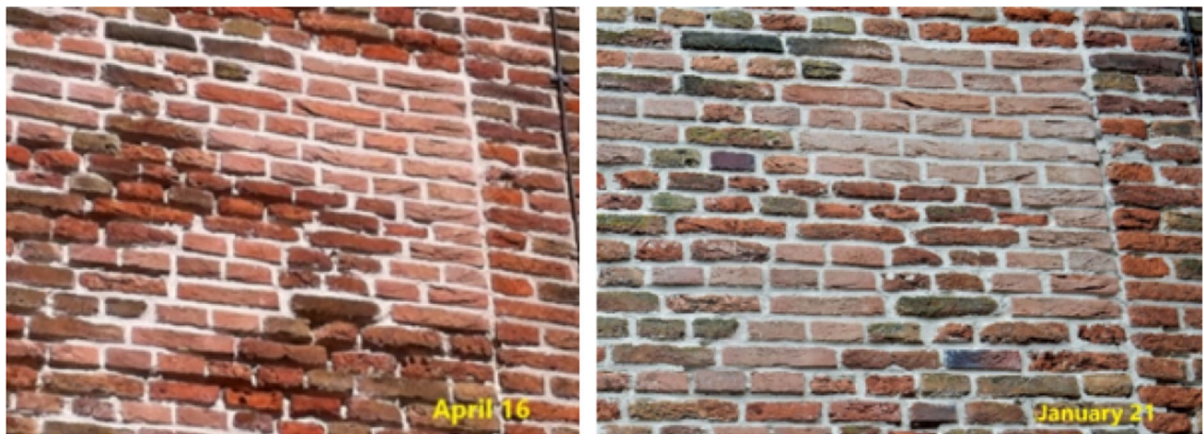
**Fig. 22** Comparison of part of the south wall in April 2016 (before repair), respectively January 2021. Most of the underfired bricks are still in place (some of the weakest were replaced). The repair repointing performs rather satisfactorily

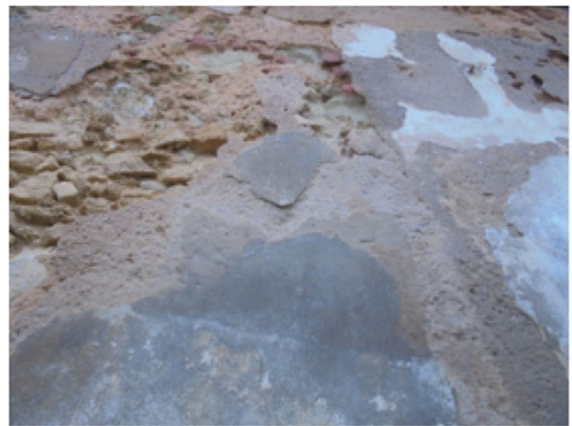
**Fig. 24** Detail of the degradation showing cementitious repair mortars

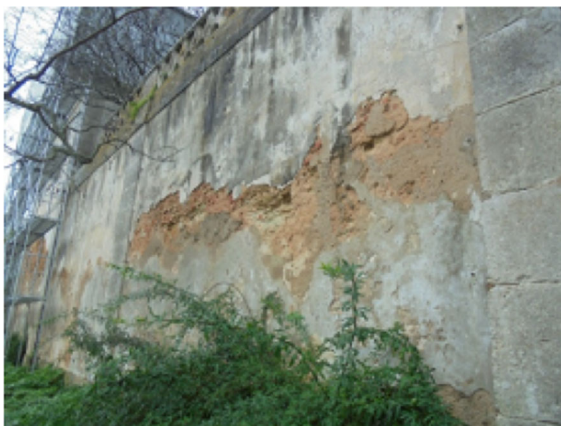
**Fig. 23** Degradation on the East façade

The main types of degradation observed on the most degraded façade consist of crumbling and loss of adhesion of the render, in a zone of the wall in between 1.40 and 1.80 m from the soil.

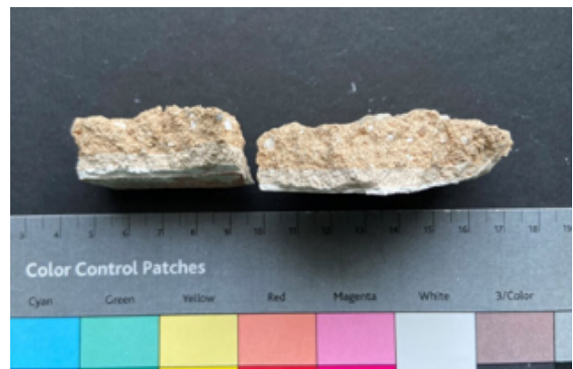
**Fig. 25** Samples of the old lime render in two coats

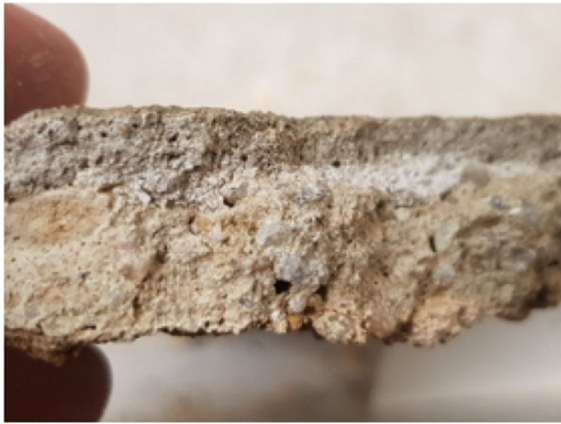
**Fig. 26** Sample of the render of the East façade with a cementitious repair coat

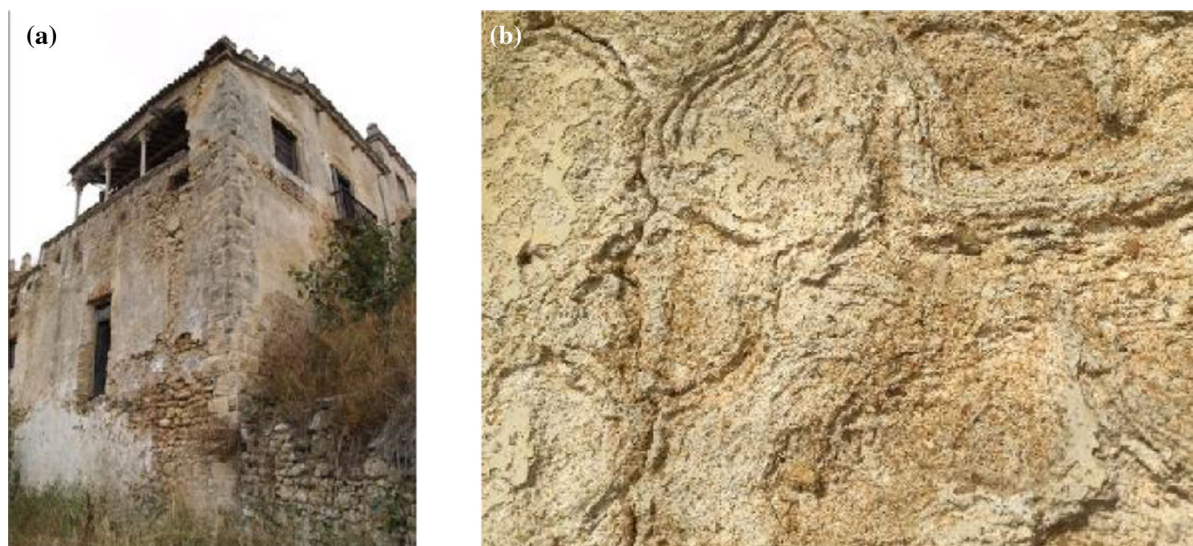
**Fig. 27** Valflores Palace in St. Iria da Azoia, Loures, Portugal **(a)**, and Liesegang phenomenon in a rendered façade **(b)**

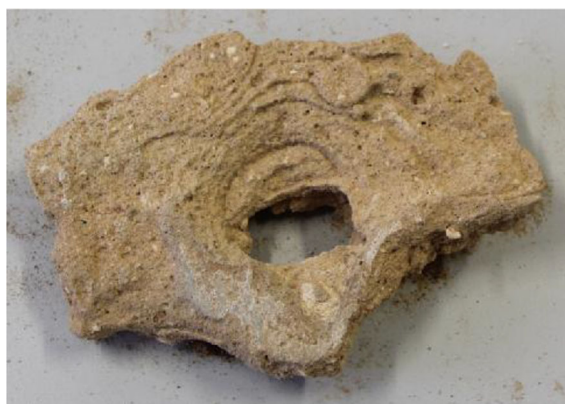
**Fig. 28** Deep circular erosion on a render sample of Valflores Palace

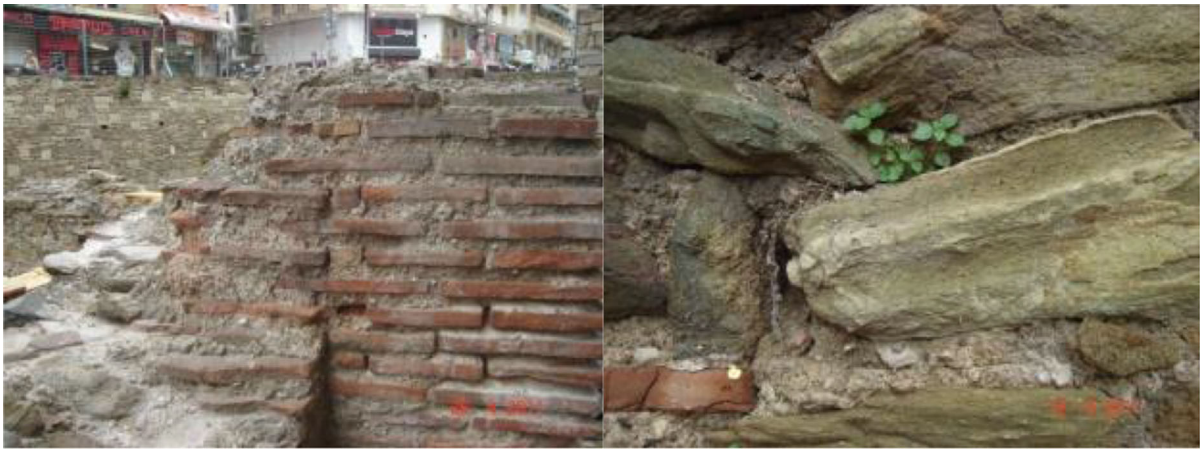
**Fig. 29** Deterioration problems of the masonries before the intervention works

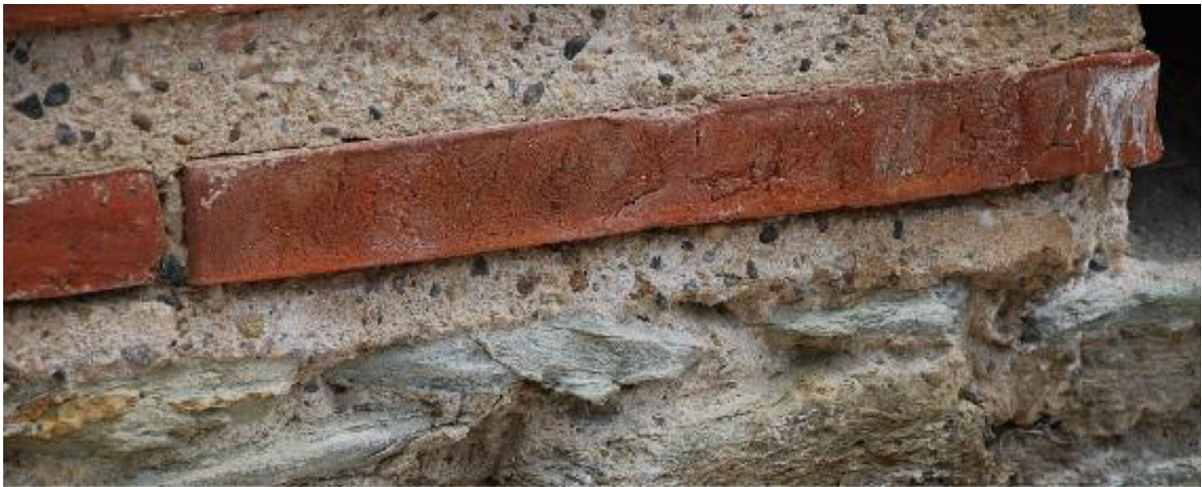
**Fig. 30** Repair mortar in a mix structural system of Galerius Palace in Thessaloniki, Greece

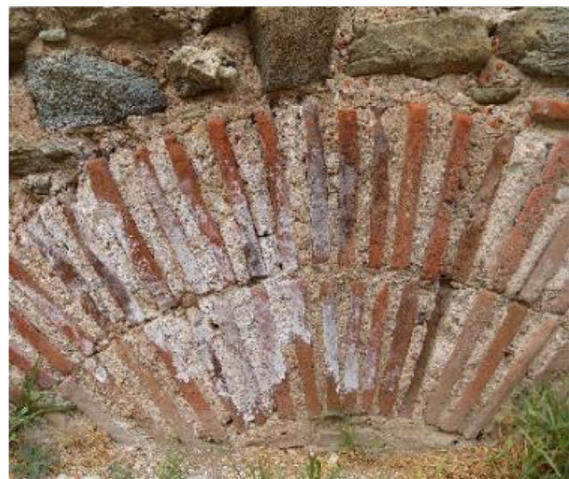
**Fig. 31** Efflorescence near to the ground level

Apart from avoiding water percolation through fresh masonry it is important to use the right mortar mix and take well care of the necessary execution conditions. This means to use a mortar containing a (highly) reactive pozzolan, in order to bind the calcium hydroxide from the binder (both from lime

and from cement hydration); further, for the pozzolanic reaction to occur, a good curing is necessary (keep masonry wet for the first 15 days) [119].

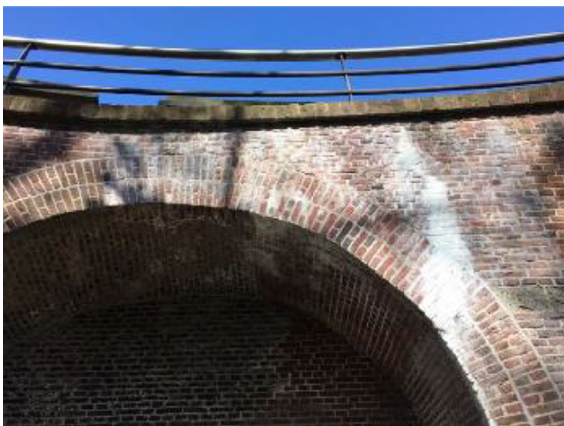
**Fig. 33** Arch section in the masonry of the motte castle of Leiden, after reconstruction of the section

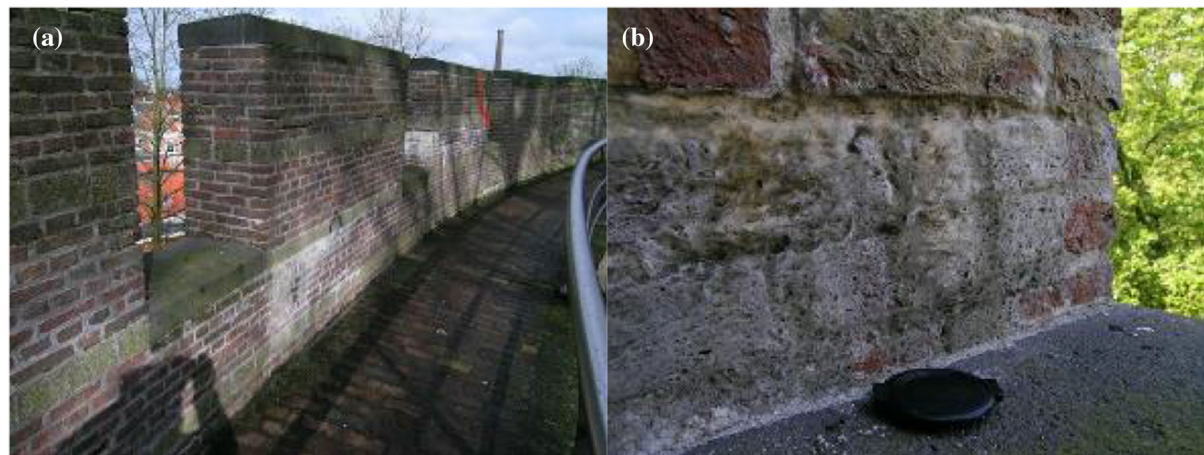
**Fig. 32** a) Encrustation, due to leaching of mortar in very exposed masonry, the battlements of a motte castle; b) Detail

Leaching of lime is a phenomenon that may cause considerable esthetical damage to repaired sections in historic masonry. The example described, shows that it is not always easy to avoid this problem.
